Expertise

Protocol number: 41165663  
Order No. / Reference: 25093896  
Inspection date: 20 Aug 2025

Manufacturer: Skoda  
VIN: TMBJW7NP0L7073317

Model: Superb Combi 1.4 TSI iV DSG Style

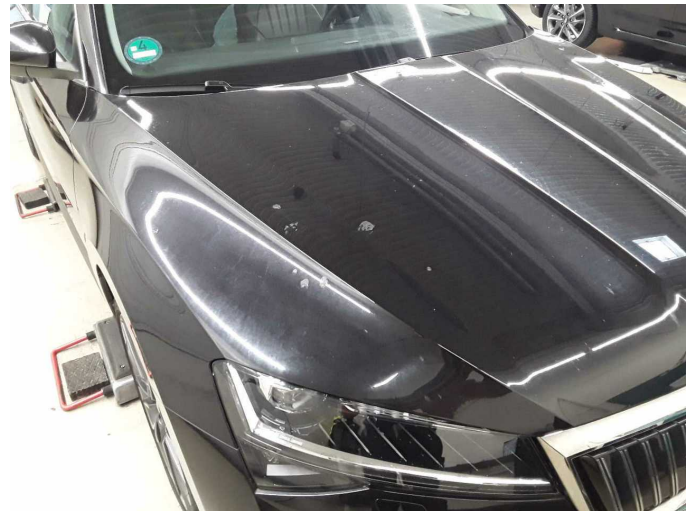
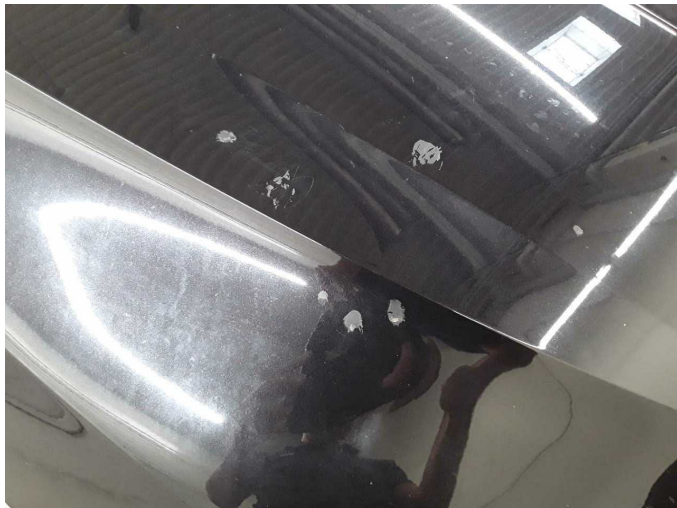
| No. | Component group | Description |
|---|---|---|
| 1 | Bonnet | Bonnet (Baumharz) - Soiled - Clean |

**Damage 1:** Bonnet: Bonnet (Baumharz) - Soiled - Clean

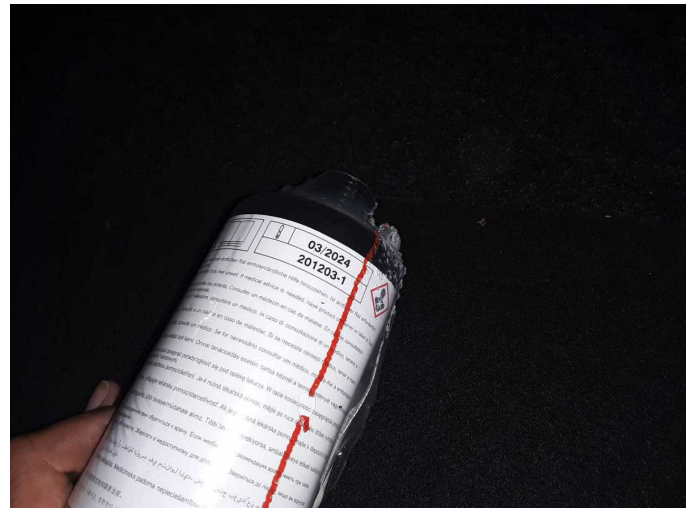
| No. | Component group | Description |
|---|---|---|
| 2 | Equipment | Tirefit filler - Due - Replace |

**Damage 2:** Equipment: Tirefit filler - Due - Replace

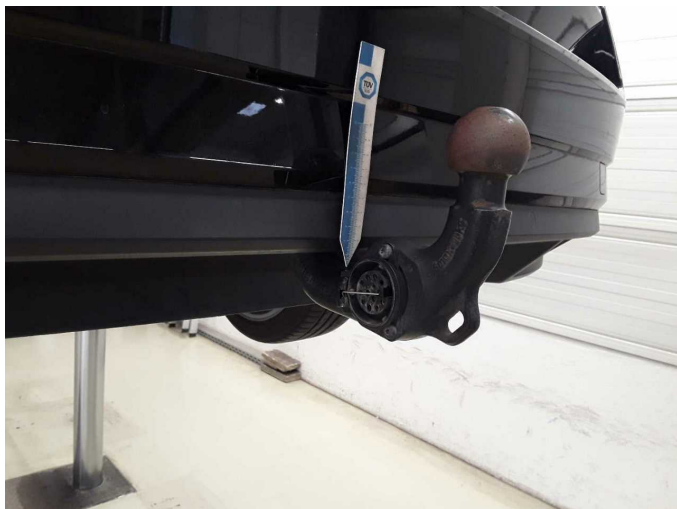
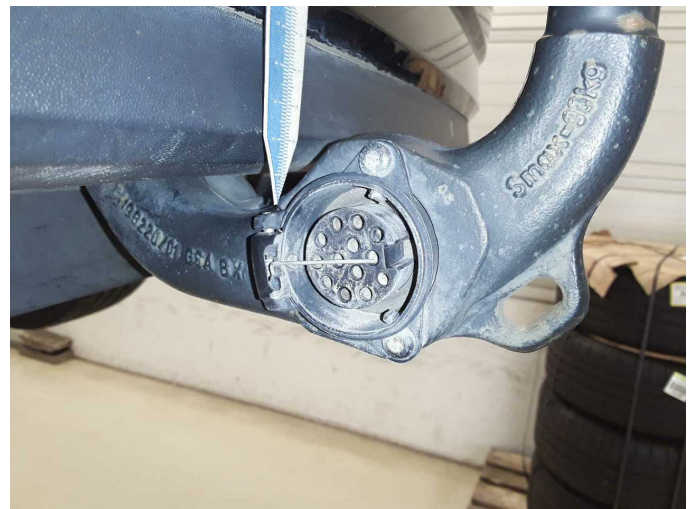
| No. | Component group | Description |
|---|---|---|
| 3 | Rear of vehicle | Trailer connector socket - Broken / torn - Replace |

**Damage 3:** Rear of vehicle: Trailer connector socket - Broken / torn - Replace

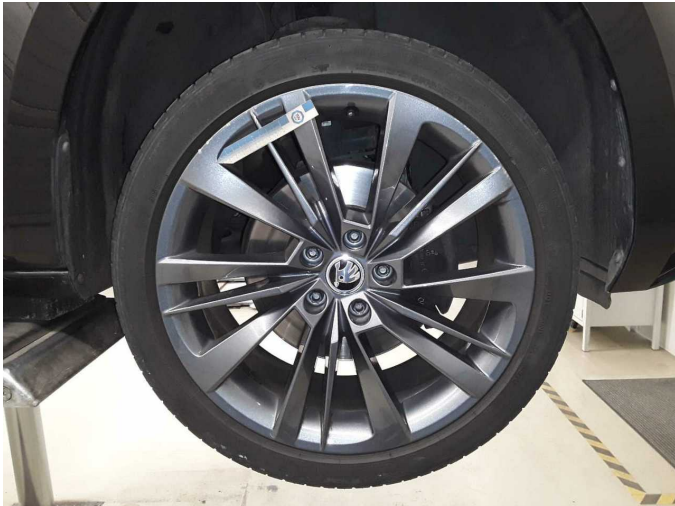
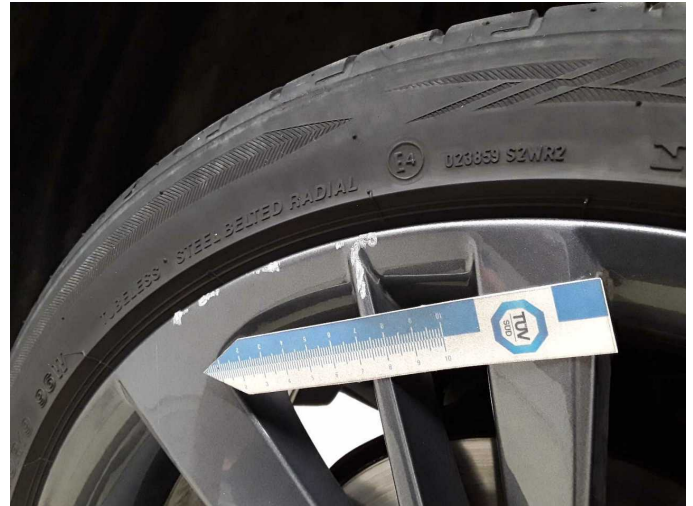
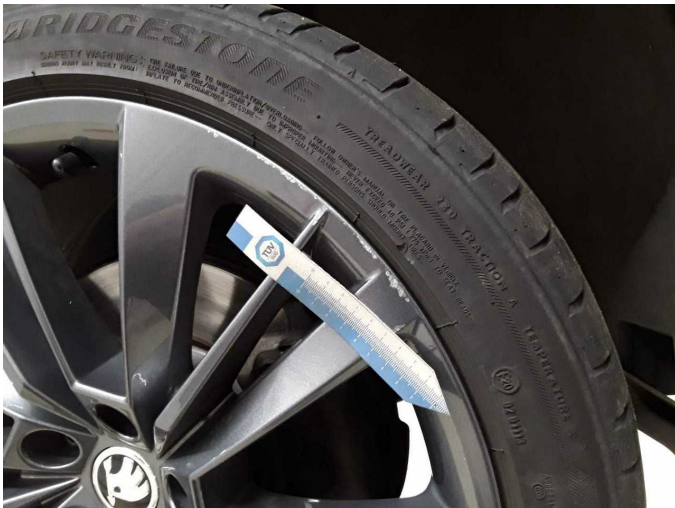
| No. | Component group | Description |
|---|---|---|
| 4 | Wheel / tyres | Alloy rim - front right side - Scratched - Loss in value |

**Damage 4:** Wheel / tyres: Alloy rim - front right side - Scratched - Loss in value

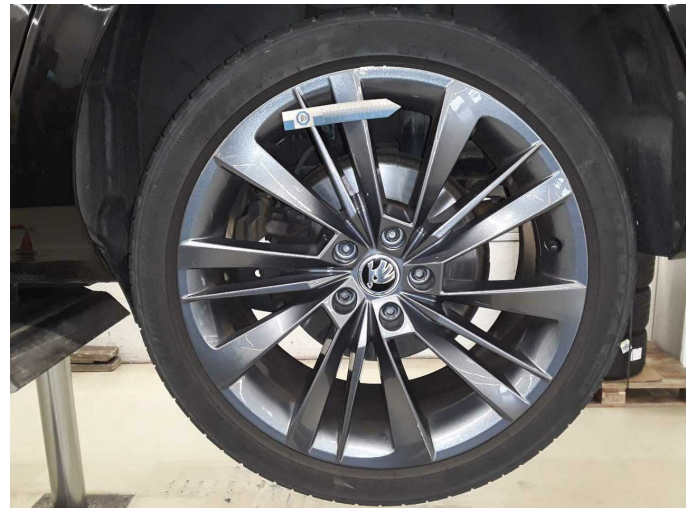
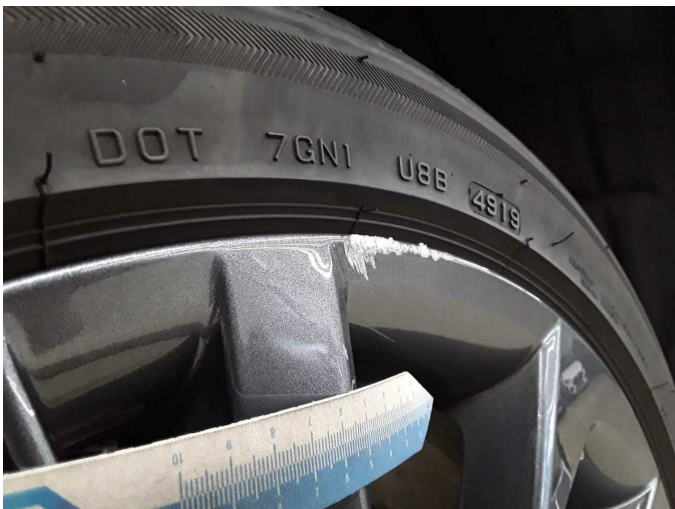
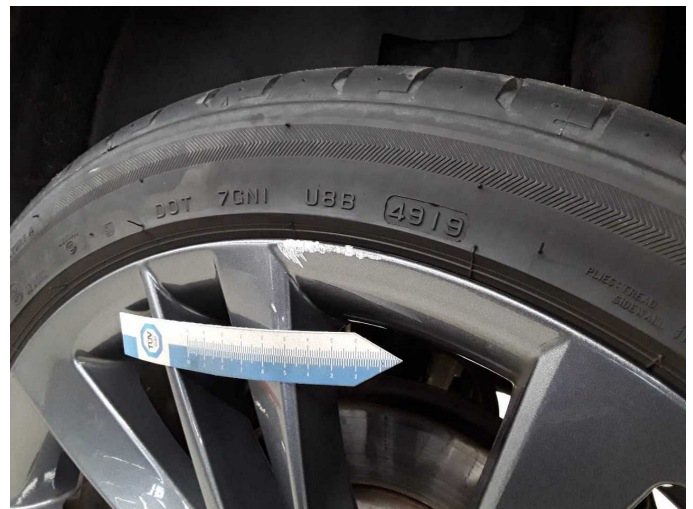
| No. | Component group | Description |
|---|---|---|
| 5 | Wheel / tyres | Alloy rim - rear left side - Scratched - Loss in value |

**Damage 5:** Wheel / tyres: Alloy rim - rear left side - Scratched - Loss in value

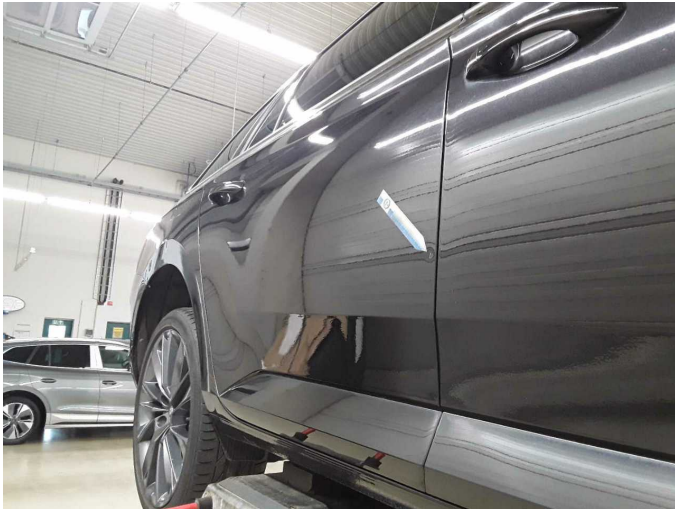
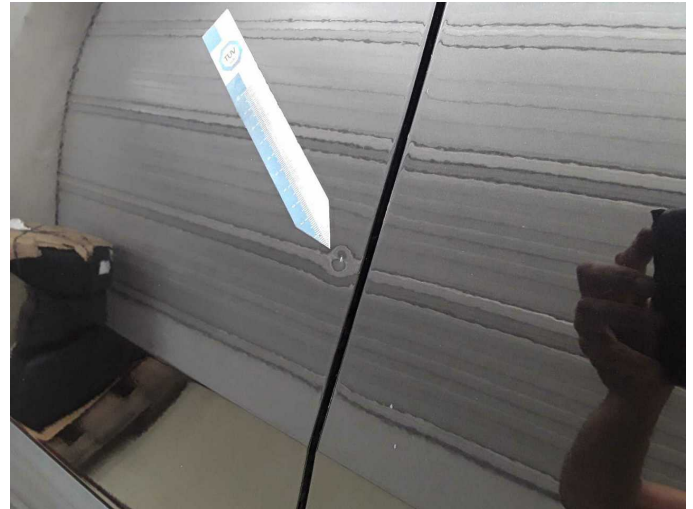
| No. | Component group | Description |
|---|---|---|
| 6 | Door - rear right side | Door - dent(s) - Smart repair |

**Damage 6:** Door - rear right side: Door - dent(s) - Smart repair

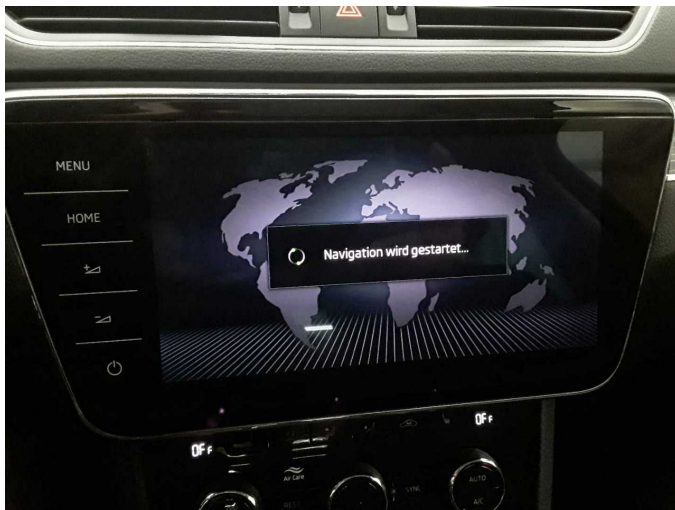
| No. | Component group | Description |
|---|---|---|
| 7 | Misc. | Misc. (Navigation wird nicht gestartet) - Non-operational - Perform diagnosis |

**Damage 7:** Misc.: Misc. (Navigation wird nicht gestartet) - Non-operational - Perform diagnosis

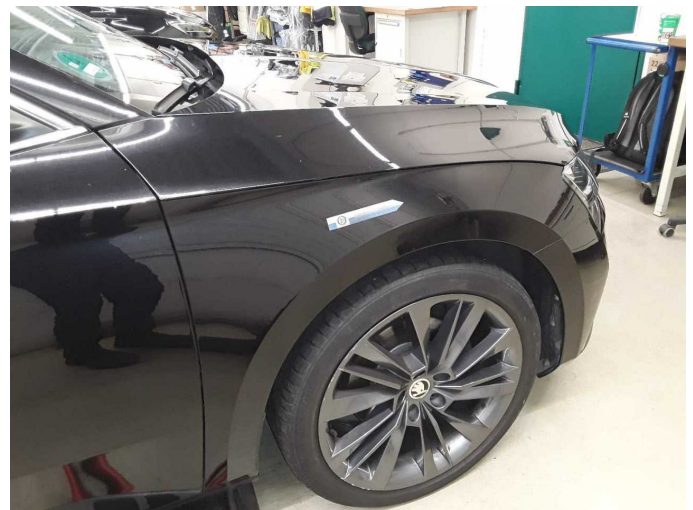
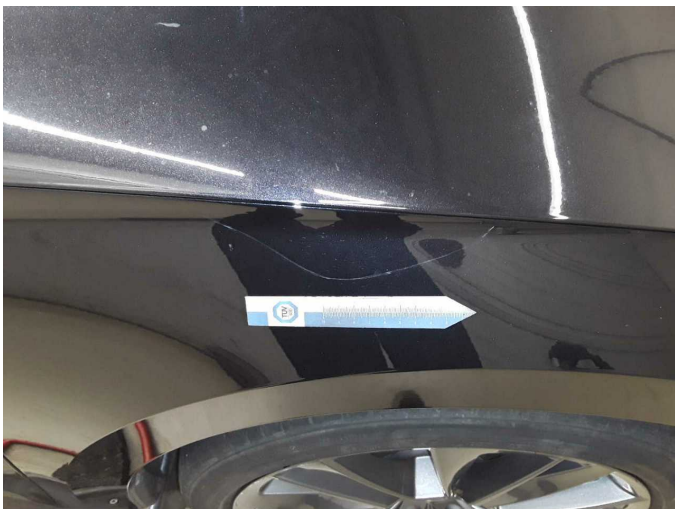
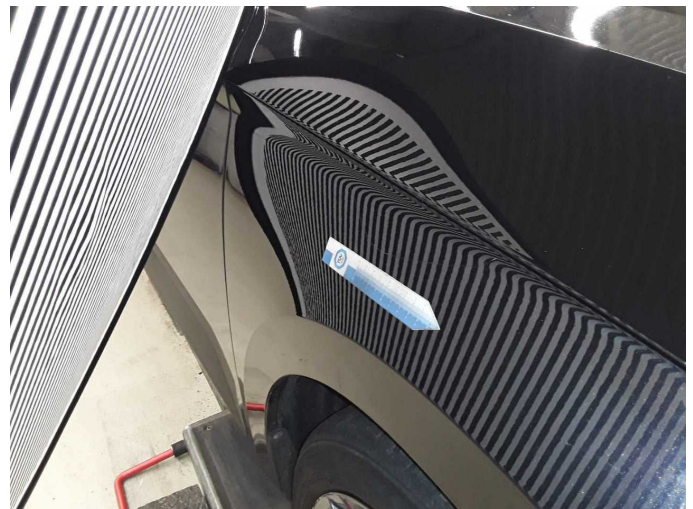
| No. | Component group | Description |
|---|---|---|
| 8 | Mudguard - right side | Mudguard - right side - Scratch(es) - Paint |

**Damage 8:** Mudguard - right side: Mudguard - right side - Scratch(es) - Paint

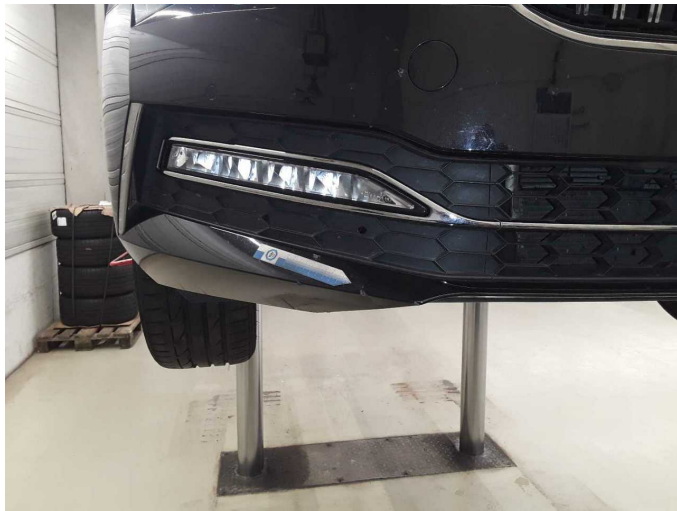
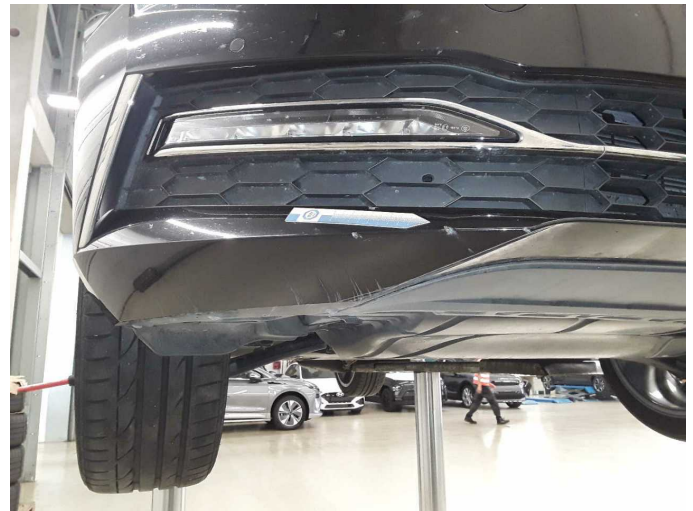
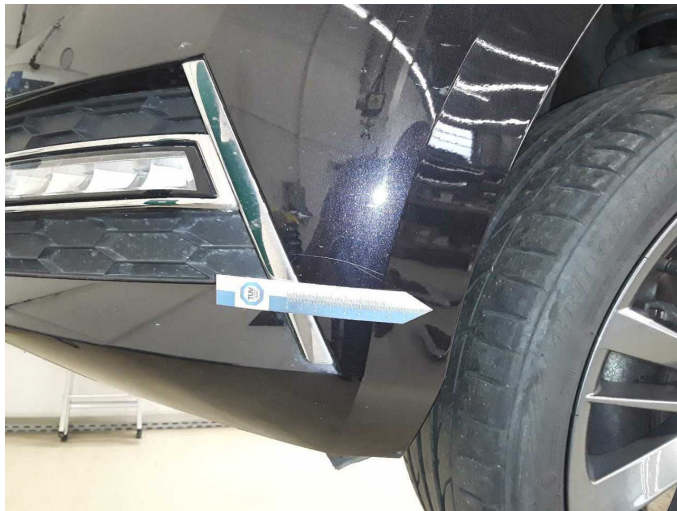
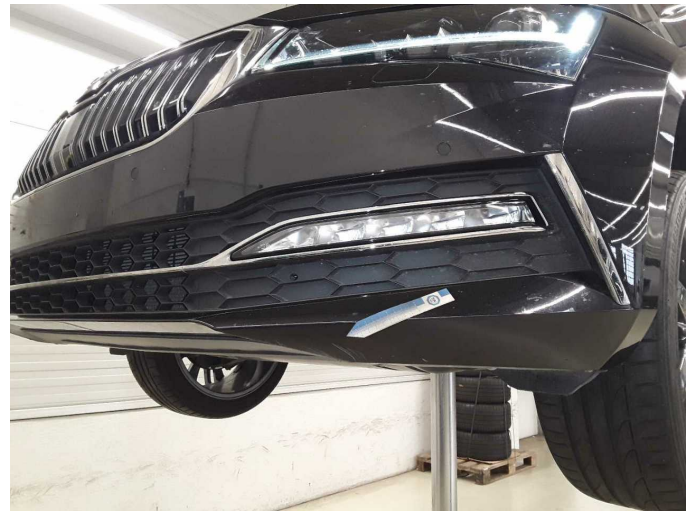
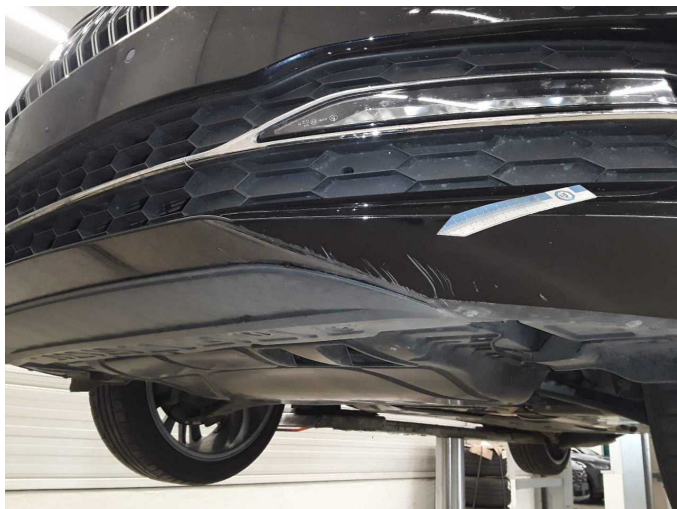
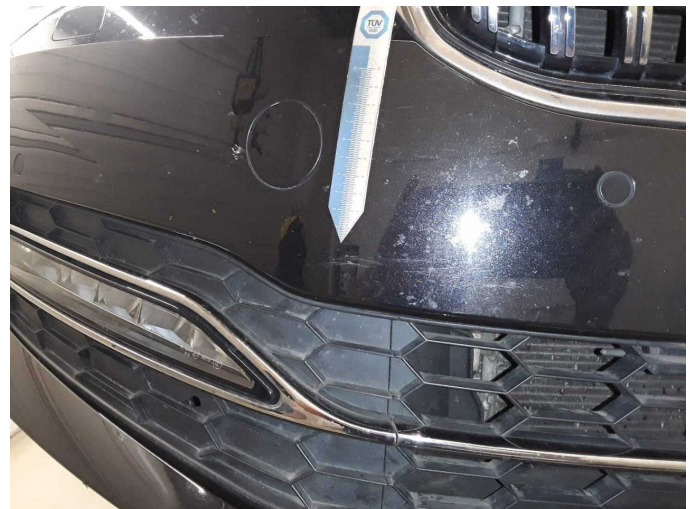
| No. | Component group | Description |
|---|---|---|
| 9 | Front bumper | Front bumper - Scratched - Paint |

**Damage 9:** Front bumper: Front bumper - Scratched - Paint

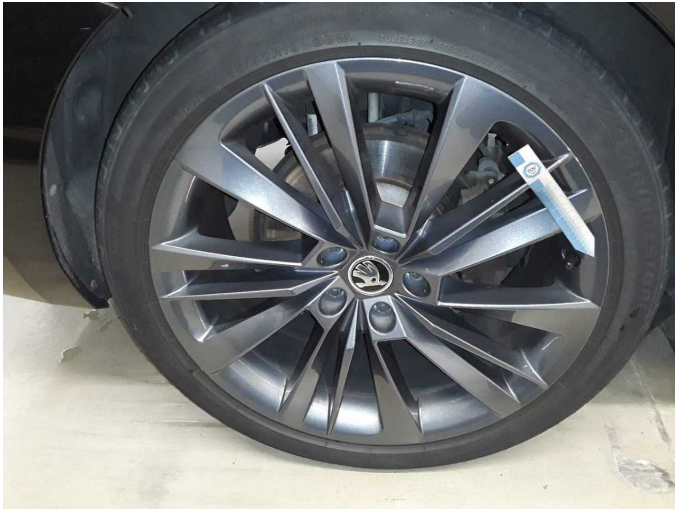
| No. | Component group | Description |
|---|---|---|
| 2 | Wheel / tyres | Alloy rim - rear right side - Scratch(es) - No deduction |

**Wear and tear 2:** Wheel / tyres: Alloy rim - rear right side - Scratch(es) - No deduction

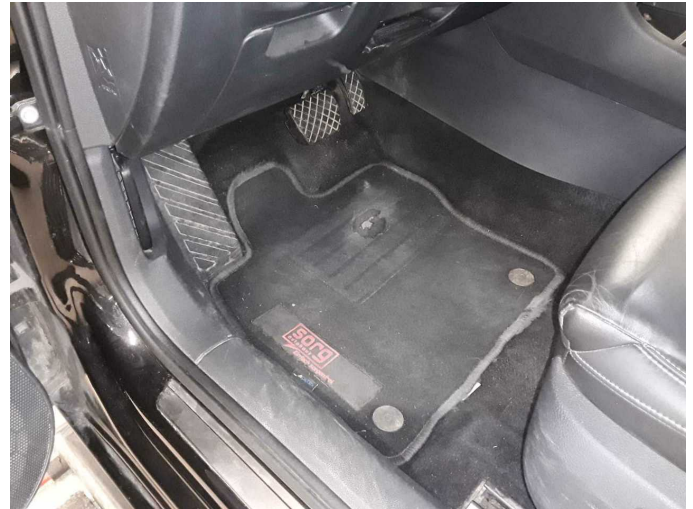
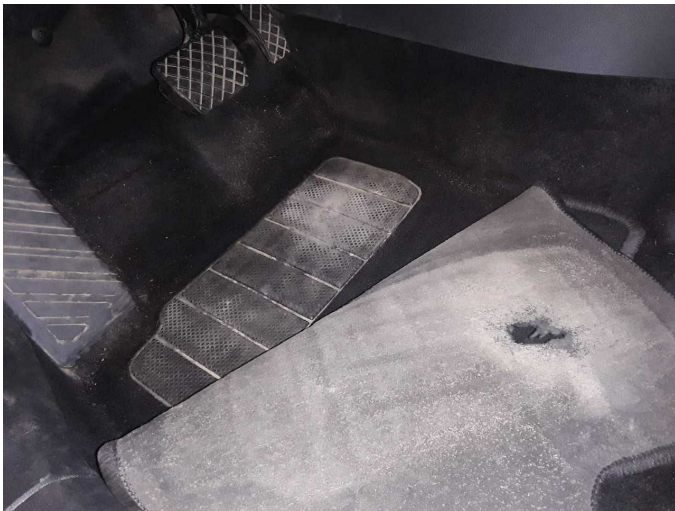
| No. | Component group | Description |
|---|---|---|
| 5 | Trim / covers | Floor mats - Broken / torn - No deduction |

**Wear and tear 5:** Trim / covers: Floor mats - Broken / torn - No deduction

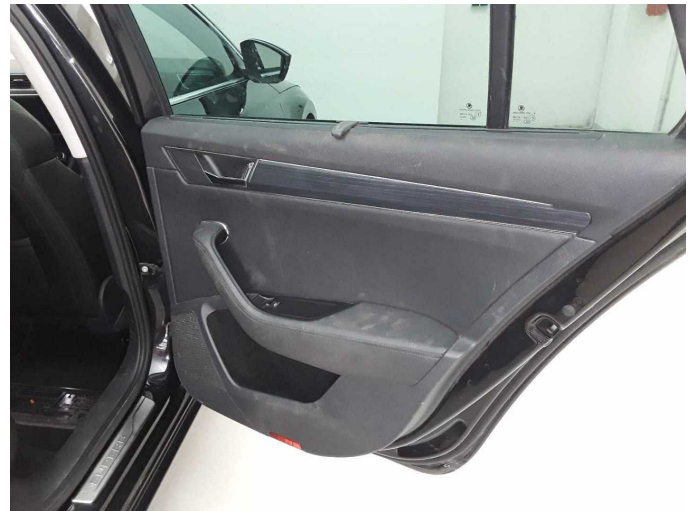
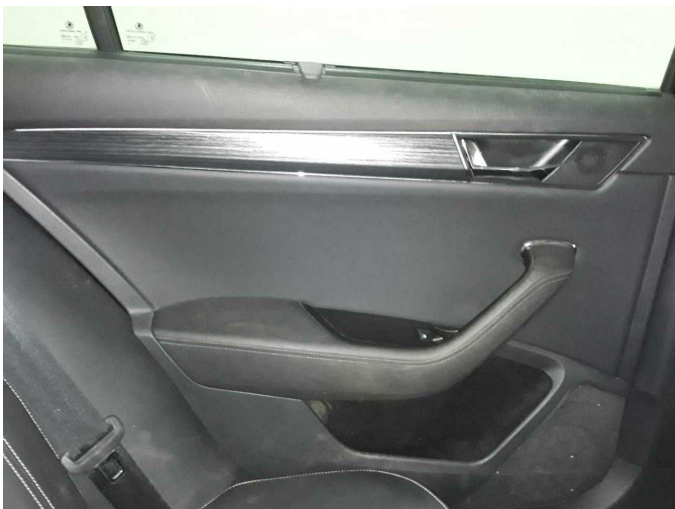
| No. | Component group | Description |
|---|---|---|
| 6 | Trim / covers | Door trim - rear right side - Soiled - No deduction |

**Wear and tear 6:** Trim / covers: Door trim - rear right side - Soiled - No deduction

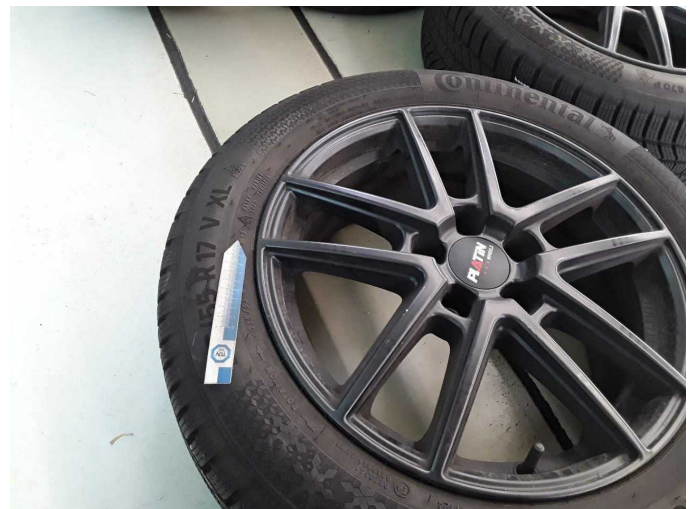
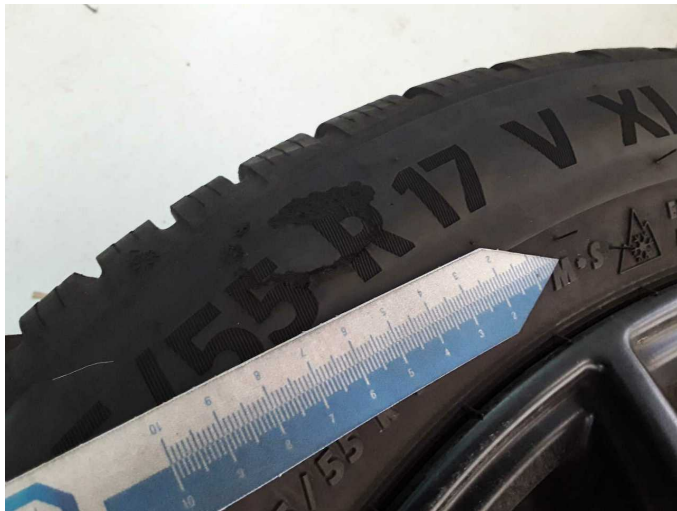
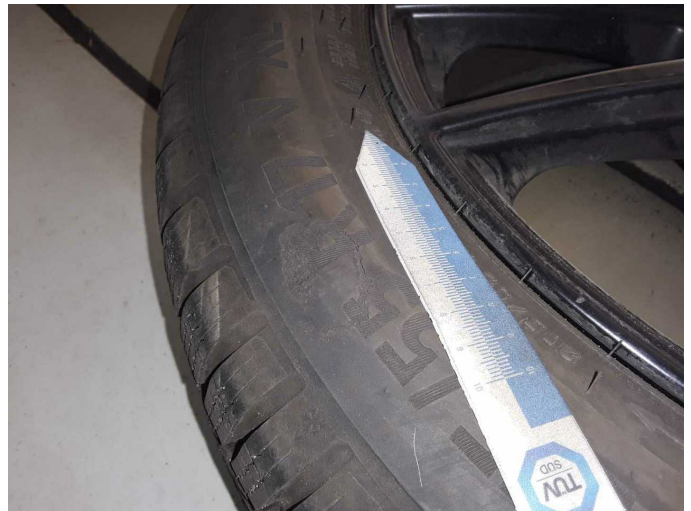
| No. | Component group | Description |
|---|---|---|
| 7 | 2nd wheel set | 1 tyre - Broken / torn - No deduction |

**Wear and tear 7:** 2nd wheel set: 1 tyre - Broken / torn - No deduction

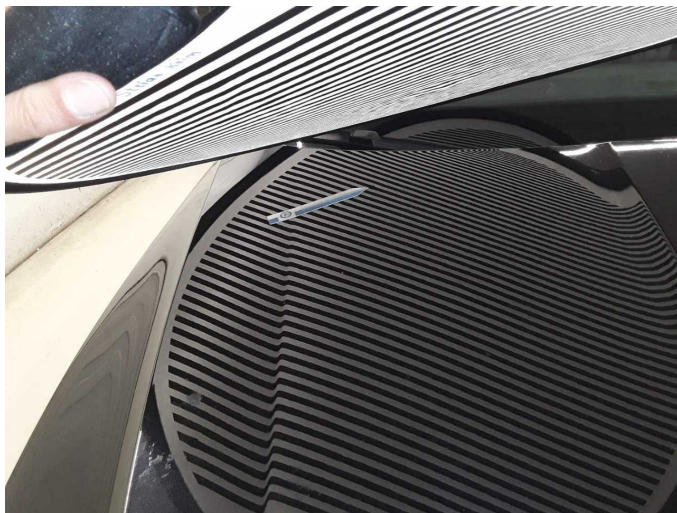
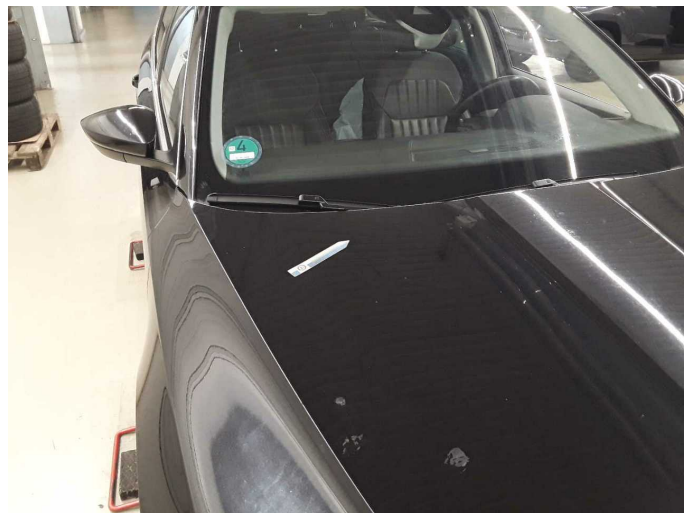
| No. | Component group | Description |
|---|---|---|
| 9 | Bonnet | Bonnet - dent(s) - Smooth repair work |

**Wear and tear 9:** Bonnet: Bonnet - dent(s) - Smooth repair work

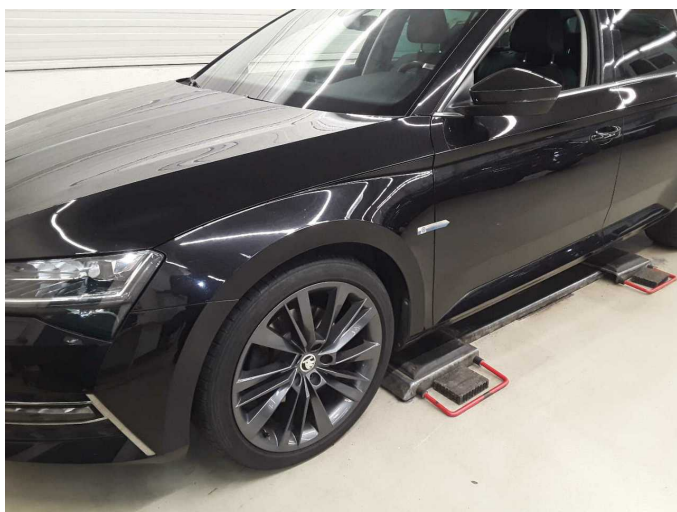
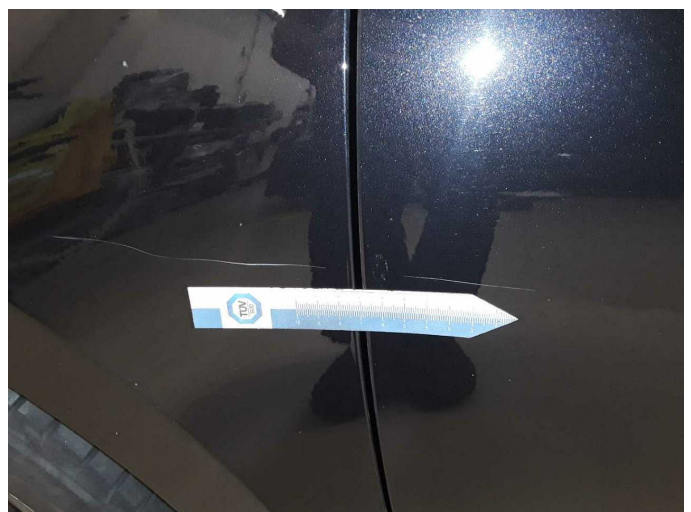
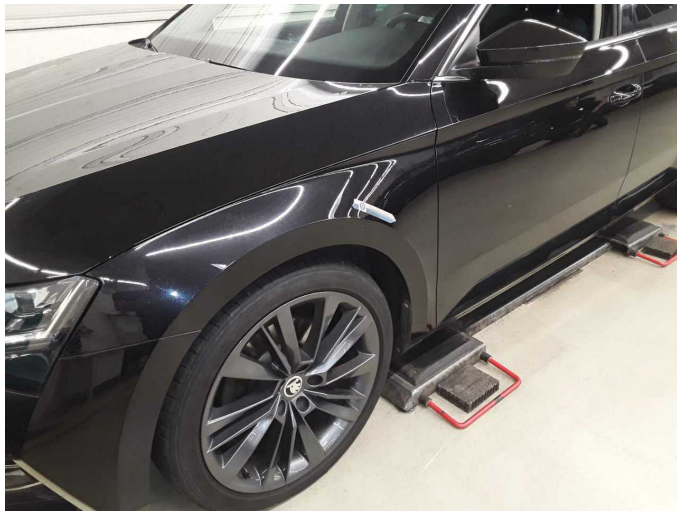
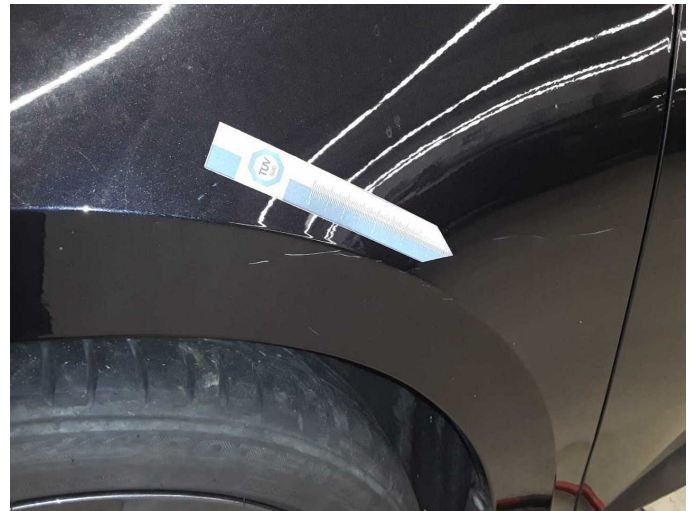
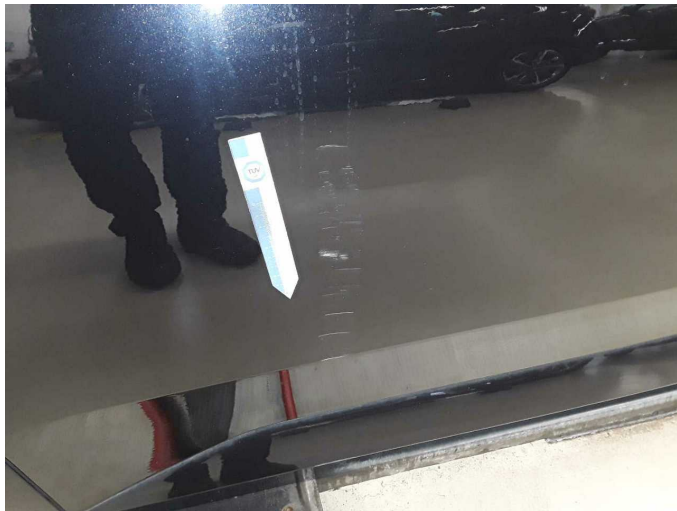
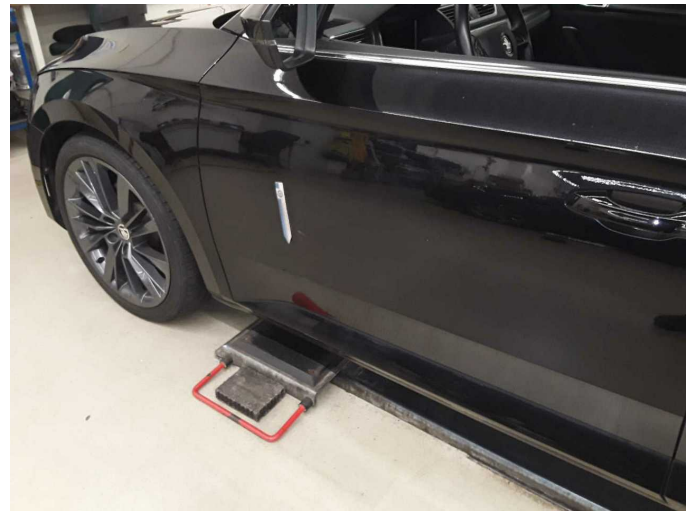
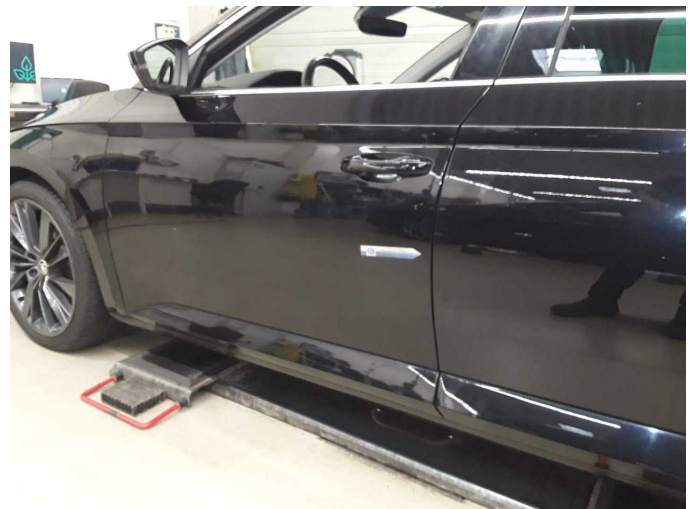
| No. | Previous damage | Extent of damage (Net) |
|---|---|---|
| 1 | Side - left, Provided by user / customer, from 8 Sept 2021 | 929,06 € |

- Side - left
- Side right

**Accident 1:** Side - left

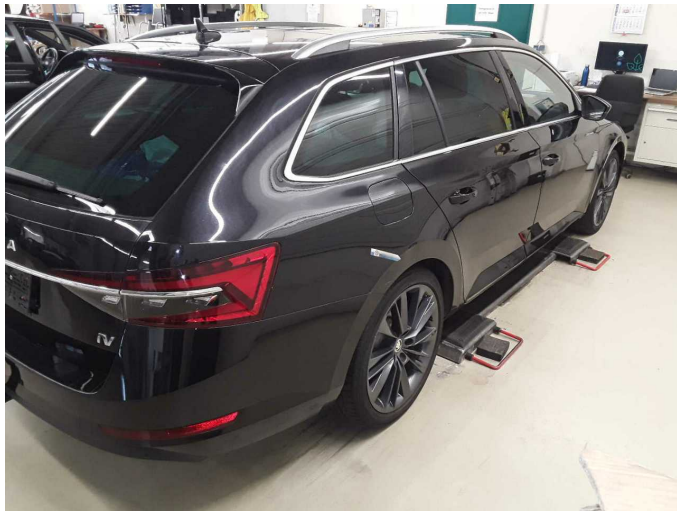
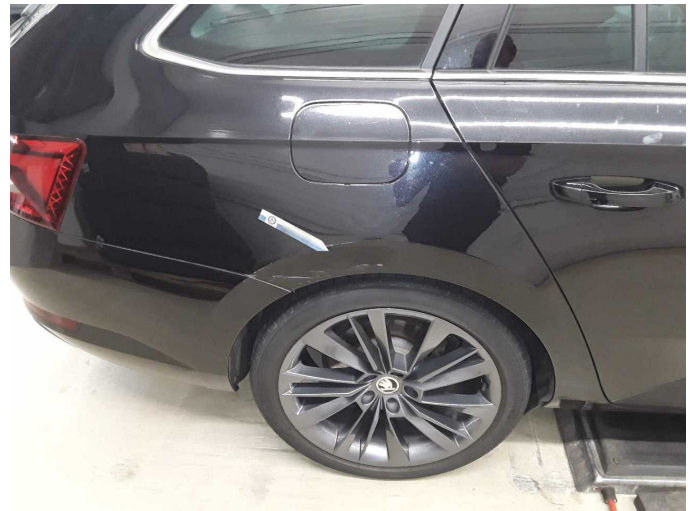
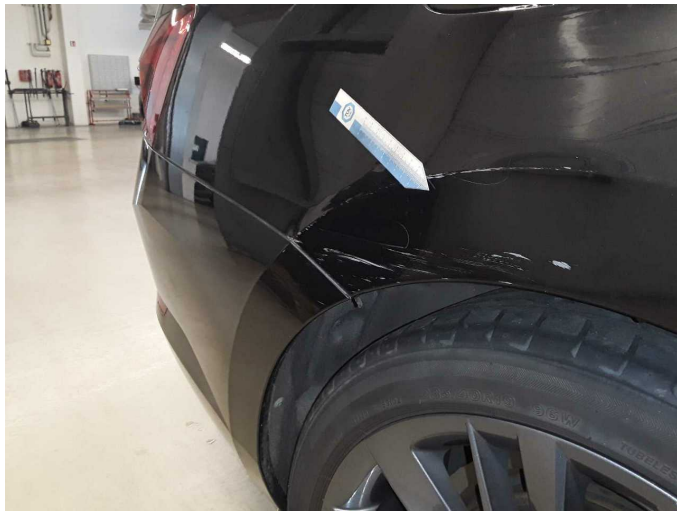
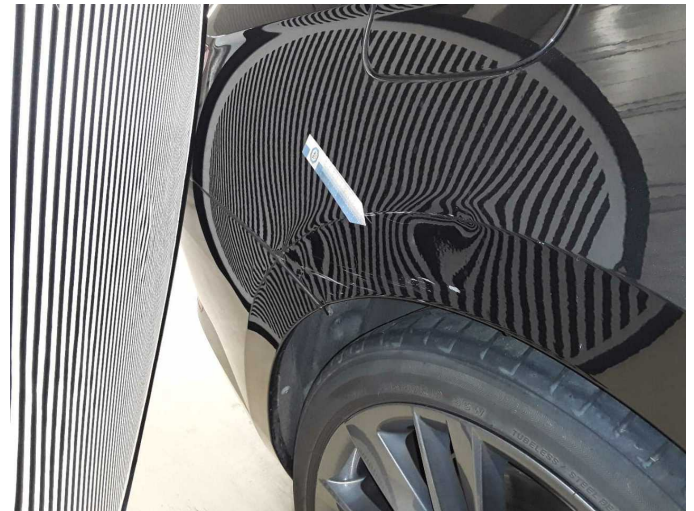
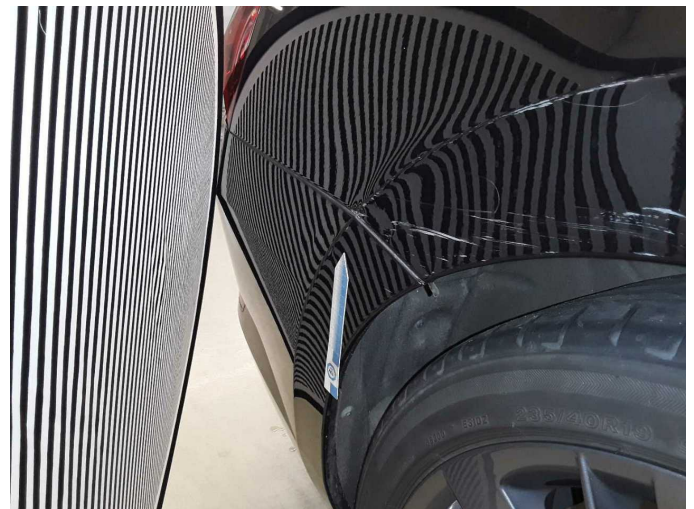
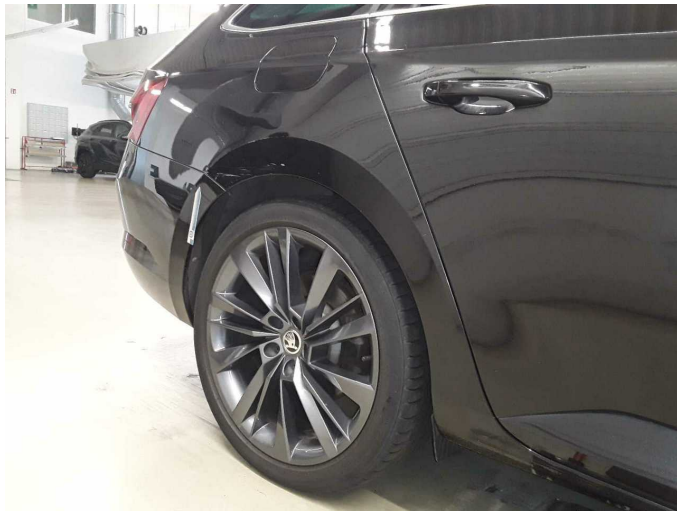
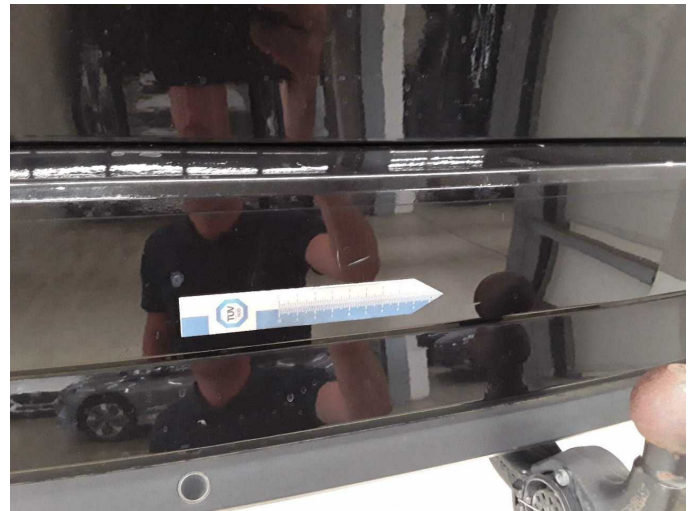
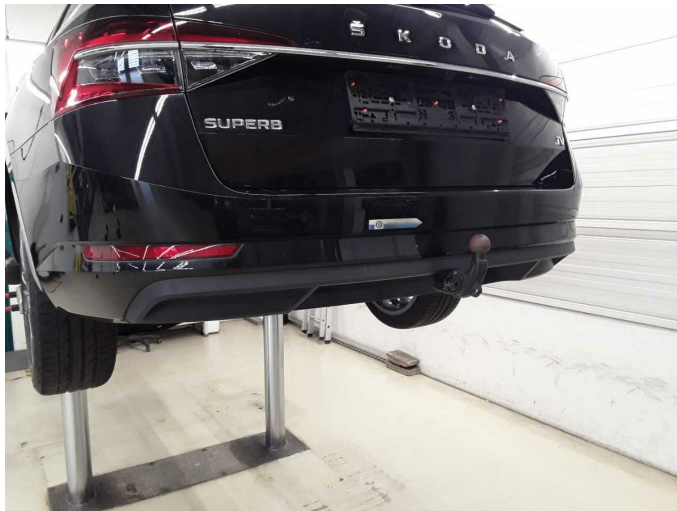
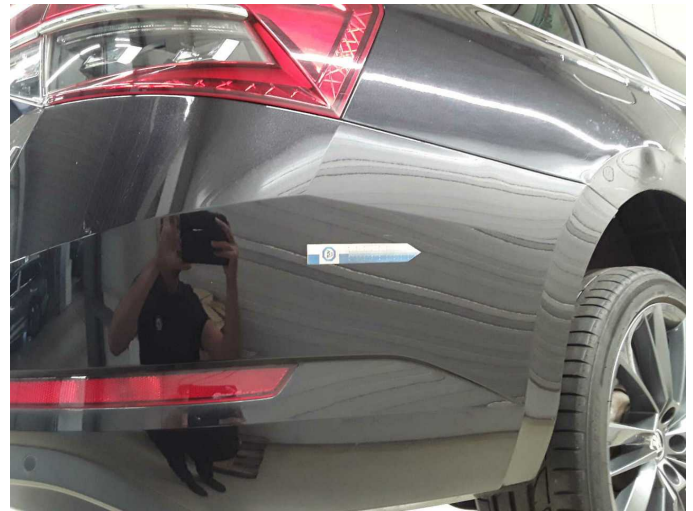
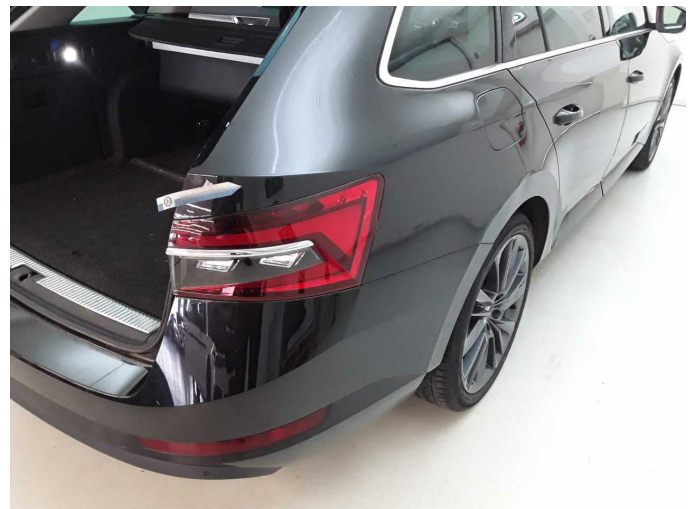
**Accident 2: Side right**

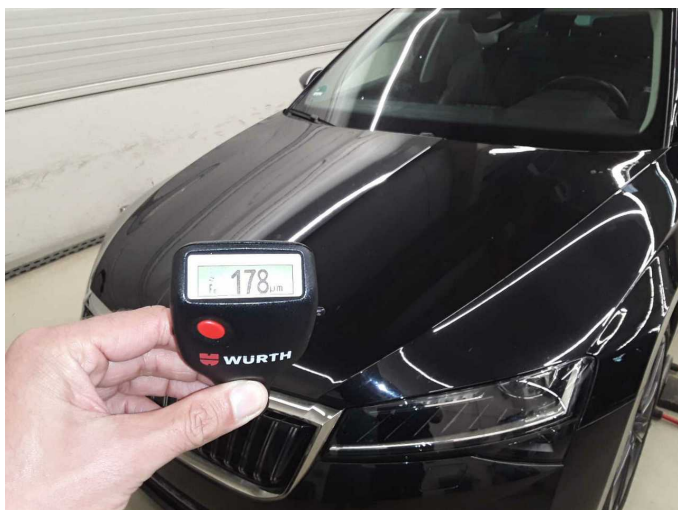
- Bonnet, Professionally carried out

Bonnet 178 µm |

**Bonnet:** 178 µm
