Expertise

Protocol number: 39989747
Order No. / Reference: 24729115
Inspection date: 3 Jun 2025

Manufacturer: Skoda
VIN: TMBJW7NP3M7021133

Model: Superb Combi 1.4 TSI iv DSG L&K

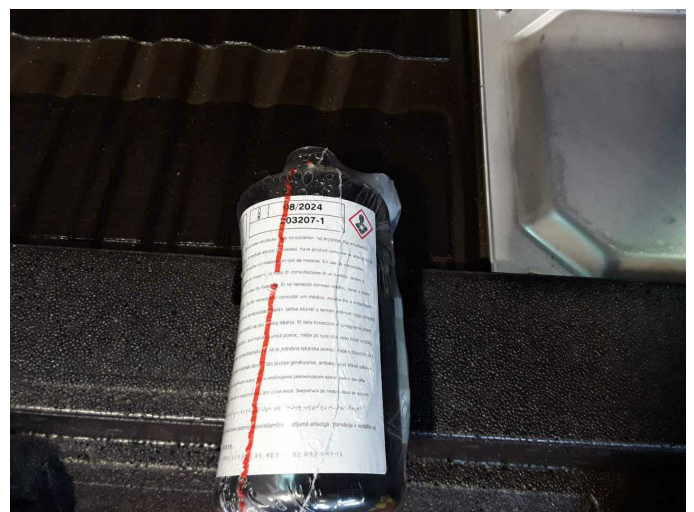
Damage 1: Equipment: Tirefit filler - Expired - Replace

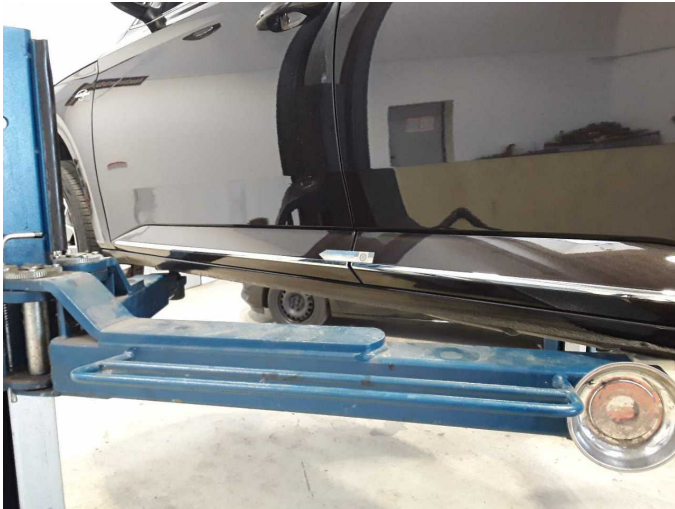
Damage 2: Door - front left side: Brightware - lower - Scratch(es) - Loss in value

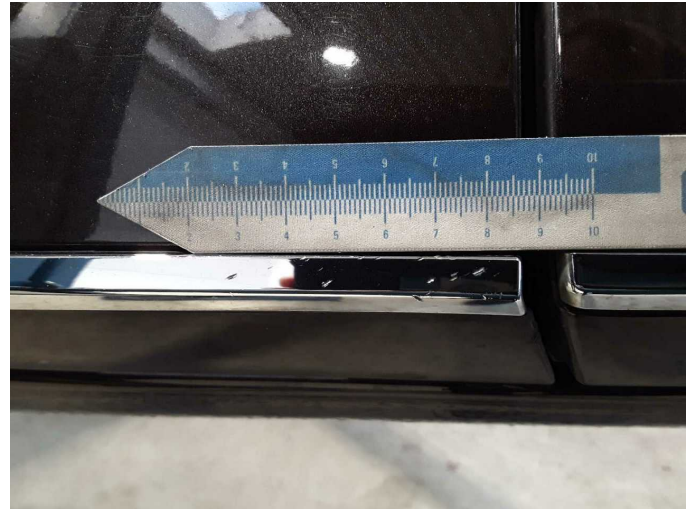
Damage 2: Door - front left side: Brightware - lower - Scratch(es) - Loss in value

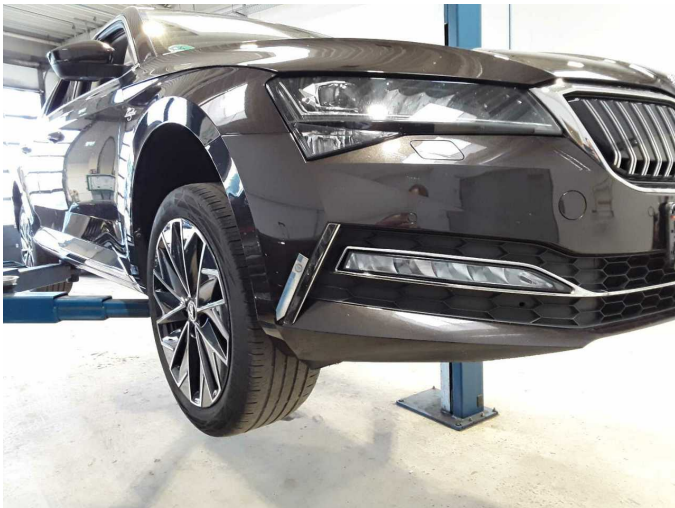
Damage 3: Front bumper: Cover bumper - front - Differs from the original configuration - Un- / install

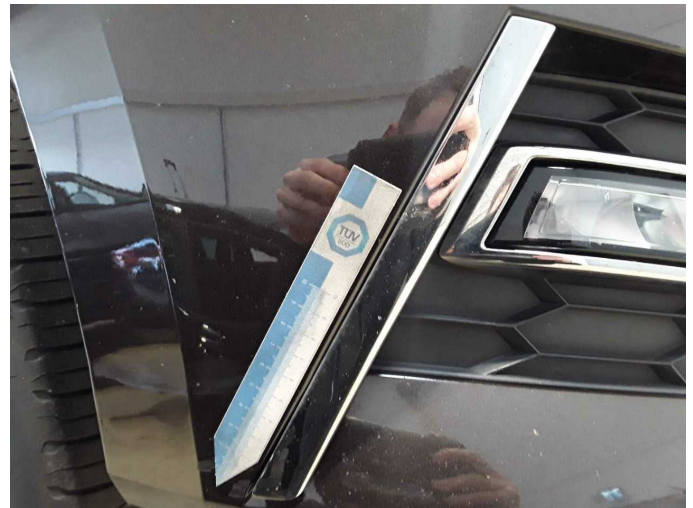
Damage 3: Front bumper: Cover bumper - front - Differs from the original configuration - Un- / install

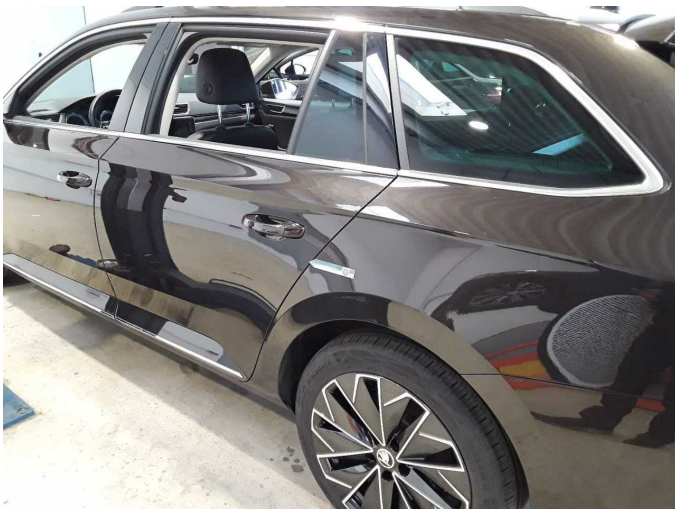
Damage 4: Side panel - rear left side: Side panel - Dent / paintcoat damage - Smart repair

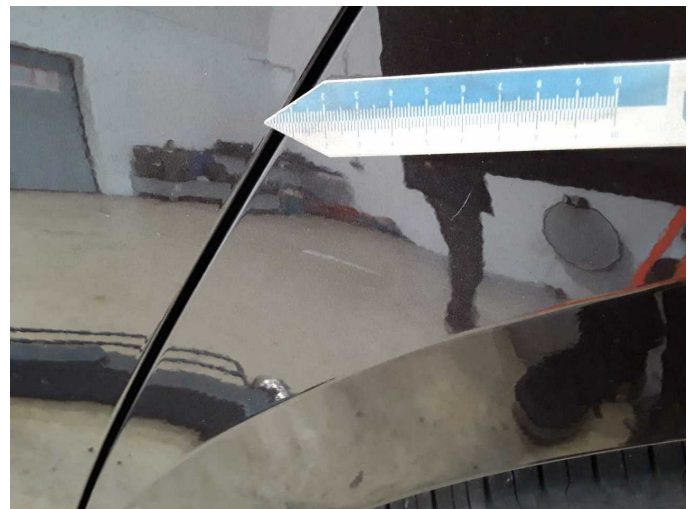
Damage 4: Side panel - rear left side: Side panel - Dent / paintcoat damage - Smart repair

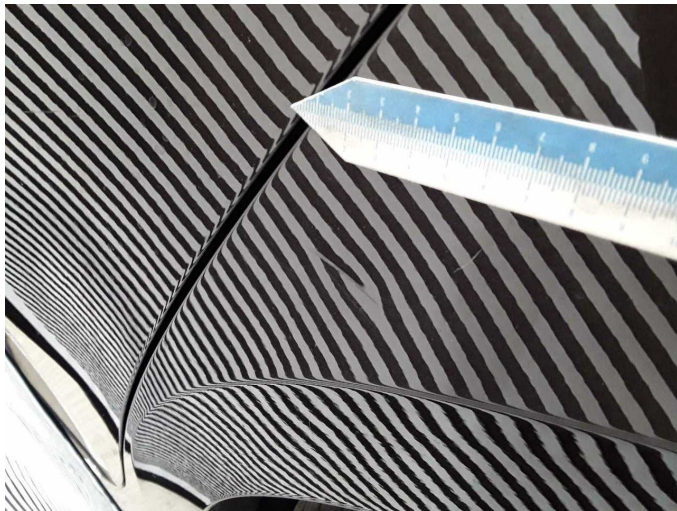
Damage 4: Side panel - rear left side: Side panel - Dent / paintcoat damage - Smart repair

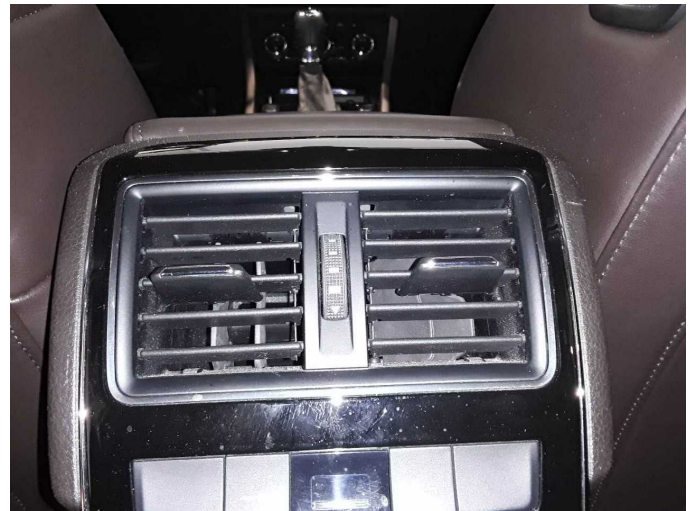
Damage 5: Instrument panel: Air nozzle - centre - Damaged - Replace

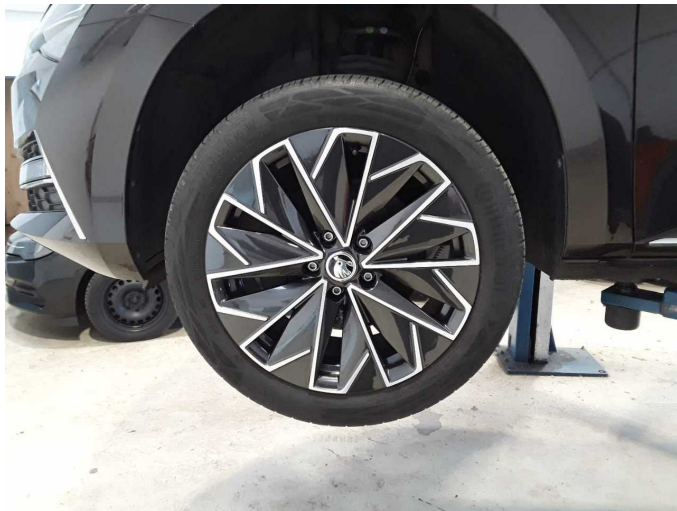
Damage 6: Wheel / tyres: Alloy rim - front left side - Scratched - Loss in value

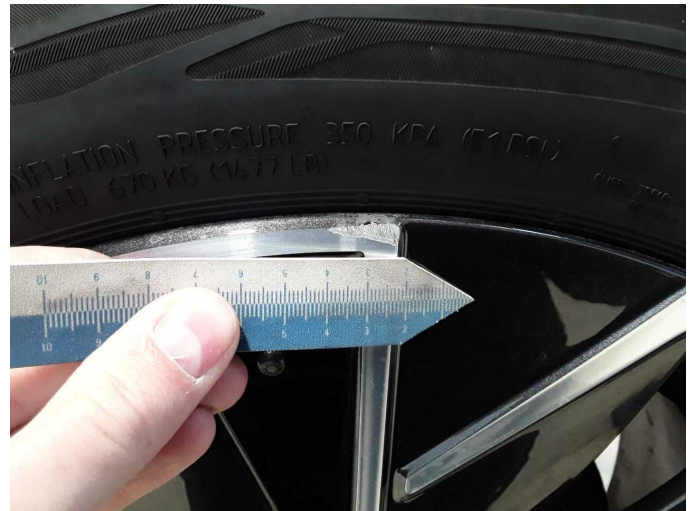
Damage 6: Wheel / tyres: Alloy rim - front left side - Scratched - Loss in value

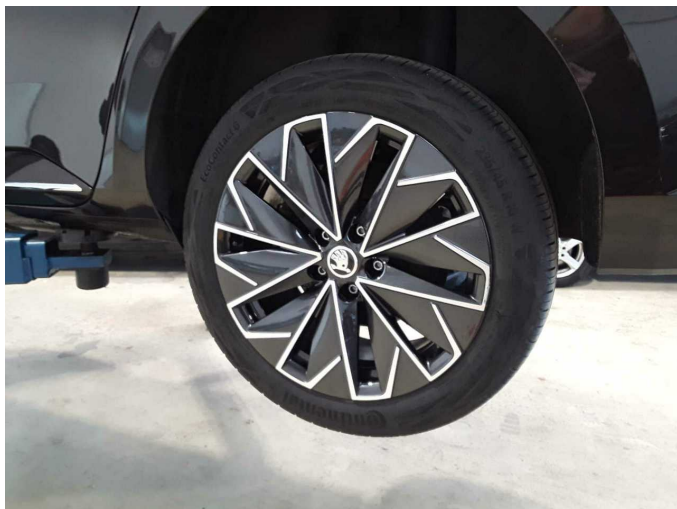
Damage 7: Wheel / tyres: Tyre - rear left side - Damaged - Replace

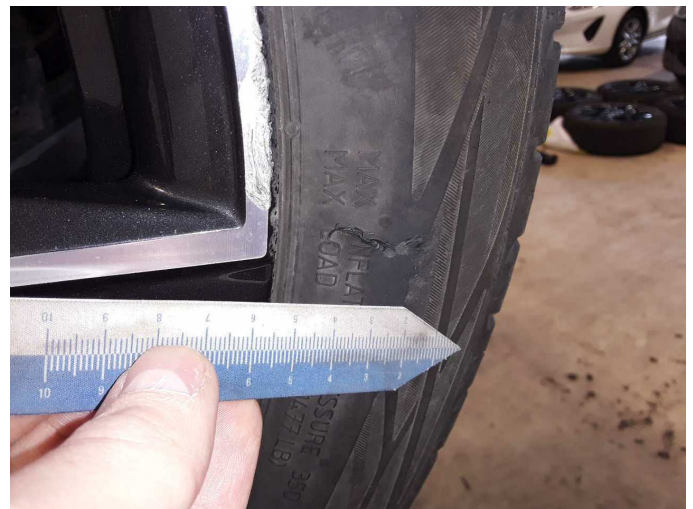
Damage 7: Wheel / tyres: Tyre - rear left side - Damaged - Replace

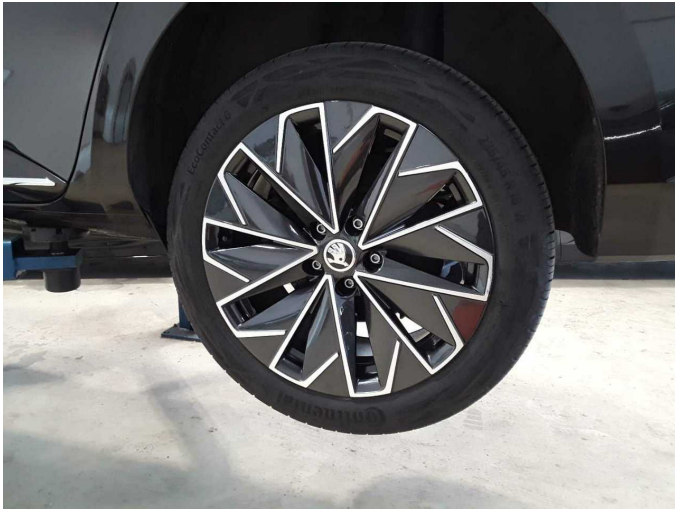
Damage 8: Wheel / tyres: Alloy rim - rear left side - Scratched - Loss in value

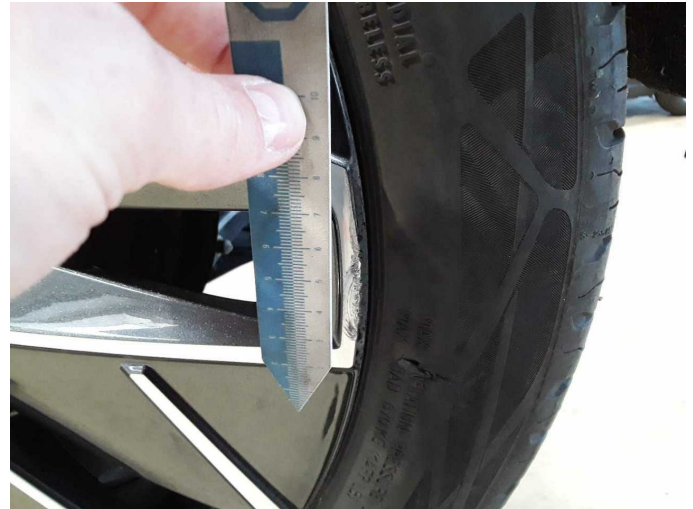
Damage 8: Wheel / tyres: Alloy rim - rear left side - Scratched - Loss in value

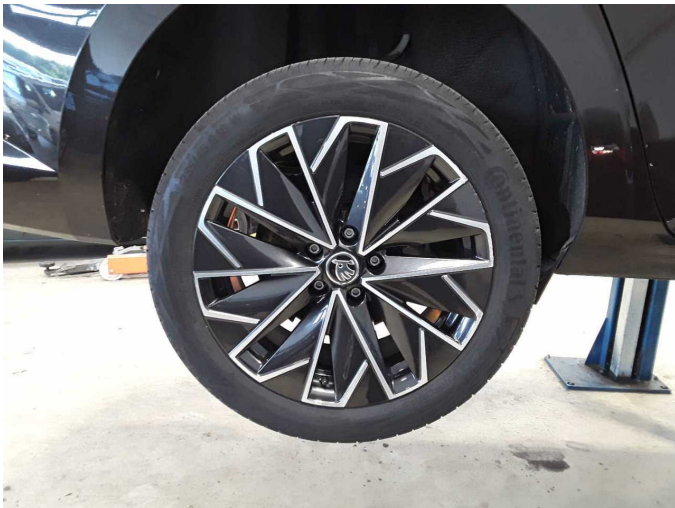
Damage 9: Wheel / tyres: Alloy rim - rear right side - Scratched - Loss in value

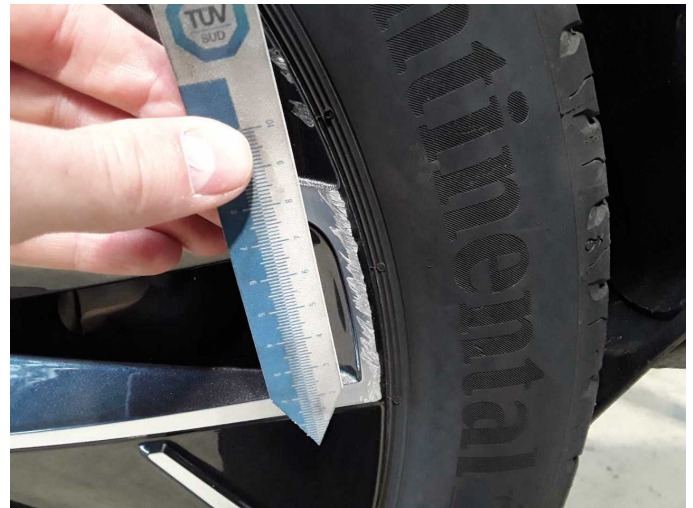
Damage 9: Wheel / tyres: Alloy rim - rear right side - Scratched - Loss in value

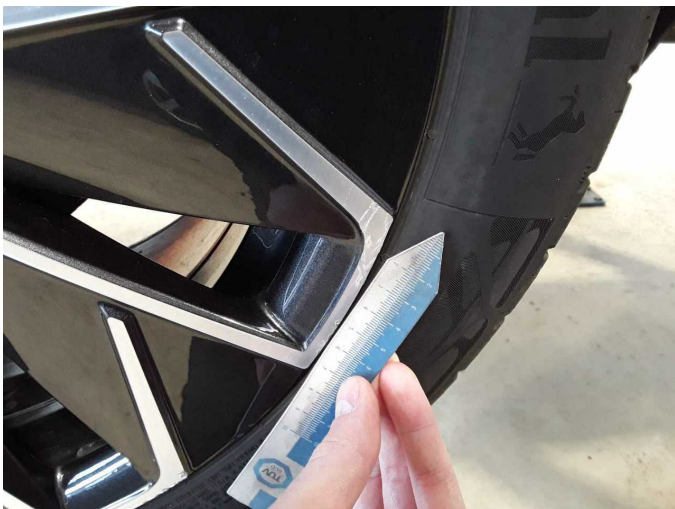
Damage 9: Wheel / tyres: Alloy rim - rear right side - Scratched - Loss in value

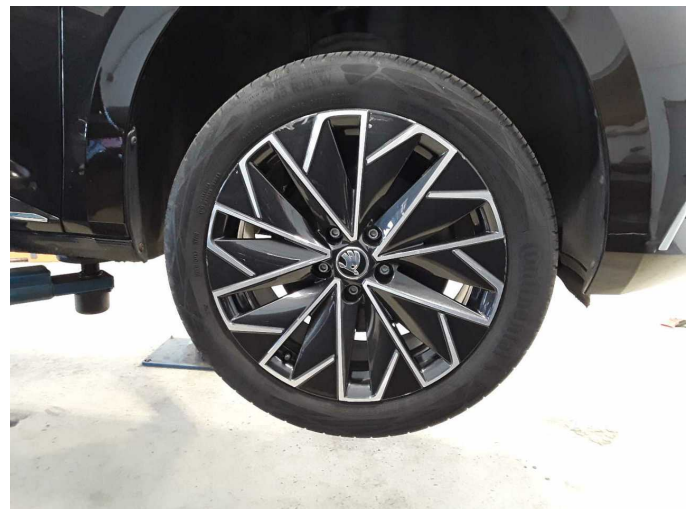
Damage 10: Wheel / tyres: Alloy rim - front right side - Scratched - Loss in value

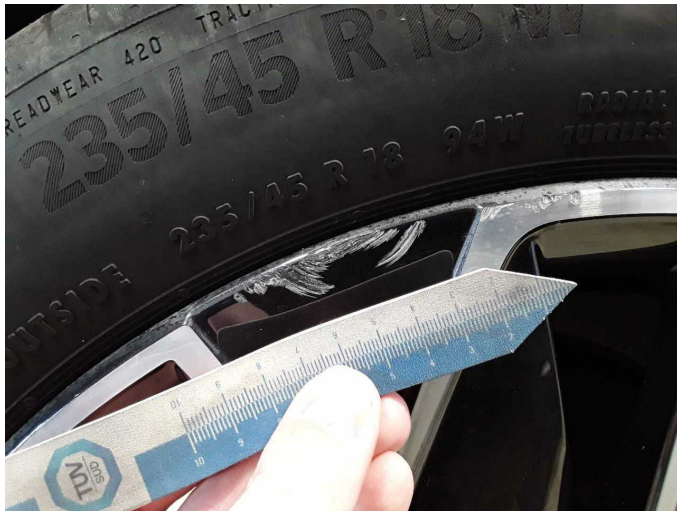
Damage 10: Wheel / tyres: Alloy rim - front right side - Scratched - Loss in value

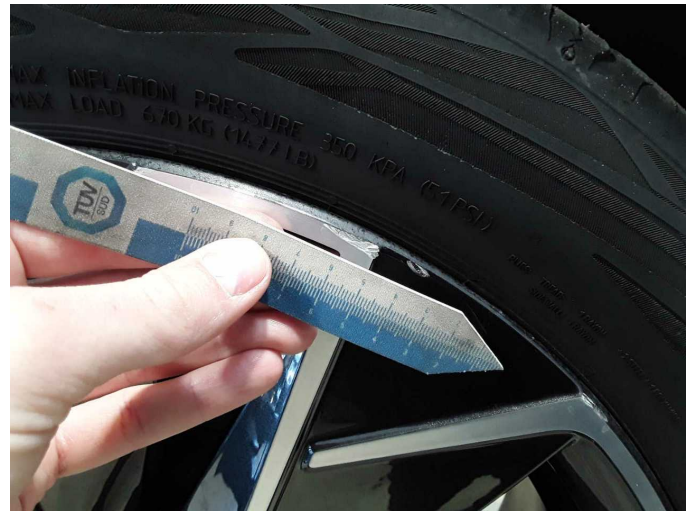
Damage 10: Wheel / tyres: Alloy rim - front right side - Scratched - Loss in value

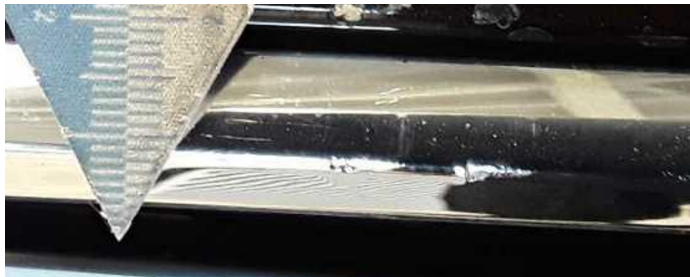
Damage 11: Boot lid / rear door: Boot lid (Zierleiste) - Damaged - Replace

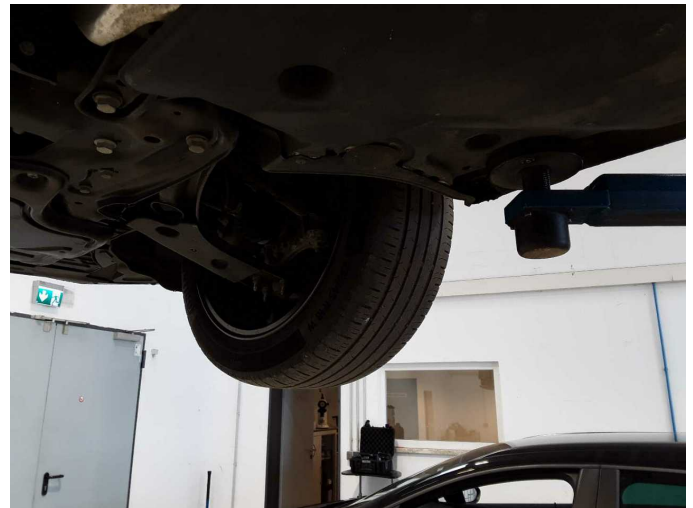
Damage 12: Wheel / tyres: Tyre - front (Innen abgefahren) - Worn - Replace

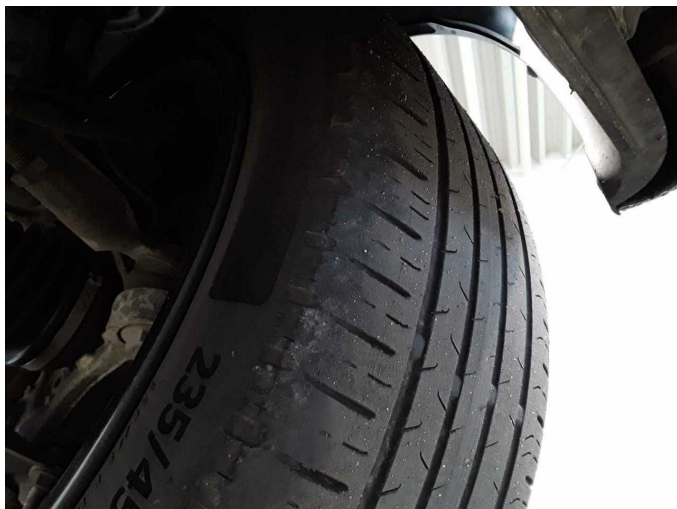
Damage 12: Wheel / tyres: Tyre - front (Innen abgefahren) - Worn - Replace

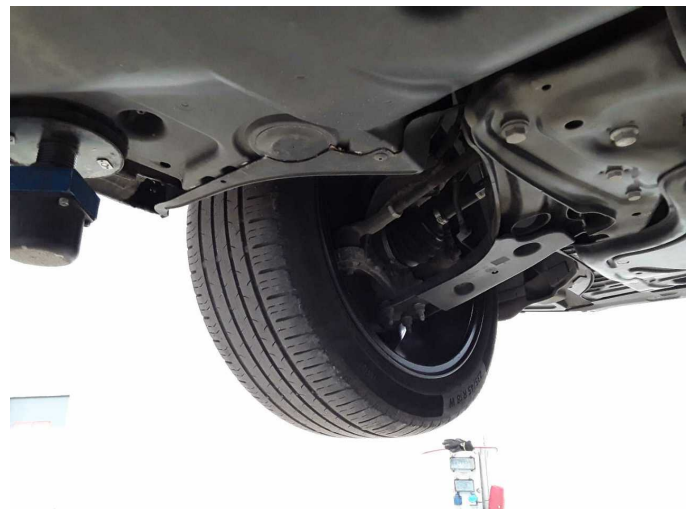
Damage 12: Wheel / tyres: Tyre - front (Innen abgefahren) - Worn - Replace

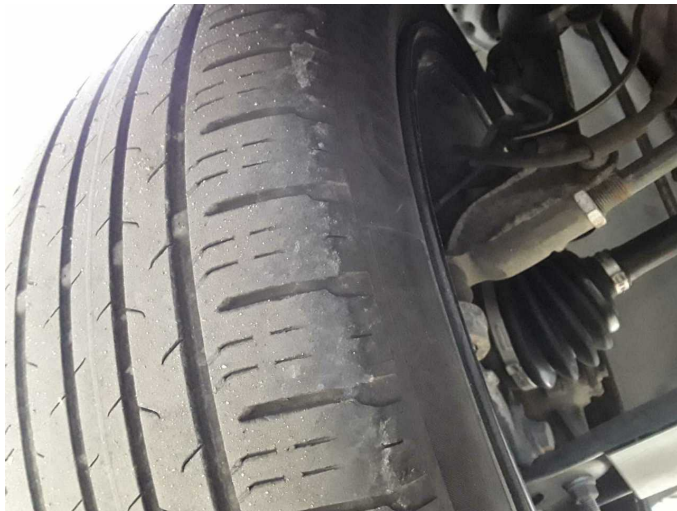
Damage 12: Wheel / tyres: Tyre - front (Innen abgefahren) - Worn - Replace

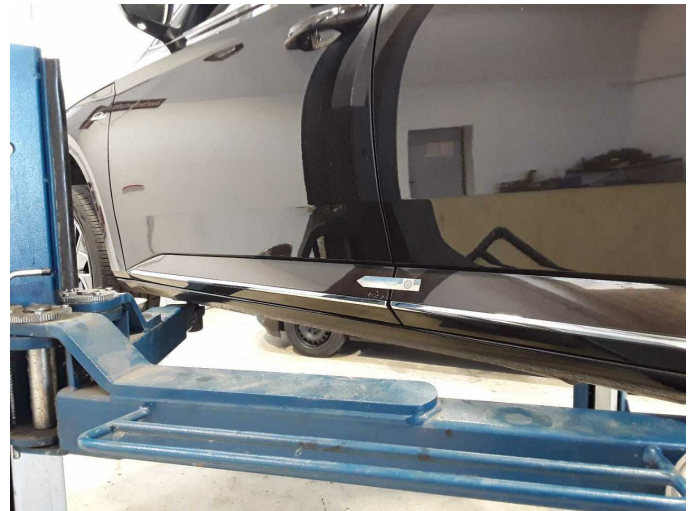
Damage 13: Door - front left side: Brightware - lower - Scratched - Replace

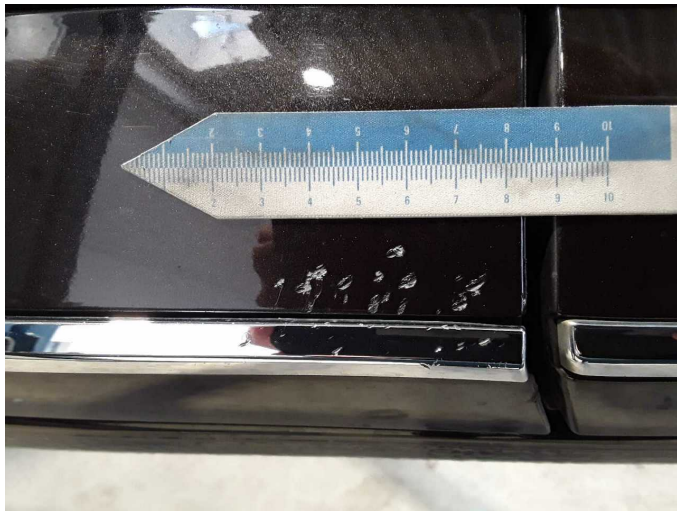
Damage 13: Door - front left side: Brightware - lower - Scratched - Replace

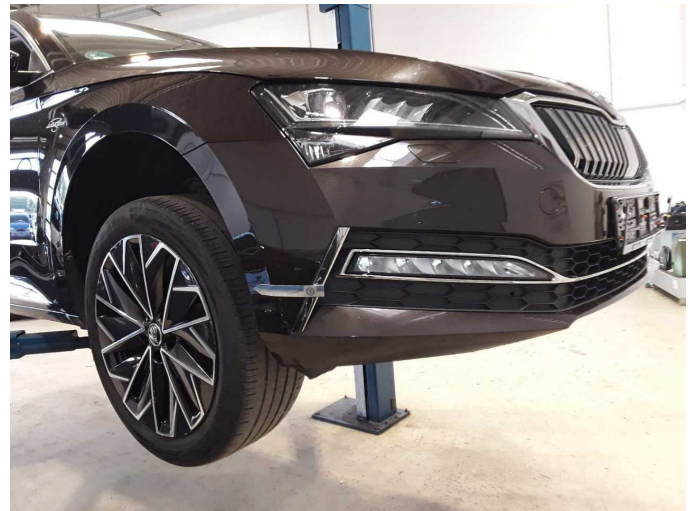
14	Front bumper	Front bumper - Scratched - Paint
15	Rear bumper	Rear bumper - Scratched - Paint
16	Boot lid / rear door	Boot lid - Dent / paintcoat damage - Repair and paint

Damage 14: Front bumper: Front bumper - Scratched - Paint

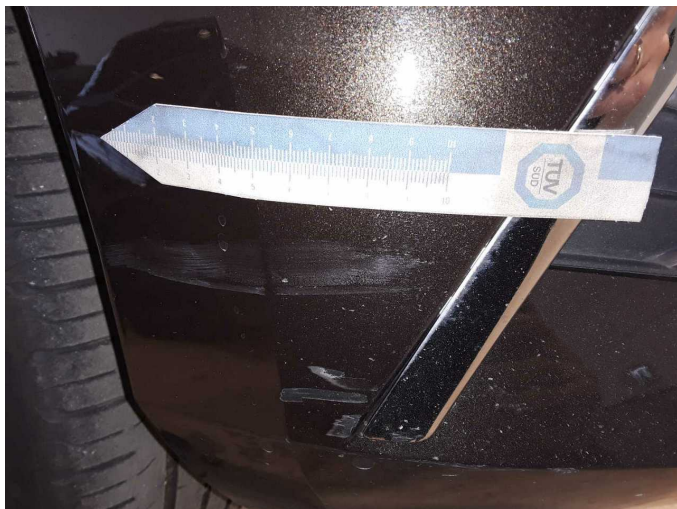
Damage 14: Front bumper: Front bumper - Scratched - Paint

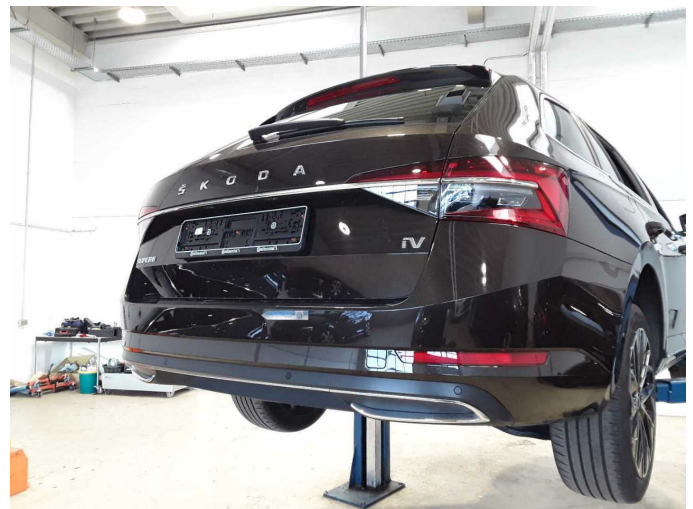
Damage 15: Rear bumper: Rear bumper - Scratched - Paint

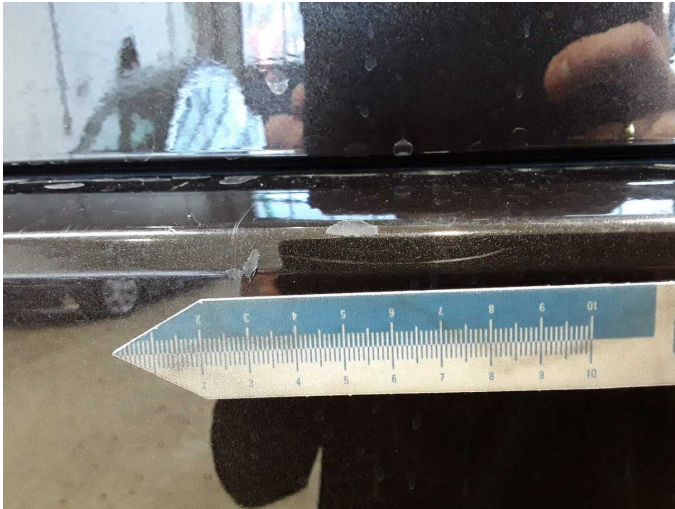
Damage 15: Rear bumper: Rear bumper - Scratched - Paint

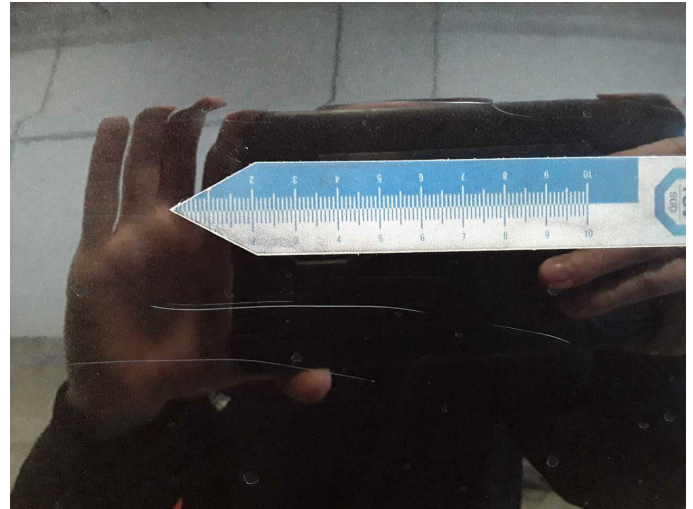
Damage 15: Rear bumper: Rear bumper - Scratched - Paint

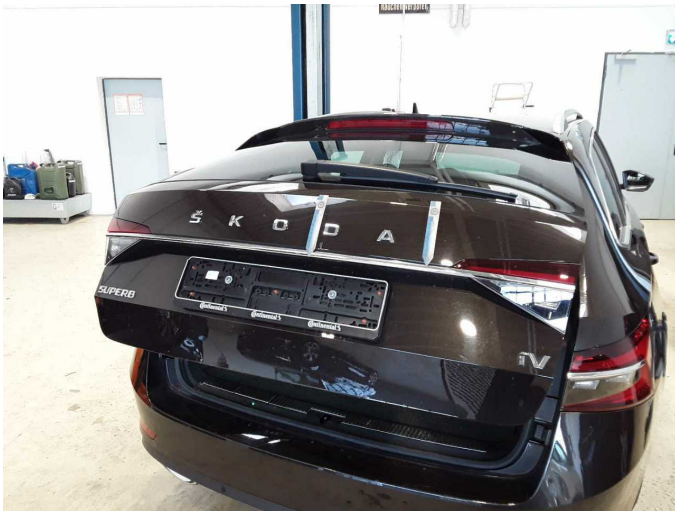
Damage 16: Boot lid / rear door: Boot lid - Dent / paintcoat damage - Repair and paint

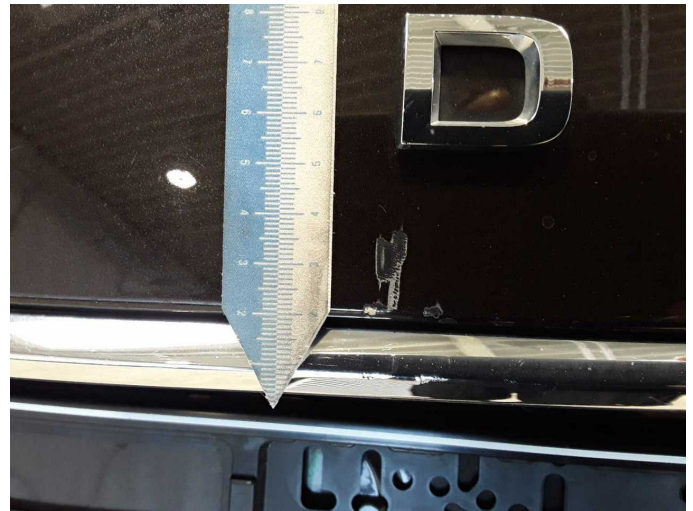
Damage 16: Boot lid / rear door: Boot lid - Dent / paintcoat damage - Repair and paint

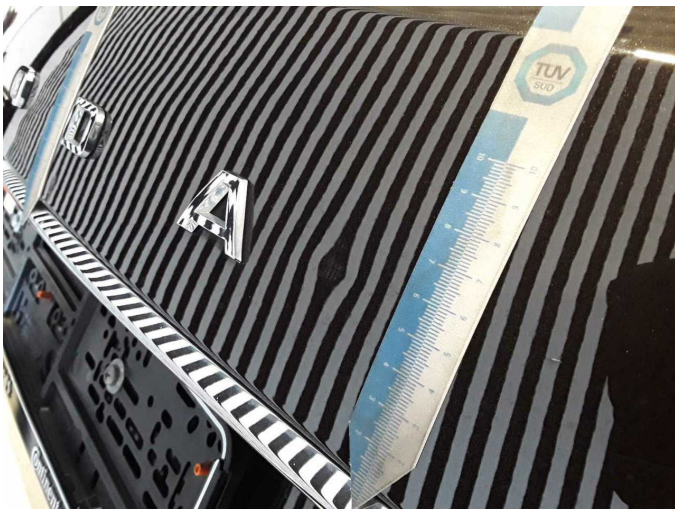
Damage 16: Boot lid / rear door: Boot lid - Dent / paintcoat damage - Repair and paint

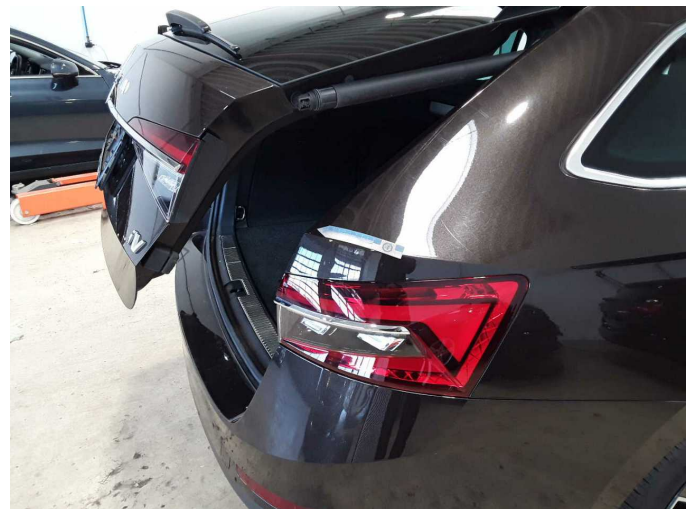
No.	Component group	Description
1	Side panel - rear right side	Side panel - Stone chips - No deduction
2	Vehicle glazing	Windscreen - Stone chips - No deduction
3	Side panel - rear right side	Side panel - dent(s) - Smooth repair work

Wear and tear 3: Side panel - rear right side: Side panel - dent(s) - Smooth repair work

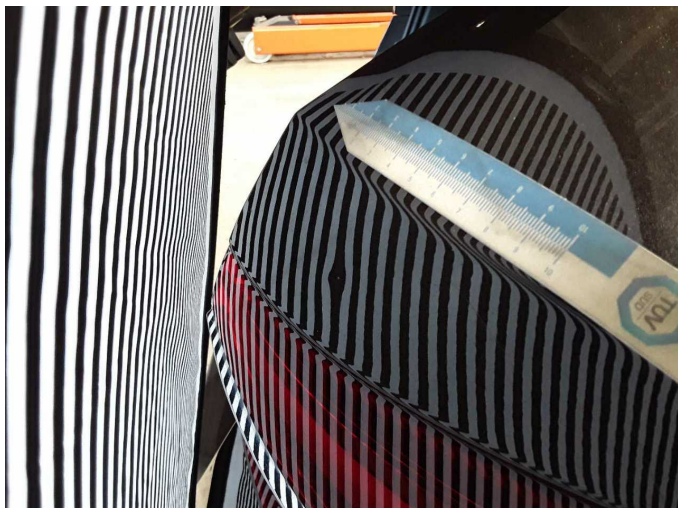
Wear and tear 3: Side panel - rear right side: Side panel - dent(s) -
Smooth repair work
