Expertise

Protocol number: 40873599  
Order No. / Reference: 25023681  
Inspection date: 1 Aug 2025

Manufacturer: Skoda  
VIN: TMBJW7NP5M7024678

Model: Superb Combi 1.4 TSI iV DSG Ambition

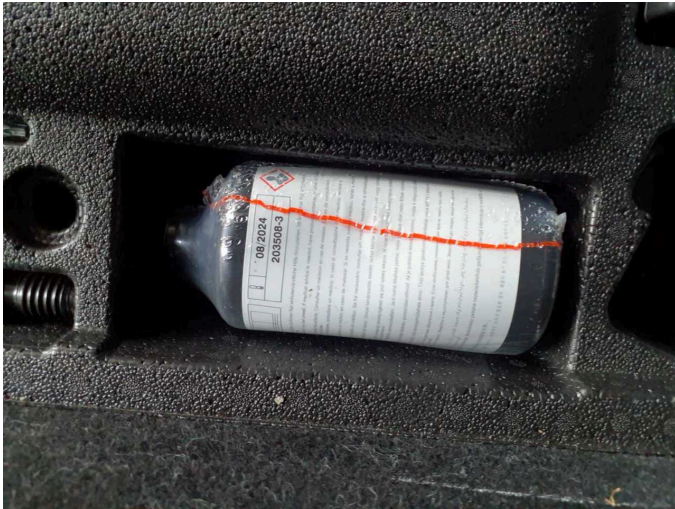
**Damage 1:** Equipment: Tirefit filler - Expired - Replace

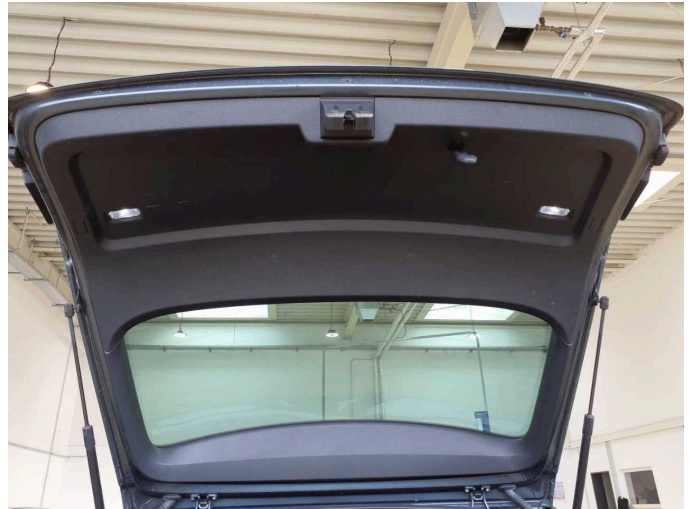
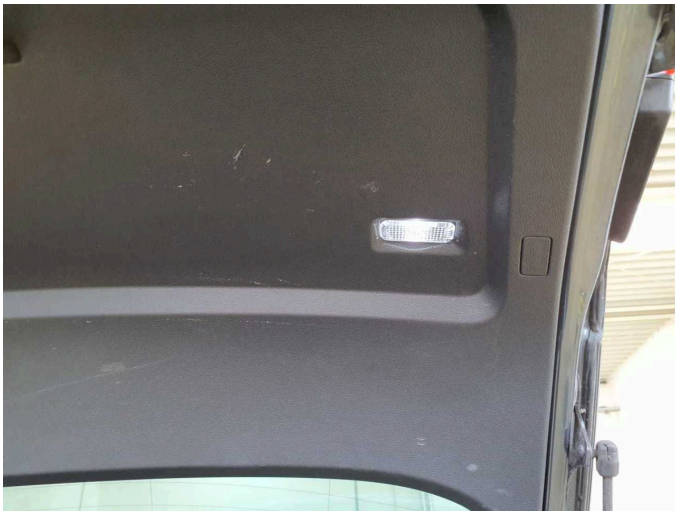
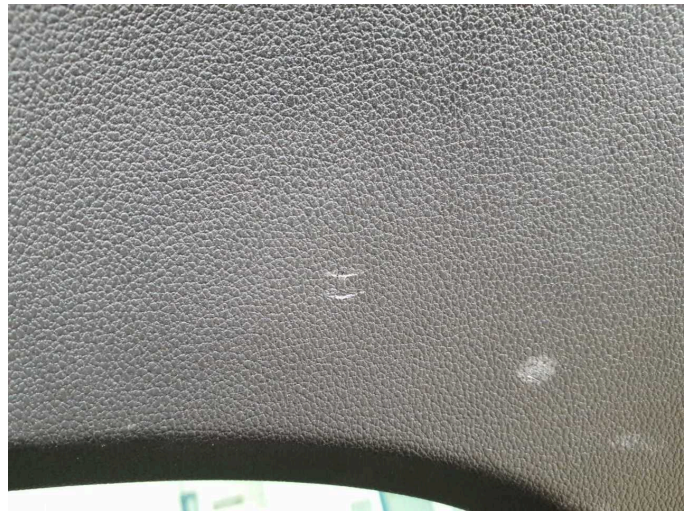
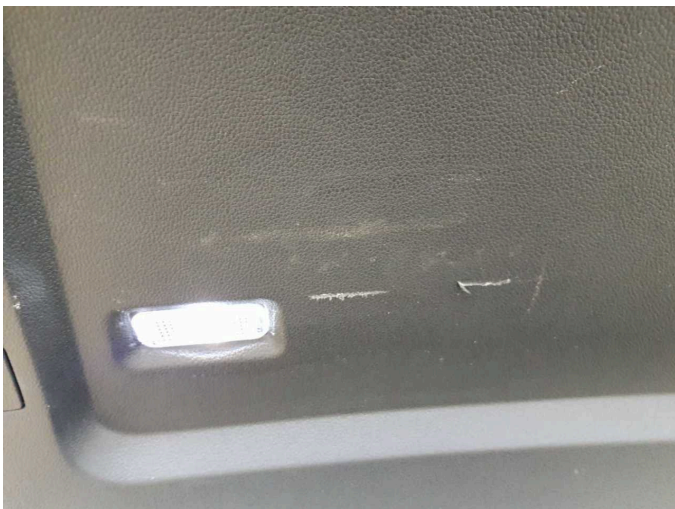
**Damage 2:** Trim / covers: Boot lid - interior trim - Scratch(es) - Loss in value

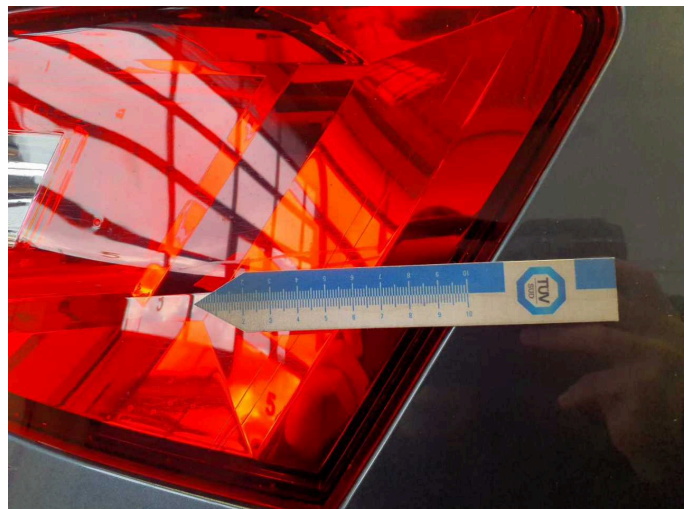
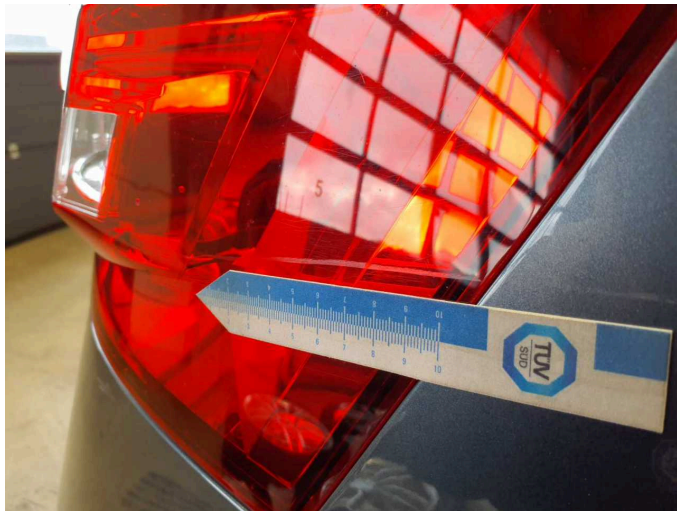
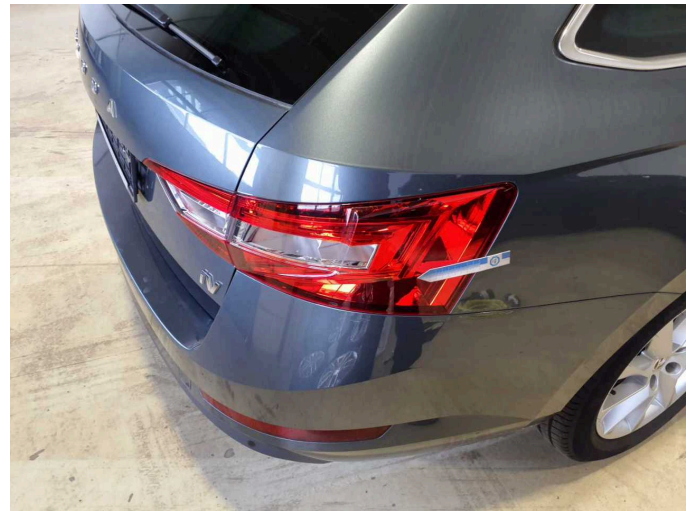
**Damage 3:** Tail light: Tail lamp - right side - Scratch(es) - Loss in value

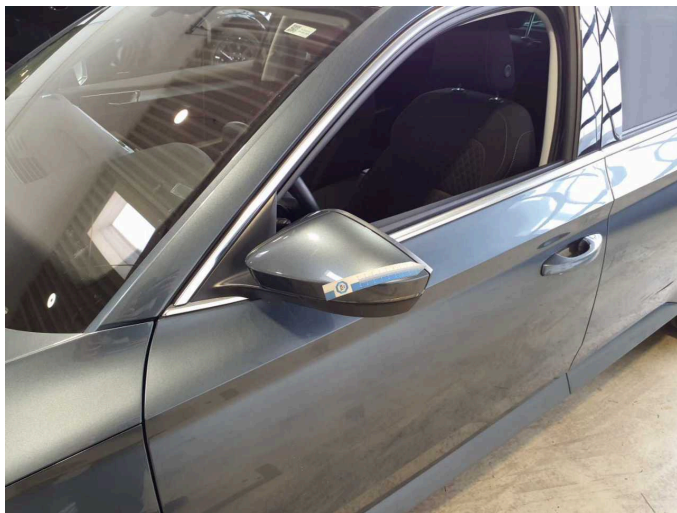
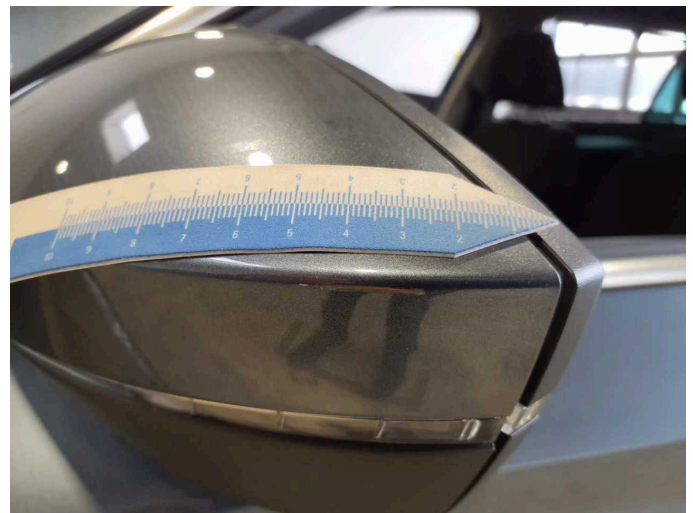
**Damage 4:** Wing mirror - left side: Cap - Scratch(es) - Paint

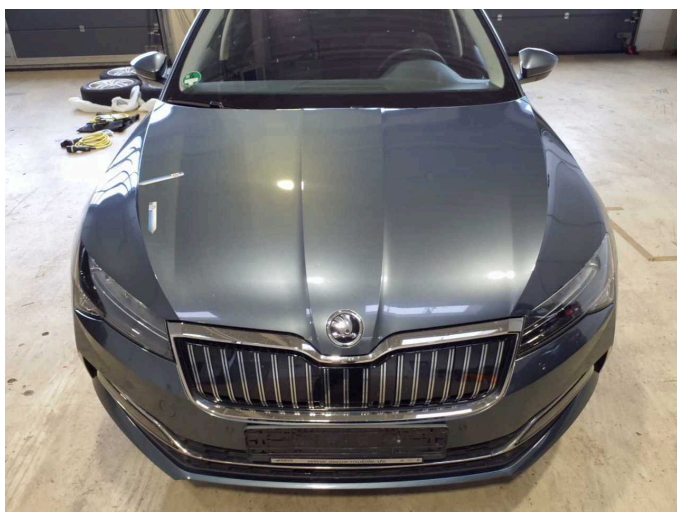
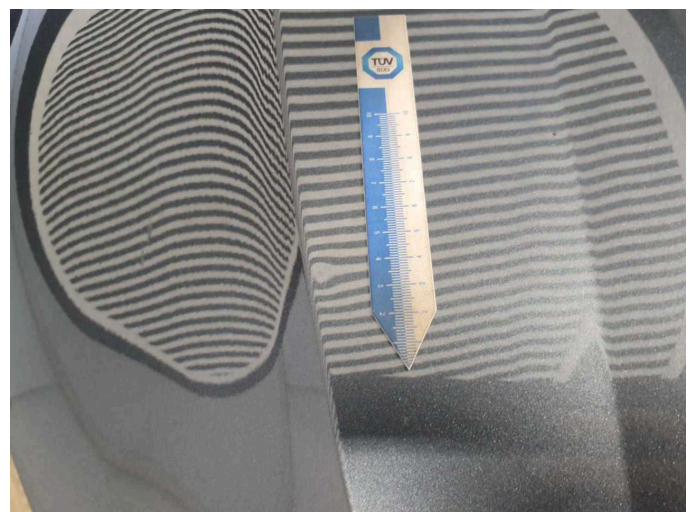
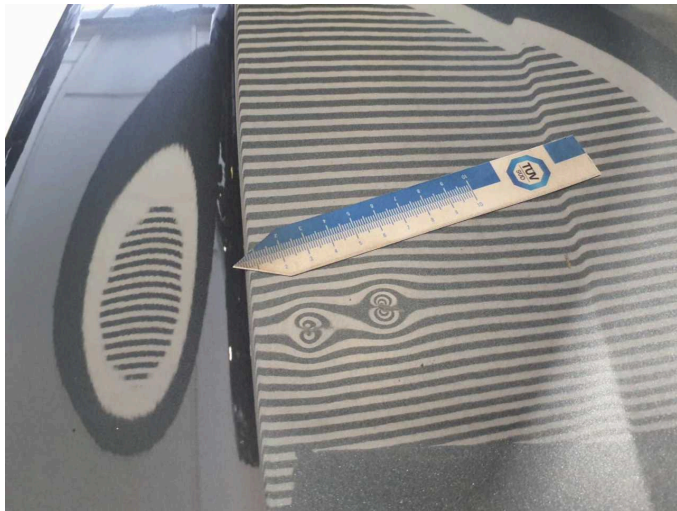
**Damage 5:** Bonnet: Bonnet - dent(s) - Smart repair

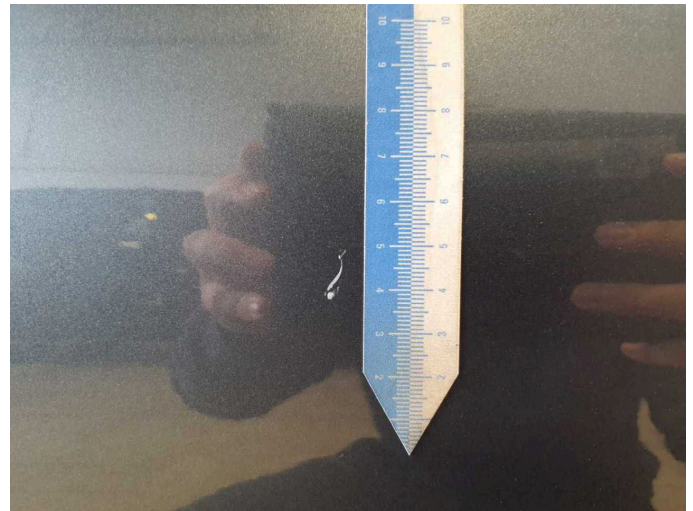
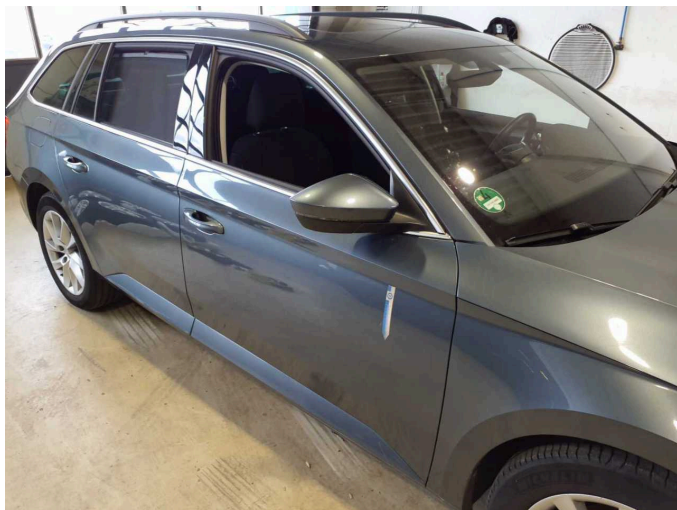
**Damage 6:** Door - front right side: Door - Scratch(es) - Smart repair

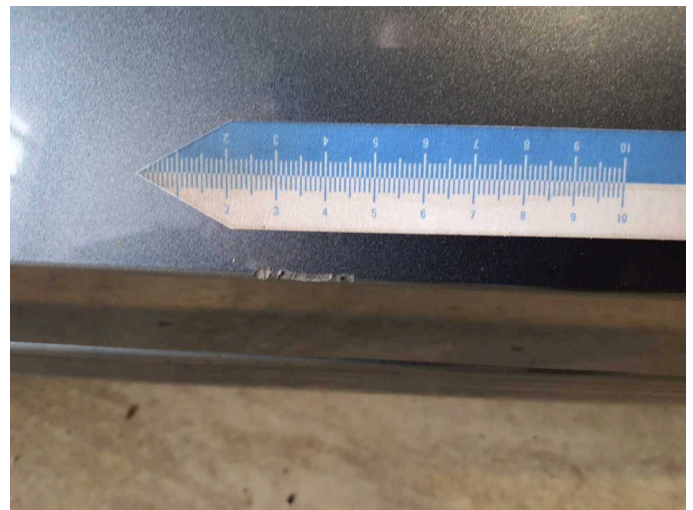
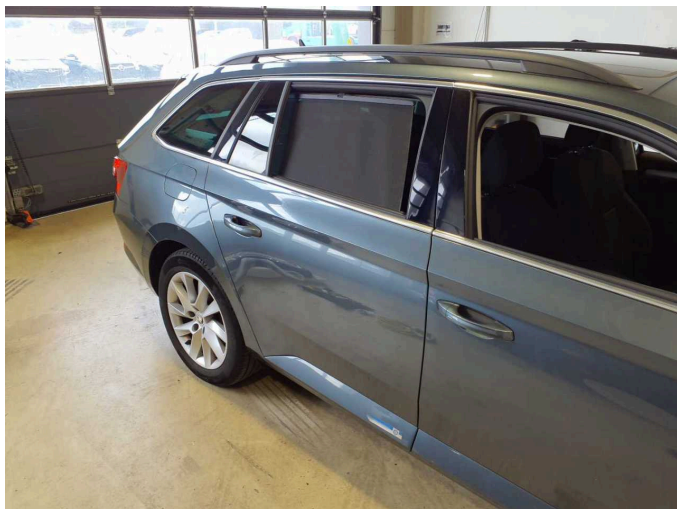
**Damage 7:** Door - rear right side: Door (Zierleiste) - Scratch(es) - Smart repair

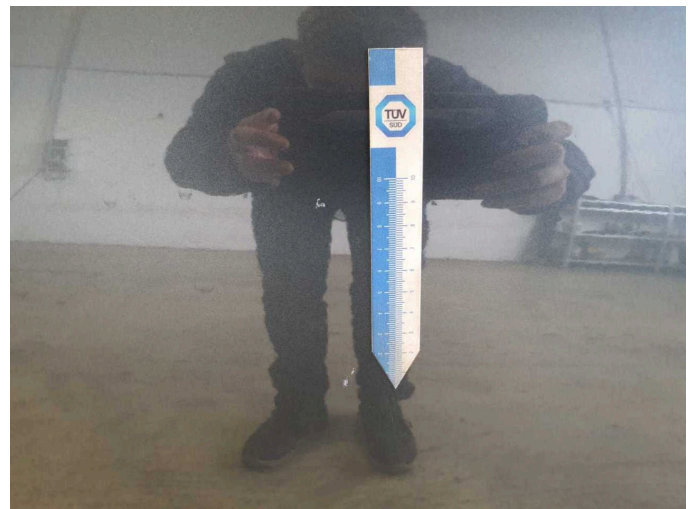
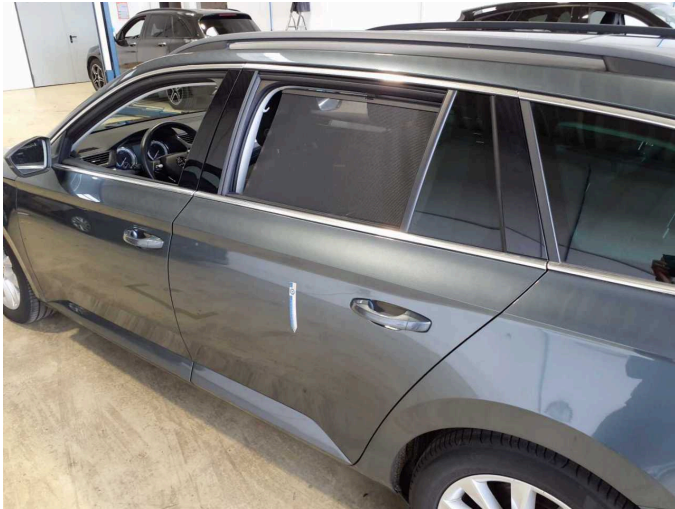
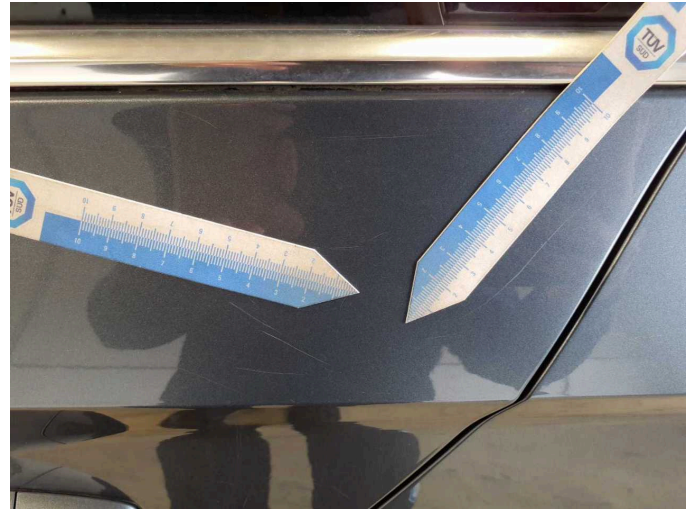
**Damage 8:** Door - rear left side: Door - Scratch(es) - Smart repair

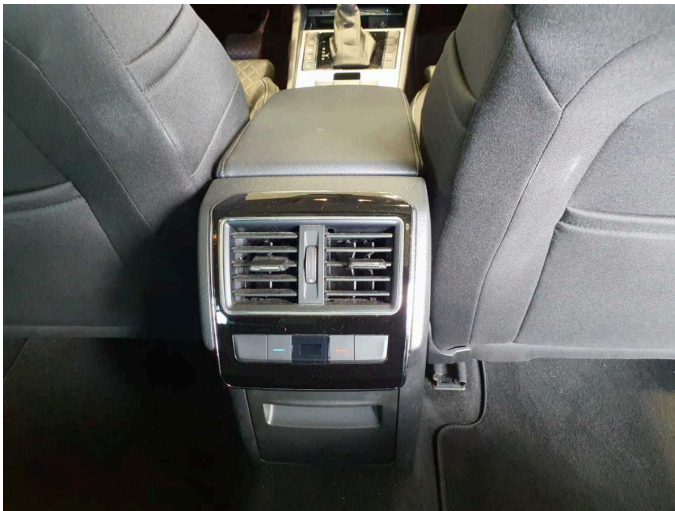
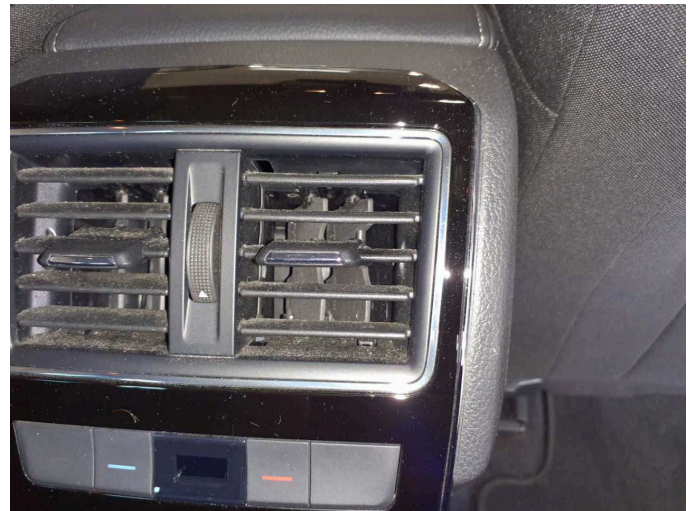
**Damage 9:** Instrument panel: Air nozzle - centre (Hinten) - Damaged - Replace

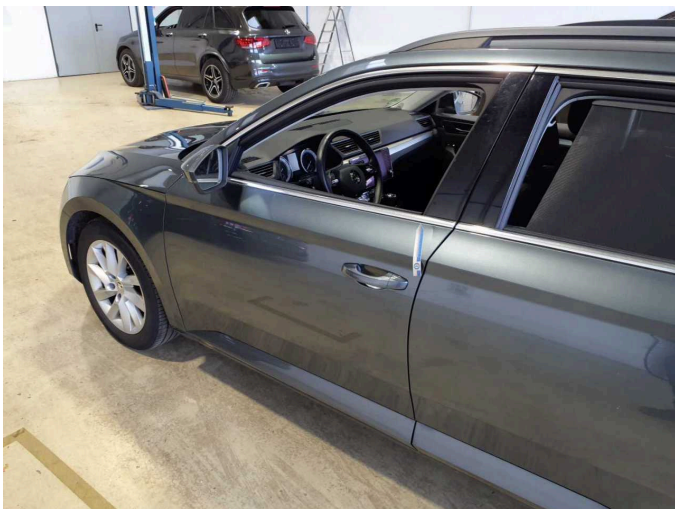
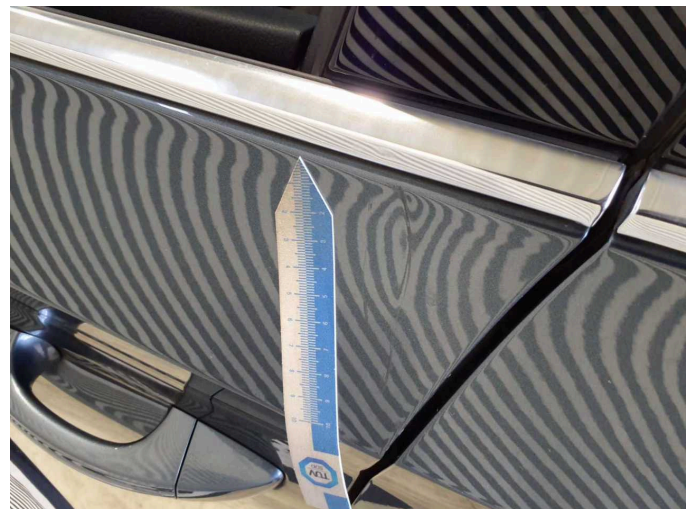
**Damage 10:** Door - front left side: Door - Deformed - Repair and paint

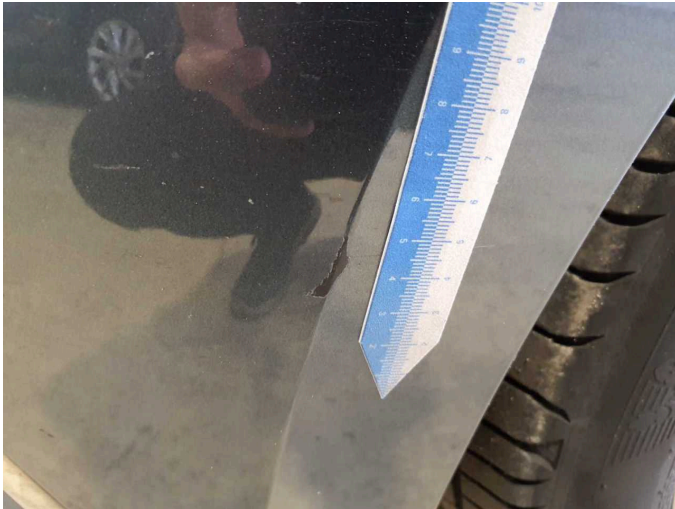
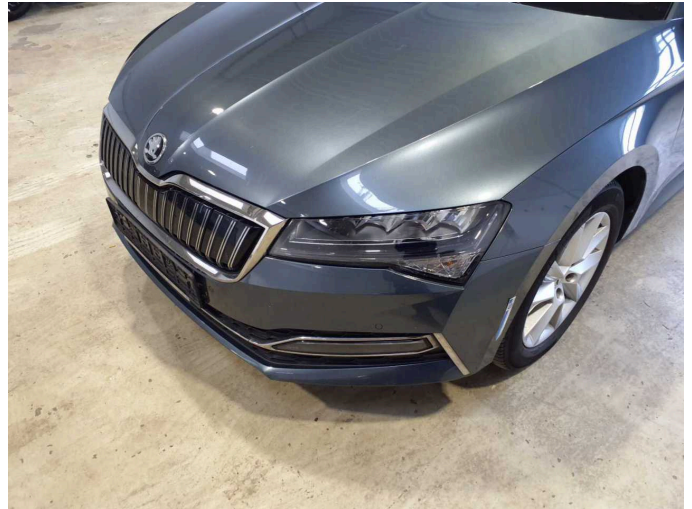
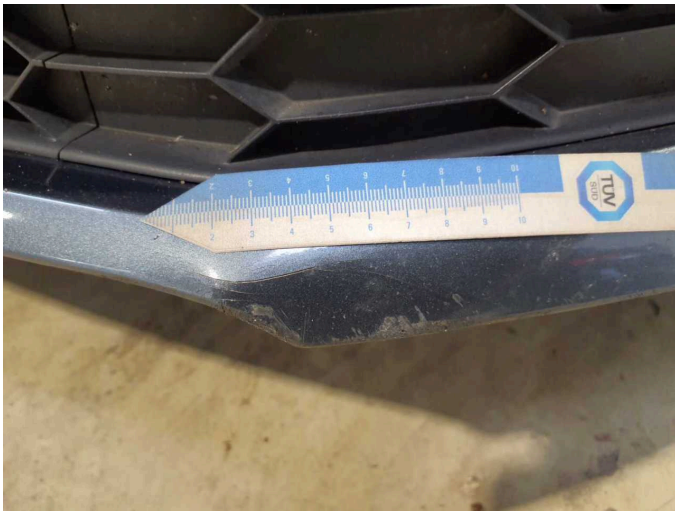
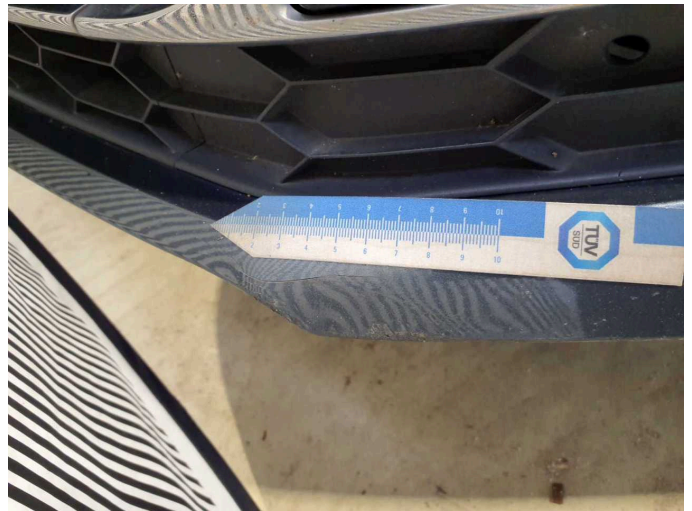
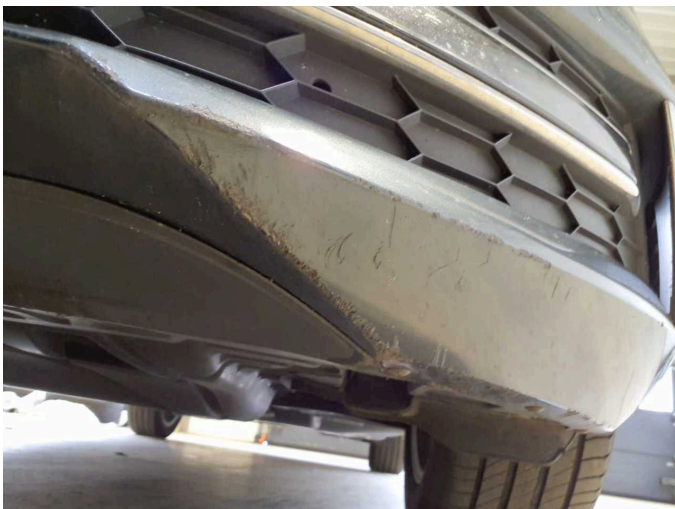
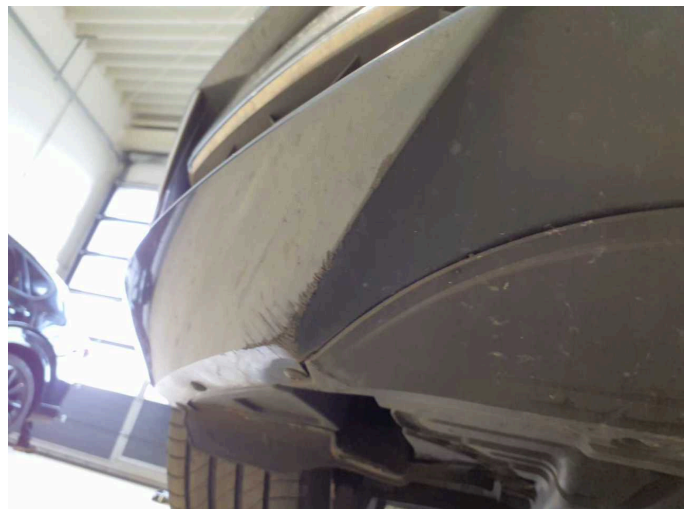
**Damage 11:** Front bumper: Front bumper - Dent / paintcoat damage - Repair and paint

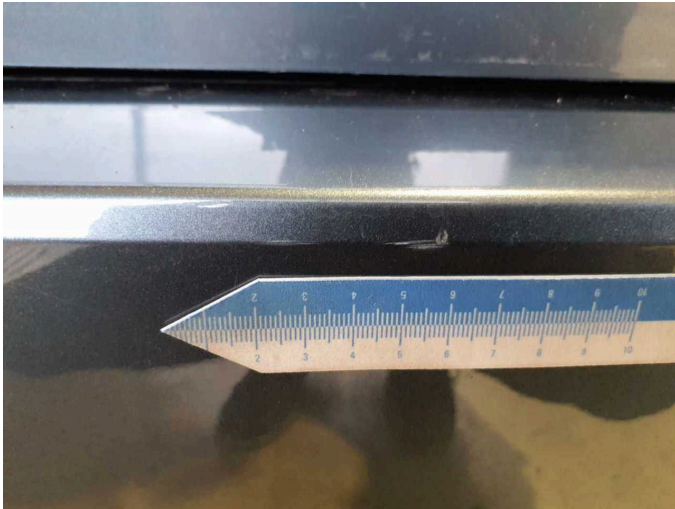
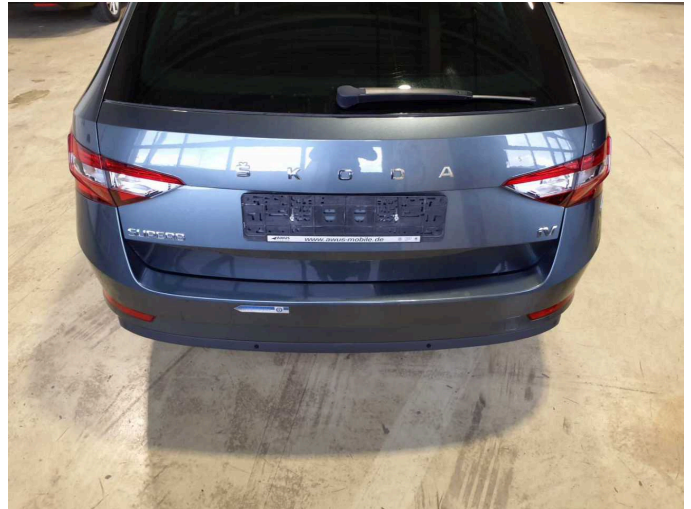
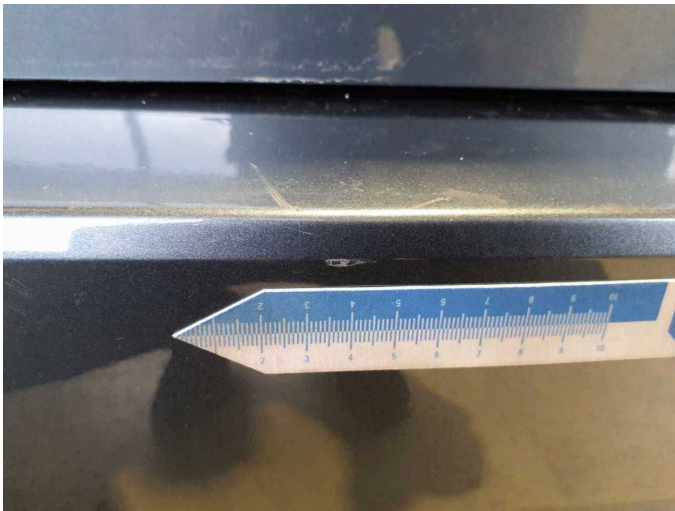
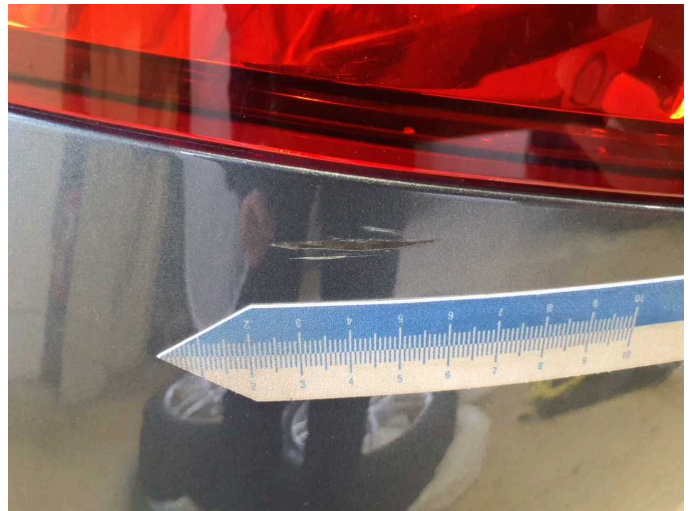
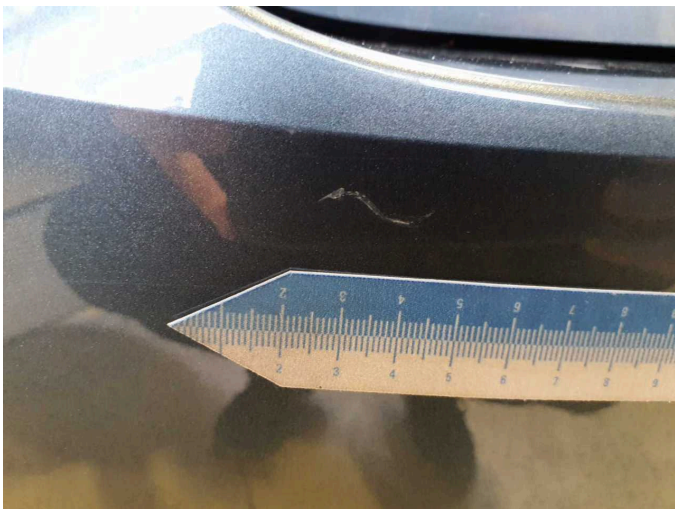
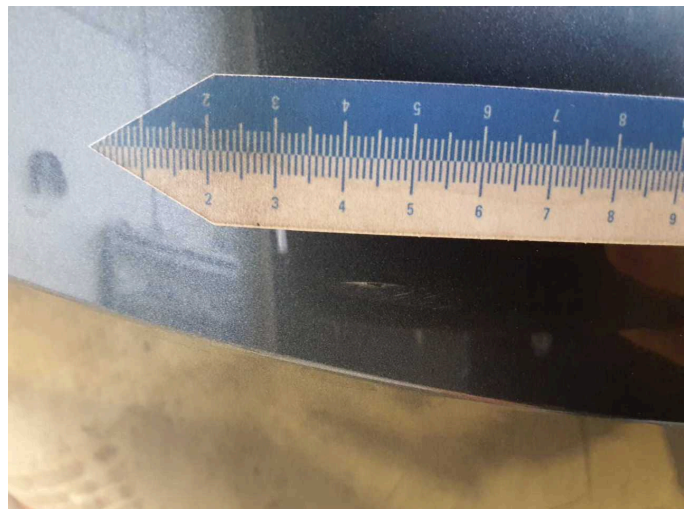
**Damage 12:** Rear bumper: Rear bumper - Scratch(es) - Paint

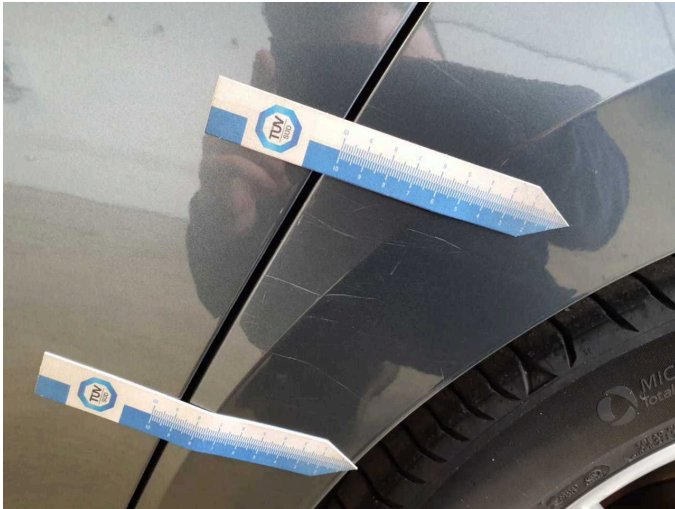
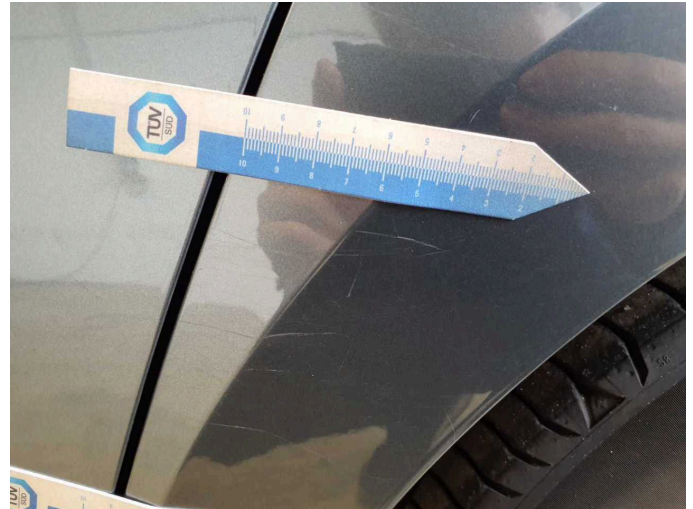
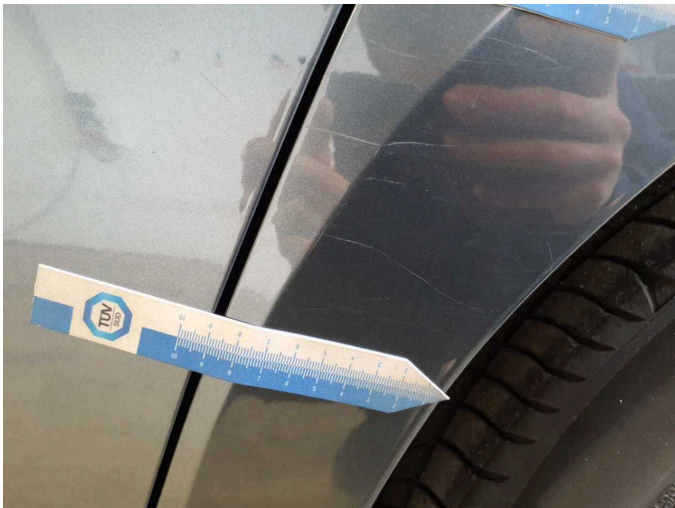
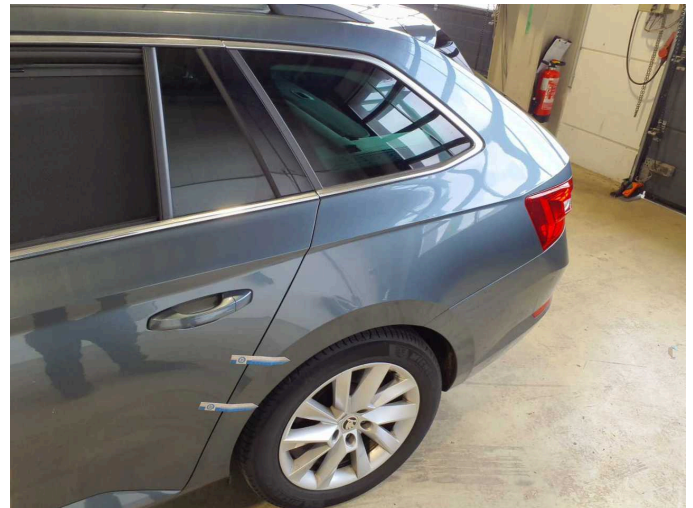
**Damage 13:** Side panel - rear left side: Side panel - Scratch(es) - Paint

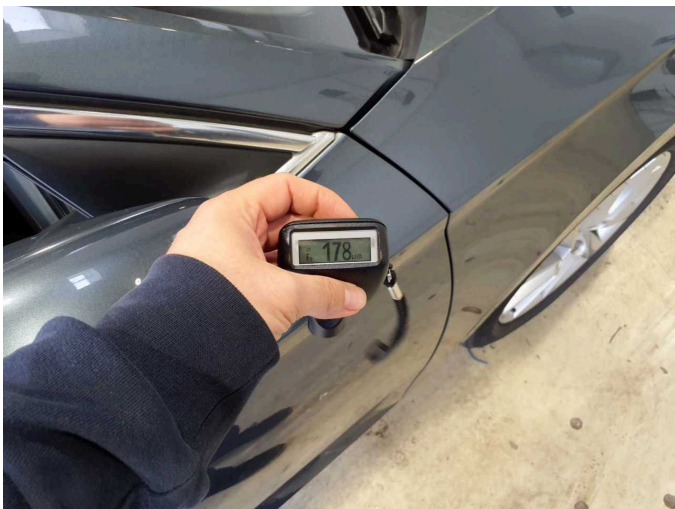
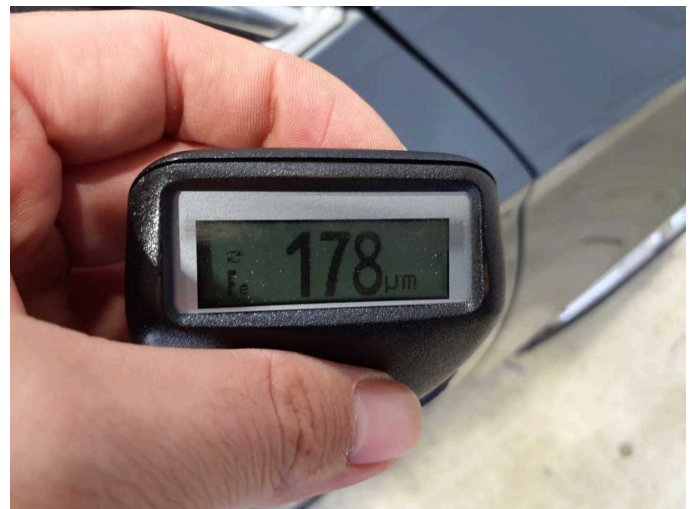
Door - front right side 178 µm

**Repainting 1:** Door - front right side
