Expertise

Protocol number: 41202101
Order No. / Reference: 25113827
Inspection date: 20 Aug 2025

Manufacturer: Skoda
VIN: TMBJW7NP7M7062123

Model: Superb Combi 1.4 TSI iV DSG Sportline

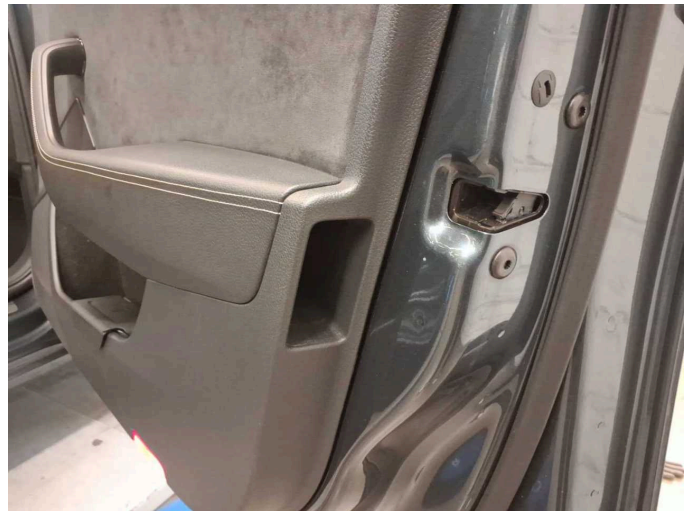
Damage 1: Interior: Umbrella - Missing - Replace

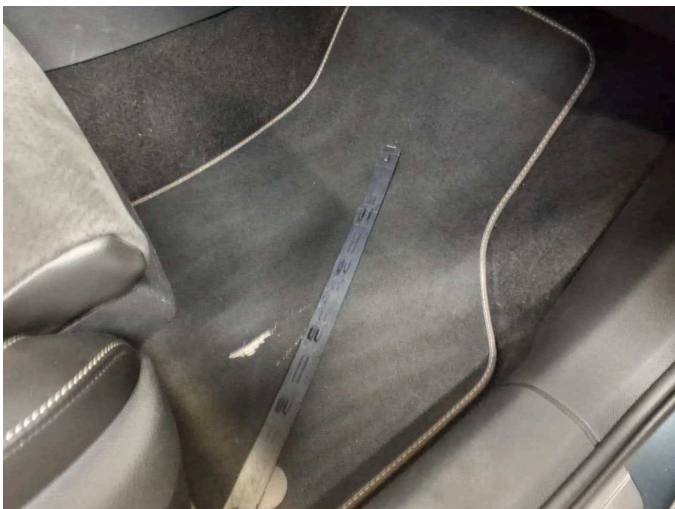
Damage 2: Trim / covers: Floor mats - Holes - Replace

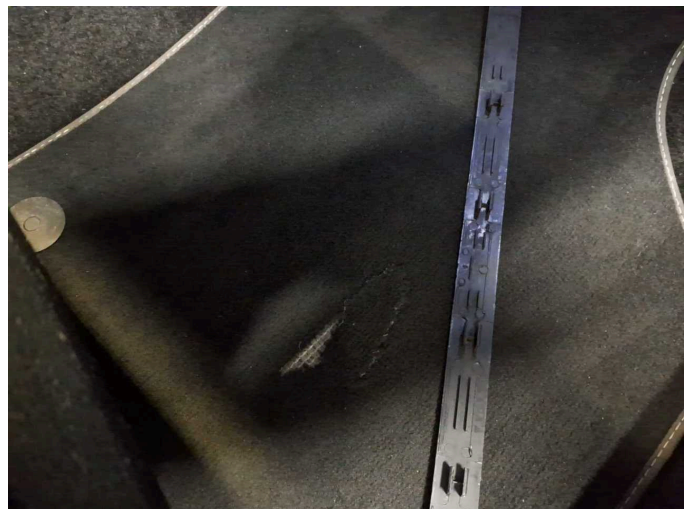
Damage 2: Trim / covers: Floor mats - Holes - Replace

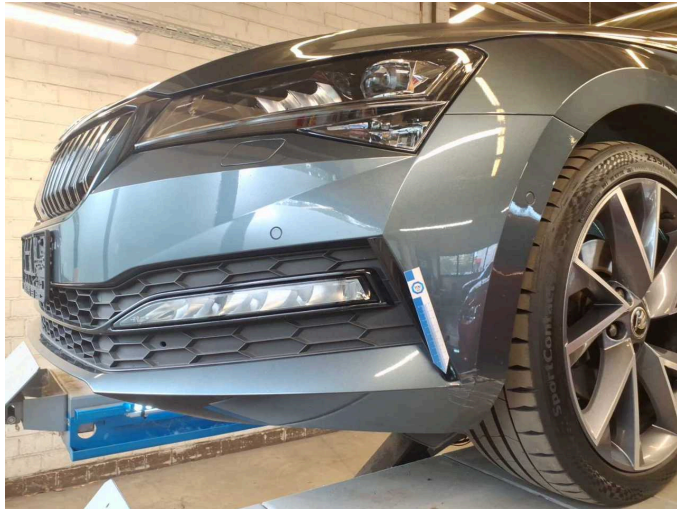
Damage 3: Trim / covers: Brightware / decorative strip - Scratch(es) - Smart repair

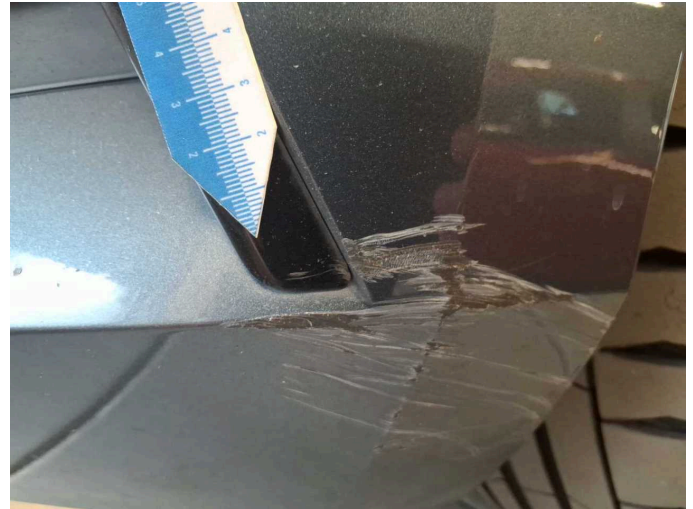
Damage 3: Trim / covers: Brightware / decorative strip - Scratch(es) - Smart repair

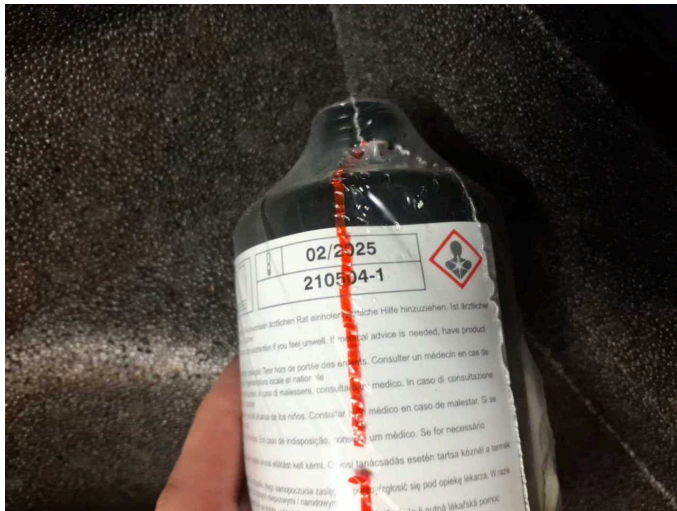
Damage 4: Equipment: Tirefit filler - Expired - Replace

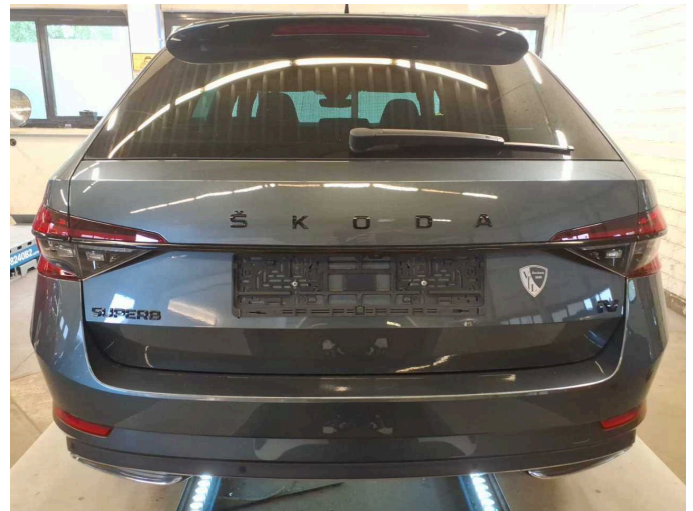
Damage 5: Boot lid / rear door: Boot lid - Glued / labelled - De-glue / neutralise

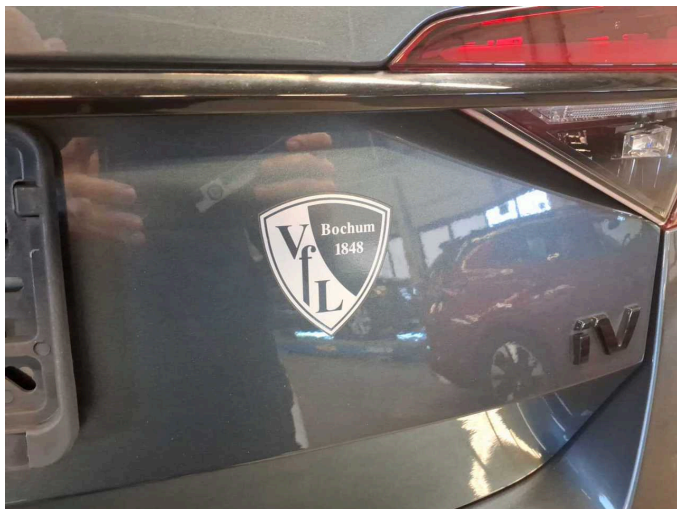
Damage 5: Boot lid / rear door: Boot lid - Glued / labelled - De-glue / neutralise

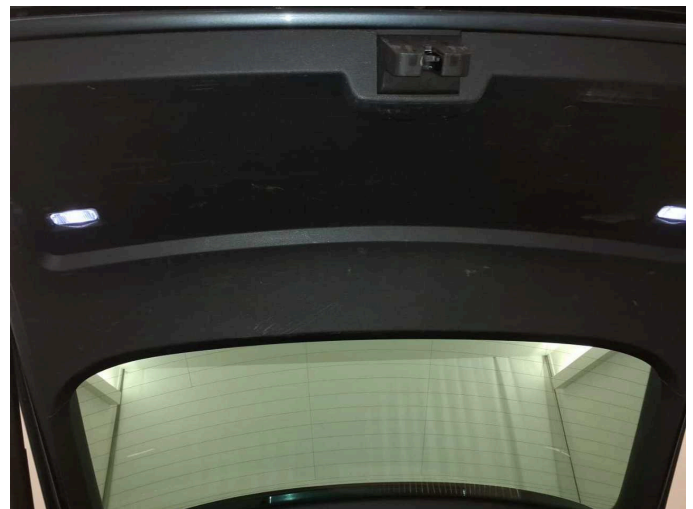
Damage 6: Trim / covers: Boot lid - interior trim - Scratched - Loss in value

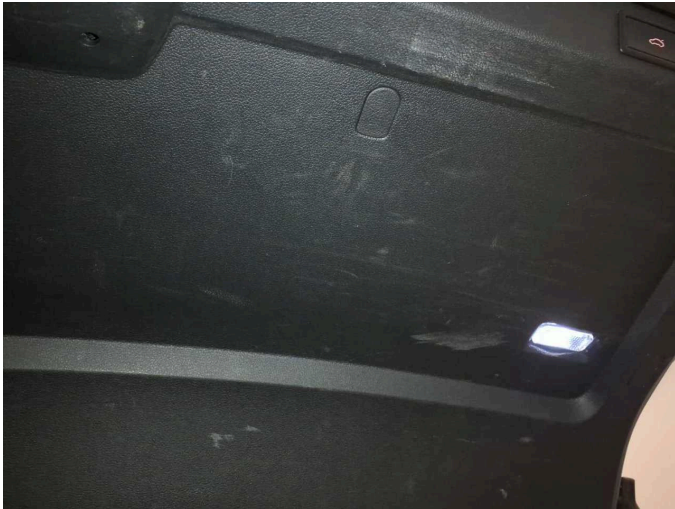
Damage 6: Trim / covers: Boot lid - interior trim - Scratched - Loss in value

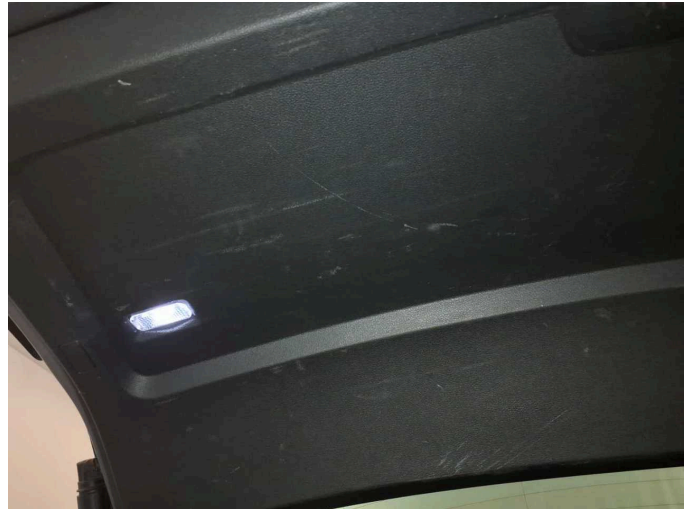
Damage 6: Trim / covers: Boot lid - interior trim - Scratched - Loss in value

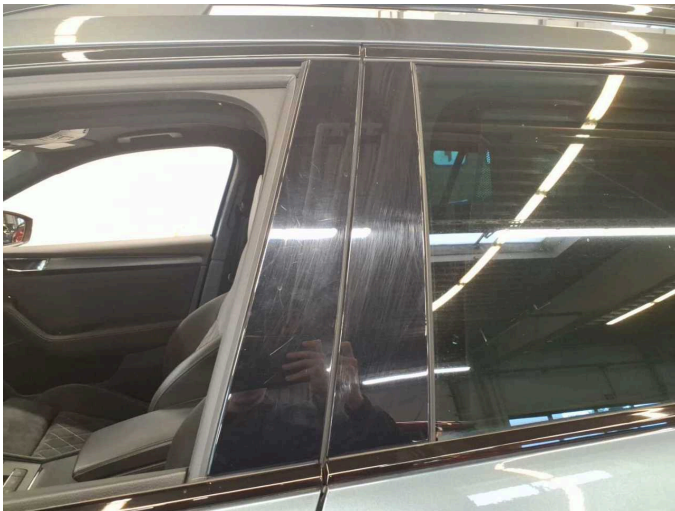
Damage 7: Trim / covers: Brightware / decorative strip - Scratch(es) - Loss in value

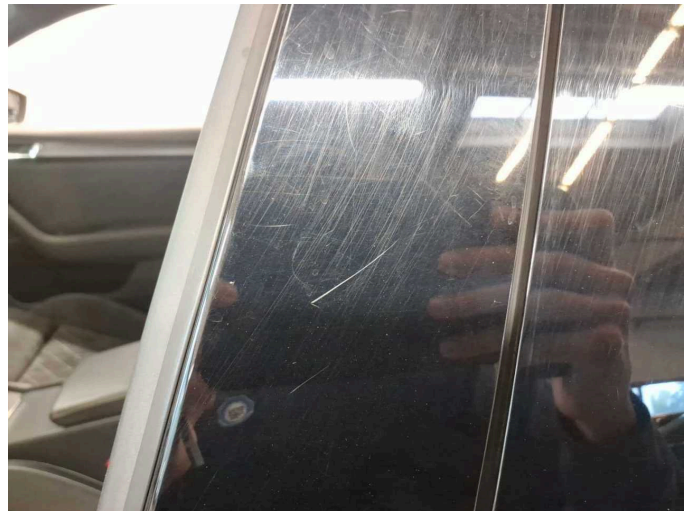
Damage 7: Trim / covers: Brightware / decorative strip - Scratch(es) - Loss in value

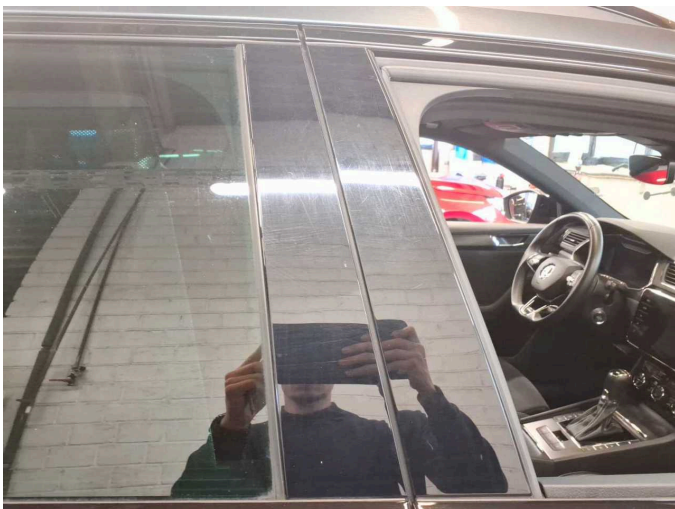
Damage 7: Trim / covers: Brightware / decorative strip - Scratch(es) - Loss in value

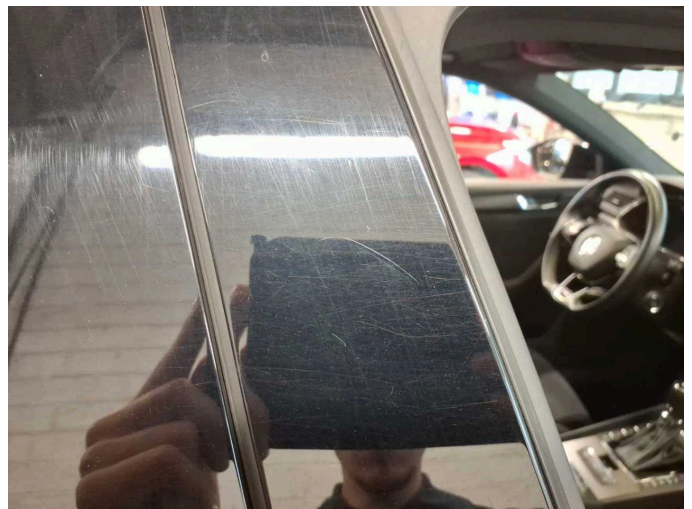
Damage 7: Trim / covers: Brightware / decorative strip - Scratch(es) - Loss in value

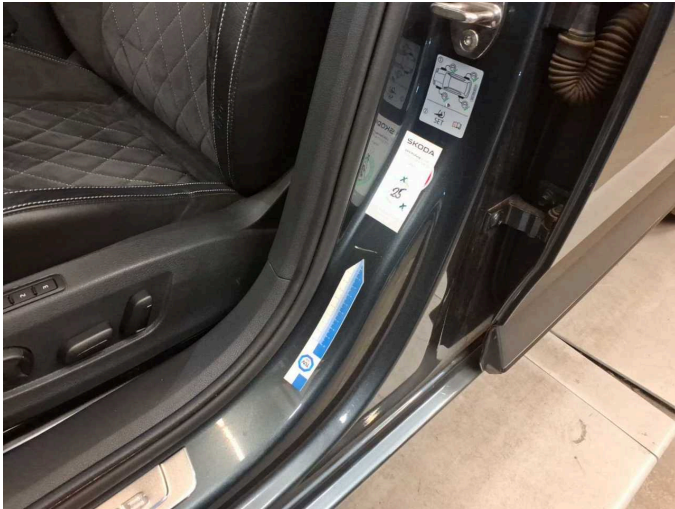
Damage 8: Sill - left side: Sill - Scratch(es) - Smart repair

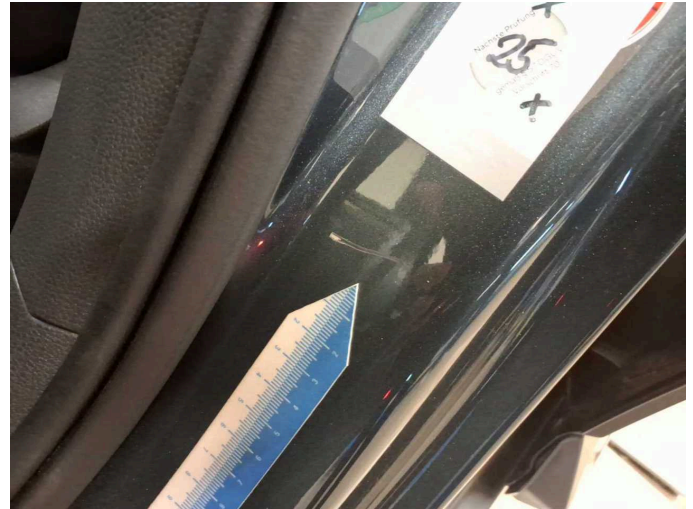
Damage 8: Sill - left side: Sill - Scratch(es) - Smart repair

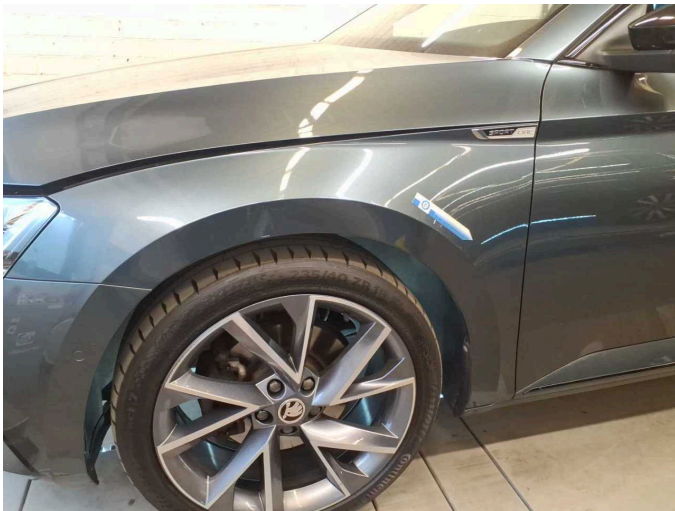
Damage 9: Mudguard - left side: Mudguard - left side - Scratch(es) - Smart repair

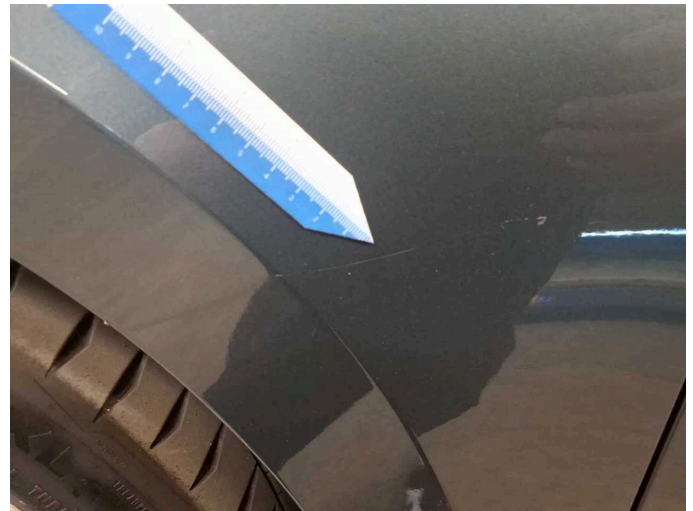
Damage 9: Mudguard - left side: Mudguard - left side - Scratch(es) - Smart repair

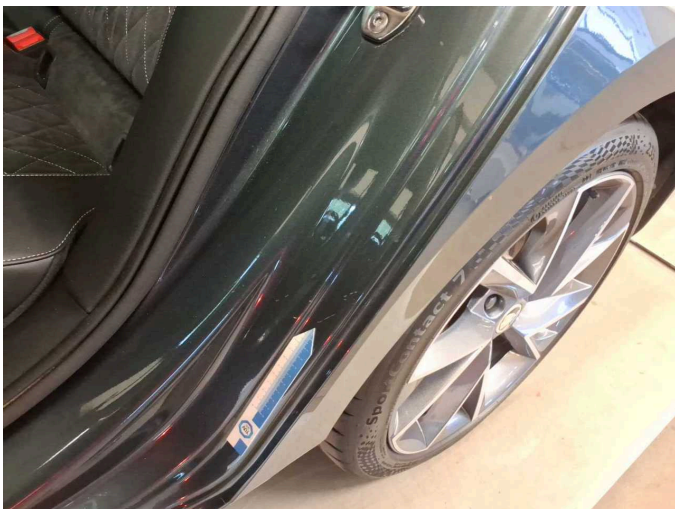
Damage 10: Side panel - rear left side: Sill - Scratch(es) - Smart repair

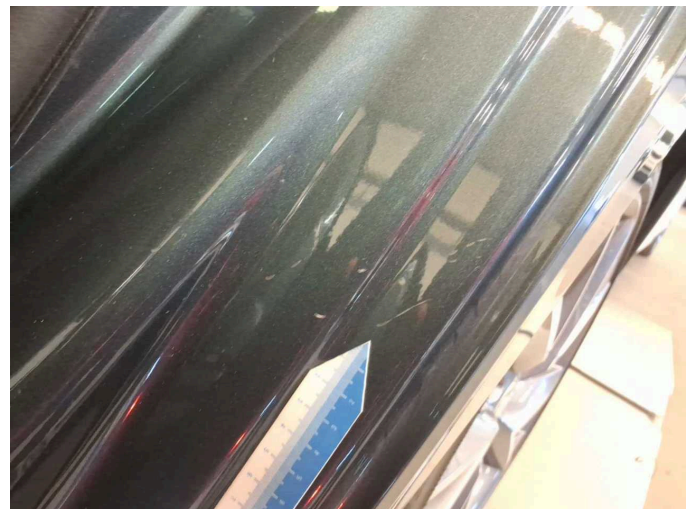
Damage 10: Side panel - rear left side: Sill - Scratch(es) - Smart repair

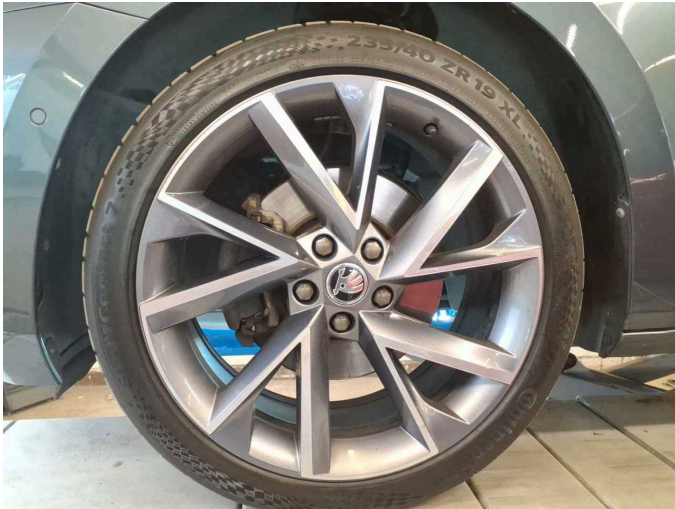
Damage 11: Wheel / tyres: Alloy rim - front left side - Scratch(es) - Loss in value

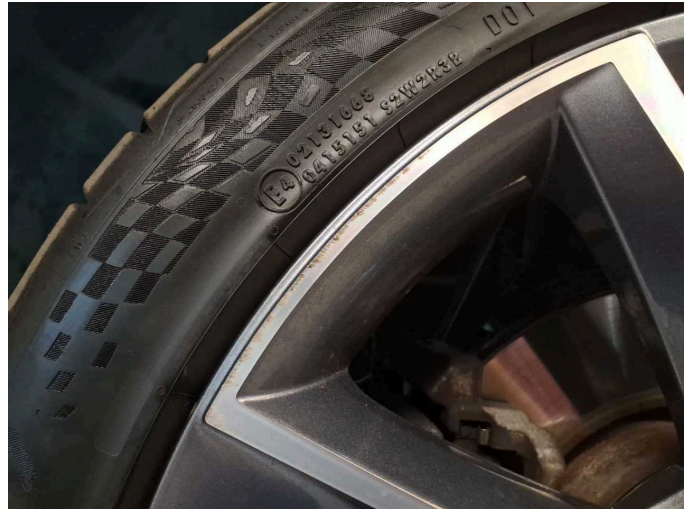
Damage 11: Wheel / tyres: Alloy rim - front left side - Scratch(es) - Loss in value

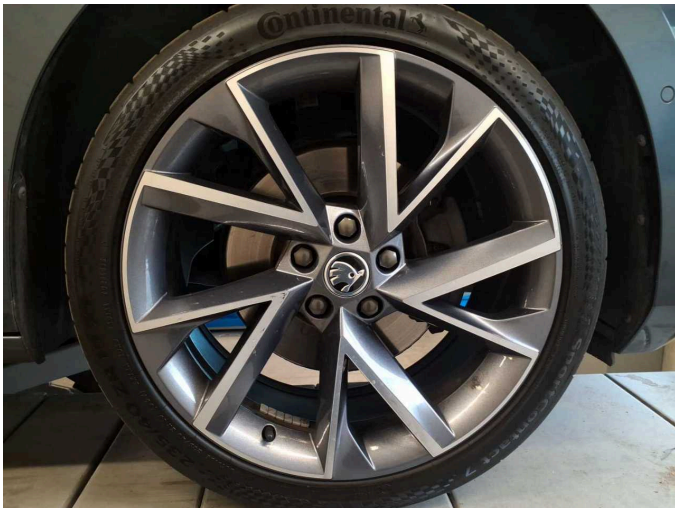
Damage 12: Wheel / tyres: Alloy rim - front right side - Scratch(es) - Loss in value

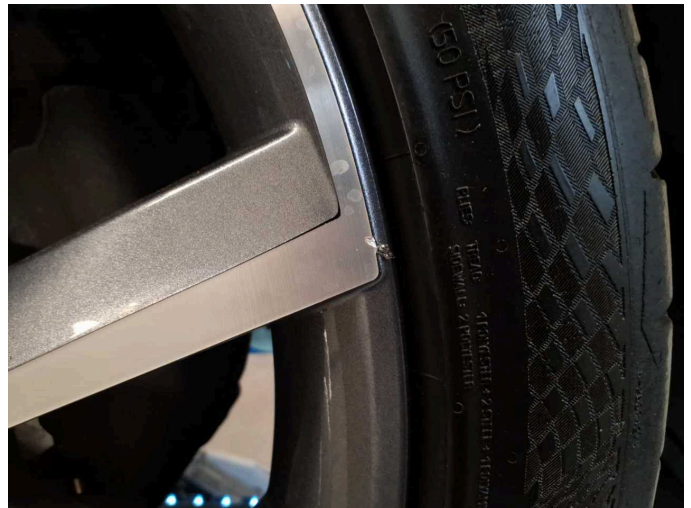
Damage 12: Wheel / tyres: Alloy rim - front right side - Scratch(es) - Loss in value

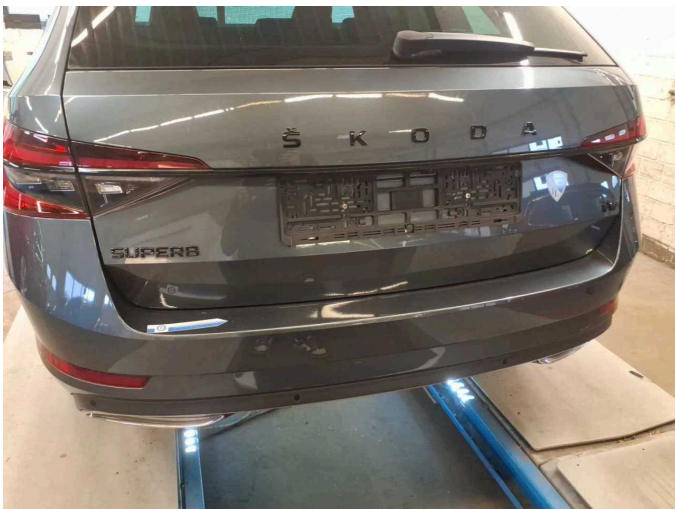
Damage 13: Rear bumper: Rear bumper - Scratch(es) - Paint

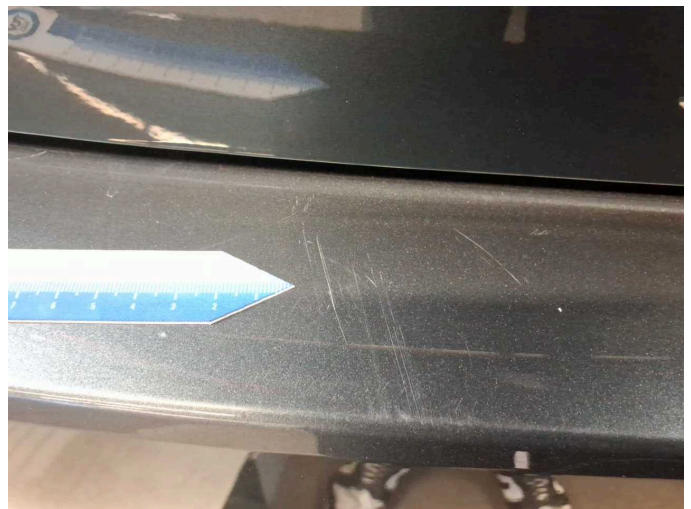
Damage 13: Rear bumper: Rear bumper - Scratch(es) - Paint

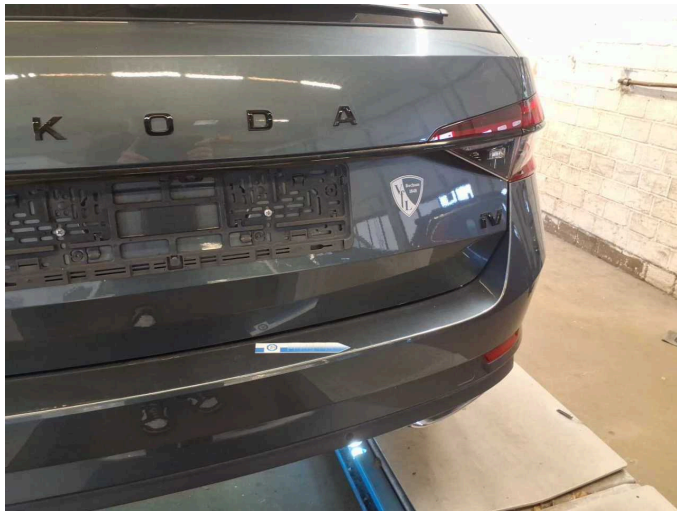
Damage 13: Rear bumper: Rear bumper - Scratch(es) - Paint

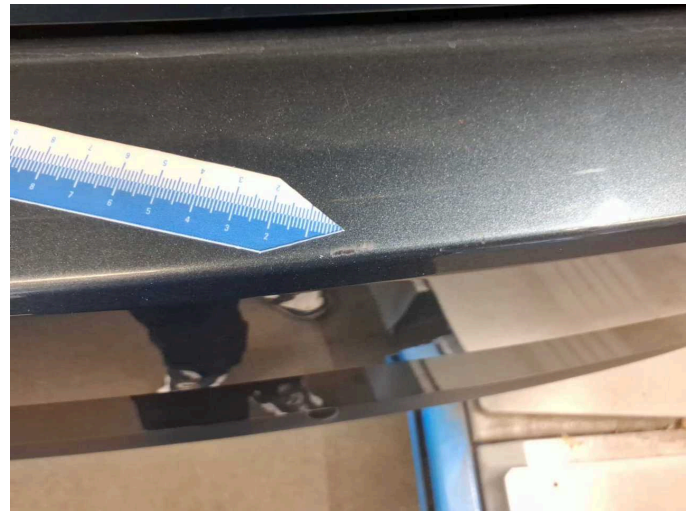
Damage 13: Rear bumper: Rear bumper - Scratch(es) - Paint

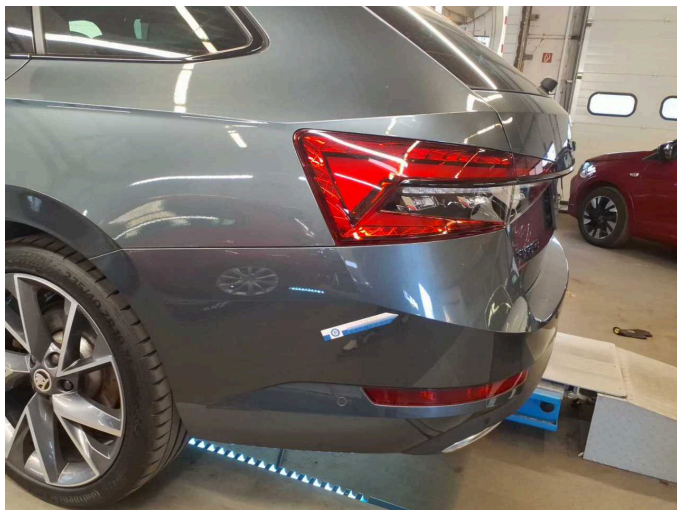
Damage 13: Rear bumper: Rear bumper - Scratch(es) - Paint

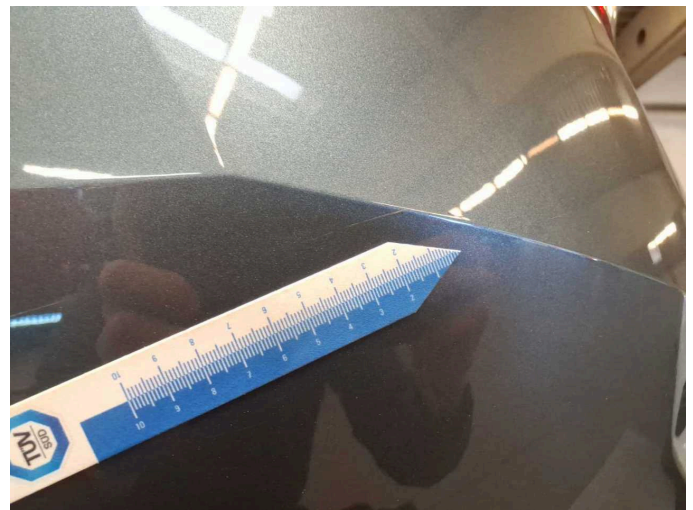
Damage 13: Rear bumper: Rear bumper - Scratch(es) - Paint

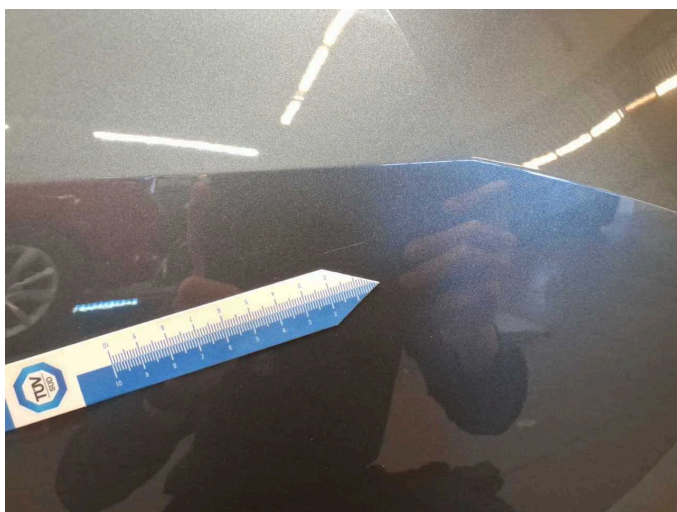
Damage 13: Rear bumper: Rear bumper - Scratch(es) - Paint

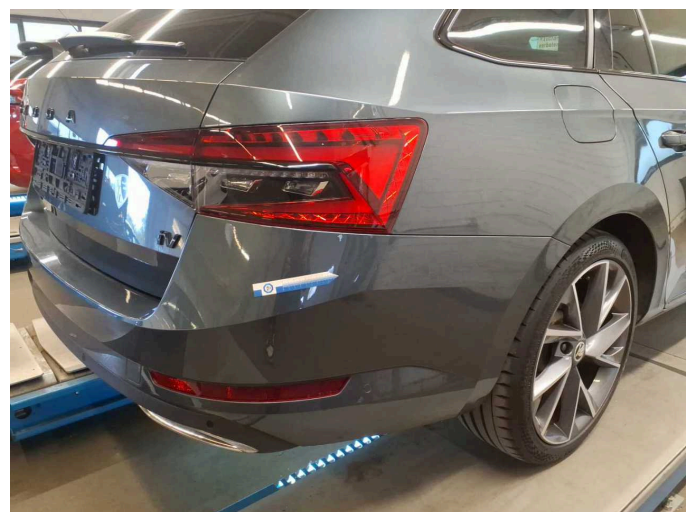
Damage 13: Rear bumper: Rear bumper - Scratch(es) - Paint

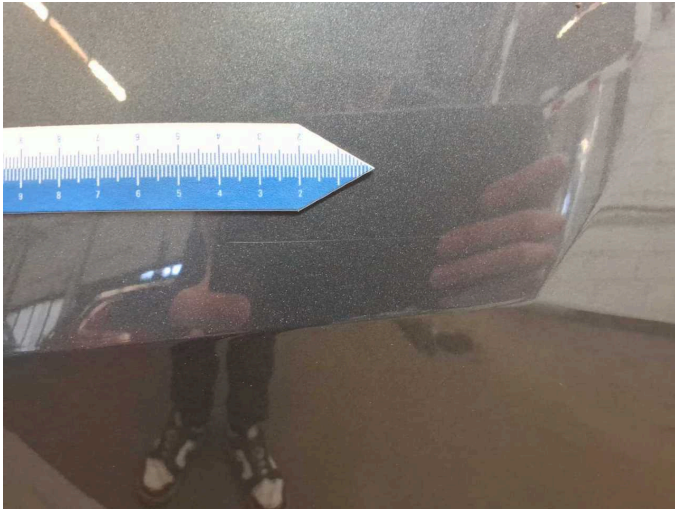
Damage 13: Rear bumper: Rear bumper - Scratch(es) - Paint

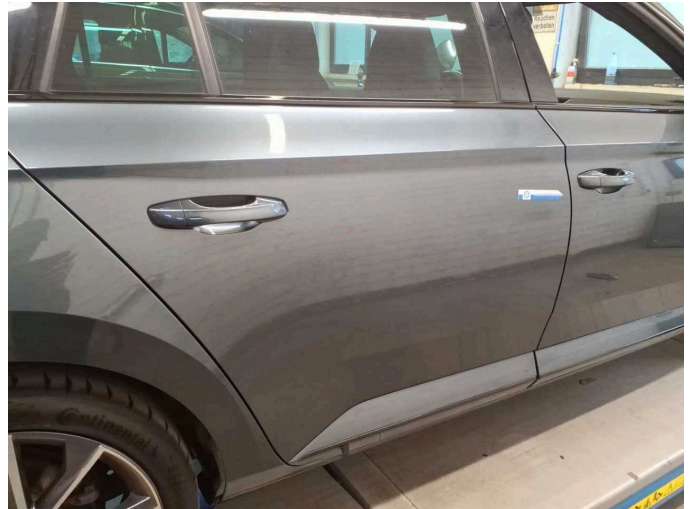
Damage 14: Door - rear right side: Door - Scratch(es) - Paint

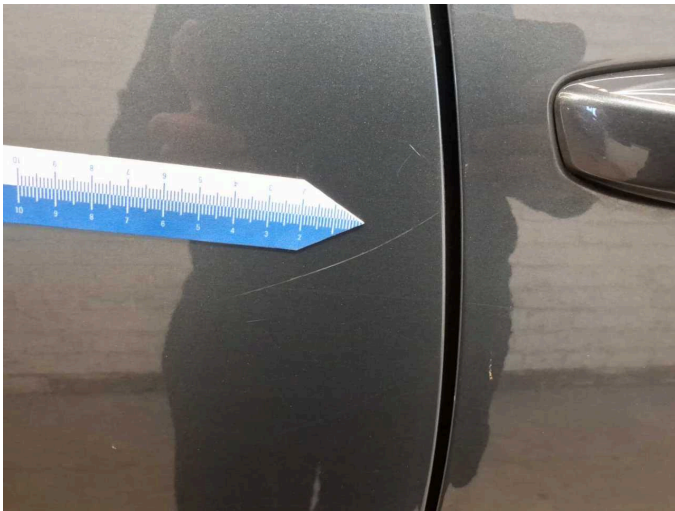
Damage 14: Door - rear right side: Door - Scratch(es) - Paint

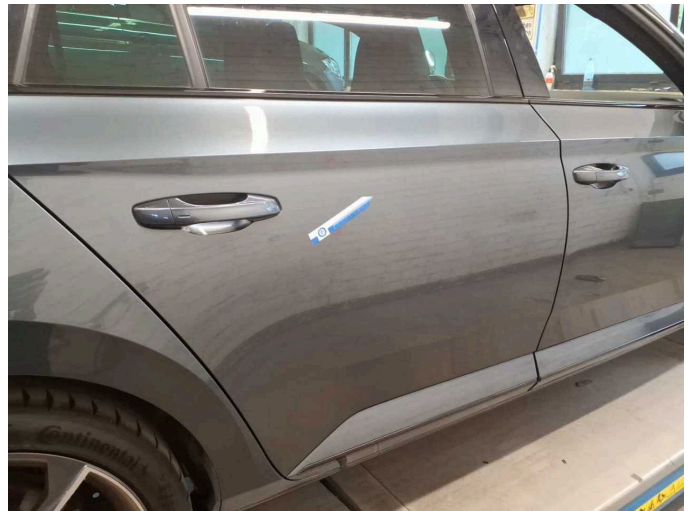
Damage 14: Door - rear right side: Door - Scratch(es) - Paint

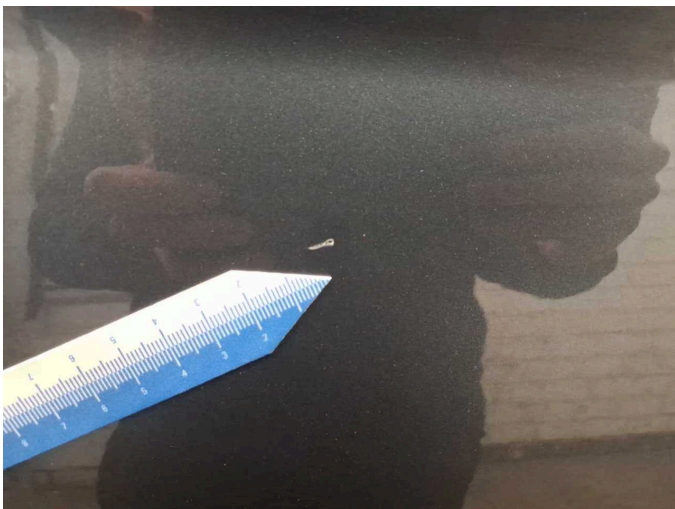
Damage 14: Door - rear right side: Door - Scratch(es) - Paint

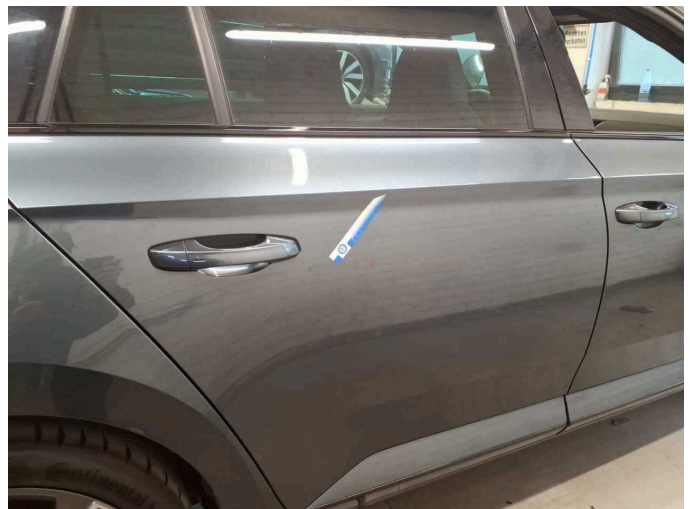
Damage 14: Door - rear right side: Door - Scratch(es) - Paint

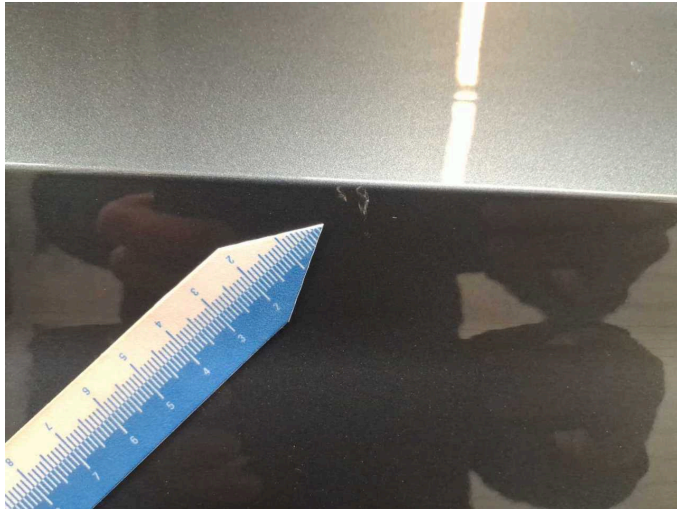
Damage 14: Door - rear right side: Door - Scratch(es) - Paint

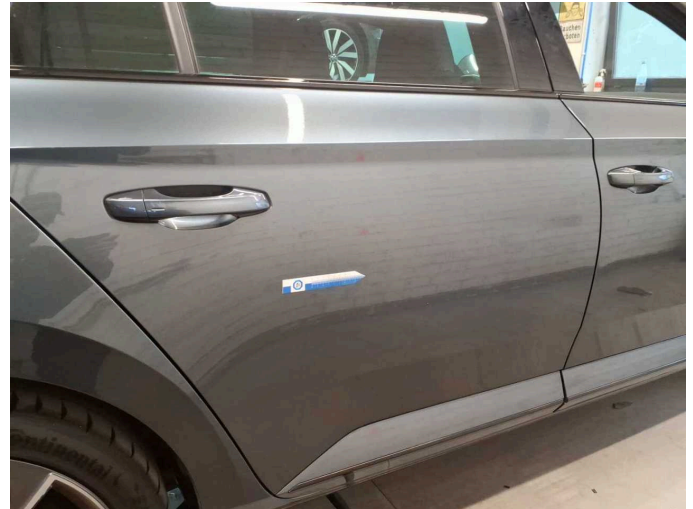
Damage 14: Door - rear right side: Door - Scratch(es) - Paint

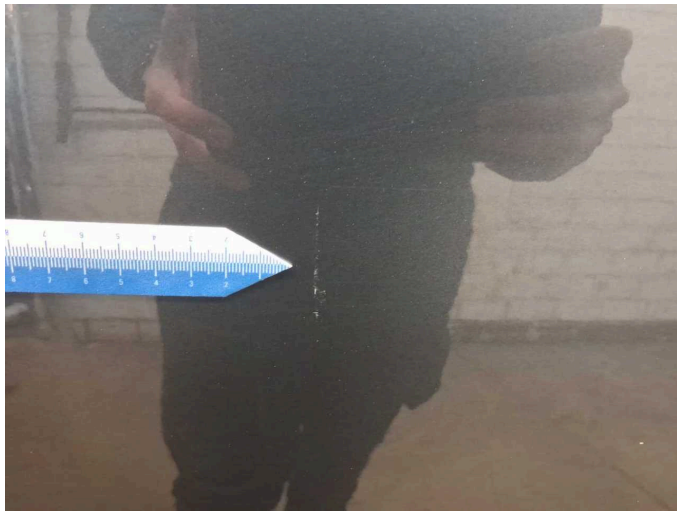
Damage 14: Door - rear right side: Door - Scratch(es) - Paint

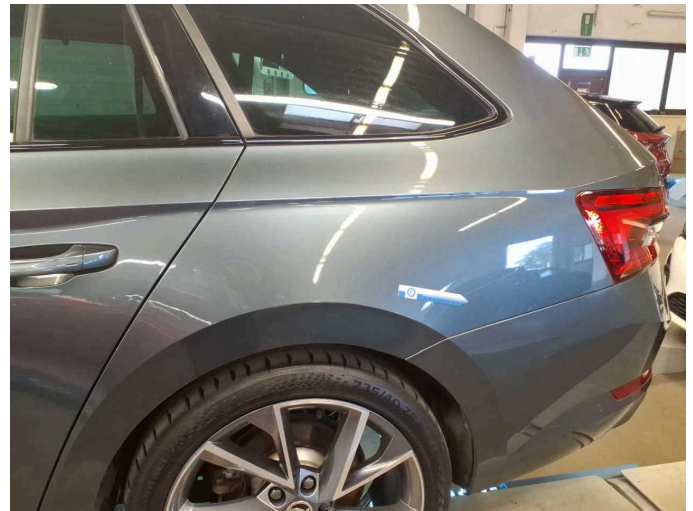
Damage 15: Side panel - rear left side: Side panel - Dent / paintcoat damage - Repair and paint

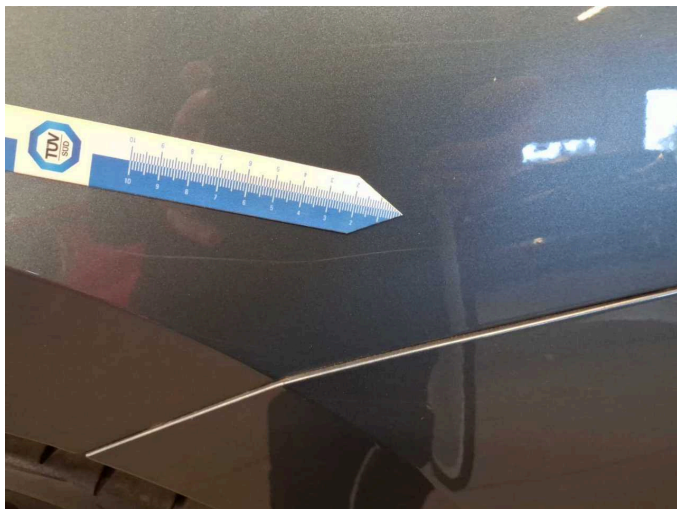
Damage 15: Side panel - rear left side: Side panel - Dent / paintcoat damage - Repair and paint

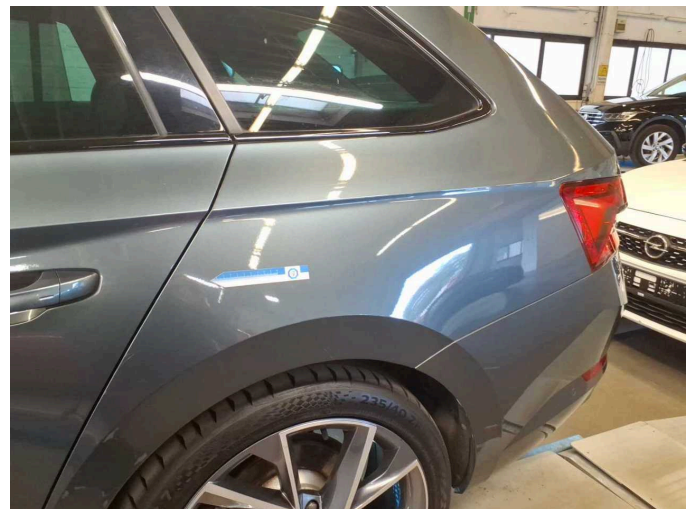
Damage 15: Side panel - rear left side: Side panel - Dent / paintcoat damage - Repair and paint

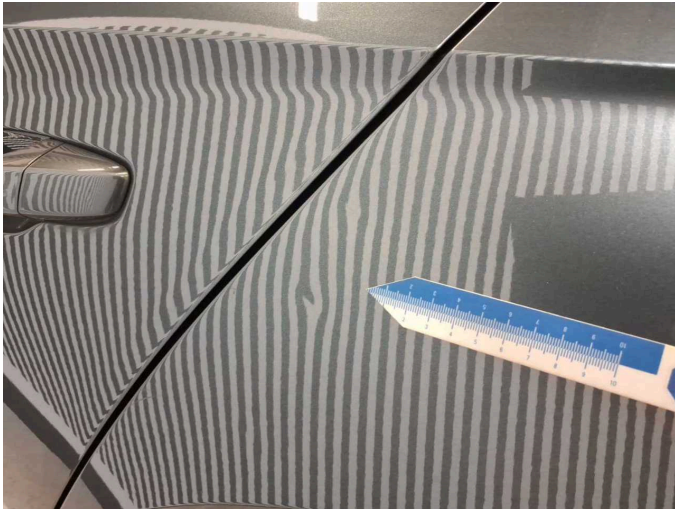
Damage 15: Side panel - rear left side: Side panel - Dent / paintcoat damage - Repair and paint

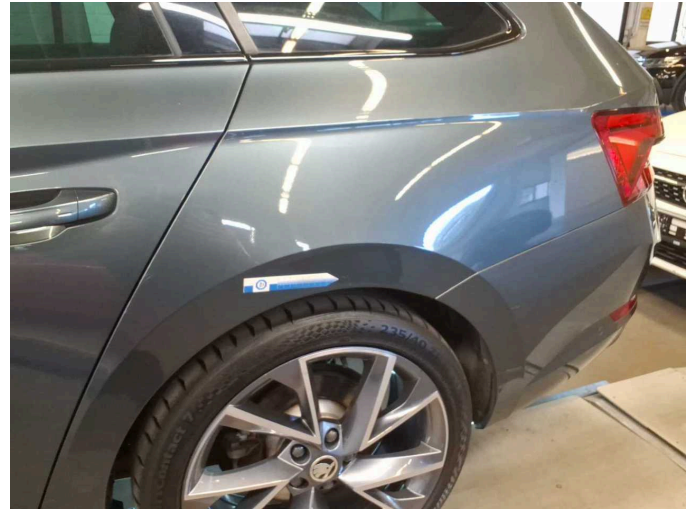
Damage 15: Side panel - rear left side: Side panel - Dent / paintcoat damage - Repair and paint

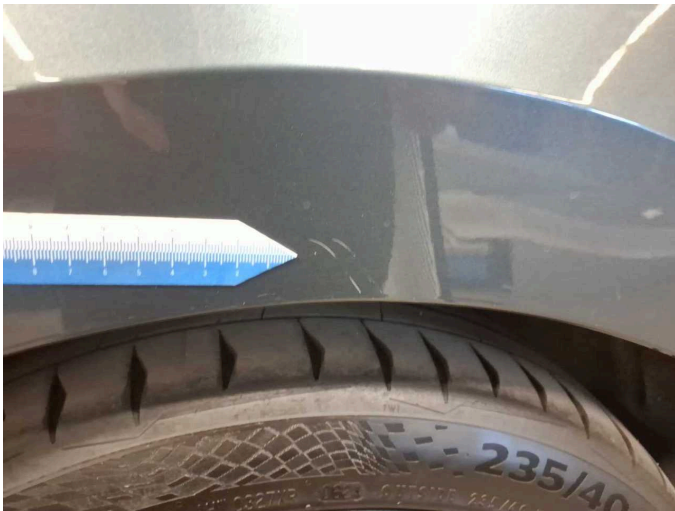
Damage 15: Side panel - rear left side: Side panel - Dent / paintcoat damage - Repair and paint

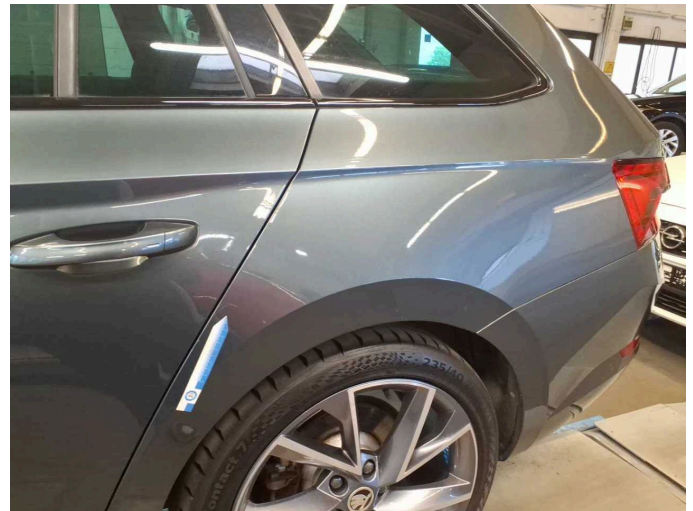
Damage 15: Side panel - rear left side: Side panel - Dent / paintcoat damage - Repair and paint

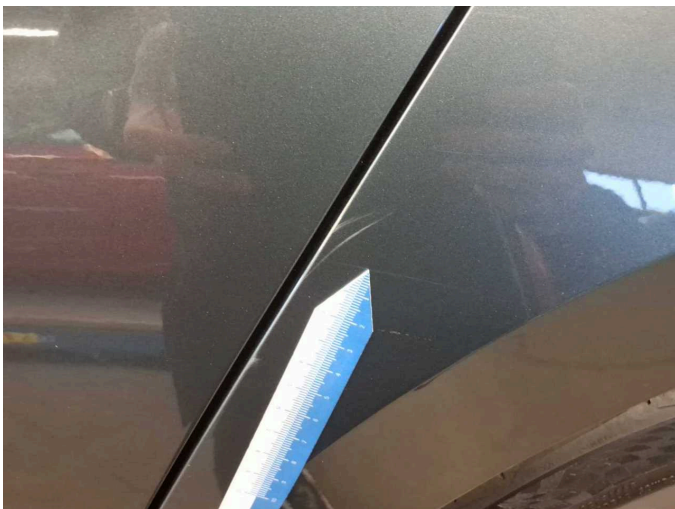
Damage 15: Side panel - rear left side: Side panel - Dent / paintcoat damage - Repair and paint

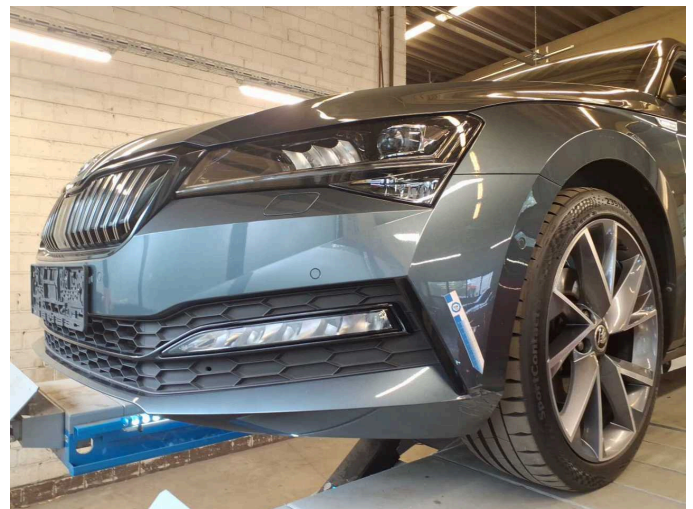
Damage 16: Front bumper: Front bumper - Scratch(es) - Paint

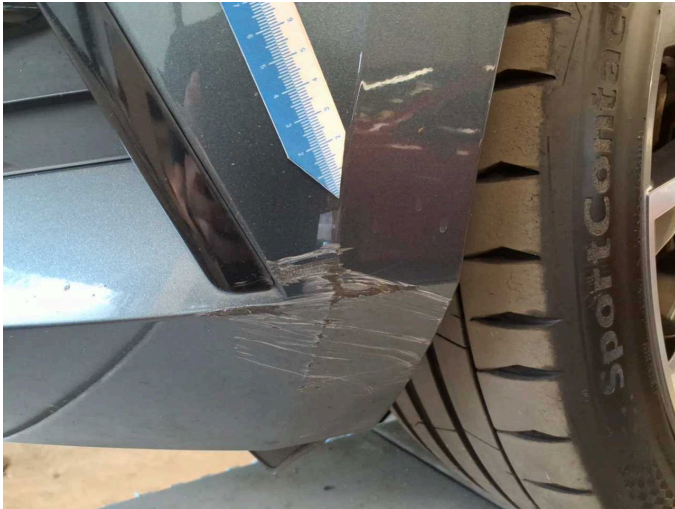
Damage 16: Front bumper: Front bumper - Scratch(es) - Paint

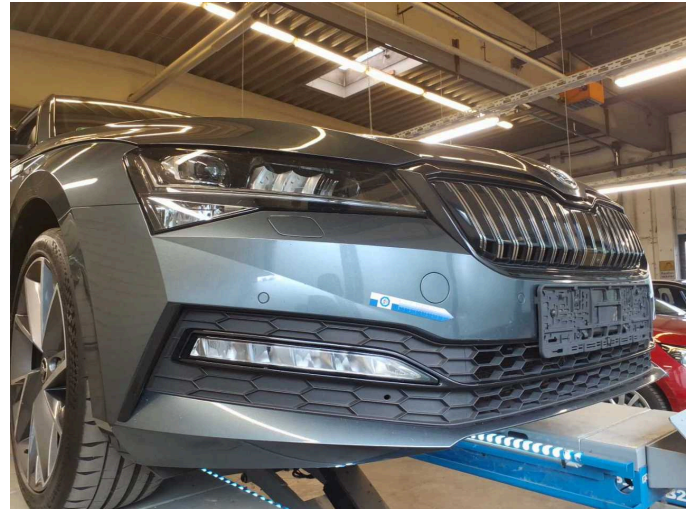
Damage 16: Front bumper: Front bumper - Scratch(es) - Paint

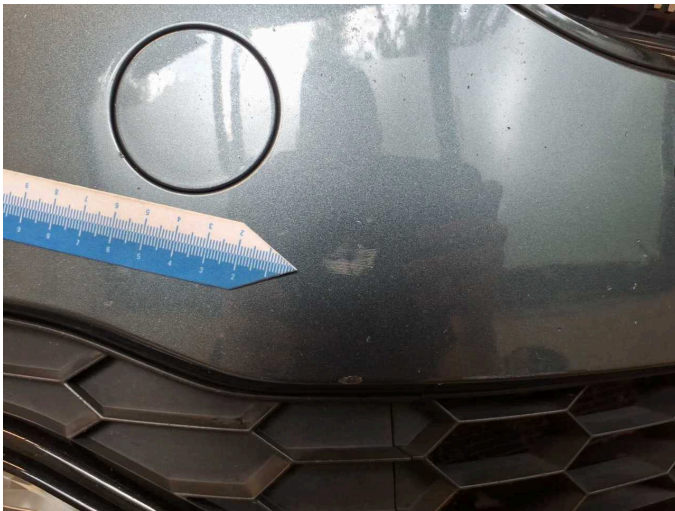
Damage 16: Front bumper: Front bumper - Scratch(es) - Paint

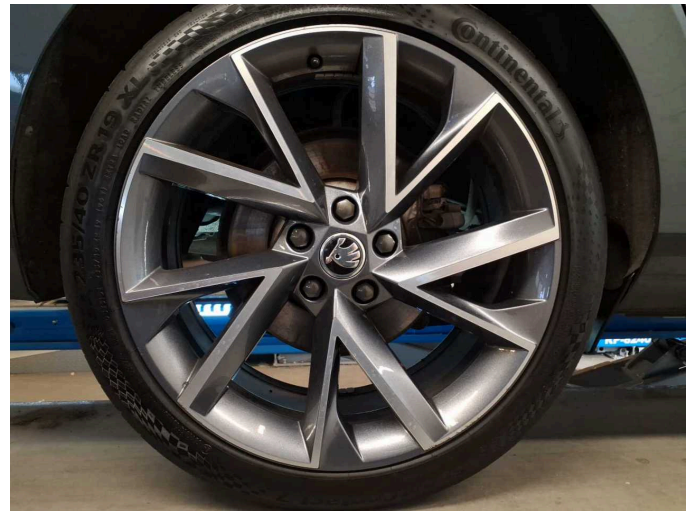
Damage 17: Wheel / tyres: Alloy rim - rear right side (Mit Materialabtrag) - Scratch(es) - Replace

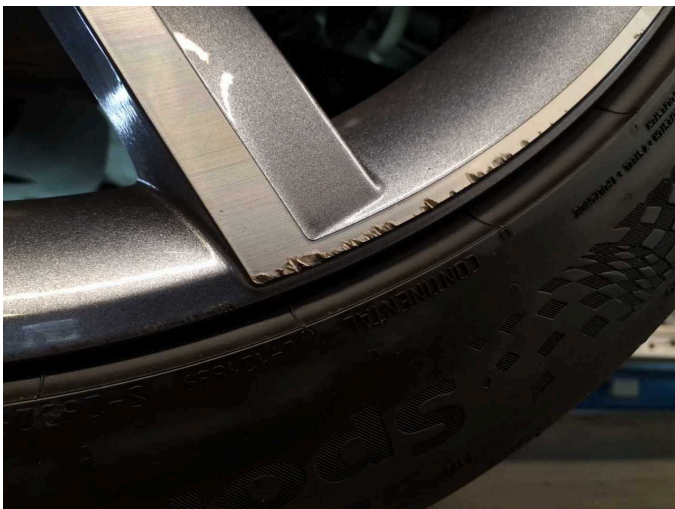
Damage 17: Wheel / tyres: Alloy rim - rear right side (Mit Materialabtrag) - Scratch(es) - Replace

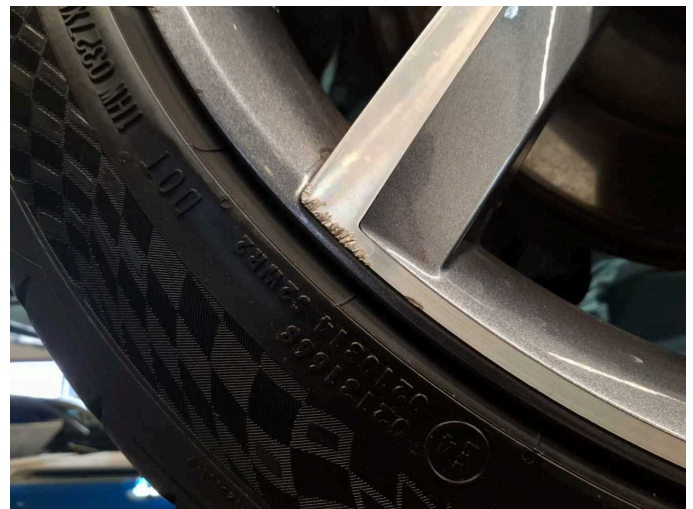
Damage 17: Wheel / tyres: Alloy rim - rear right side (Mit Materialabtrag) - Scratch(es) - Replace

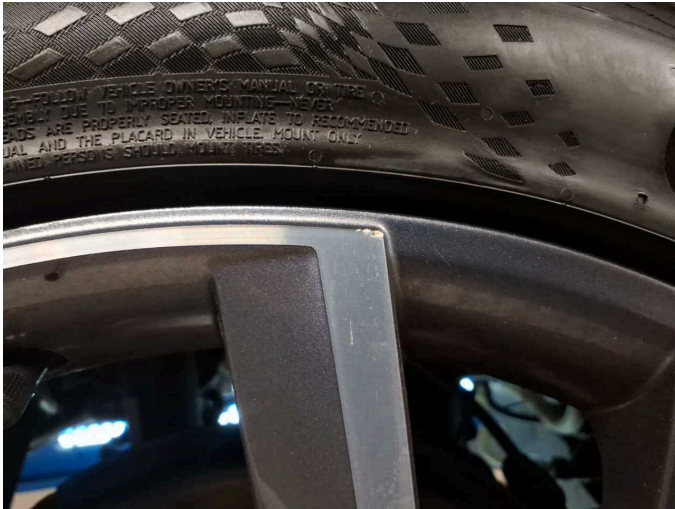
Damage 17: Wheel / tyres: Alloy rim - rear right side (Mit Materialabtrag) - Scratch(es) - Replace

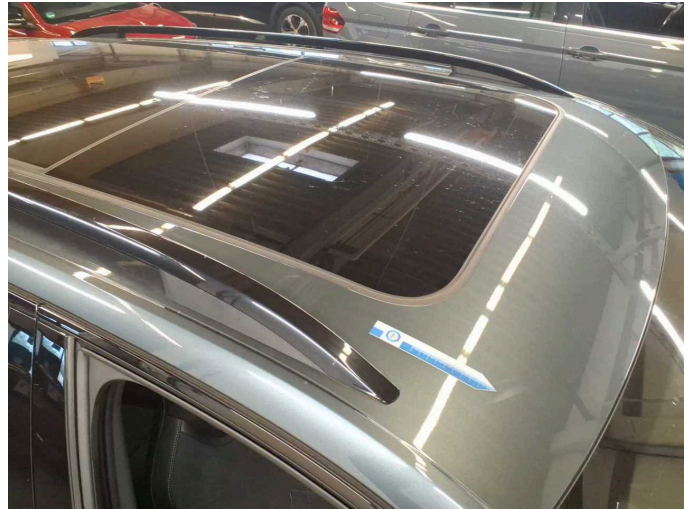
Damage 18: Roof: Roof - Scratch(es) - Paint

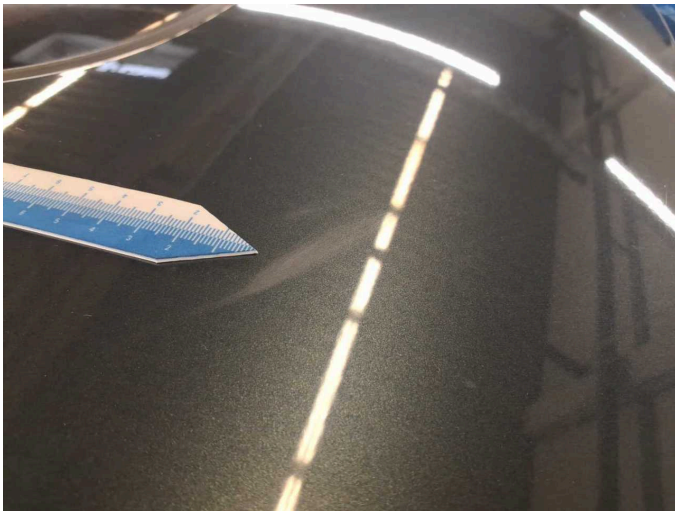
Damage 18: Roof: Roof - Scratch(es) - Paint
