SKODA Octavia Octavia 1.6 Combi

VIN NO TMBJX21U898852852
Registration Number U898852852

Inspection Report Summary

Customer	BCA Online	Report Number	P20250925115034
Inspection Date / Place	2025-09-25 / BCA Oberndorf	Cosmetic Grade	4

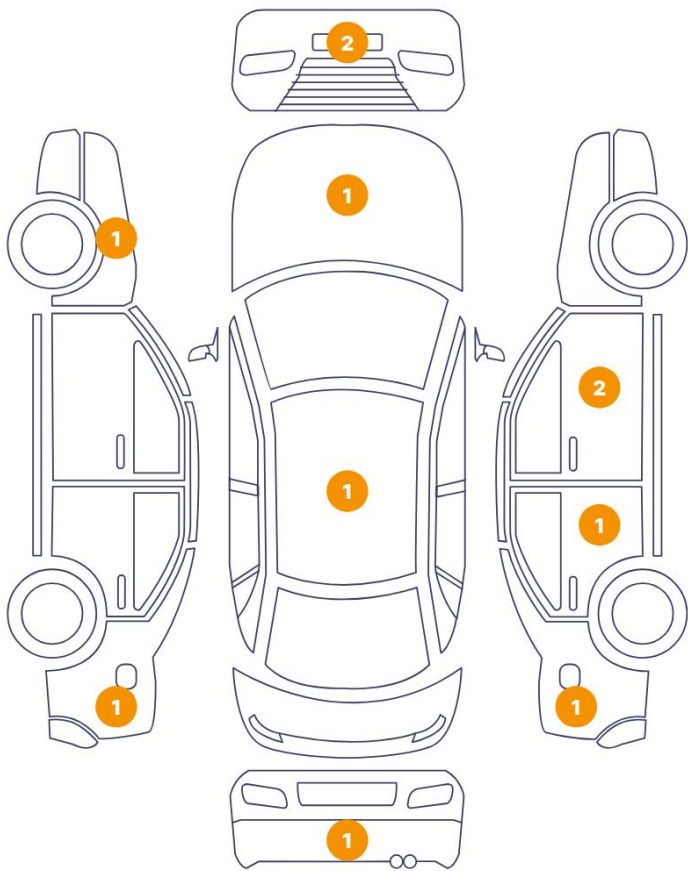
11 Schäden

Component		Damage	Comments
1	Hood	Bodywork / Dent / Dent	
2	Bumper / Front	Paint / Scratch / Scuff	
3	Roof	Bodywork / Dent / Dent	
4	Bumper / Front	Paint / Stone Chip	
5	Fender / Front Left	Paint / Scratch / Line	
6	Steering Wheel / Front	Interior / Scratched	
7	Seat / Front Left	Interior / Dirty	
8	Fender / Back Left	Bodywork / Dent / Dent	
9	Bumper / Back	Bodywork / Dent / Dent	
10	Fender / Back Right	Bodywork / Dent / Dent	
11	Door / Back Right	Paint / Scratch / Line	
12	Door / Front Right	Bodywork / Dent / Dent

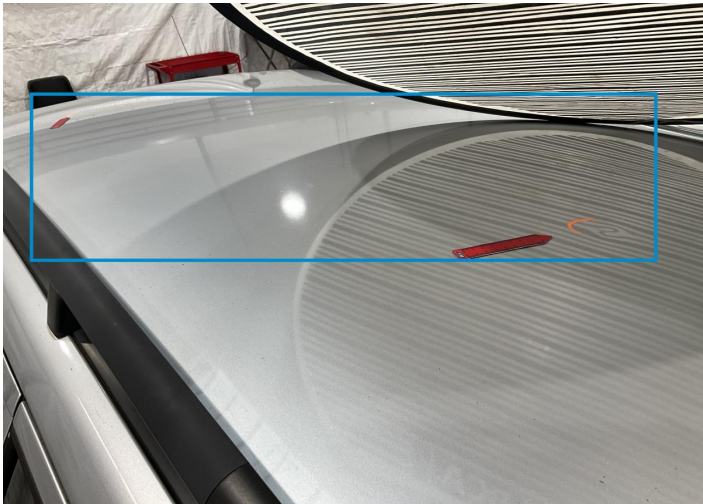
3. Roof
Bodywork / Dent / Dent -

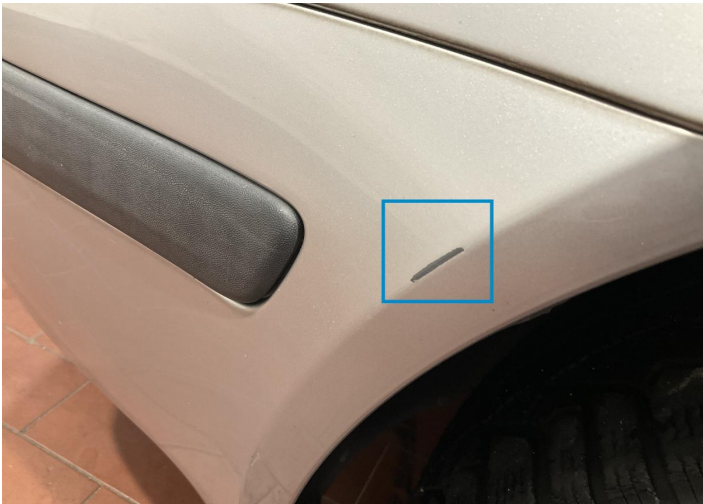
4. Bumper / Front
Paint / Stone Chip -

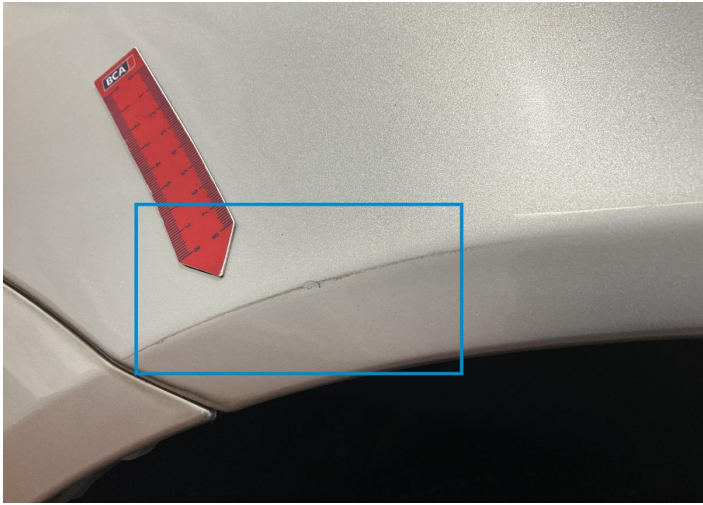
5. Fender / Front Left
Paint / Scratch / Line -

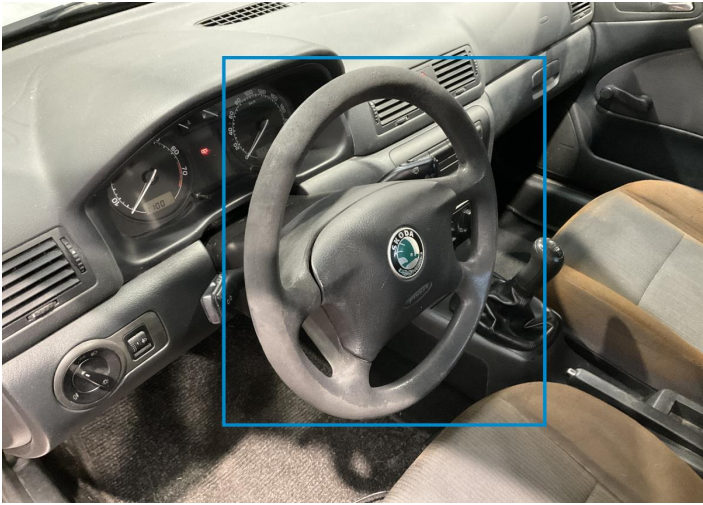
6. Steering Wheel / Front
Interior / Scratched -
