# SKODA Octavia

## Octavia 1.6 Combi

VIN NO TMBJX21U898852852  
Registration Number U898852852

### Inspection Report Summary

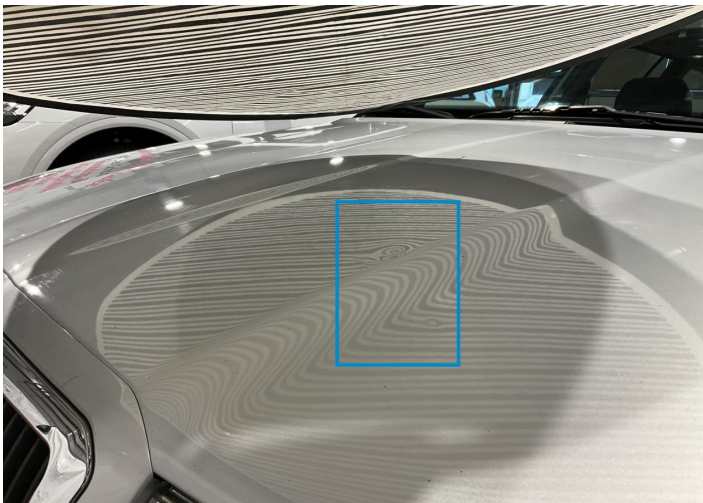
| Component | | Damage | Comments |
|---|---|---|---|
| 1 | Hood | Bodywork / Dent / Dent | |

1. Hood  
Bodywork / Dent / Dent -

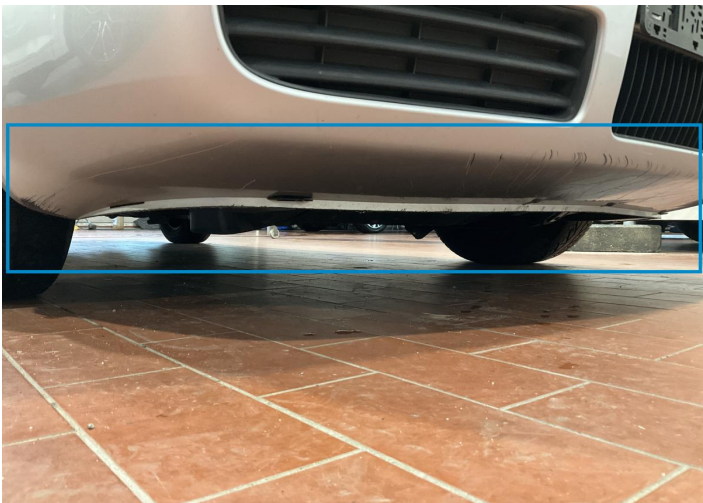
| Component | | Damage | Comments |
|---|---|---|---|
| 2 | Bumper / Front | Paint / Scratch / Scuff | |

2. Bumper / Front  
Paint / Scratch / Scuff -

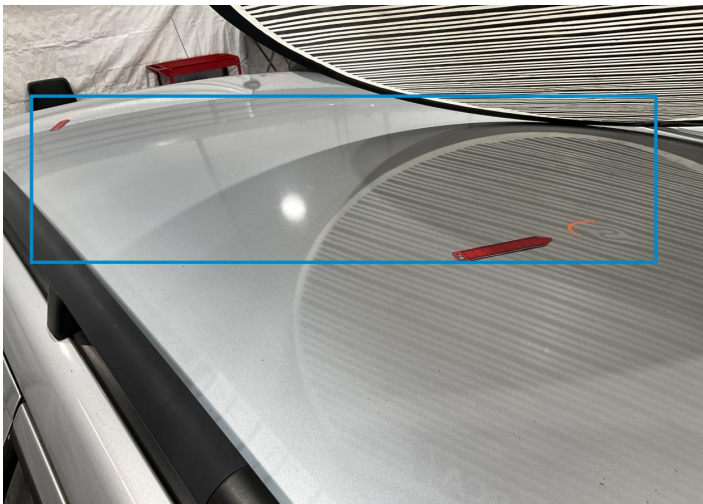
| Component | | Damage | Comments |
|---|---|---|---|
| 3 | Roof | Bodywork / Dent / Dent | |

3. Roof  
Bodywork / Dent / Dent -

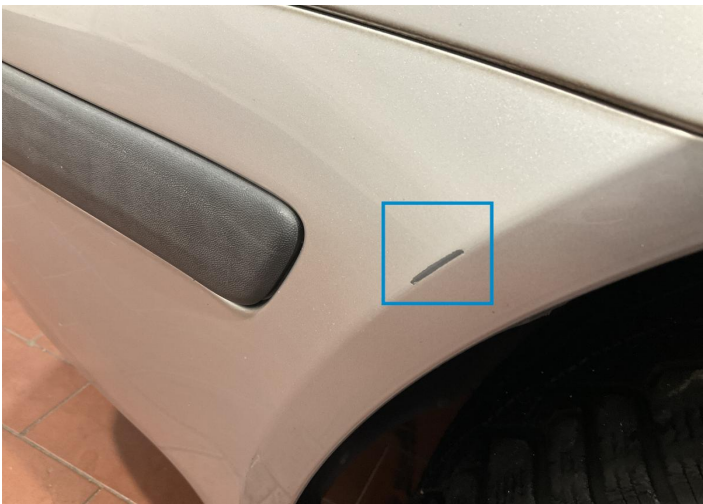
| Component | | Damage | Comments |
|---|---|---|---|
| 4 | Bumper / Front | Paint / Stone Chip | |

4. Bumper / Front  
Paint / Stone Chip -

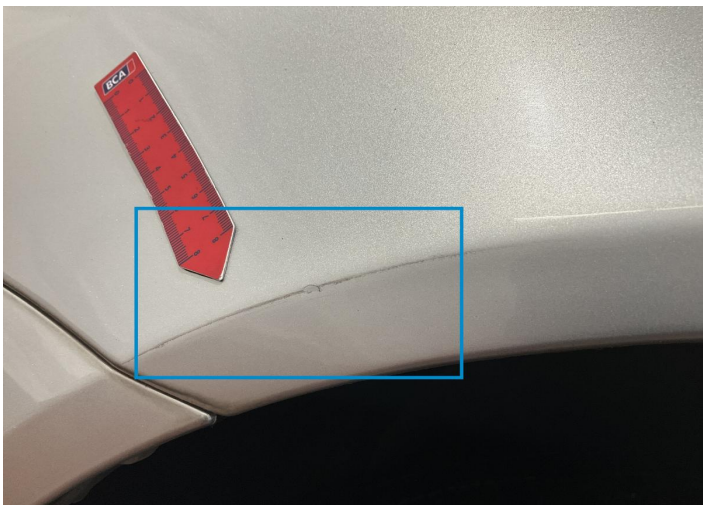
| Component | | Damage | Comments |
|---|---|---|---|
| 5 | Fender / Front Left | Paint / Scratch / Line | |

5. Fender / Front Left  
Paint / Scratch / Line -

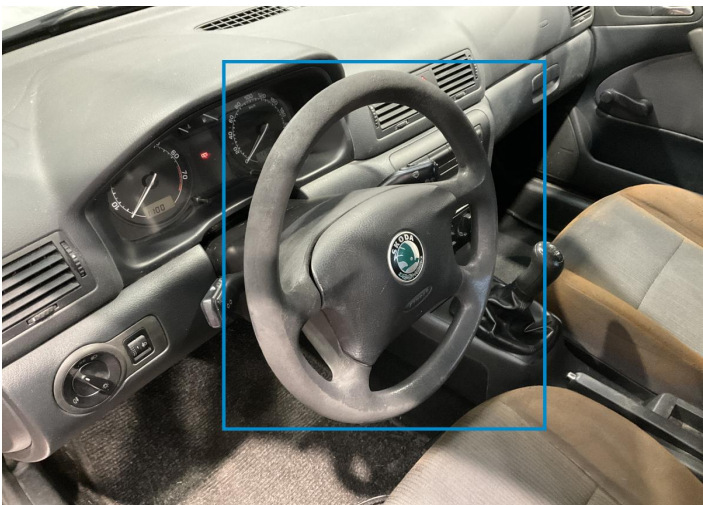
| Component | | Damage | Comments |
|---|---|---|---|
| 6 | Steering Wheel / Front | Interior / Scratched | |

6. Steering Wheel / Front  
Interior / Scratched -

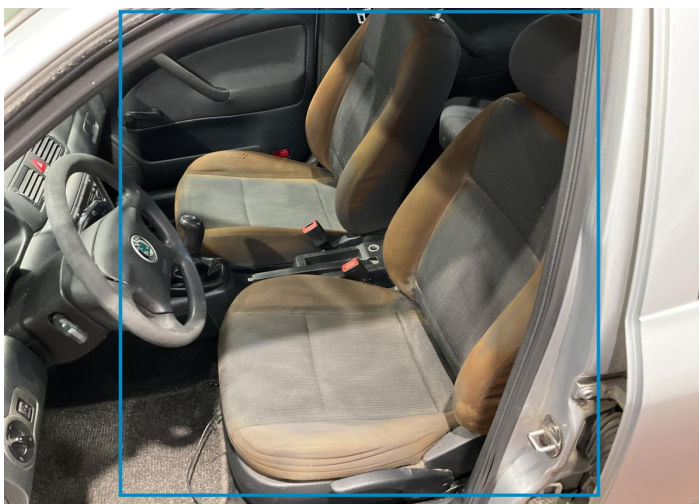
| Component | | Damage | Comments |
|---|---|---|---|
| 7 | Seat / Front Left | Interior / Dirty | |

7. Seat / Front Left  
Interior / Dirty -

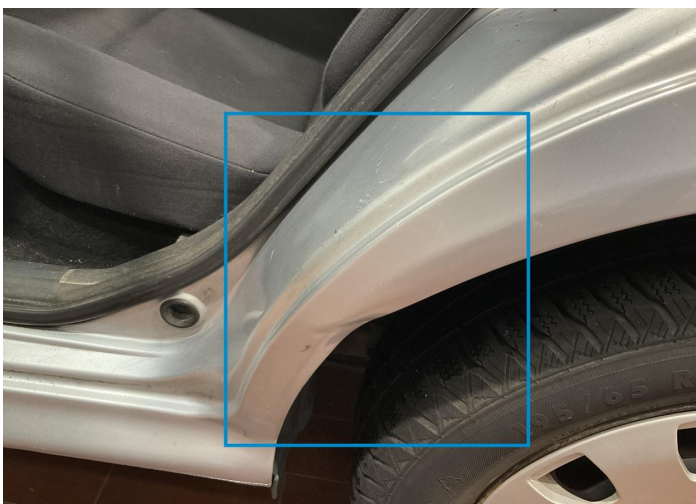
| Component | | Damage | Comments |
|---|---|---|---|
| 8 | Fender / Back Left | Bodywork / Dent / Dent | |

8. Fender / Back Left  
Bodywork / Dent / Dent -

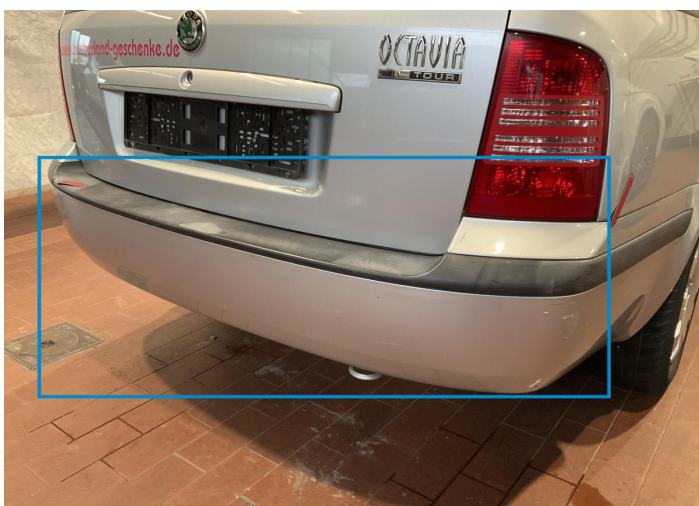
| Component | | Damage | Comments |
|---|---|---|---|
| 9 | Bumper / Back | Bodywork / Dent / Dent | |

9. Bumper / Back  
Bodywork / Dent / Dent -

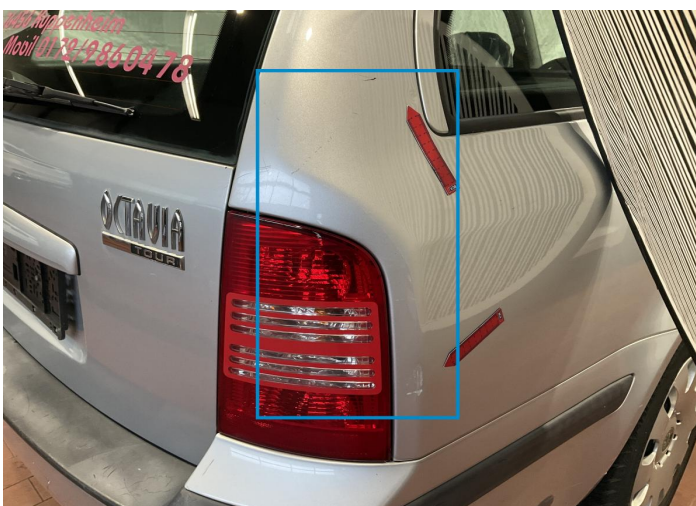
| Component | | Damage | Comments |
|---|---|---|---|
| 10 | Fender / Back Right | Bodywork / Dent / Dent | |

10. Fender / Back Right  
Bodywork / Dent / Dent -

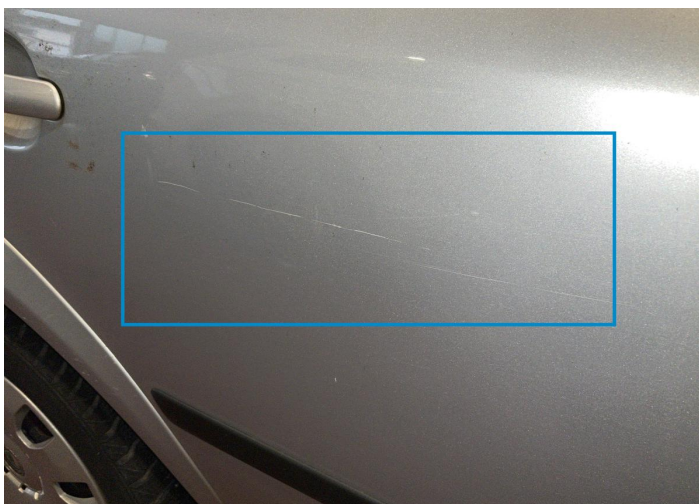
| Component | | Damage | Comments |
|---|---|---|---|
| 11 | Door / Back Right | Paint / Scratch / Line | |

11. Door / Back Right  
Paint / Scratch / Line -

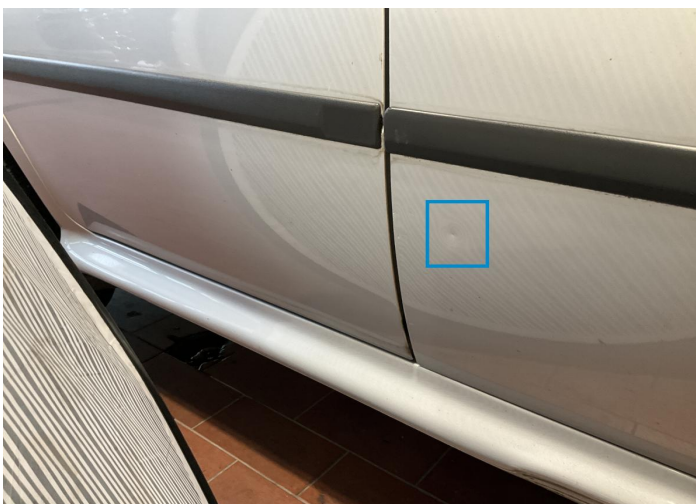
| Component | | Damage | Comments |
|---|---|---|---|
| 12 | Door / Front Right | Bodywork / Dent / Dent | |

12. Door / Front Right  
Bodywork / Dent / Dent -

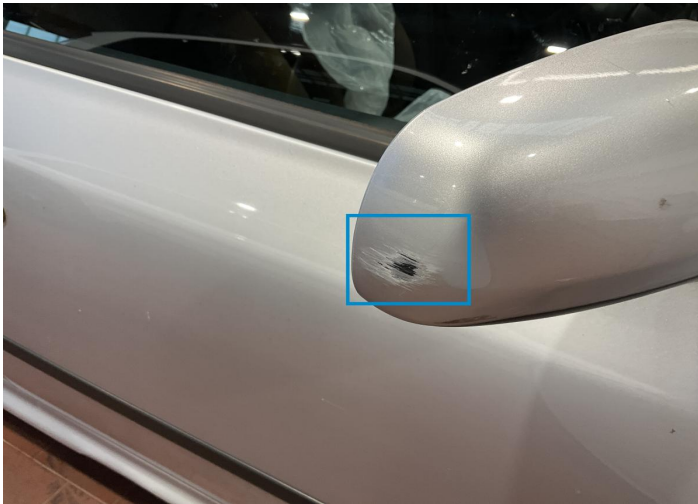
| 13 | Mirror / Front Right | Paint / Scratch / Scuff |

13. Mirror / Front Right  
Paint / Scratch / Scuff -

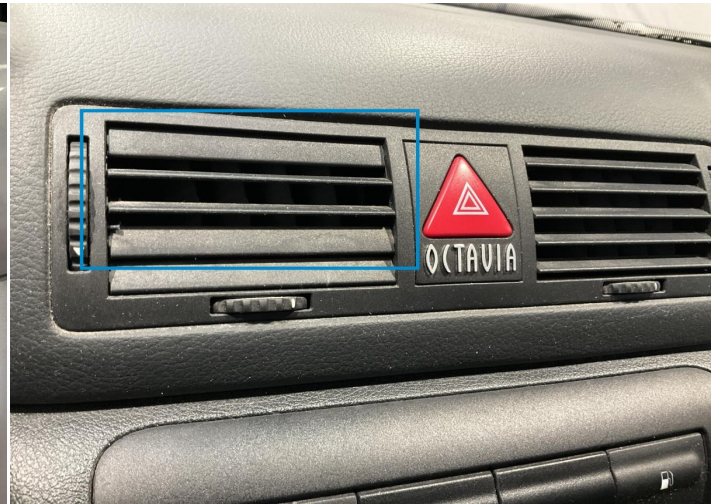
| 14 | Aeration Grid / Front Center | Interior / Not Working |

14. Aeration Grid / Front Center  
Interior / Not Working -
