Expertise

Protocol number: 39992895
Order No. / Reference: 24820158
Inspection date: 3 Jun 2025

Manufacturer: Skoda
VIN: TMBLJ7NP1L7062494

Model: Superb Combi 2.0 TDI 4x4 DSG Scout

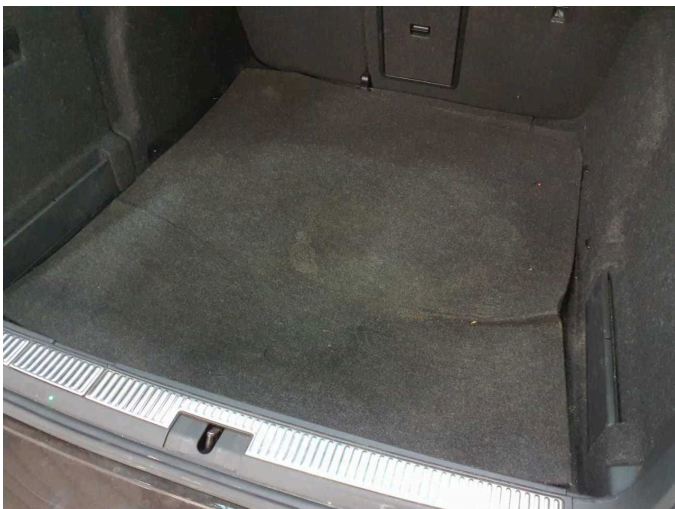
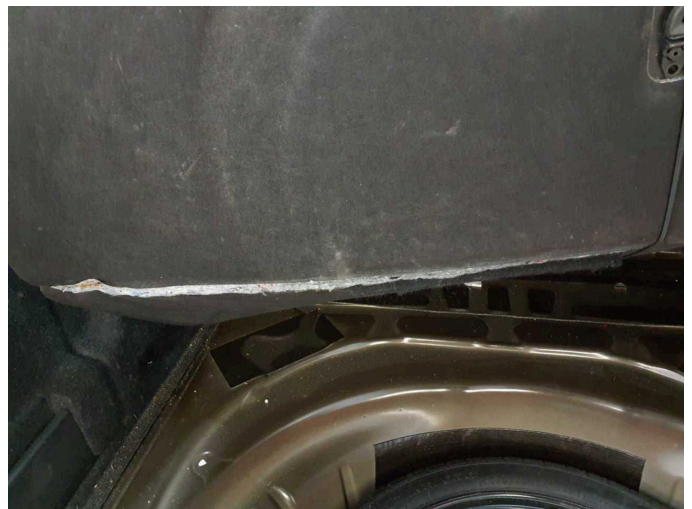
Damage 1: Interior: Cargo area floor - Damaged - Replace

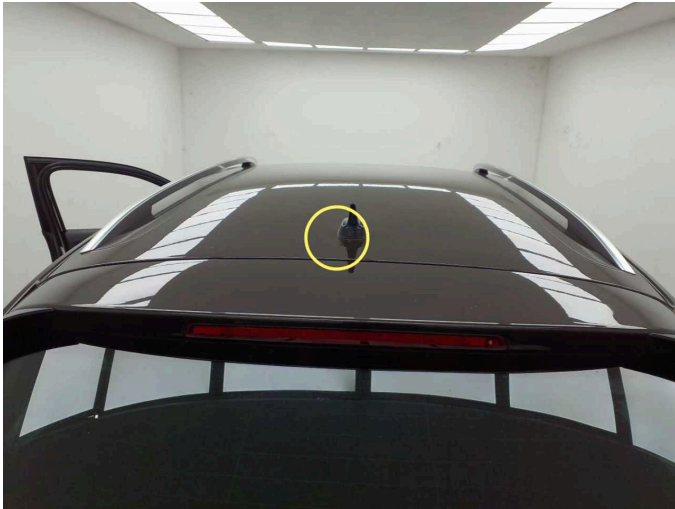
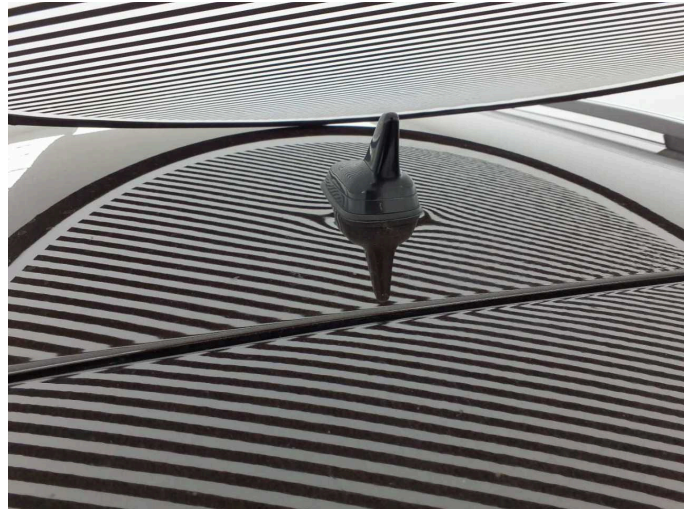
Damage 2: Roof: Roof - dent(s) - Smooth repair work

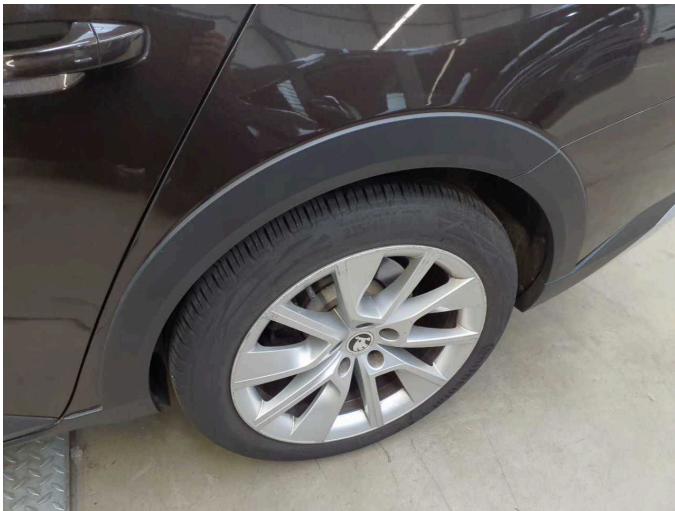
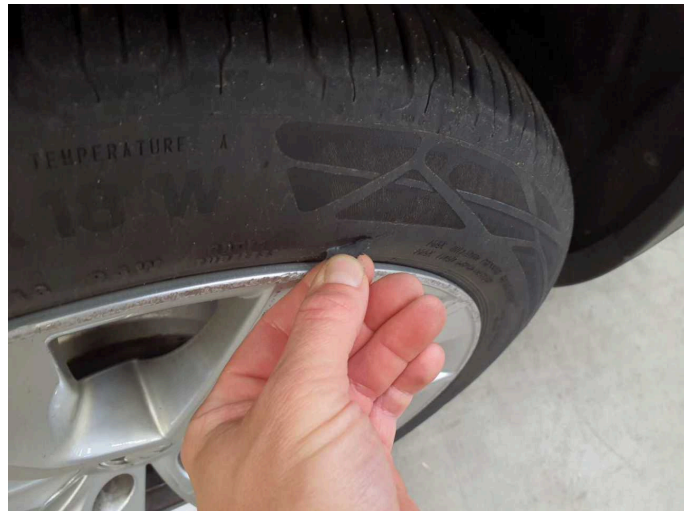
Damage 3: Wheel / tyres: Tyre - rear left side - Damaged - Replace

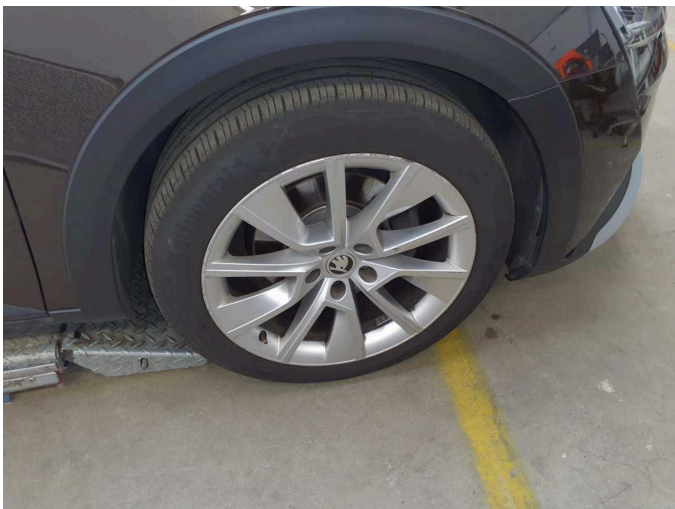
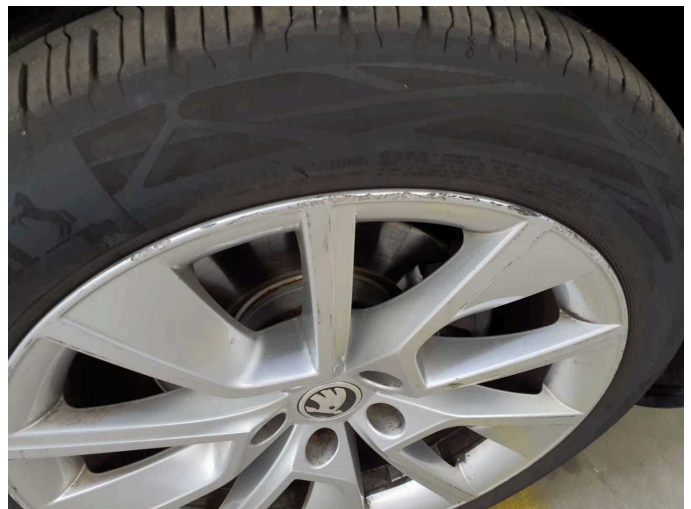
Damage 4: Wheel / tyres: Alloy rim - front right side - Scratched - Loss in value

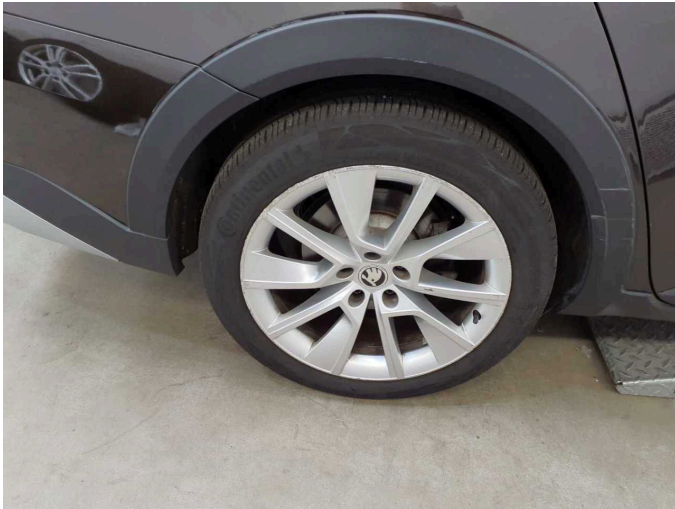
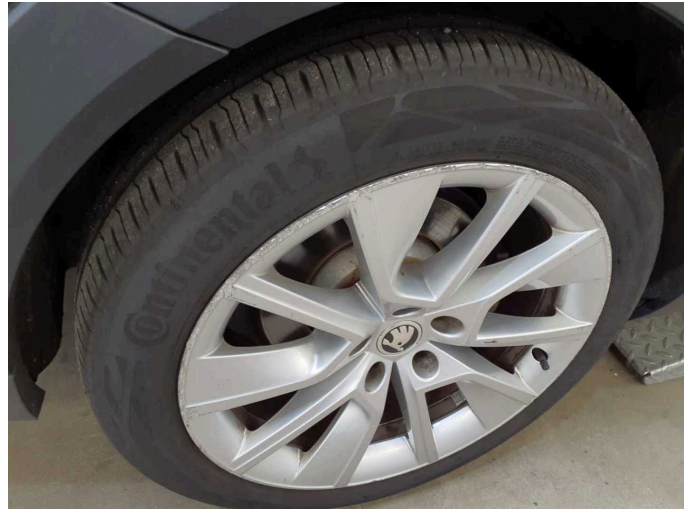
Damage 5: Wheel / tyres: Alloy rim - rear right side - Scratched - Loss in value

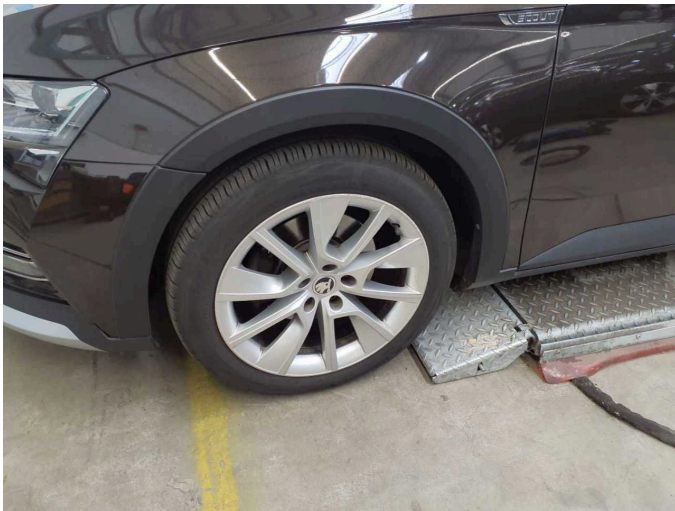
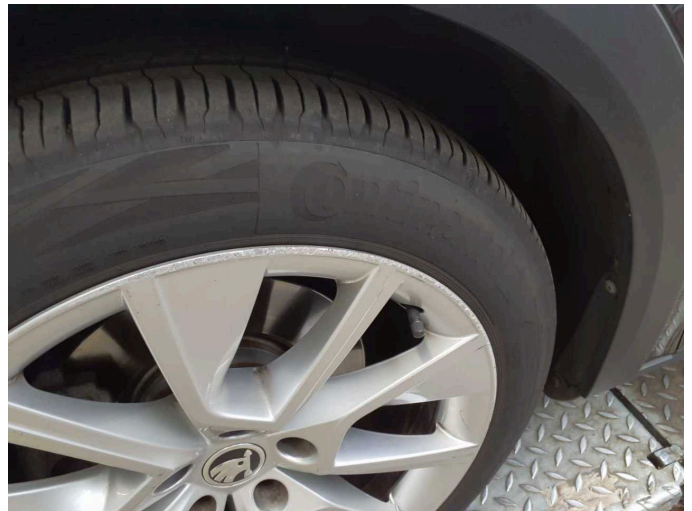
Damage 6: Wheel / tyres: Alloy rim - front left side - Scratched - Loss in value

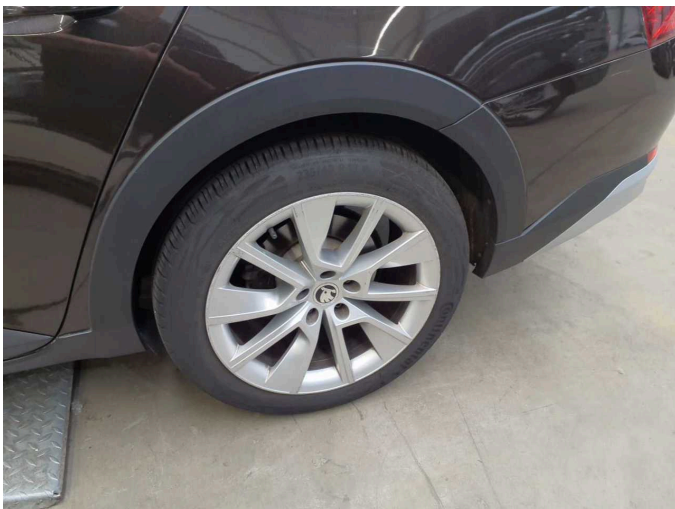
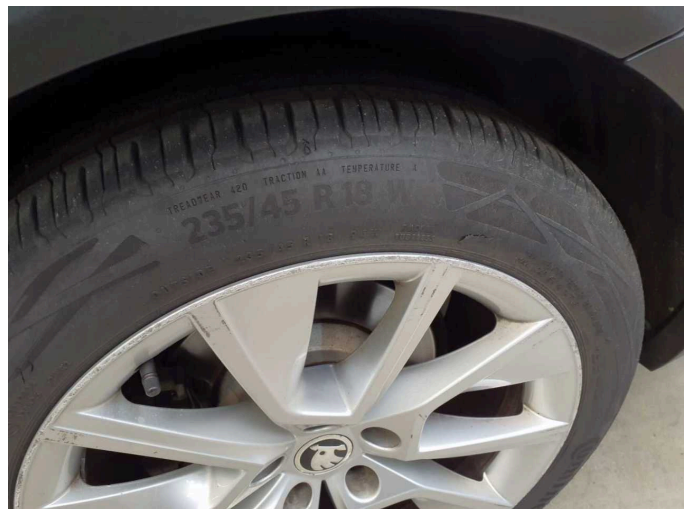
Damage 7: Wheel / tyres: Alloy rim - rear left side - Scratched - Loss in value

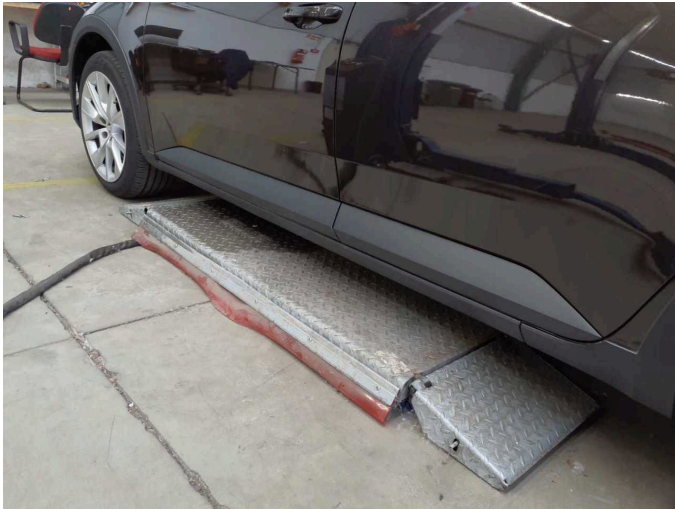
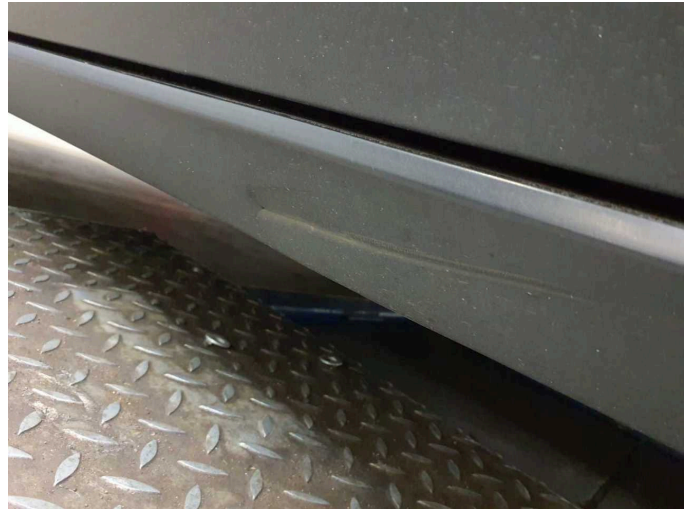
Damage 8: Sill - left side: Trim - Damaged - Replace

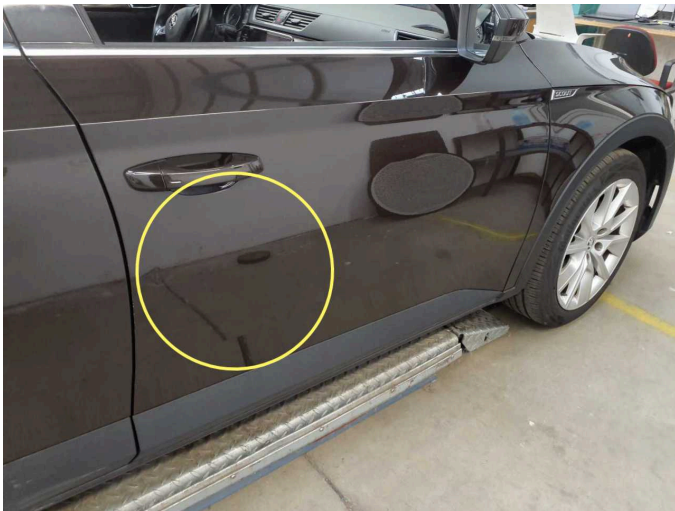
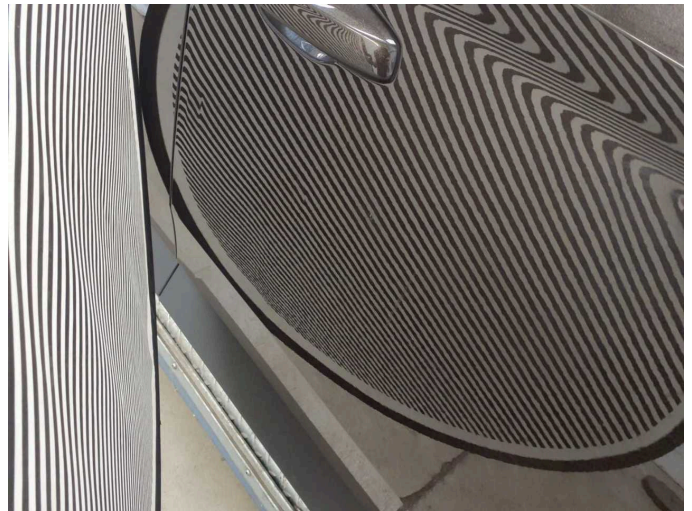
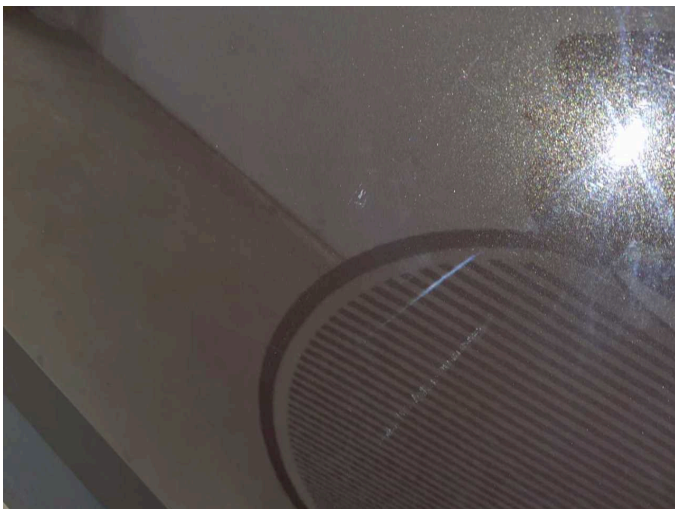
Damage 9: Door - front right side: Door - Dent / paintcoat damage - Repair and paint

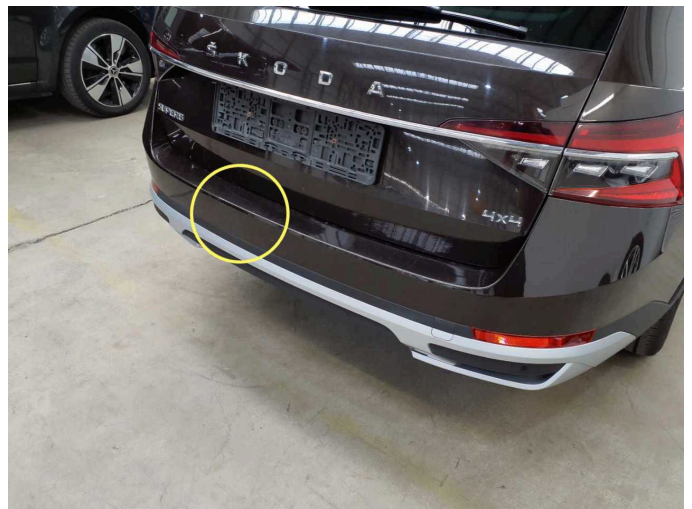
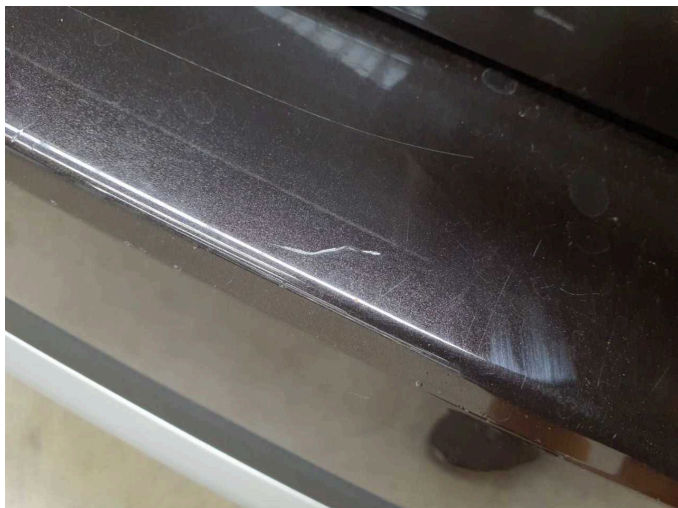
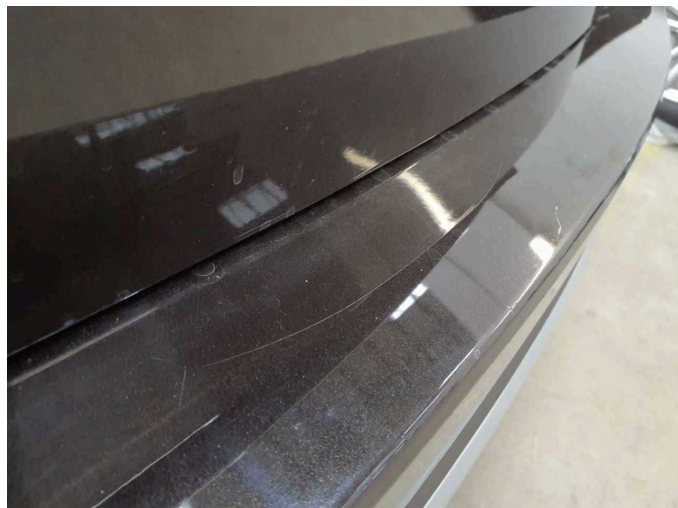
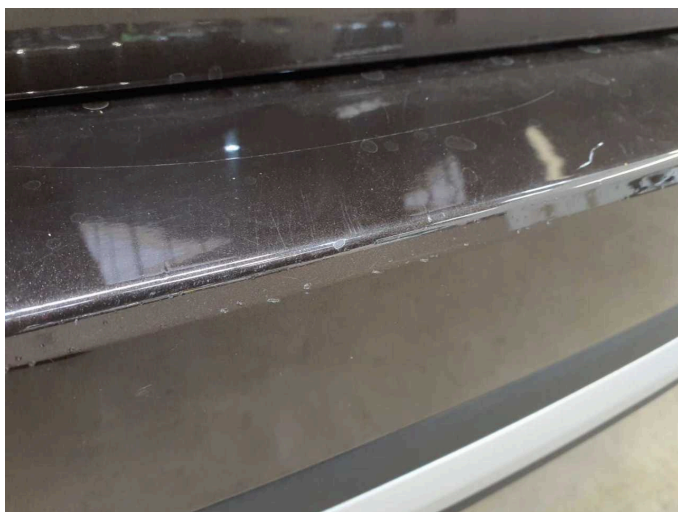
Damage 10: Rear bumper: Rear bumper - Scratch(es) - Paint

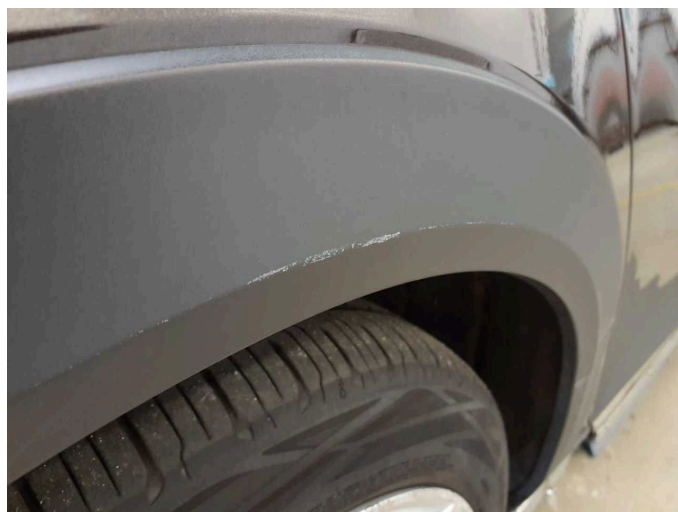
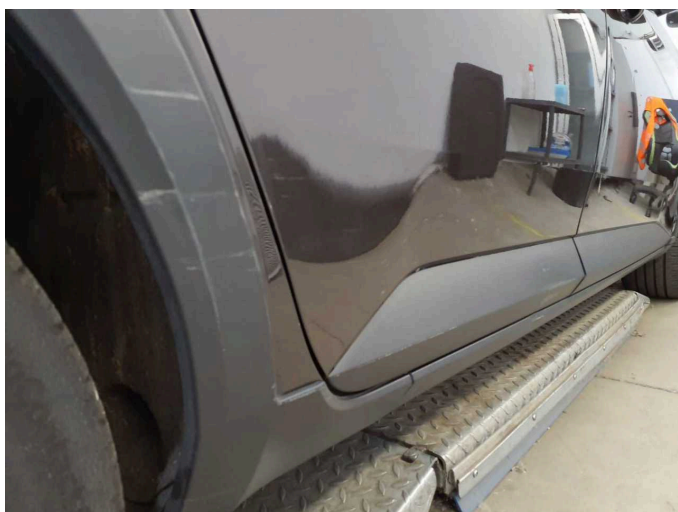
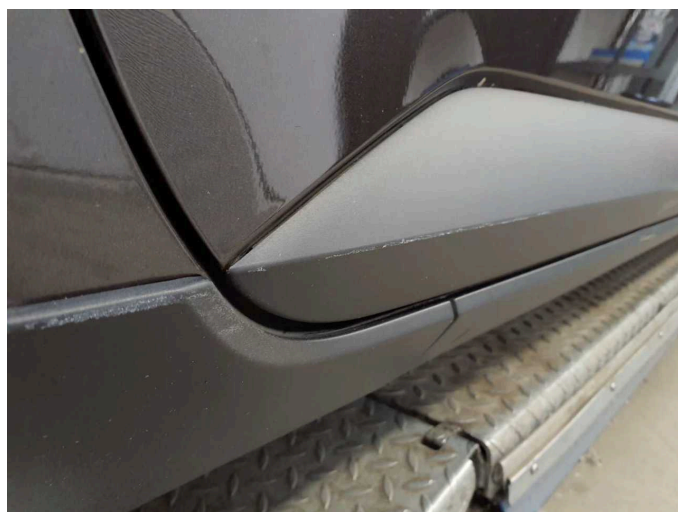
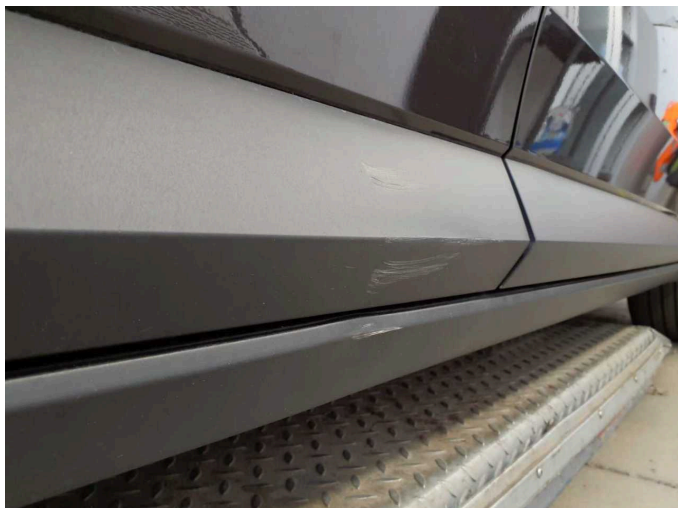
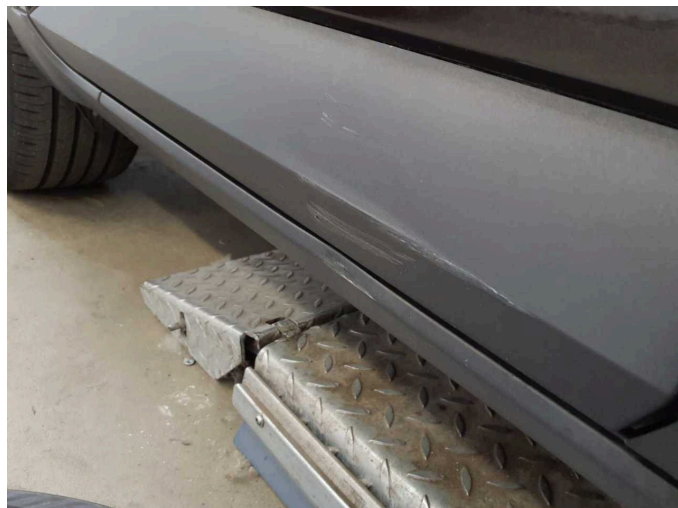
Damage 11: Body: Body (Radlauf, Schweller, Verkleidung, Türzierleiste) - Scratched - Replace

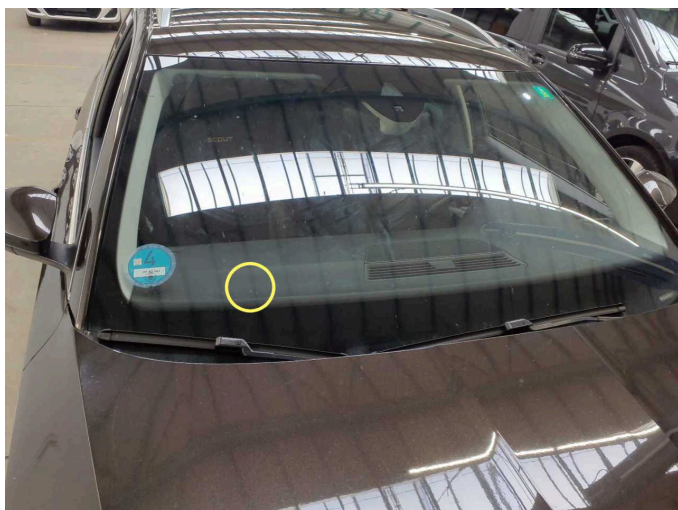
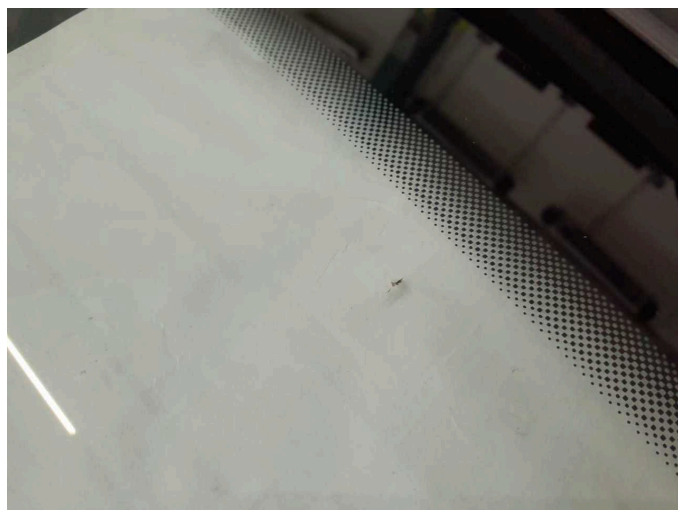
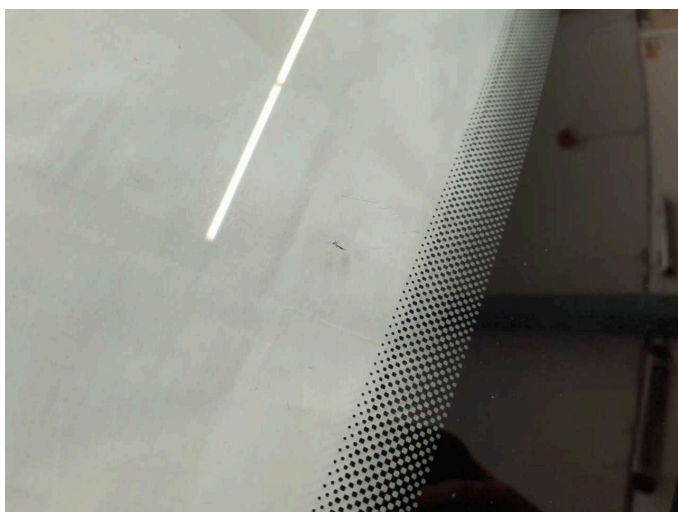
Damage 12: Vehicle glazing: Windscreen (Mit Rissbildung) - Stone chips - repair according to calculation

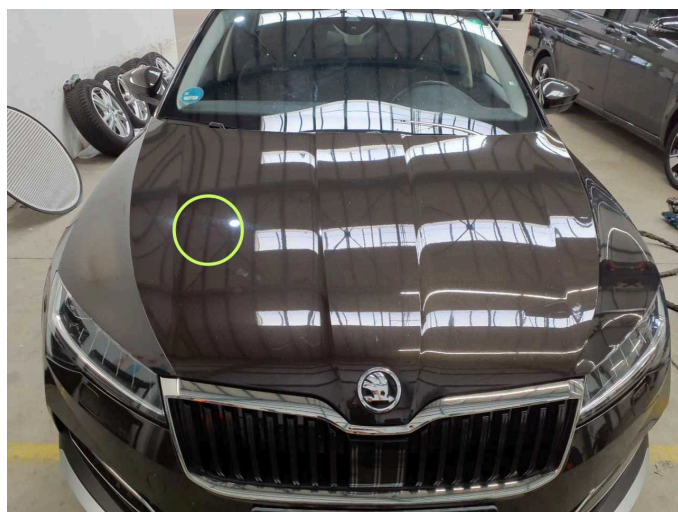
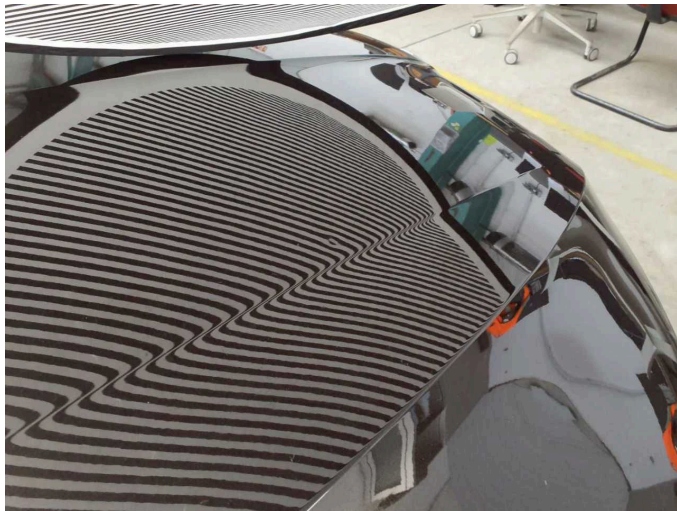
Wear and tear 3: Bonnet: Bonnet - dent(s) - Smooth repair work

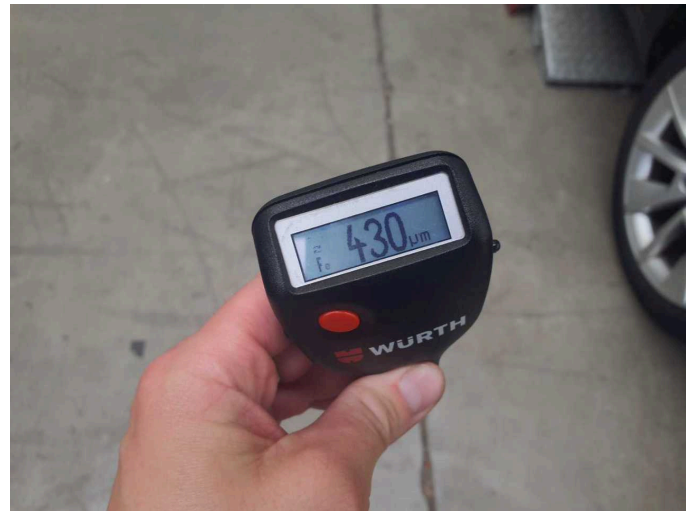
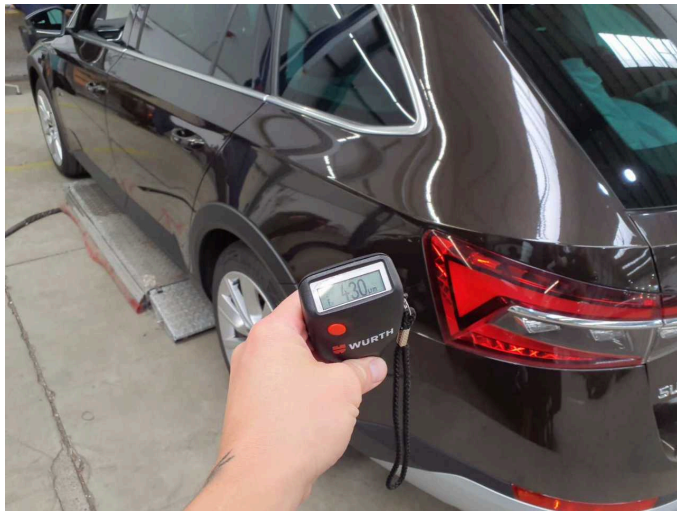
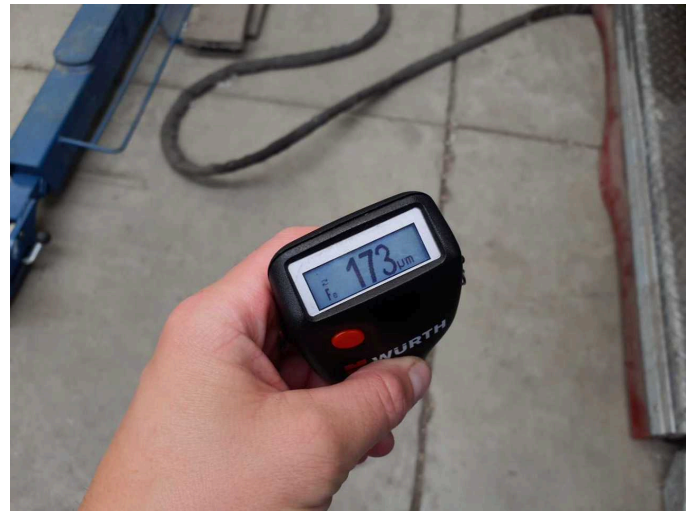
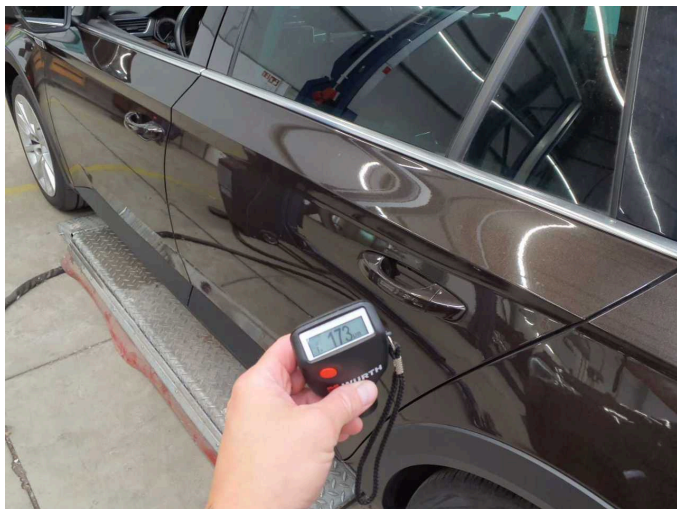
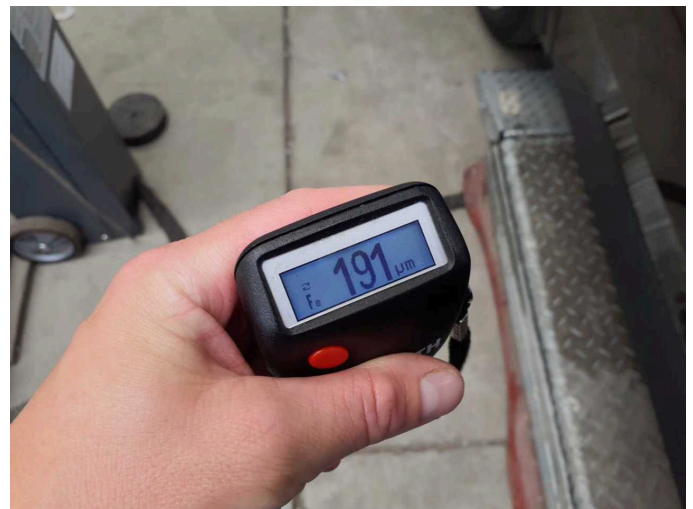
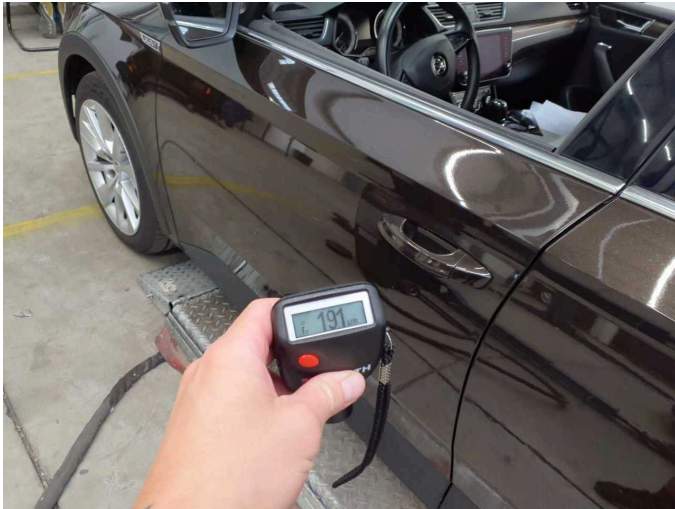
| 1 | Side panel - rear left side, Door - rear left side, Door - front left side, Professionally carried out, Invoice of repair done Non-existent |

Side panel - rear left side	430 µm	Door - rear left side	173 µm
Door - front left side	191 µm

Repainting 1: Side panel - rear left side, Door - rear left side, Door - front left side
