Expertise

Protocol number: 41681451
Order No. / Reference: 25223415
Inspection date: 24 Sept 2025

Manufacturer: Skoda
VIN: TMBLJ7NP3L7026726

Model: Superb Combi 2.0 TDI 4x4 DSG Sportline

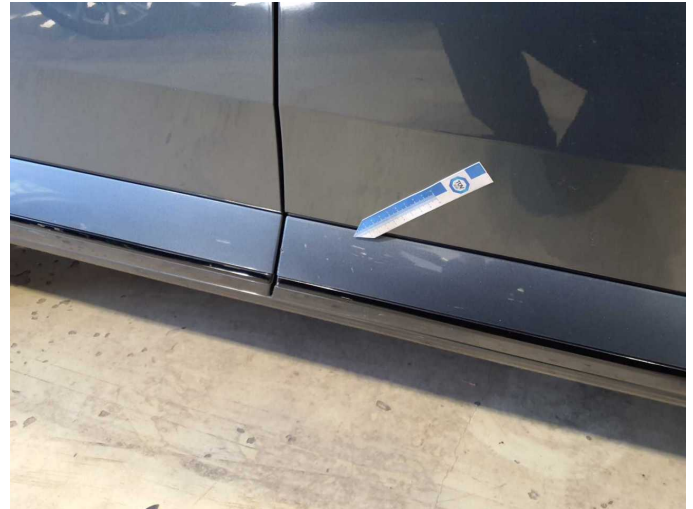
Damage 1: Door - front right side: Brightware - lower - Scratched - Paint

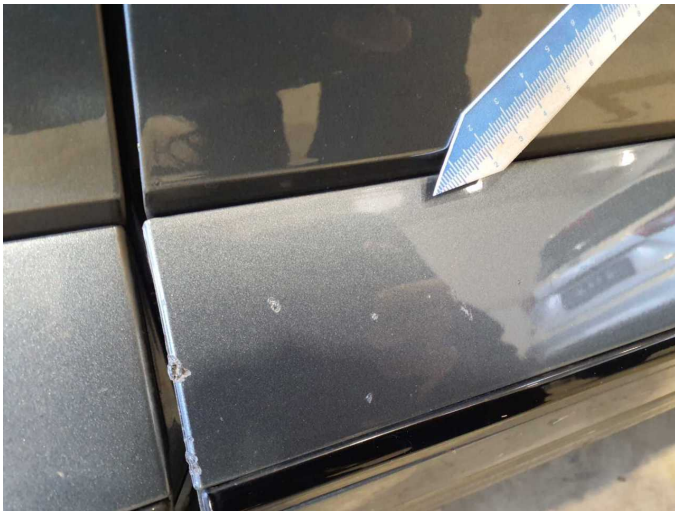
Damage 1: Door - front right side: Brightware - lower - Scratched - Paint

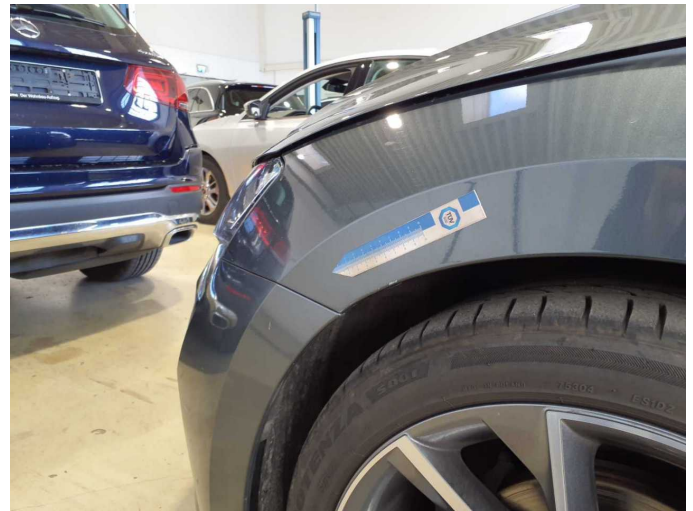
Damage 2: Mudguard - left side: Mudguard - left side - Scratched - Smart repair

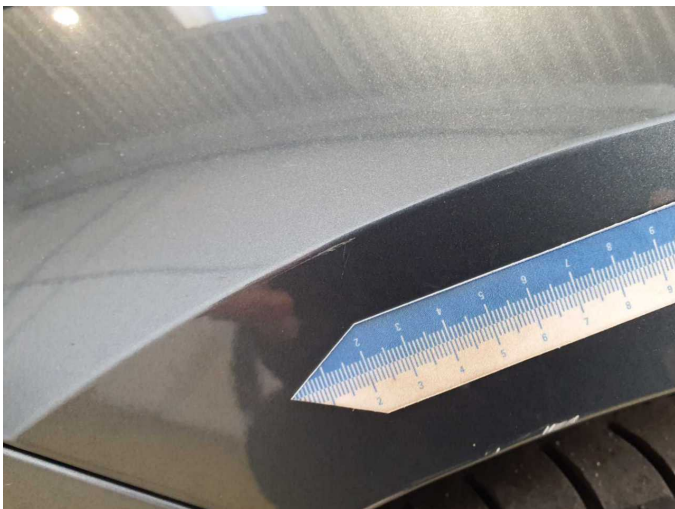
Damage 2: Mudguard - left side: Mudguard - left side - Scratched - Smart repair

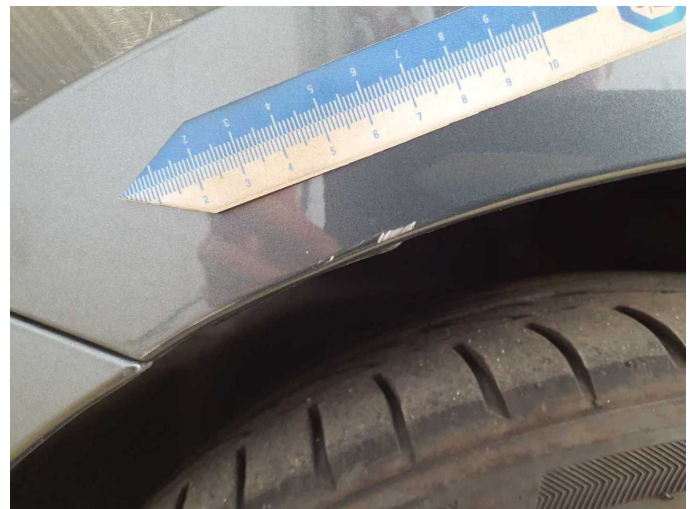
Damage 2: Mudguard - left side: Mudguard - left side - Scratched - Smart repair

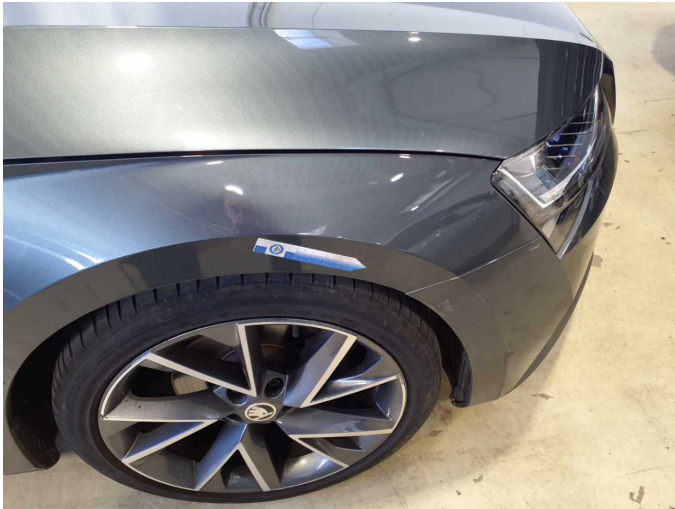
Damage 3: Mudguard - right side: Mudguard - right side - Scratch(es) - Smart repair

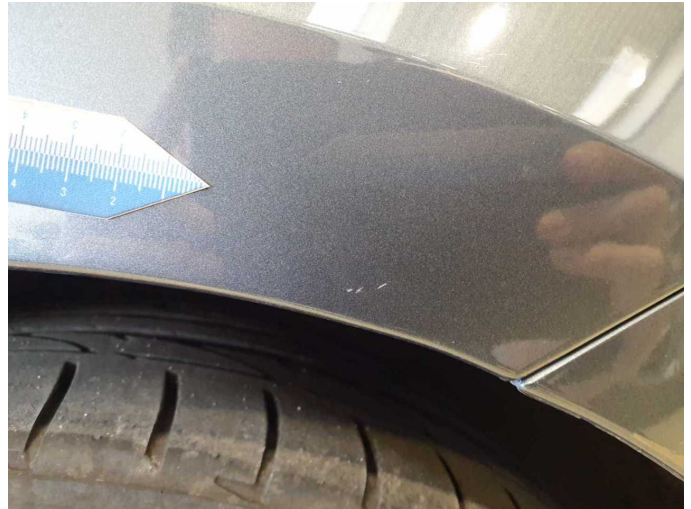
Damage 3: Mudguard - right side: Mudguard - right side - Scratch(es) - Smart repair

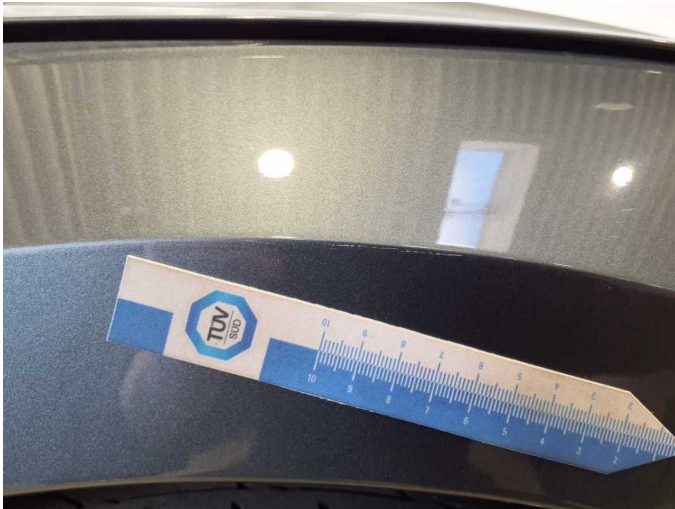
Damage 3: Mudguard - right side: Mudguard - right side - Scratch(es) - Smart repair

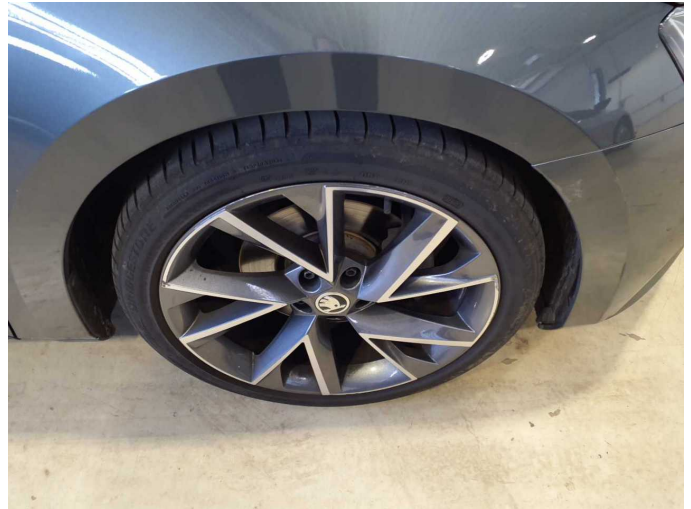
Damage 4: Wheel / tyres: Alloy rim - front right side - Scratch(es) - Loss in value

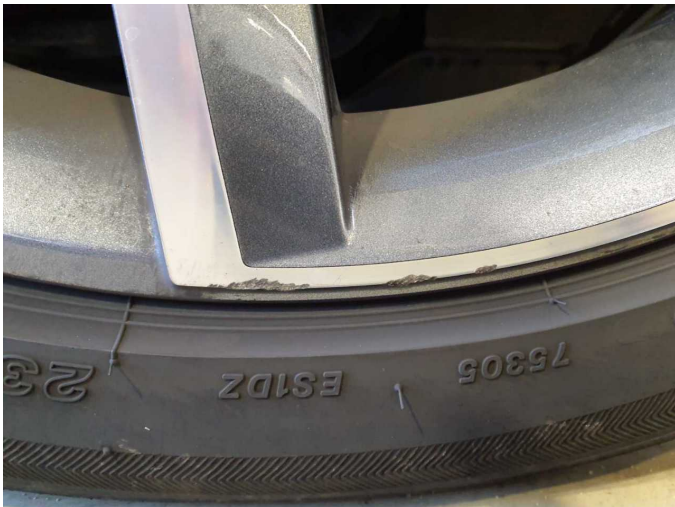
Damage 4: Wheel / tyres: Alloy rim - front right side - Scratch(es) - Loss in value

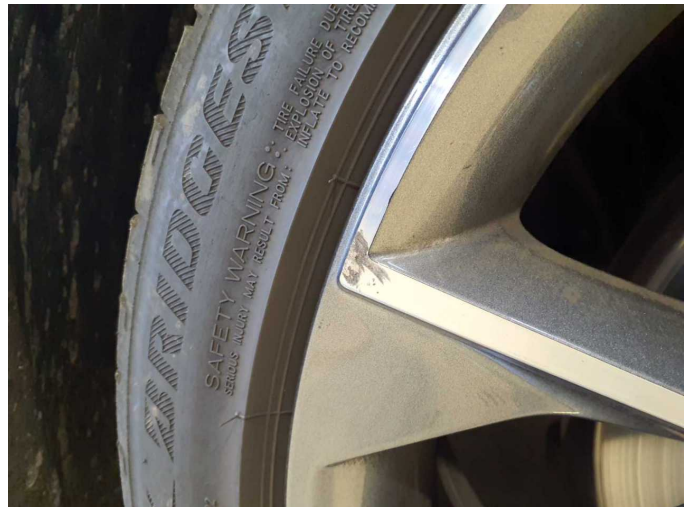
Damage 4: Wheel / tyres: Alloy rim - front right side - Scratch(es) - Loss in value

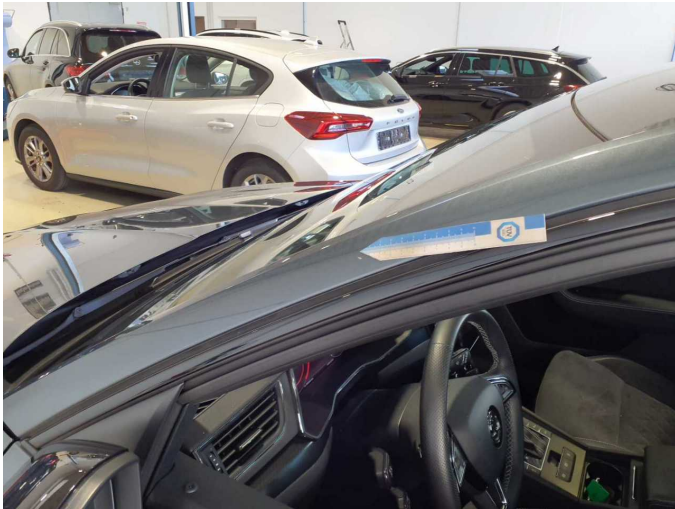
Damage 5: Body: A-pillar - left side - Stone chips - Paint

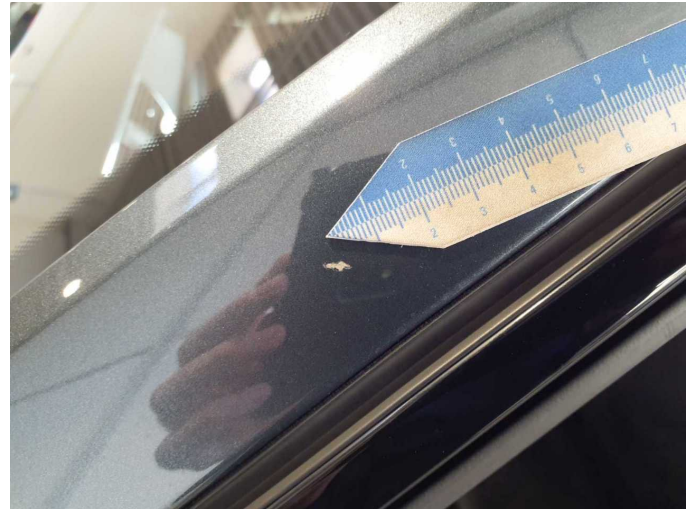
Damage 5: Body: A-pillar - left side - Stone chips - Paint

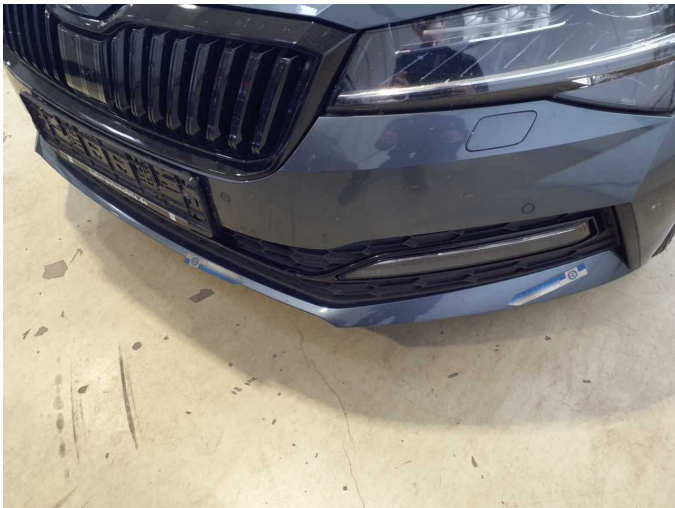
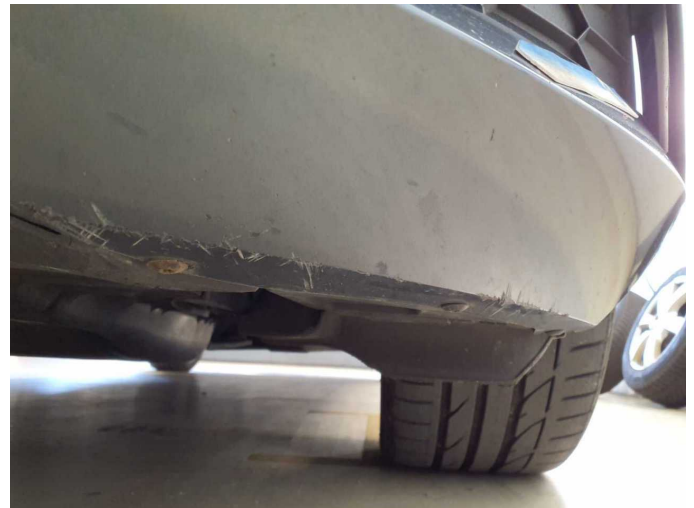
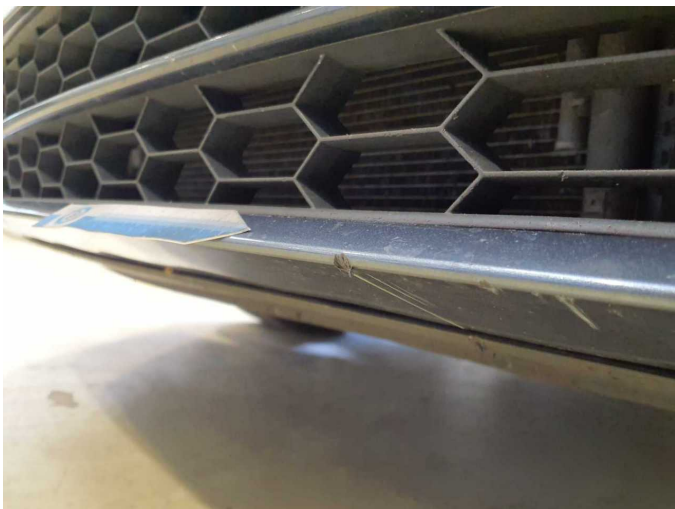
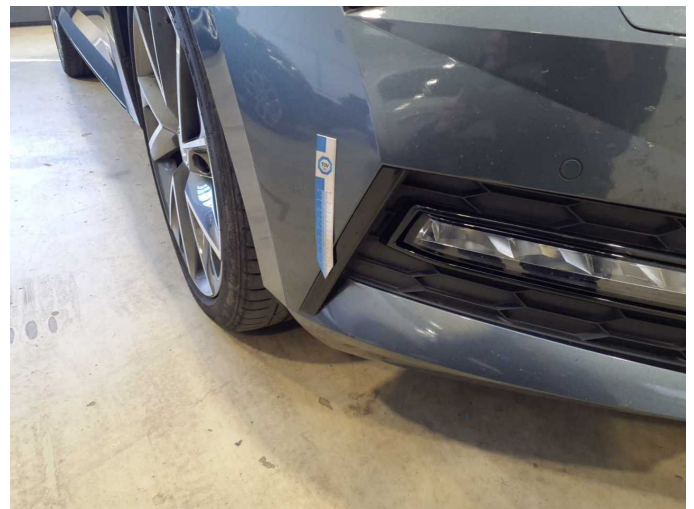
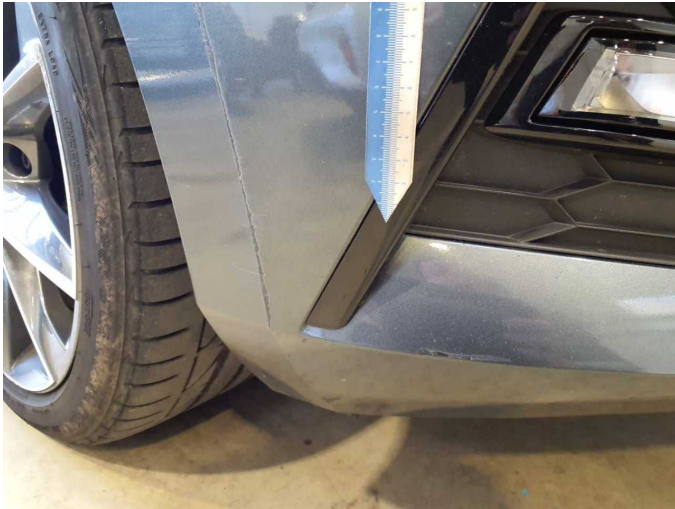
Damage 6: Front bumper: Front bumper - Scratched - Repair and paint

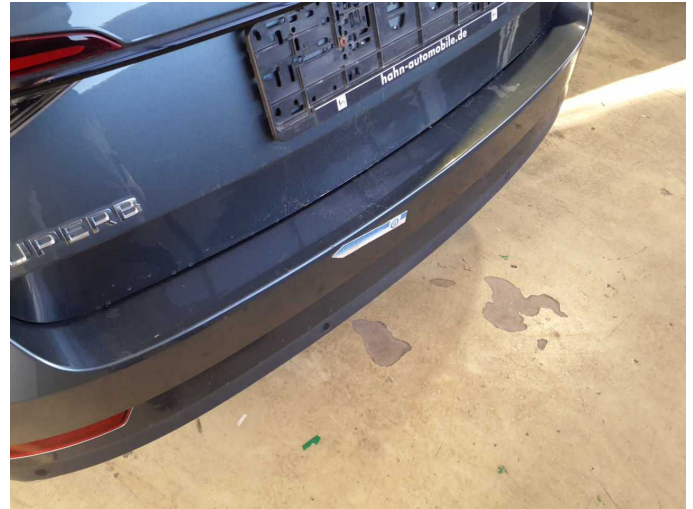
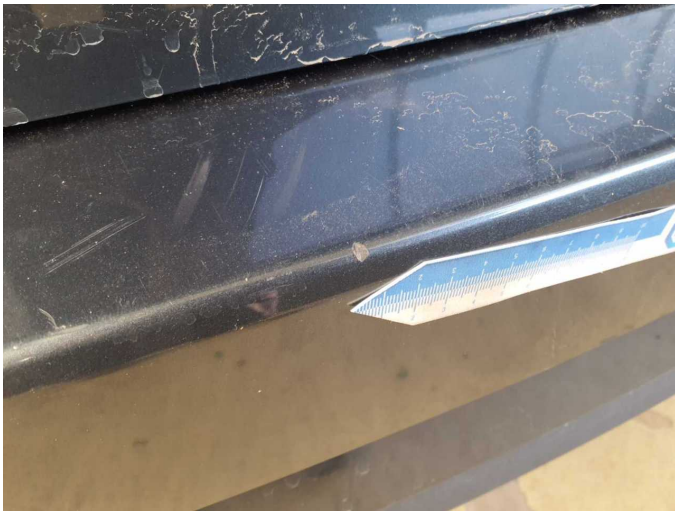
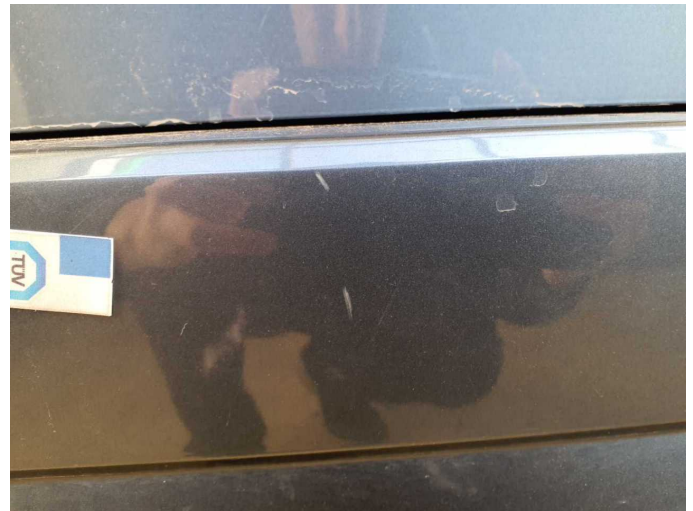
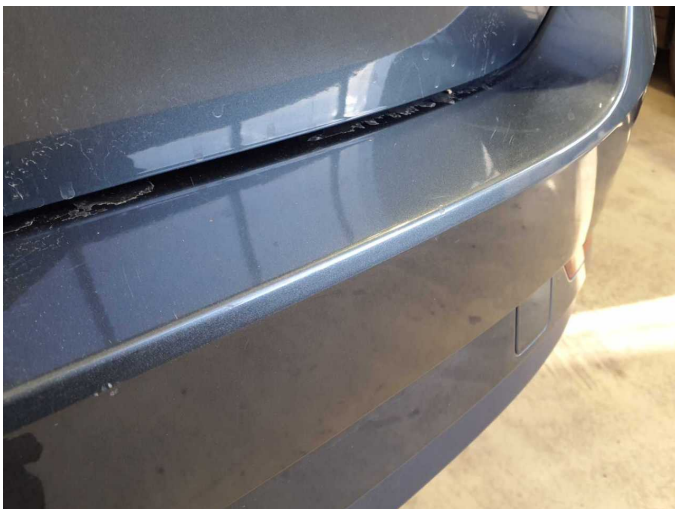
Damage 7: Rear bumper: Rear bumper - Scratched - Repair and paint

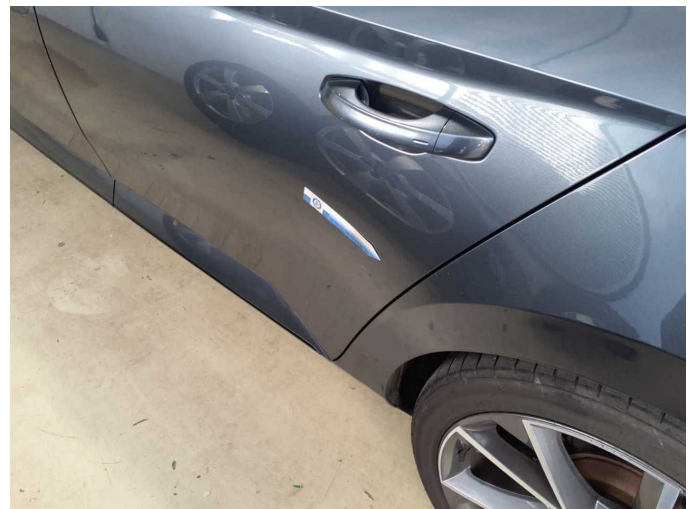
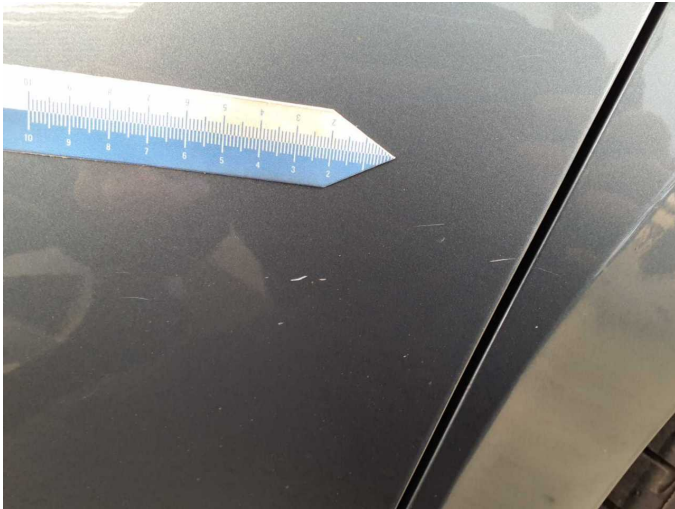
Damage 8: Door - rear left side: Door - Scratched - Paint

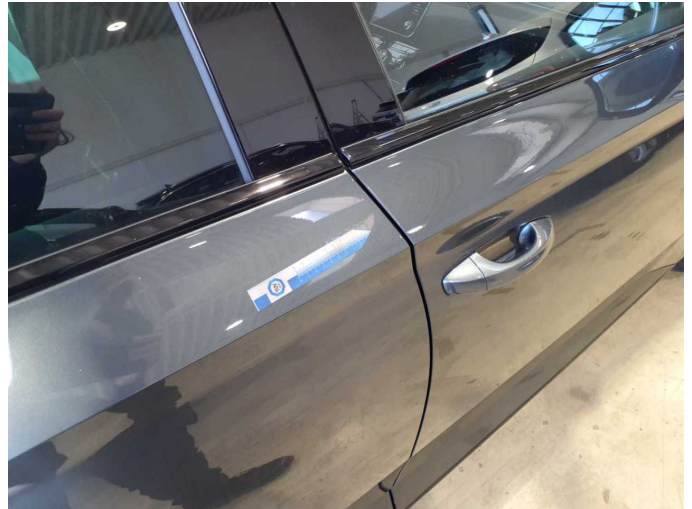
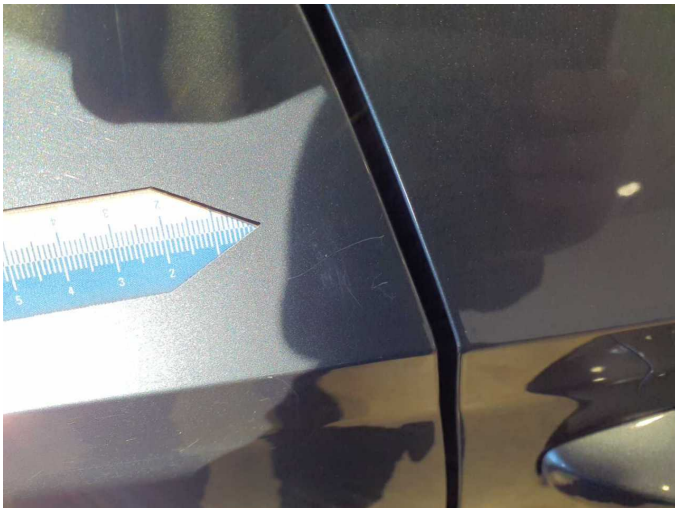
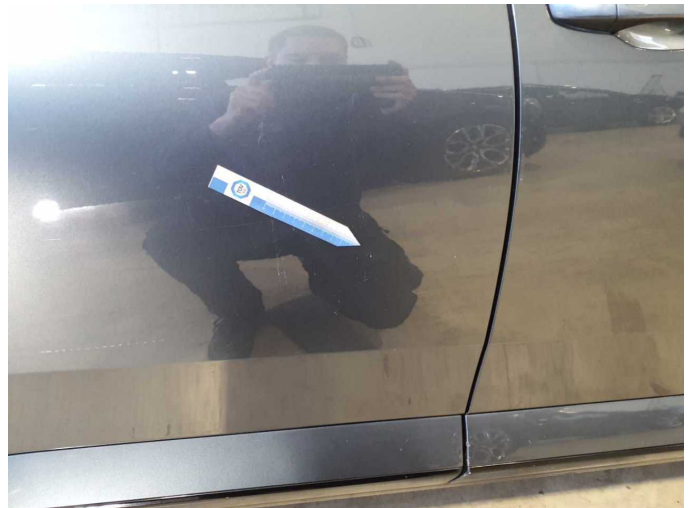
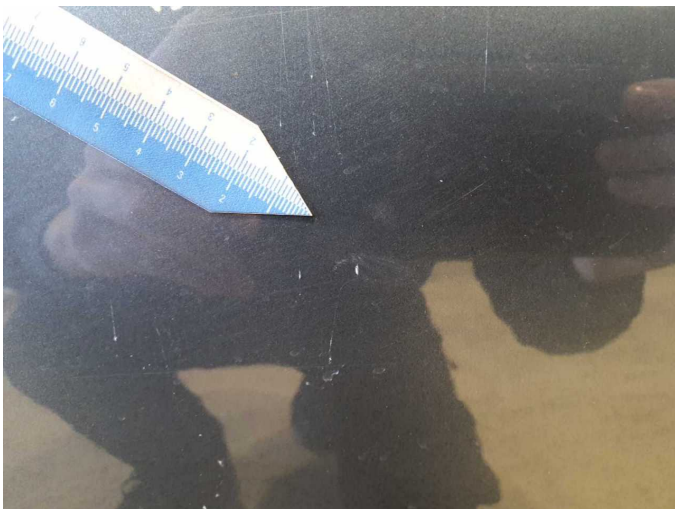
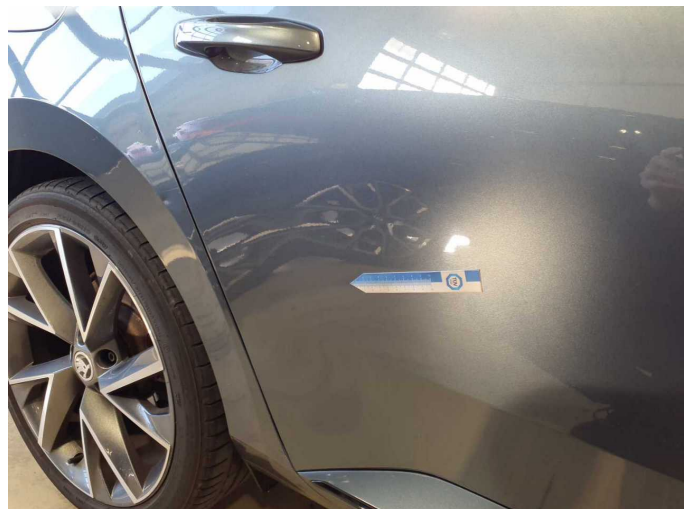
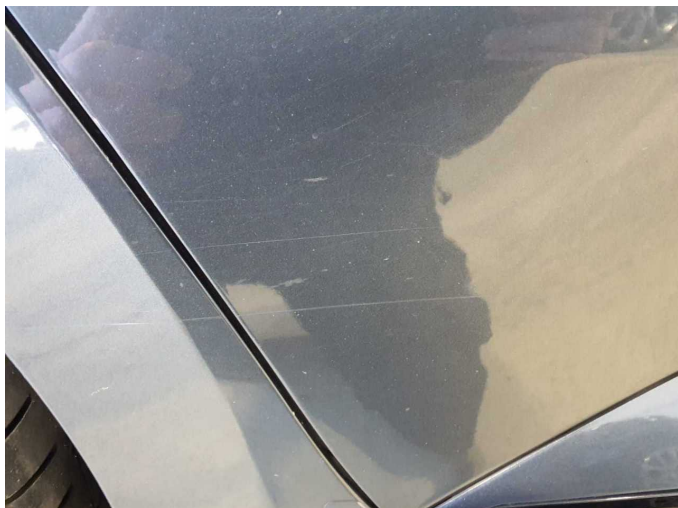
Damage 9: Door - rear right side: Door - Scratch(es) - Paint

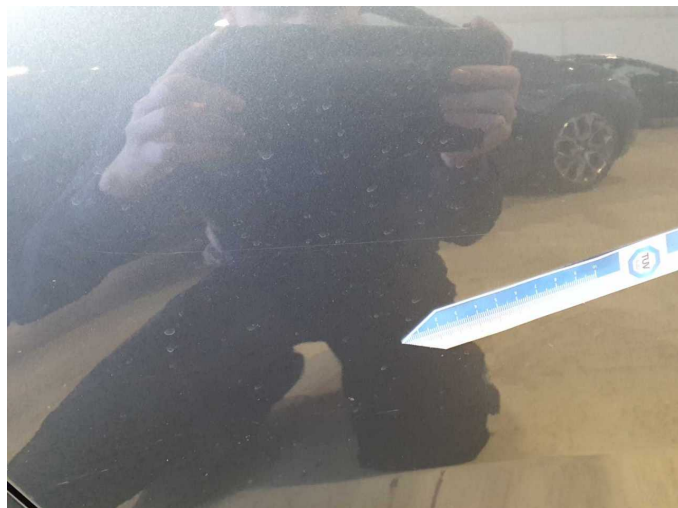
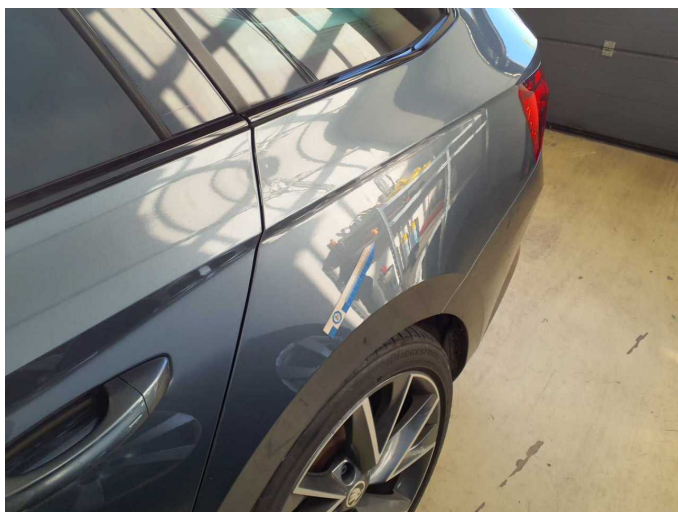
No.	Repainting
1	Door - front right side, Professionally carried out, Invoice of repair done Non-existent
2	Side panel - rear left side, Unprofessionally carried out, Invoice of repair done Non-existent

Damage 10: Side panel - rear left side: Side panel (Wellig) - Unprofessionally repaired - Paint

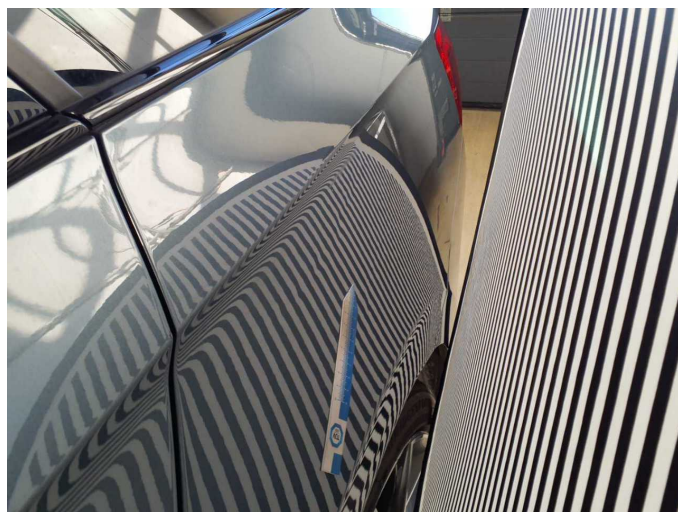
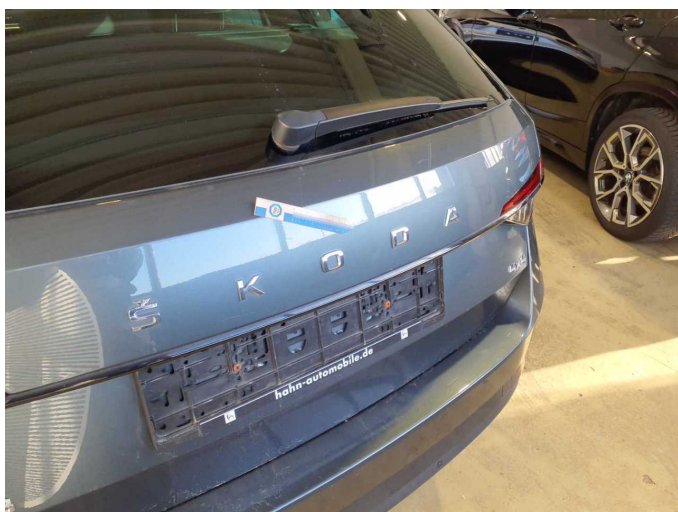
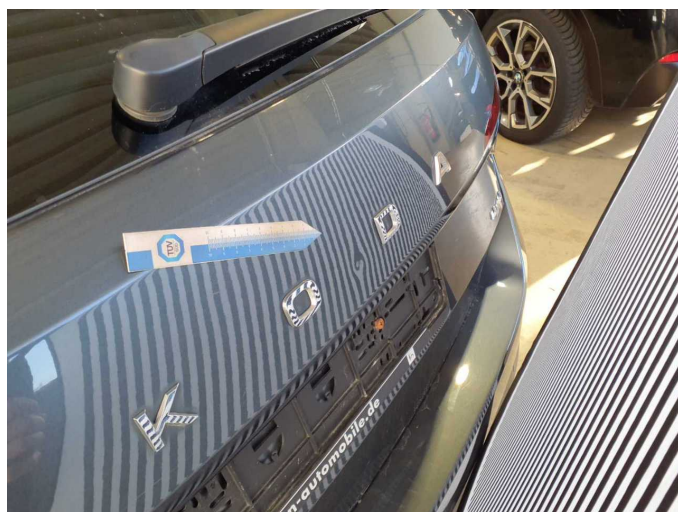
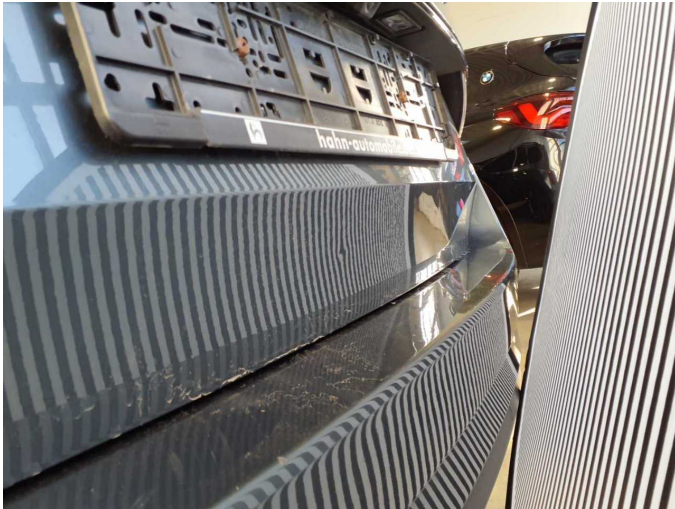
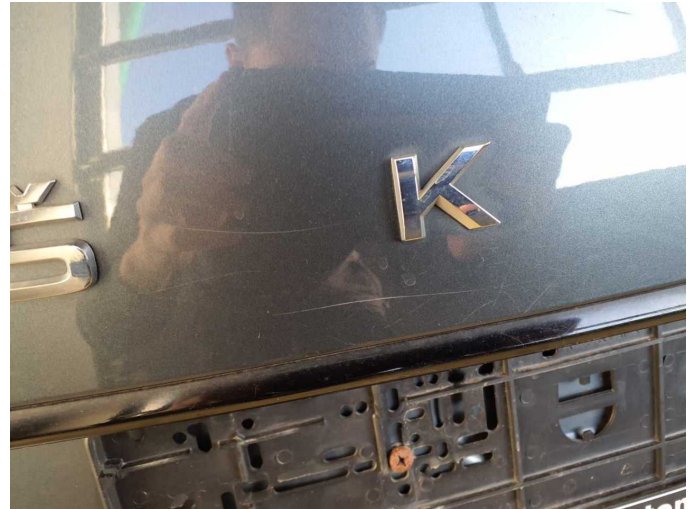
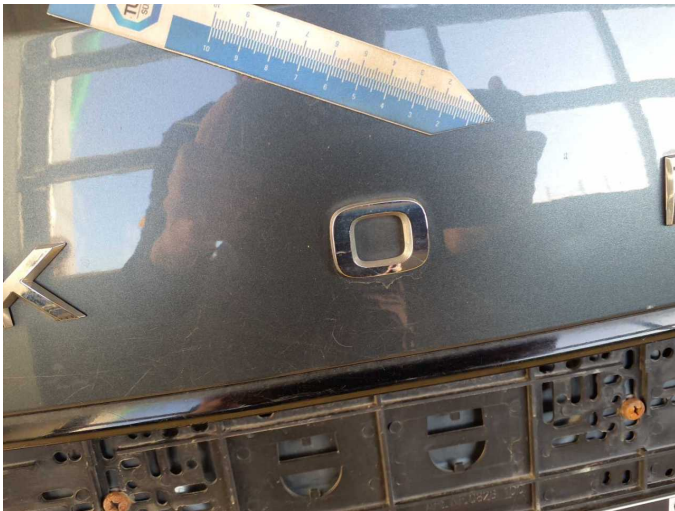
Damage 11: Boot lid / rear door: Boot lid (+ Kratzer) - Dent / paintcoat damage - Repair and paint

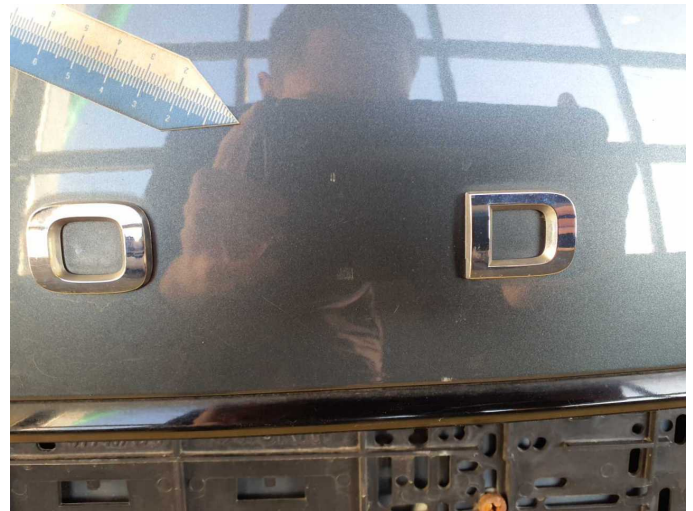
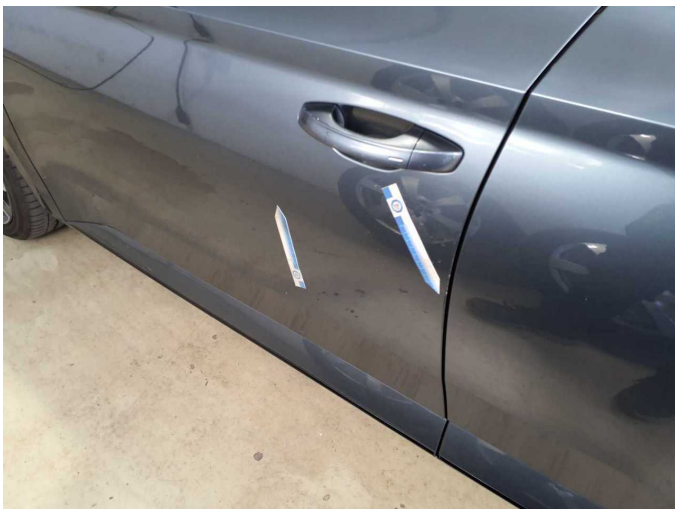
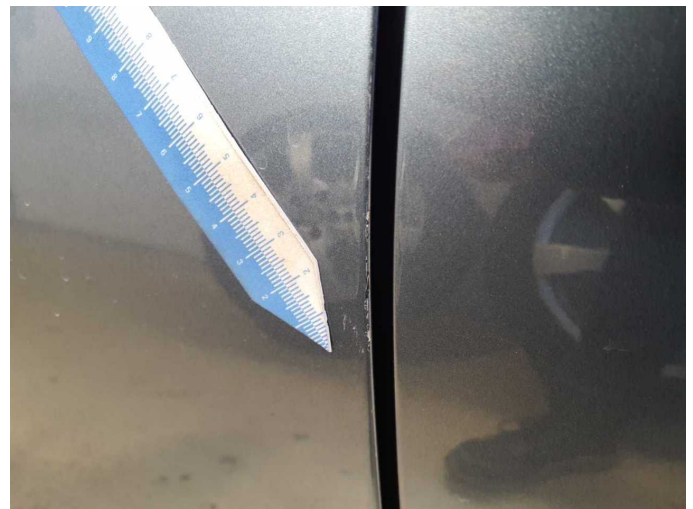
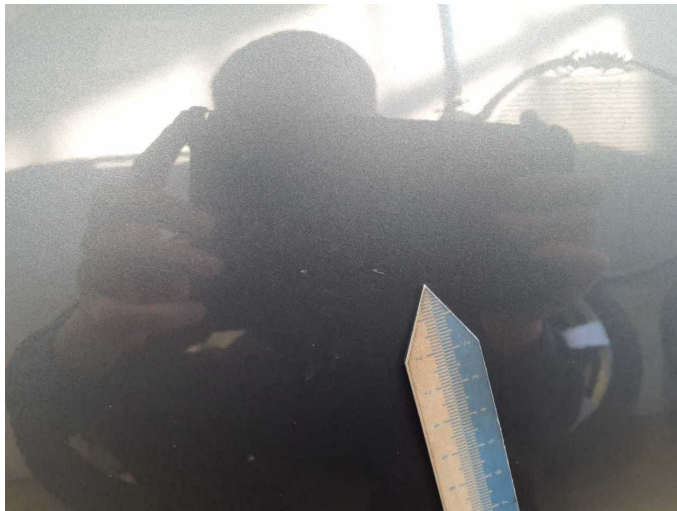
Damage 12: Door - front left side: Door - Scratched - Paint

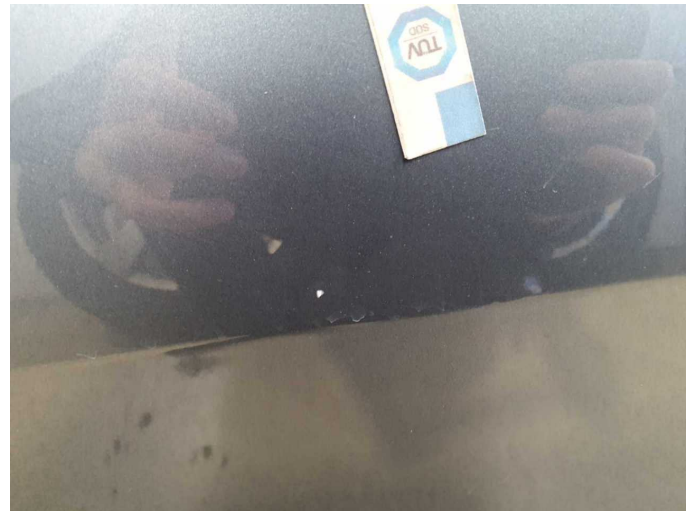
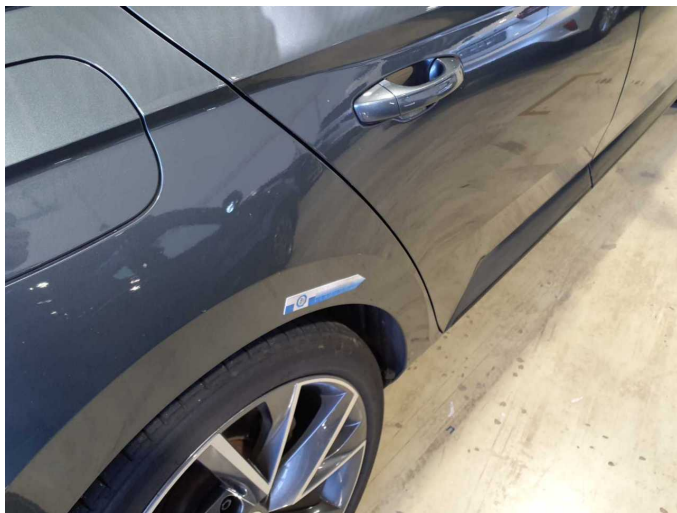
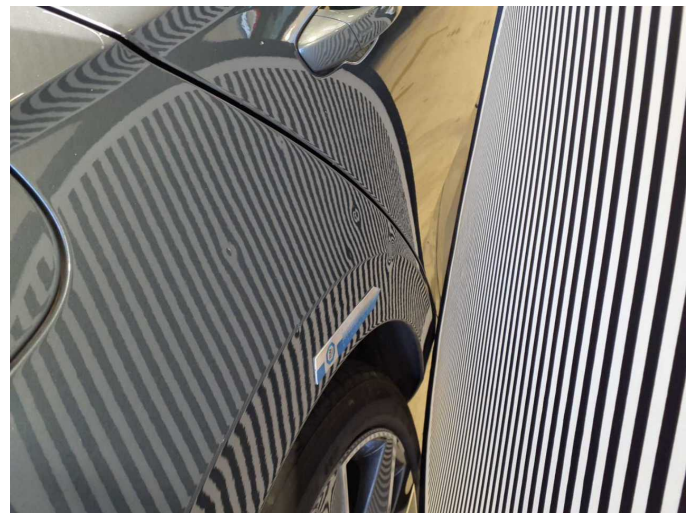
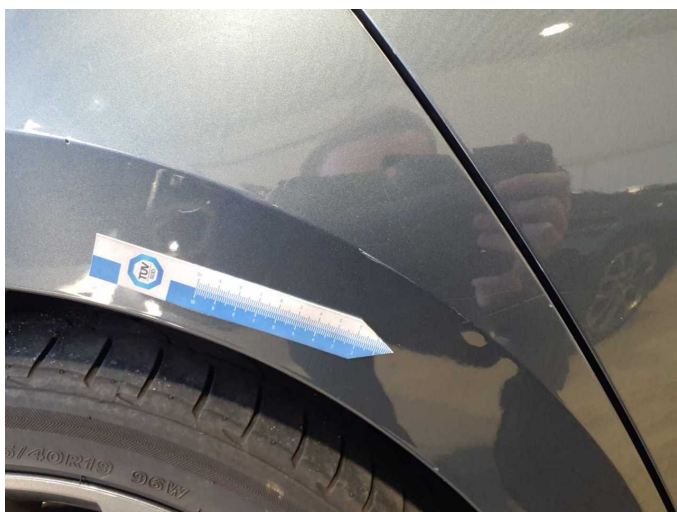
Damage 13: Side panel - rear right side: Side panel - Dent / paintcoat damage - Repair and paint

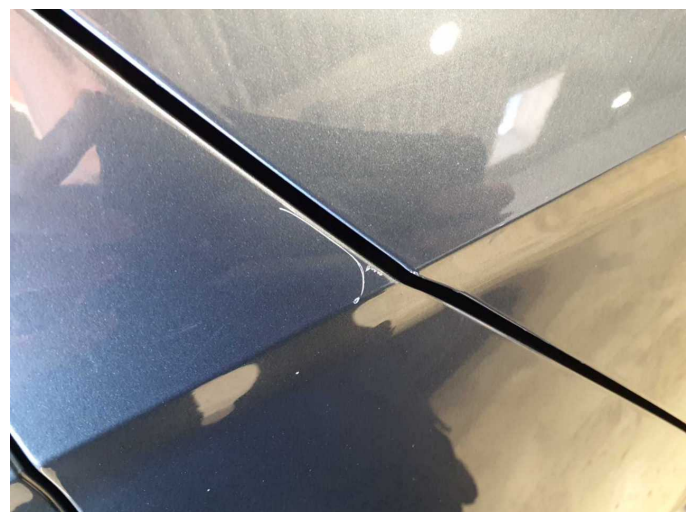
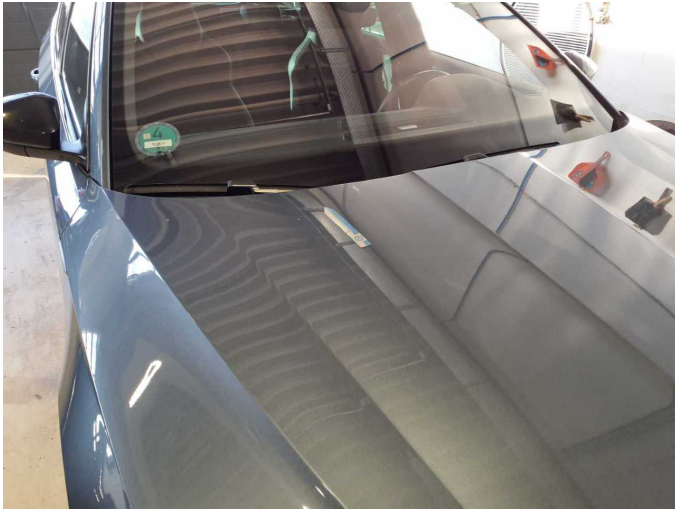
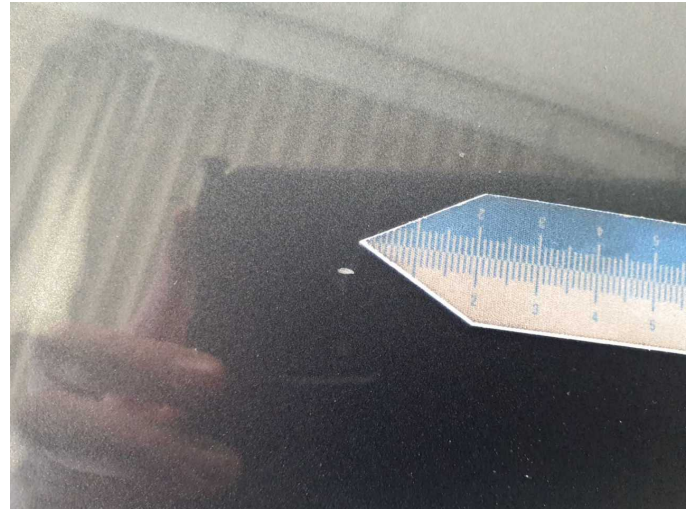
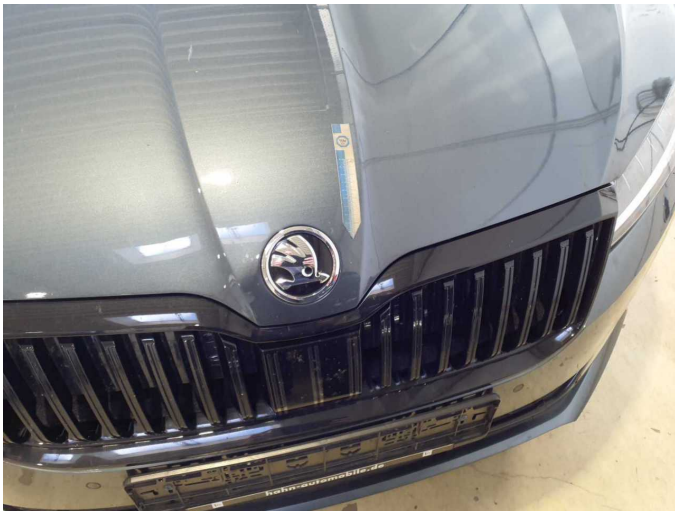
Damage 14: Bonnet: Bonnet - Scratch(es) - Paint

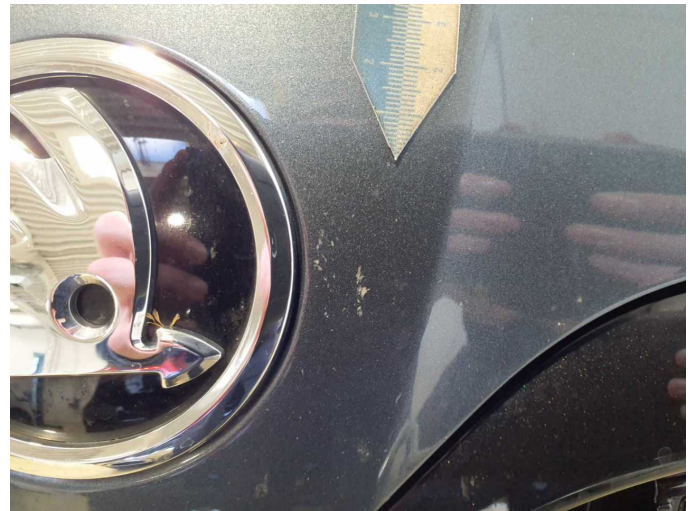
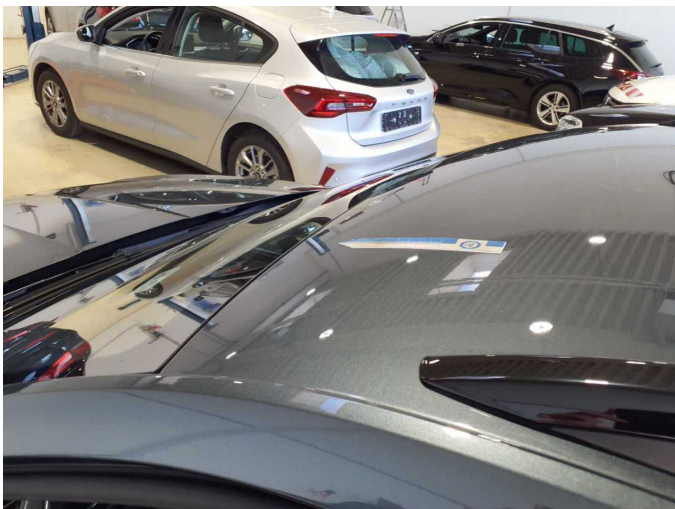
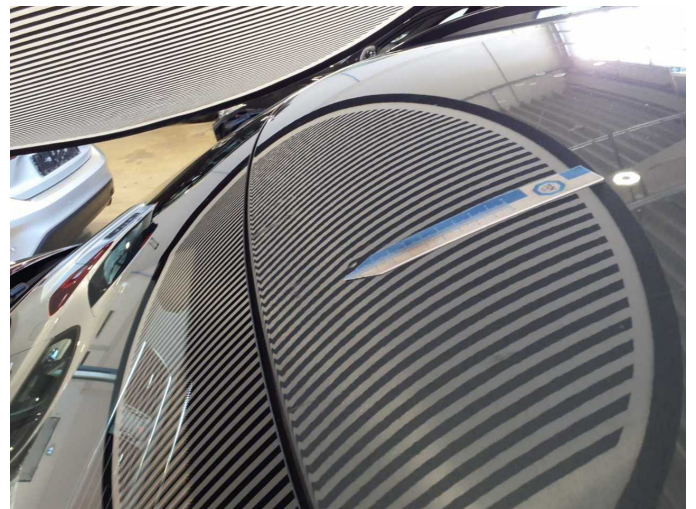
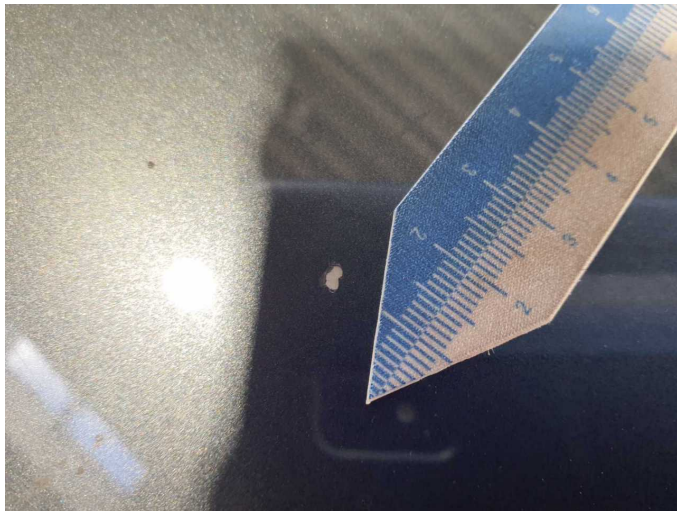
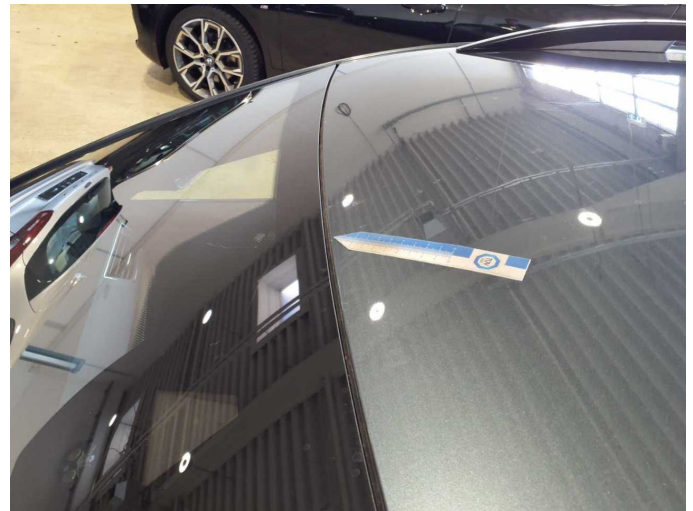
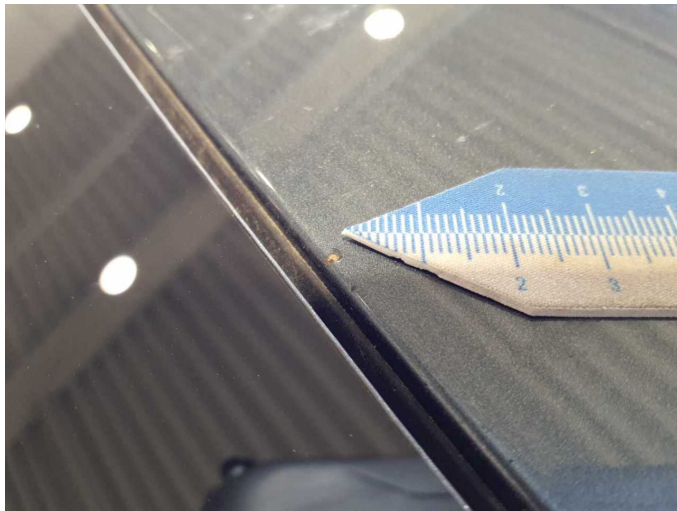
Damage 15: Roof: Roof (+korrosion) - Dent / paintcoat damage - Repair and paint

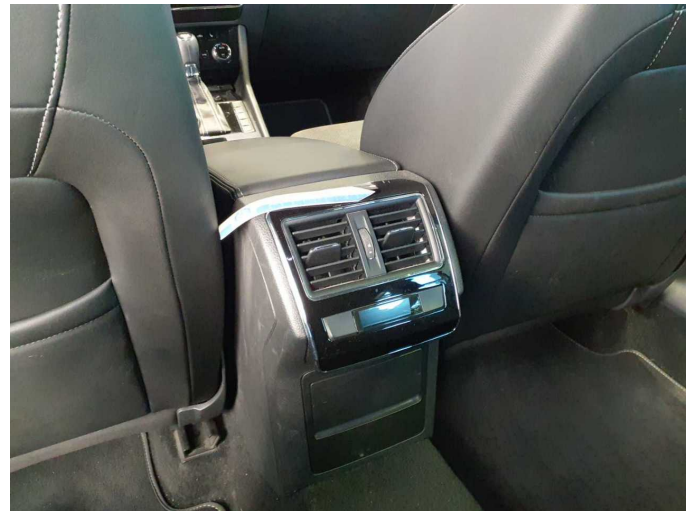
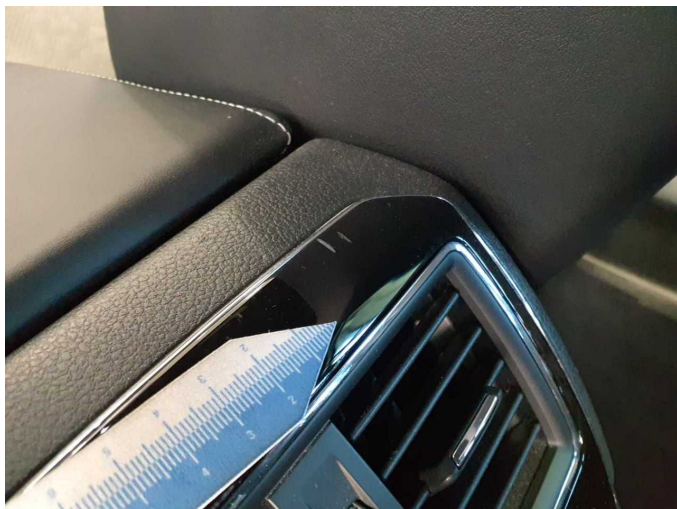
Wear and tear 2: Instrument panel: Centre console - rear - Scratch(es) - No deduction

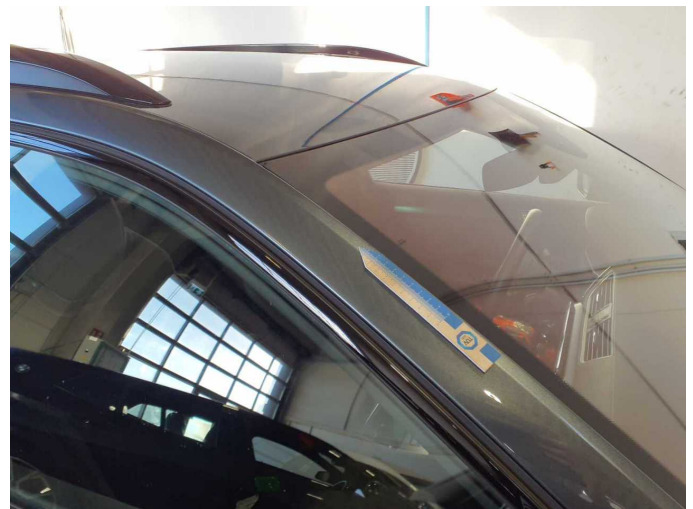
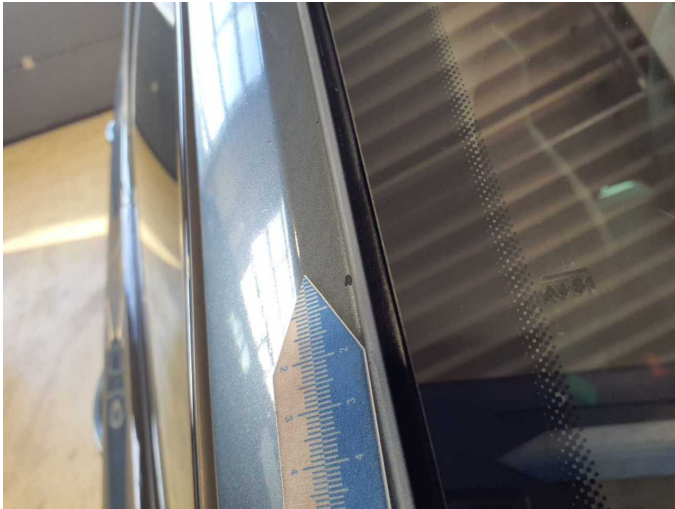
Wear and tear 3: Body: A-pillar - right side - Stone chips - No deduction

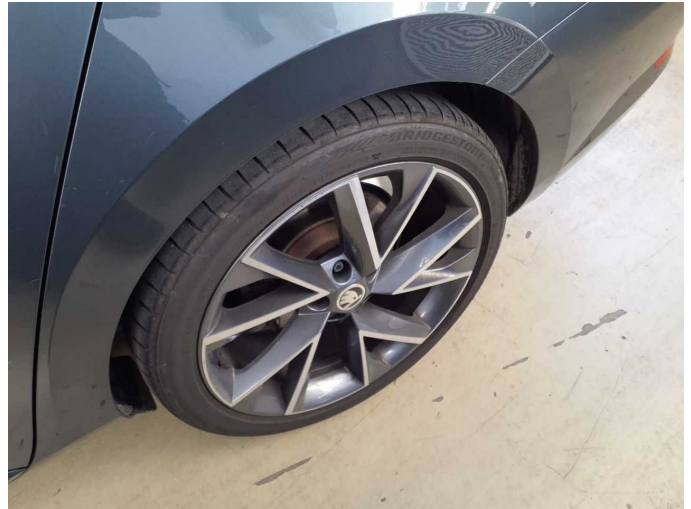
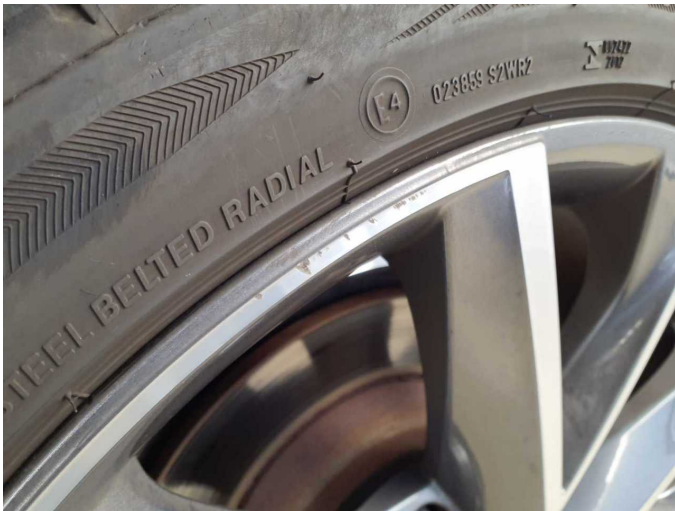
Wear and tear 4: Wheel / tyres: Alloy rim - rear left side - Scratch(es) - No deduction

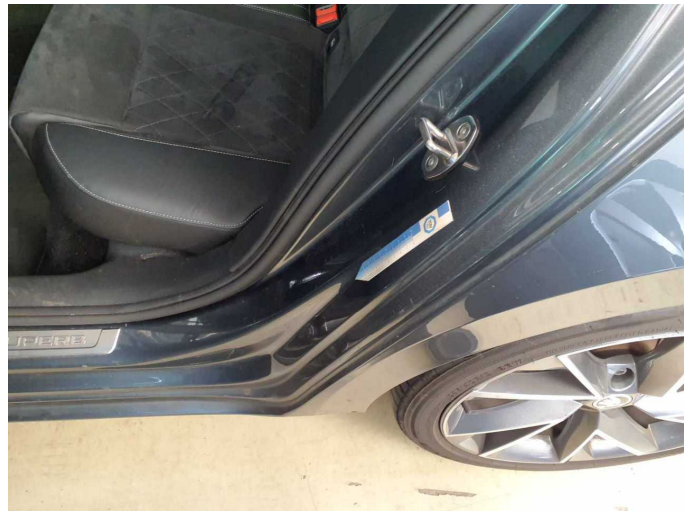
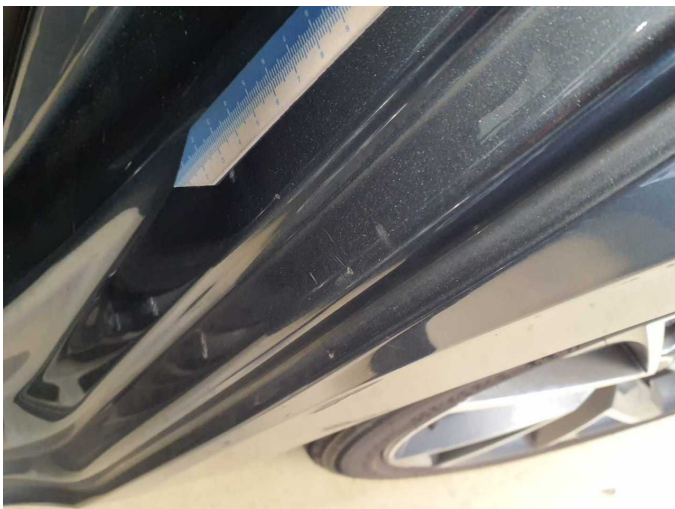
Wear and tear 5: Side panel - rear left side: Sill - Scratch(es) - No deduction
