Expertise

Protocol number: 41681451
Order No. / Reference: 25223415
Inspection date: 24 Sept 2025

Manufacturer: Skoda
VIN: TMBLJ7NP3L7026726

Model: Superb Combi 2.0 TDI 4x4 DSG Sportline

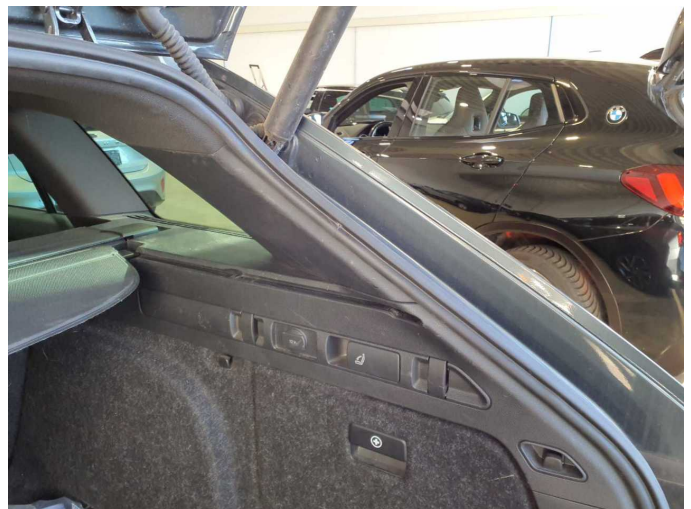
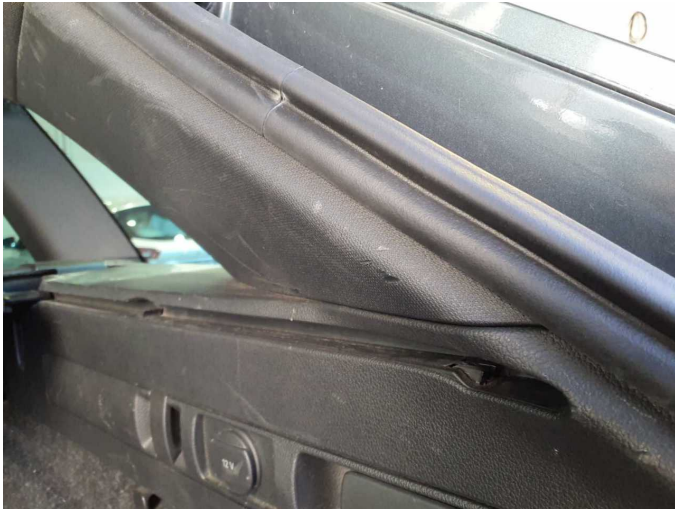
Wear and tear 6: Trim / covers: D-pillar - trim - interior, right side - Scratch(es) - No deduction

Wear and tear 6: Trim / covers: D-pillar - trim - interior, right side -
Scratch(es) - No deduction

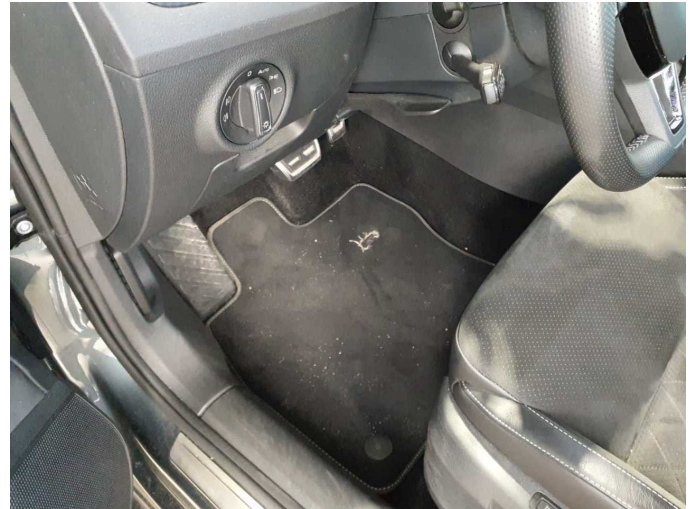
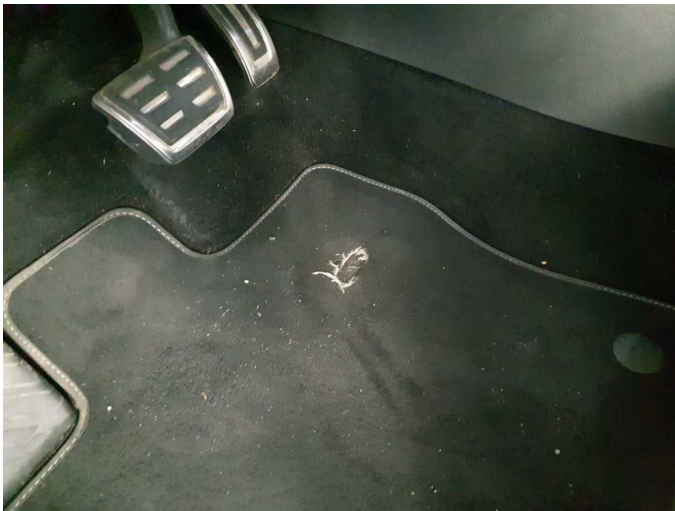
Wear and tear 7: Trim / covers: Floor mats - Damaged - No deduction
