Expertise

Protocol number: 39986546
Order No. / Reference: 24842454
Inspection date: 2 Jun 2025

Manufacturer: Skoda

Model: Superb Combi 2.0 TDI 4x4 DSG Sportline

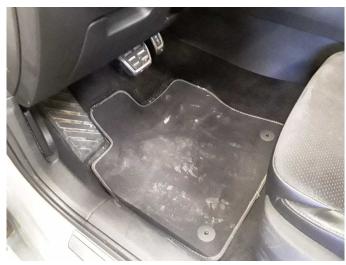
Damage 1: Trim / covers: Floor mats - Damaged - Replace

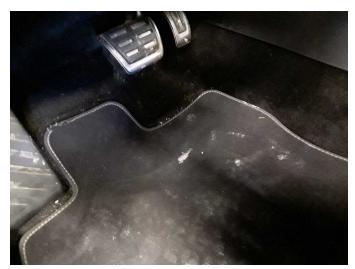
Damage 1: Trim / covers: Floor mats - Damaged - Replace

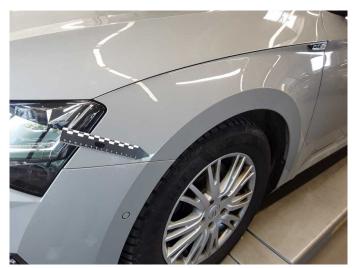
Damage 3: Mudguard - left side: Mudguard - left side - Scratch(es) - Paint

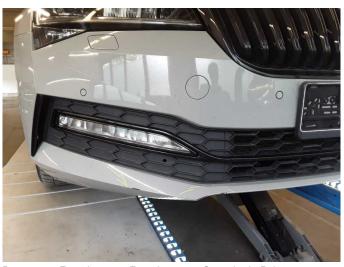
Damage 4: Front bumper: Front bumper - Scratched - Paint

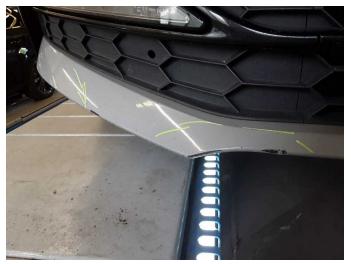
Damage 4: Front bumper: Front bumper - Scratched - Paint

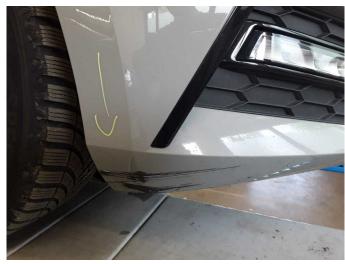
Damage 4: Front bumper: Front bumper - Scratched - Paint

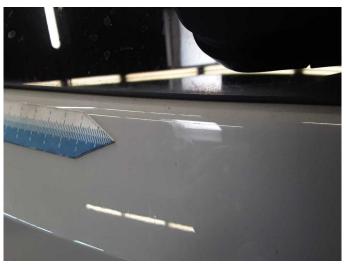
Damage 6: Boot lid / rear door: Boot lid (Vogelkot) - Paint defect - Paint

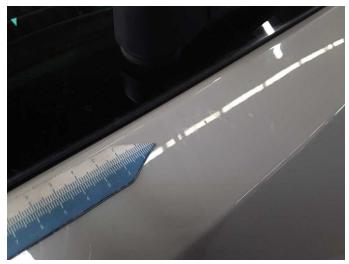
Damage 6: Boot lid / rear door: Boot lid (Vogelkot) - Paint defect - Paint

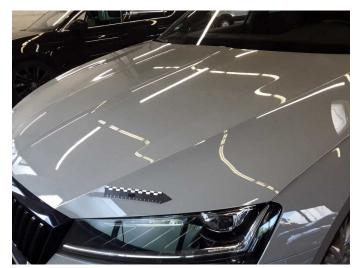
Damage 7: Bonnet: Bonnet - Dent / paintcoat damage - Repair and paint

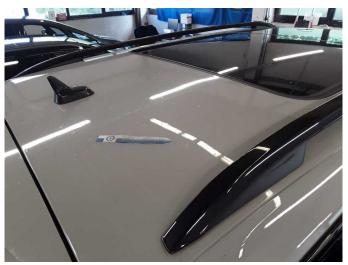
Damage 7: Bonnet: Bonnet - Dent / paintcoat damage - Repair and paint Damage 8: Roof: Roof - Corrosion - Repair and paint

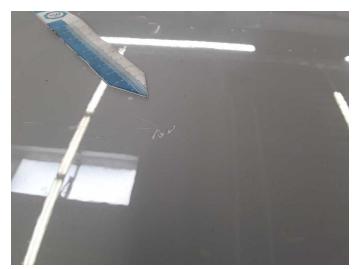
Damage 8: Roof: Roof - Corrosion - Repair and paint

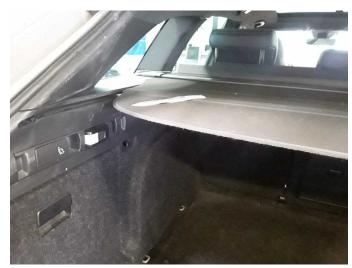
Wear and tear 1: Interior: Interior - Scratch(es) - No deduction

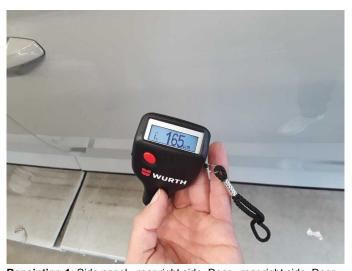
Repainting 1: Side panel - rear right side, Door - rear right side, Door - front right side

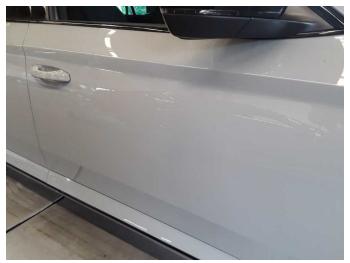
Repainting 1: Side panel - rear right side, Door - rear right side, Door - front right side

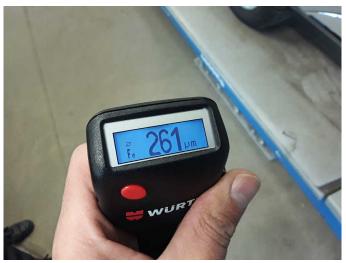
Repainting 1: Side panel - rear right side, Door - rear right side, Door - front right side

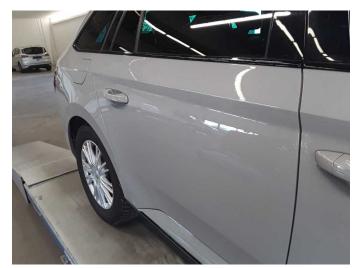
Repainting 1: Side panel - rear right side, Door - rear right side, Door - front right side

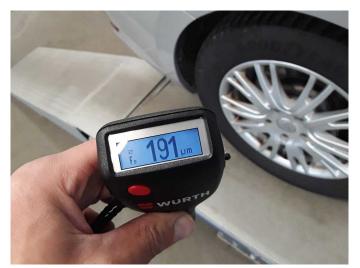
Repainting 1: Side panel - rear right side, Door - rear right side, Door - front right side

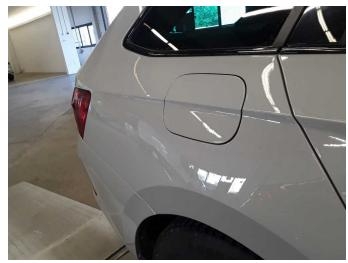
Repainting 1: Side panel - rear right side, Door - rear right side, Door - front right side
