Expertise

Protocol number: 41486708
Order No. / Reference: 25143311
Inspection date: 12 Sept 2025

Manufacturer: Skoda	Model: Kodiah 2.0 TDI 4x4 DSG L&K
VIN: TMBLJ7NS2M8060365

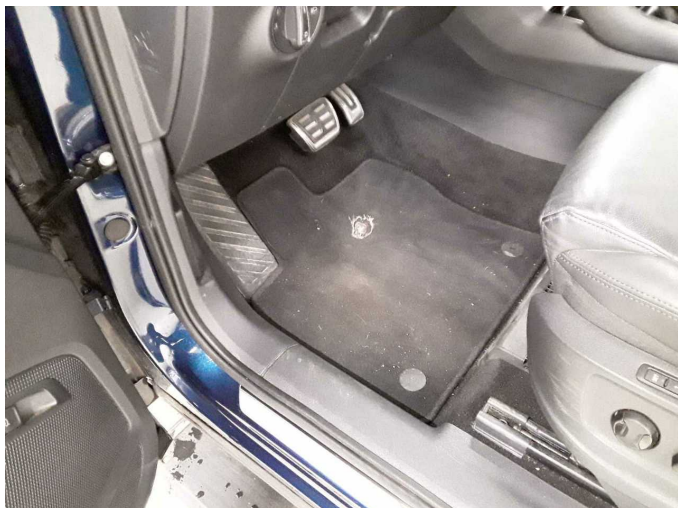
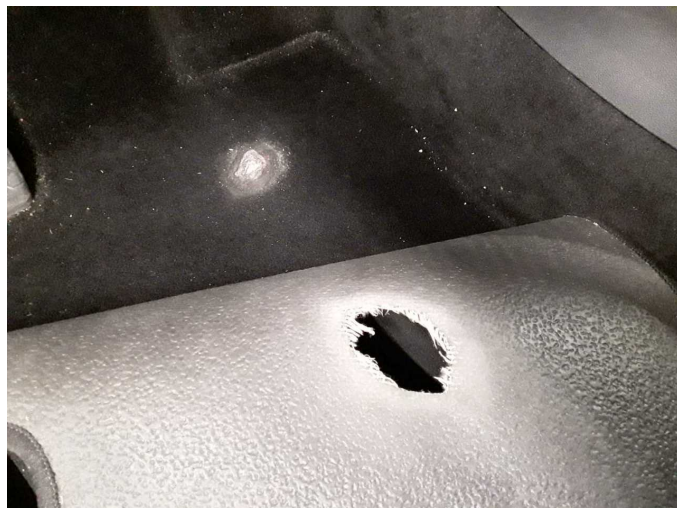
Damage 2: Trim / covers: Floor mats - Broken / torn - Replace

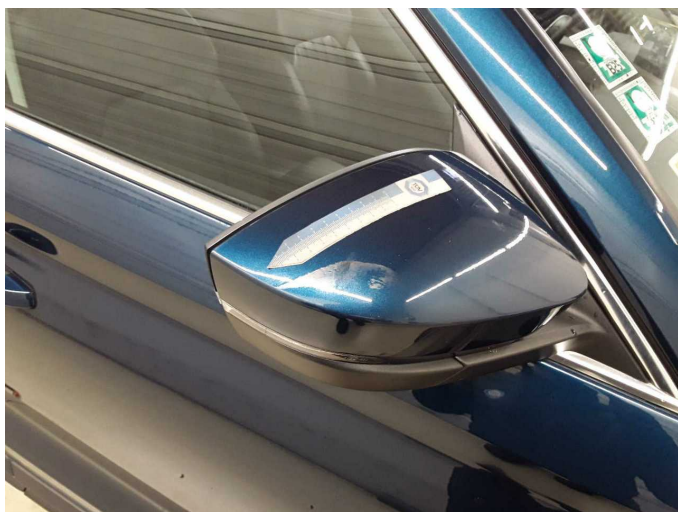
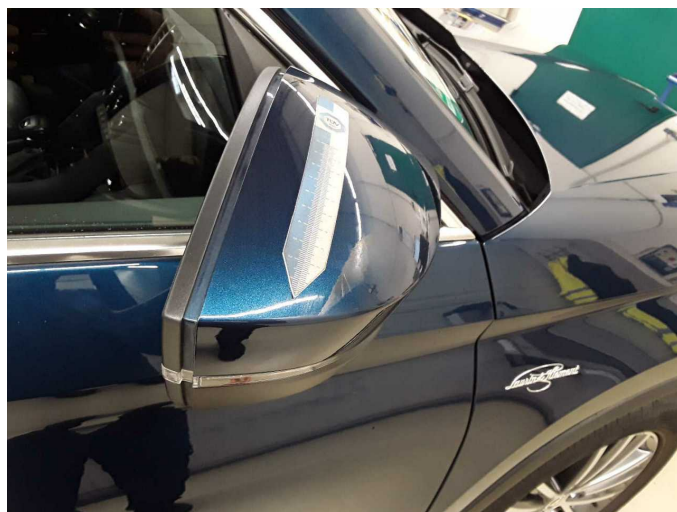
Damage 3: Wing mirror - right side: Cap - Scratch(es) - Smart repair

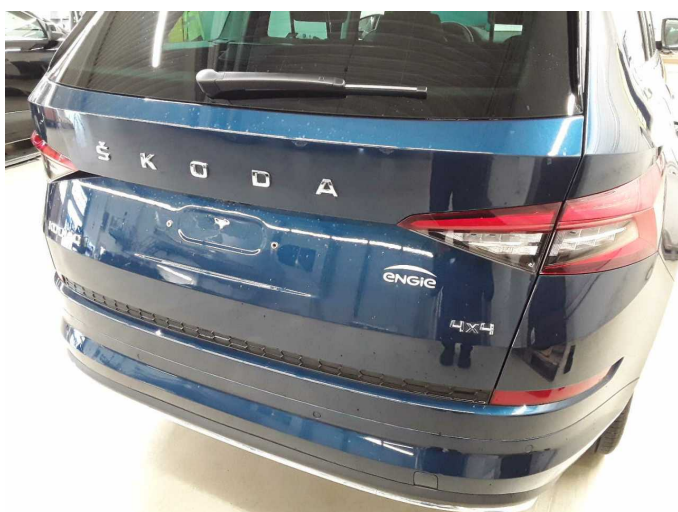
Damage 4: Boot lid / rear door: Boot lid - Glued / labelled - De-glue / neutralise

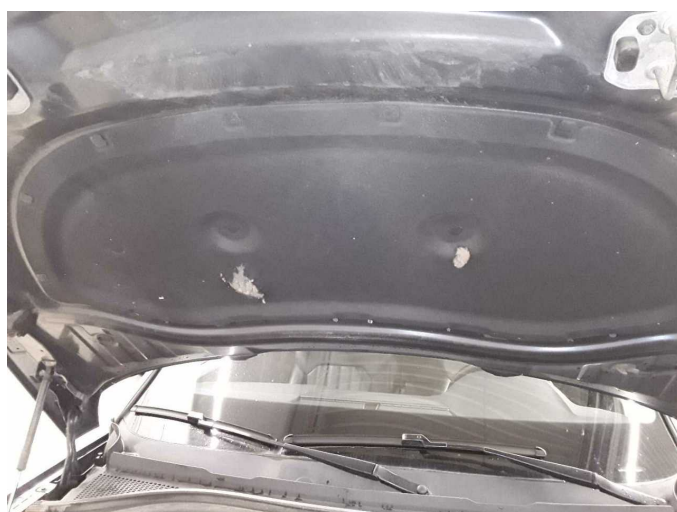
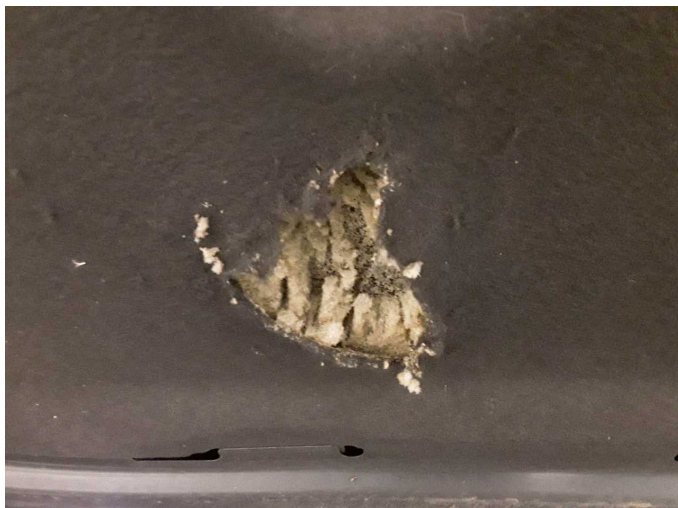
Damage 5: Bonnet: Insulation lining - Broken / torn - Replace

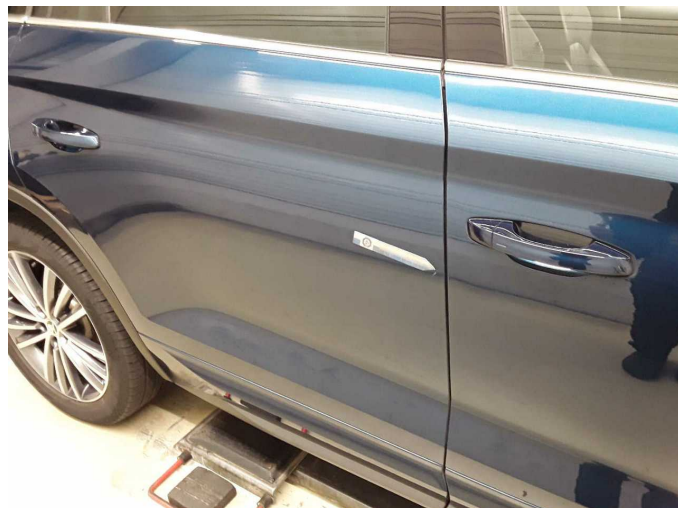
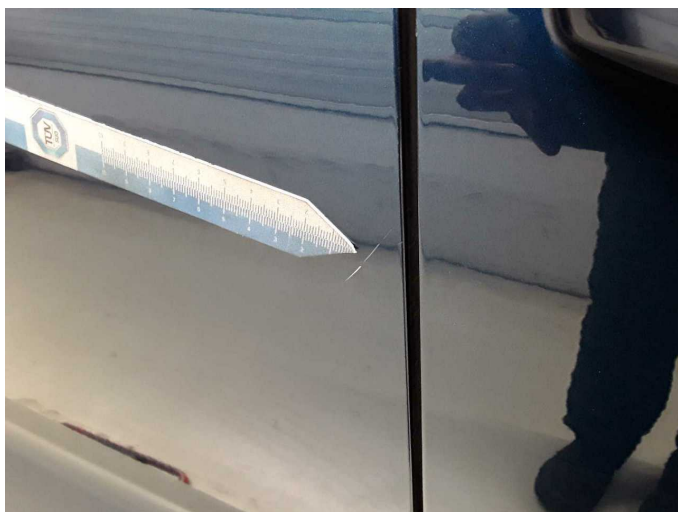
Damage 6: Door - rear right side: Door - Scratch(es) - Smart repair

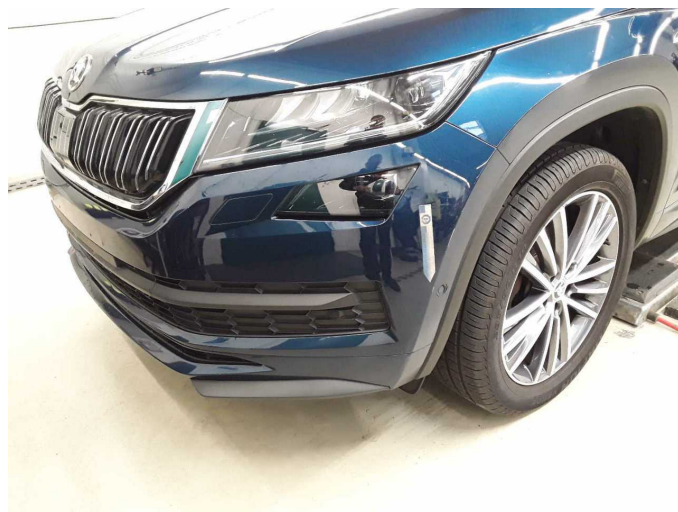
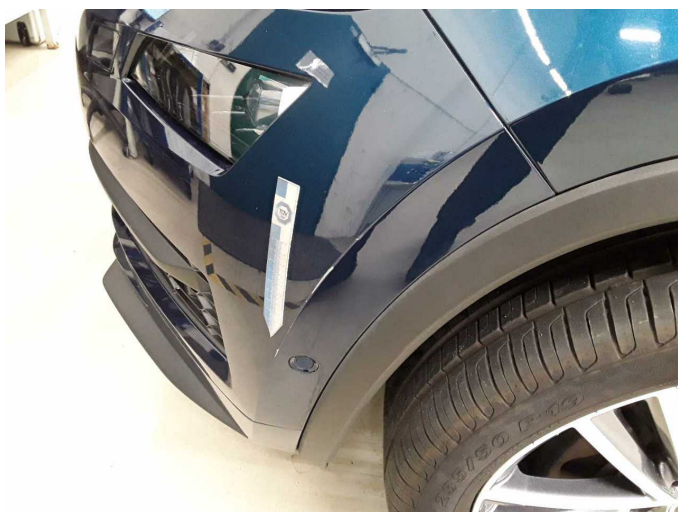
Damage 7: Front bumper: Front bumper - Scratch(es) - Smart repair

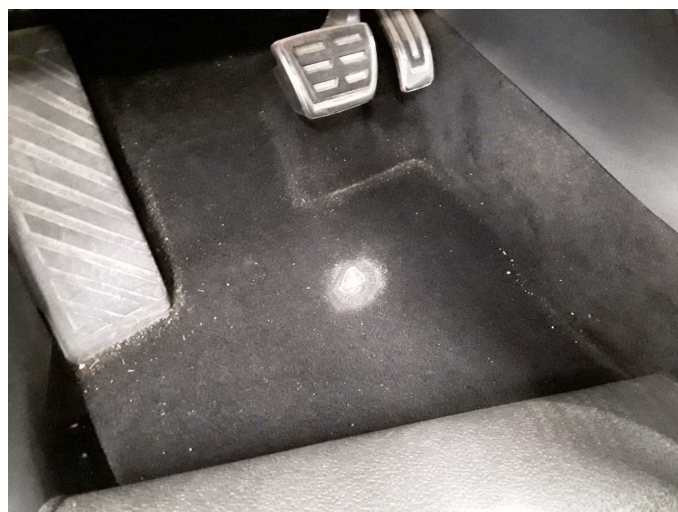
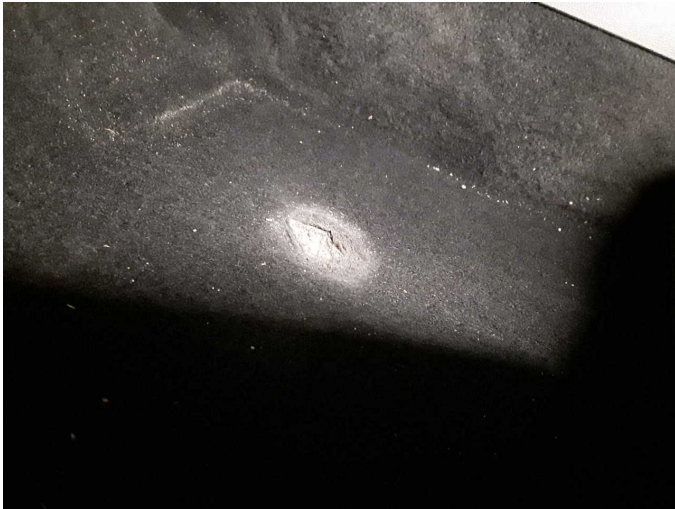
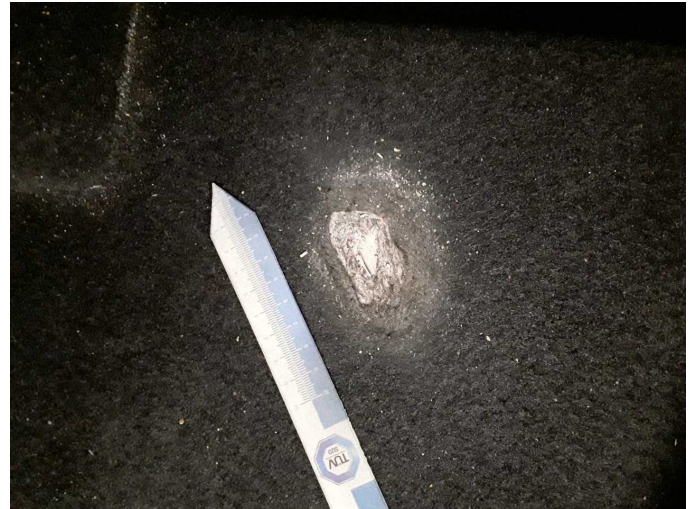
Damage 8: Trim / covers: Carpet - front left side (Verschleissen) - Holes - Smart repair

Damage 8: Trim / covers: Carpet - front left side (Verschleßen) - Holes - Smart repair

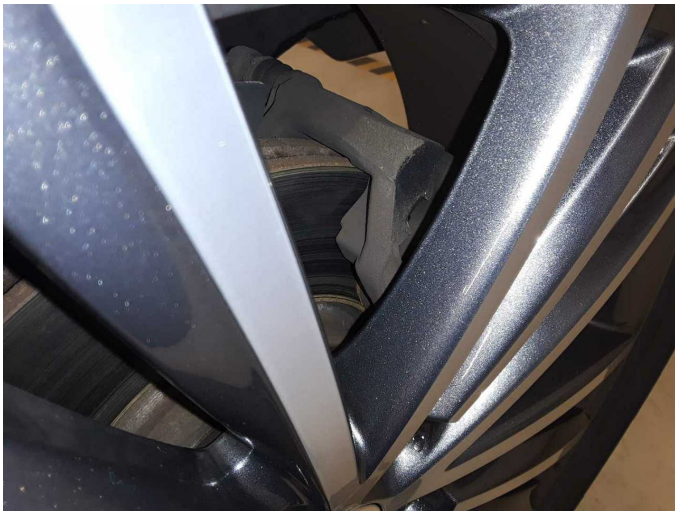
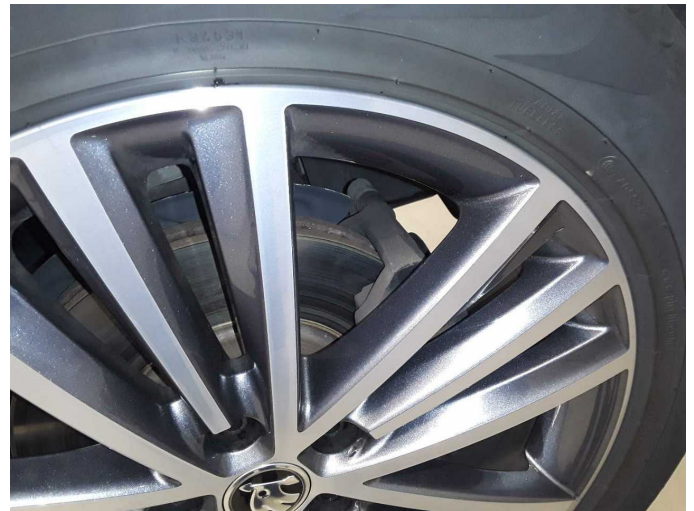
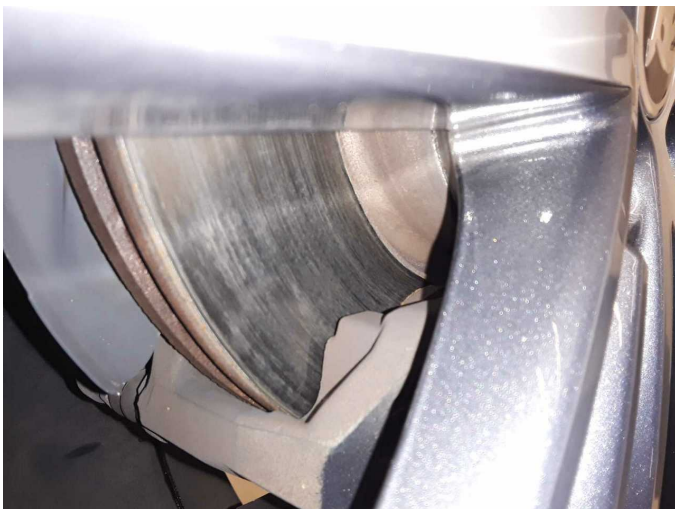
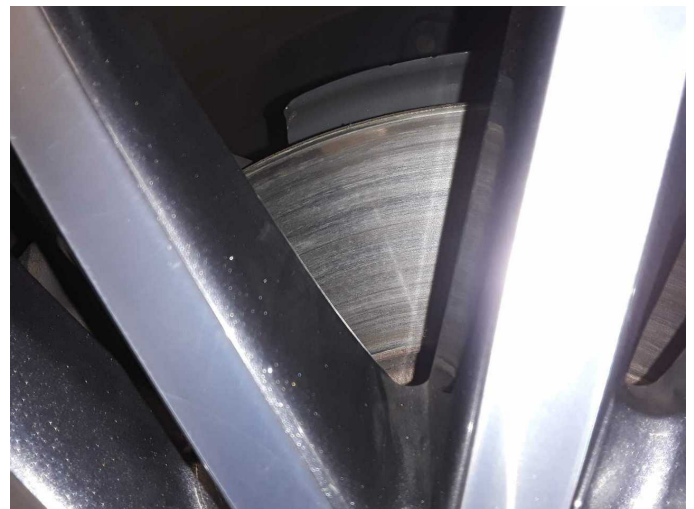
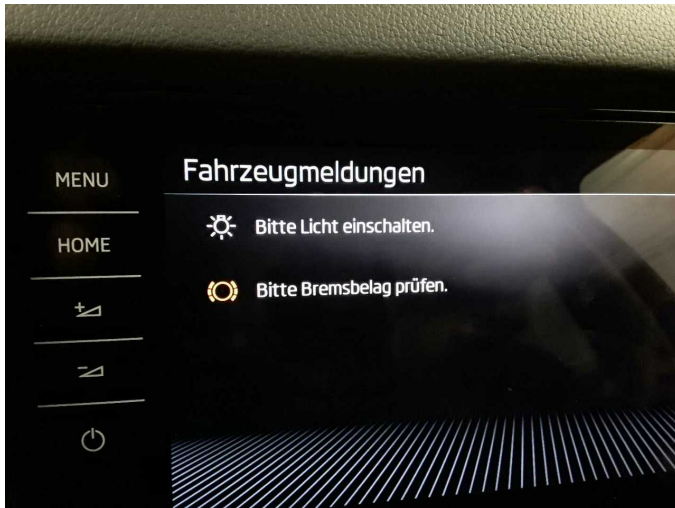
Damage 9: Braking system: Brake discs and brake pads - front (Scheiben sind eingelaufen und Geringer Belag.) - Worn - Replace

Damage 9: Braking system: Brake discs and brake pads - front
(Scheiben sind eingelaufen und Geringer Belag.) - Worn - Replace

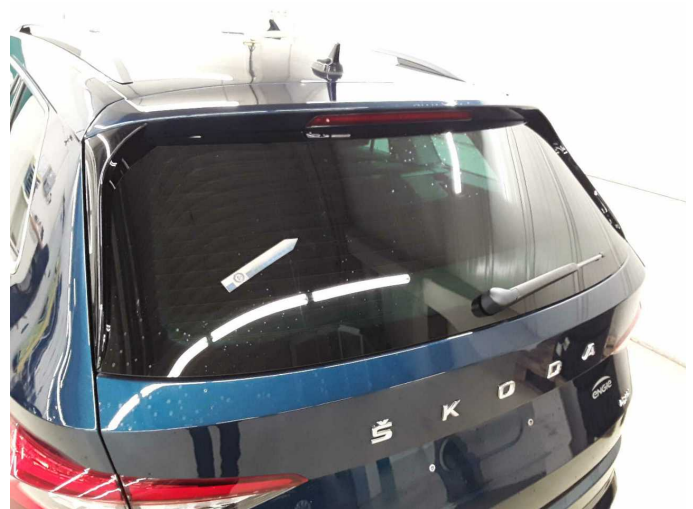
Wear and tear 1: Vehicle glazing: Rear window - Scratch(es) - No deduction

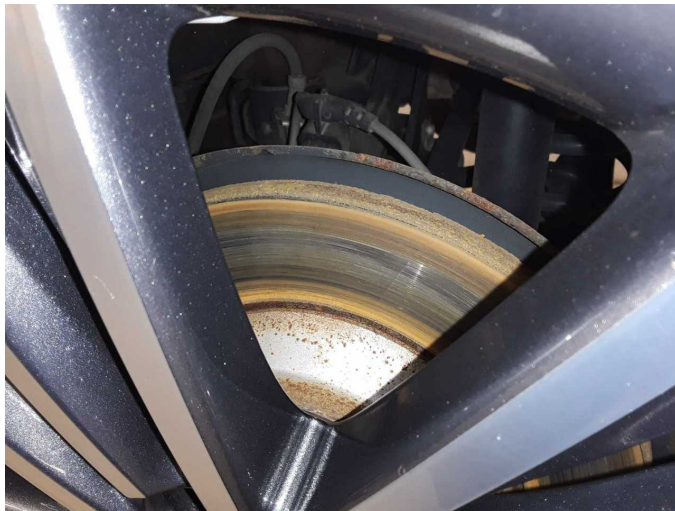
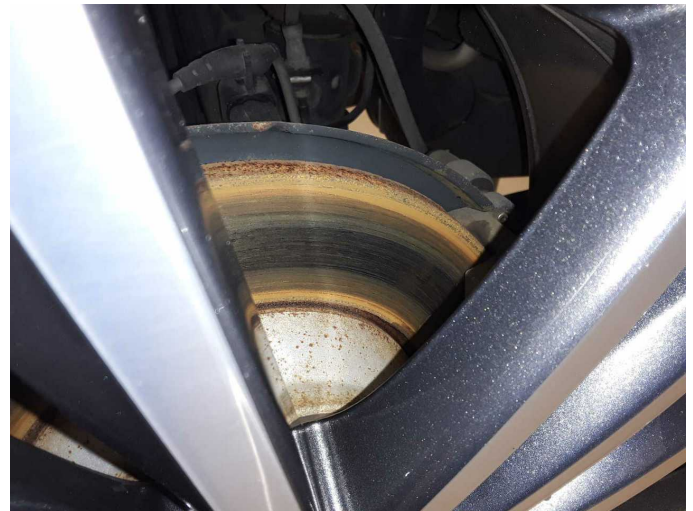
Wear and tear 5: Braking system: Brake discs - rear - Corrosion - No deduction

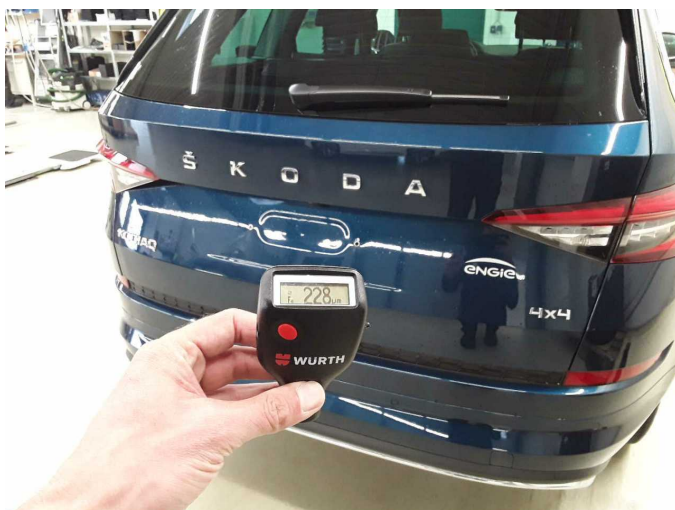
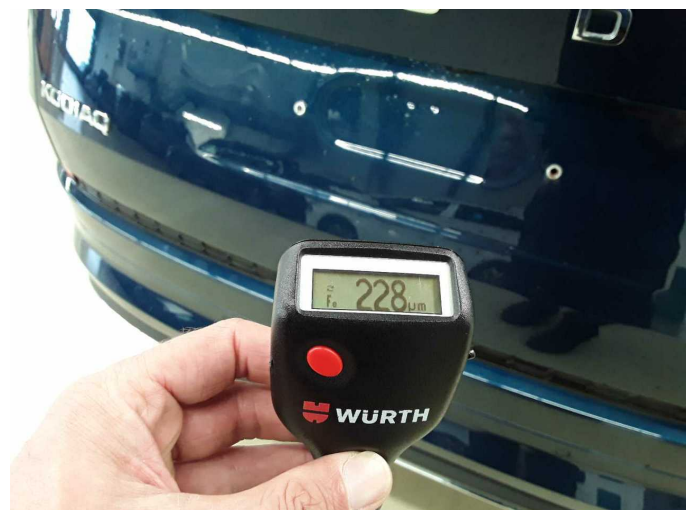
1 Boot lid / rear door, Mudguard - right side, Professionally carried out

Boot lid / rear door: 228 µm

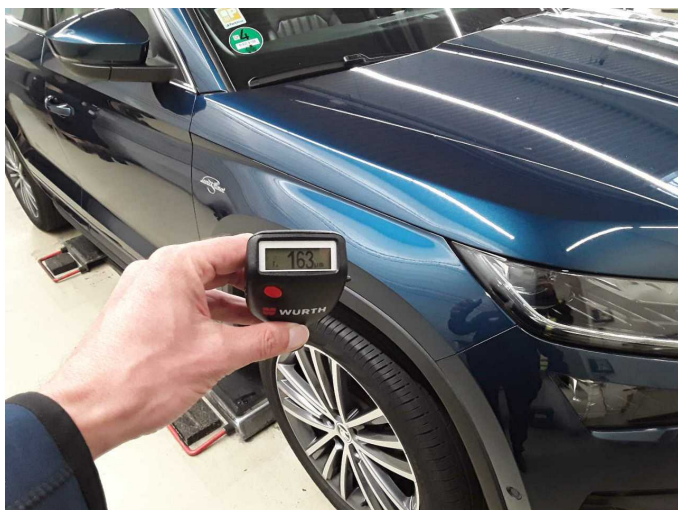
Mudguard - right side: 163 μ m
