Expertise

Protocol number: 39570670  
Order No. / Reference: 24660994  
Inspection date: 28 Apr 2025

Manufacturer: Skoda  
VIN: TMBLJ7NU1M5057590

Model: Karoq 2.0 TDI SCR 4x4 DSG Ambition

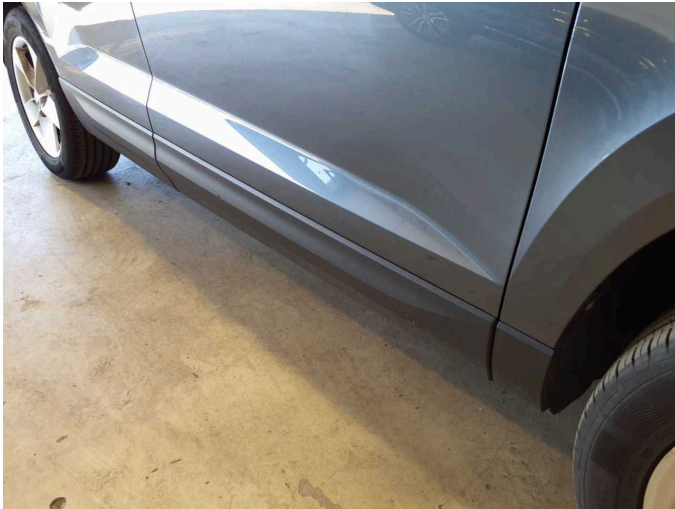
**Damage 1:** Door - front right side: Brightware - lower - Damaged - Replace

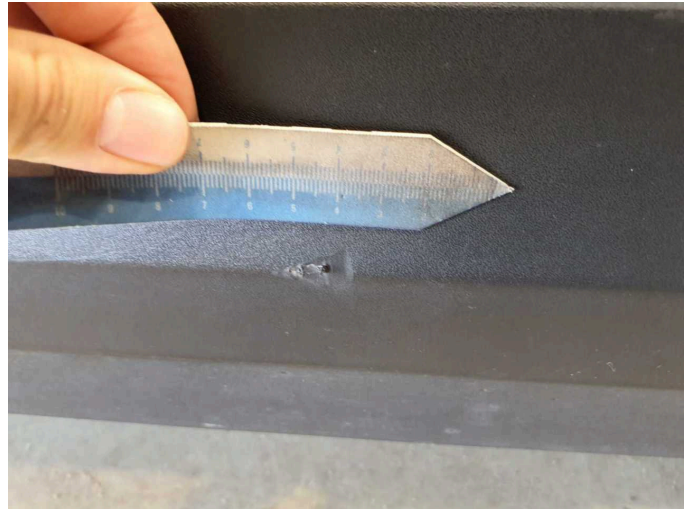
**Damage 1:** Door - front right side: Brightware - lower - Damaged - Replace

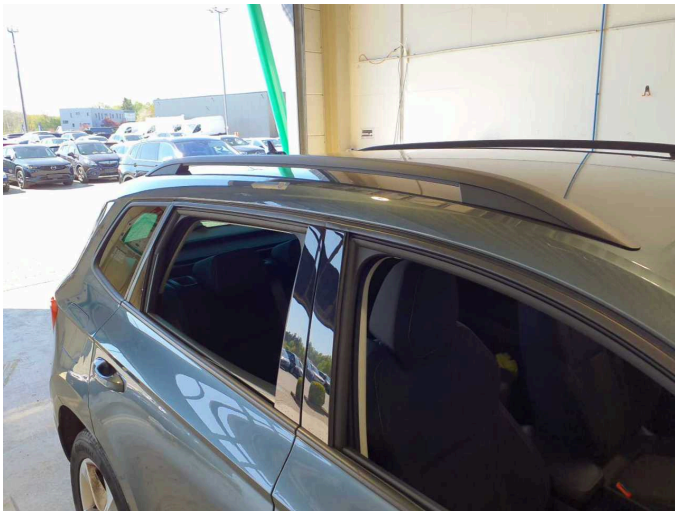
**Damage 2:** Roof: Roof rail - right side (Anätzung) - Paint defect - Paint

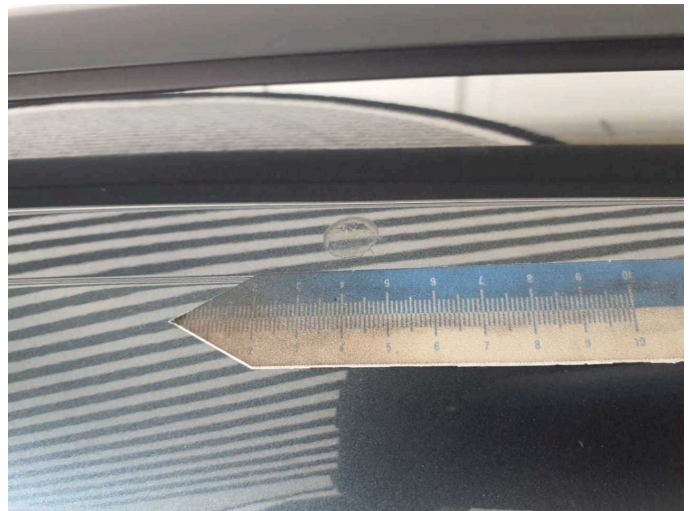
**Damage 2:** Roof: Roof rail - right side (Anätzung) - Paint defect - Paint

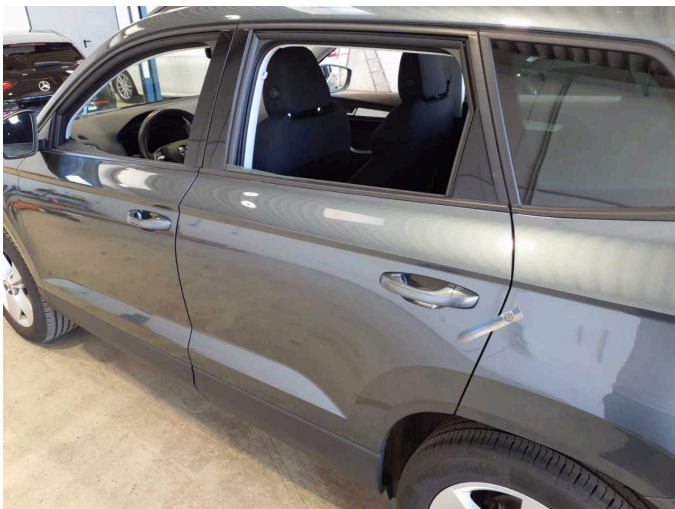
**Damage 3:** Door - rear left side: Door - Scratch(es) - Paint

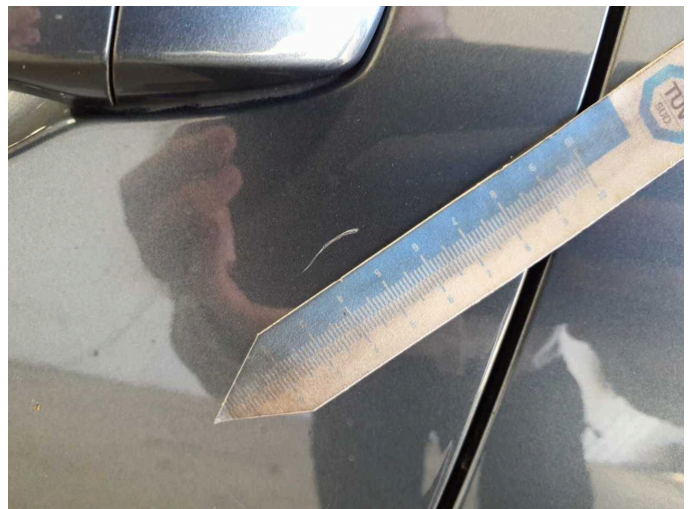
**Damage 3:** Door - rear left side: Door - Scratch(es) - Paint

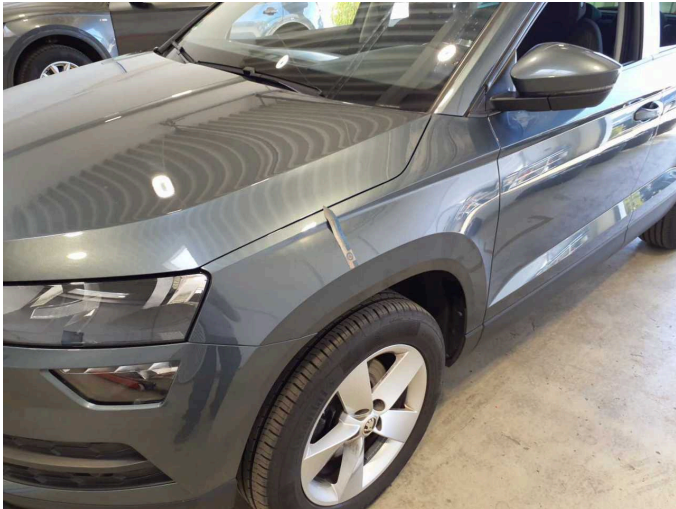
**Damage 4:** Mudguard - left side: Mudguard - left side (Stellenweise matt)  
- Paint defect - Paint

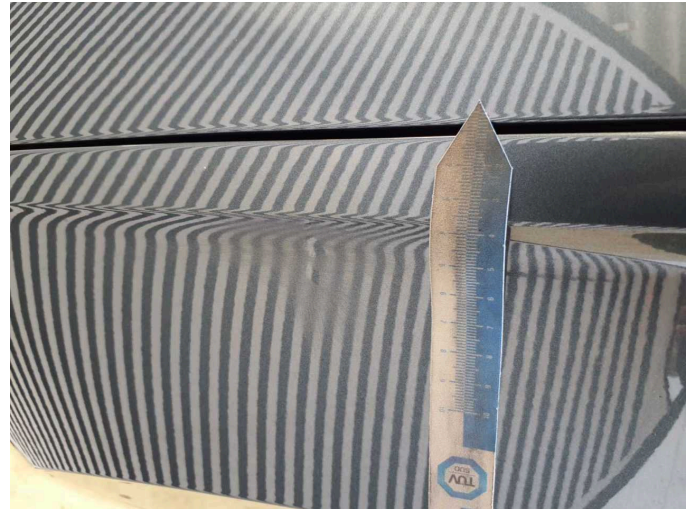
**Damage 4:** Mudguard - left side: Mudguard - left side (Stellenweise matt)  
- Paint defect - Paint

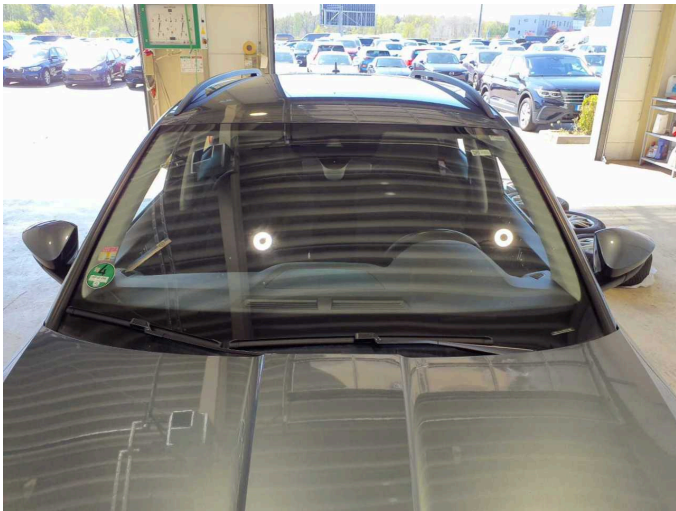
**Damage 5:** Vehicle glazing: Windscreen - Damaged - Replace

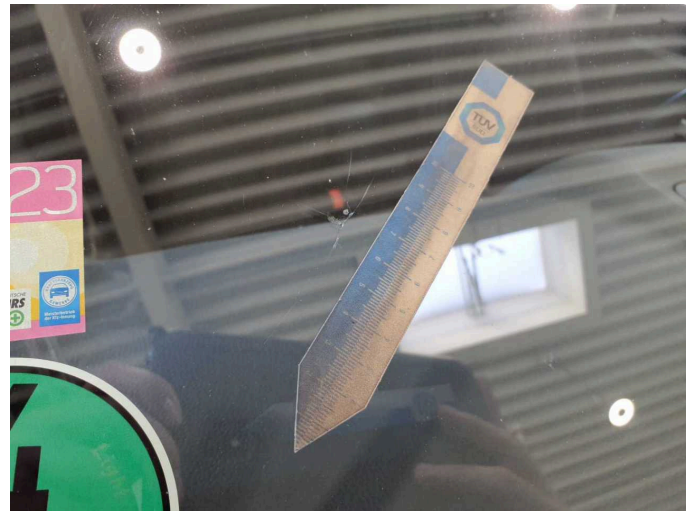
**Damage 5:** Vehicle glazing: Windscreen - Damaged - Replace

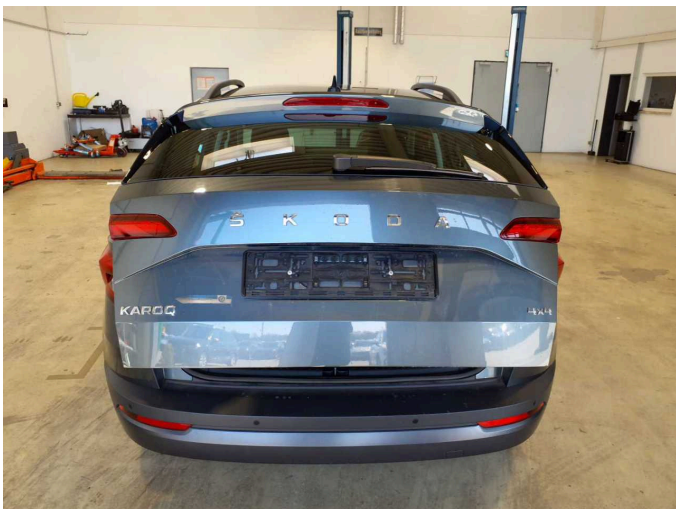
**Wear and tear 5:** Boot lid / rear door: Boot lid - dent(s) - No deduction

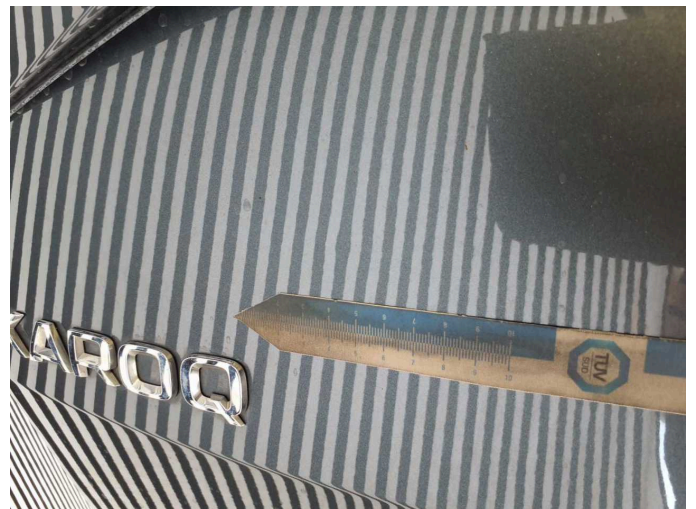
**Wear and tear 5:** Boot lid / rear door: Boot lid - dent(s) - No deduction

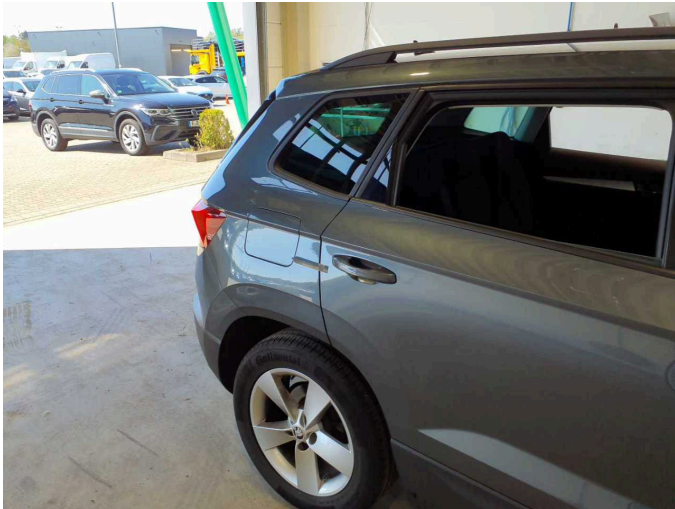
**Wear and tear 6:** Side panel - rear right side: Side panel - dent(s) - No deduction

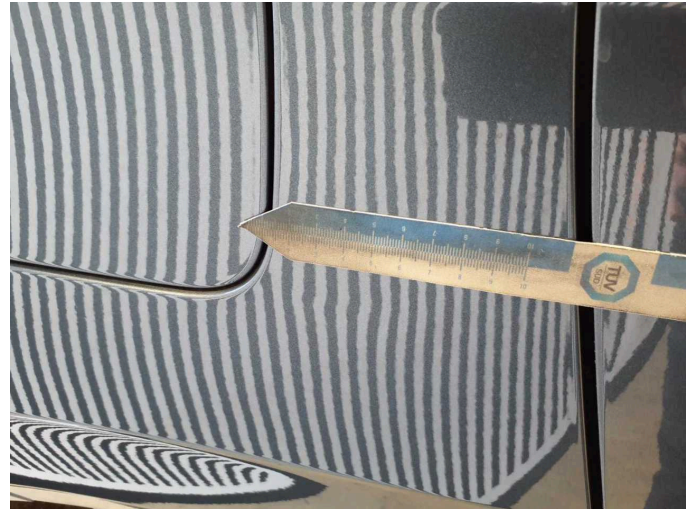
**Wear and tear 6:** Side panel - rear right side: Side panel - dent(s) - No deduction

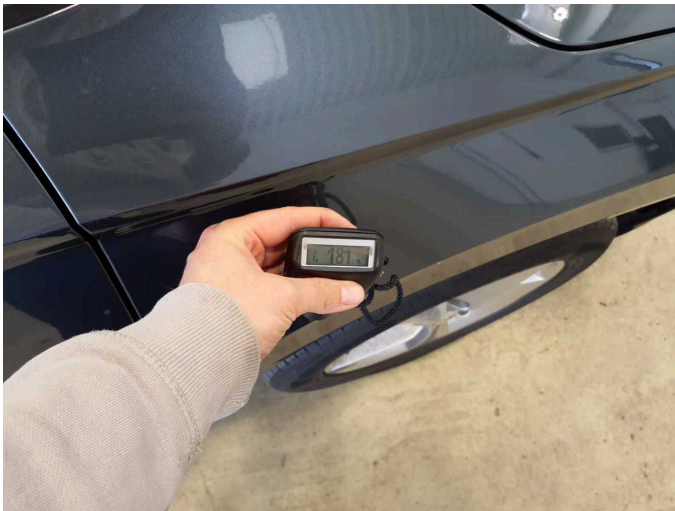
**Repainting 1:** Mudguard - right side, Side panel - rear right side, Door - rear right side

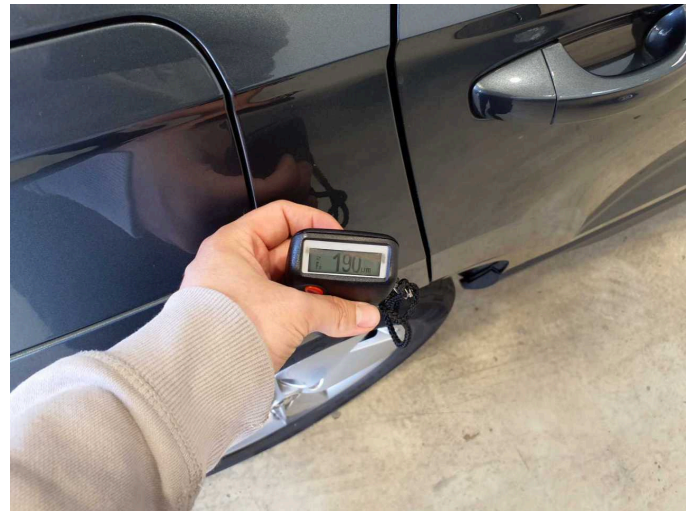
**Repainting 1:** Mudguard - right side, Side panel - rear right side, Door - rear right side

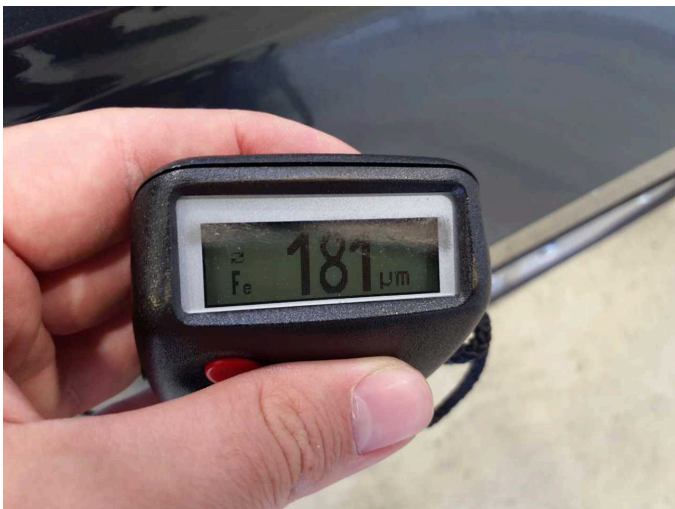
**Repainting 1:** Mudguard - right side, Side panel - rear right side, Door - rear right side

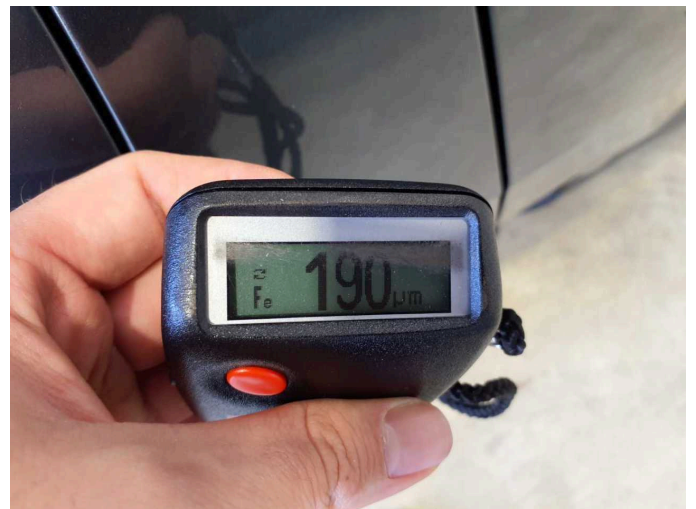
**Repainting 1:** Mudguard - right side, Side panel - rear right side, Door - rear right side

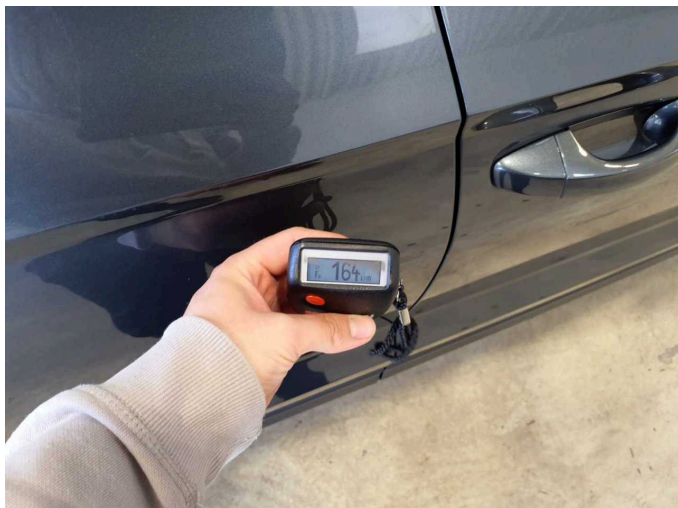
**Repainting 1:** Mudguard - right side, Side panel - rear right side, Door - rear right side

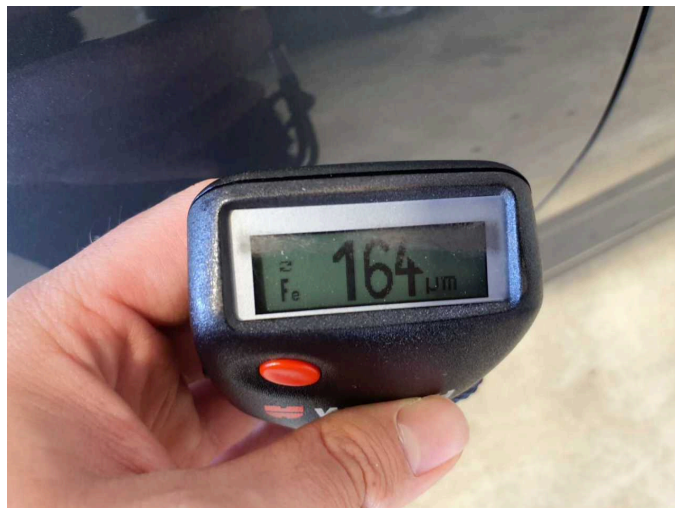
**Repainting 1:** Mudguard - right side, Side panel - rear right side, Door - rear right side
