Expertise

Protocol number: 41167087
Order No. / Reference: 25117882
Inspection date: 21 Aug 2025

Manufacturer: Skoda
VIN: TMBLJ7NU3N5016525

Model: Karoq 2.0 TDI SCR 4x4 DSG Style

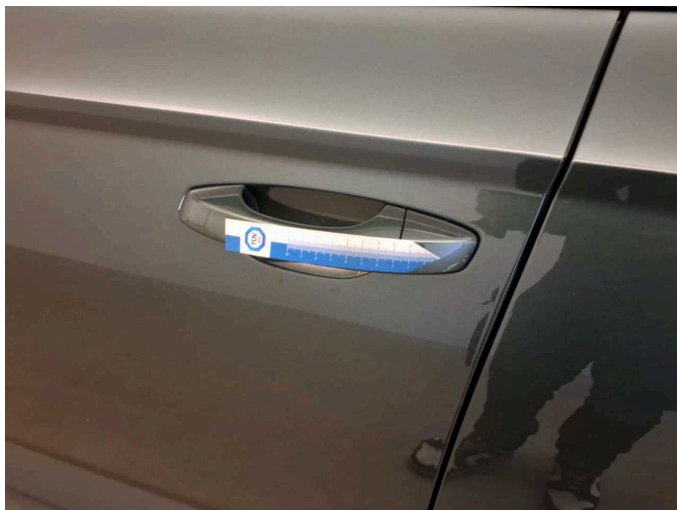
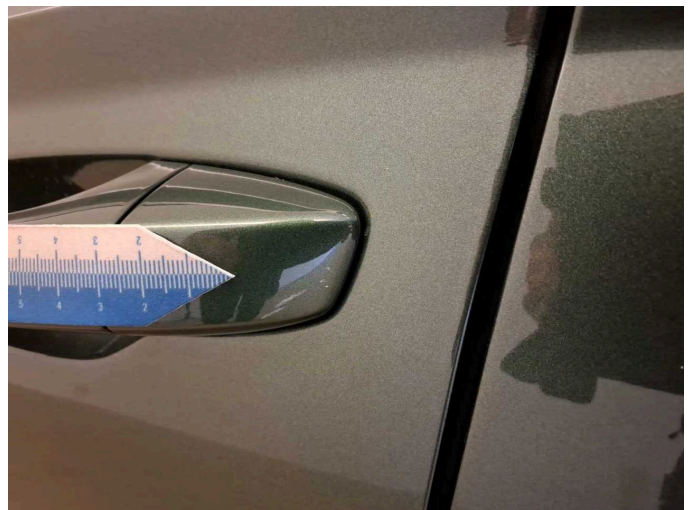
| No. | Component group | Description |
|---|---|--|
| 1 | Door - front left side | Door handle - outside - Scratch(es) - Smart repair |

Damage 1: Door - front left side: Door handle - outside - Scratch(es) - Smart repair

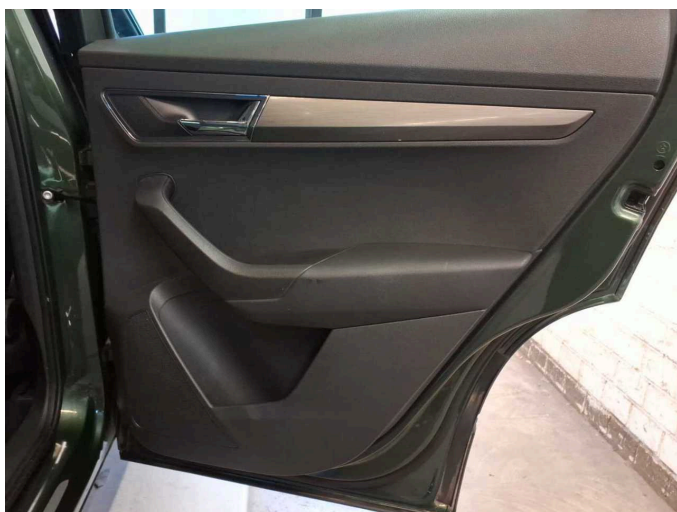
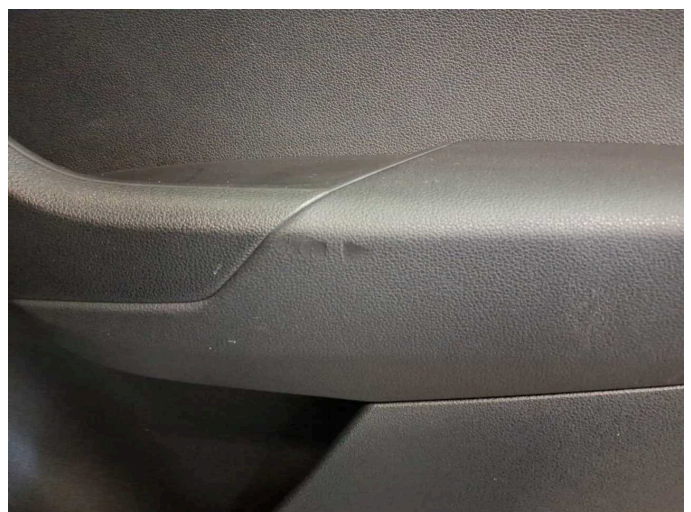
| No. | Component group | Description |
|---|---|--|
| 2 | Trim / covers | Door trim - rear right side - Scratched - Smart repair |

Damage 2: Trim / covers: Door trim - rear right side - Scratched - Smart repair

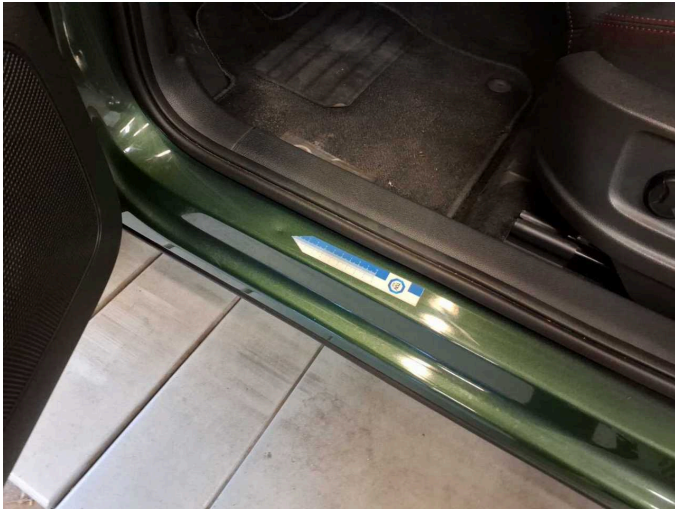
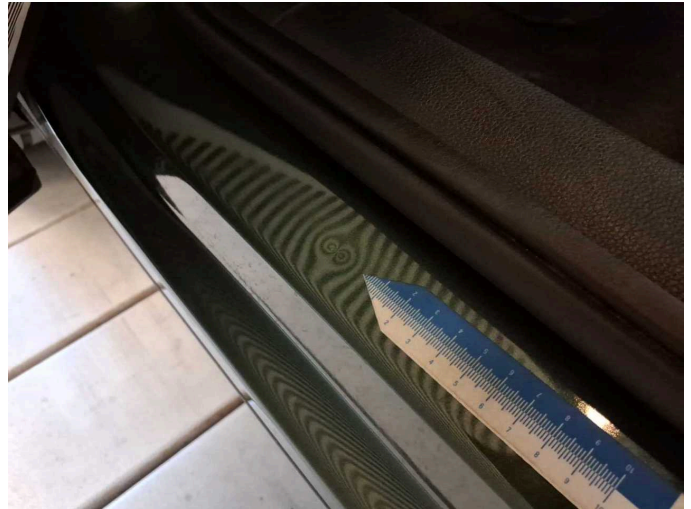
| No. | Component group | Description |
|---|---|--|
| 3 | Sill - left side | Sill - dent(s) - Smart repair |

Damage 3: Sill - left side: Sill - dent(s) - Smart repair

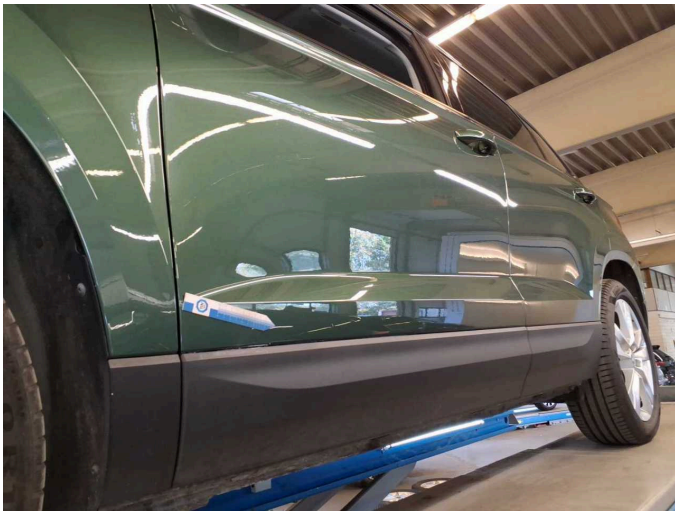
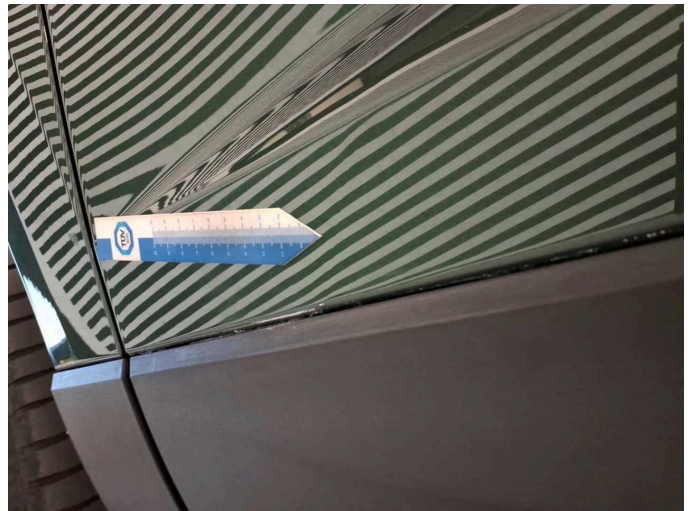
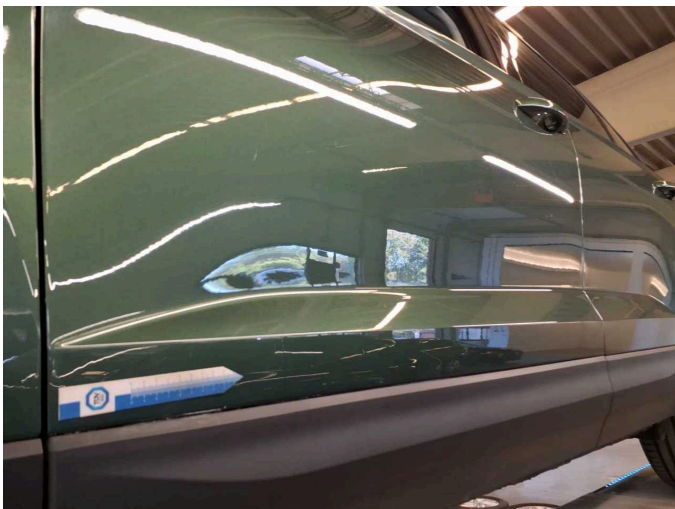
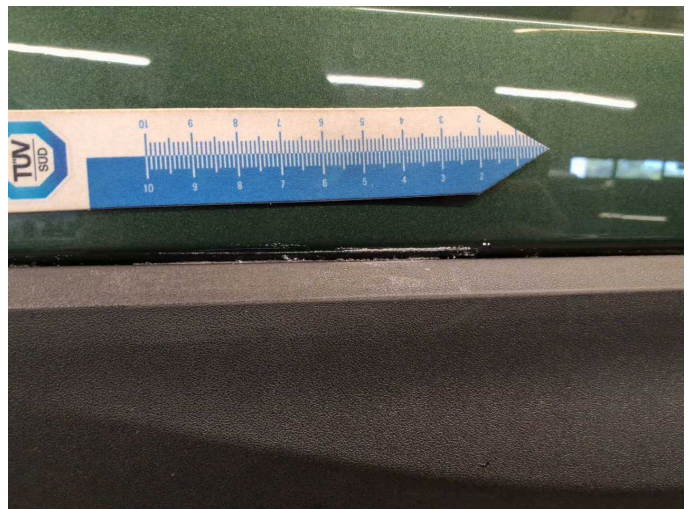
| No. | Component group | Description |
|---|---|--|
| 4 | Door - front left side | Door - Dent / paintcoat damage - Repair and paint |

Damage 4: Door - front left side: Door - Dent / paintcoat damage - Repair and paint

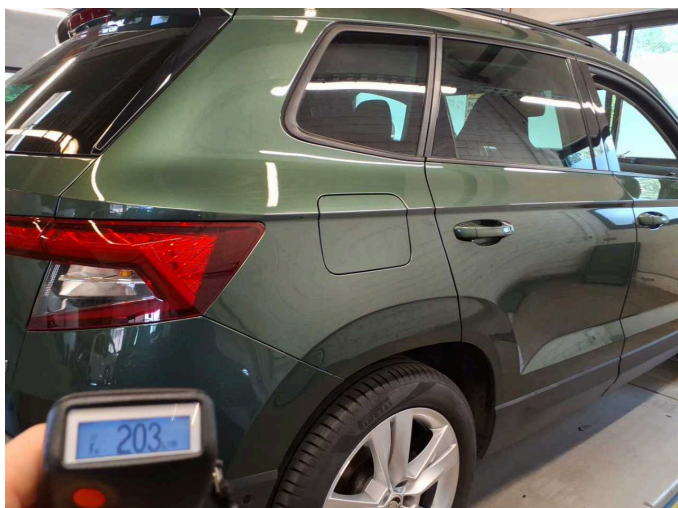
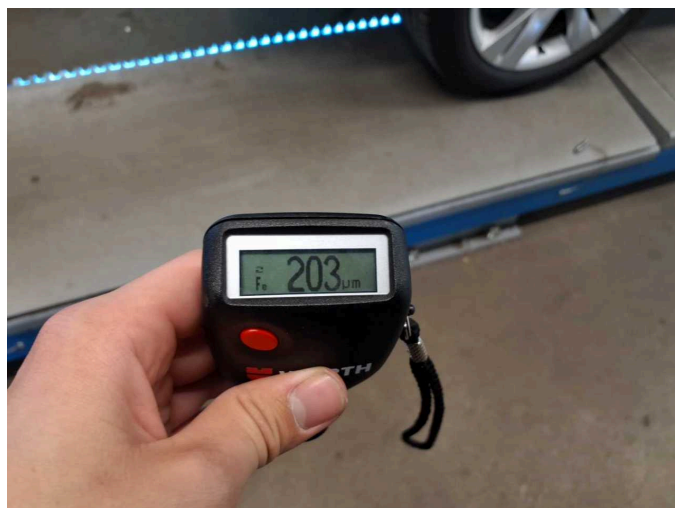
| No. | Repainting |
|---|---|
| 1 | Side panel - rear right side, Professionally carried out, Invoice of repair done Non-existent |

| Side panel - rear right side | 203 µm | Door - rear left side | 193 µm |

Repainting 1: Side panel - rear right side

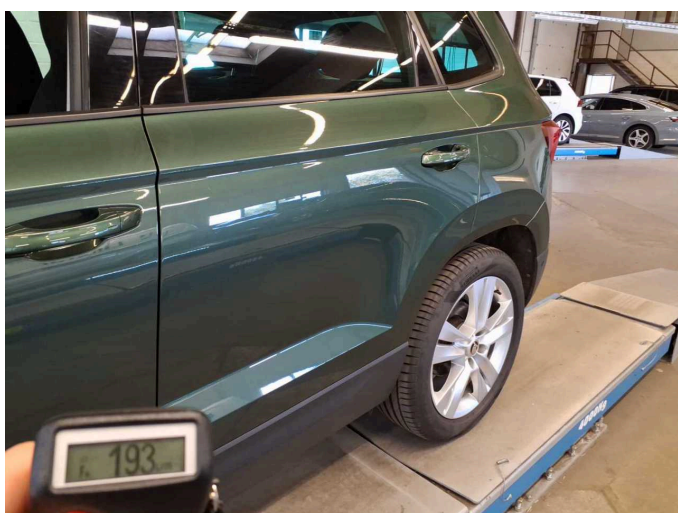
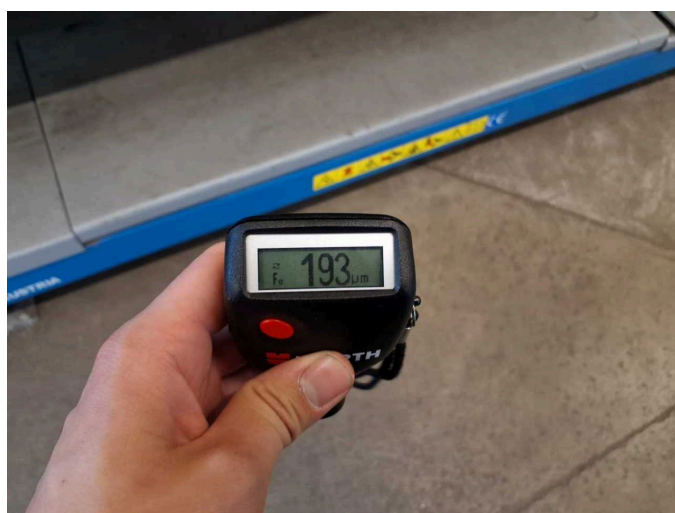
| No. | Repainting |
|---|---|
| 2 | Door - rear left side, Professionally carried out, Invoice of repair done Non-existent |

Repainting 2: Door - rear left side

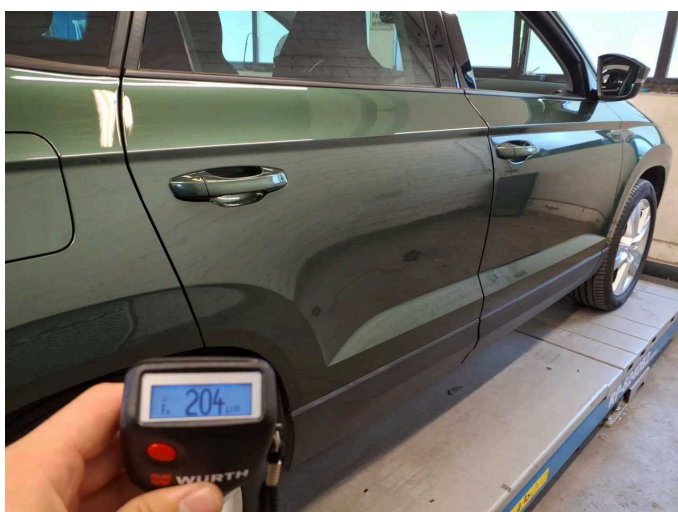
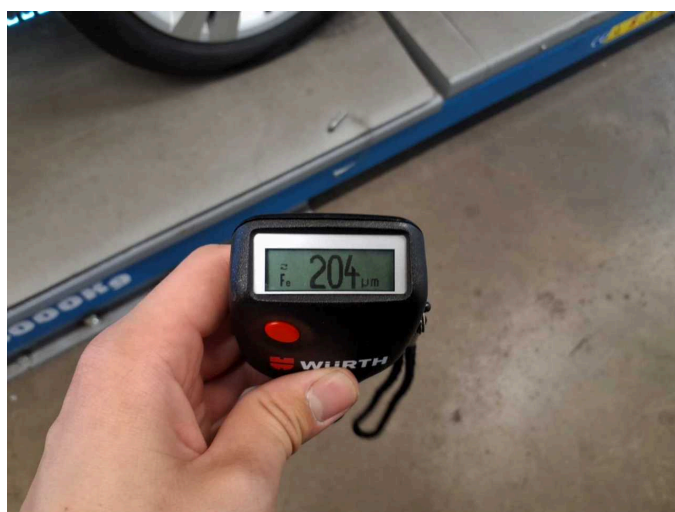
| No. | Repainting |
|---|---|
| 3 | Door - rear right side, Professionally carried out, Invoice of repair done Non-existent |

| Door - rear right side | 204 µm | Door - front left side | 181 µm |

Repainting 3: Door - rear right side

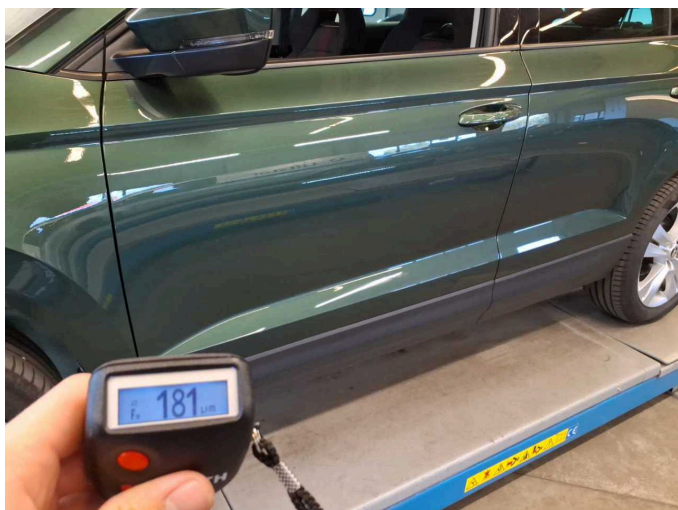
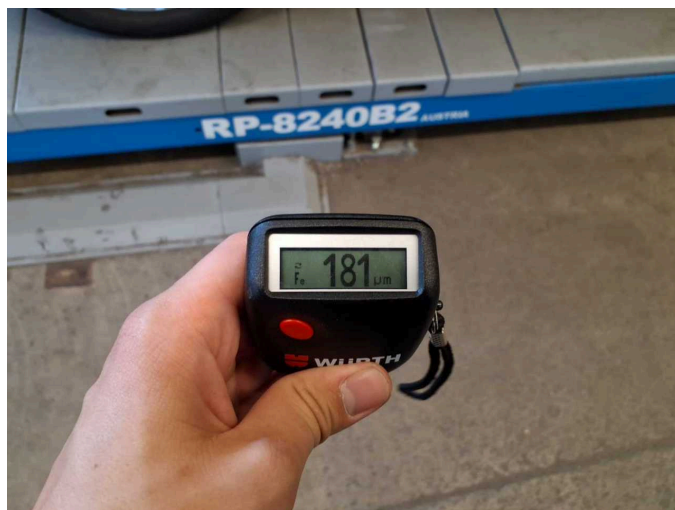
| No. | Repainting |
|---|---|
| 4 | Door - front left side, Professionally carried out, Invoice of repair done Non-existent |

Repainting 4: Door - front left side

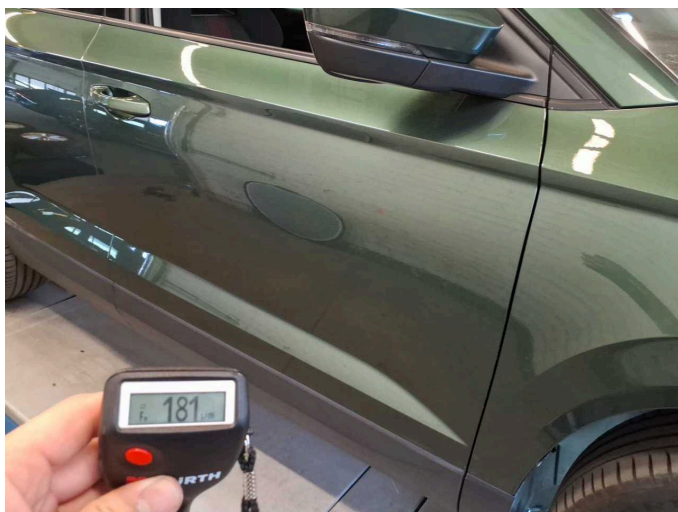
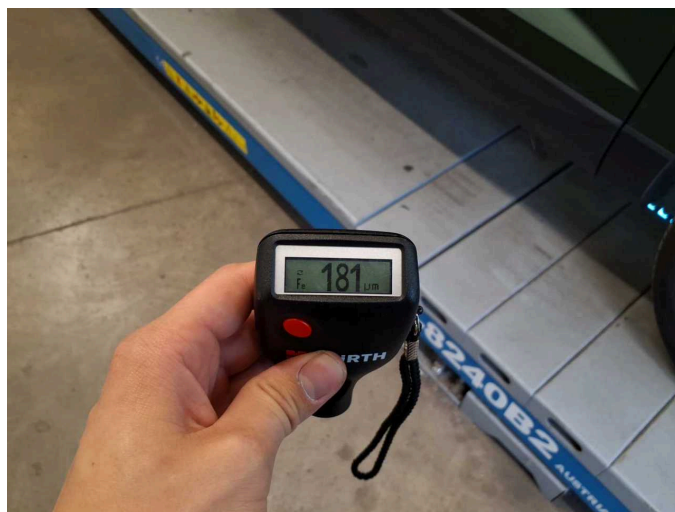
| No. | Repainting |
|---|---|
| 5 | Door - front right side, Professionally carried out, Invoice of repair done Non-existent |

| Door - front right side | 181 µm | | |

Repainting 5: Door - front right side
