Expertise

Protocol number: 41032244
Order No. / Reference: 25069892
Inspection date: 7 Aug 2025

Manufacturer: Skoda
VIN: TMBLJ7NUXM5037628

Model: Karoq 2.0 TDI SCR 4x4 DSG Clever

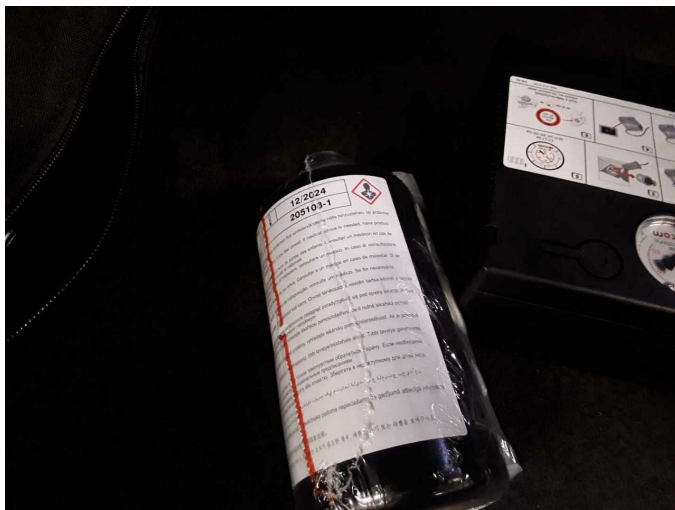
Damage 1: Equipment: Tirefit filler - Expired - Replace

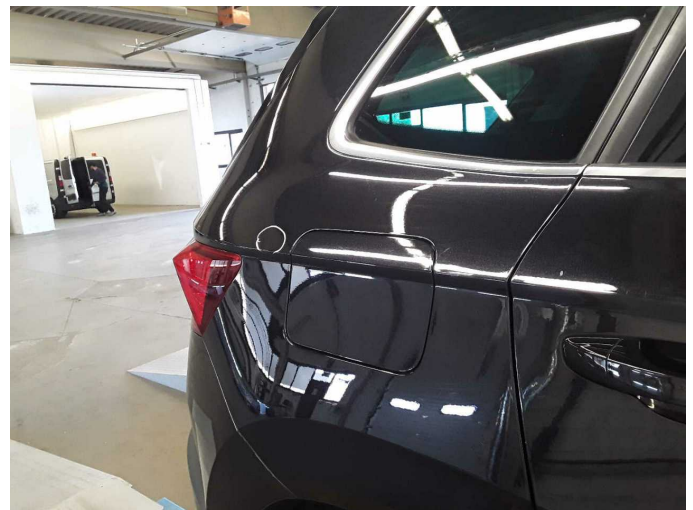
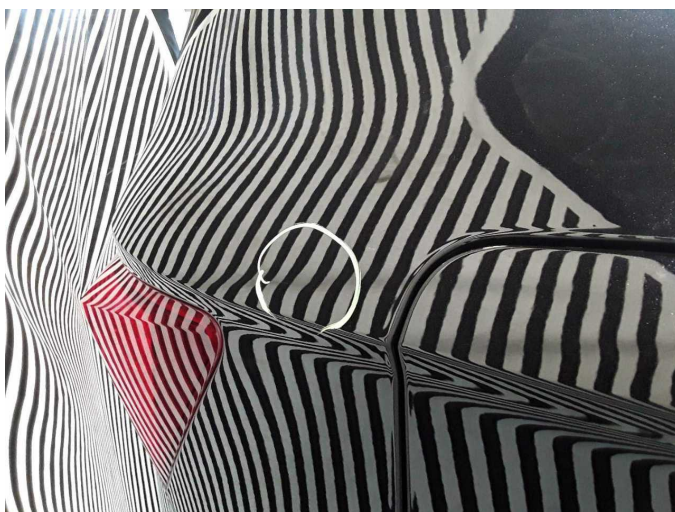
Damage 2: Side panel - rear right side: Side panel - dent(s) - Smooth repair work

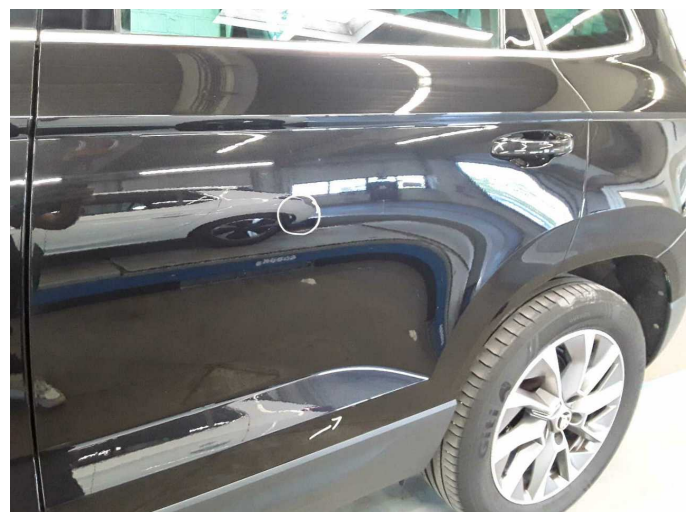
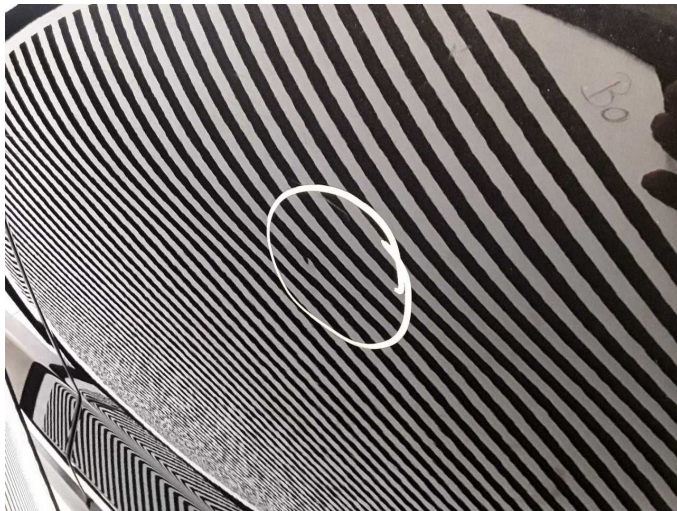
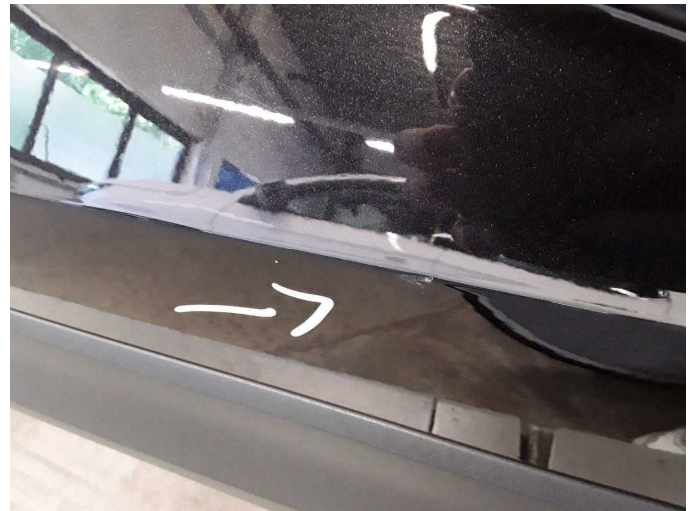
Damage 3: Door - rear left side: Door - Dent / paintcoat damage - Repair and paint

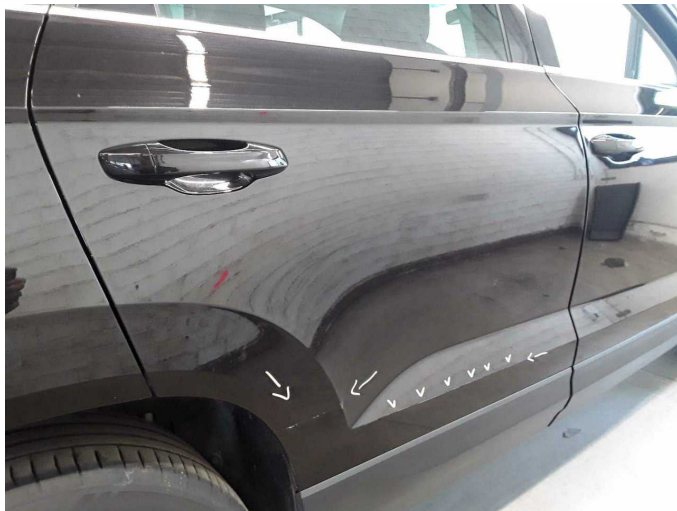
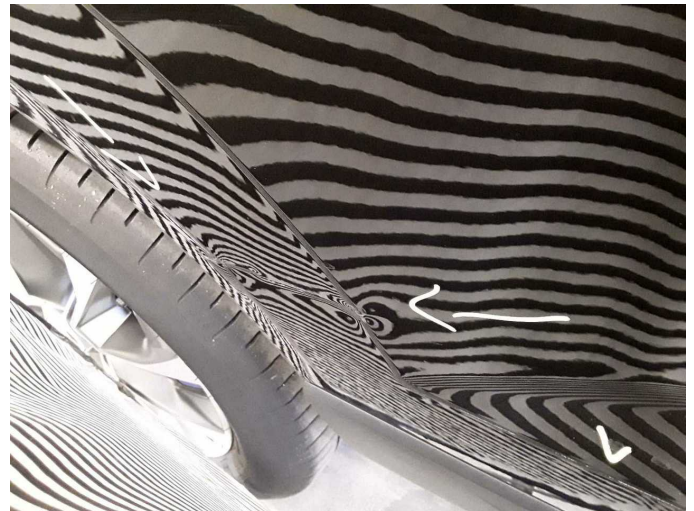
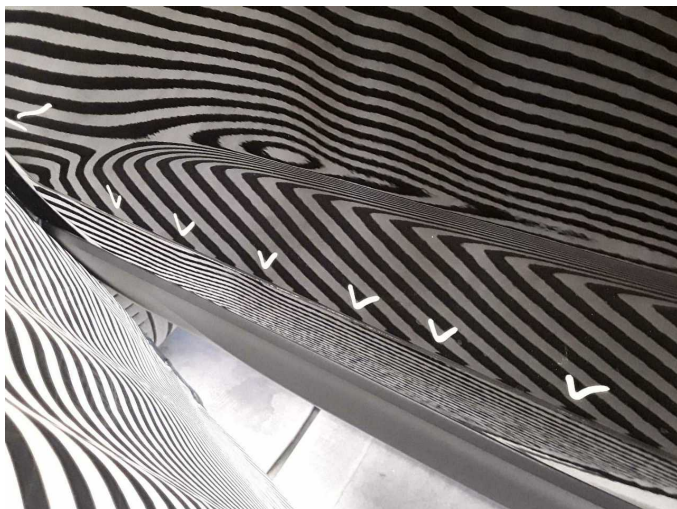
Damage 4: Door - rear right side: Door - Dent / paintcoat damage - Repair and paint
