Expertise

Protocol number: 41359098  
Order No. / Reference: 25084328  
Inspection date: 3 Sept 2025

Manufacturer: Skoda	Model: Kodiaq 2.0 TDI 4x4 DSG Sportline
VIN: TMBLK7NS0L8043138

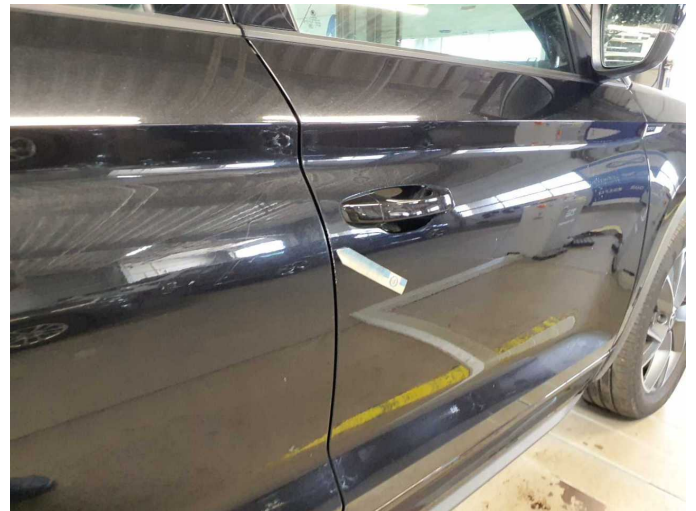
Damage 1: Door - front right side: Door edge - Scratch(es) - Smart repair

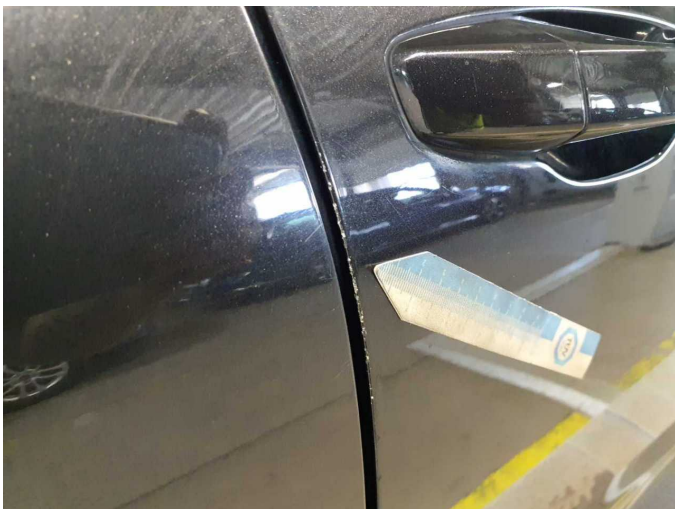
Damage 1: Door - front right side: Door edge - Scratch(es) - Smart repair

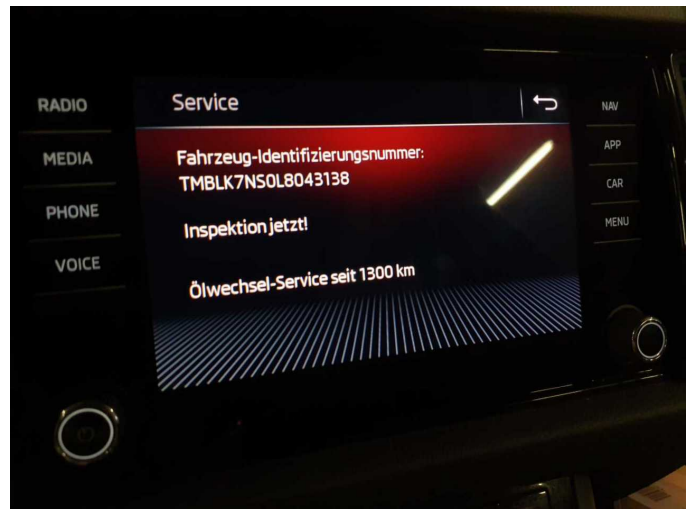
Damage 2: Misc.: Inspection / maintenance - Due - Perform

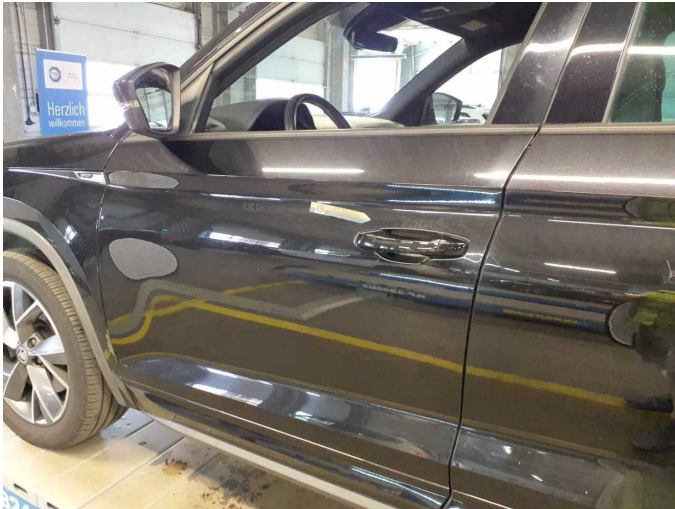
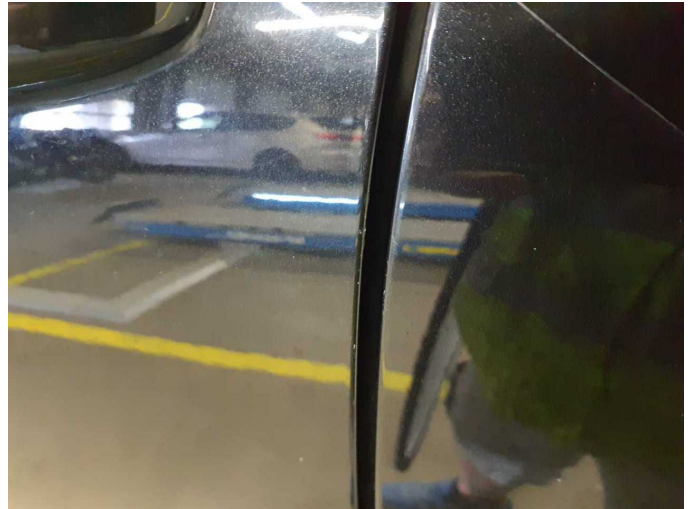
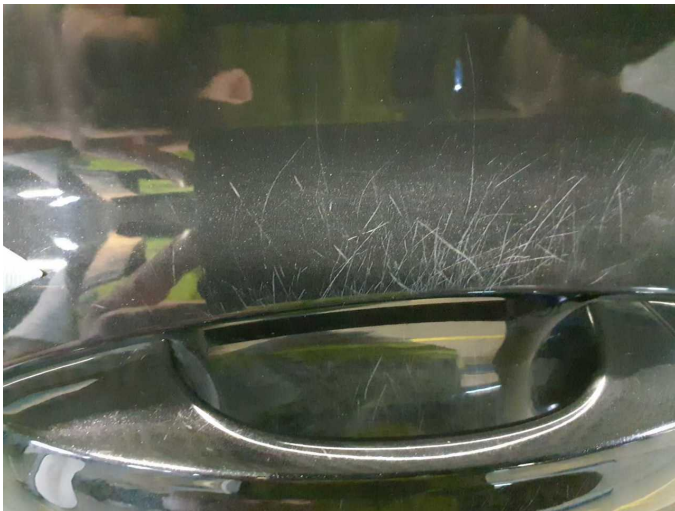
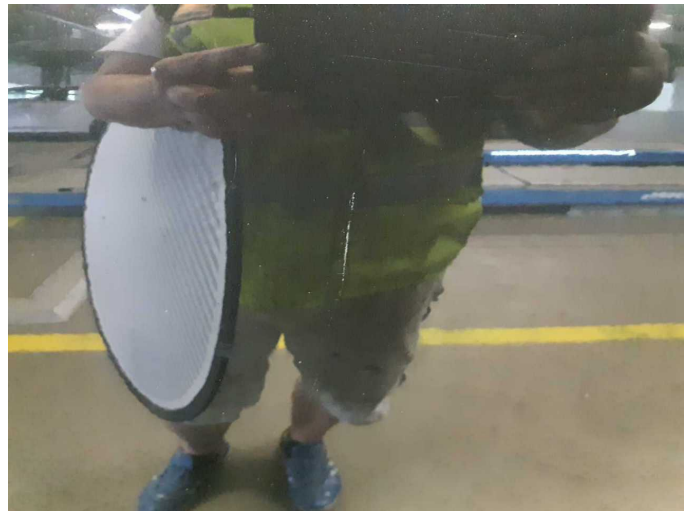
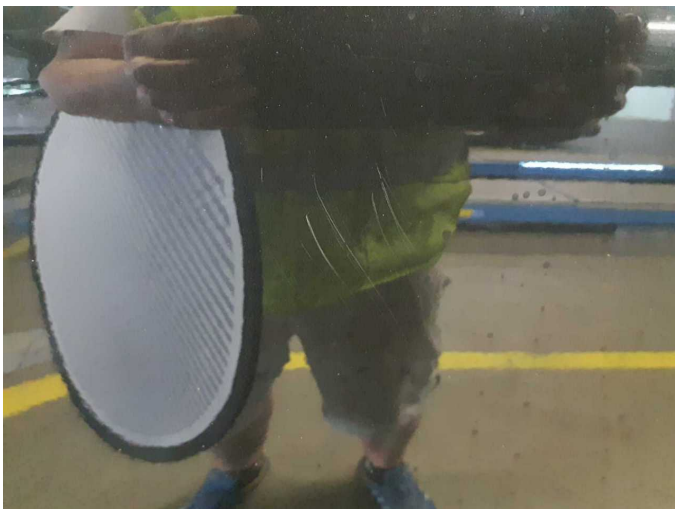
**Damage 3:** Door - front left side: Door - Scratched - Paint

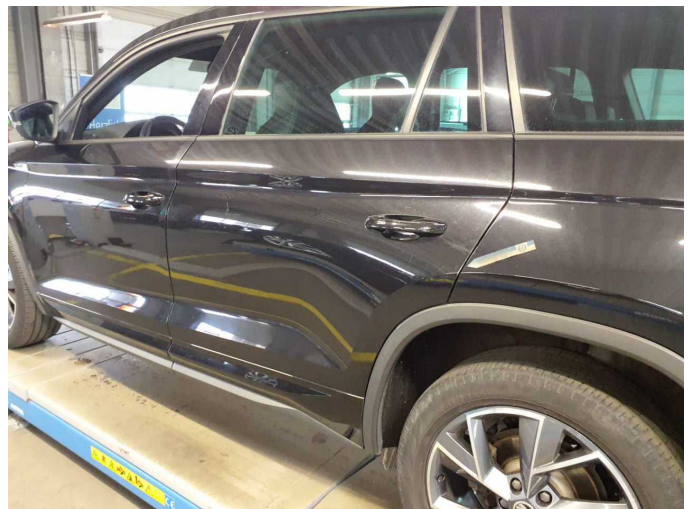
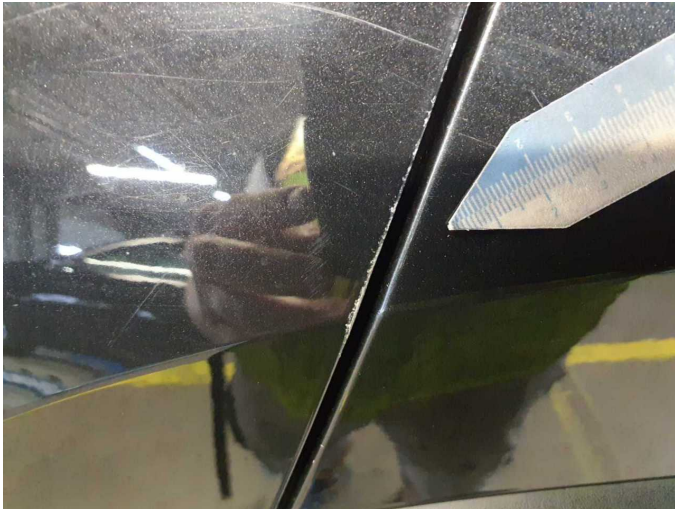
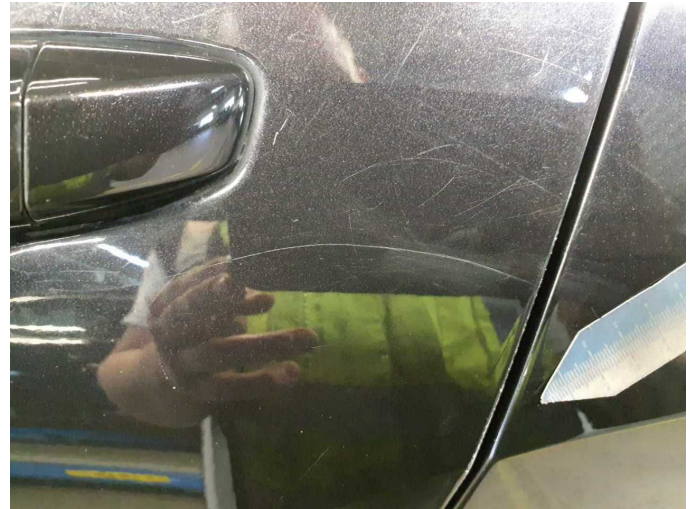
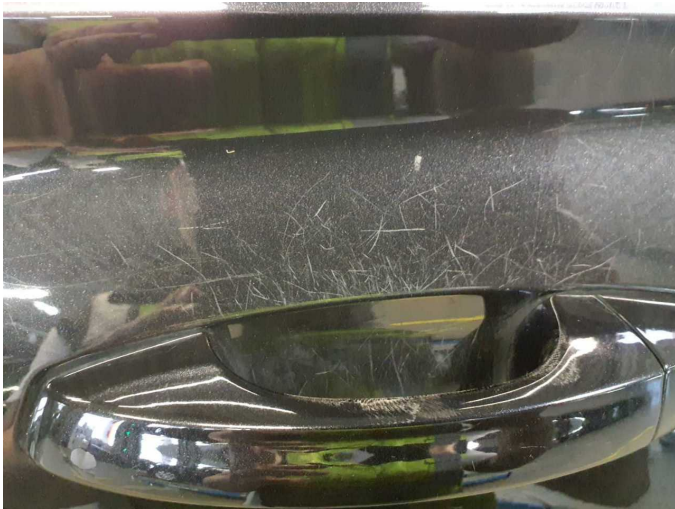
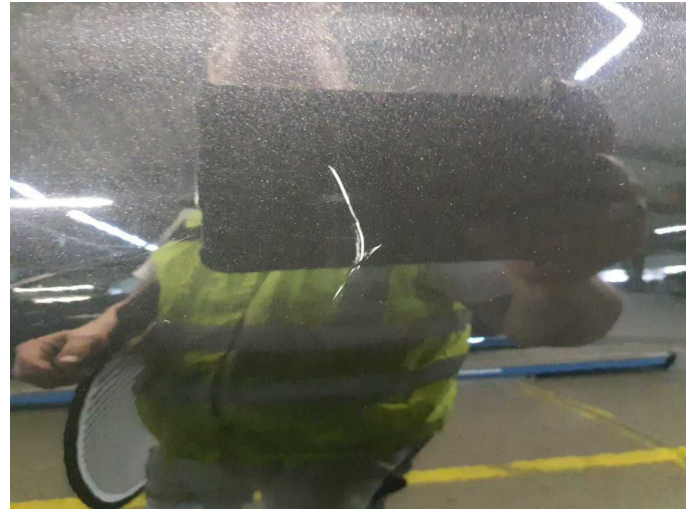
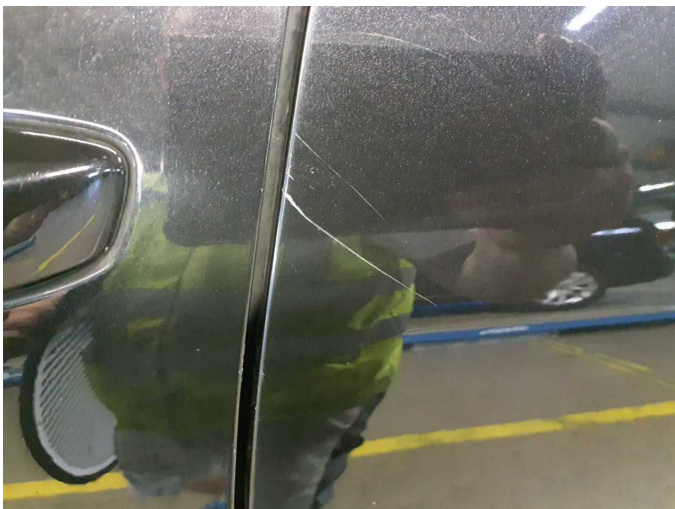
**Damage 4:** Door - rear left side: Door - Scratched - Paint

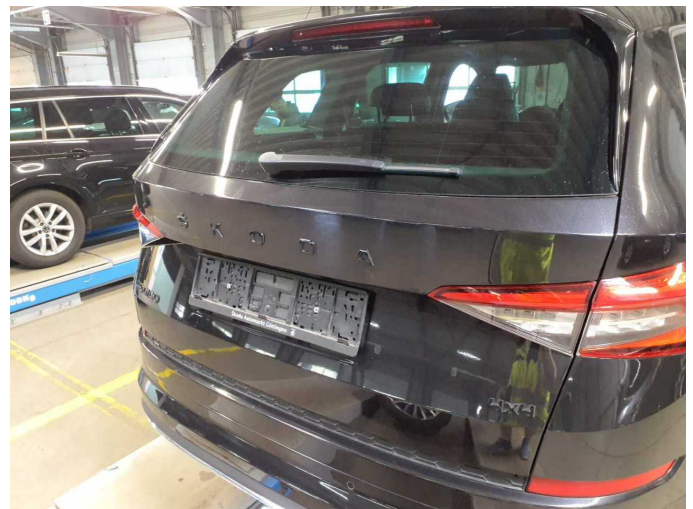
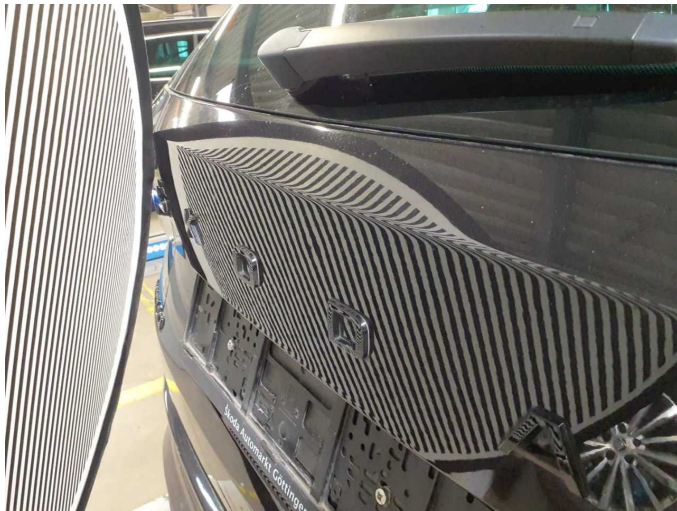
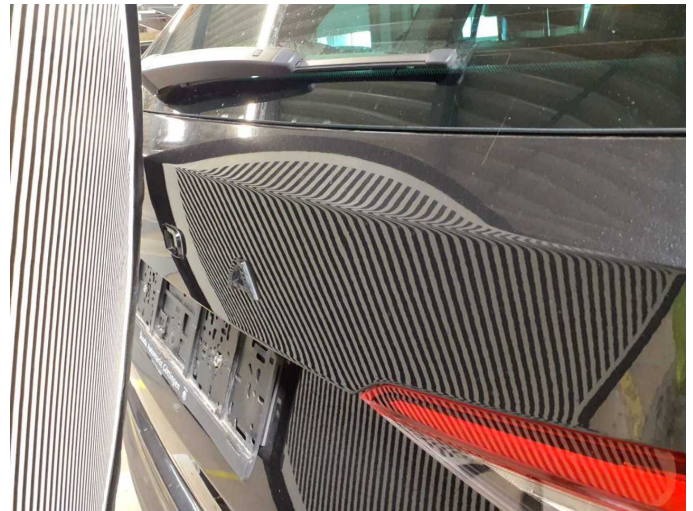
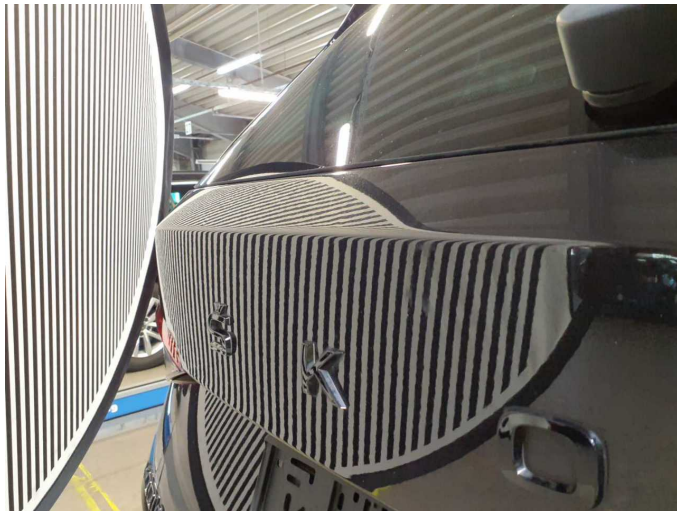
**Wear and tear 4:** Boot lid / rear door: Boot lid - dent(s) - Smooth repair work

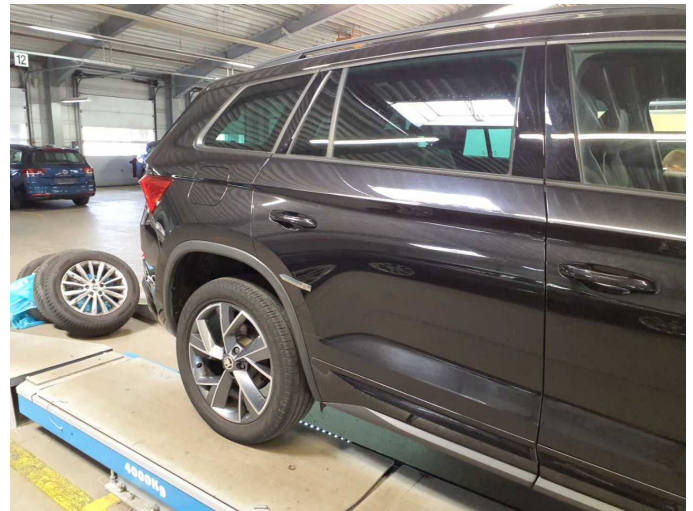
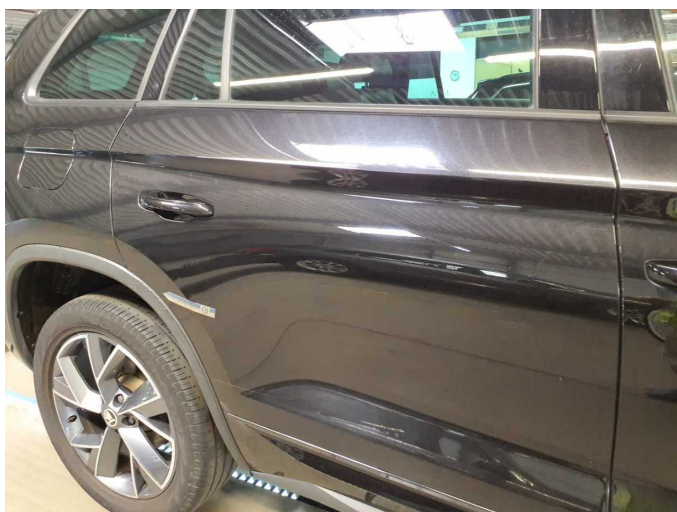
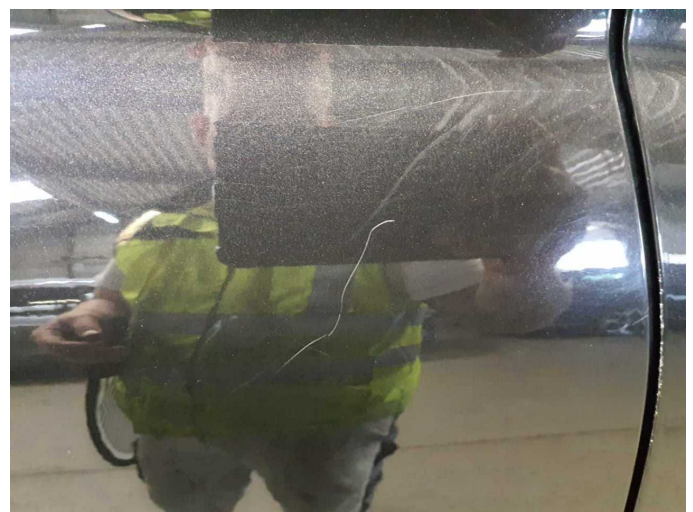
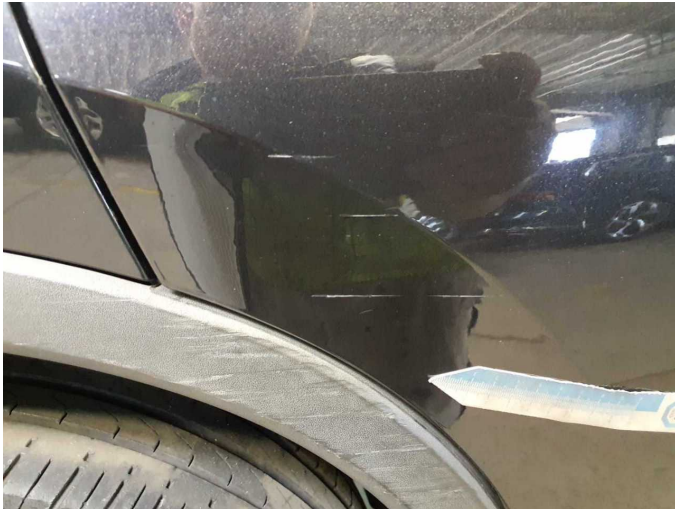
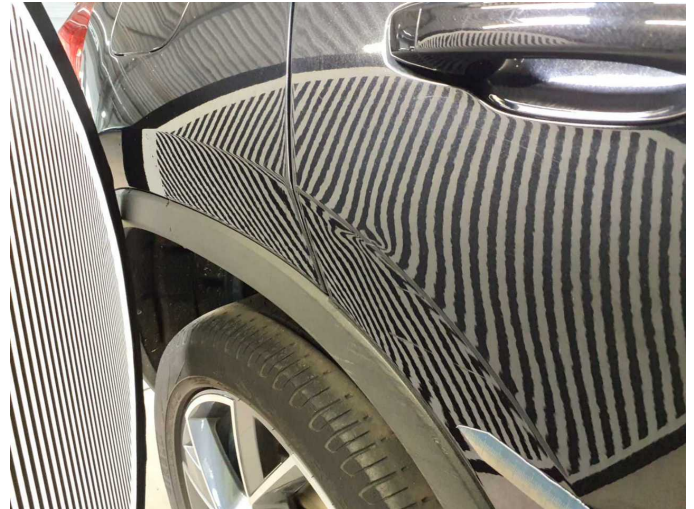
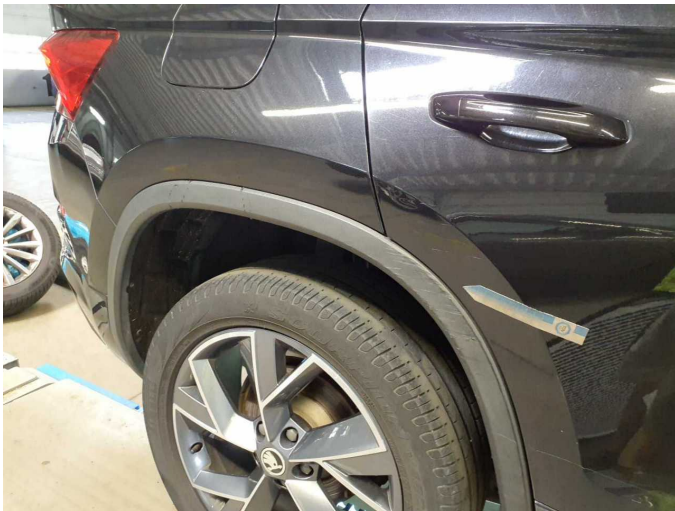
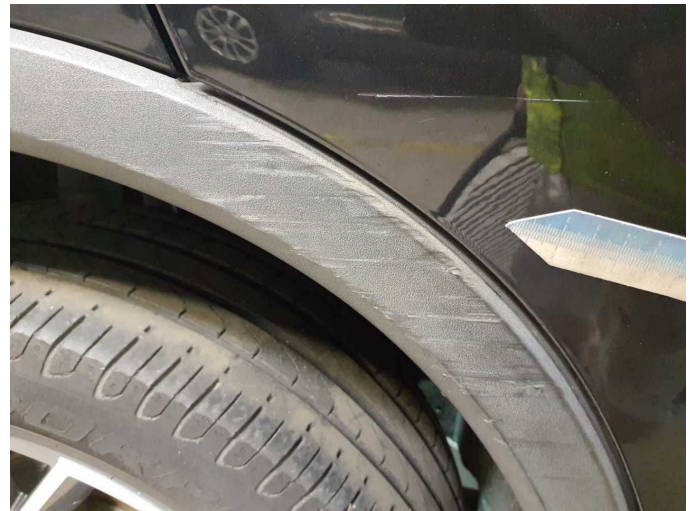
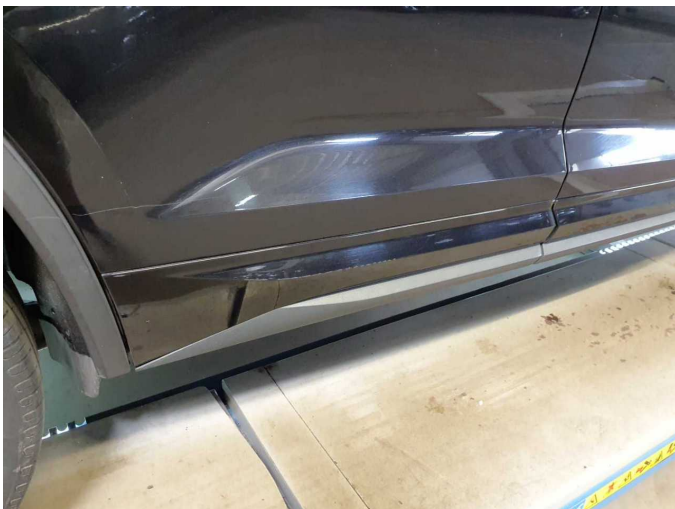
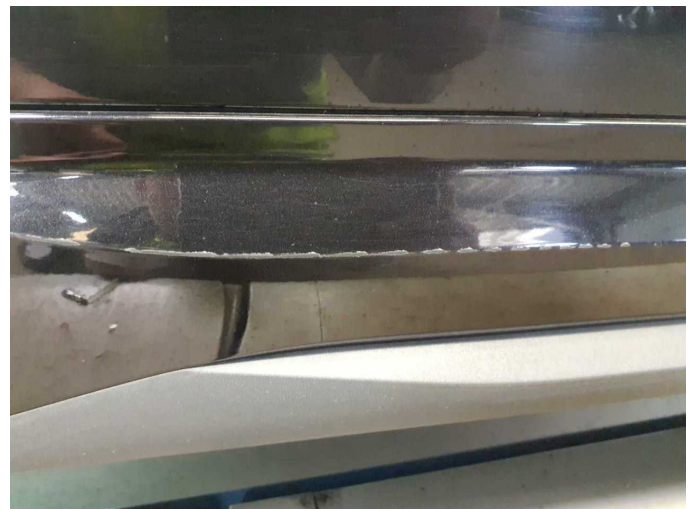
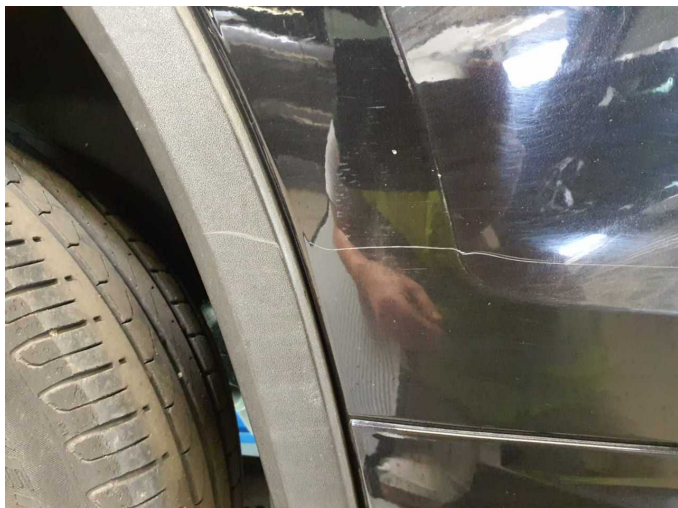
No.	Previous damage	Extent of damage (Net)
1	Side right, Provided by user / customer, from 6 Sept 2021	1.683,64 €
2	Rear, Provided by user / customer, from 15 May 2024	5.243,90 €

**Accident 1:** Side right

**Accident 1: Side right**

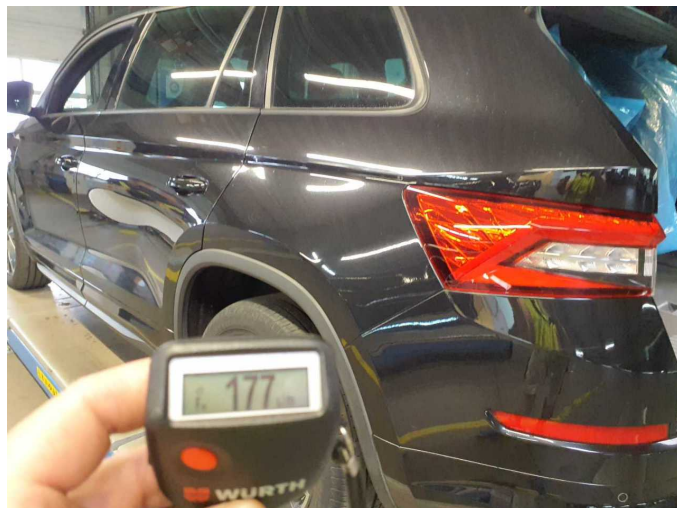
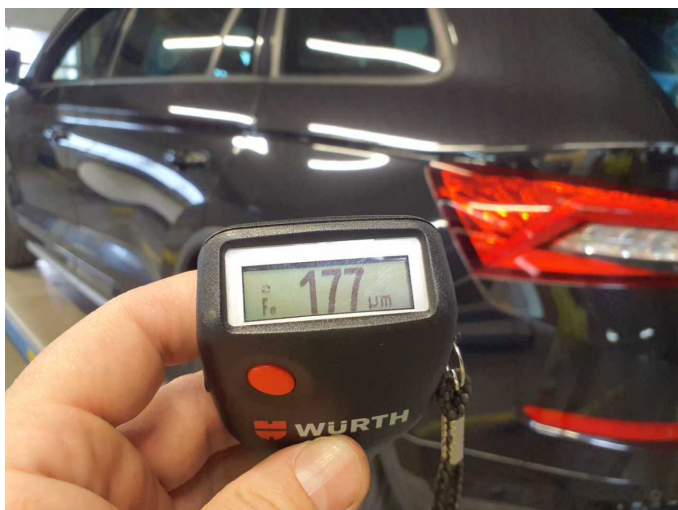
Side panel - rear left side	177 µm	Side panel - rear right side	171 µm
-----------------------------	--------	------------------------------	--------

**Repainting 1: Side panel - rear left side**

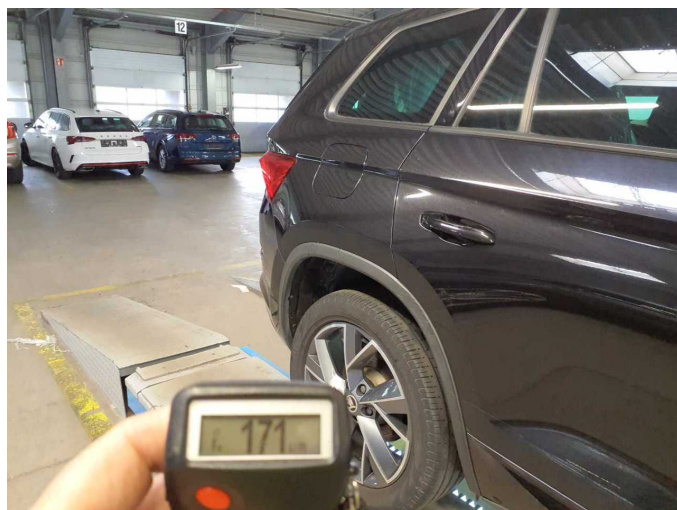
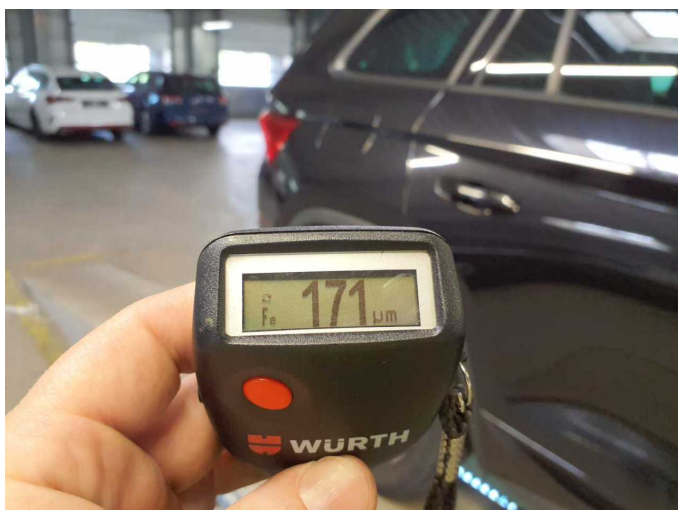
**Repainting 2: Side panel - rear right side**
