Expertise

Protocol number: 41173373 Order No. / Reference: 25104860 Inspection date: 21 Aug 2025

Manufacturer: Skoda Model: Kodiaq 2.0 TDI 4x4 DSG L&K

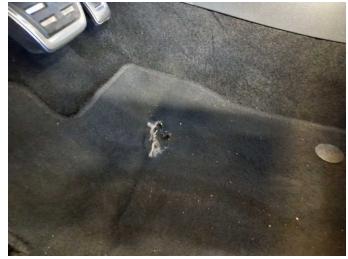
Damage 2: Trim / covers: Floor mats - Holes - Replace

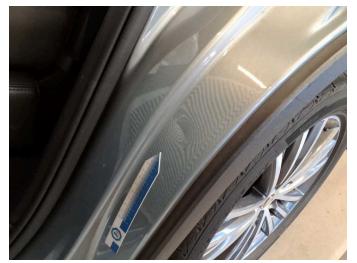
Damage 3: Side panel - rear left side: Sill - Dent / paintcoat damage - Smart repair

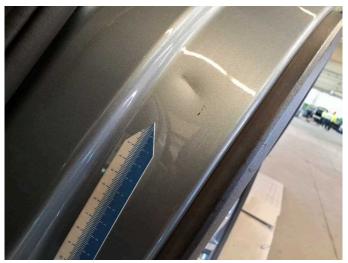
Damage 3: Side panel - rear left side: Sill - Dent / paintcoat damage - Smart repair

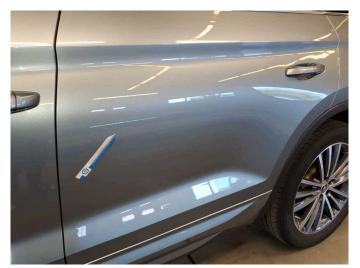
Damage 3: Side panel - rear left side: Sill - Dent / paintcoat damage - Smart repair

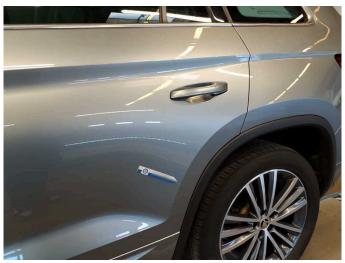
Damage 4: Door - rear left side: Door - Scratch(es) - Paint

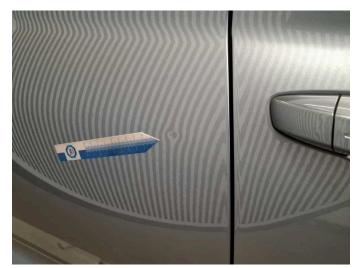
Damage 5: Door - rear right side: Door - Dent / paintcoat damage - Repair and paint

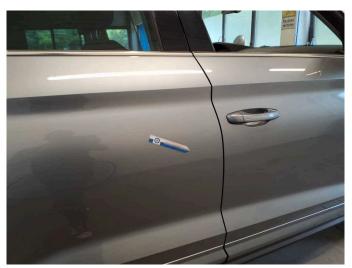
Damage 5: Door - rear right side: Door - Dent / paintcoat damage - Repair and paint

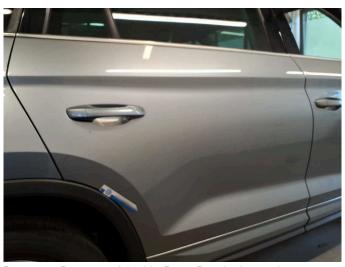
Damage 5: Door - rear right side: Door - Dent / paintcoat damage - Repair and paint

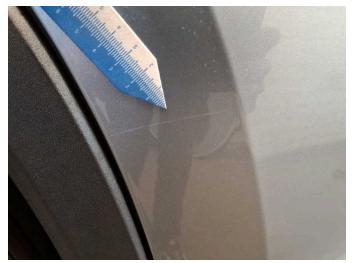
Damage 5: Door - rear right side: Door - Dent / paintcoat damage - Repair and paint

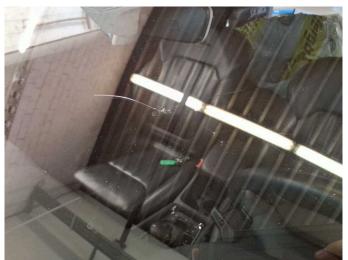
Damage 7: Vehicle glazing: Windscreen - Broken / torn - Replace

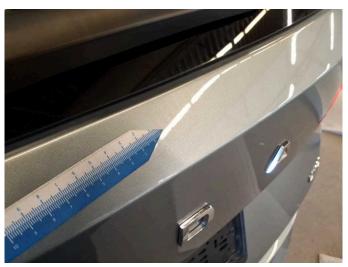
Wear and tear 8: Boot lid / rear door: Boot lid - Scratch(es) - No deduction

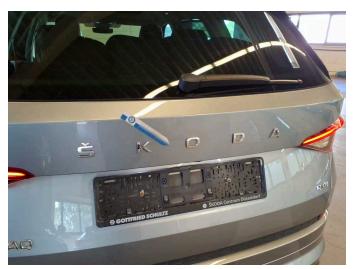
Wear and tear 8: Boot lid / rear door: Boot lid - Scratch(es) - No deduction

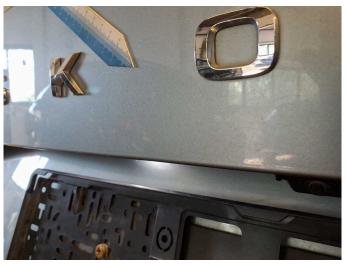
Wear and tear 8: Boot lid / rear door: Boot lid - Scratch(es) - No deduction

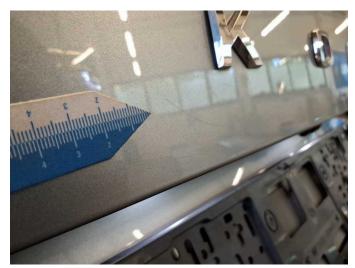
Wear and tear 8: Boot lid / rear door: Boot lid - Scratch(es) - No deduction
