status report

vehicle data			
Å koda Kodiaq			
Vehicle identification number	TMBLK9NSXK8016216	mileage read:	107996 km
First Registration / construction year:	19.11.2018 / 0	Visit Date / place of birth:	16.05.2025 Hoppegarten
Bodywork:	cars	Re - import:	no
Body type:	station wagon	KBA no. :	8004//ARX
Fuel / emission class:	diesel / € 6	transmission type:	automatic
Displacement / power:	1968 ccm / 140 kW (190 PS)	Engine:	four-wheel
paint:	blue	Number of previous owners:	3
Doors / seats:	5 / 5	number keys:	3
Next HU / AU:	01.2027 / 01.2027	cushion type:	Leather / Alcantara
Service book available:	-	Interior Color:	black
smoking vehicle:	no	Last service km / on the:	- / -
Vehicle roadworthy:	yes	Vehicle roadworthy:	yes
Submitted vehicle documents:	For example, I \u0026 II For example,	state outside:	3 - Average
visit condition:	-	condition inside:	3 - Average
state general:	3 - Average

Hüsges GmbH
Gießerallee 23
47877 Willich
Tel.: 02154 / 9534 0
E-Mail: gutachten@huesges-group.eu

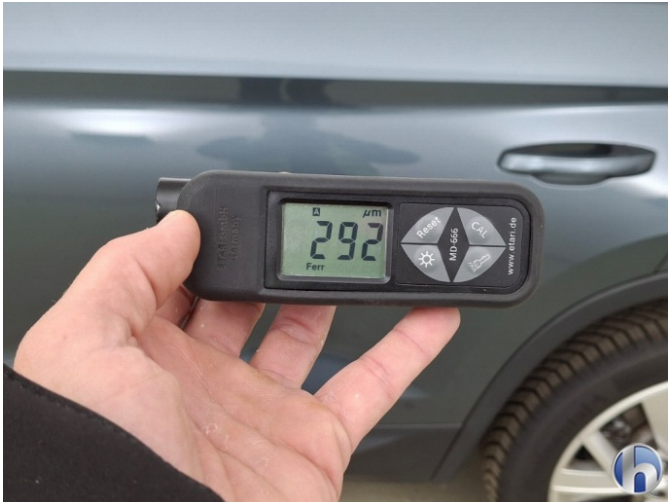
component	Damage	Rep kind
1. Rear door - left	Subsequently painted	acceptable
2. Front door - left	Subsequently painted	acceptable
3. Felge vorne links	Scratch(es)	Refurbish and paint
4. Felge vorne rechts	Scratch(es)	Refurbish and paint
5. Tür hinten links Kantenschutz abgebrochen	Breakage	Replace
6. maintenance	Missing	Replace
7. proof of maintenance	Missing	Replace

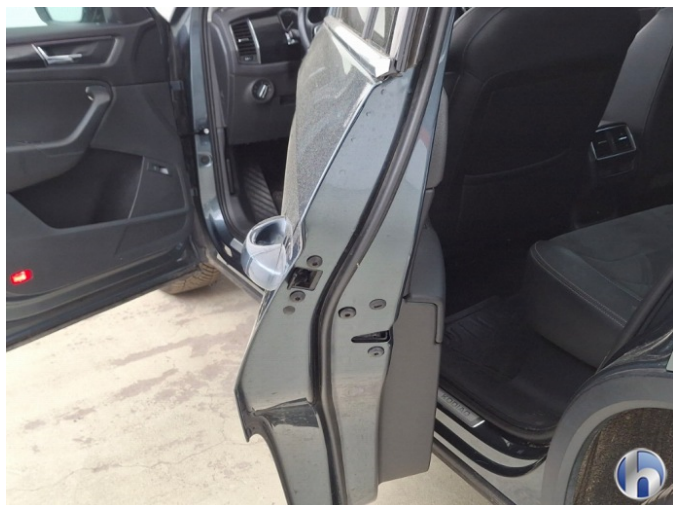
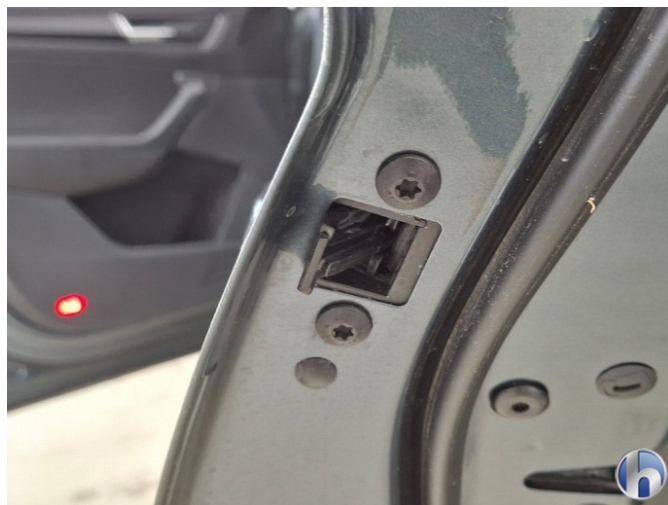
5. Tür hinten links Kantenschutz abgebrochen
