Expertise

Protocol number: 41631304
Order No. / Reference: 25197308
Inspection date: 22 Sept 2025

Manufacturer: Skoda Model: Kodiaq 2.0 TDI 4x4 DSG L&K

VIN: TMBLN7NS7P8024812

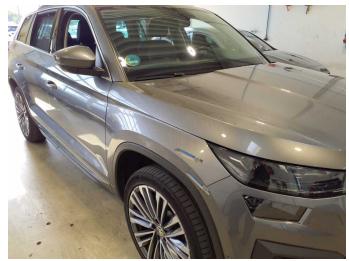
Damage 2: Mudguard - right side: Mudguard - right side - dent(s) - Smooth repair work

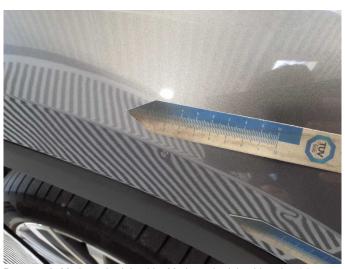
Damage 2: Mudguard - right side: Mudguard - right side - dent(s) - Smooth repair work

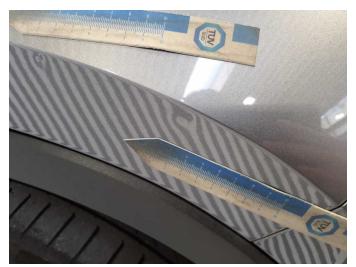
Damage 2: Mudguard - right side: Mudguard - right side - dent(s) - Smooth repair work

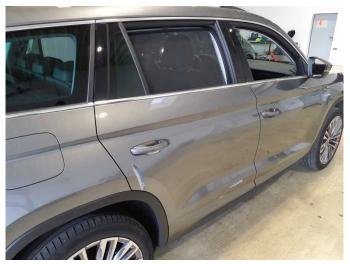
Damage 4: Door - rear right side: Door - dent(s) - Smart repair

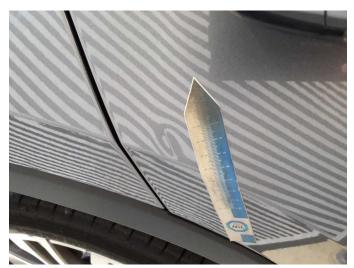
Damage 4: Door - rear right side: Door - dent(s) - Smart repair

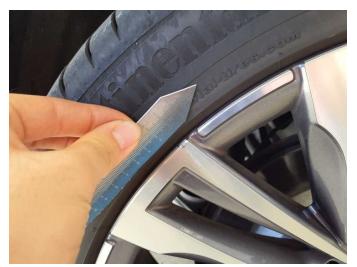
Damage 5: Wheel / tyres: Alloy rim - rear right side - Scratch(es) - Loss in Damage 6: Seat - rear: Backrest cover - Scratch(es) - Loss in value value

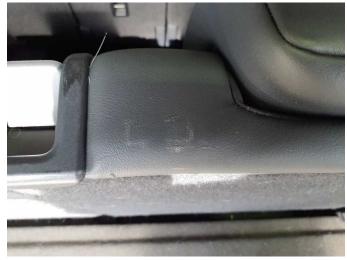
Damage 6: Seat - rear: Backrest cover - Scratch(es) - Loss in value

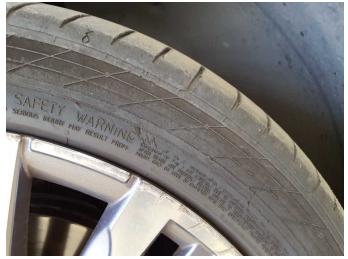
Damage 7: Wheel / tyres: Tyre - front right side - Damaged - Replace

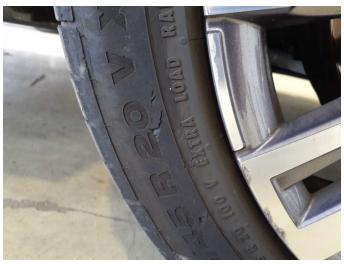
Damage 7: Wheel / tyres: Tyre - front right side - Damaged - Replace

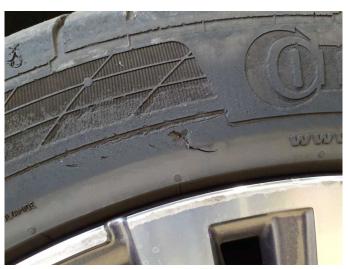
Damage 7: Wheel / tyres: Tyre - front right side - Damaged - Replace

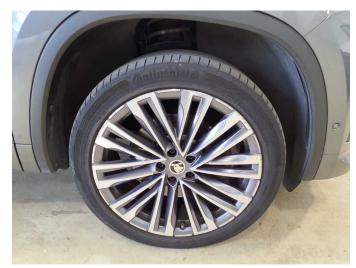
Damage 7: Wheel / tyres: Tyre - front right side - Damaged - Replace

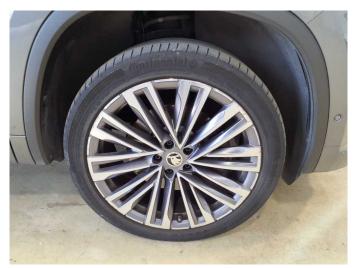
Damage 8: Wheel / tyres: Alloy rim - front right side - Scratch(es) - Replace

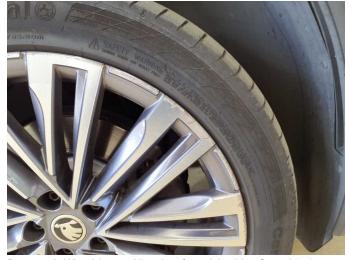
Damage 8: Wheel / tyres: Alloy rim - front right side - Scratch(es) - Replace

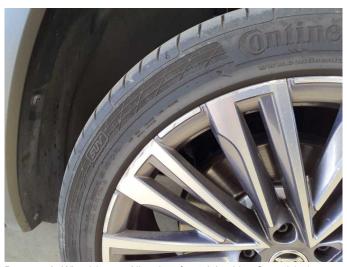
Damage 8: Wheel / tyres: Alloy rim - front right side - Scratch(es) - Replace

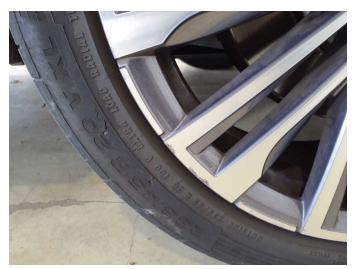
Damage 8: Wheel / tyres: Alloy rim - front right side - Scratch(es) - Replace

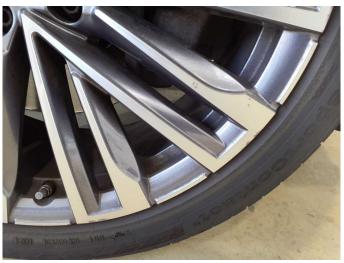
Damage 8: Wheel / tyres: Alloy rim - front right side - Scratch(es) - Replace

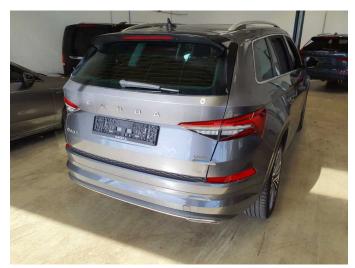
Accident 1: Rear

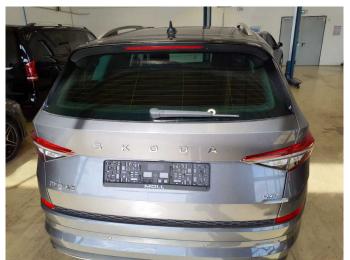
Accident 1: Rear

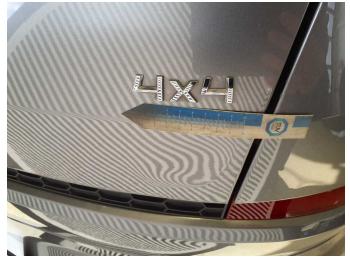
Accident 1: Rear

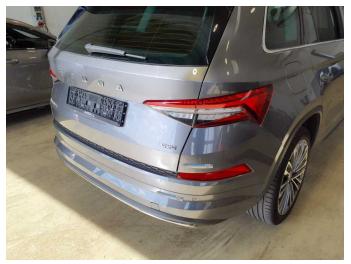
Accident 1: Rear

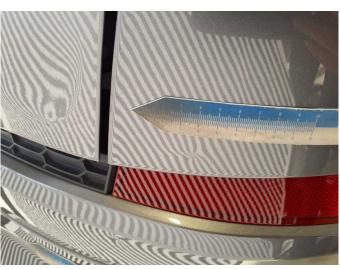
Accident 1: Rear

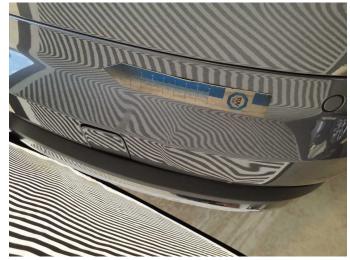
Accident 1: Rear

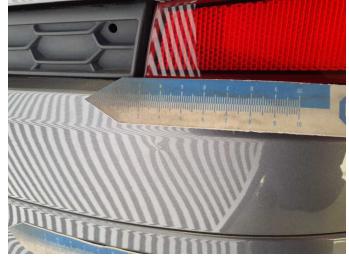
Accident 1: Rear

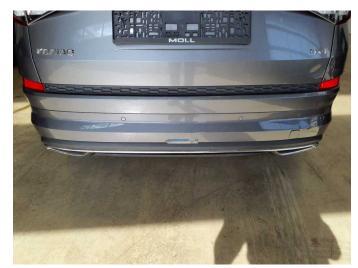
Accident 1: Rear
