## status report

| <b>customer:</b> | <b>Bank 11, Neuss</b> |

| vehicle data | | | |
|---|---|---|---|
| <b>Skoda Kodiaq Style 4x4</b> | | | |
| Vehicle identification number | <b>TMBLN7NS9P8524020</b> | mileage read: | <b>76904 km</b> |

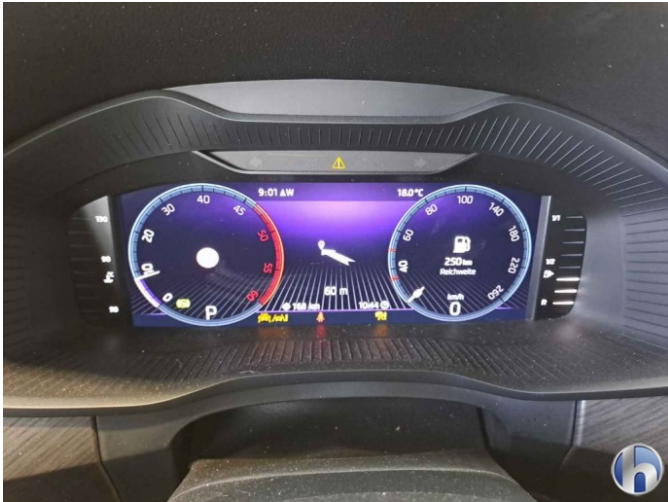
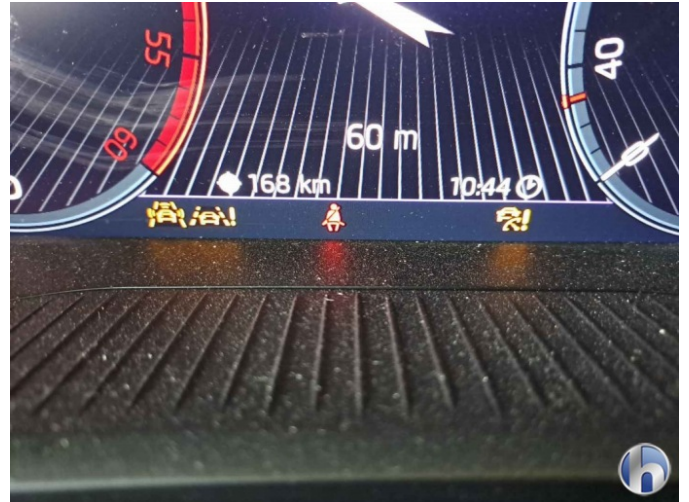
| component | Damage | Rep kind |
|---|---|---|
| 3. instrument cluster | Error message | Carry out a fault diagnosis |

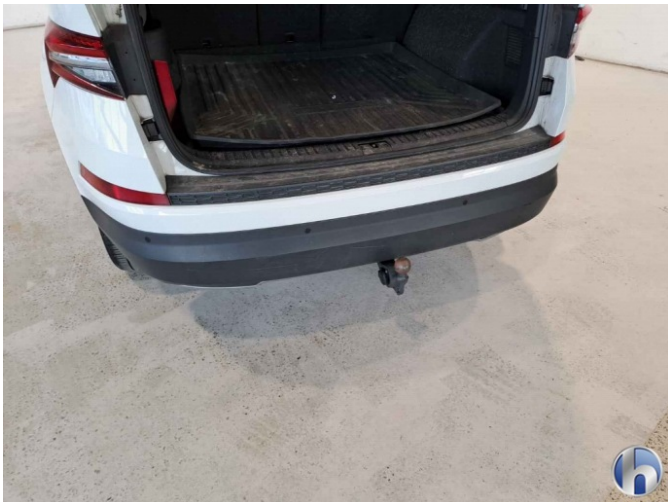
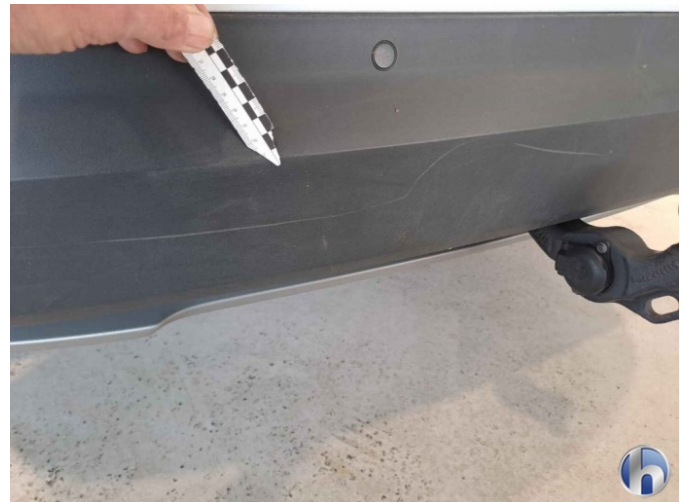
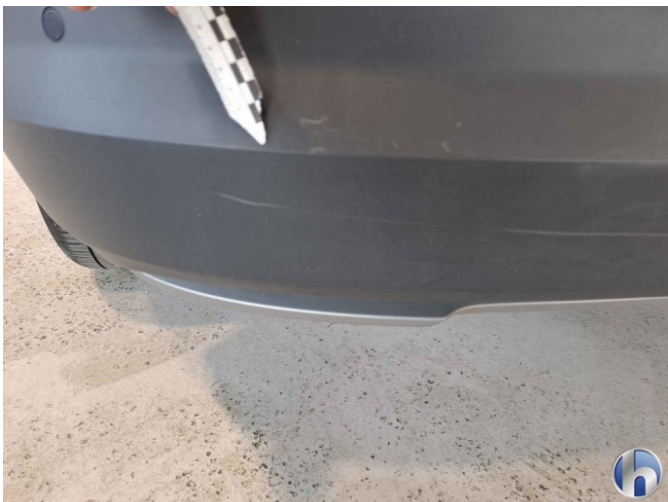
| component | Damage | Rep kind |
|---|---|---|
| 4. Rear bumper | Scrape | Replace |

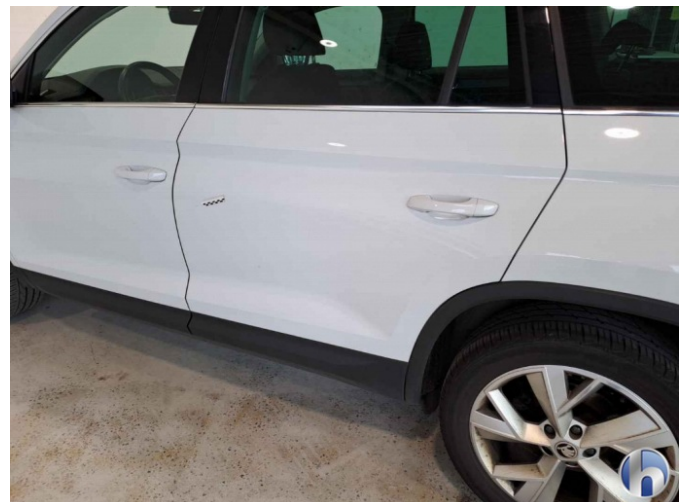
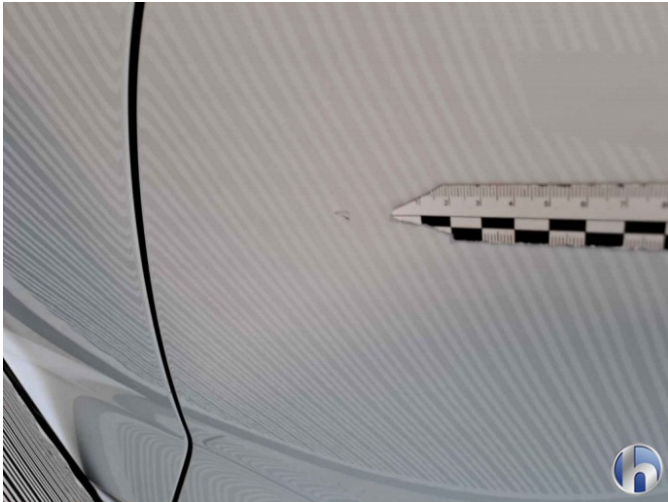
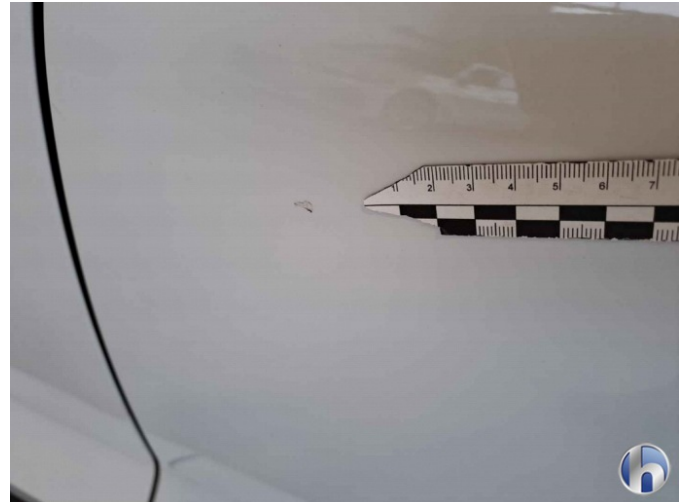
| component | Damage | Rep kind |
|---|---|---|
| 5. Rear door - left | Damaged | Refurbish and paint |

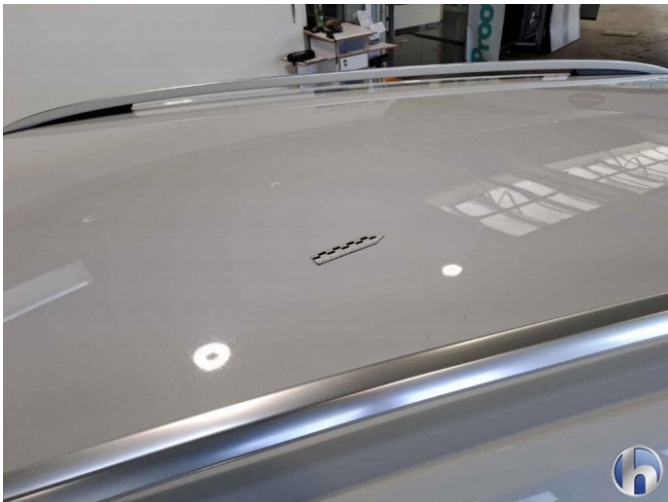
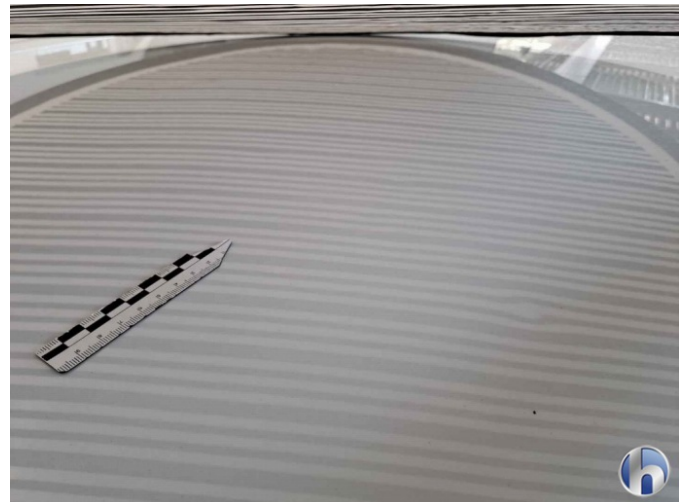
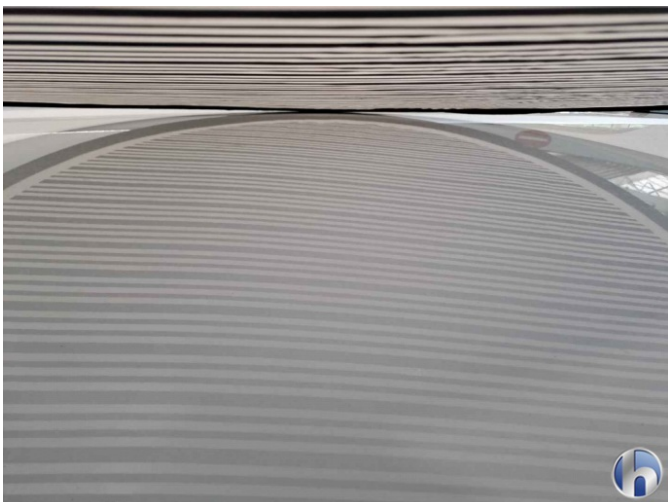
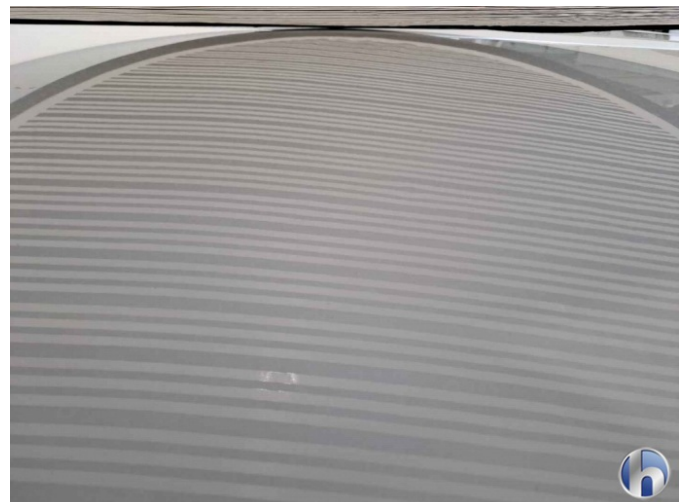
| component | Damage | Rep kind |
|---|---|---|
| 6. roof | Dented | Smart repair |

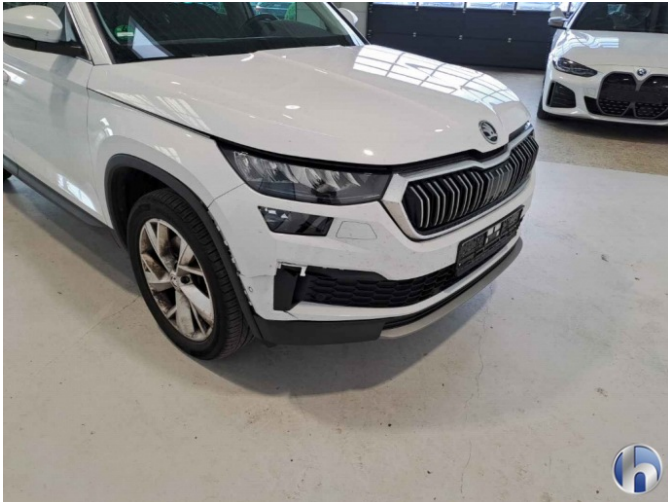
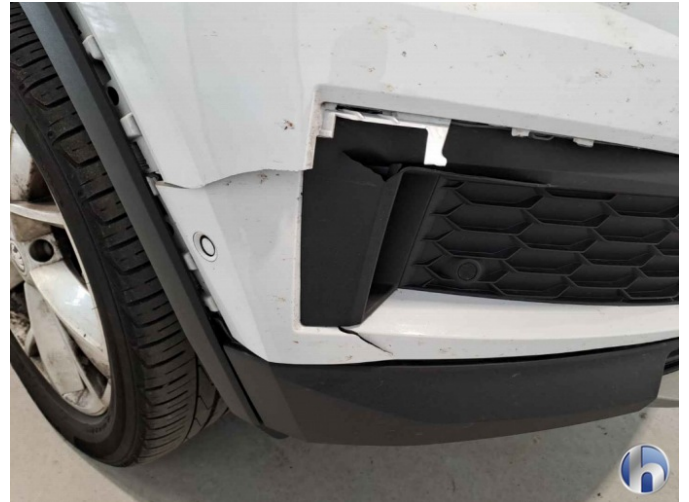
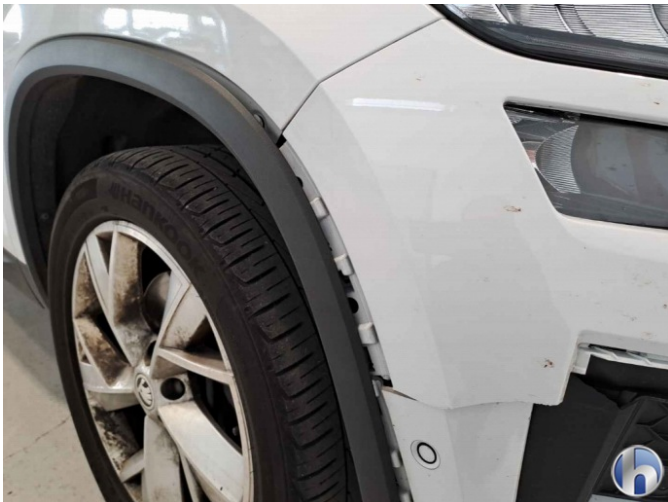
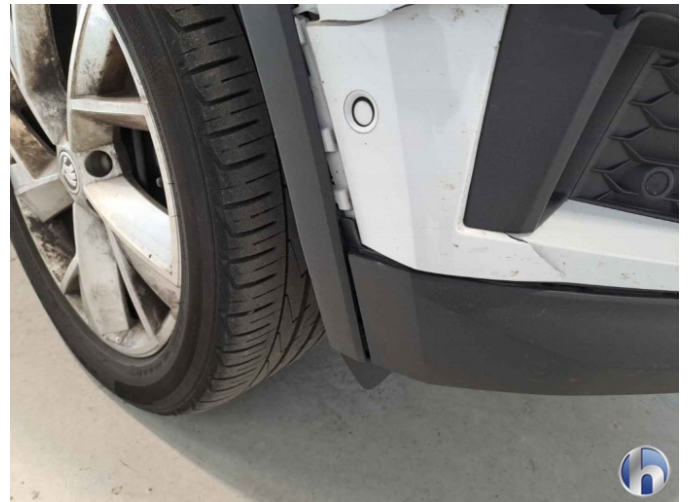
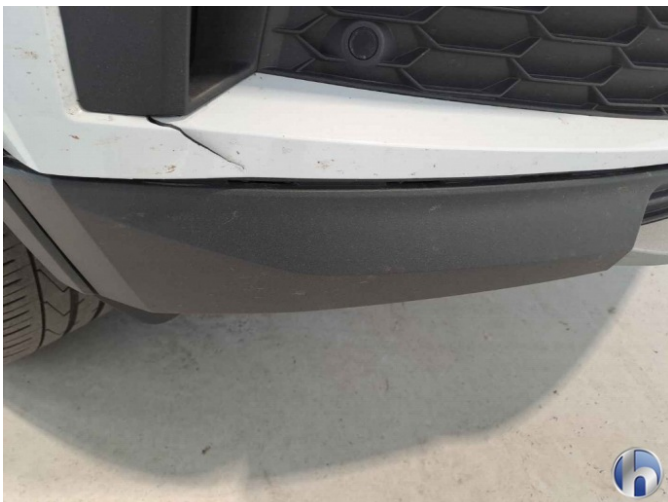
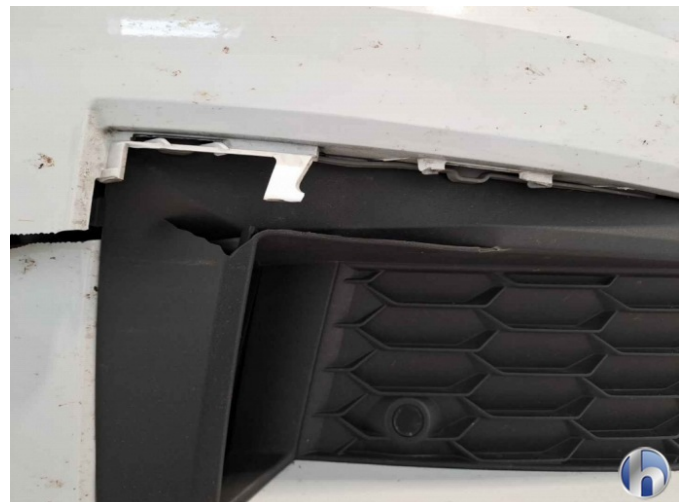
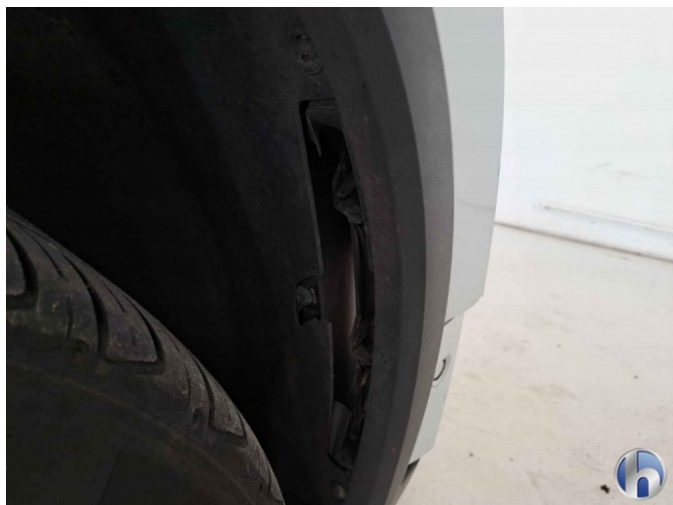
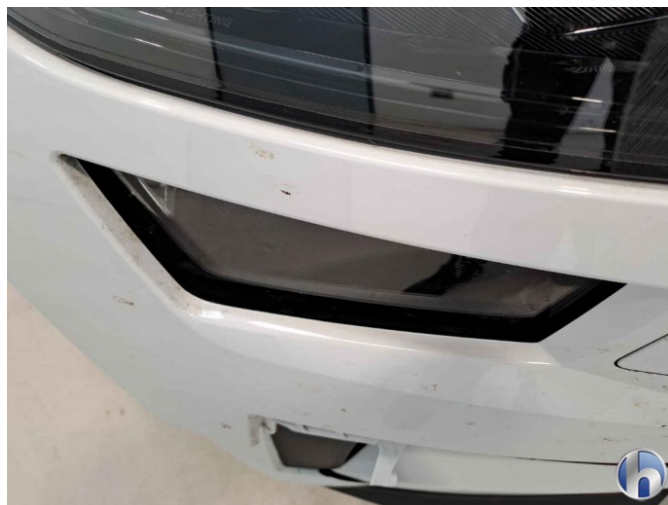
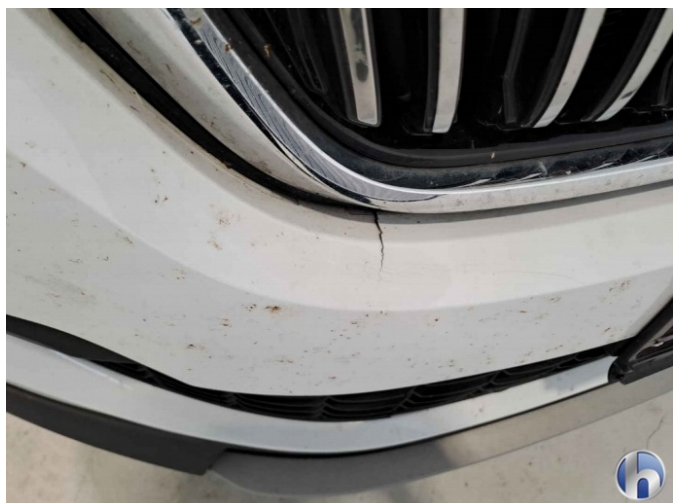
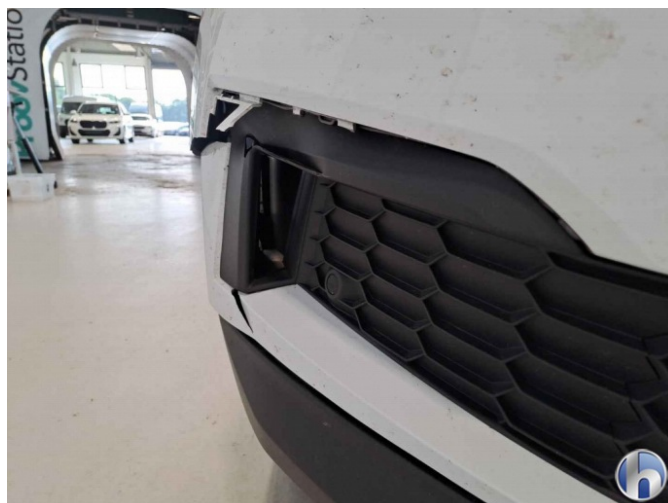
| Accident injury assessment | |
|---|---|
| <b>Existing collision damage:</b> | <b>found</b><br>At the unrepaired vehicle accident damage were observed on visual examination on the body skin . |
| <b>reference:</b> | Fahrzeug mit bestehenden Unfallschaden, zur Schadensermittlung wurden keine Demontagearbeiten durchgeführt, verborgen gebliebene Schäden können nicht ausgeschlossen werden. Unfallschaden Kosten wurden überschlägig Kalkuliert, Kostenerweiterung möglich. |

| component | Damage | Rep kind |
|---|---|---|
| 7. Front bumper | Accident damage | Replace |

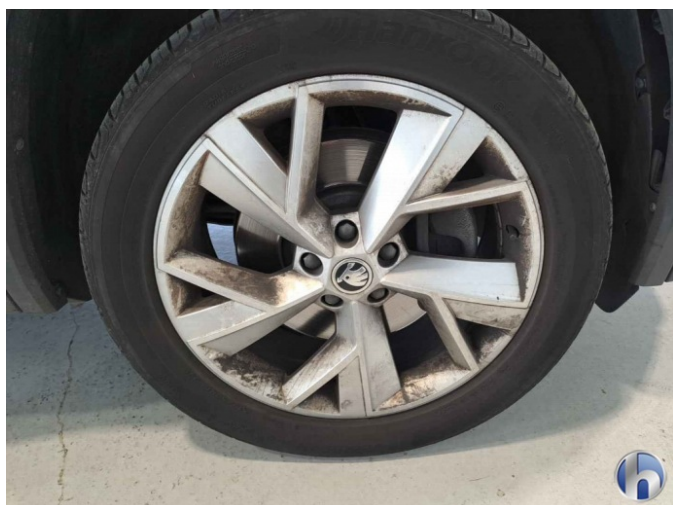
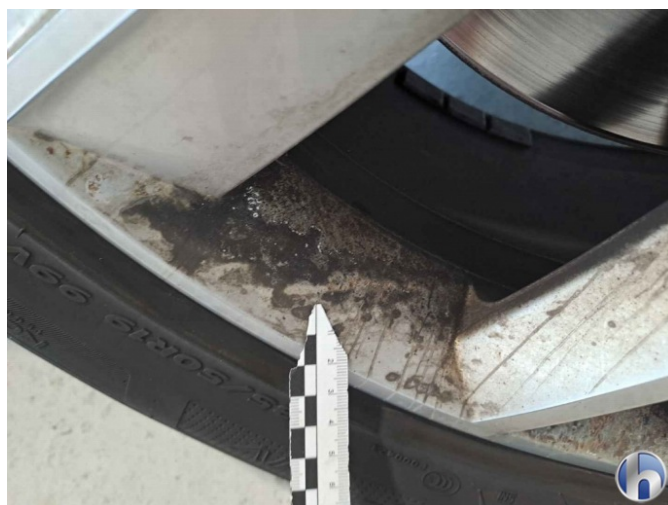
| component | Damage | Rep kind |
|---|---|---|
| 8. Rim front - right | Damaged | Replace |

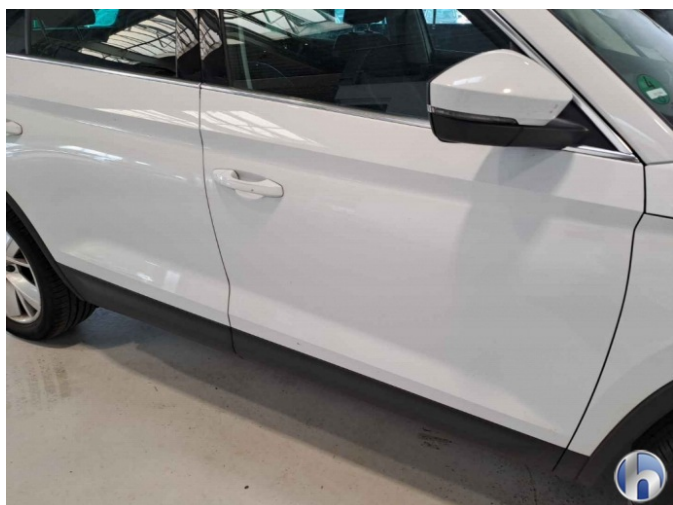
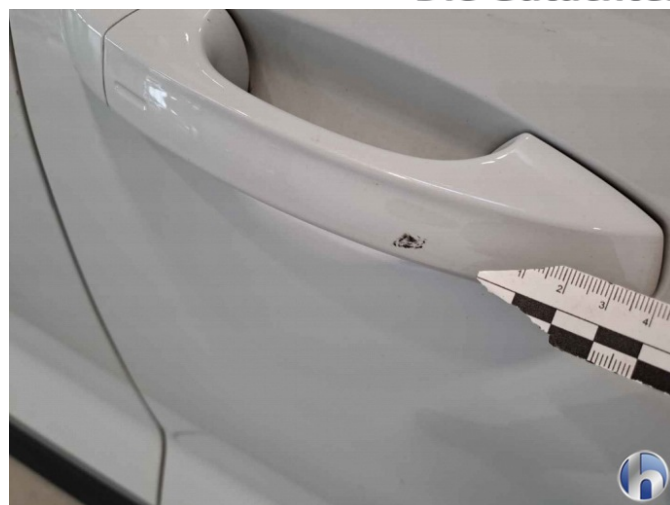
| component | Damage | Rep kind |
|---|---|---|
| 9. Türgriff VR | Scrape | Smart repair |

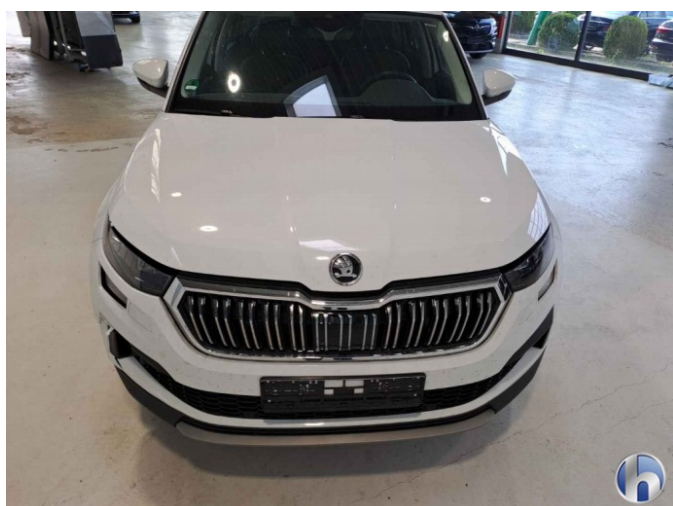
| component | Damage | Rep kind |
|---|---|---|
| 10. exterior body | Surface scratch(es) | |

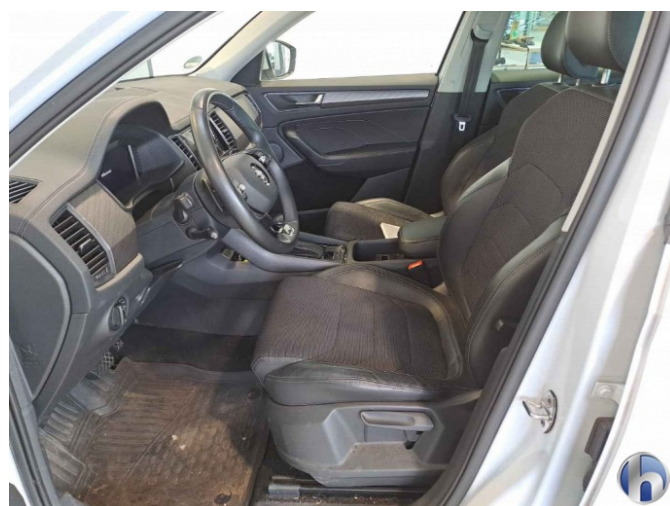
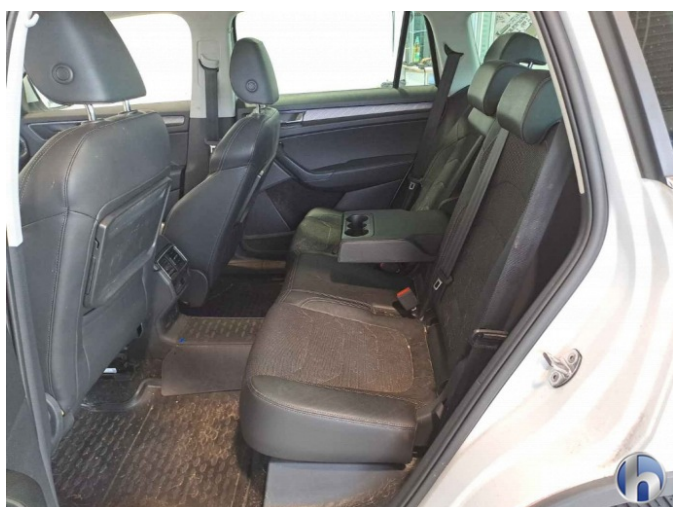
| component | Damage | Rep kind |
|---|---|---|
| 11. | Wear and tear | acceptable |

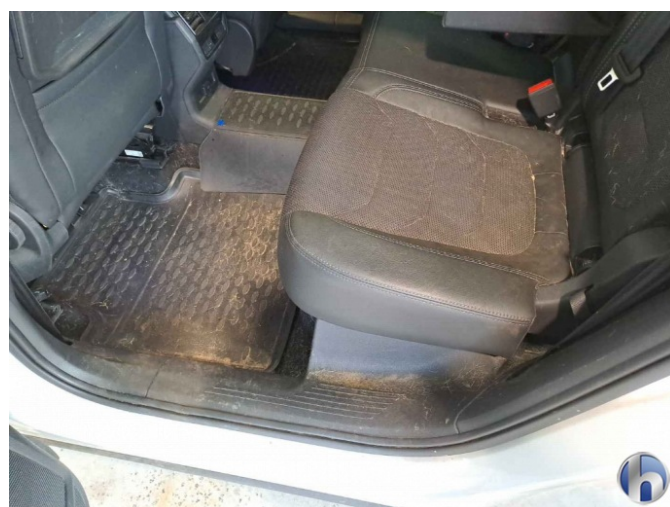
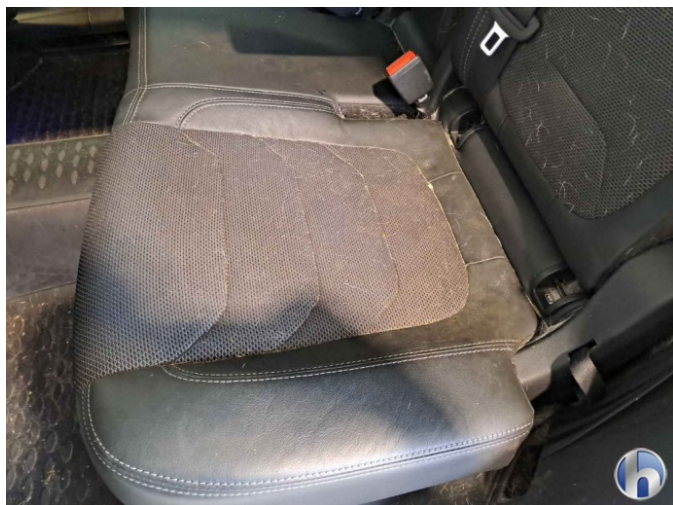
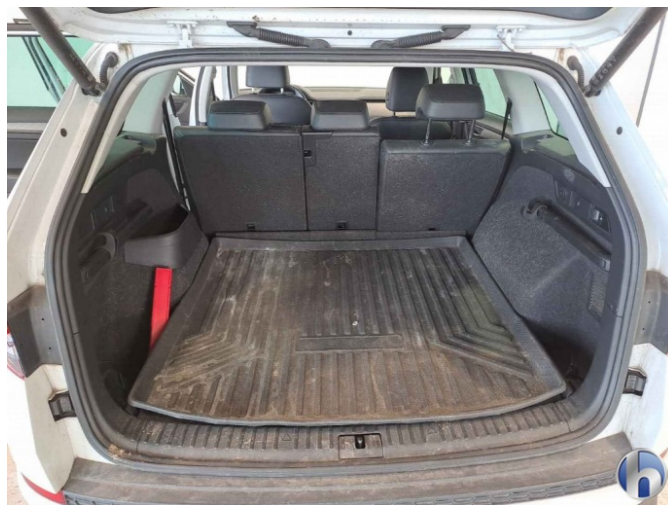
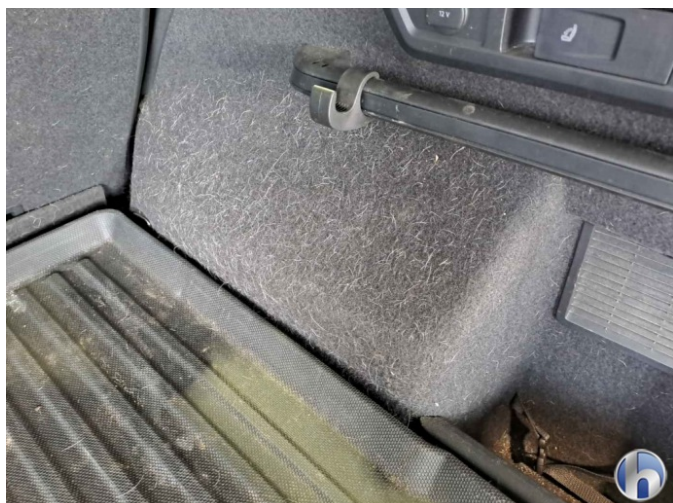
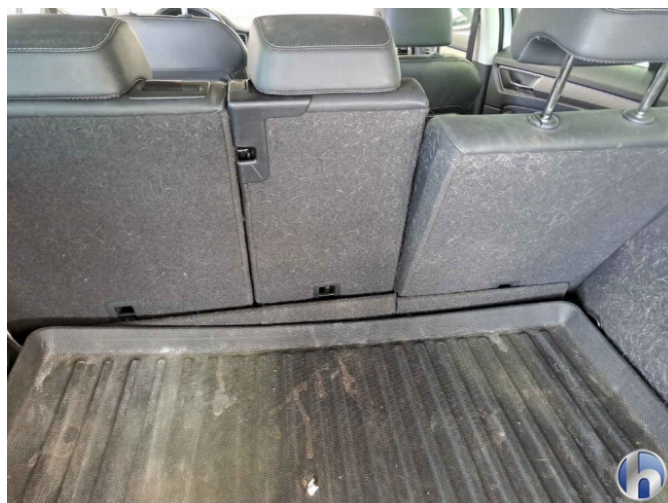
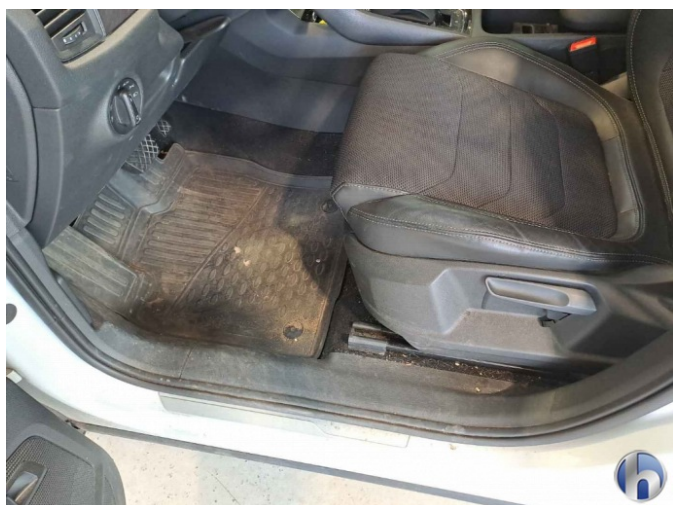
| component | Damage | Rep kind |
|---|---|---|
| 12. | Dirty (animal hair) | |

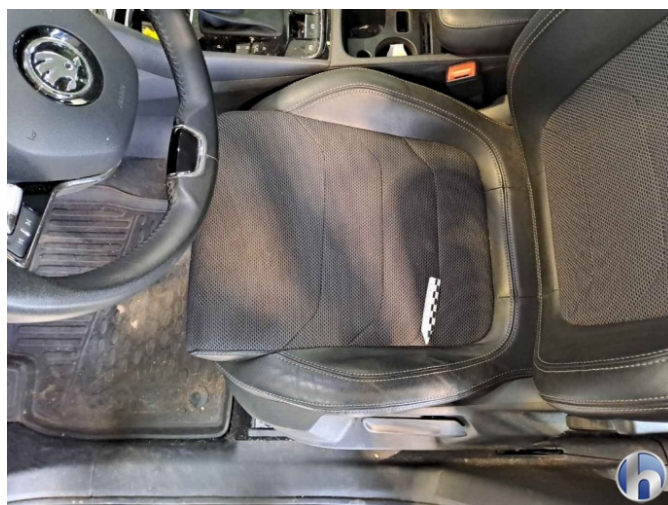
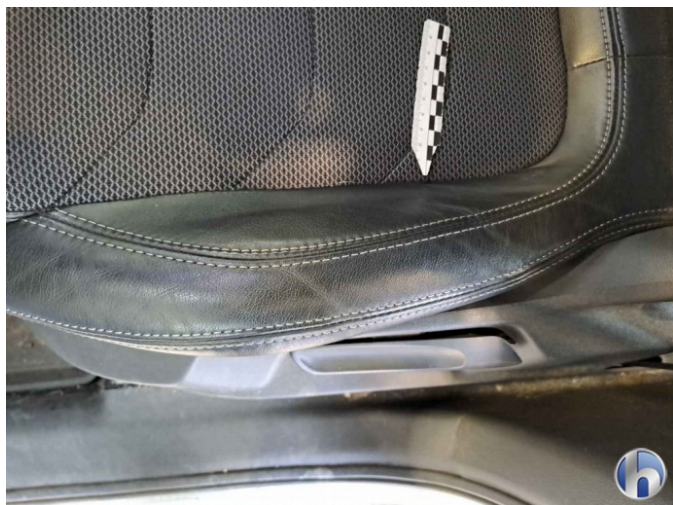
| component | Damage | Rep kind |
|---|---|---|
| 14. | Damaged | Replace |

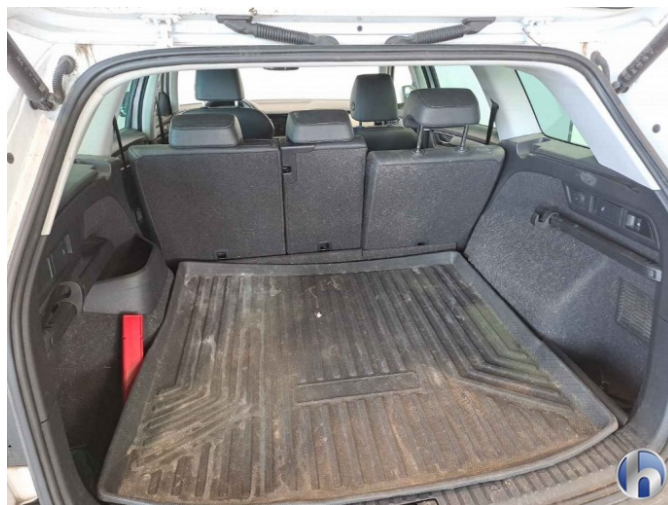
| component | Damage | Rep kind |
|---|---|---|
| 15. Cargo cover | Missing | Replace |
