## status report

#### Skoda Octavia Combi RS

| Vehicle identification number | <b>TMBUF61Z4B2054683</b> | mileage read: | <b>185933 km</b> |
| First Registration /<br>construction year: | <b>04.11.2010 / 2010</b> | Visit Date / place of birth: | <b>25.09.2025 Riedstadt-<br/>Goddelau</b> |

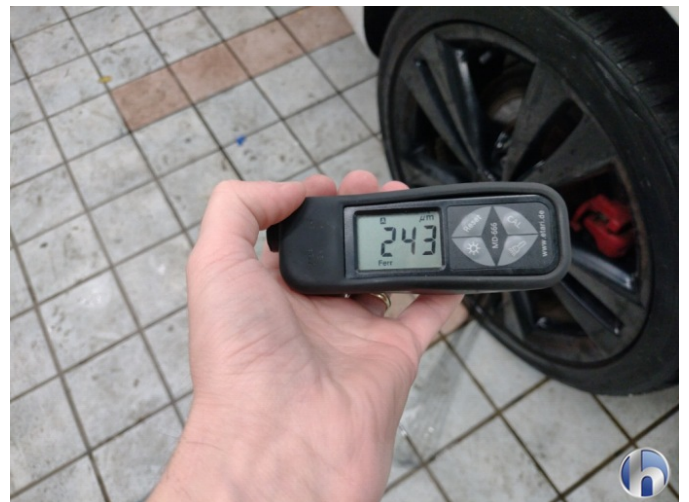
| component | Damage | Rep kind |
|---|---|---|
| 1. Sidewall - Rear - right | Subsequently painted | acceptable |

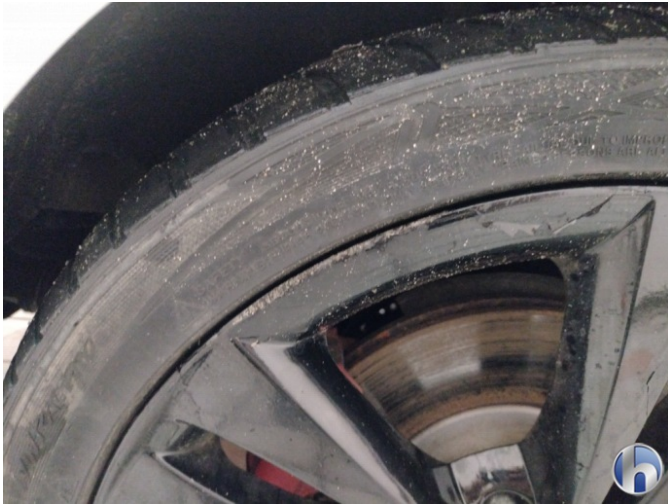
| component | Damage | Rep kind |
|---|---|---|
| 2. Rim front - left | Scratch(es) | Smart repair |

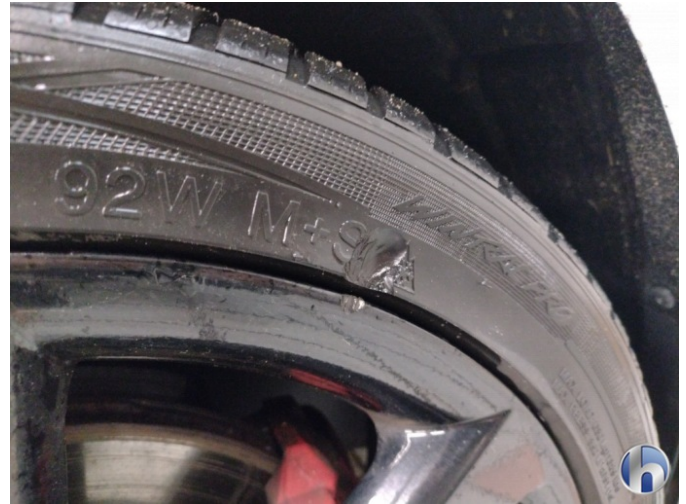
| component | Damage | Rep kind |
|---|---|---|
| 3. tire front - right | Damaged | Replace |

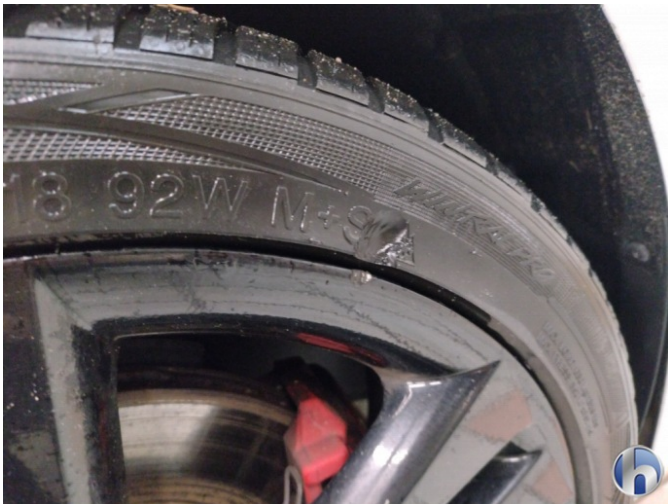
| component | Damage | Rep kind |
|---|---|---|
| 4. Rim front - right | Scratch(es) | Smart repair |

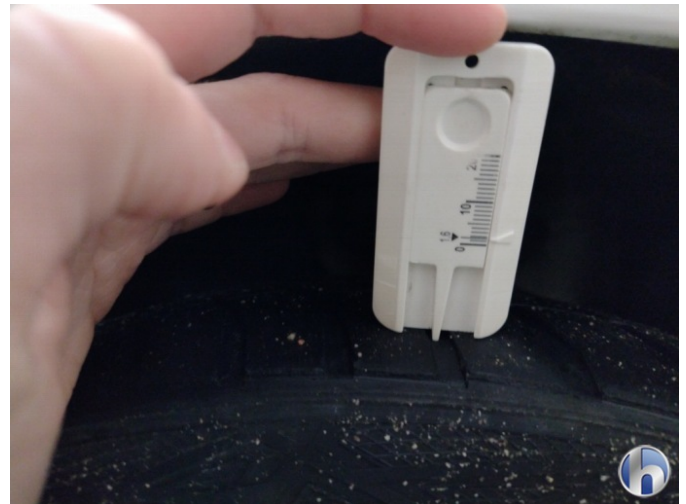
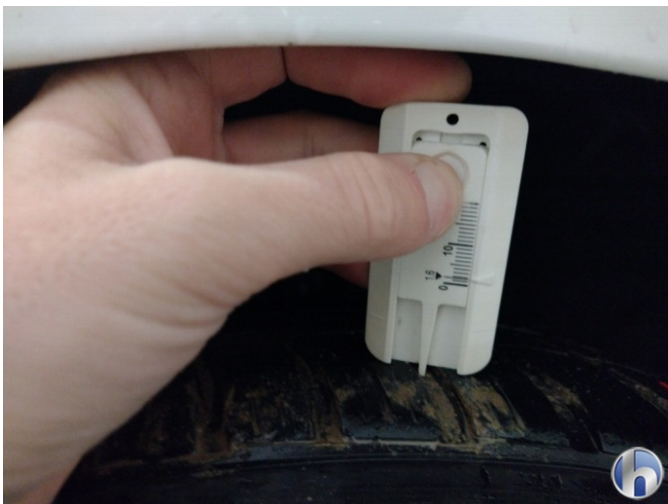
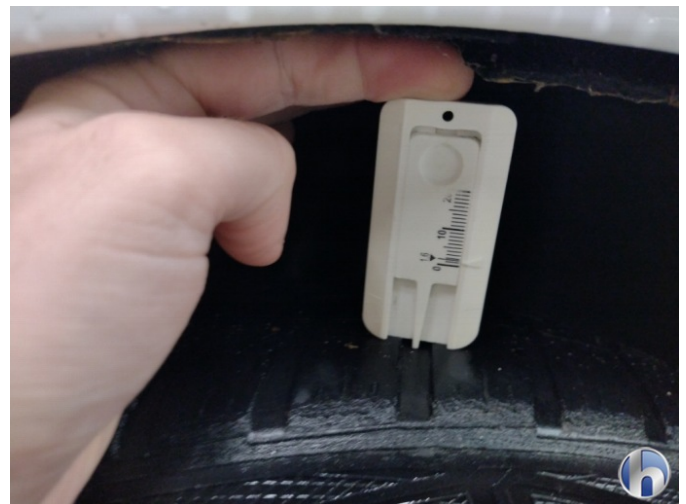
| component | Damage | Rep kind |
|---|---|---|
| 5. 3x Reifen | Worn | Replace |

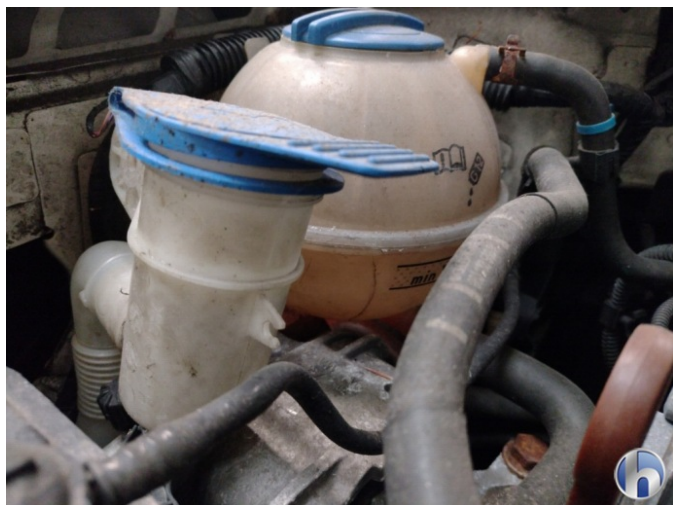
| component | Damage | Rep kind |
|---|---|---|
| 6. Ausgleichsbehälter Kühlwasser | Missing | Carry out a fault diagnosis |

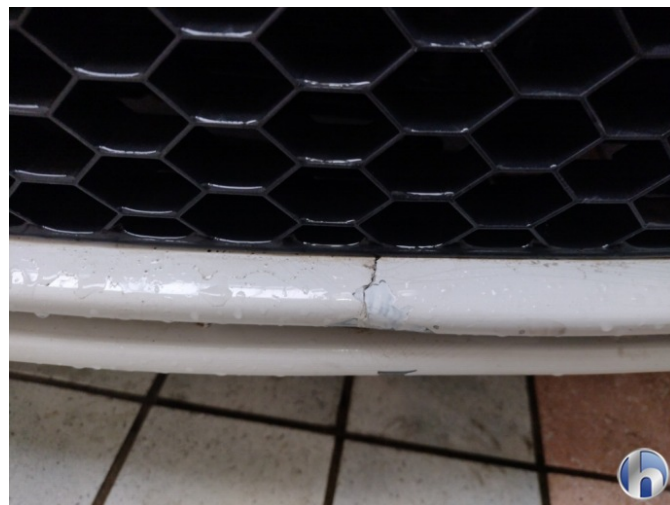
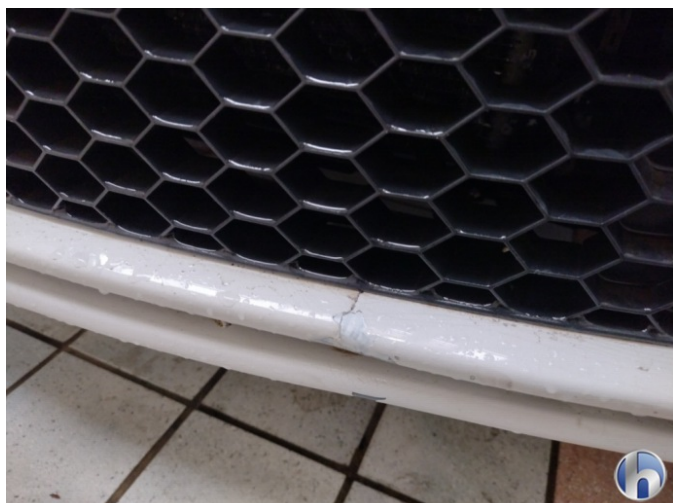
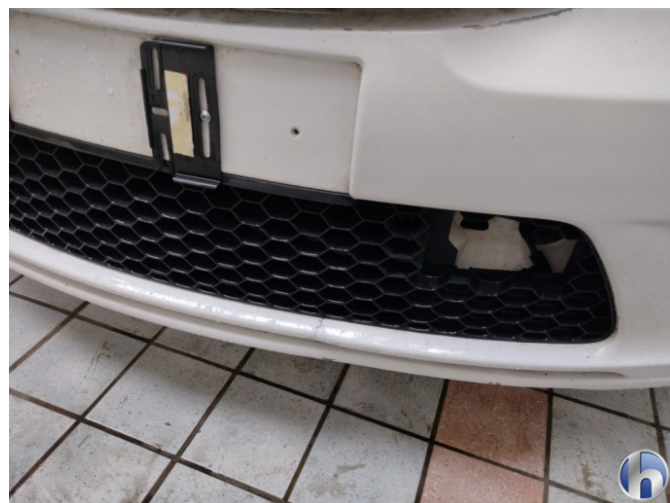
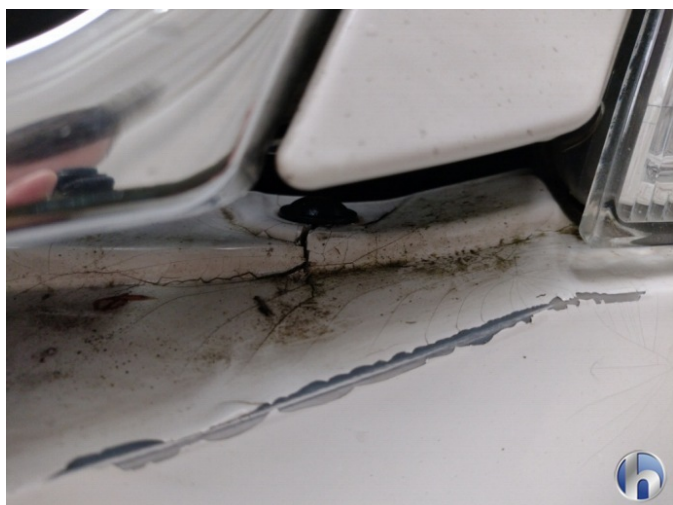
| component | Damage | Rep kind |
|---|---|---|
| 7. Front bumper | Breakage | Replace |

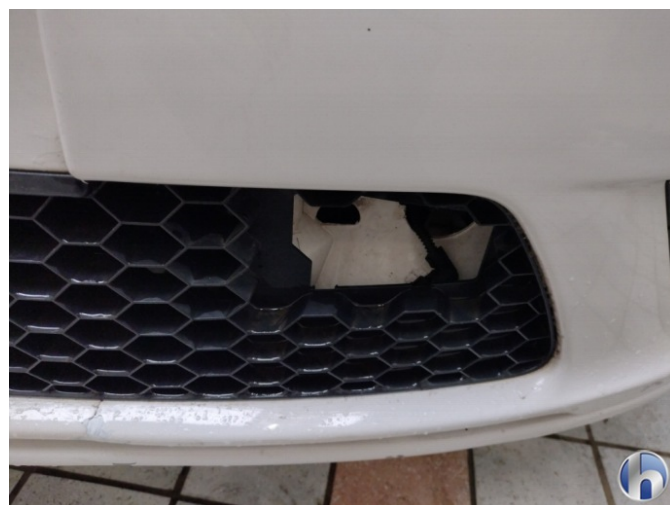
| component | Damage | Rep kind |
|---|---|---|
| 8. Frontgrill Stoßfänger Unten Kappe | Missing | Replace |

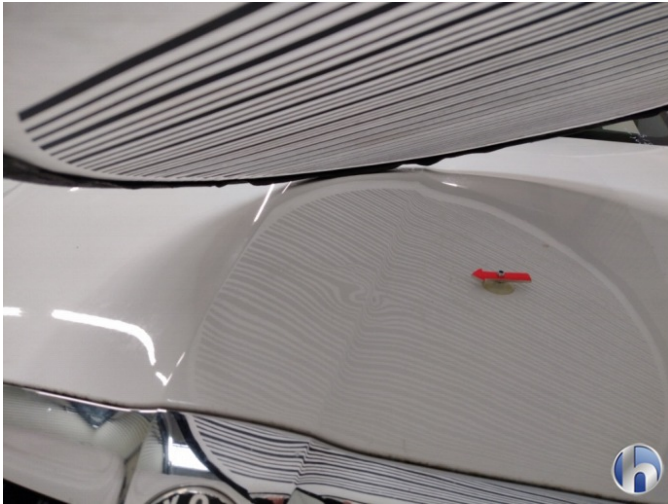
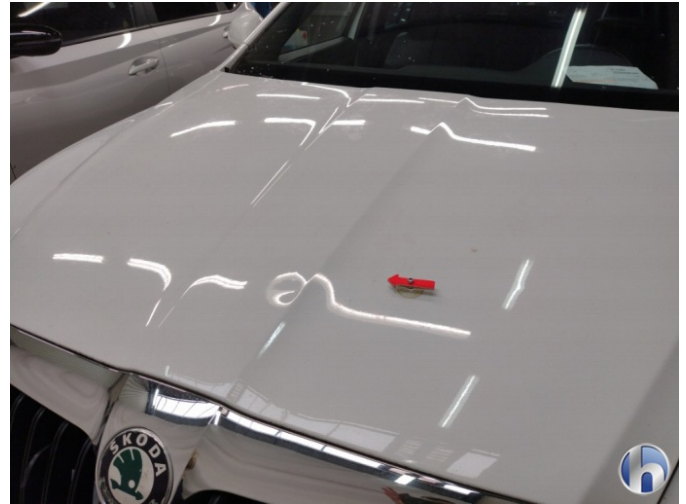
| component | Damage | Rep kind |
|---|---|---|
| 9. hood | Deformed | Refurbish and paint |

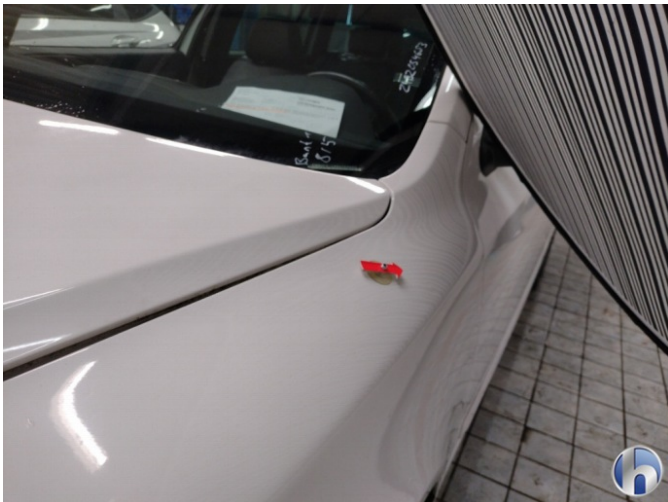
| component | Damage | Rep kind |
|---|---|---|
| 10. Front fender - left | Delle | Smart repair |

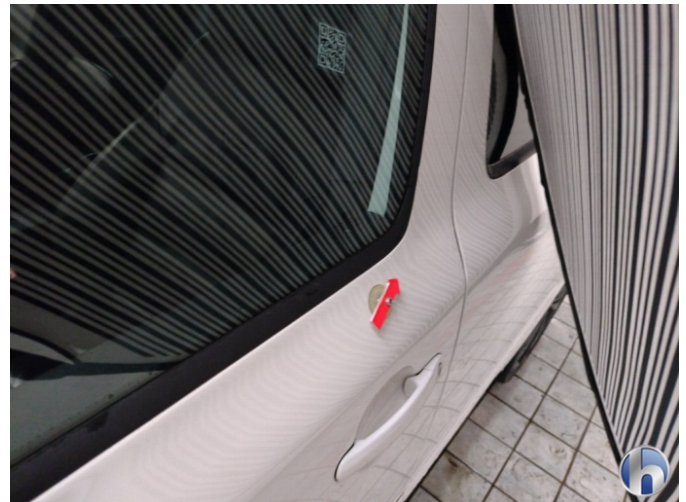
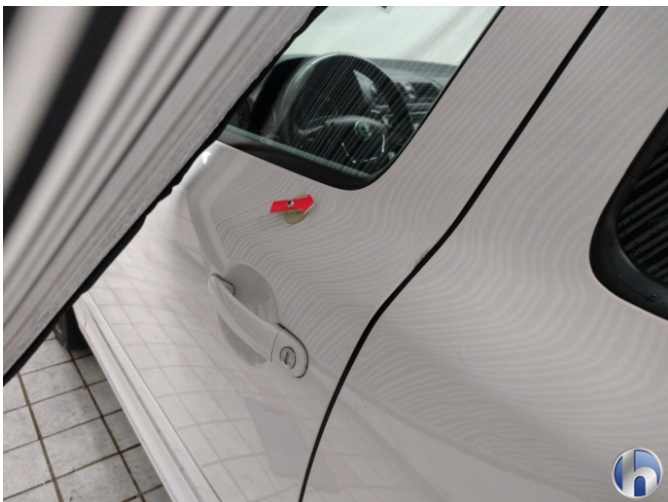
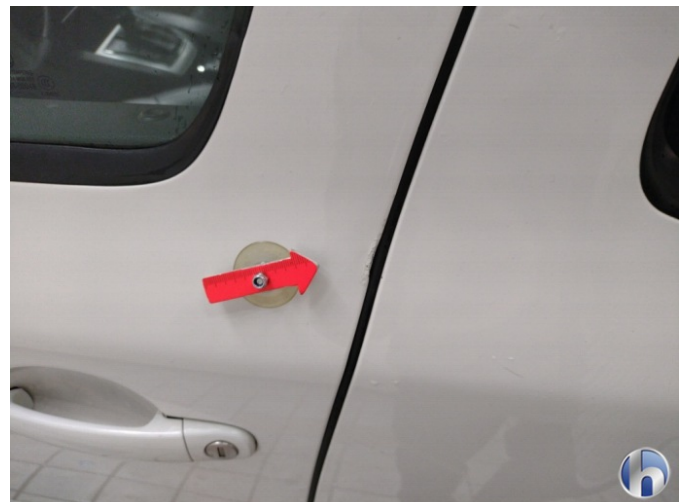
| component | Damage | Rep kind |
|---|---|---|
| 11. Front door - left | Deformed | Refurbish and paint |

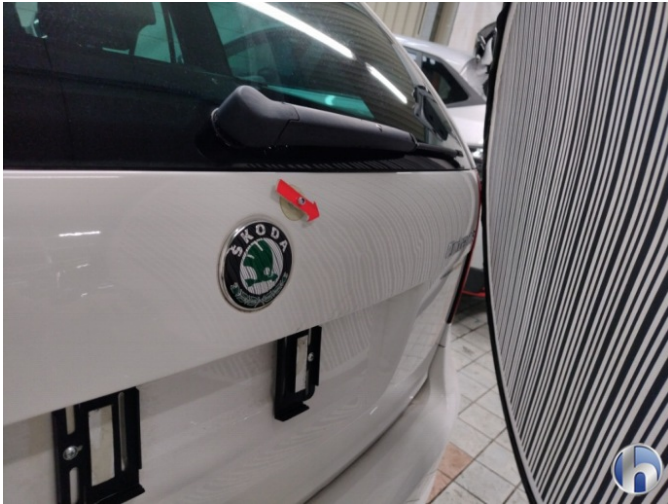
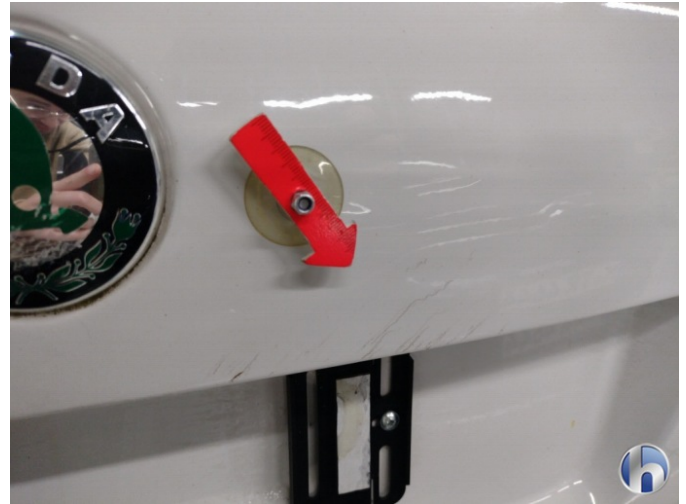
| component | Damage | Rep kind |
|---|---|---|
| 12. tailgate | Deformed | Refurbish and paint |

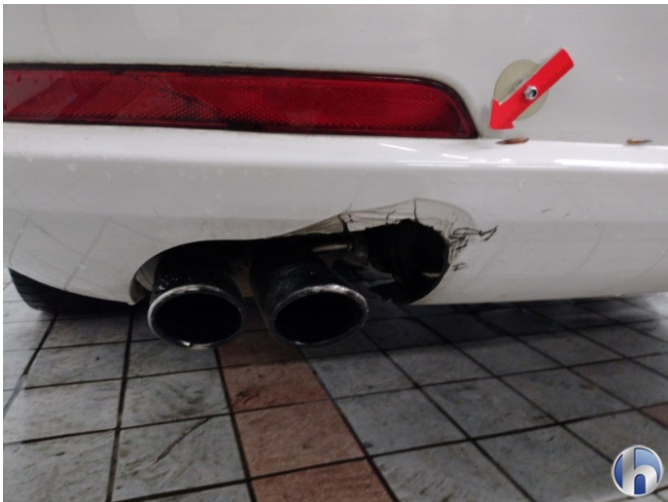
| component | Damage | Rep kind |
|---|---|---|
| 13. Rear bumper | Damaged | Replace |

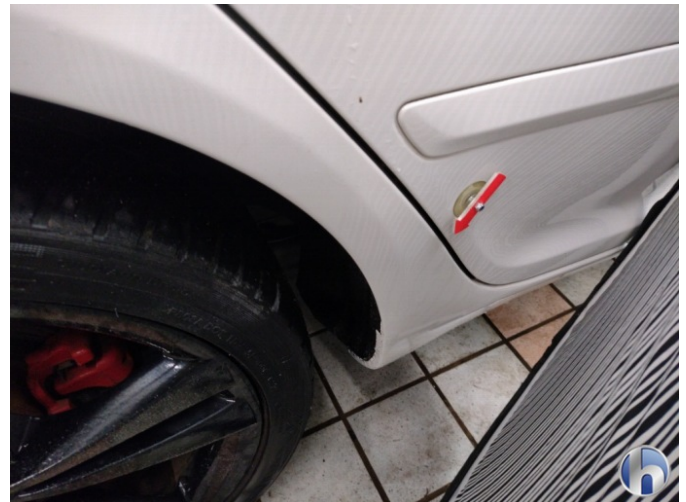
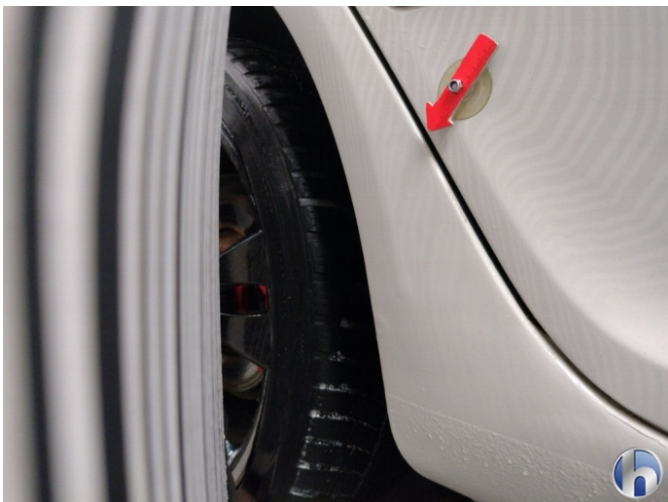
| component | Damage | Rep kind |
|---|---|---|
| 14. Sidewall - Rear - right | Execution defect | Refurbish and paint |

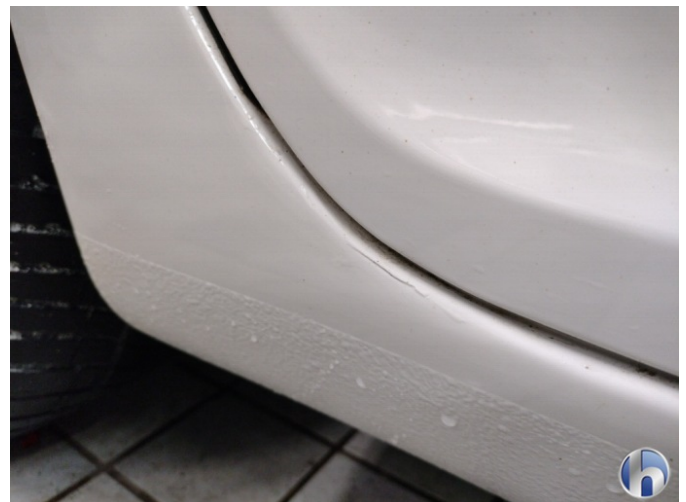
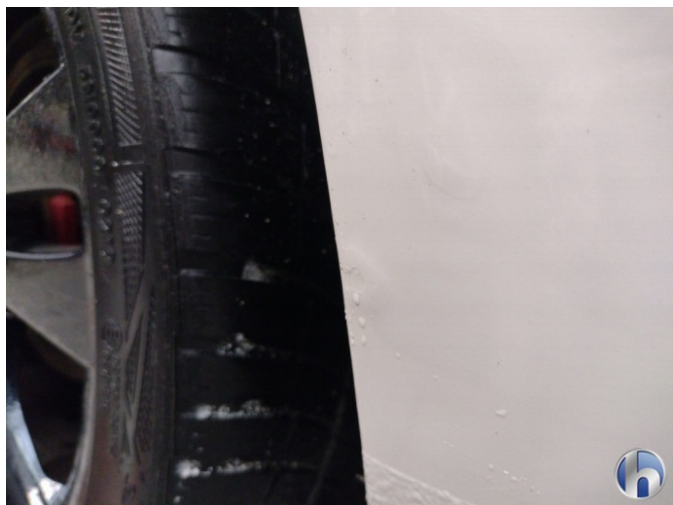
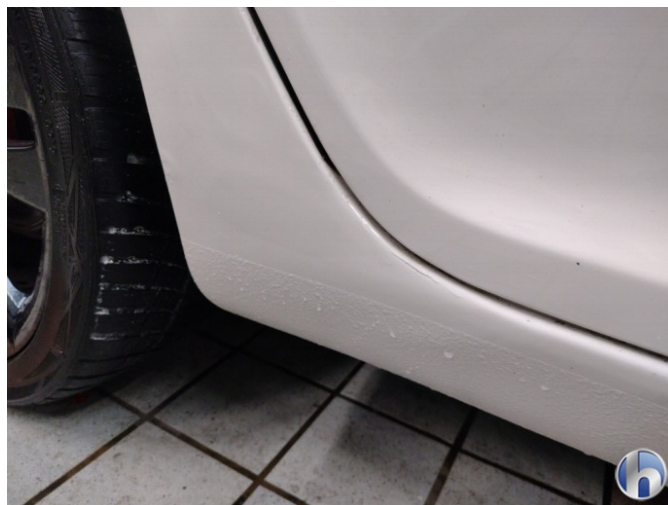
| component | Damage | Rep kind |
|---|---|---|
| 15. side skirt - right | Execution defect | Refurbish and paint |

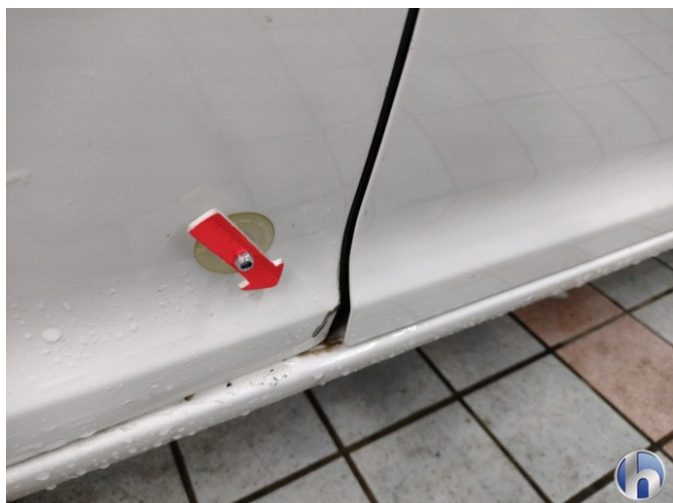
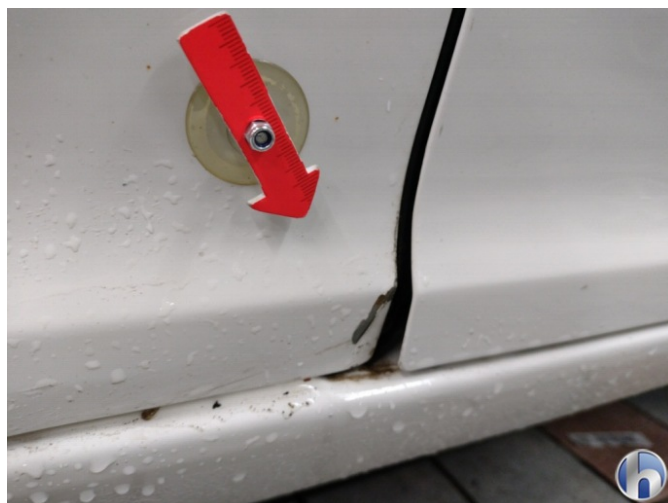
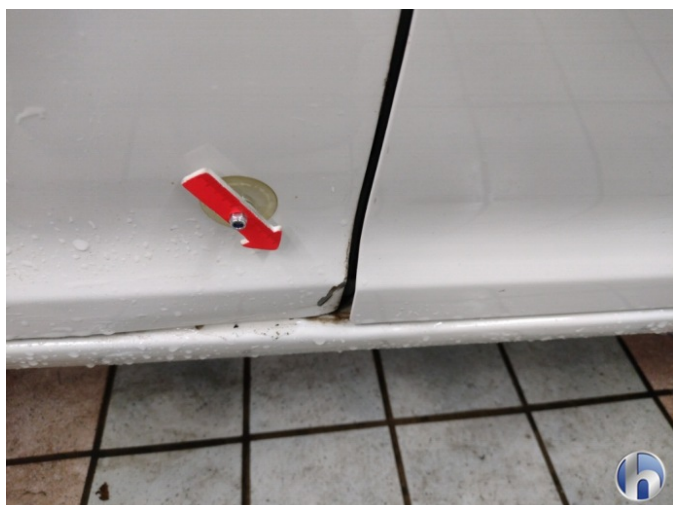
| component | Damage | Rep kind |
|---|---|---|
| 16. Door Rear - right | Deformed | Refurbish and paint |

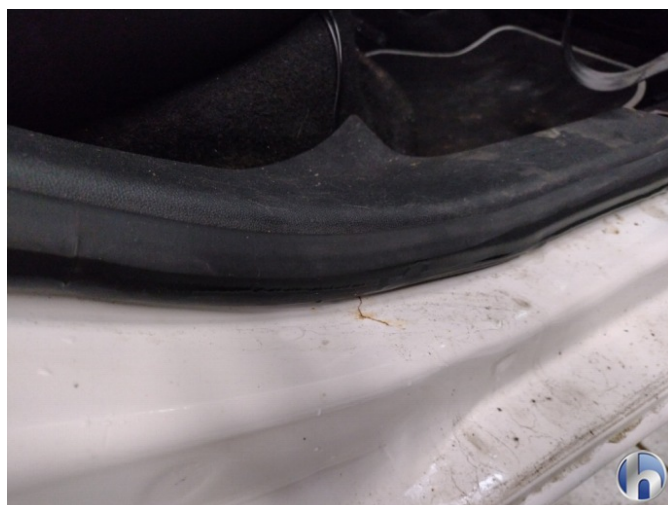
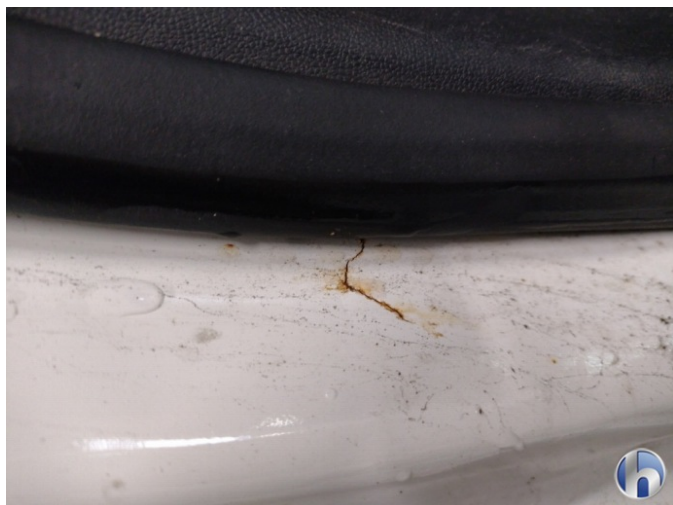
| component | Damage | Rep kind |
|---|---|---|
| 17. Türeinstieg Hinten - Rechts | Execution defect | Refurbish and paint |

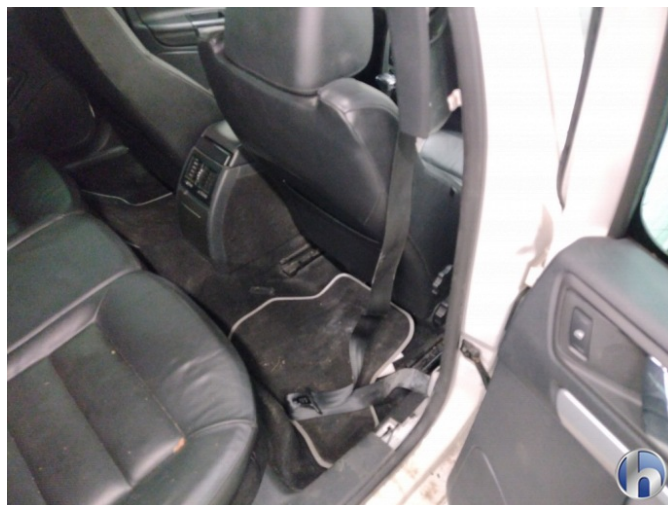
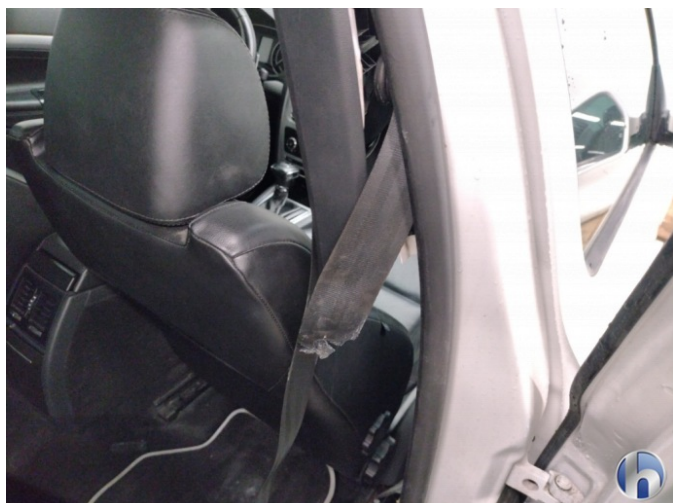
| component | Damage | Rep kind |
|---|---|---|
| 18. Gurt Vorne Rechts | Damaged | Replace |

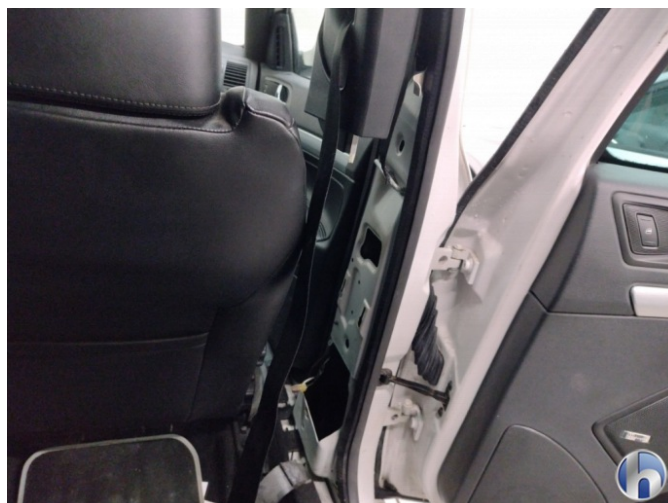
| component | Damage | Rep kind |
|---|---|---|
| 19. | Missing | Replace |

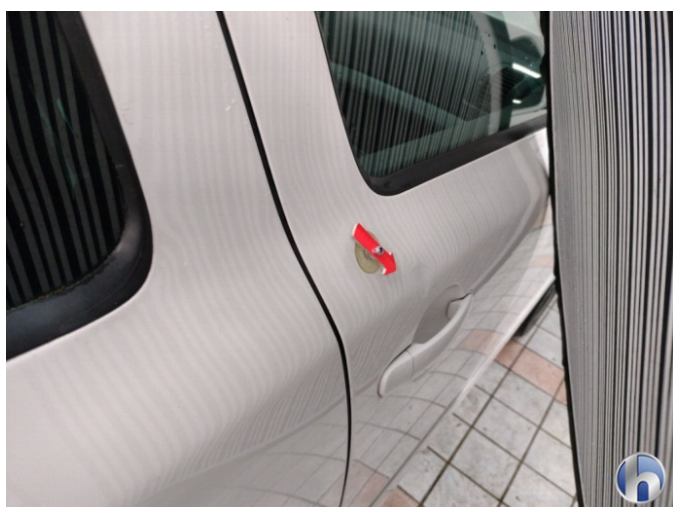
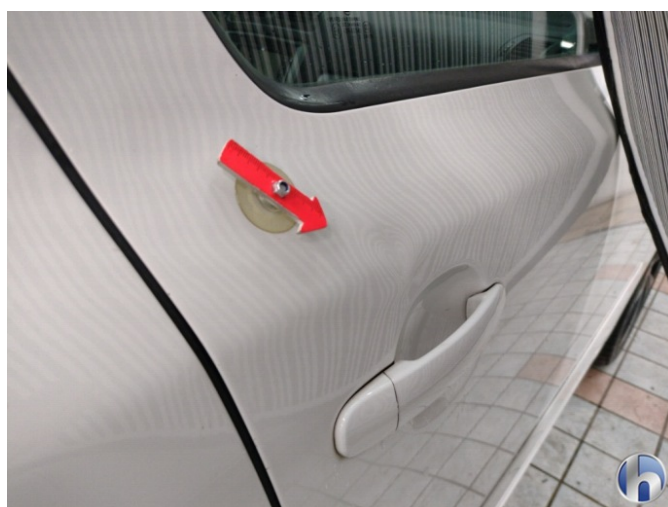
| component | Damage | Rep kind |
|---|---|---|
| 20. Front door - right | Deformed | Refurbish and paint |

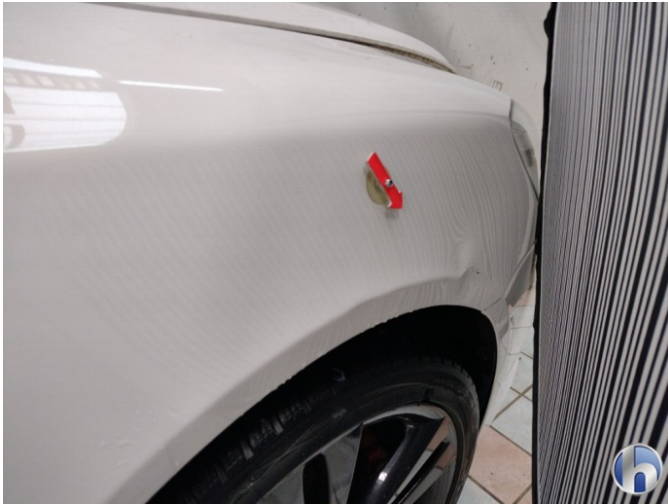
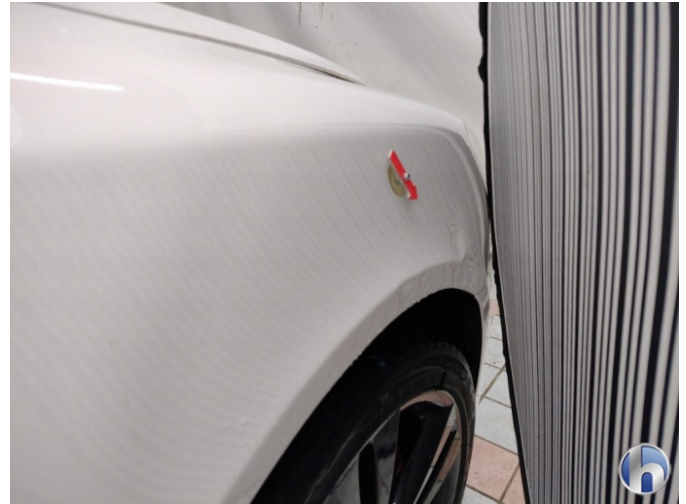
| component | Damage | Rep kind |
|---|---|---|
| 21. Front fender - right | Deformed | Refurbish and paint |

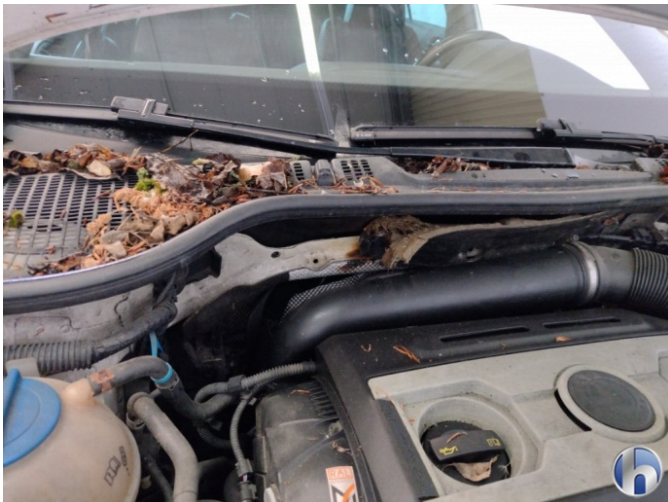
| component | Damage | Rep kind |
|---|---|---|
| 22. | Damaged | Replace |

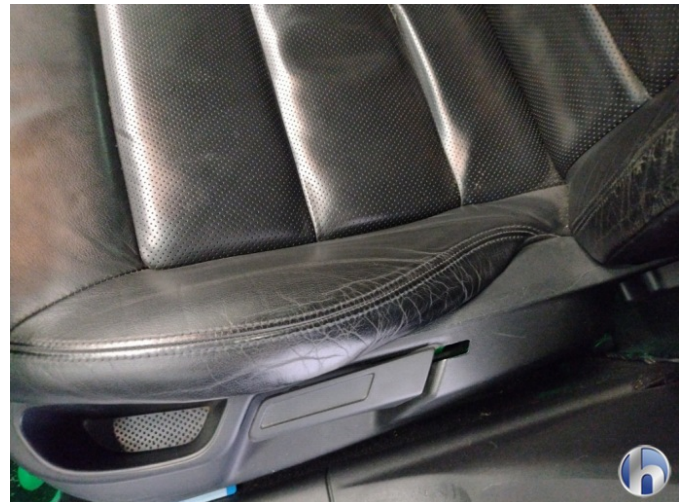
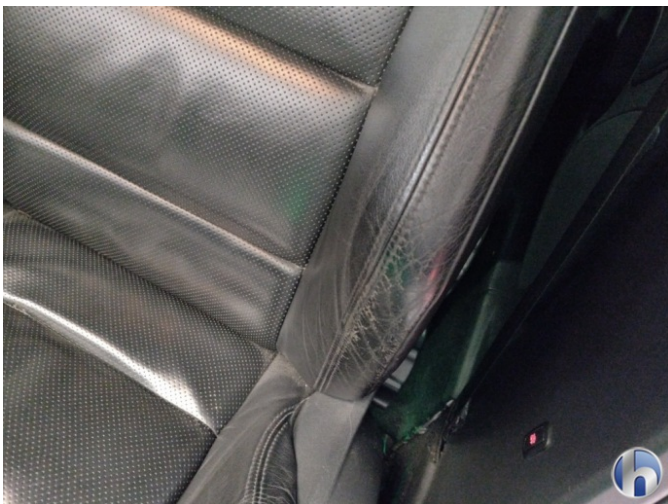
| component | Damage | Rep kind |
|---|---|---|
| 24. Sitz Vorne Links | Damaged | Replace |

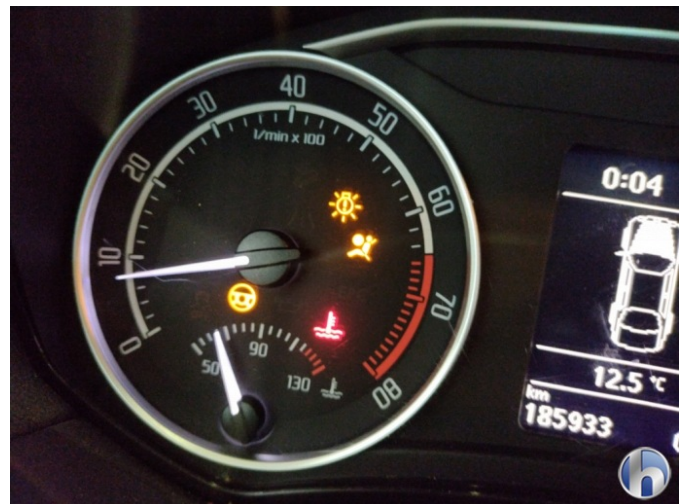
| component | Damage | Rep kind |
|---|---|---|
| 25. Airbag | Error message | Carry out a fault diagnosis |

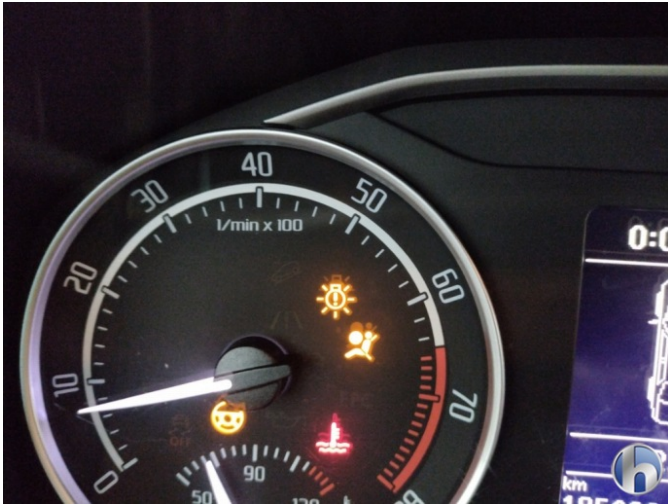
| Performed testing technology | |
|---|---|
| <b>lighting system:</b> | For sightseeing timing defects in the lighting system were noted .<br>*Fehlermeldung |

| component | Damage | Rep kind |
|---|---|---|
| 26. Beleuchtung | Error message | Carry out a fault diagnosis |

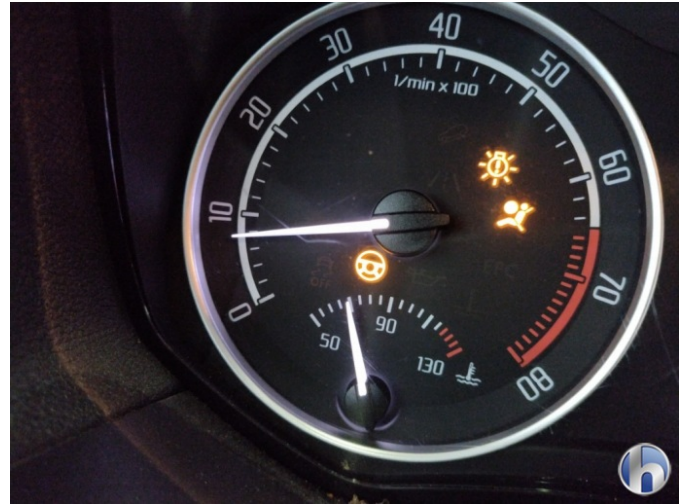
| component | Damage | Rep kind |
|---|---|---|
| 27. Lenkung | Error message | Carry out a fault diagnosis |

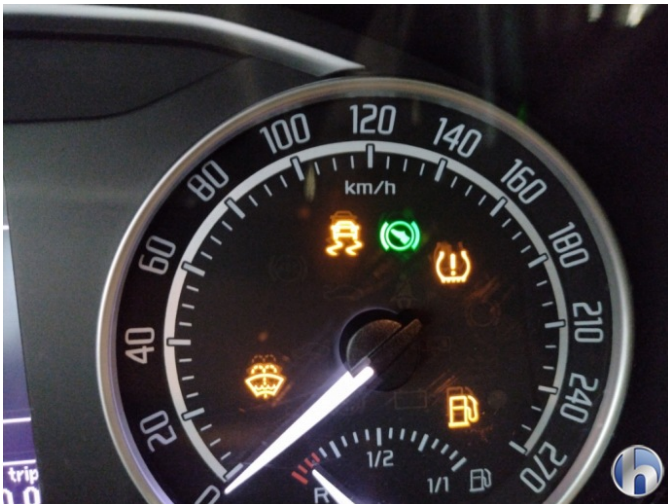
| component | Damage | Rep kind |
|---|---|---|
| 28. ESP | Error message | Carry out a fault diagnosis |

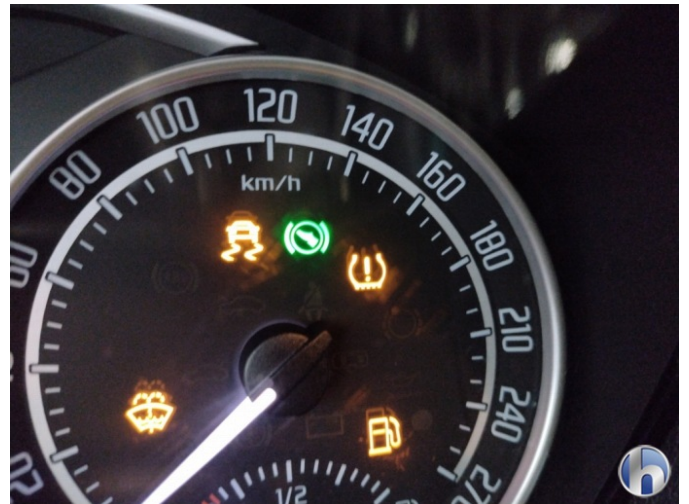
| component | Damage | Rep kind |
|---|---|---|
| 29. Reifendruckkontrollleuchte | Error message | Carry out a fault diagnosis |

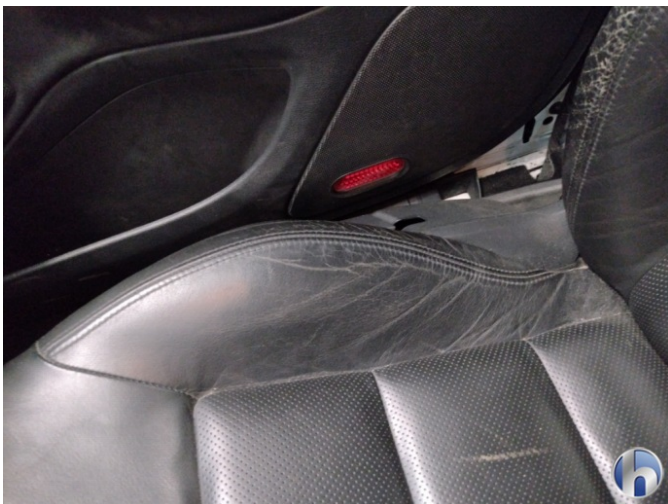
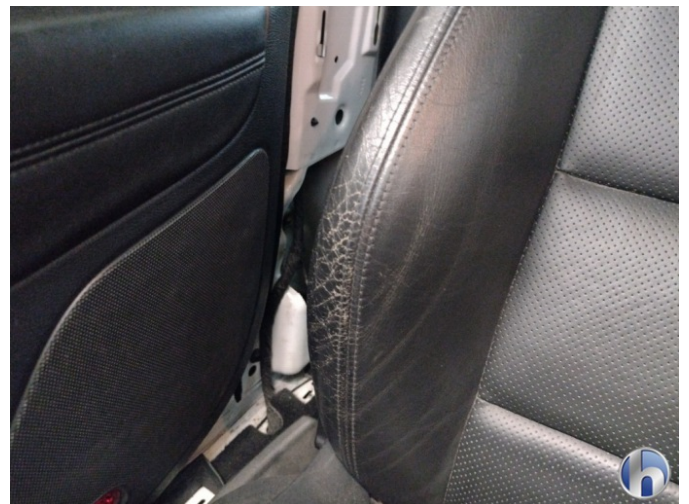
| component | Damage | Rep kind |
|---|---|---|
| 31. Sitz Vorne Rechts | Damaged | Replace |

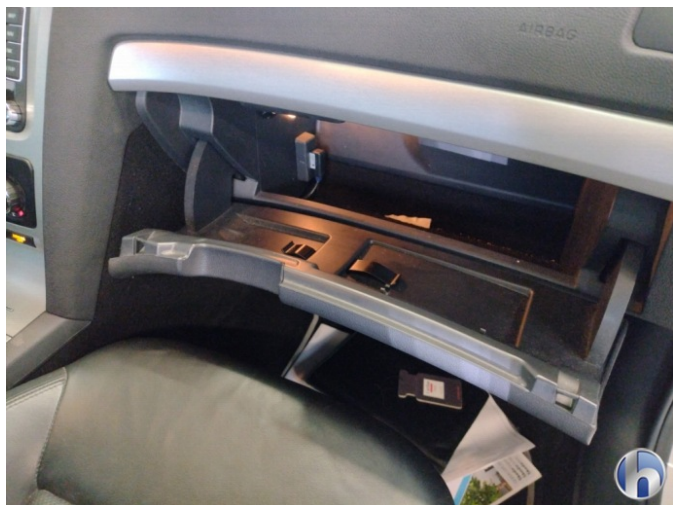
| component | Damage | Rep kind |
|---|---|---|
| 33. Glove compartment | Damaged | Replace |

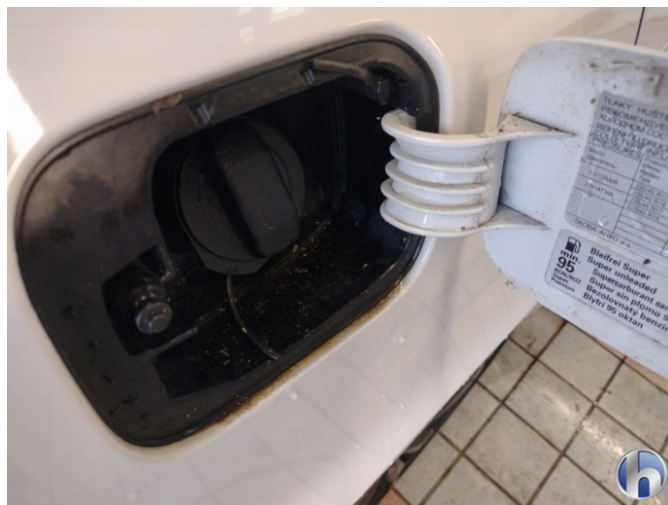
| component | Damage | Rep kind |
|---|---|---|
| 34. Tankdeckel Fangband | Damaged | Replace |

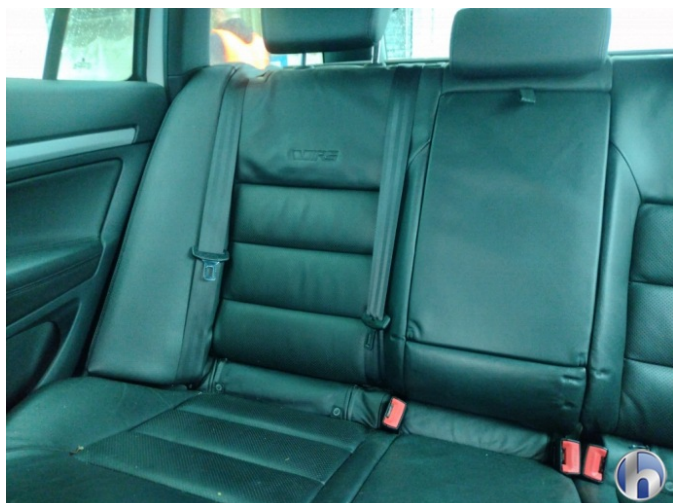
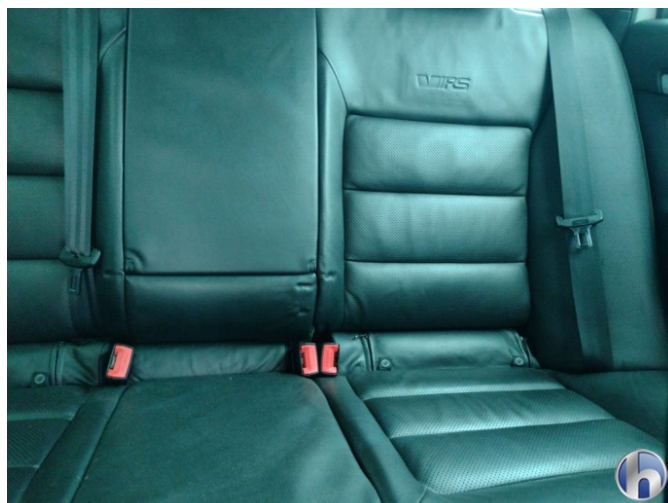
| component | Damage | Rep kind |
|---|---|---|
| 35. Sitzreihe Hinten | Wear and tear | acceptable |
