SKODA Citigo

Citigo 1.0 MPI Green tec

Inspection Report Summary

Customer	BCA Online	Report Number	P20250908094927
Inspection Date / Place	2025-09-08 / Dello Eppendorf/Hamburg	Cosmetic Grade	3

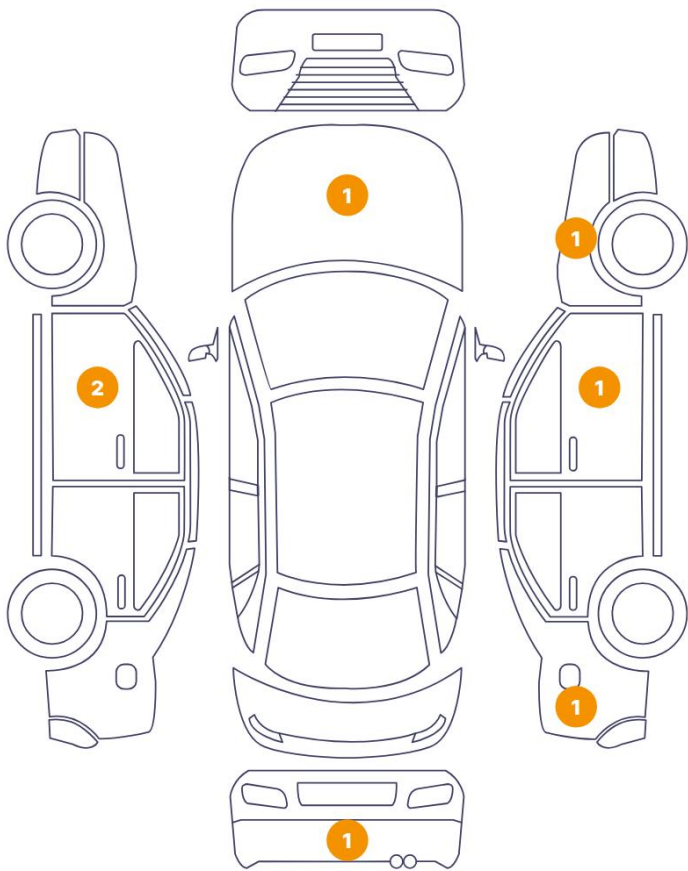
7 Schäden

Component		Damage	Comments
1	Hood	Bodywork / Dent / Dent	
2	Door / Front Left	Bodywork / Dent / Dent	
3	Door / Front Left	Bodywork / Dent / Dent	
4	Bumper / Back	Paint / Scratch / Scuff	
5	Fender / Back Right	Paint / Corrosion	
6	Door / Front Right	Paint / Scratch / Scuff	
7	Fender / Front Right	Bodywork / Dent / Deformation	
8	Steering Wheel / Front	Interior / Scraped

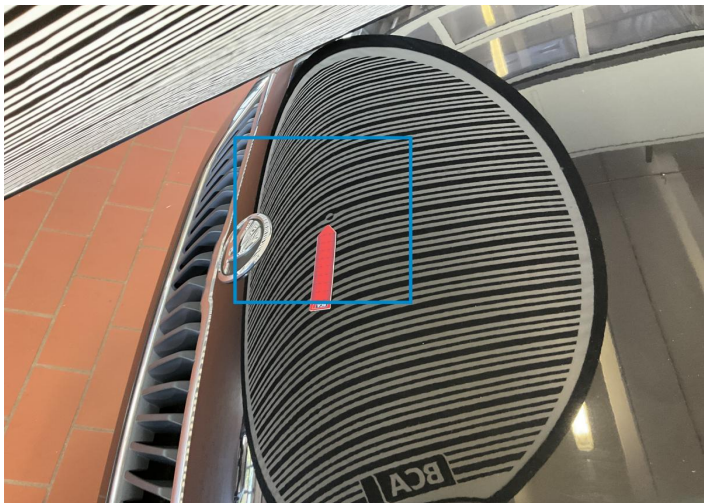
1. Hood
Bodywork / Dent / Dent -

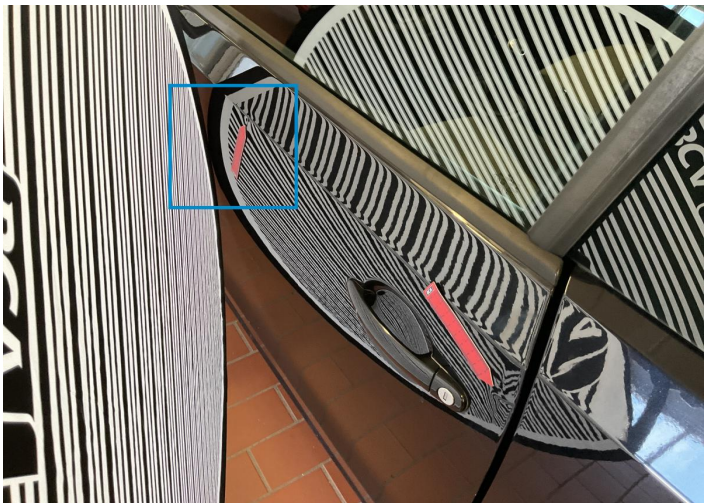
2. Door / Front Left
Bodywork / Dent / Dent -

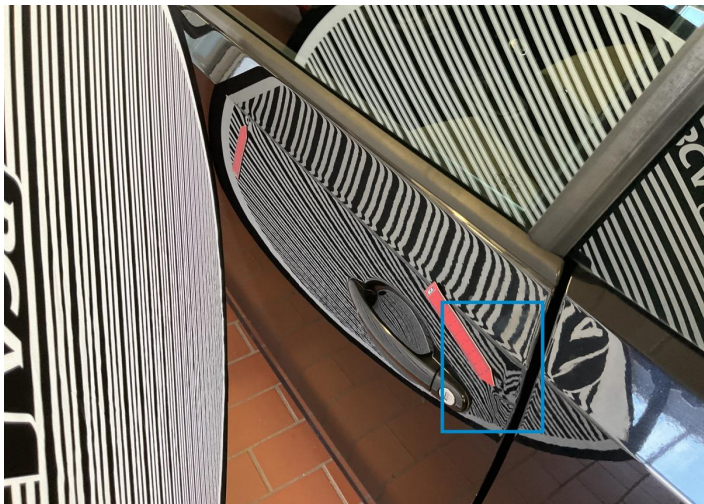
3. Door / Front Left
Bodywork / Dent / Dent -

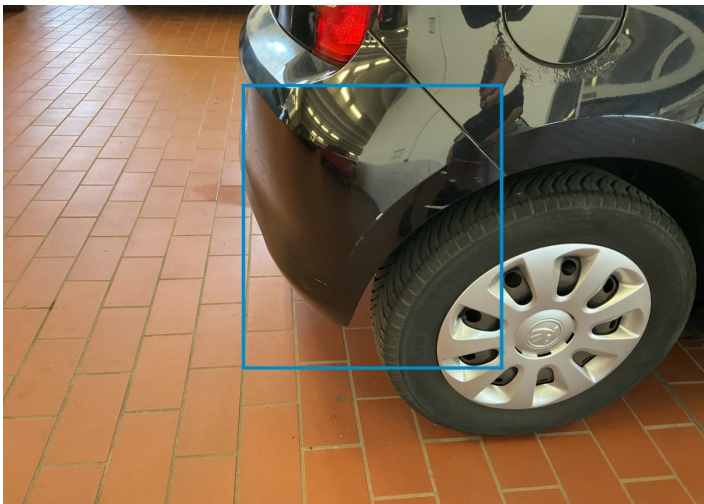
4. Bumper / Back
Paint / Scratch / Scuff -

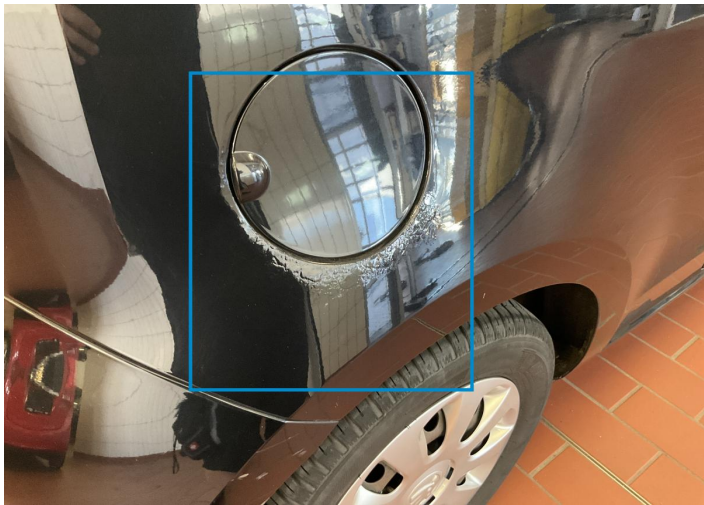
5. Fender / Back Right
Paint / Corrosion -

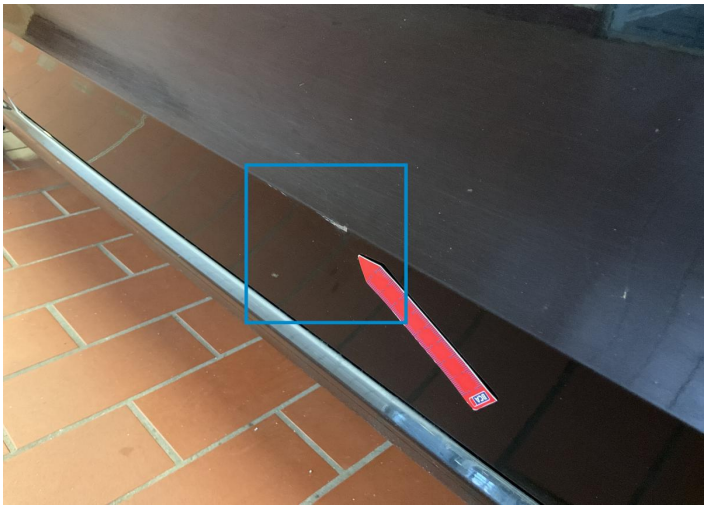
6. Door / Front Right
Paint / Scratch / Scuff -
