# SKODA Citigo

## Citigo 1.0 MPI Green tec

VIN NO TMBZZZAAZDD621475

### Inspection Report Summary

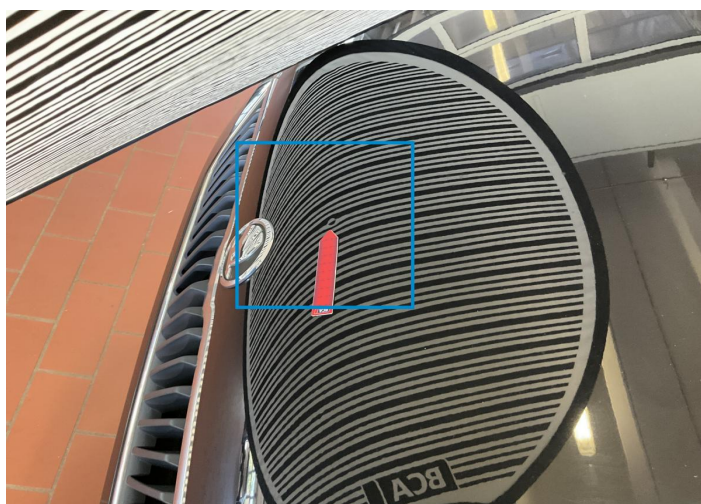
| Component | | Damage | Comments |
|---|---|---|---|
| 1 | Hood | Bodywork / Dent / Dent | |

1. Hood  
Bodywork / Dent / Dent -

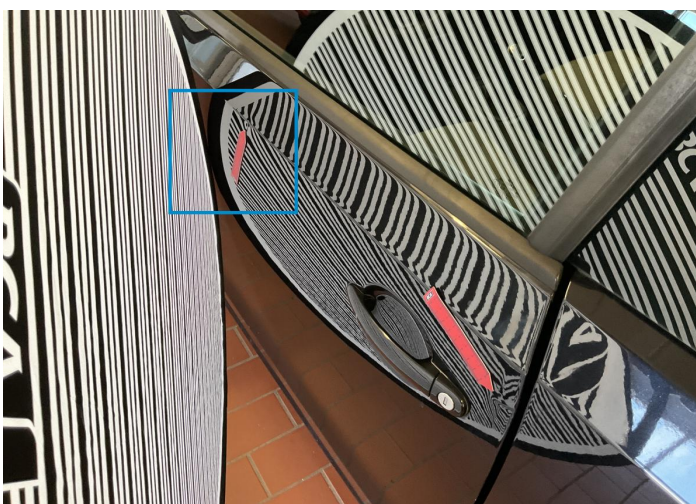
| Component | | Damage | Comments |
|---|---|---|---|
| 2 | Door / Front Left | Bodywork / Dent / Dent | |

2. Door / Front Left  
Bodywork / Dent / Dent -

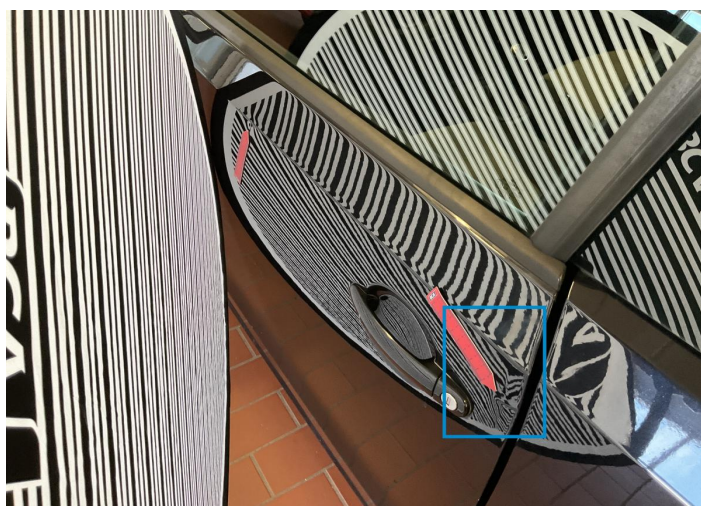
| Component | | Damage | Comments |
|---|---|---|---|
| 3 | Door / Front Left | Bodywork / Dent / Dent | |

3. Door / Front Left  
Bodywork / Dent / Dent -

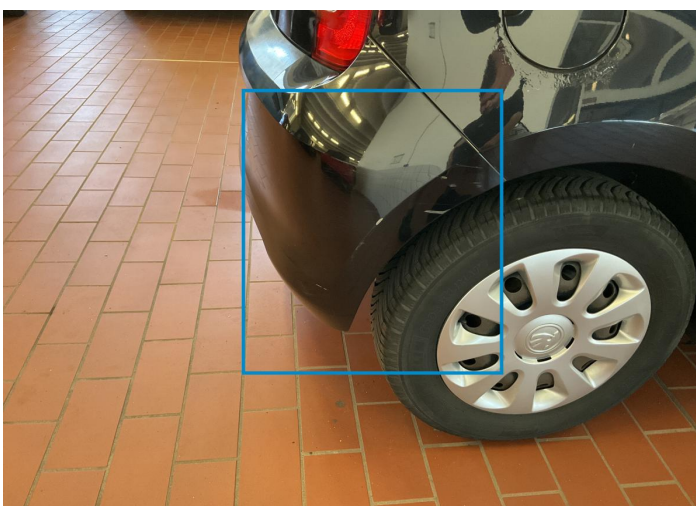
| Component | | Damage | Comments |
|---|---|---|---|
| 4 | Bumper / Back | Paint / Scratch / Scuff | |

4. Bumper / Back  
Paint / Scratch / Scuff -

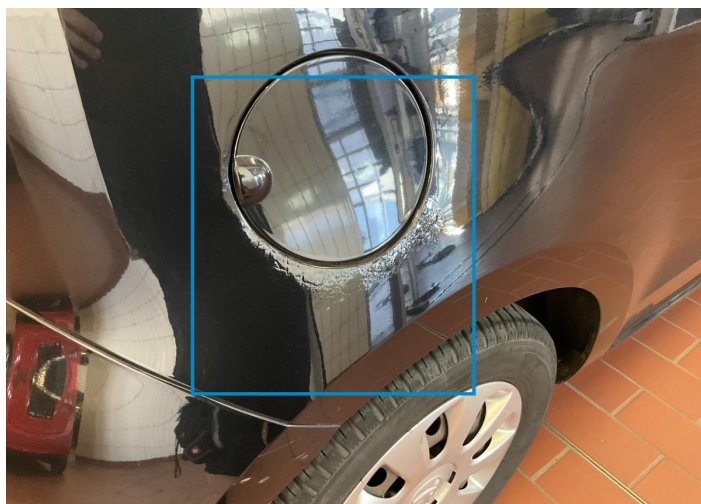
| Component | | Damage | Comments |
|---|---|---|---|
| 5 | Fender / Back Right | Paint / Corrosion | |

5. Fender / Back Right  
Paint / Corrosion -

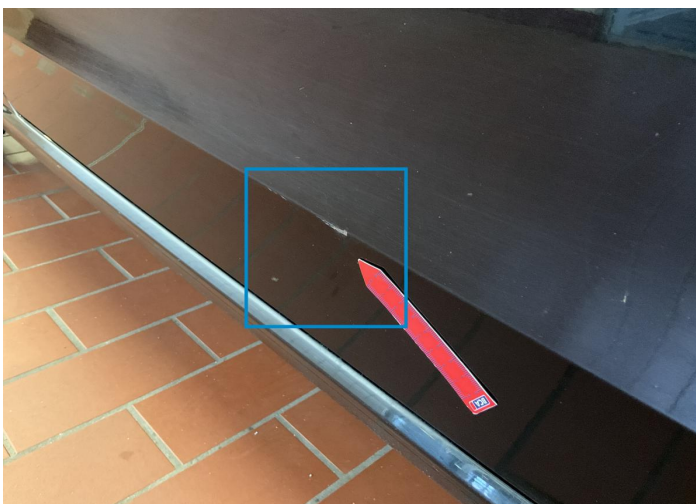
| Component | | Damage | Comments |
|---|---|---|---|
| 6 | Door / Front Right | Paint / Scratch / Scuff | |

6. Door / Front Right  
Paint / Scratch / Scuff -

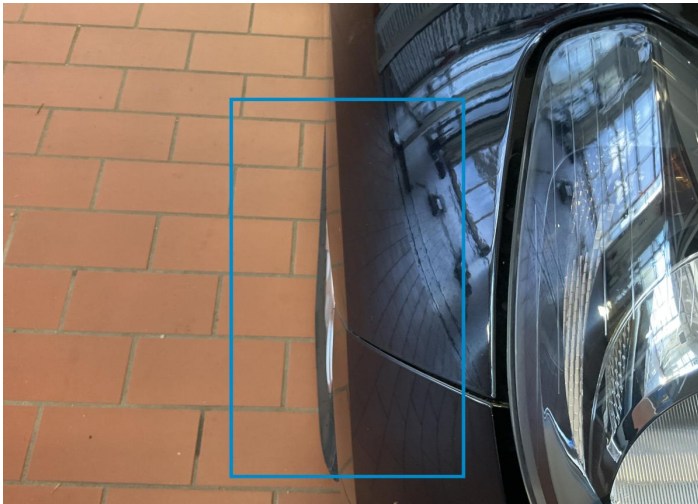
| Component | | Damage | Comments |
|---|---|---|---|
| 7 | Fender / Front Right | Bodywork / Dent / Deformation | |

7. Fender / Front Right  
Bodywork / Dent / Deformation -

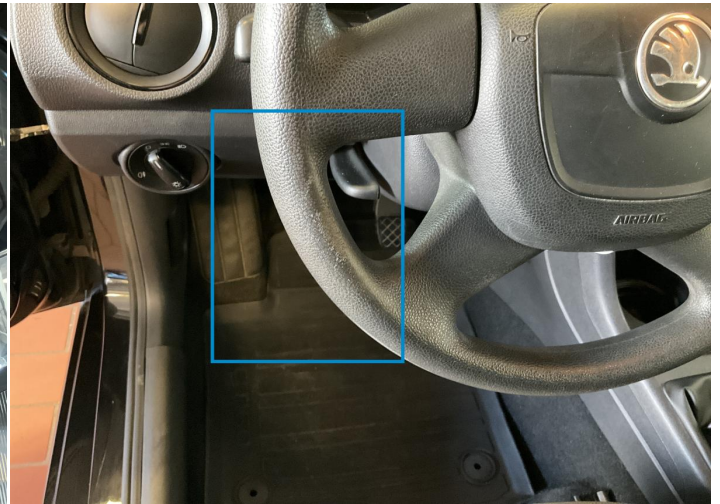
| Component | | Damage | Comments |
|---|---|---|---|
| 8 | Steering Wheel / Front | Interior / Scraped | |

8. Steering Wheel / Front  
Interior / Scraped -
