status report

Suzuki Vitara

| Vehicle identification number | TSMLYED1S00C74873 | mileage read: | 17685 km |

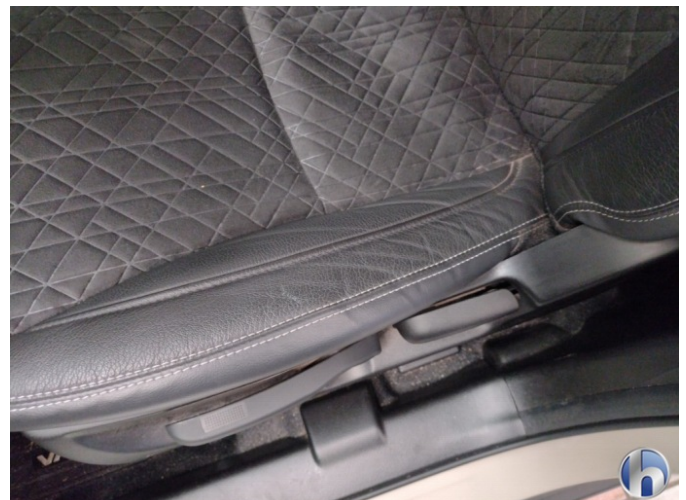
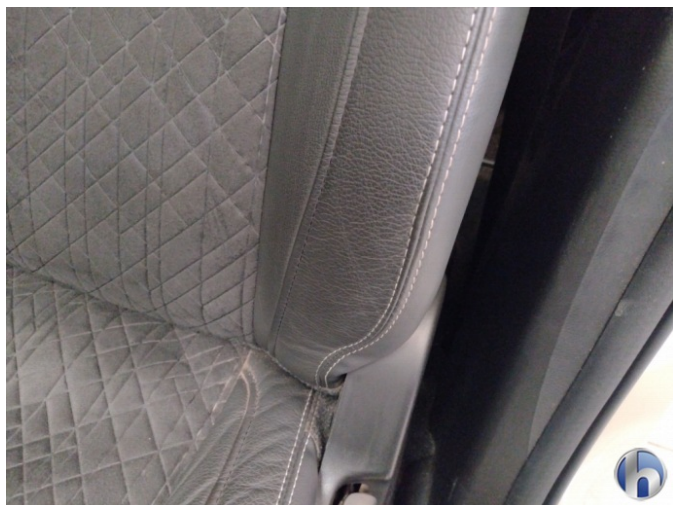
| component | Damage | Rep kind |
|---|---|---|
| 1. Sitz Vorne Links | Damaged | Smart repair |

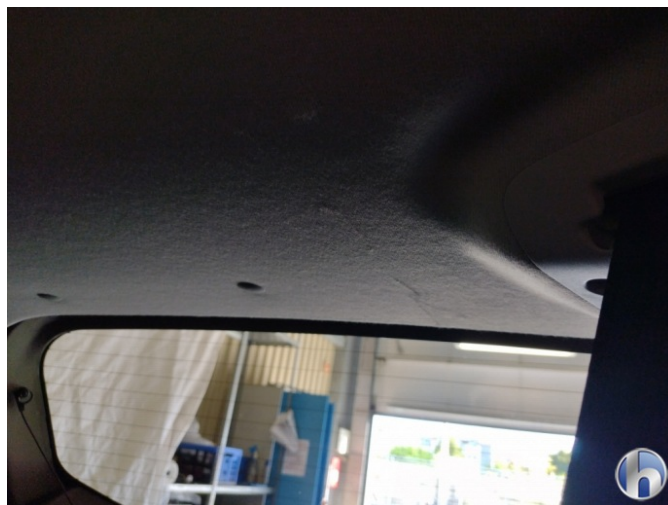
| component | Damage | Rep kind |
|---|---|---|
| 2. headlining | Damaged | Smart repair |
