## status report

#### Kia Venga Spirit

| Vehicle identification number | <b>U5YEH812BHL157931</b> | mileage read: | <b>33868 km</b> |

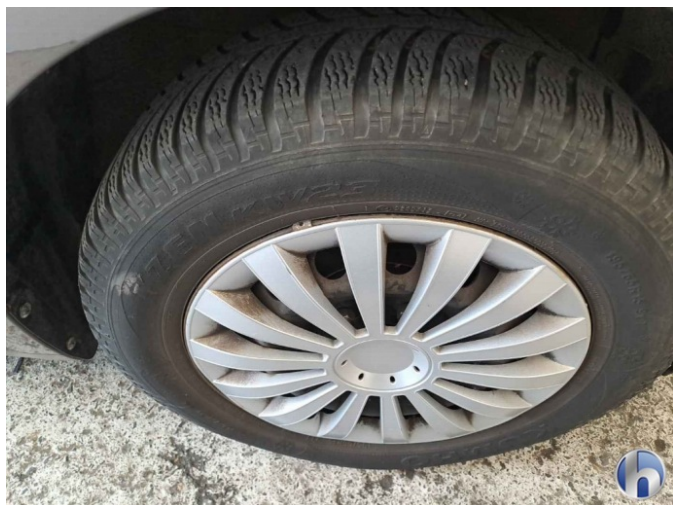
| component | Damage | Rep kind |
|---|---|---|
| 1. tire front - right | Worn | Replace |

1. tire front - right

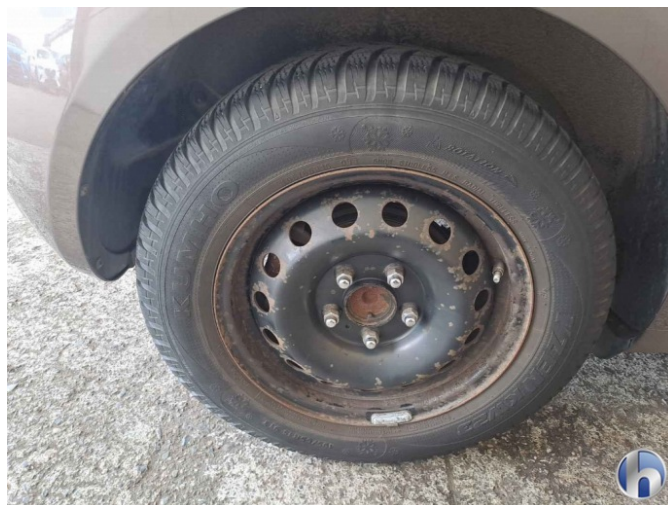
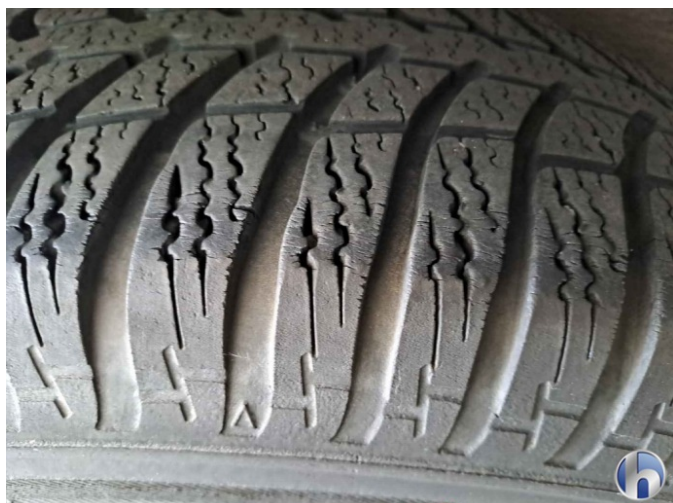
| component | Damage | Rep kind |
|---|---|---|
| 2. tire rear - right | Crack | Replace |

2. tire rear - right

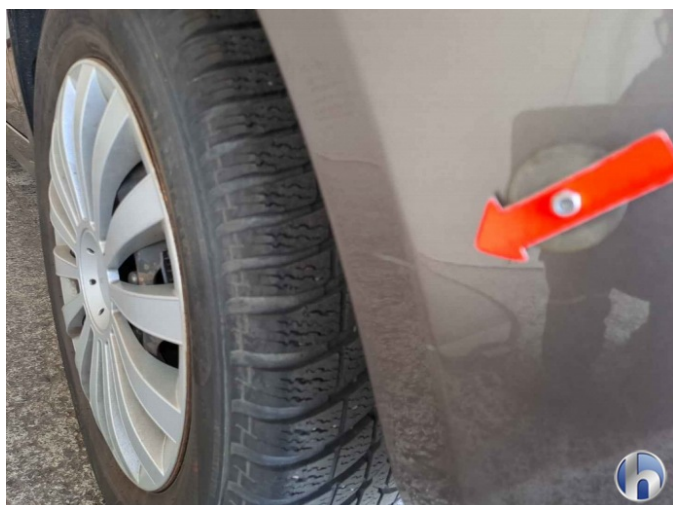
| component | Damage | Rep kind |
|---|---|---|
| 5. Rear bumper | Scratch(es) | Paint |

5. Rear bumper

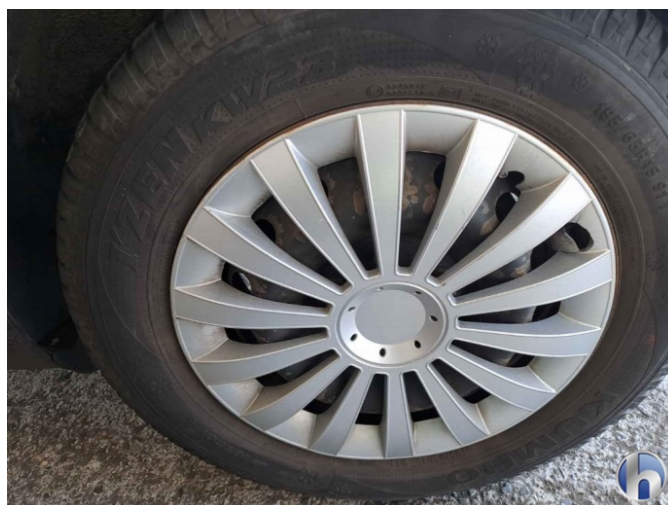
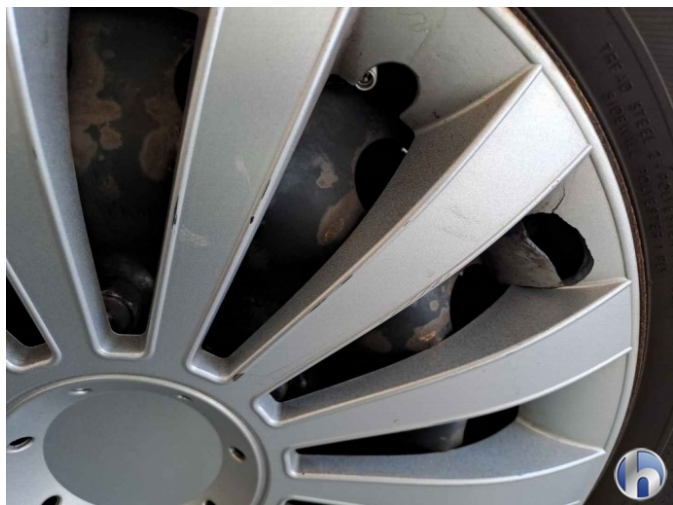
| component | Damage | Rep kind |
|---|---|---|
| 6. Radkappe - Hinten - Links | Breakage | Replace |

6. Radkappe - Hinten - Links

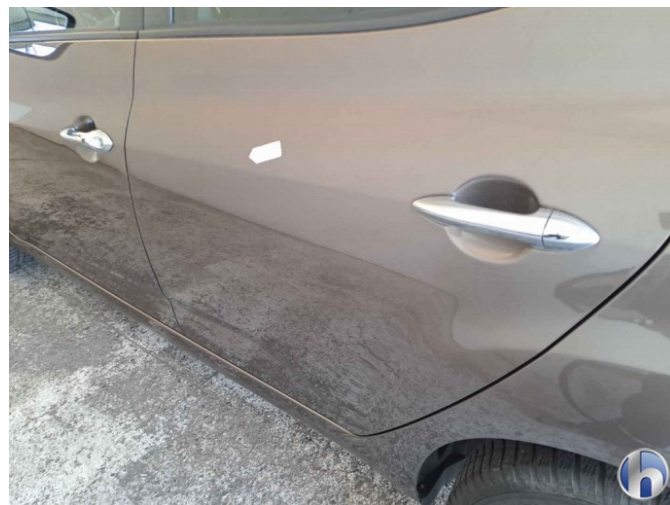
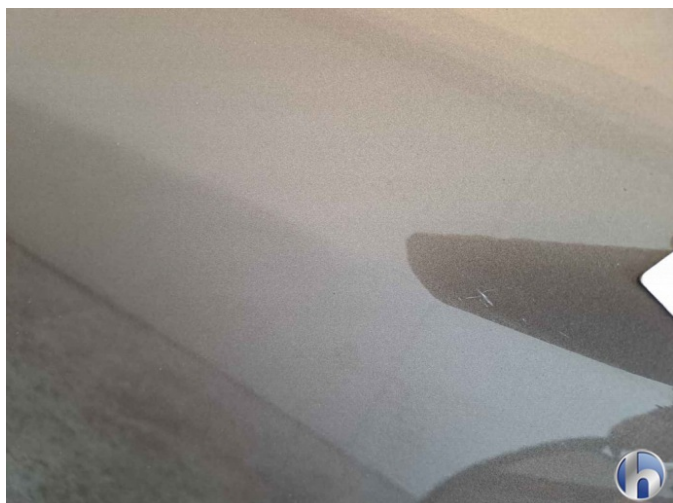
| component | Damage | Rep kind |
|---|---|---|
| 7. Rear door - left | Scratch(es) | Paint |

7. Rear door - left

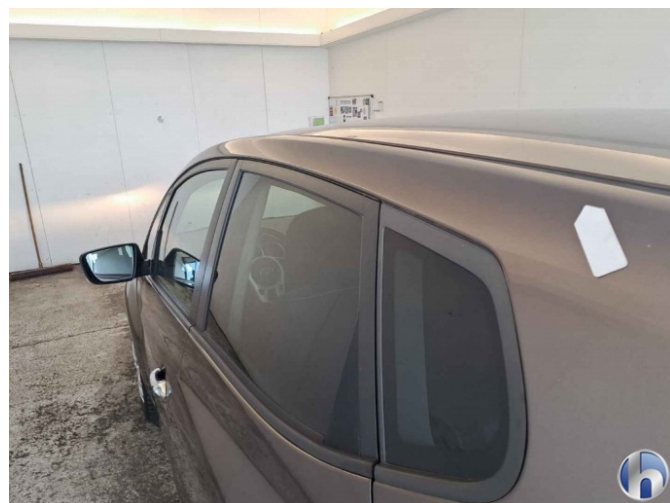
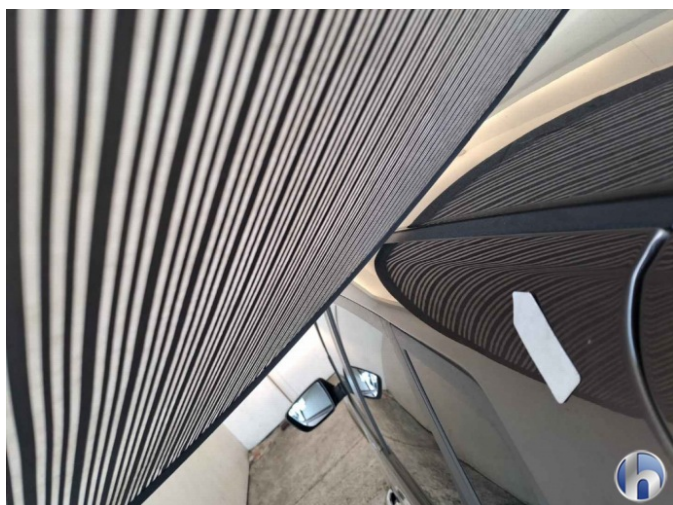
| component | Damage | Rep kind |
|---|---|---|
| 8. Roof frame - left | Deformed | Refurbish and paint |

8. Roof frame - left

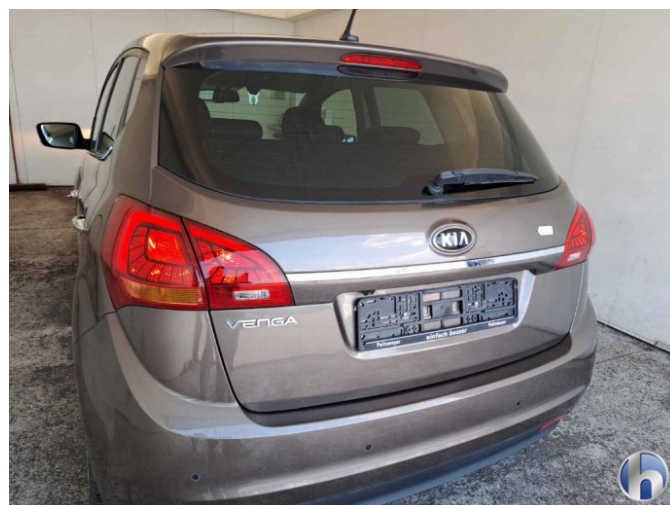
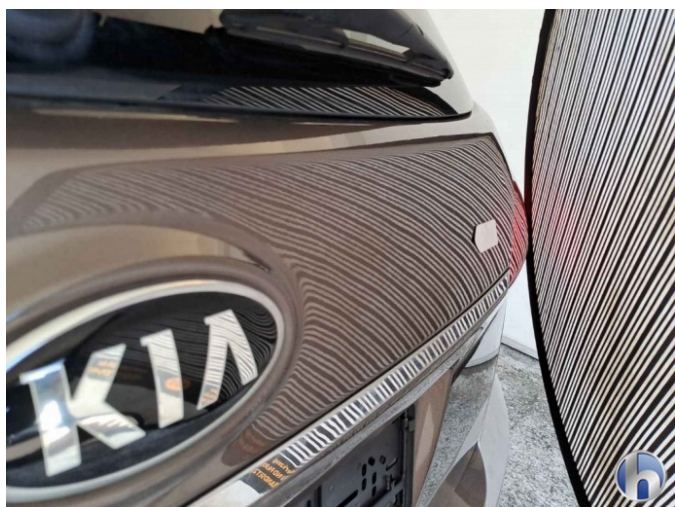
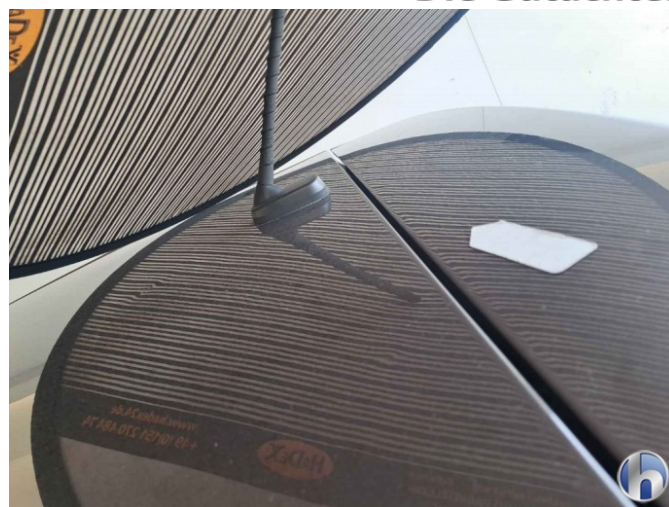
| component | Damage | Rep kind |
|---|---|---|
| 9. tailgate | Deformed | Refurbish and paint |

9. tailgate

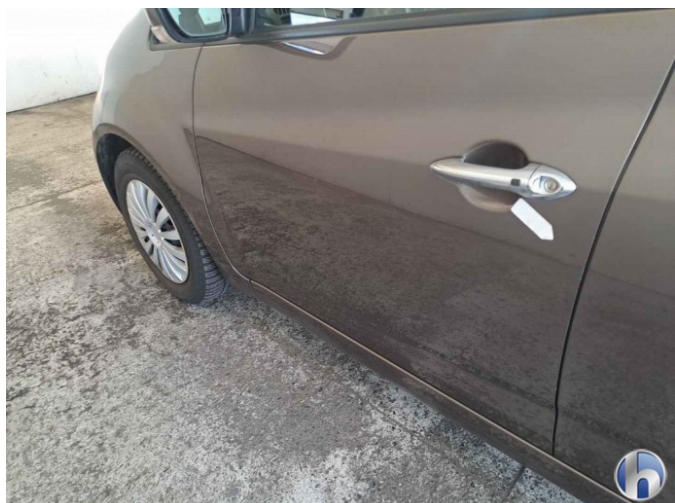
| component | Damage | Rep kind |
|---|---|---|
| 10. Front door - left | Damaged | Refurbish and paint |

10. Front door - left

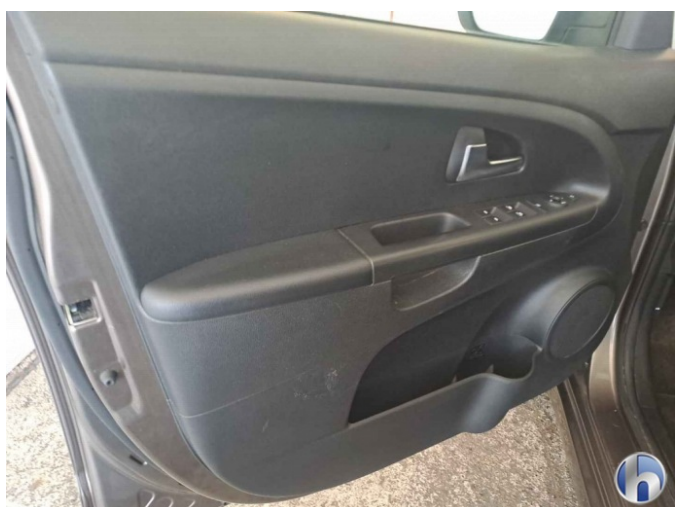
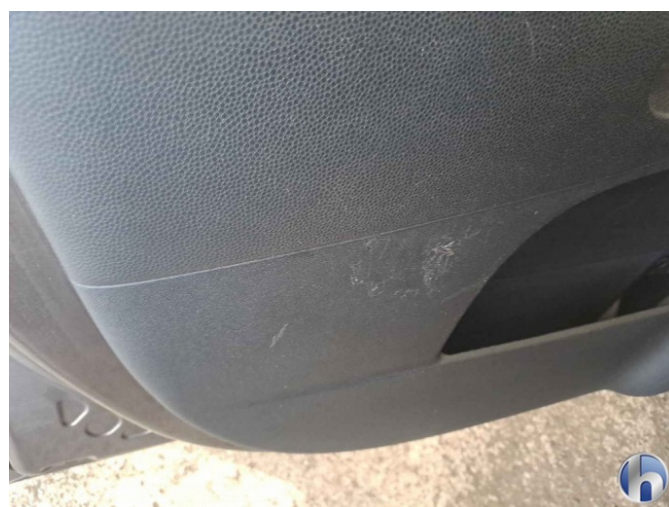
| component | Damage | Rep kind |
|---|---|---|
| 11. Front door trim - left | Scratch(es) | Replace |

11. Front door trim - left

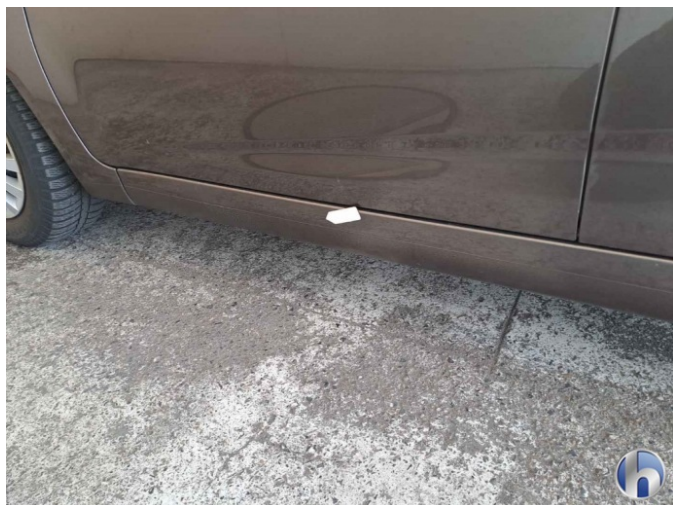
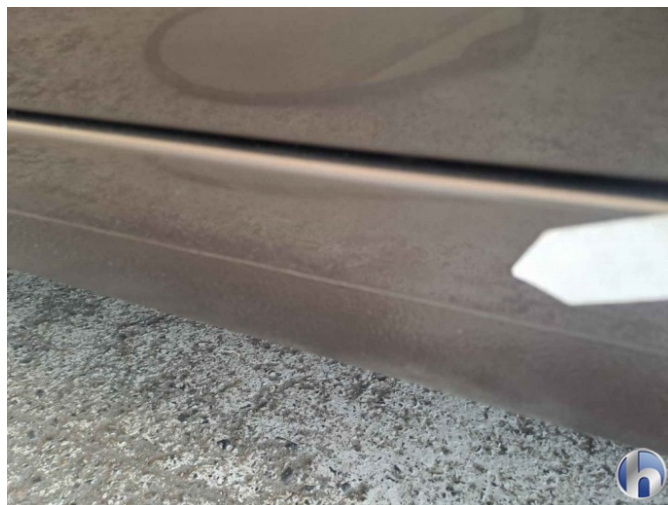
| component | Damage | Rep kind |
|---|---|---|
| 12. side skirt - left | Scratch(es) | Paint |

12. side skirt - left

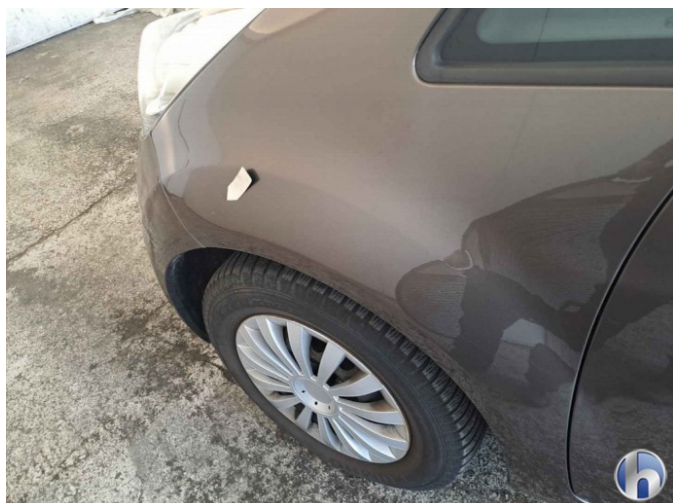
| component | Damage | Rep kind |
|---|---|---|
| 13. Front fender - left | Scratch(es) | Paint |

13. Front fender - left

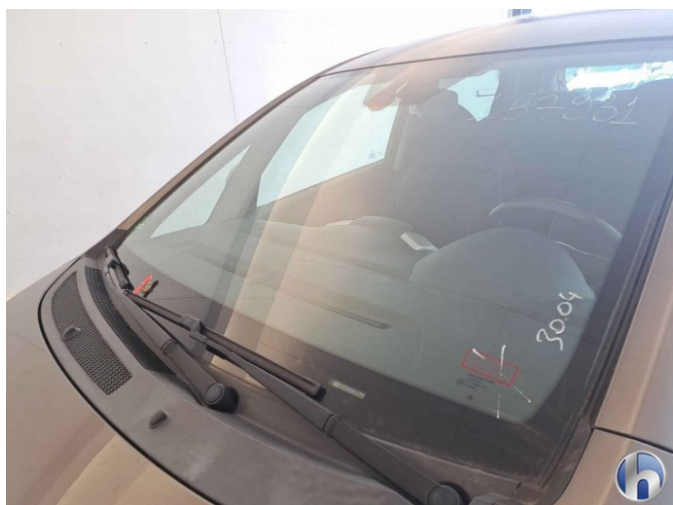
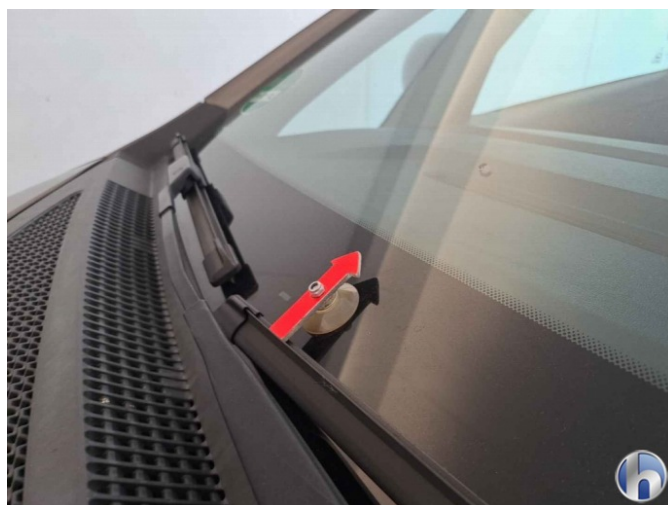
| component | Damage | Rep kind |
|---|---|---|
| 14. Windshield | Chipping from stones in field of view | Replace |

14. Windshield

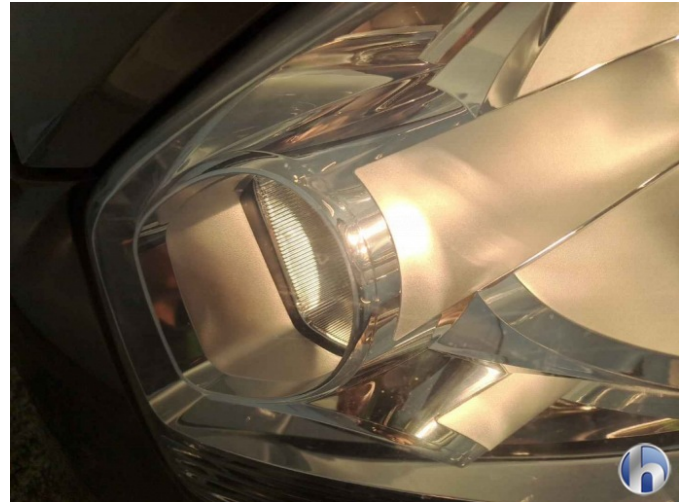
| component | Damage | Rep kind |
|---|---|---|
| 15. Halogen headlights - left | Wear and tear | acceptable |

15. Halogen headlights - left

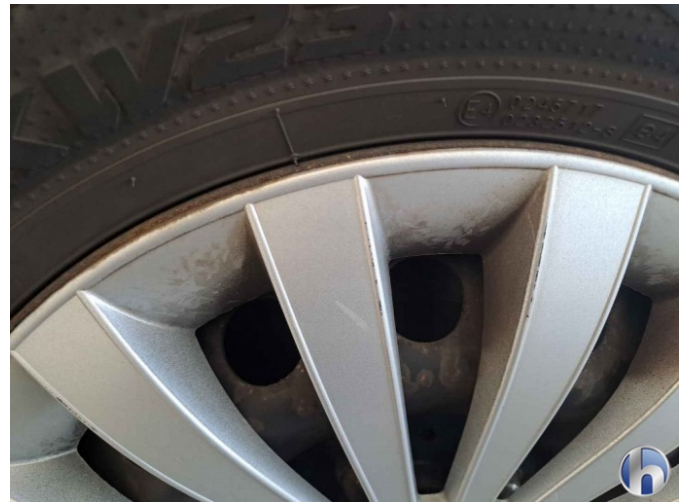
| component | Damage | Rep kind |
|---|---|---|
| 16. Radkappe - Vorne - Links | Scrape | Replace |

16. Radkappe - Vorne - Links

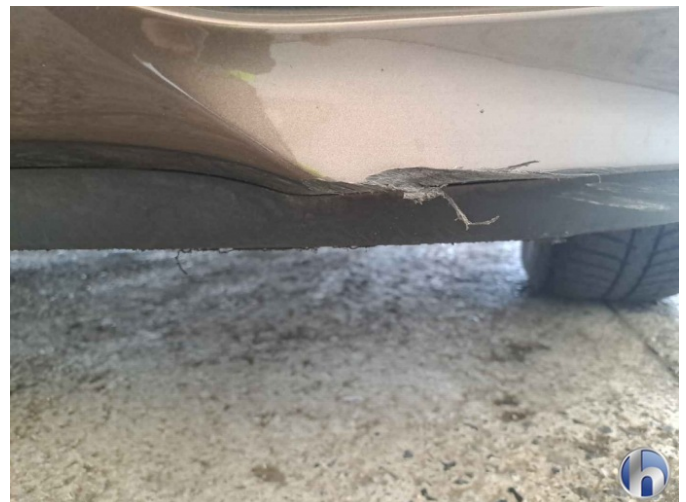
| component | Damage | Rep kind |
|---|---|---|
| 17. Front bumper | Damaged | Replace |

17. Front bumper

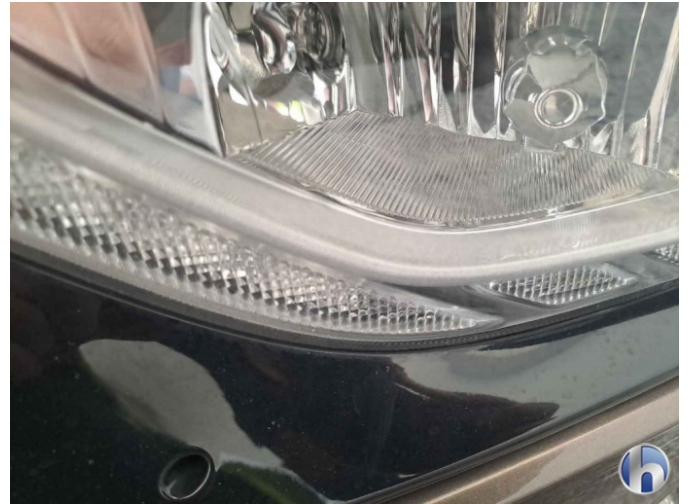
| component | Damage | Rep kind |
|---|---|---|
| 19. | Leaky | Replace |

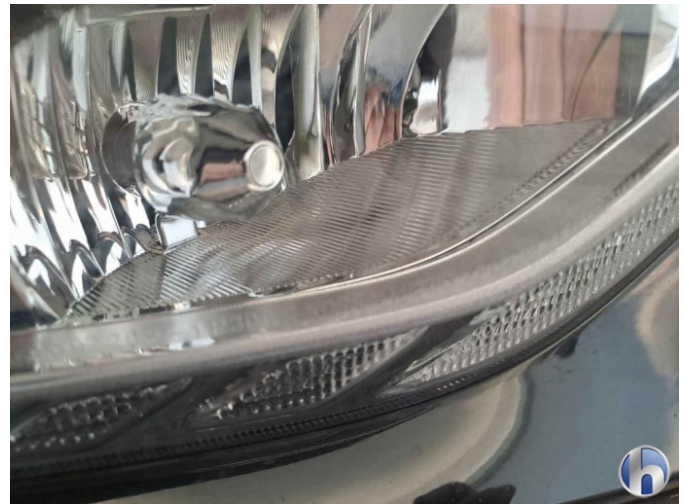
| component | Damage | Rep kind |
|---|---|---|
| 20. | Leaky | Replace |

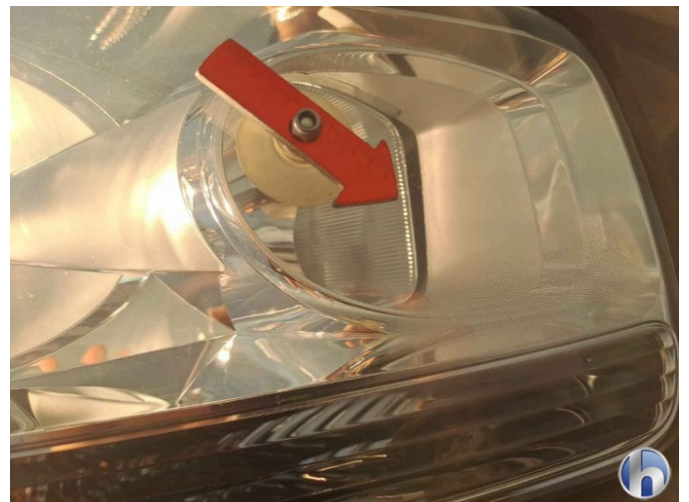
| component | Damage | Rep kind |
|---|---|---|
| 21. Halogen headlights - right | Leaky | Replace |

21. Halogen headlights - right

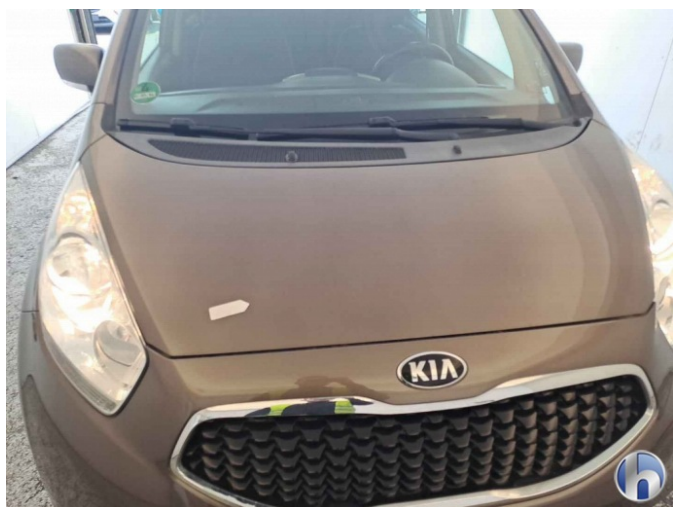
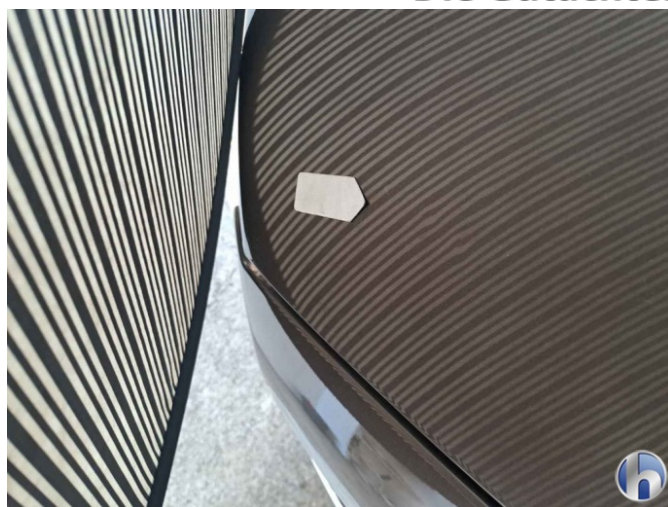
| component | Damage | Rep kind |
|---|---|---|
| 22. hood | | Smart repair |

22. hood

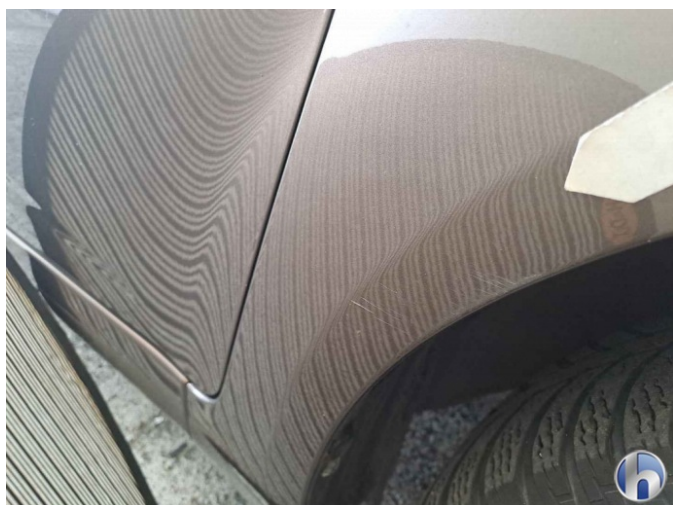
| component | Damage | Rep kind |
|---|---|---|
| 24. Front fender - right | Scratch(es) | Paint |

24. Front fender - right

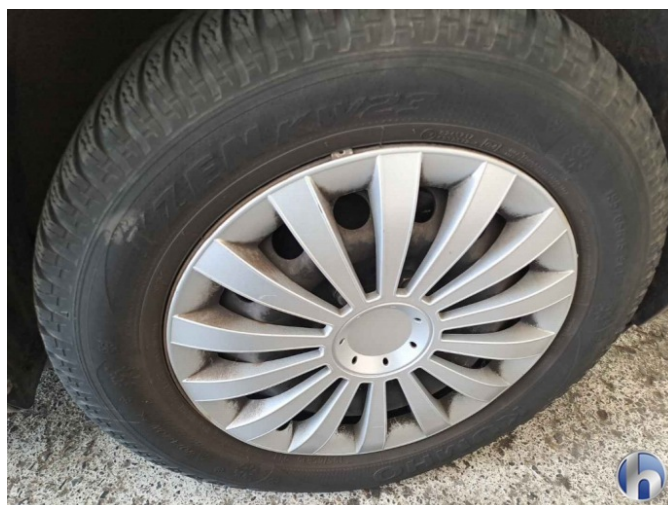
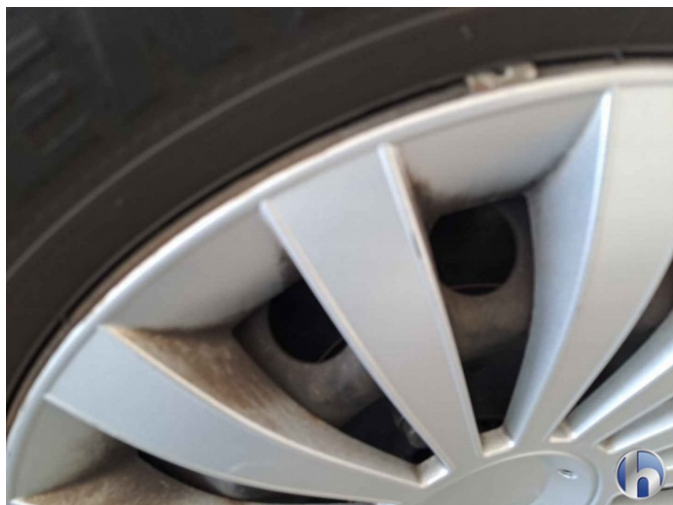
| component | Damage | Rep kind |
|---|---|---|
| 25. Radkappe - Vorne - Rechts | Scratch(es) | Replace |

25. Radkappe - Vorne - Rechts

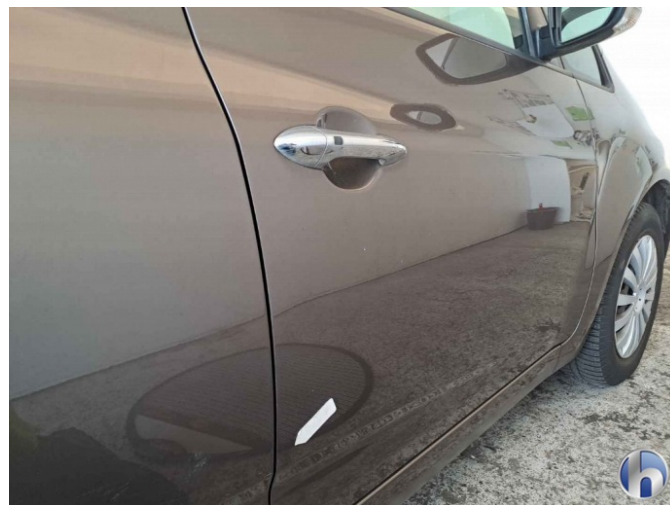
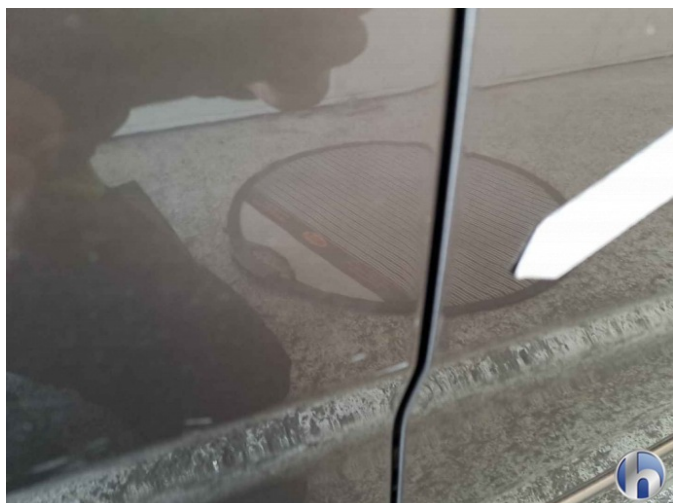
| component | Damage | Rep kind |
|---|---|---|
| 27. Front door - right | Scratch(es) | Paint |

27. Front door - right

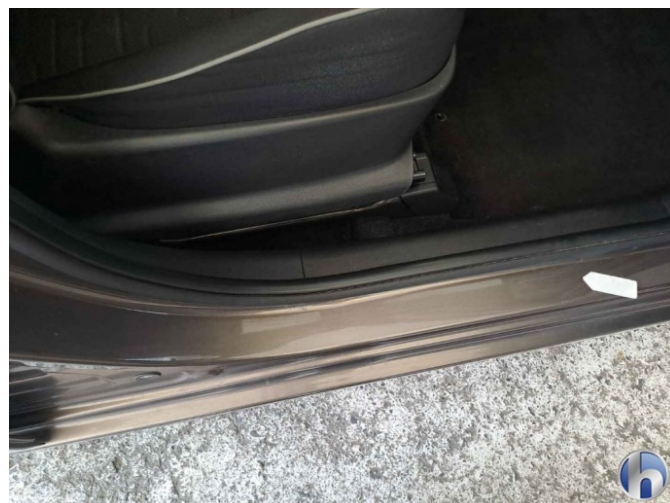
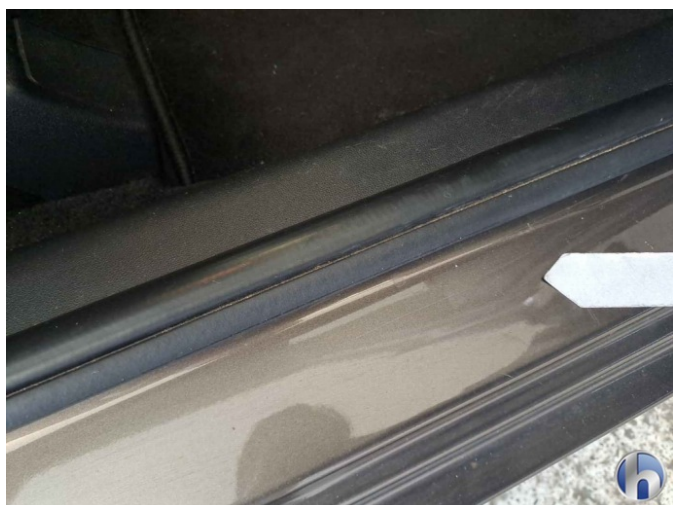
| component | Damage | Rep kind |
|---|---|---|
| 28. Türeinstieg Vorne - Rechts | Scratch(es) | Paint |

28. Türeinstieg Vorne - Rechts

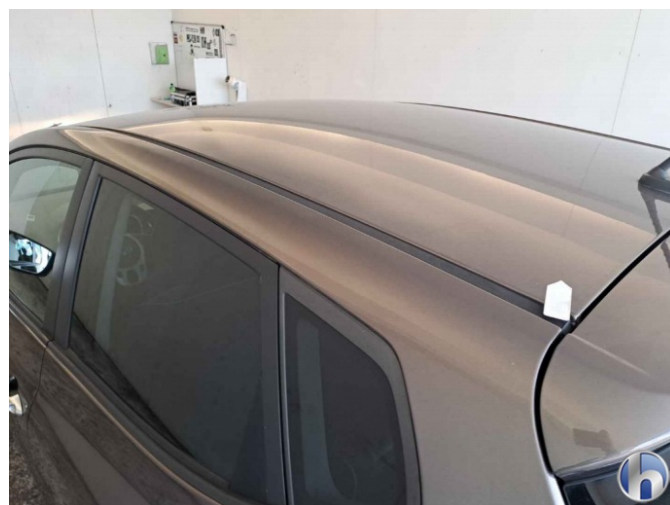
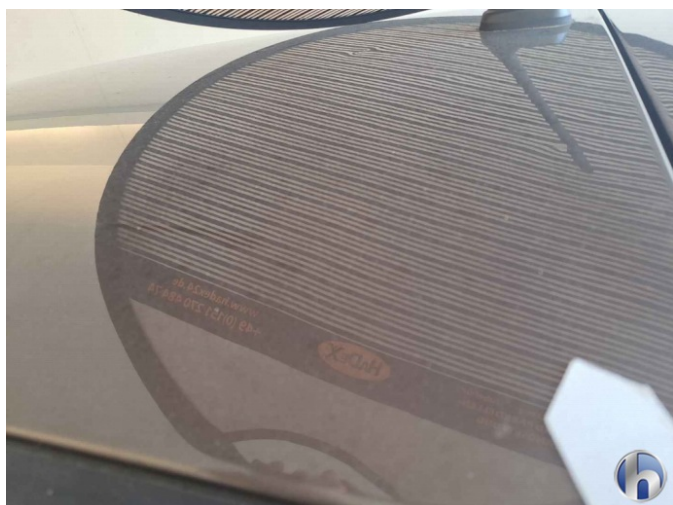
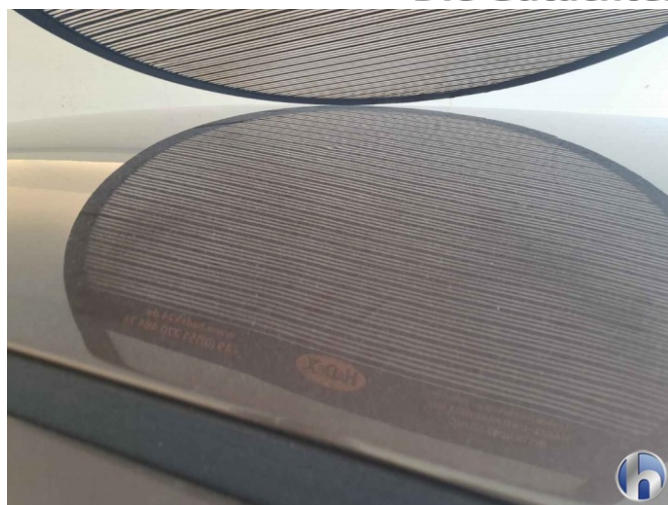
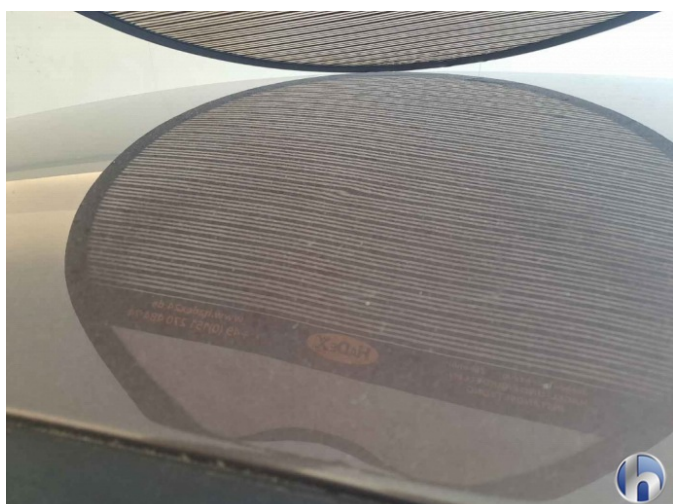
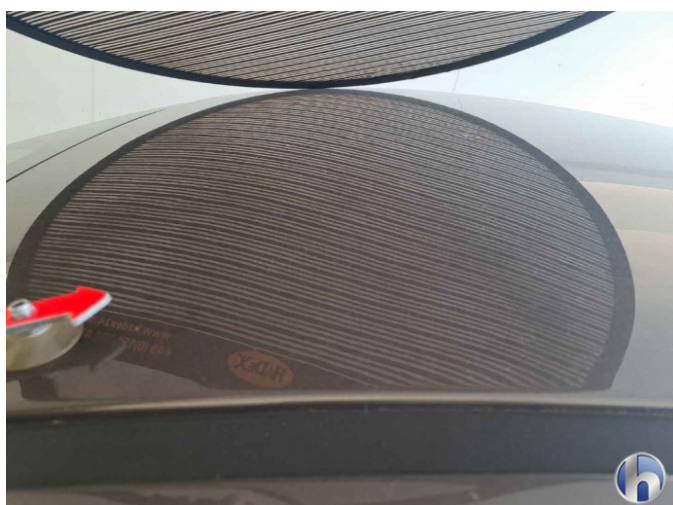
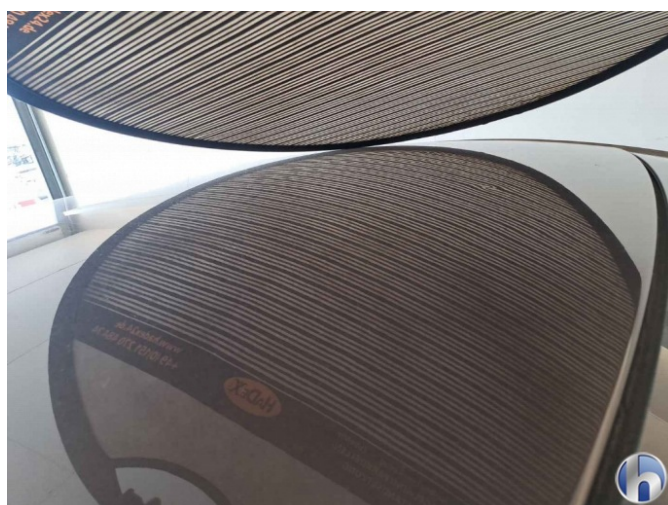
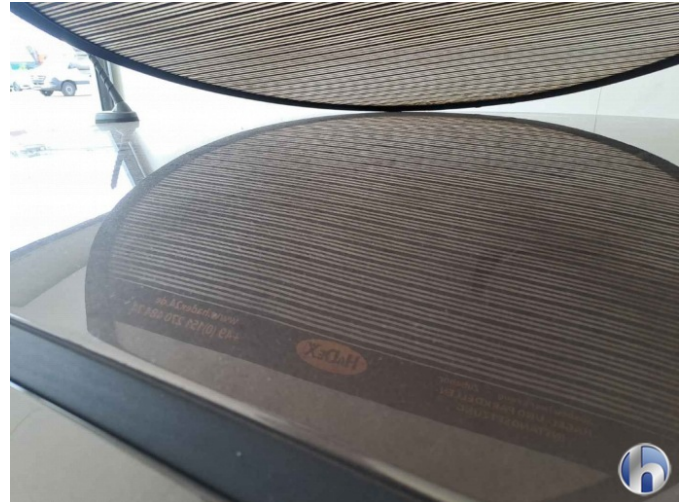
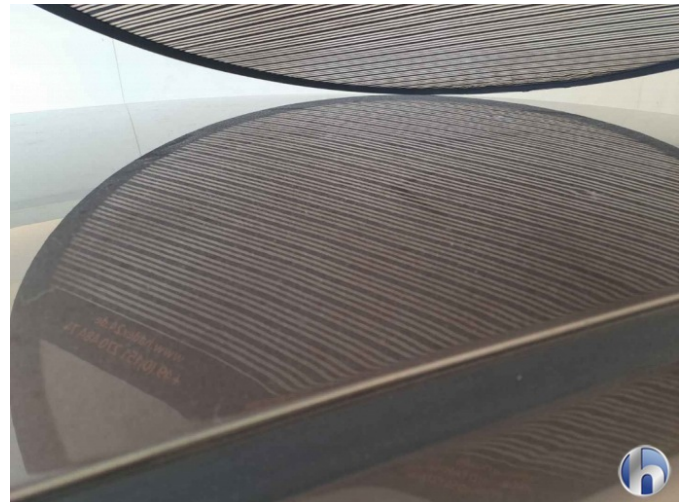
| component | Damage | Rep kind |
|---|---|---|
| 29. Dach mit 60 Dellen à 20-25mm | Hail damage | Refurbish and paint |

29. Dach mit 60 Dellen à 20-25mm

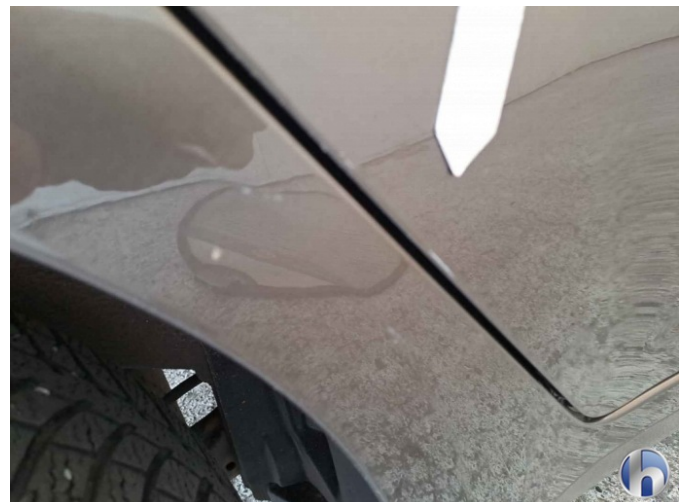
| component | Damage | Rep kind |
|---|---|---|
| 30. Door Rear - right | Scratch(es) | Paint |

30. Door Rear - right

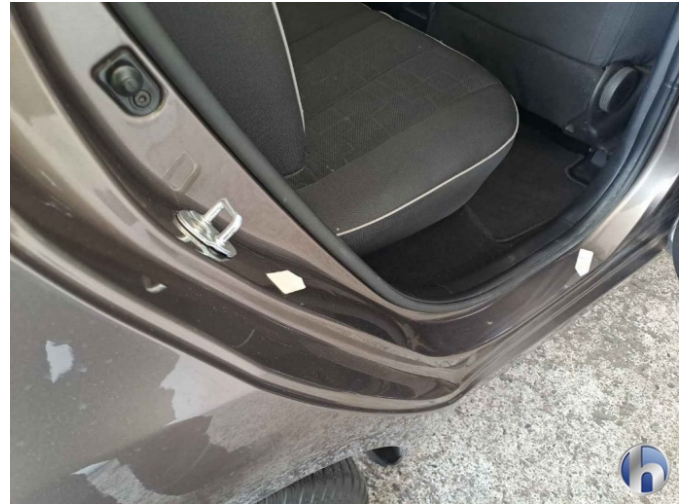
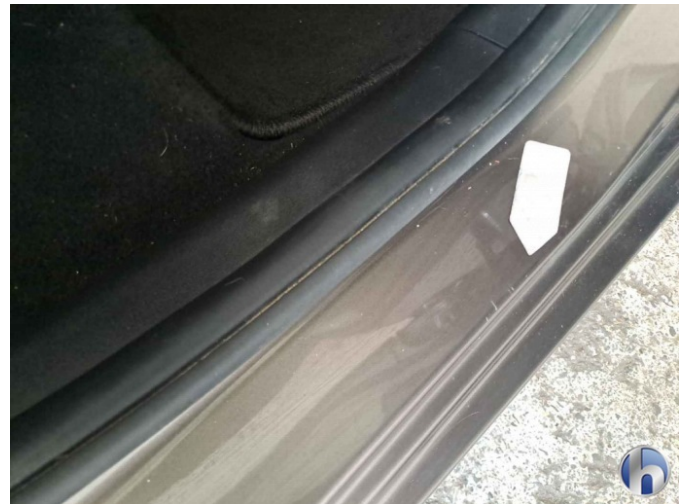
| component | Damage | Rep kind |
|---|---|---|
| 31. Türeinstieg Hinten - Rechts | Damaged | Refurbish and paint |

31. Türeinstieg Hinten - Rechts

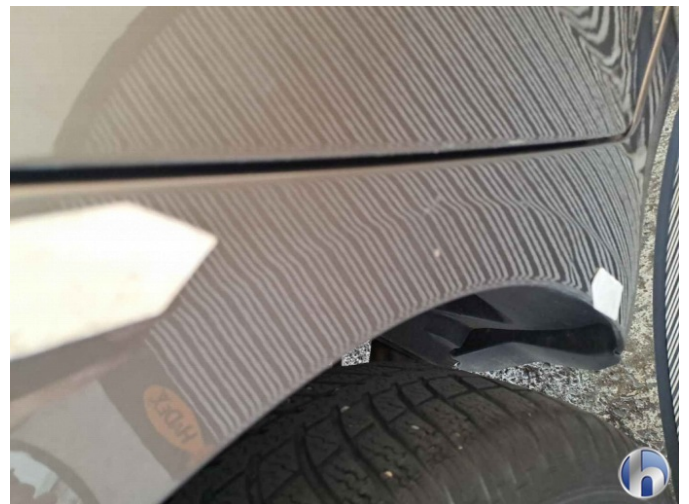
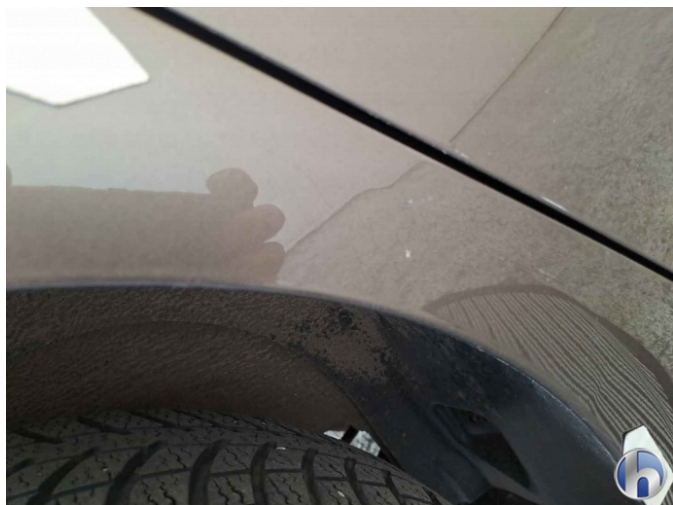
| component | Damage | Rep kind |
|---|---|---|
| 32. Sidewall - Rear - right | Damaged | Refurbish and paint |

32. Sidewall - Rear - right

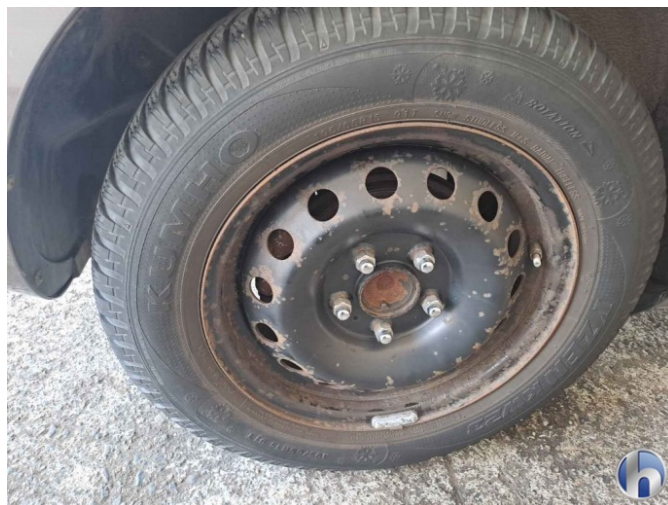
| component | Damage | Rep kind |
|---|---|---|
| 33. Radkappe - Hinten - Rechts | Missing | Replace |

33. Radkappe - Hinten - Rechts

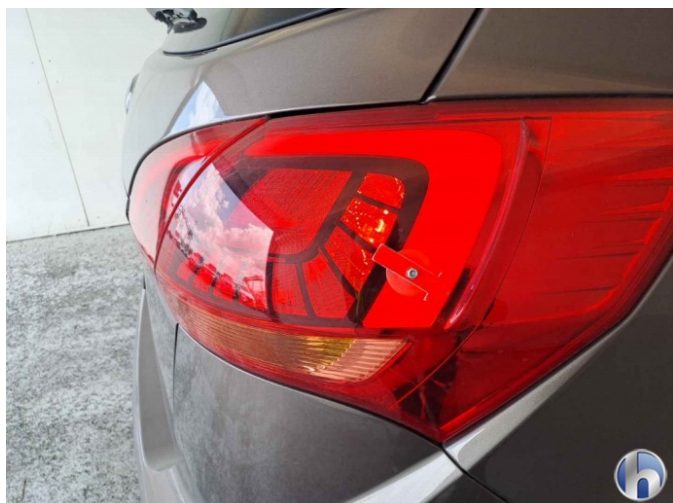
| component | Damage | Rep kind |
|---|---|---|
| 34. Taillight right | Leaky | Replace |

34. Taillight right

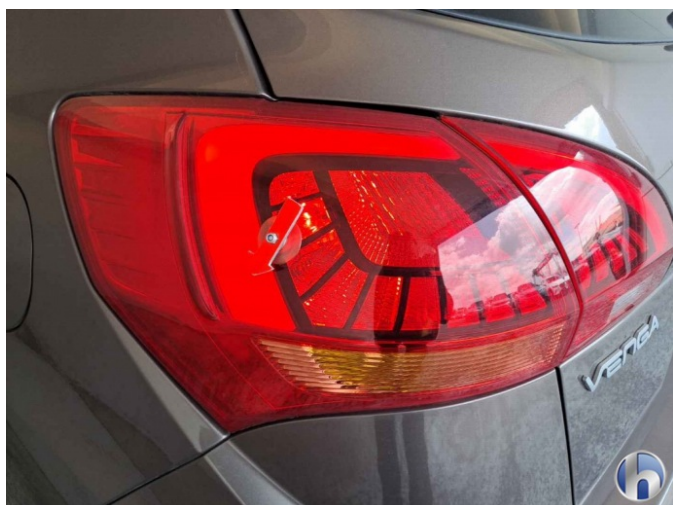
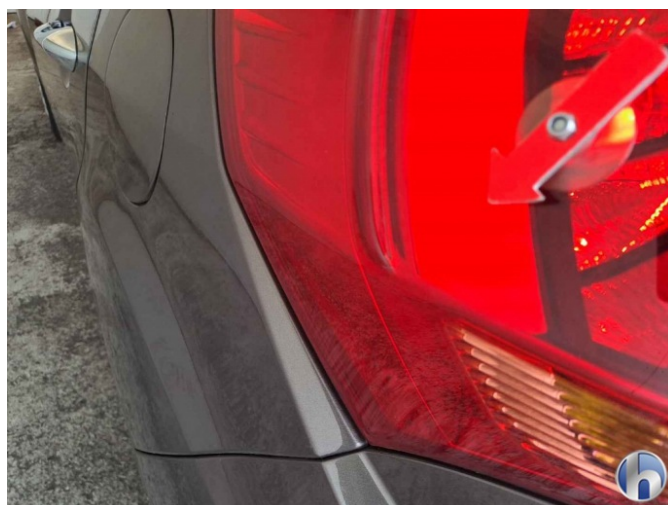
| component | Damage | Rep kind |
|---|---|---|
| 35. Taillight left | Leaky | Replace |

35. Taillight left
