## status report

**customer:** Bank 11, Neuss  
**contract number:** 1161993730  
**reference:**

#### Kia Sportage Spirit 2WD

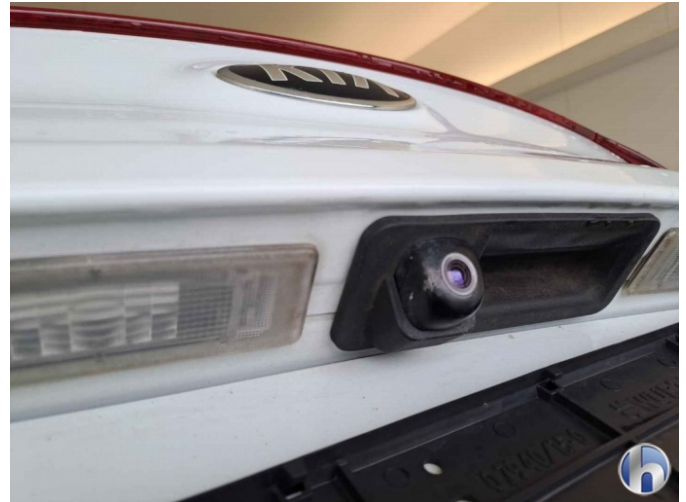
| component | Damage | Rep kind |
|---|---|---|
| 5. Rückfahrkamera | Corroded | Replace |

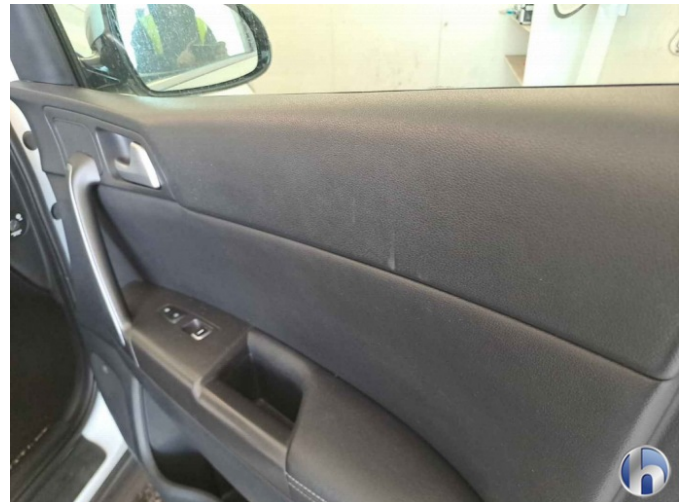
| component | Damage | Rep kind |
|---|---|---|
| 6. Door trim Front - right | Damaged | Replace |

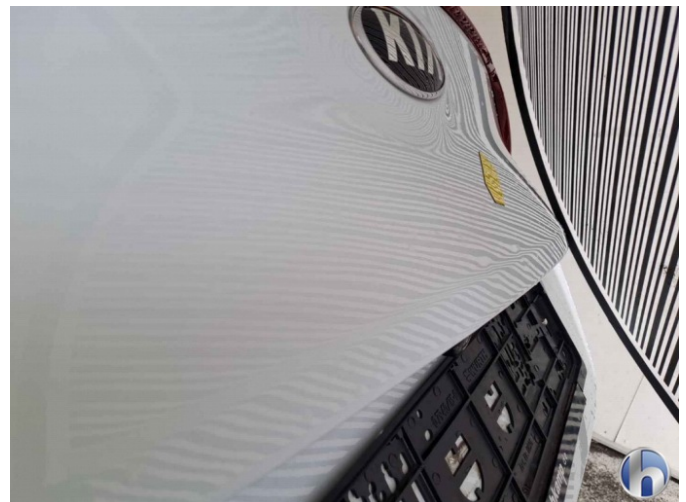
| component | Damage | Rep kind |
|---|---|---|
| 7. tailgate | Deformed | Refurbish and paint |

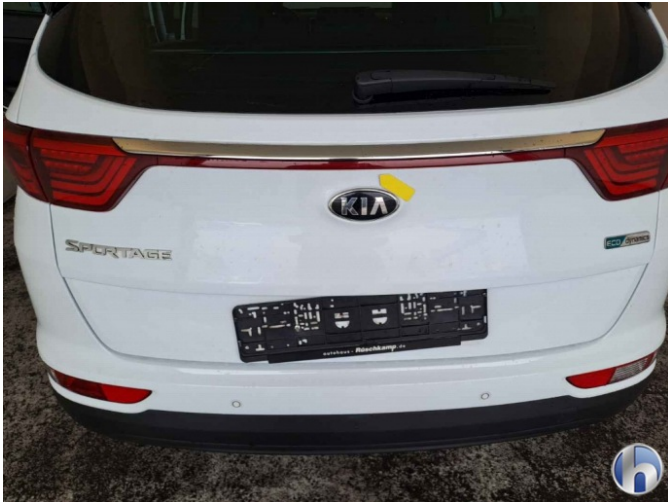
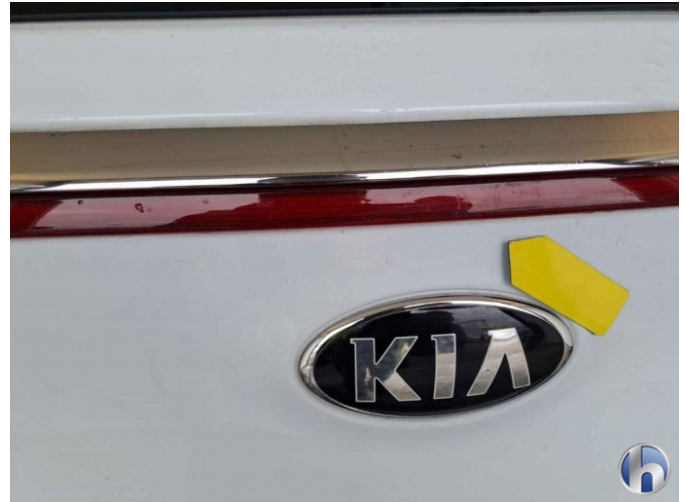
| component | Damage | Rep kind |
|---|---|---|
| 8. Rückleuchte Mitte | Scrape | Replace |

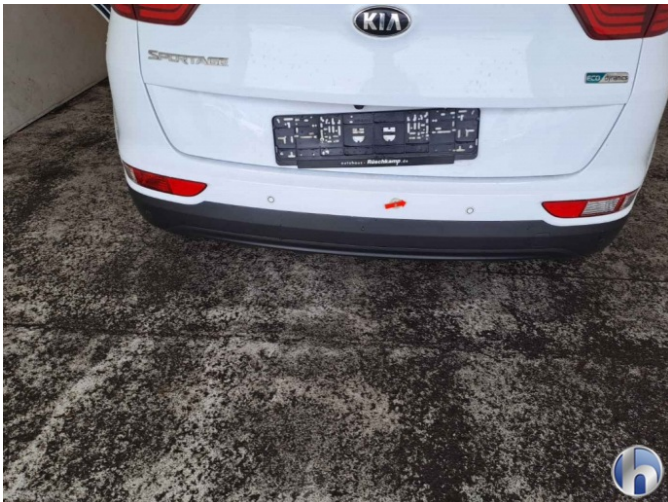
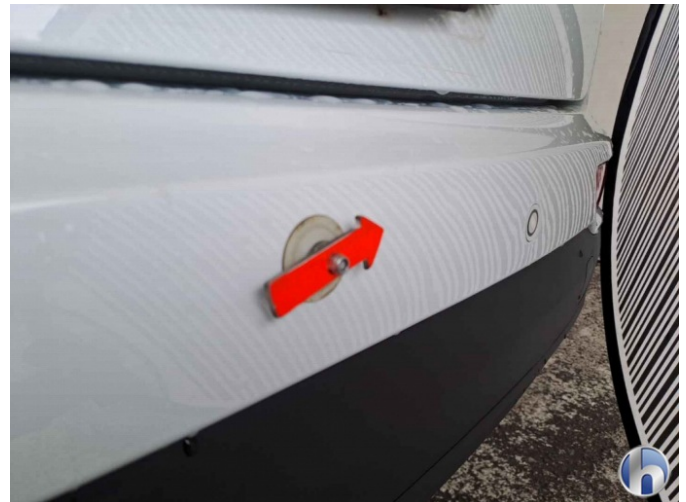
| component | Damage | Rep kind |
|---|---|---|
| 9. Rear bumper | Damaged | Refurbish and paint |

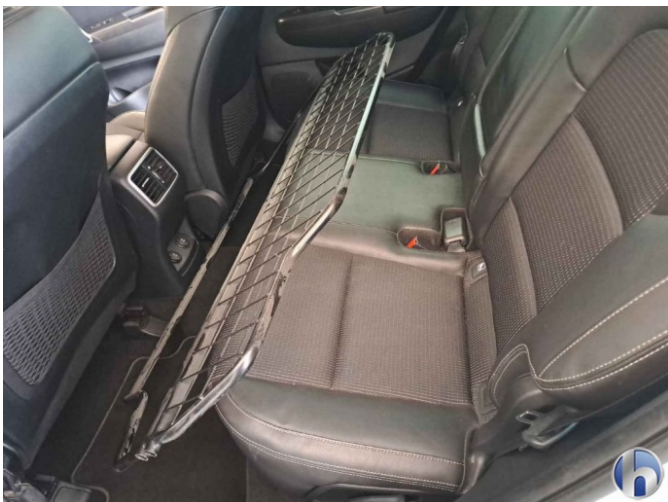
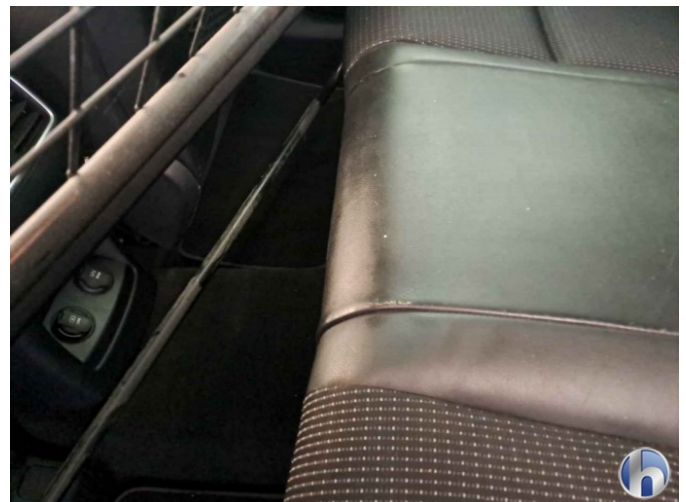
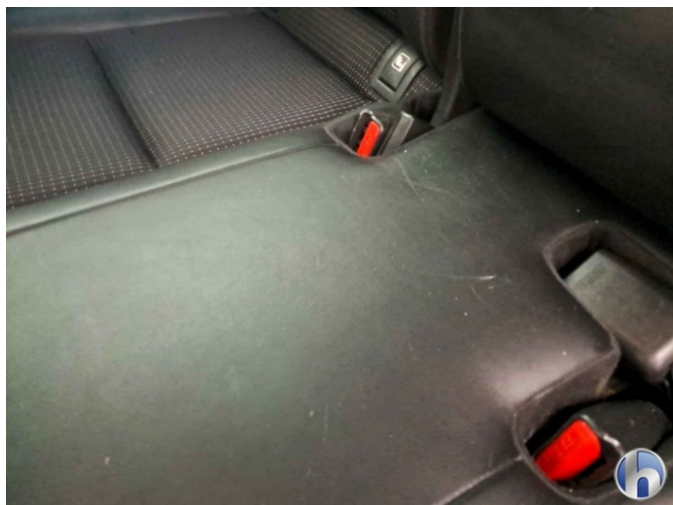
| component | Damage | Rep kind |
|---|---|---|
| 10. | Damaged | Replace |

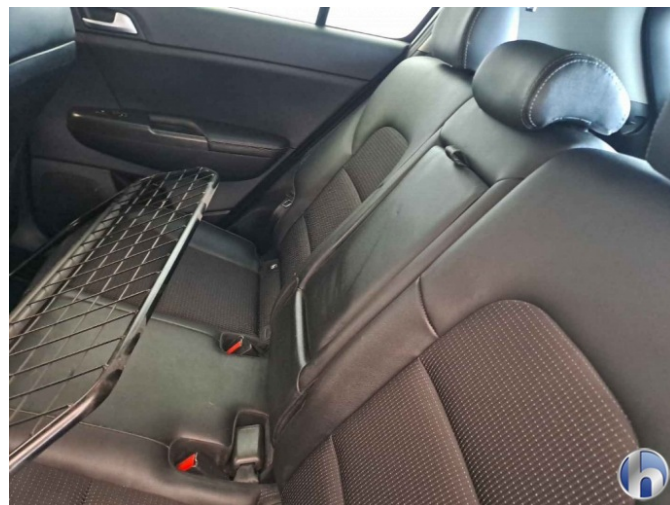
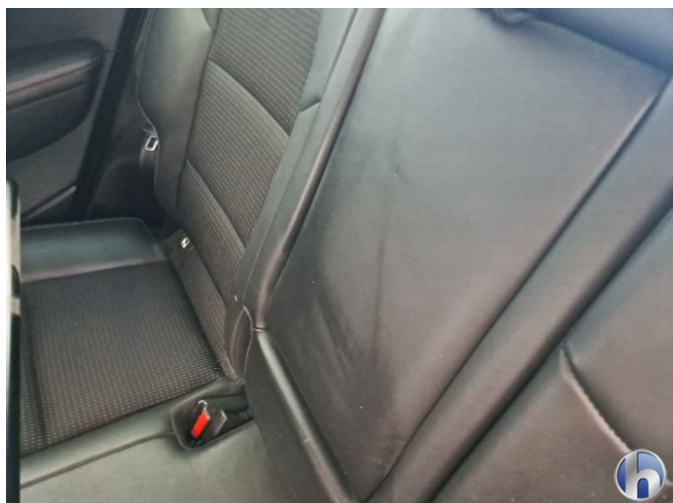
| component | Damage | Rep kind |
|---|---|---|
| 11. Sitz - Hinten - Mitte: Lehne (Leder) | Damaged | Replace |

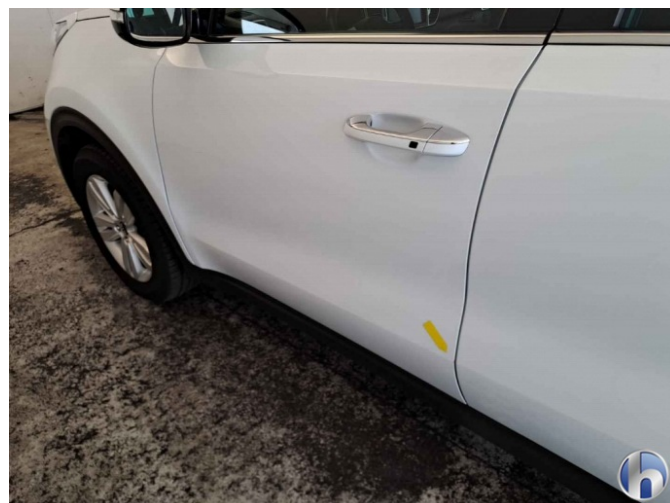
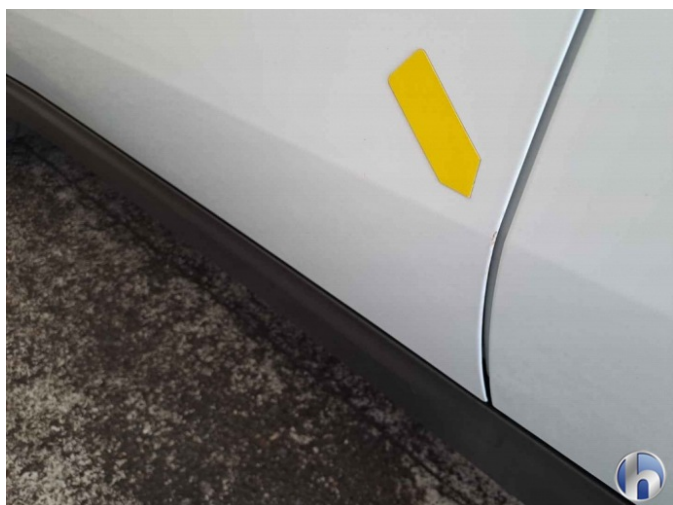
| component | Damage | Rep kind |
|---|---|---|
| 12. Front door - left | Scratch(es) | Paint |

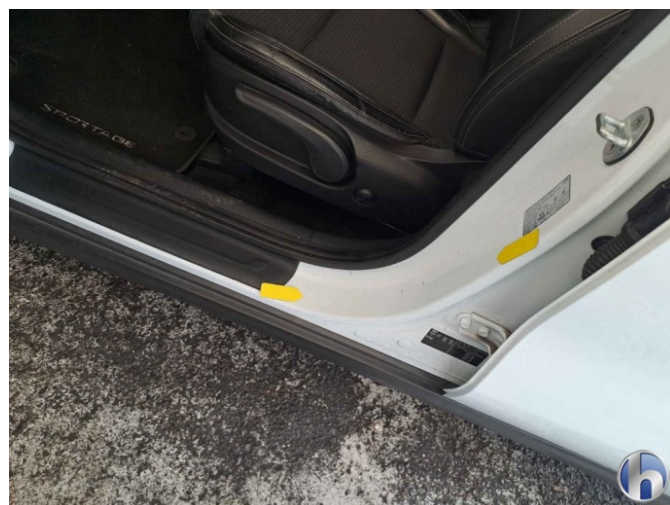
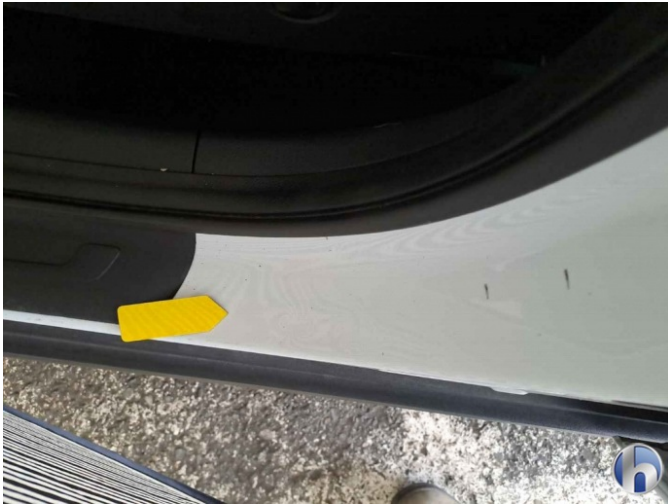
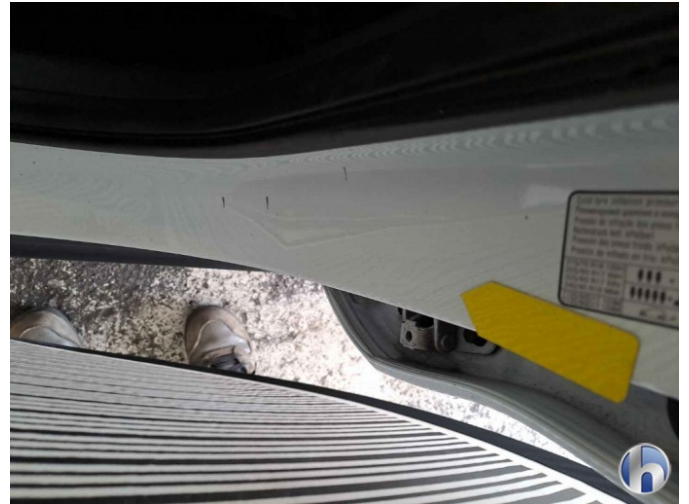
| component | Damage | Rep kind |
|---|---|---|
| 13. Türeinstieg Vorne - Links | Damaged | Refurbish and paint |

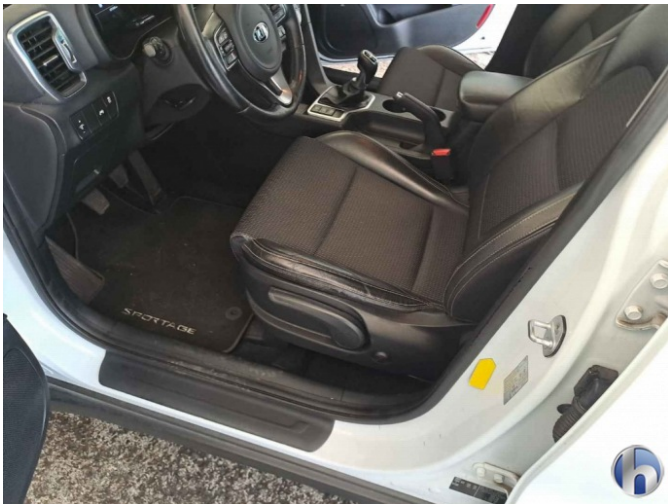
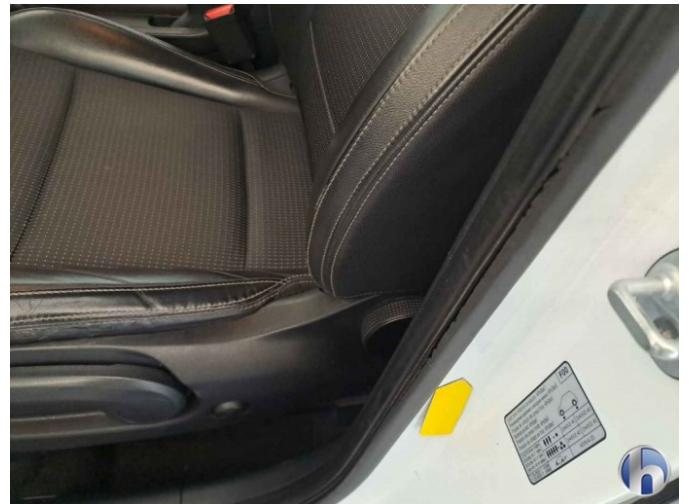
| component | Damage | Rep kind |
|---|---|---|
| 14. Front door seal - left | Damaged | Replace |

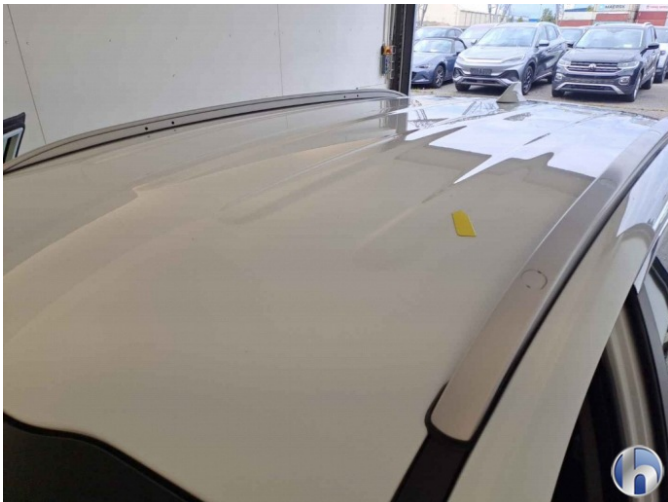
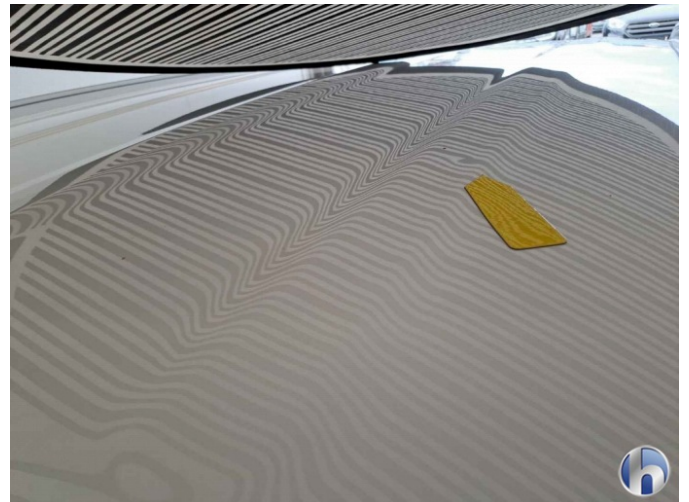
| component | Damage | Rep kind |
|---|---|---|
| 17. roof | Delle | Refurbish and paint |

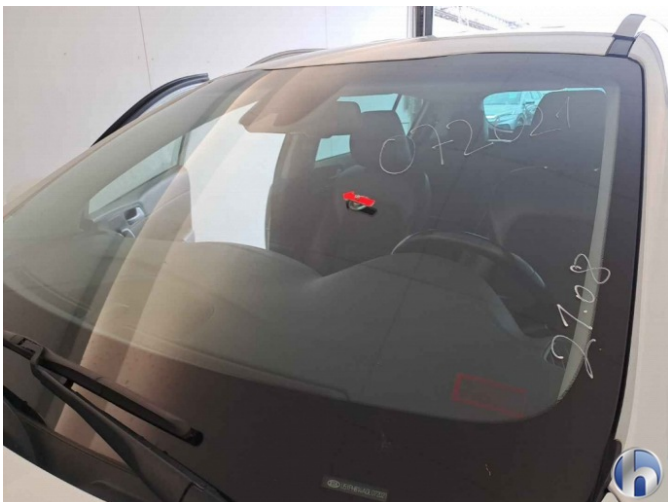
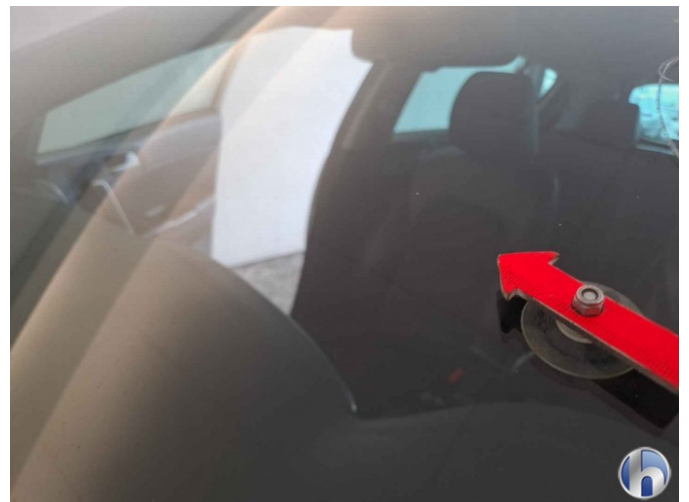
| component | Damage | Rep kind |
|---|---|---|
| 18. Windshield | Chipping from stones in field of view | Replace |

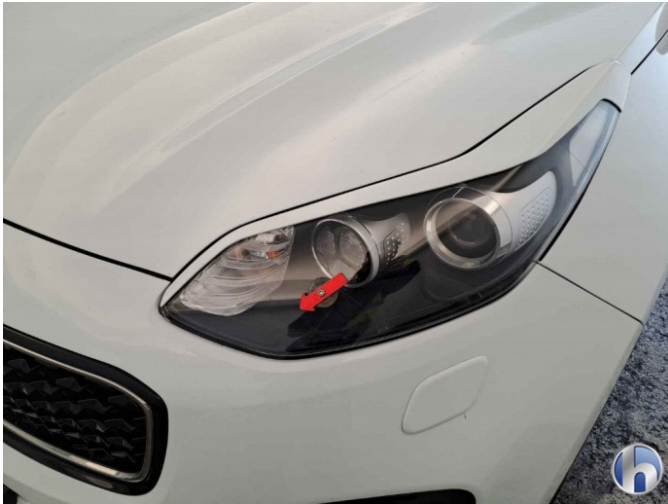
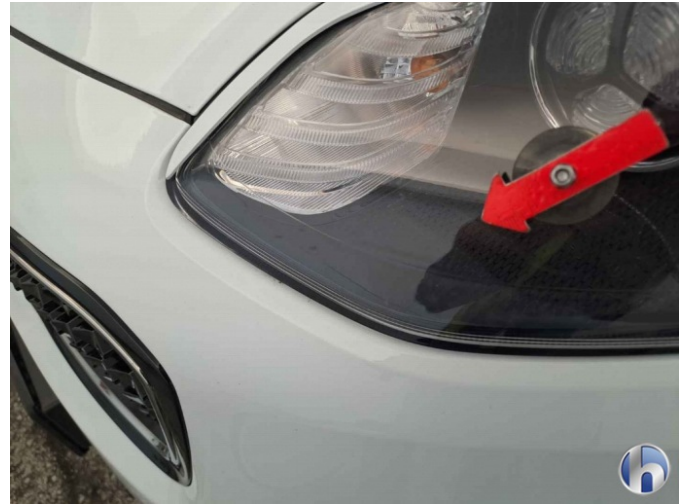
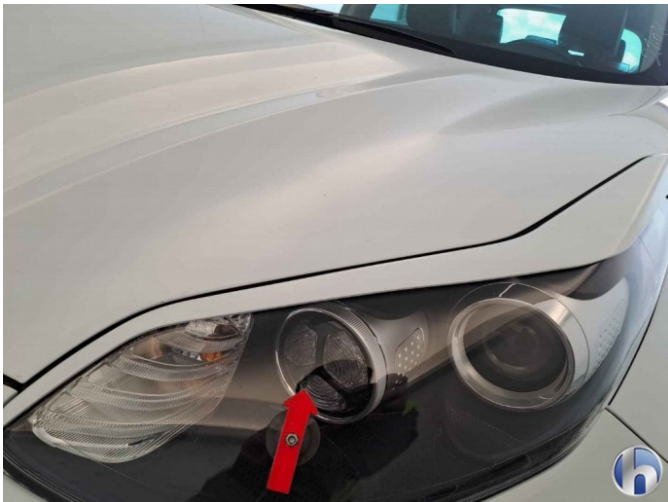
| component | Damage | Rep kind |
|---|---|---|
| 19. Bi xenon headlights - left | Damaged | Replace |

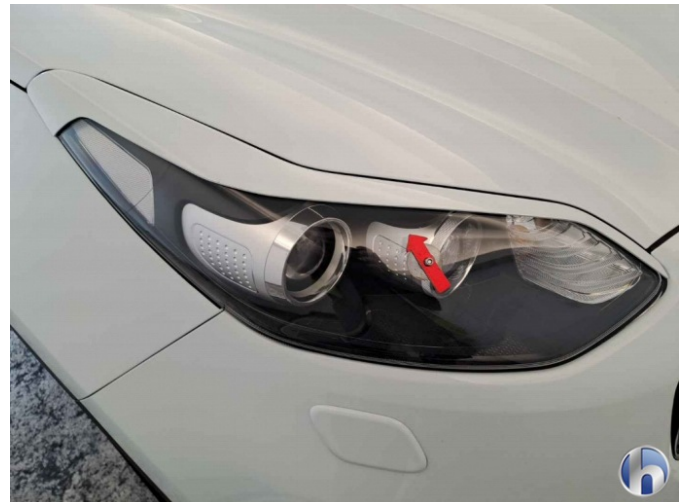
| component | Damage | Rep kind |
|---|---|---|
| 20. Bi xenon headlights - Right | Damaged | Replace |

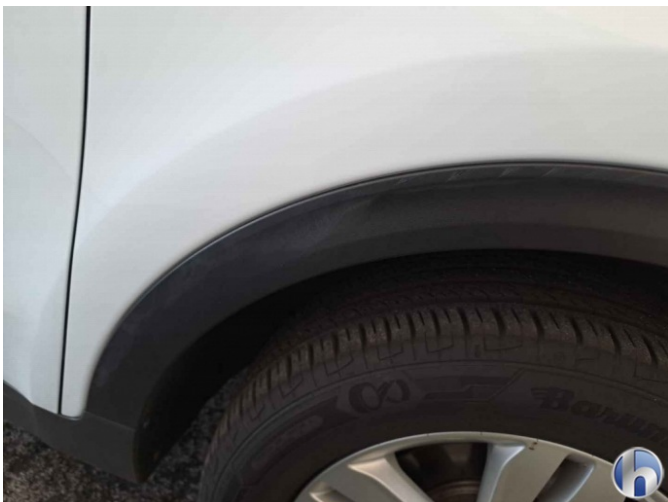
| component | Damage | Rep kind |
|---|---|---|
| 21. exterior body | Dirty | |

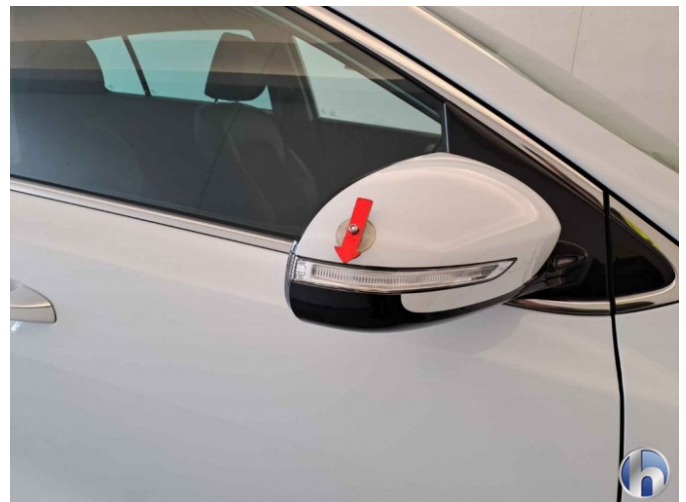
| component | Damage | Rep kind |
|---|---|---|
| 22. Outside mirror - left | Scrape | Paint |

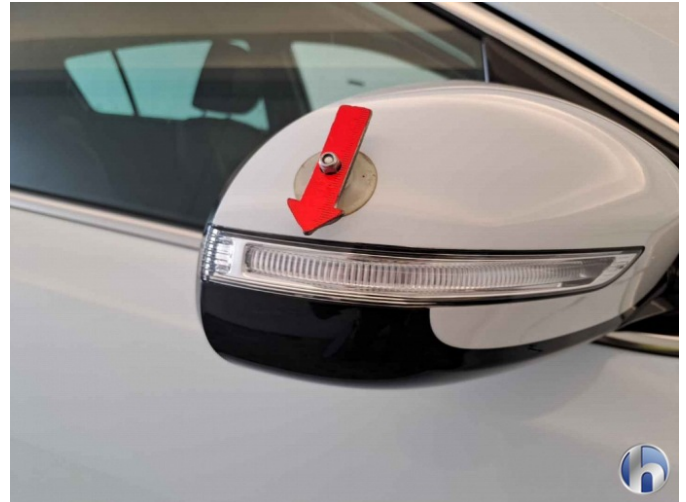
| component | Damage | Rep kind |
|---|---|---|
| 23. | Scrape | Replace |

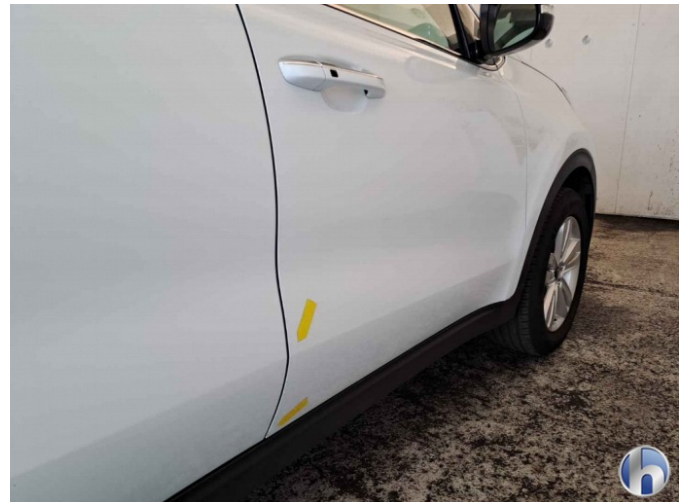
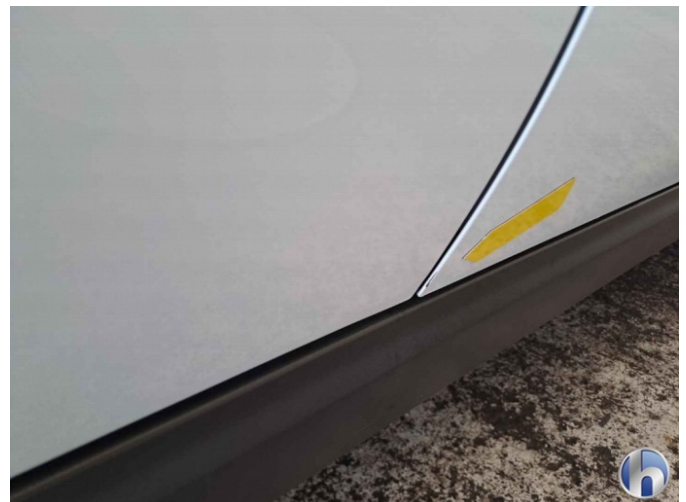
| component | Damage | Rep kind |
|---|---|---|
| 24. Front door - right | Scratch(es) | Paint |

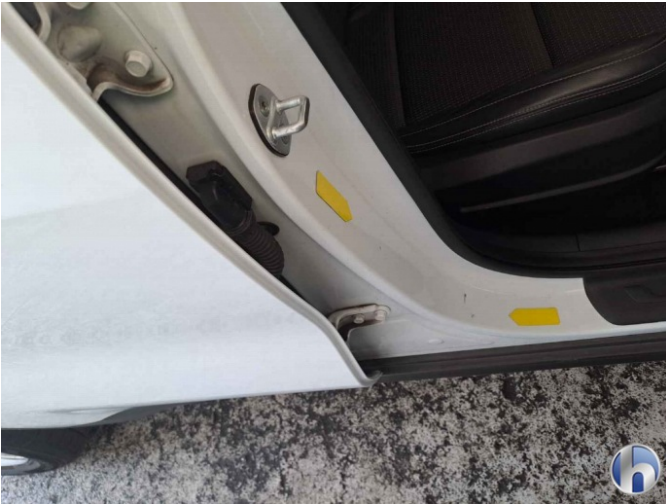
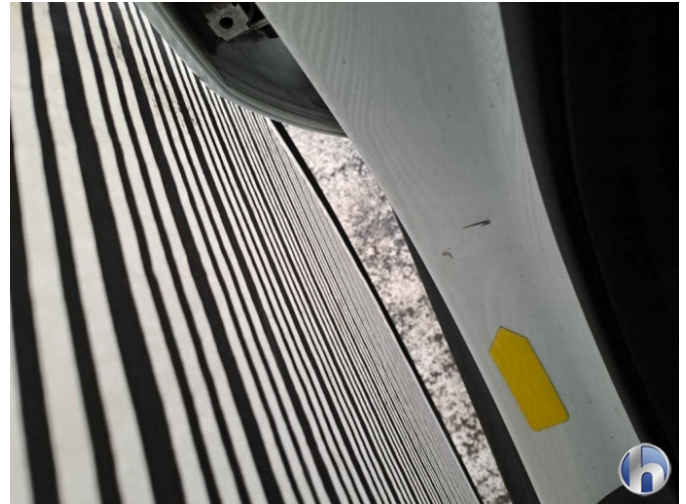
| component | Damage | Rep kind |
|---|---|---|
| 25. Türeinstieg Vorne - Rechts | Damaged | Refurbish and paint |

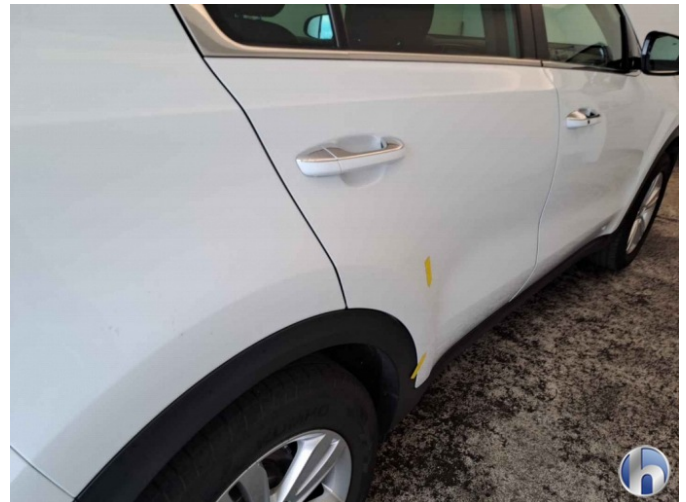
| component | Damage | Rep kind |
|---|---|---|
| 26. Door Rear - right | Deformed | Refurbish and paint |

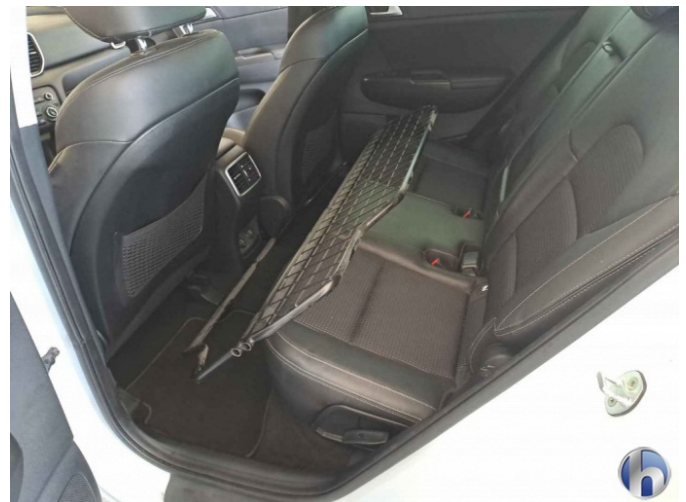
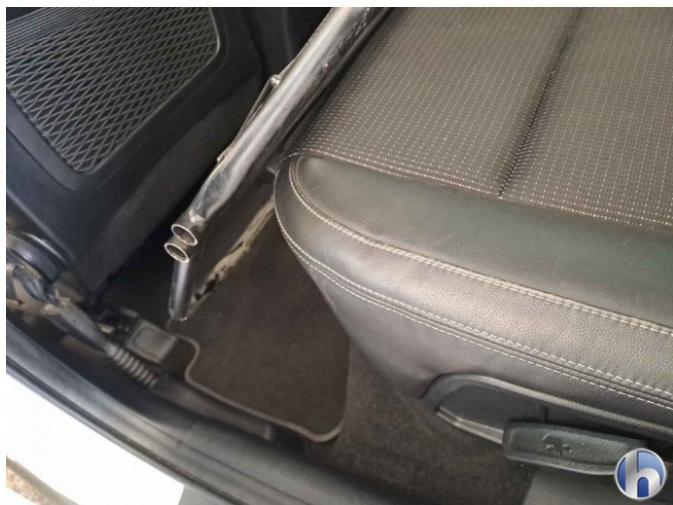
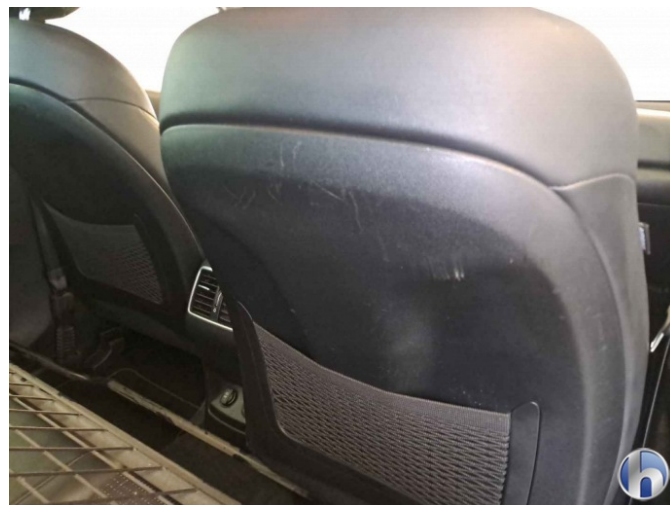
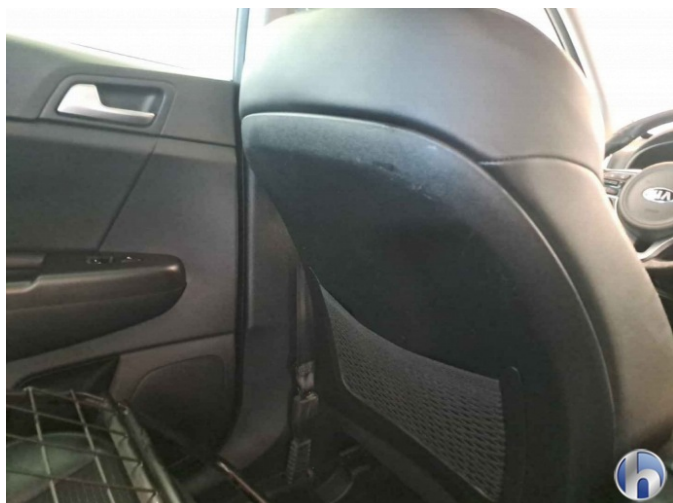
| component | Damage | Rep kind |
|---|---|---|
| 27. | Wear and tear | acceptable |

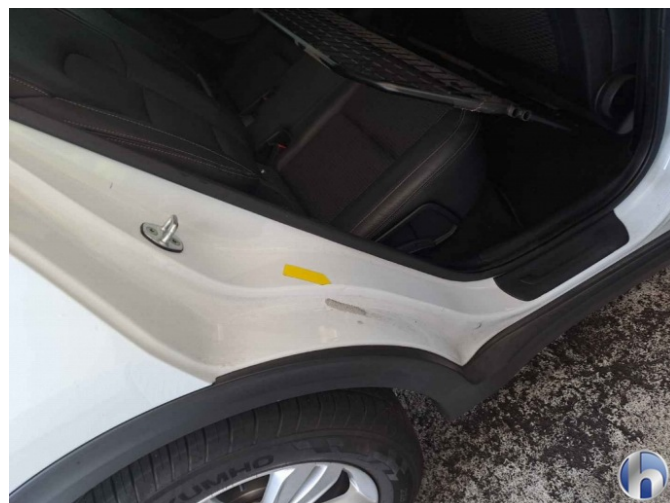
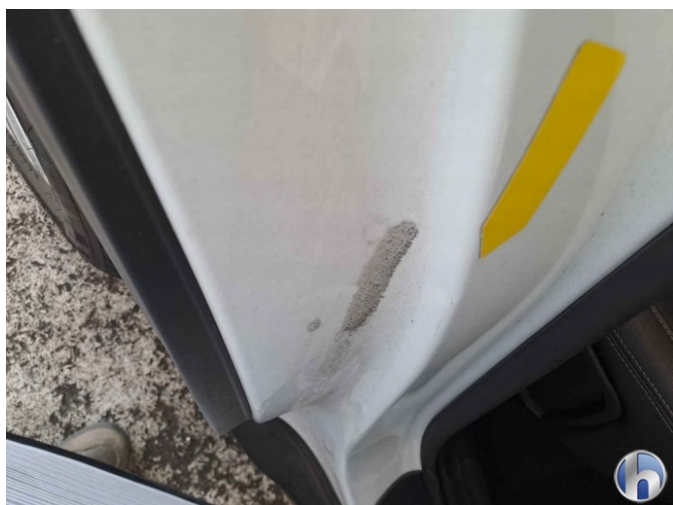
| component | Damage | Rep kind |
|---|---|---|
| 28. Türeinstieg Hinten - Rechts | Deformed | Refurbish and paint |

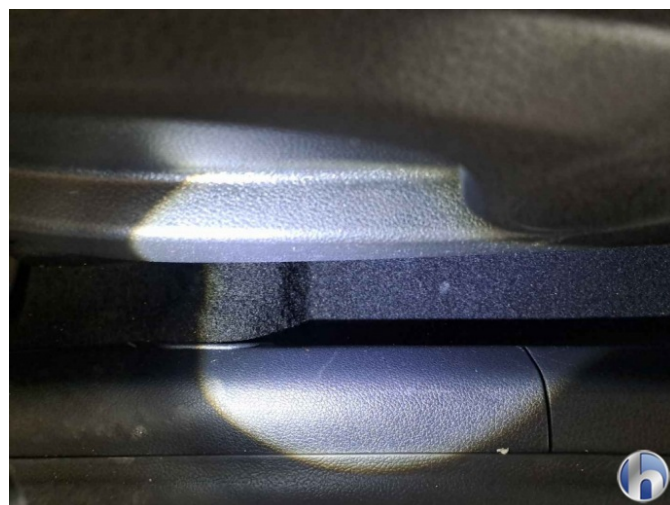
| component | Damage | Rep kind |
|---|---|---|
| 29. flooring | Burn hole | Replace |

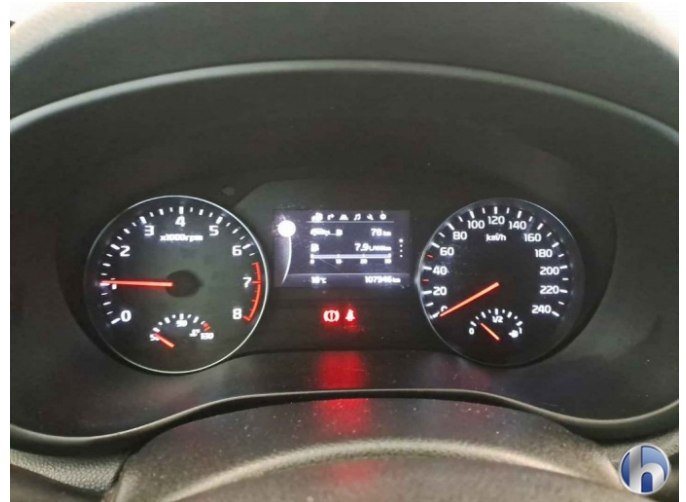
| component | Damage | Rep kind |
|---|---|---|
| 31. instrument cluster | Scratch(es) | Replace |

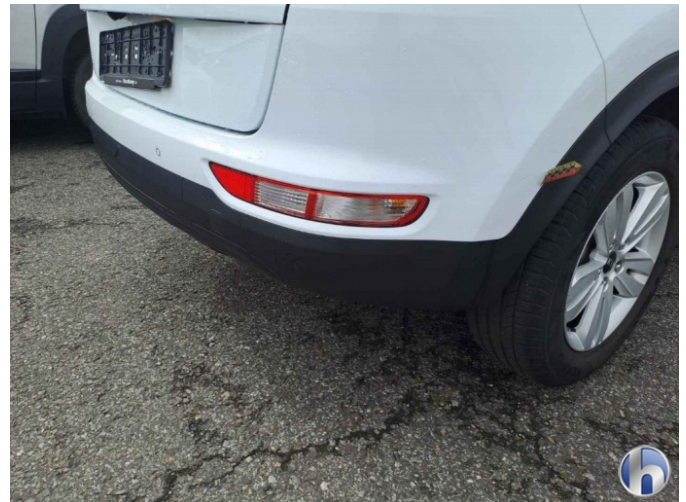
| component | Damage | Rep kind |
|---|---|---|
| 32. Diffusor | Scrape | Replace |

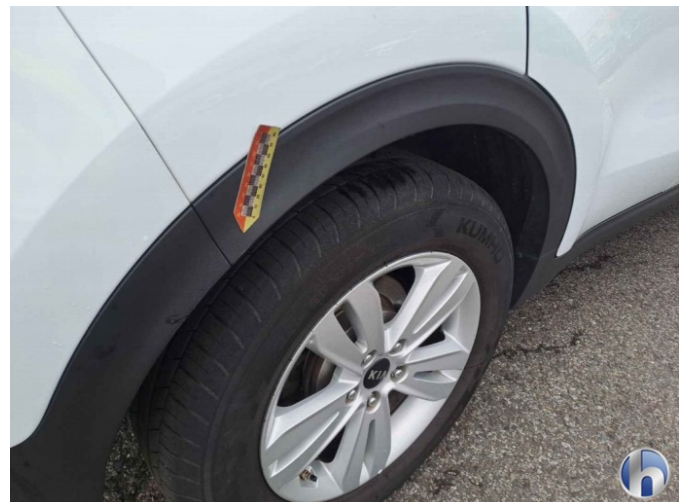
| component | Damage | Rep kind |
|---|---|---|
| 33. | Scrape | Replace |

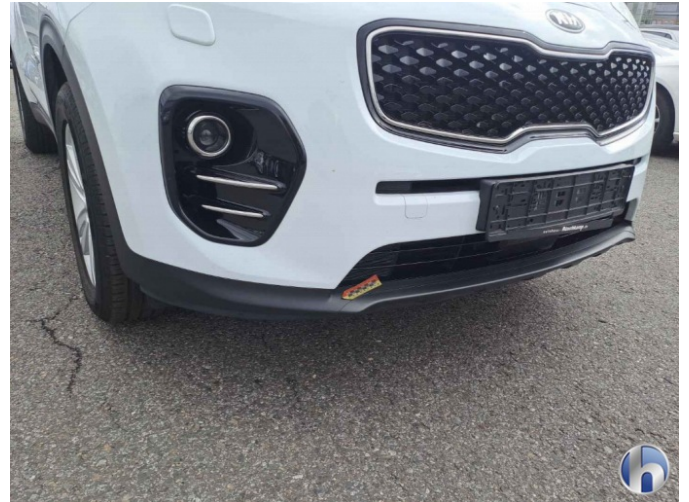
| component | Damage | Rep kind |
|---|---|---|
| 34. spoiler | Scrape | Replace |

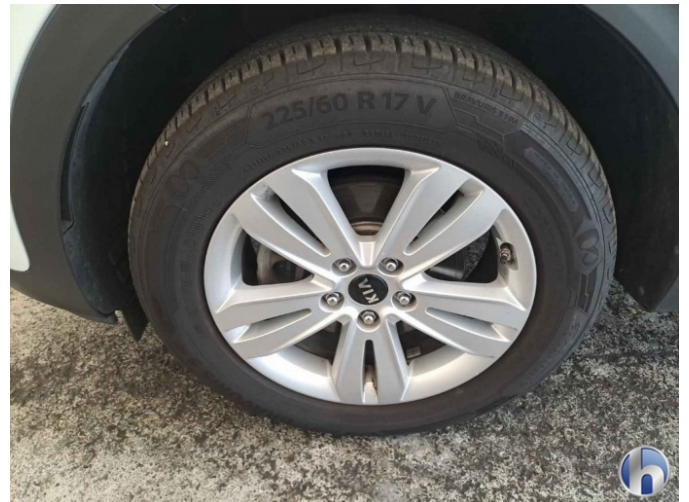
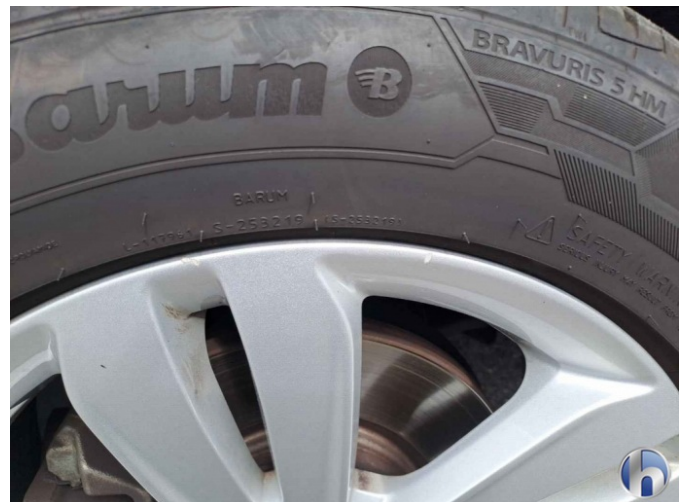
| component | Damage | Rep kind |
|---|---|---|
| 35. | Scratch(es) | Smart repair |
