## status report

**customer:** Bank 11, Neuss  
**contract number:**  
**reference:**

#### Dacia Duster Prestige 4x4

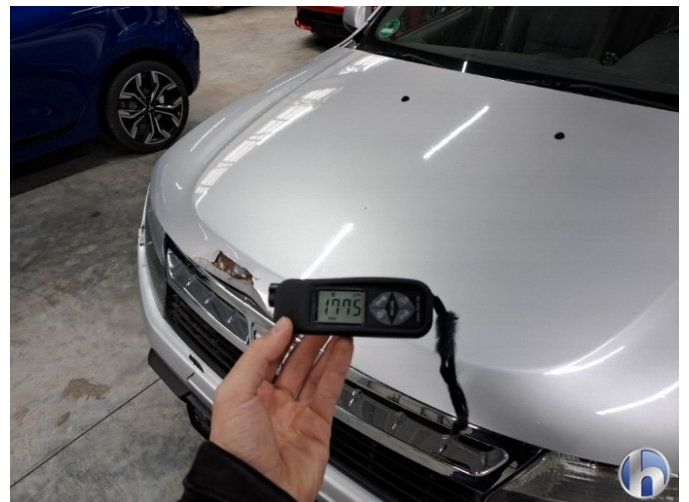
| component | Damage | Rep kind |
|---|---|---|
| 1. hood | Subsequently painted | acceptable |

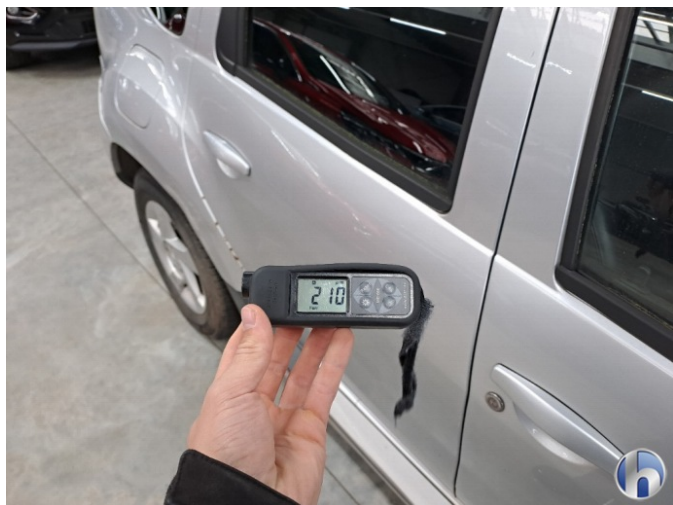
| component | Damage | Rep kind |
|---|---|---|
| 2. Door Rear - right | Subsequently painted | acceptable |

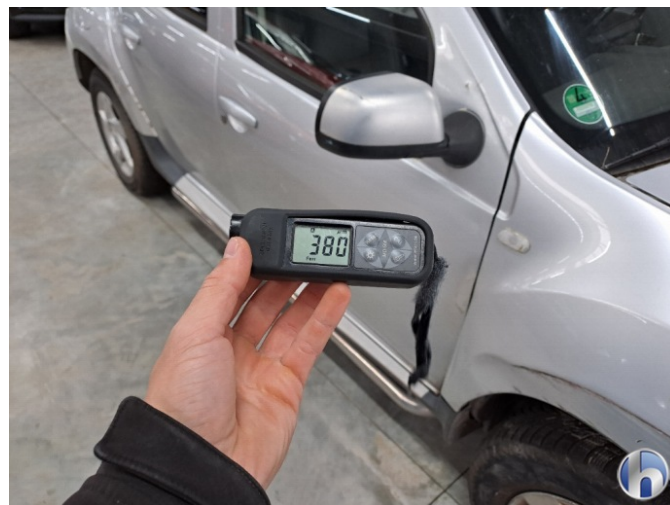
| component | Damage | Rep kind |
|---|---|---|
| 3. Front door - right | Subsequently painted | acceptable |

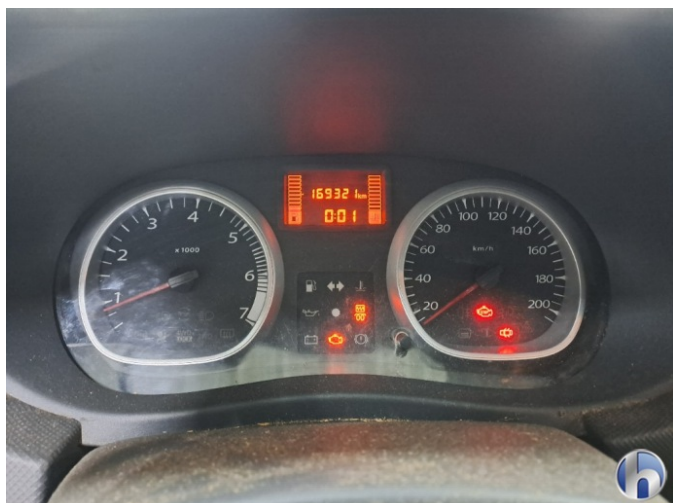
| Performed testing technology | |
|---|---|
| <b>reference:</b> | *diverse Fehlermeldungen |

| component | Damage | Rep kind |
|---|---|---|
| 4. Diverse Fehlermeldungen | Error message | Carry out a fault diagnosis |

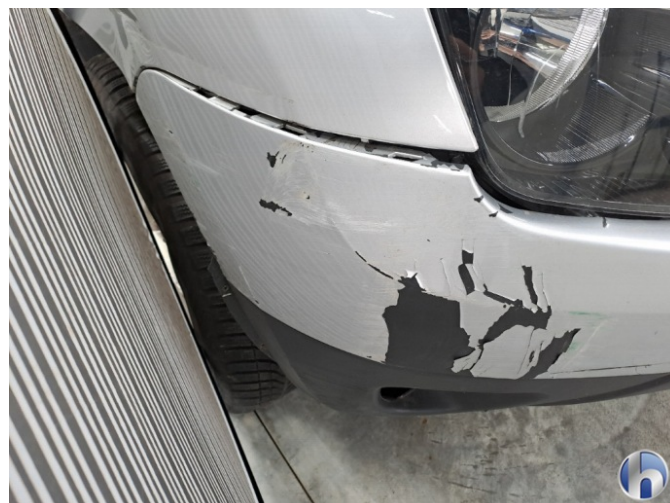
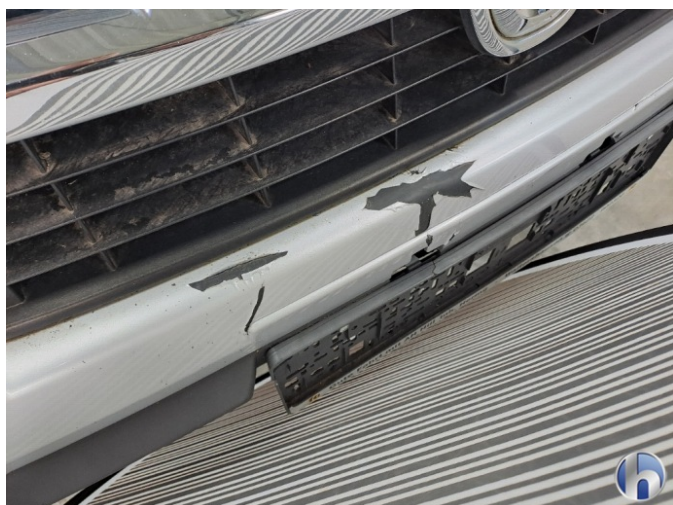
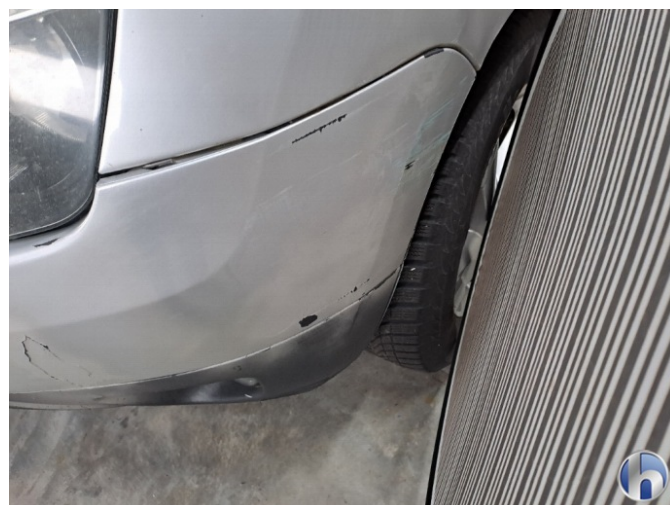
| component | Damage | Rep kind |
|---|---|---|
| 5. Front bumper | Accident damage | Replace |

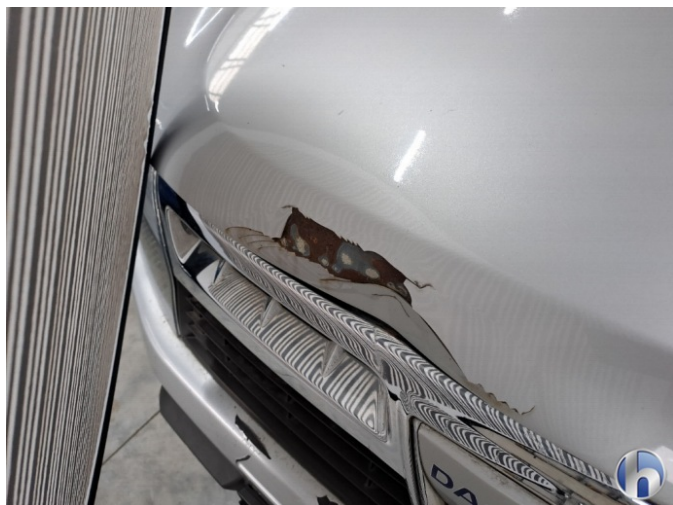
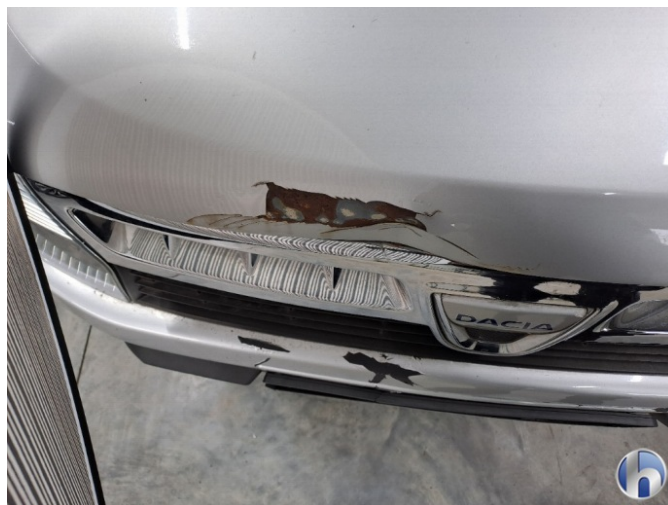
| component | Damage | Rep kind |
|---|---|---|
| 6. hood | Accident damage | Replace |

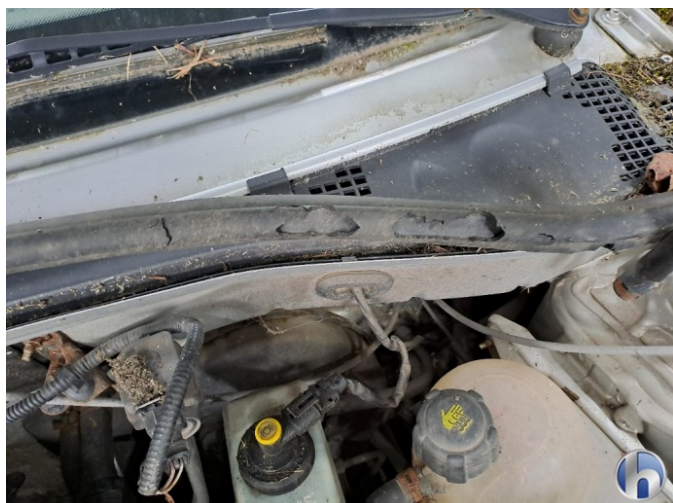
| component | Damage | Rep kind |
|---|---|---|
| 7. Dichtung Motorraum | Damaged | Replace |

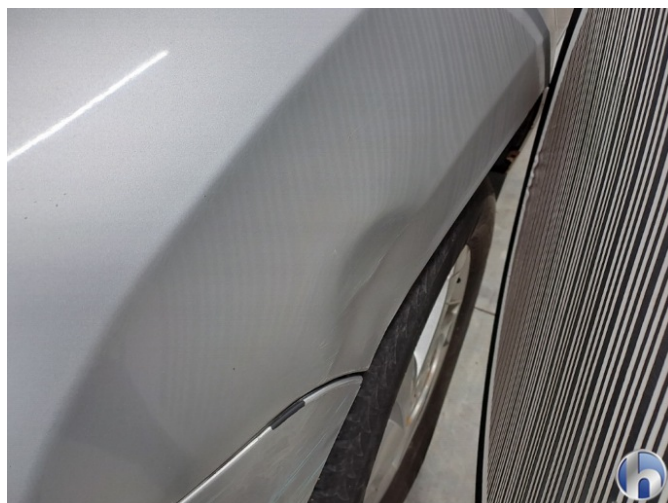
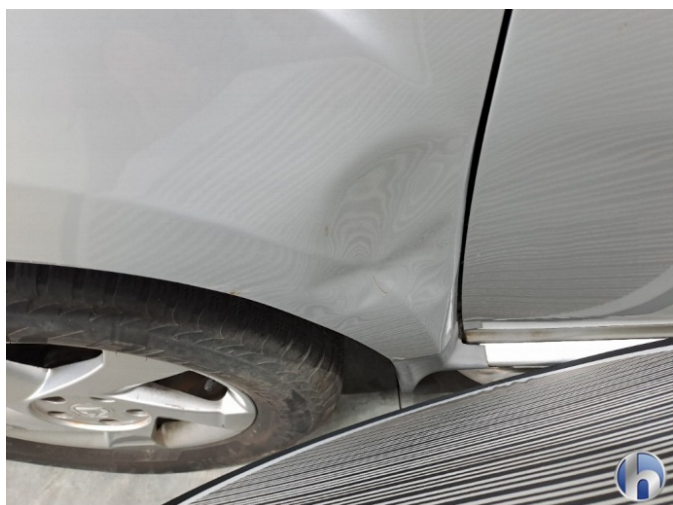
| component | Damage | Rep kind |
|---|---|---|
| 8. Front fender - left | Accident damage | Replace |

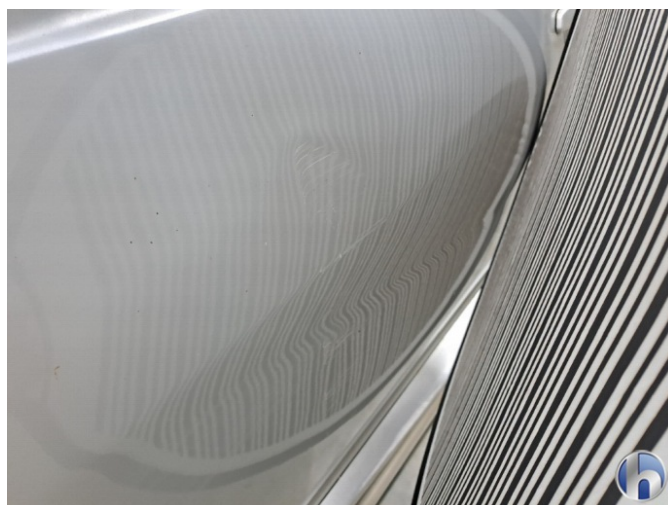
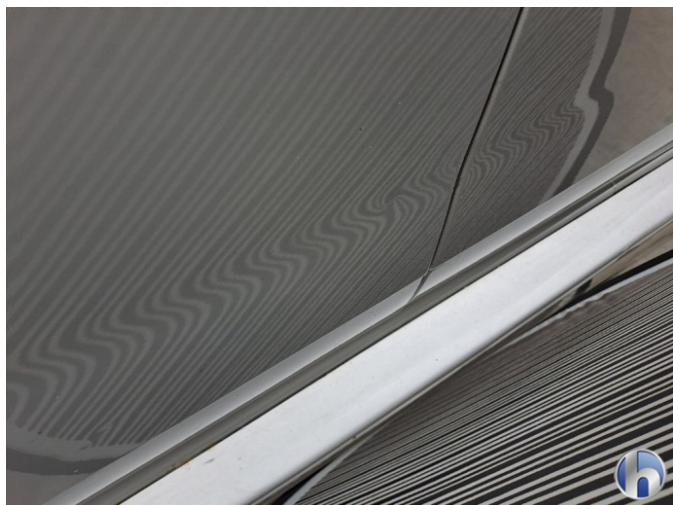
| component | Damage | Rep kind |
|---|---|---|
| 9. Front door - left | Accident damage | Replace |

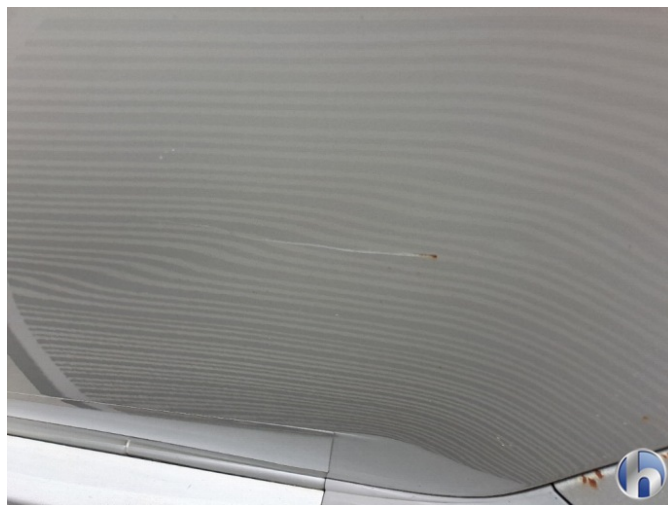
| component | Damage | Rep kind |
|---|---|---|
| 10. Rear door - left | Scratch(es) down to priming coat | Refurbish and paint |

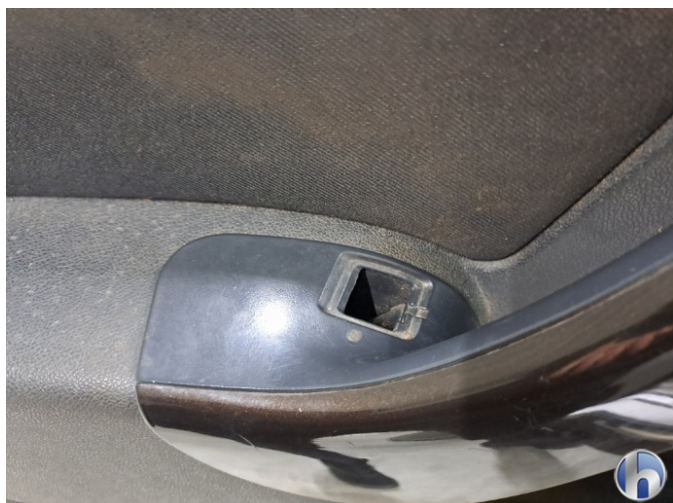
| component | Damage | Rep kind |
|---|---|---|
| 11. Abdeckung Türverkleidung Vorne links | Missing | Replace |

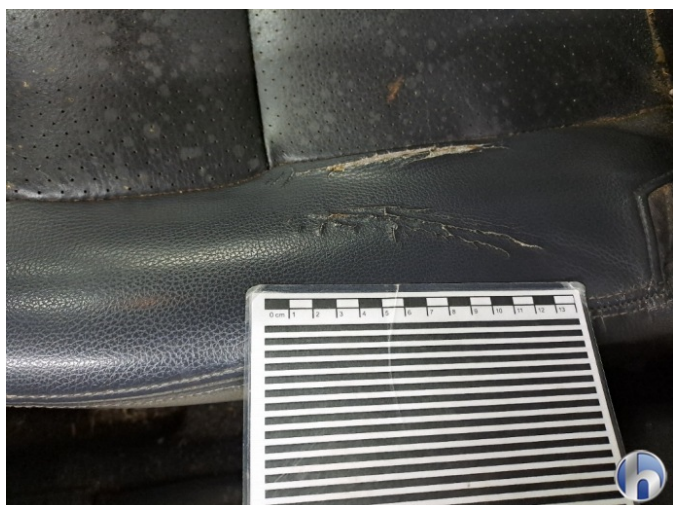
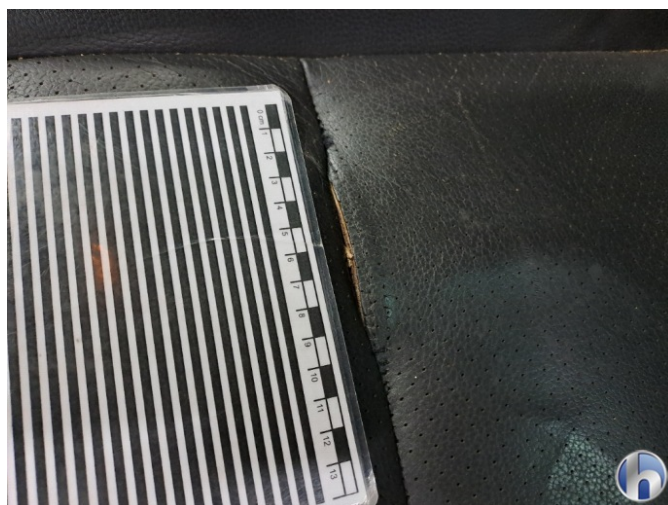
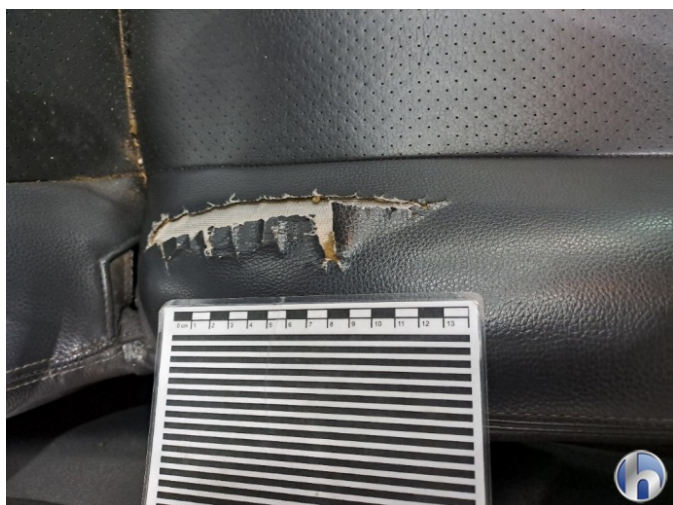
| component | Damage | Rep kind |
|---|---|---|
| 13. Sitz - Vorne - Links: Kissen und Lehne (Leder) | Damaged | Replace |

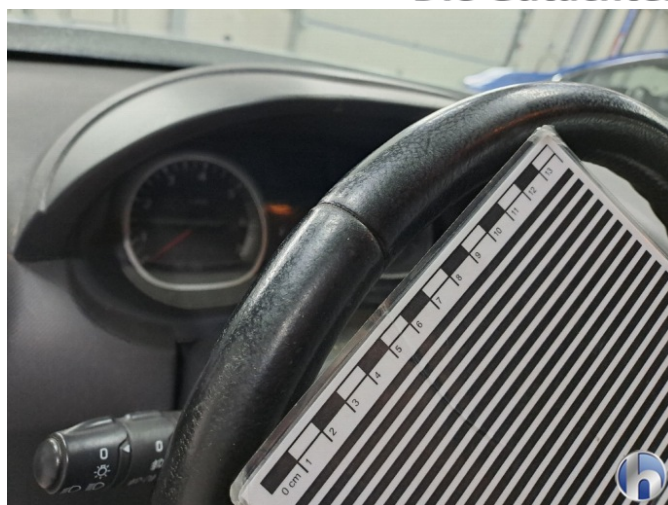
| component | Damage | Rep kind |
|---|---|---|
| 14. steering wheel | Wear and tear | acceptable |

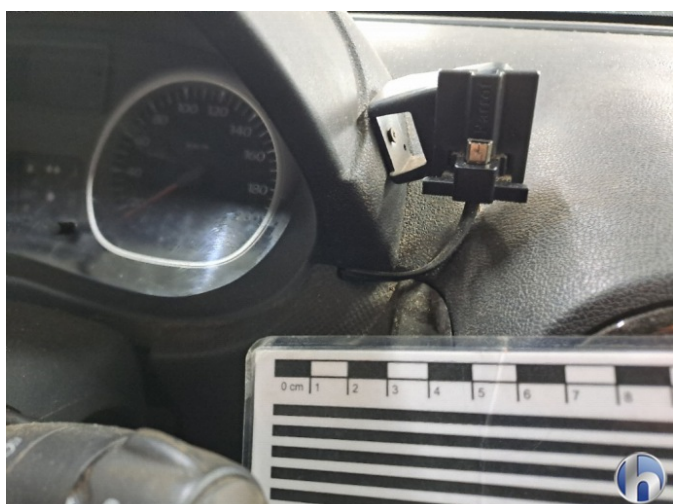
15. Amaturenbrett

| component | Damage | Rep kind |
|---|---|---|
| 15. Amaturen Brett | | Replace |

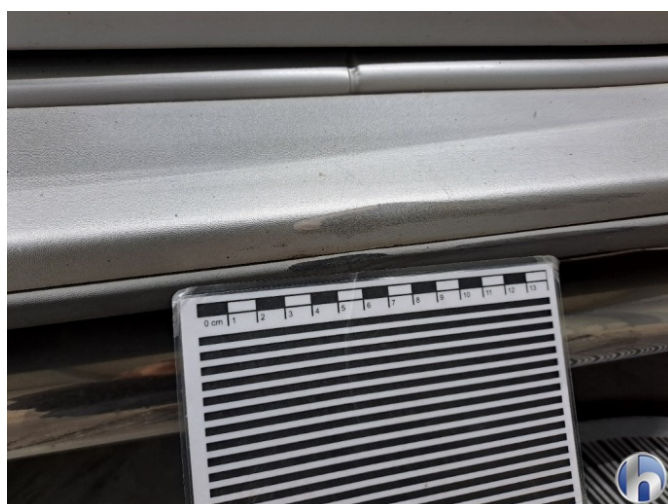
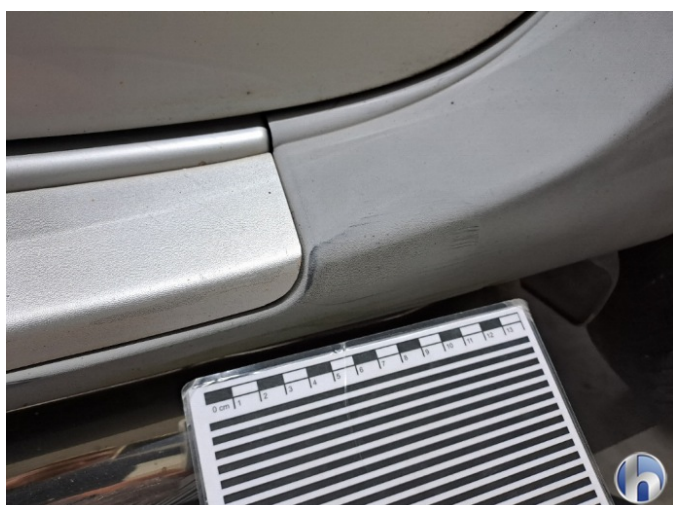
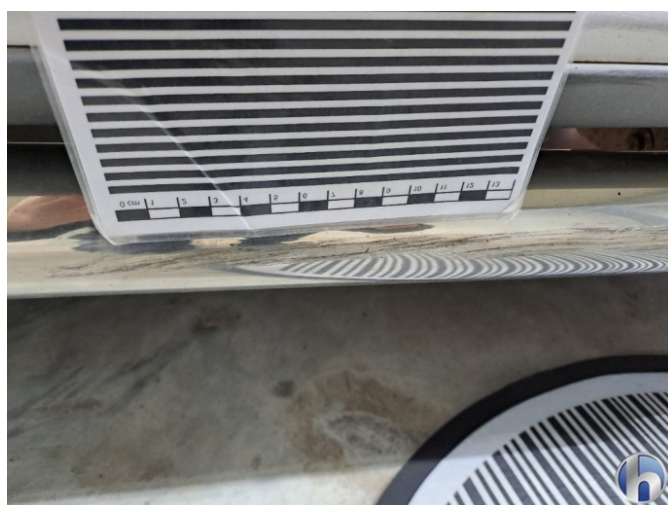
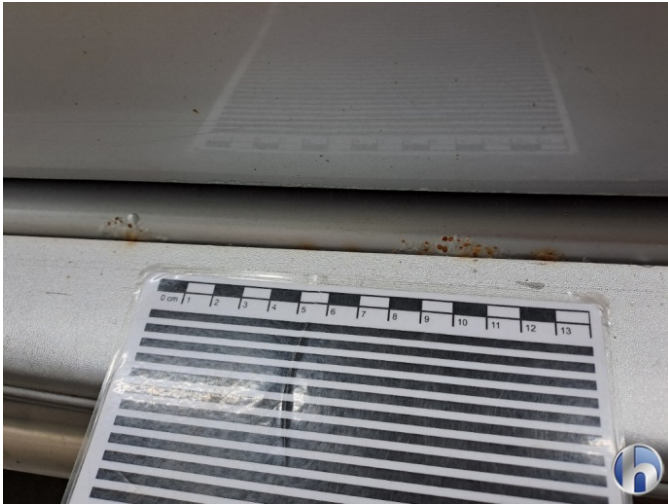
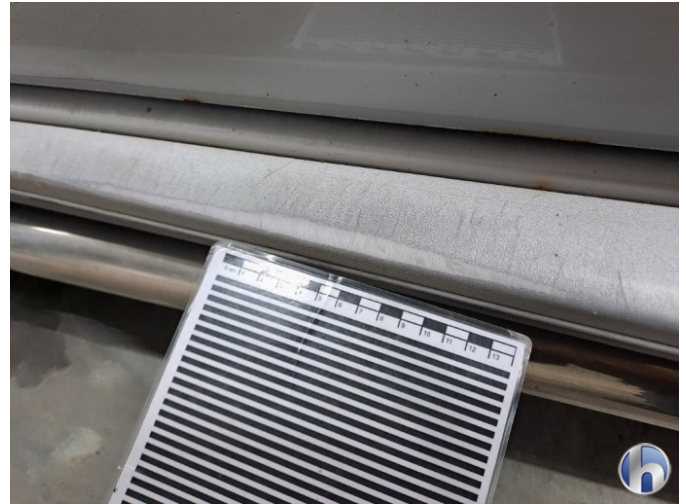
| component | Damage | Rep kind |
|---|---|---|
| 16. side skirt - left | Damaged | Replace |

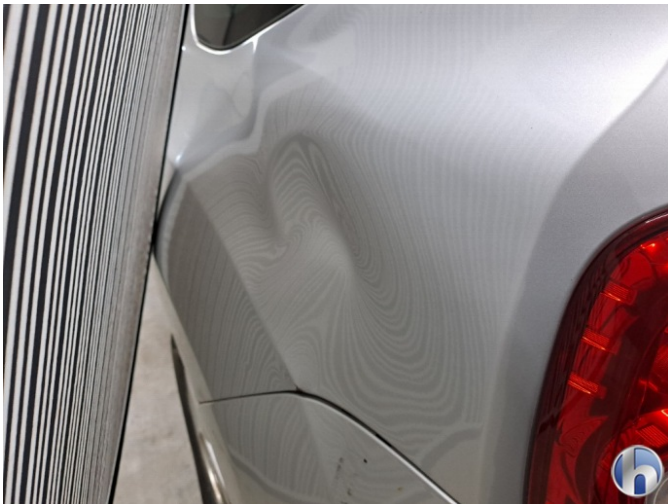
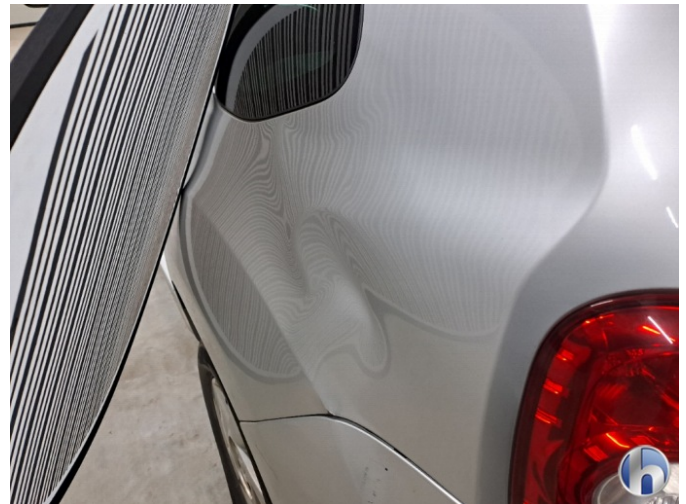
| component | Damage | Rep kind |
|---|---|---|
| 17. Sidewall - Rear - Left | Accident damage | Replace |

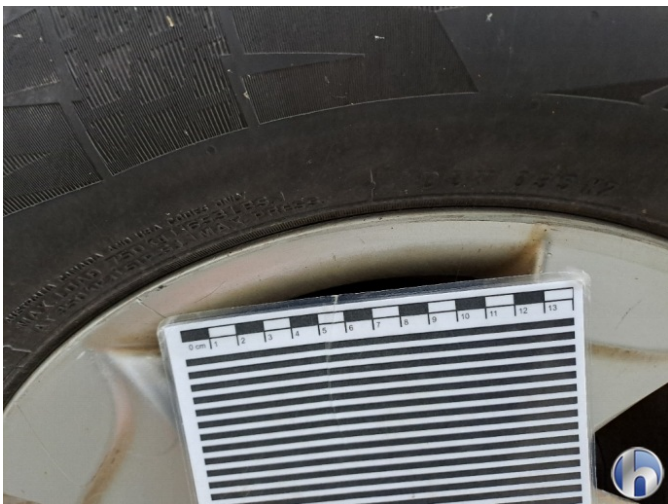
| component | Damage | Rep kind |
|---|---|---|
| 18. Rim rear - left | Damaged | Paint |

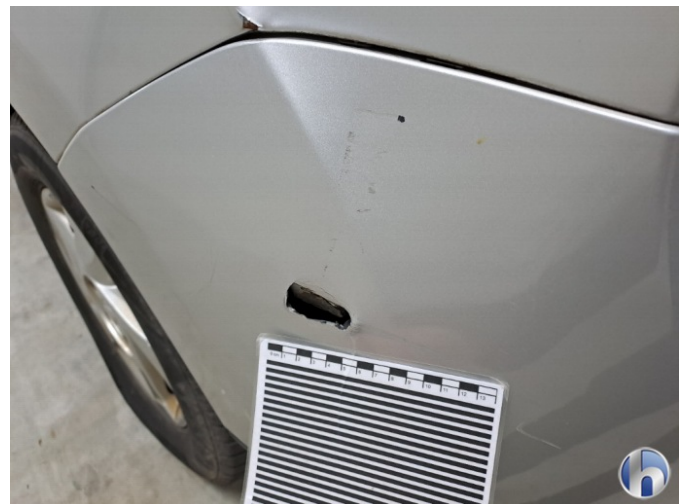
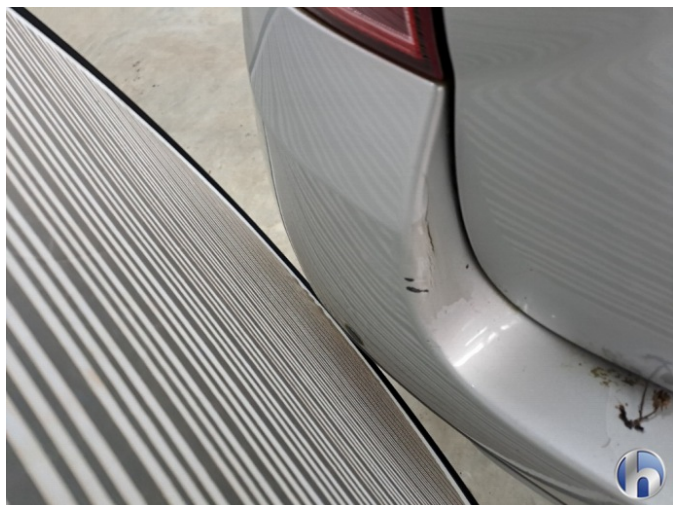
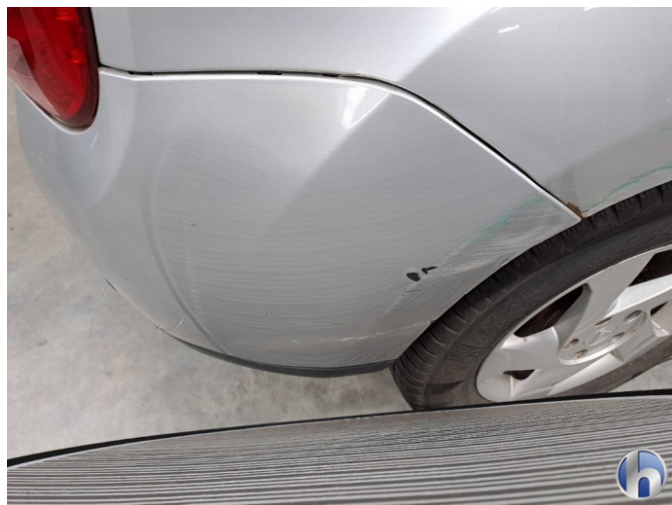
| component | Damage | Rep kind |
|---|---|---|
| 19. Rear bumper | Accident damage | Replace |

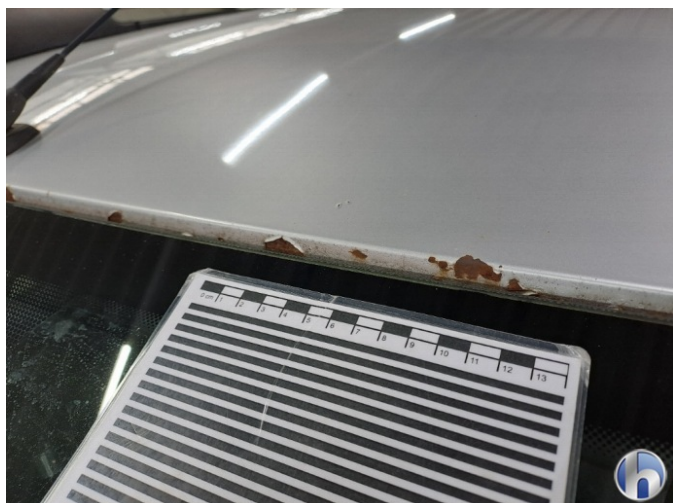
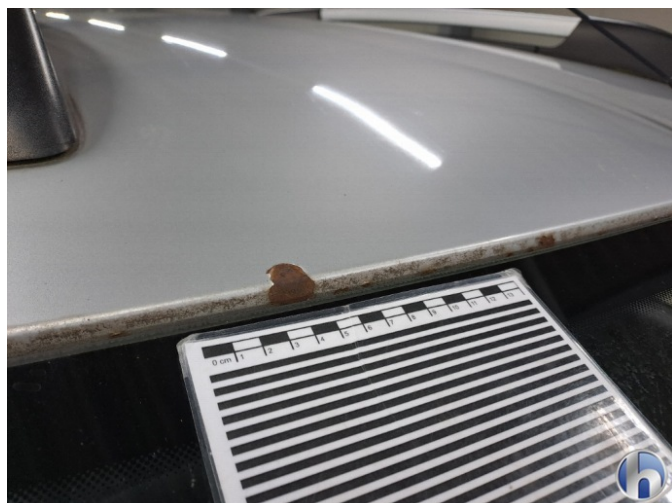
| component | Damage | Rep kind |
|---|---|---|
| 20. roof | Rust | Refurbish and paint |

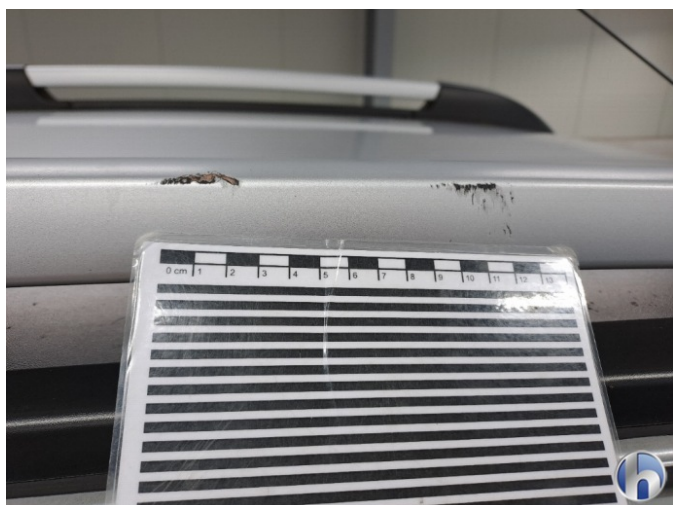
| component | Damage | Rep kind |
|---|---|---|
| 21. | Scratch(es) | Replace |

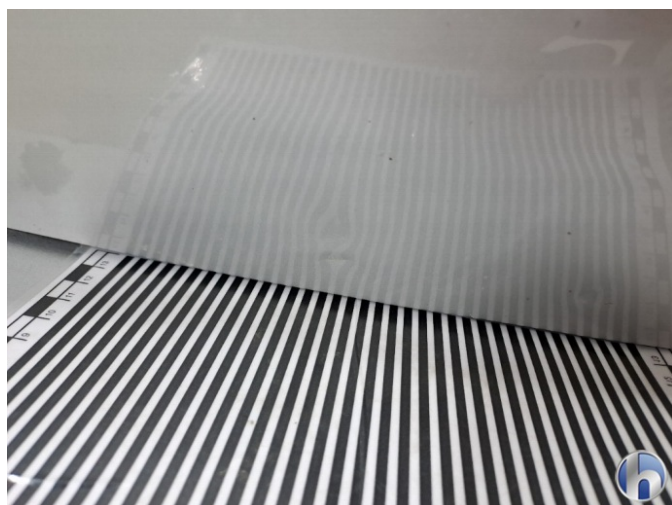
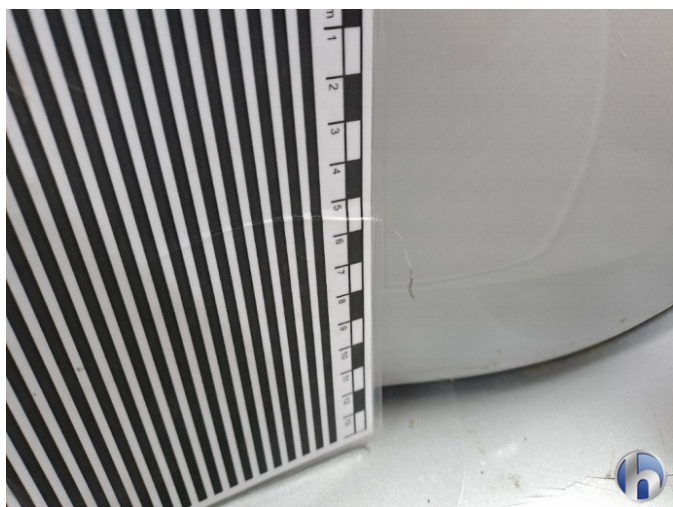
| component | Damage | Rep kind |
|---|---|---|
| 22. tailgate | Scratch(es) down to priming coat | Paint |

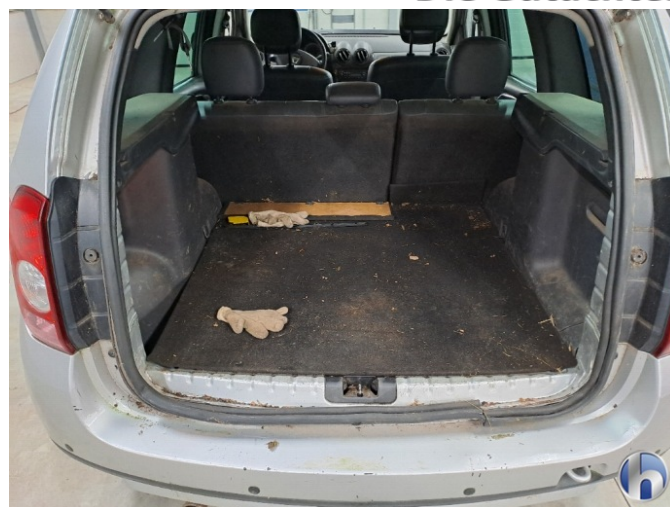
| component | Damage | Rep kind |
|---|---|---|
| 23. hat rack | Missing | Replace |

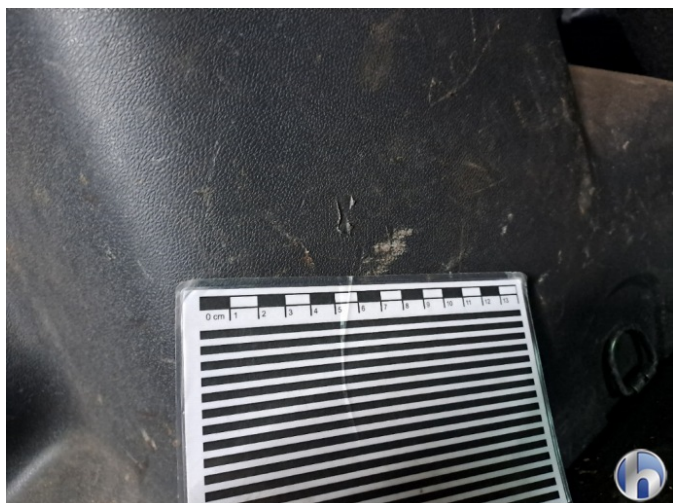
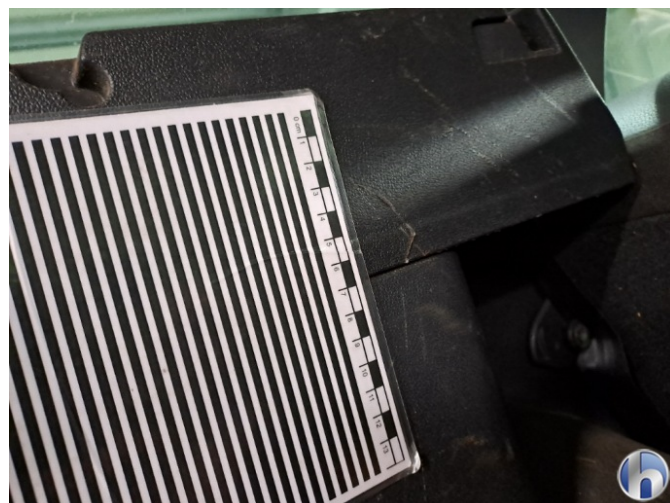
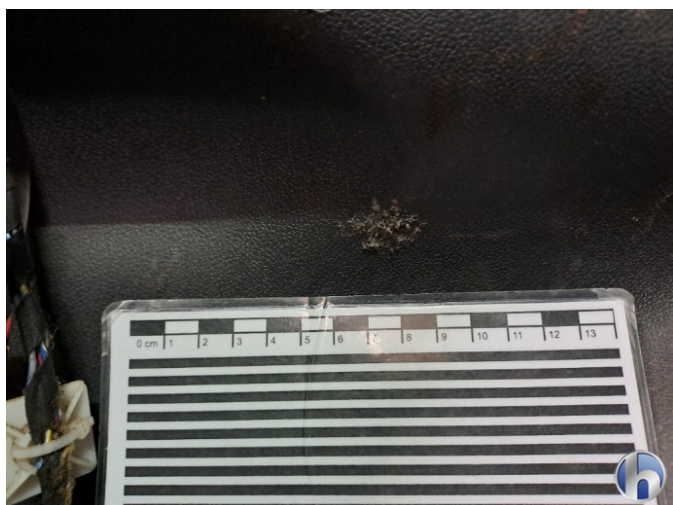
| component | Damage | Rep kind |
|---|---|---|
| 24. Trunk lining left | Scratch(es) | Replace |

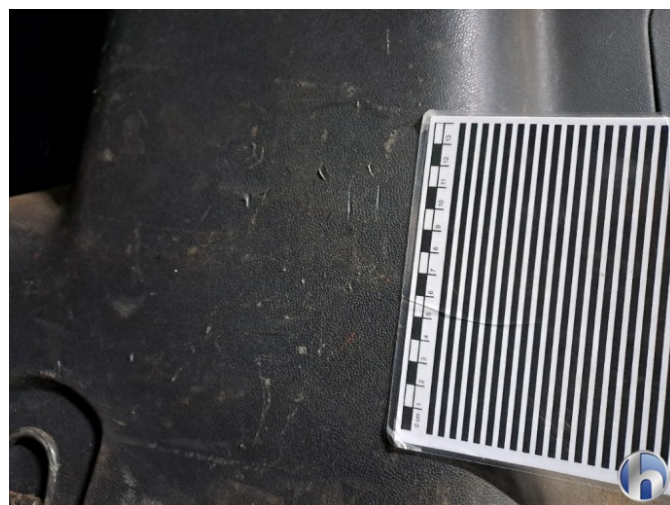
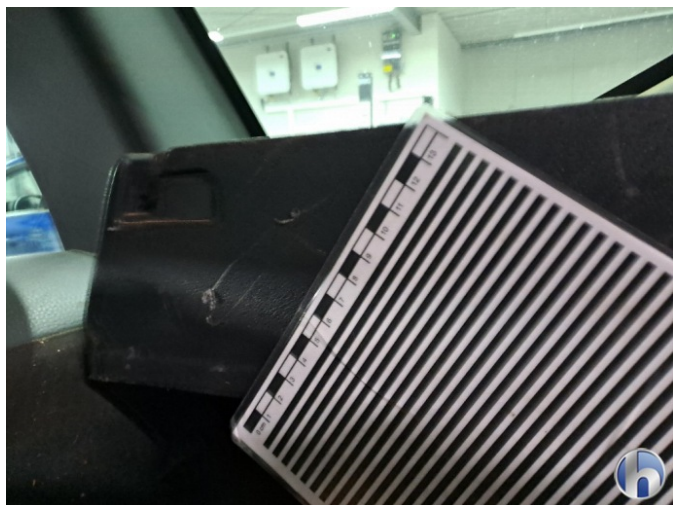
| component | Damage | Rep kind |
|---|---|---|
| 25. Trunk lining law | Scratch(es) | Replace |

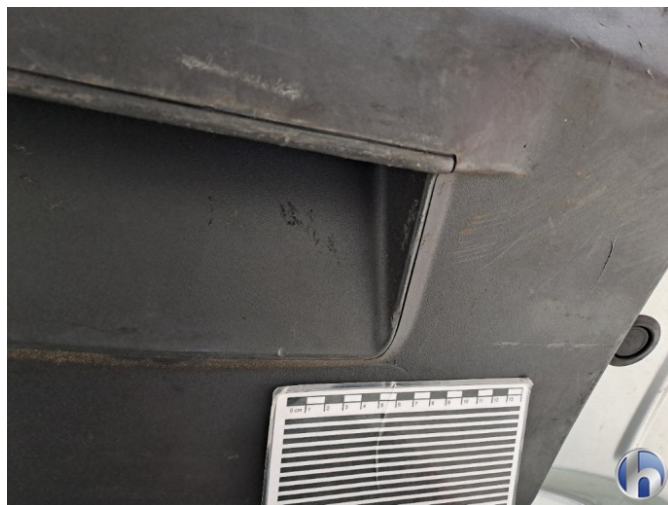
| component | Damage | Rep kind |
|---|---|---|
| 26. tailgate trim | Scratch(es) | Replace |

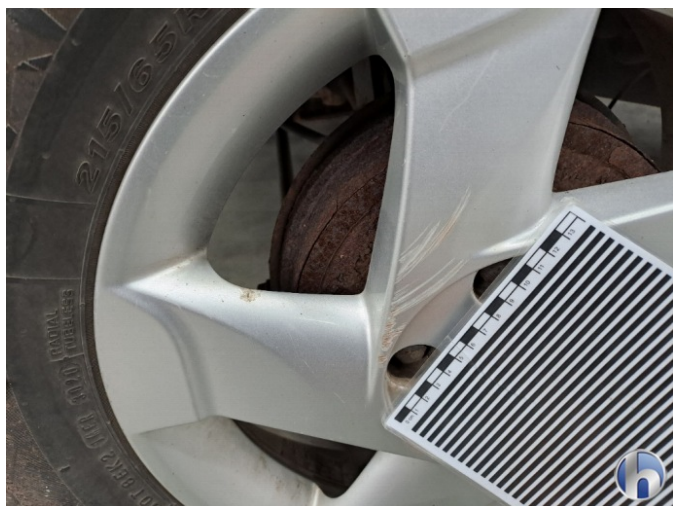
| component | Damage | Rep kind |
|---|---|---|
| 27. Rim rear - right | Damaged | Paint |

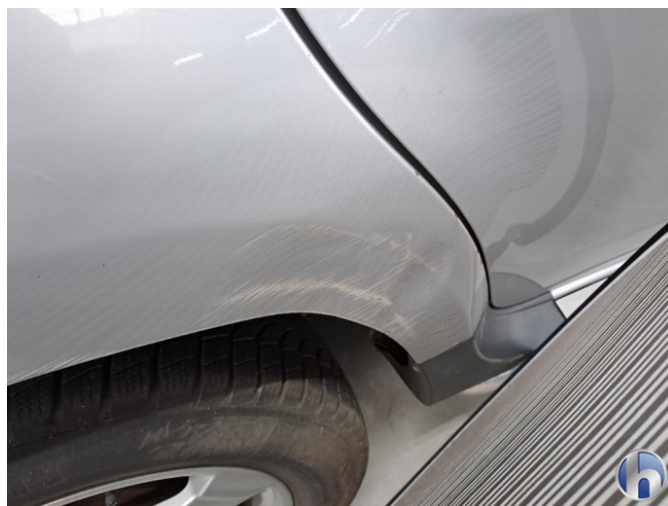
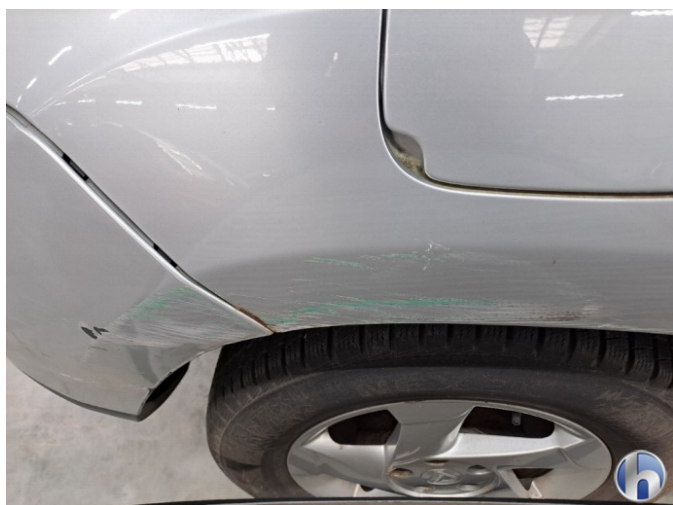
| component | Damage | Rep kind |
|---|---|---|
| 28. Sidewall - Rear - right | Accident damage | Replace |

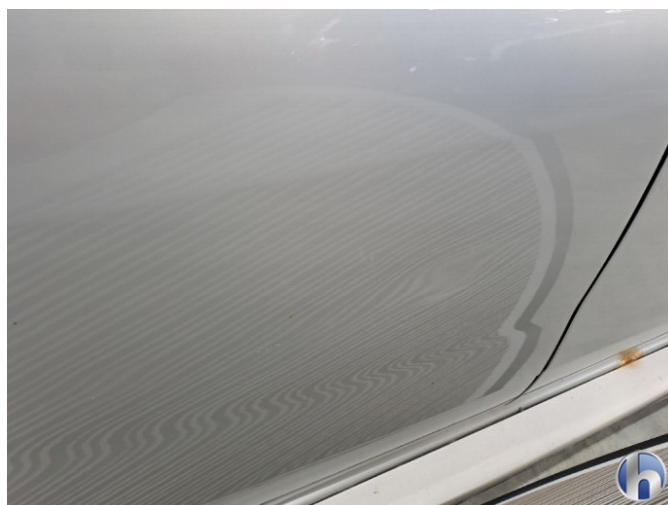
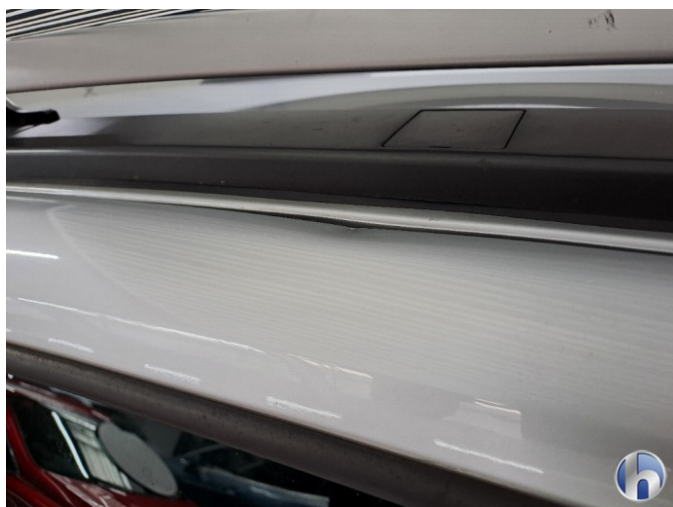
| component | Damage | Rep kind |
|---|---|---|
| 29. Door Rear - right | Damaged | Refurbish and paint |

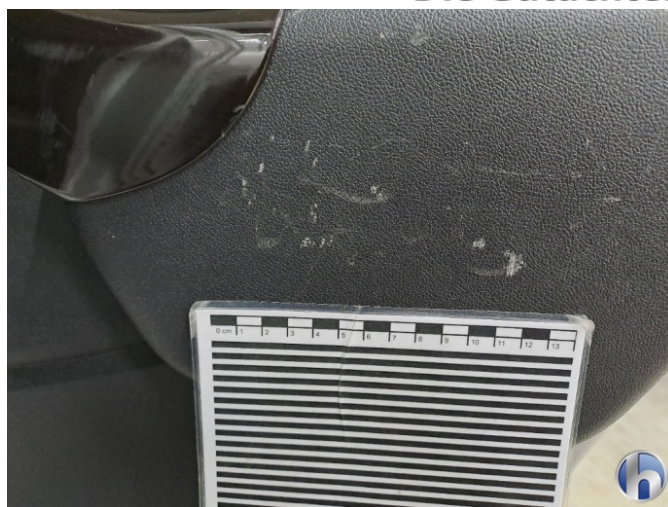
| component | Damage | Rep kind |
|---|---|---|
| 30. Door trim Rear - right | Wear and tear | acceptable |

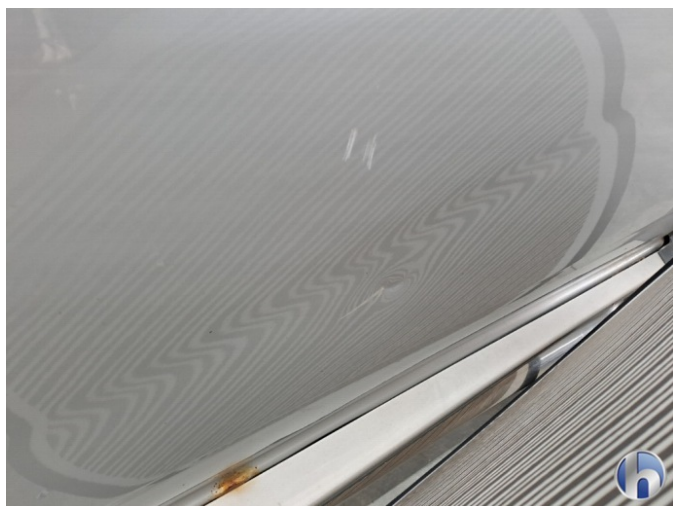
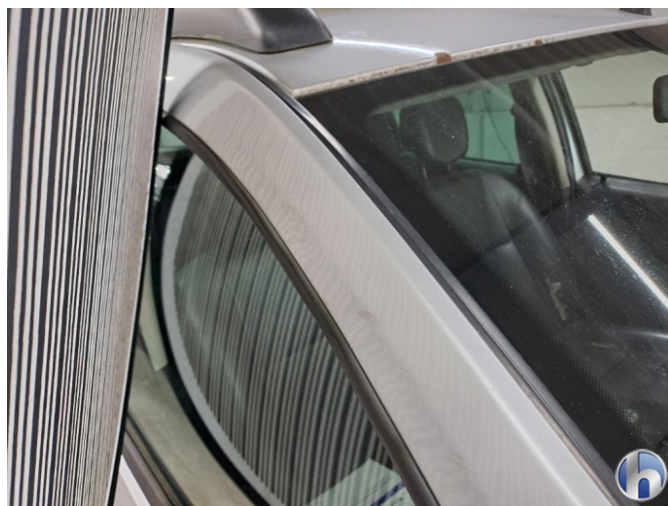
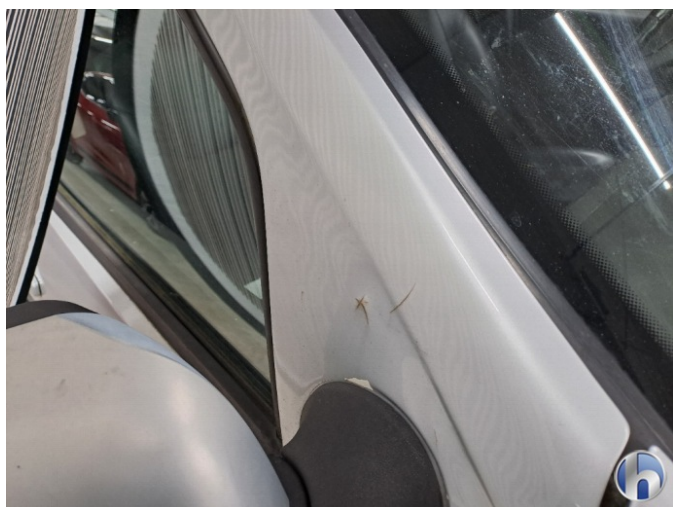
| component | Damage | Rep kind |
|---|---|---|
| 31. Front door - right | Accident damage | Replace |

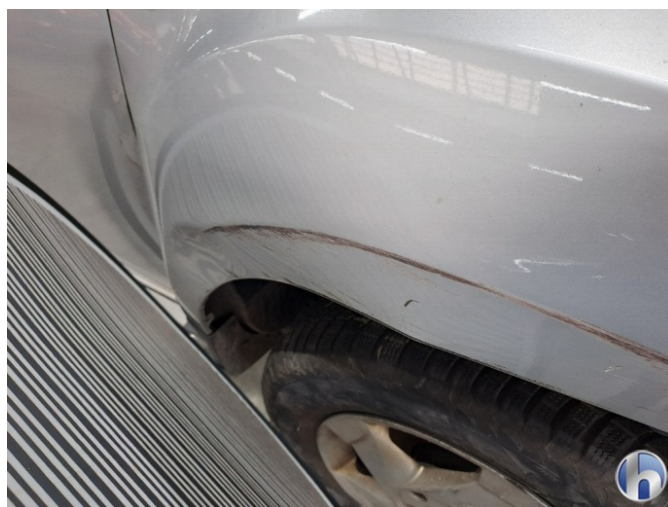
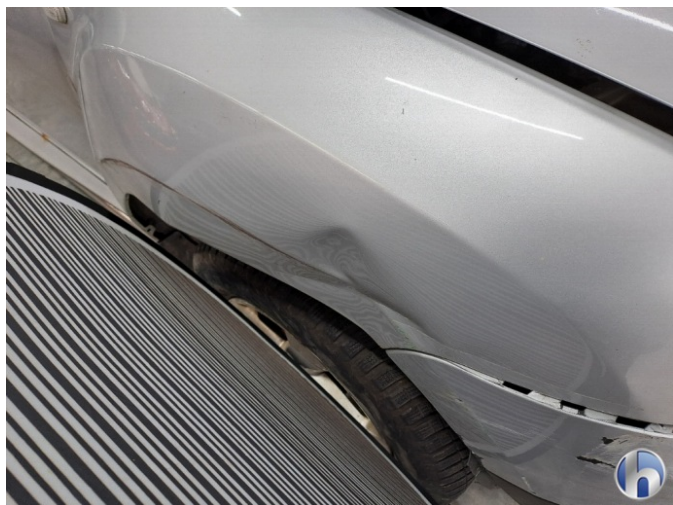
| component | Damage | Rep kind |
|---|---|---|
| 32. Front fender - right | Accident damage | Replace |

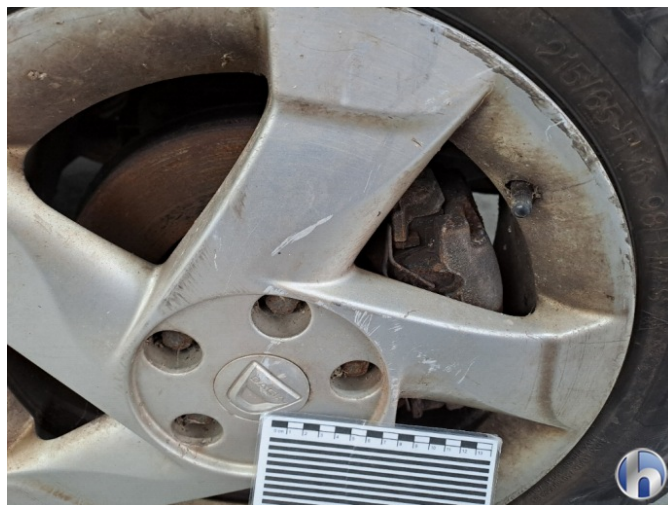
| component | Damage | Rep kind |
|---|---|---|
| 33. Rim front - right | Damaged | Paint |

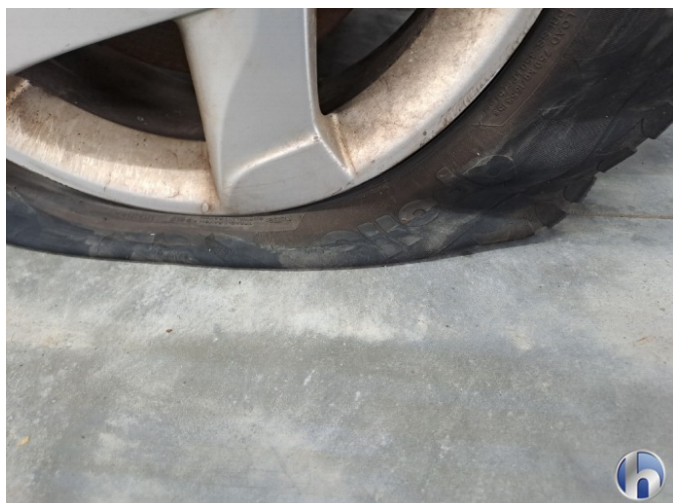
| mounted tires | | |
|---|---|---|
| 1st axis - right / states . | <b>Anderer</b> | <b>215/65/R16/98H 0 mm</b> |

| component | Damage | Rep kind |
|---|---|---|
| 34. tire front - right | Accident damage | Replace |
