DACIA DUSTER

Duster 1.5 dCi 110 4x2 Prestige

VIN NO UU1HSDADF51560358
Registration Number DK592TV

Inspection Report Summary

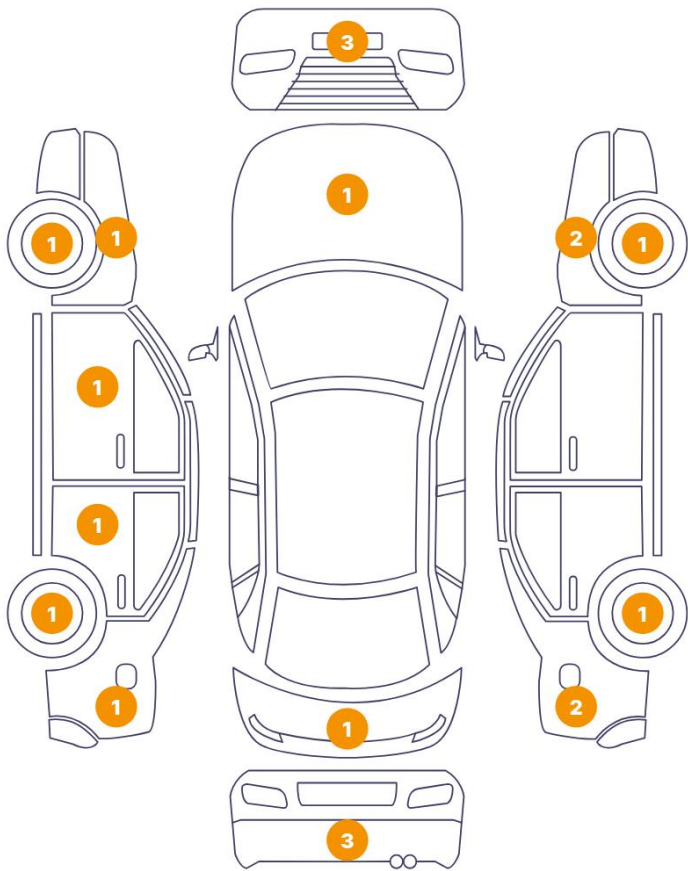
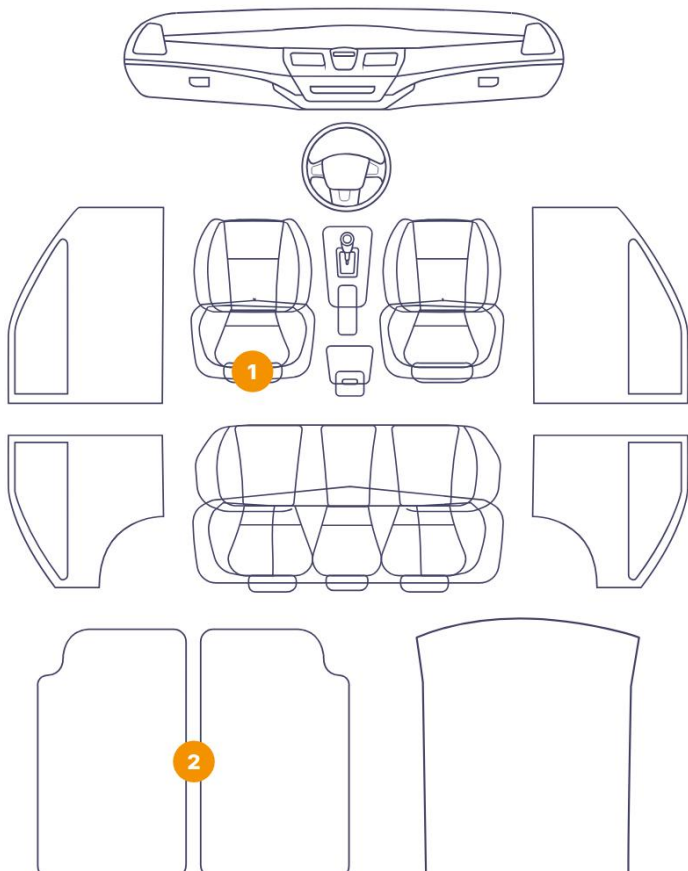
20 Dommages

Component		Damage	Comments
1	Floor Carpet	Interior / Holed	
2	Seat Cushion / Front Left	Interior / Holed	
3	Floor Carpet	Interior / Dirty	
4	Hood	Paint / Scratch / Line	
5	Corner Bumper / Front Right	Paint / Scratch / Scuff	
6	Bumper / Front	Paint / Scratch / Scuff	
7	Corner Bumper / Front Left	Paint / Scratch / Scuff	
8	Fender / Front Left	Paint / Scratch / Line	
9	Rim / Front Left	Out of Bodywork / Scratch	
10	Door / Front Left	Paint / Scratch / Line	
11	Door / Back Left	Paint / Scratch / Line	
12	Side Panel / Back Left	Bodywork / Dent / Deformation	
13	Rim / Back Left	Out of Bodywork / Scratch

14	Corner Bumper / Back Left	Paint / Scratch / Scuff
15	Bumper / Back	Paint / Scratch / Scuff
16	Corner Bumper / Back Right	Paint / Scratch / Scuff
17	Tailgate	Paint / Scratch / Line
18	Side Panel / Back Right	Paint / Scratch / Line
19	Side Panel / Back Right	Bodywork / Dent / Deformation
20	Rim / Back Right	Out of Bodywork / Scratch
21	Fender / Front Right	Paint / Scratch / Line
22	Rim / Front Right	Out of Bodywork / Scratch
23	Fender / Front Right	Paint / Chipping

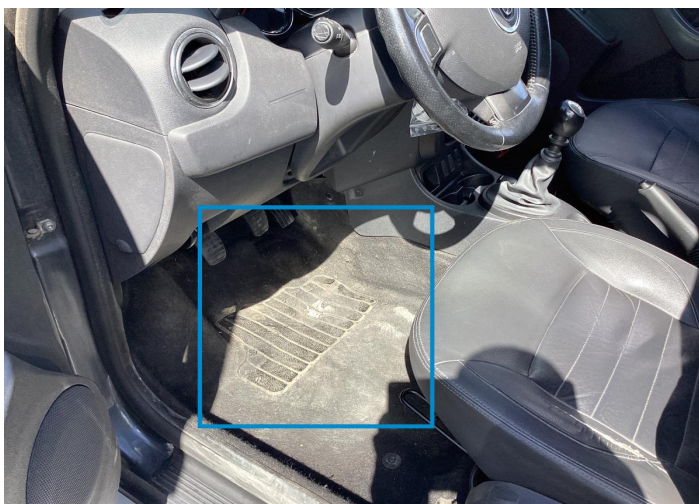
1. Floor Carpet
Interior / Holed -

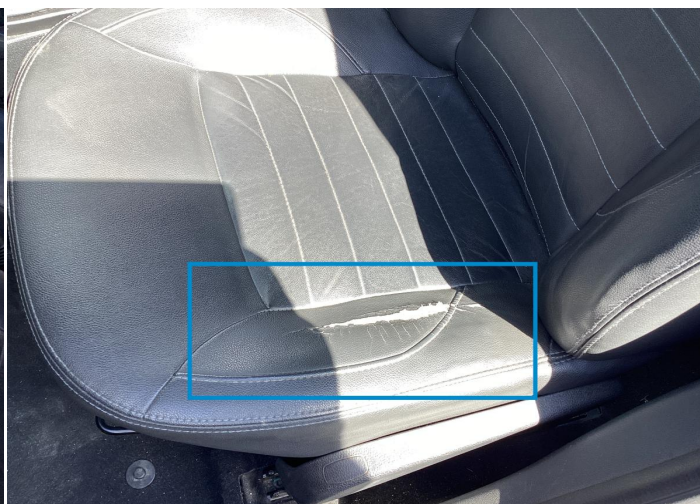
2. Seat Cushion / Front Left
Interior / Holed -

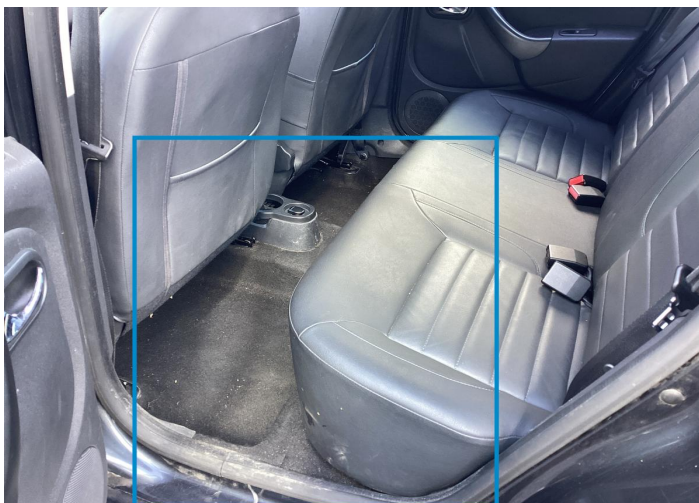
3. Floor Carpet
Interior / Dirty -

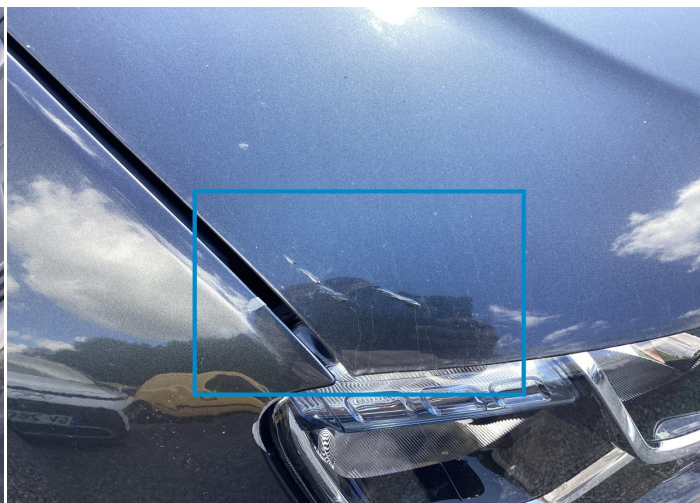
4. Hood
Paint / Scratch / Line -

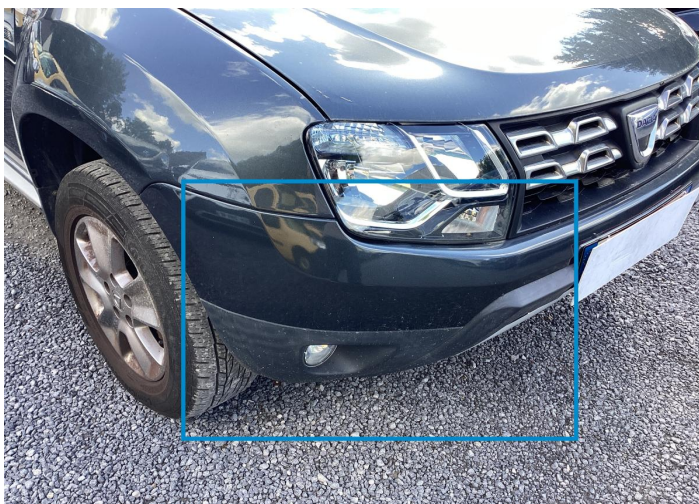
5. Corner Bumper / Front Right
Paint / Scratch / Scuff -

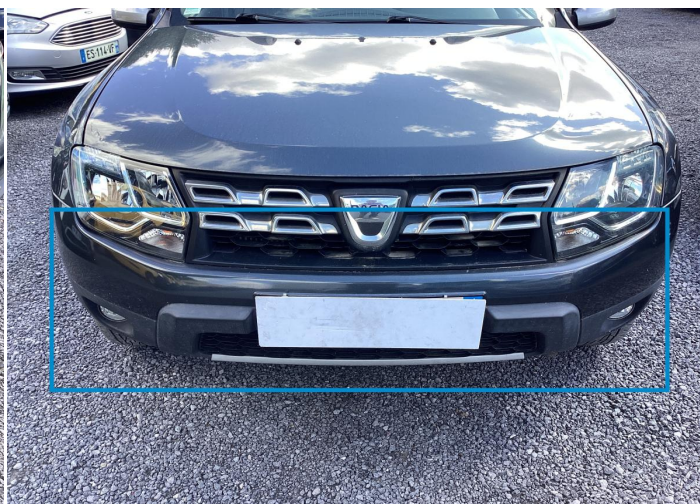
6. Bumper / Front
Paint / Scratch / Scuff -

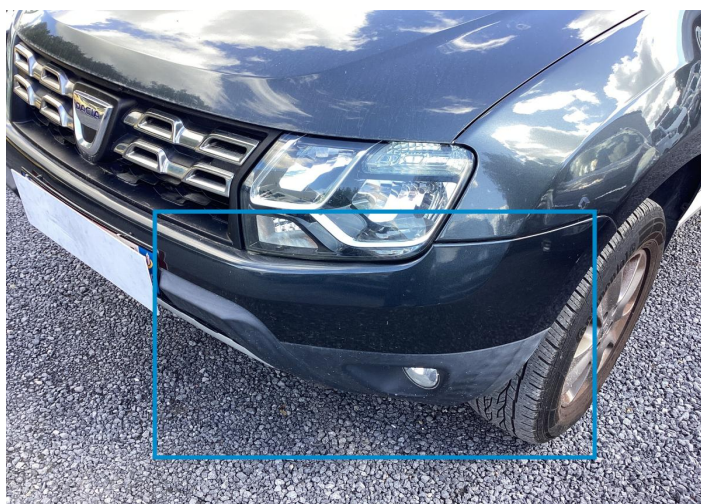
7. Corner Bumper / Front Left
Paint / Scratch / Scuff -

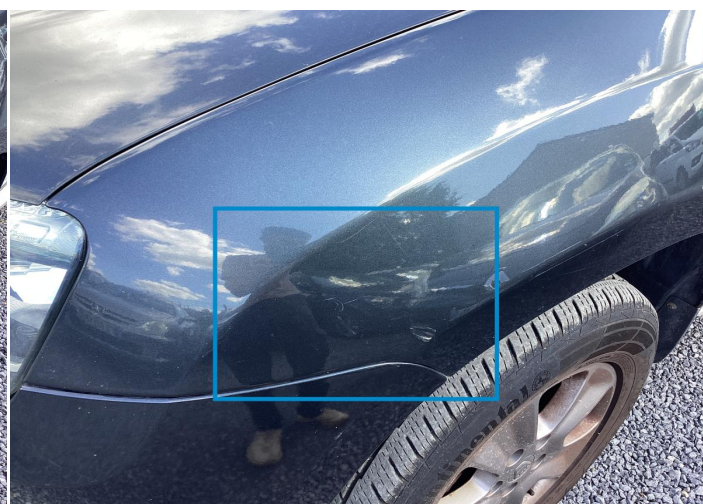
8. Fender / Front Left
Paint / Scratch / Line -

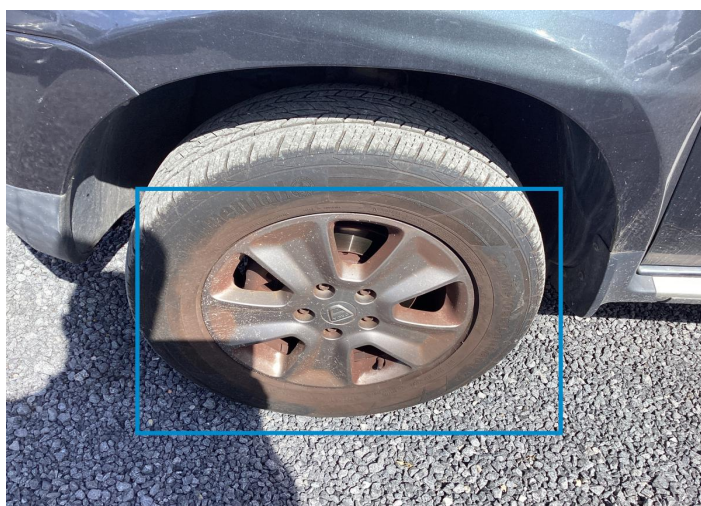
9. Rim / Front Left
Out of Bodywork / Scratch -

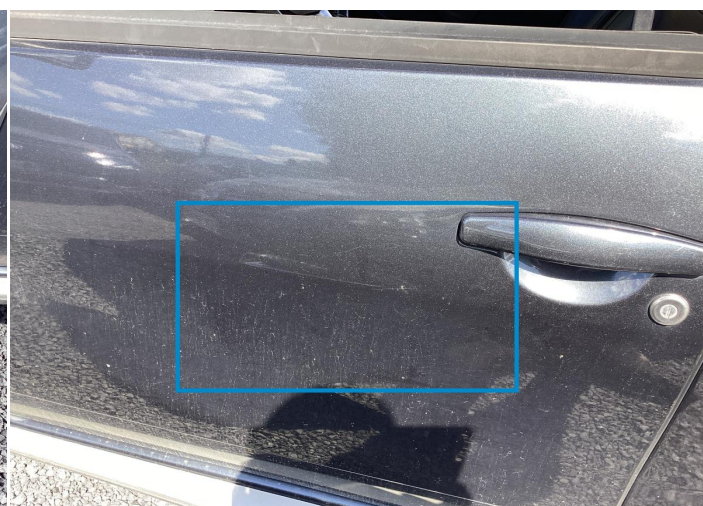
10. Door / Front Left
Paint / Scratch / Line -

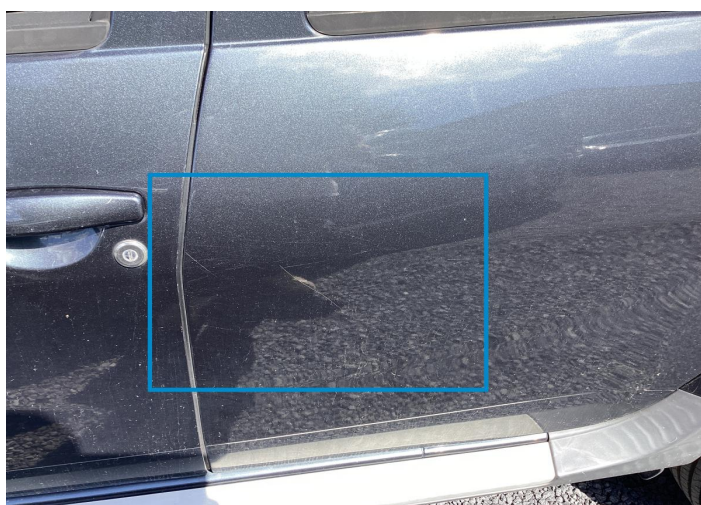
11. Door / Back Left
Paint / Scratch / Line -

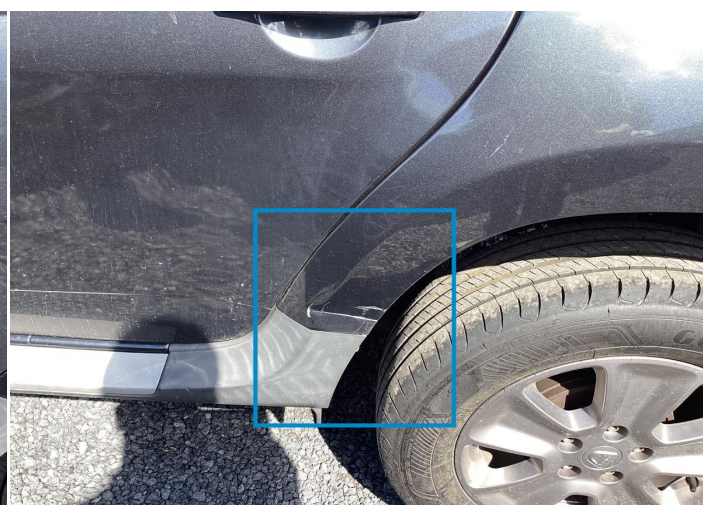
12. Side Panel / Back Left
Bodywork / Dent / Deformation -

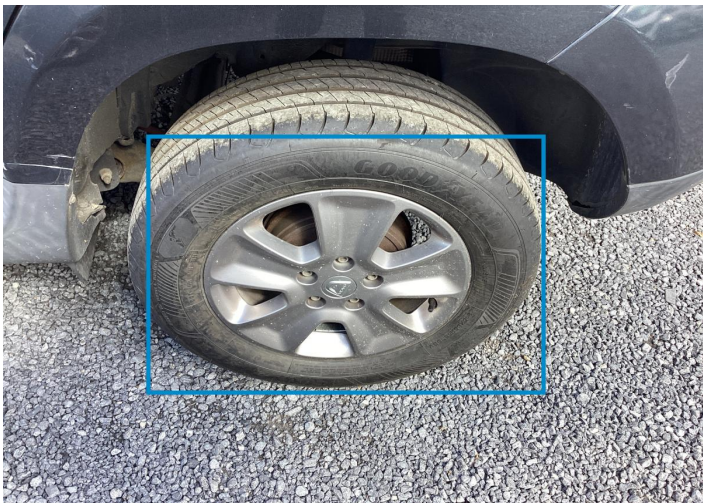
13. Rim / Back Left
Out of Bodywork / Scratch -

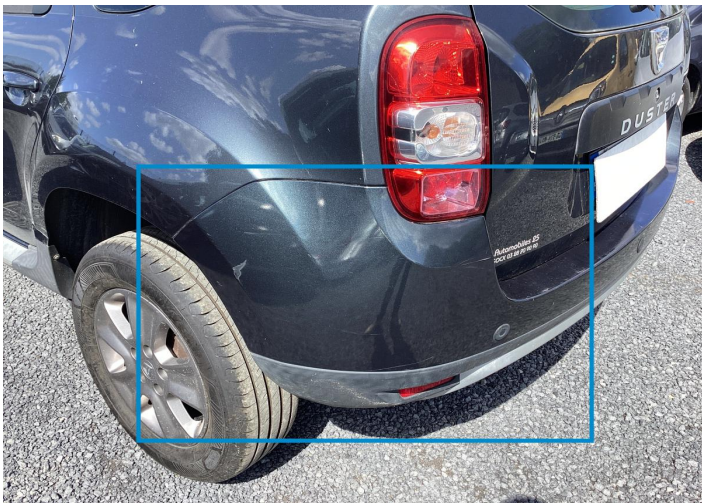
14. Corner Bumper / Back Left
Paint / Scratch / Scuff -

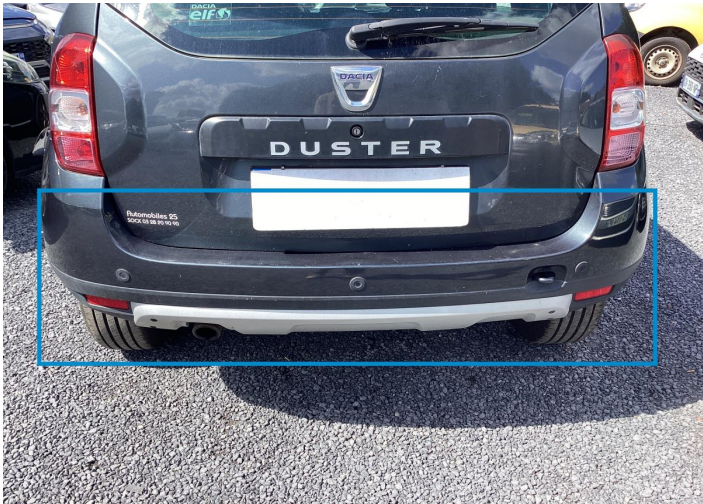
15. Bumper / Back
Paint / Scratch / Scuff -

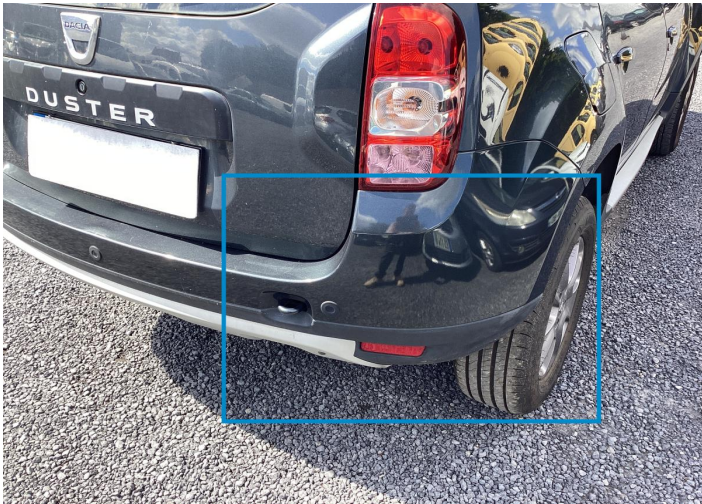
16. Corner Bumper / Back Right
Paint / Scratch / Scuff -

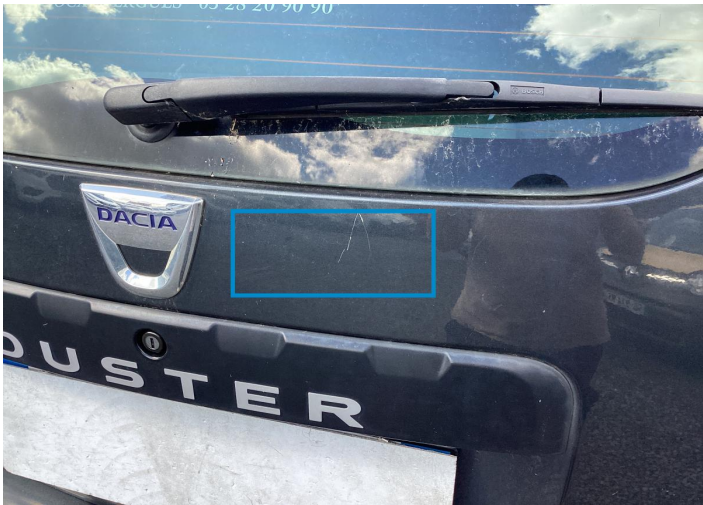
17. Tailgate
Paint / Scratch / Line -

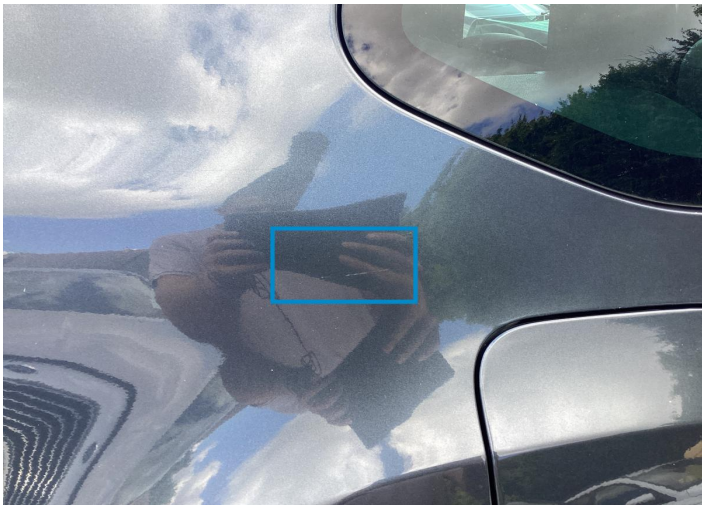
18. Side Panel / Back Right
Paint / Scratch / Line -

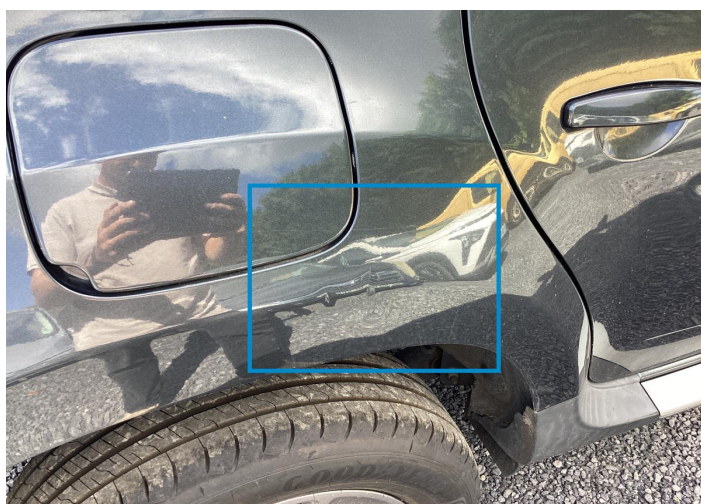
19. Side Panel / Back Right
Bodywork / Dent / Deformation -

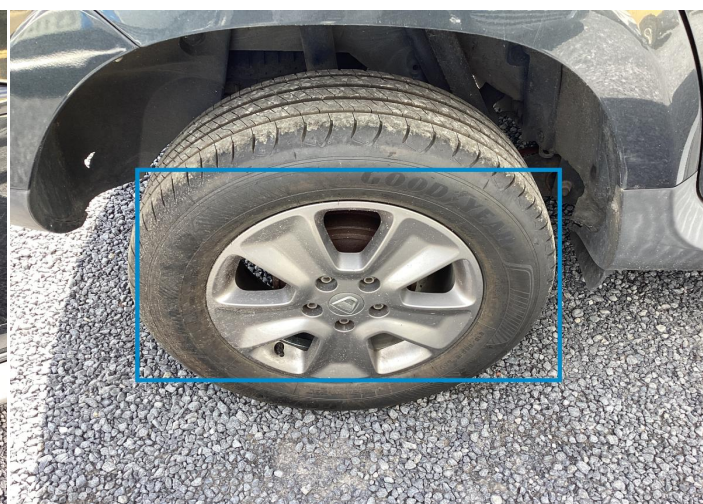
20. Rim / Back Right
Out of Bodywork / Scratch -

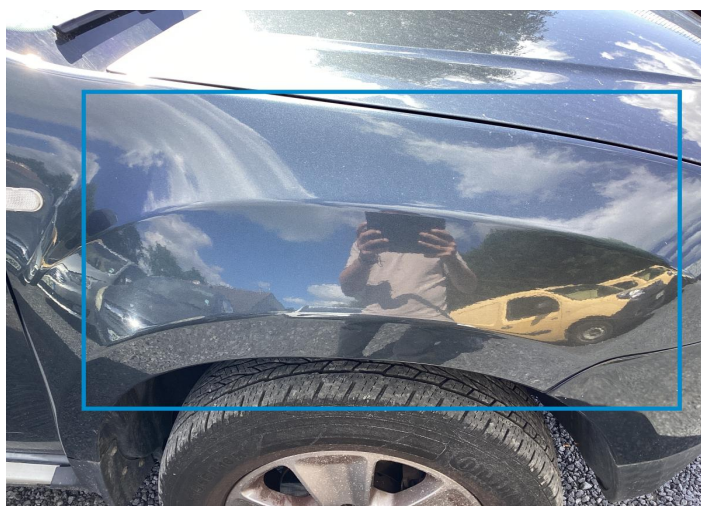
21. Fender / Front Right
Paint / Scratch / Line -

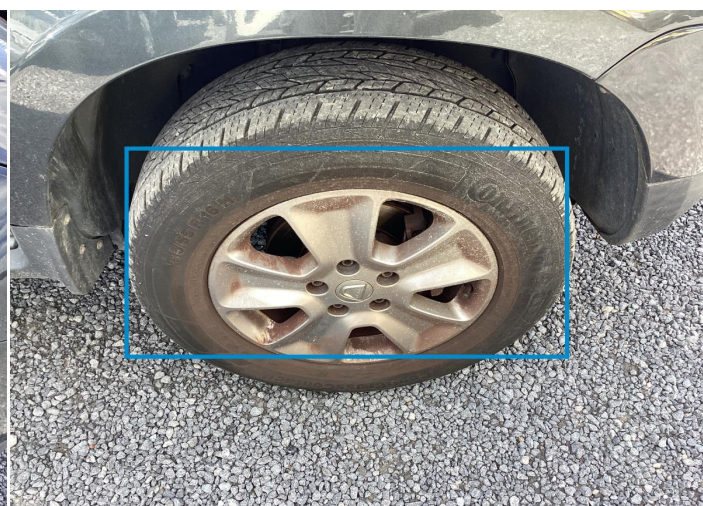
22. Rim / Front Right
Out of Bodywork / Scratch -

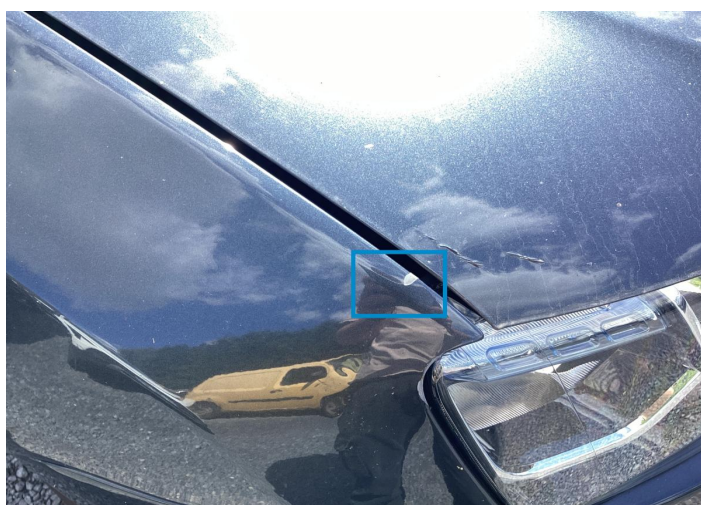
23. Fender / Front Right
Paint / Chipping -
