DACIA Duster I 2014 Diesel

Duster 1.5 dci Laureate 4x2 110cv

Inspection Report Summary

Customer	BCA Lodi	Report Number	P20250917152745
Inspection Date / Place	2025-09-17 / BCA Lodi	Cosmetic Grade	5

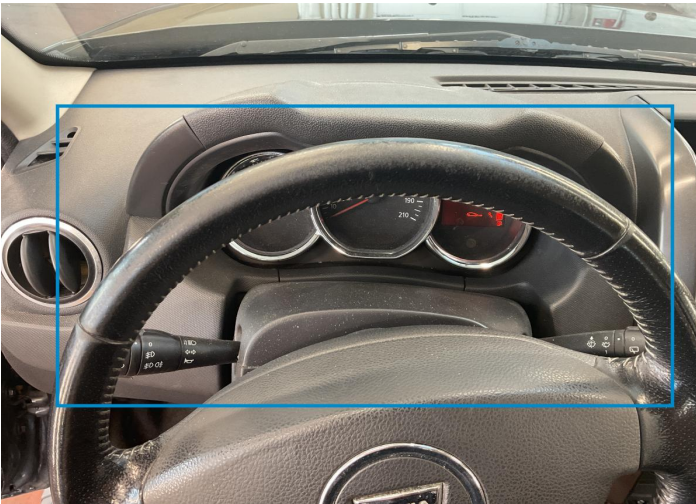
1. Steering Wheel / Front
Interior / Worn - out -

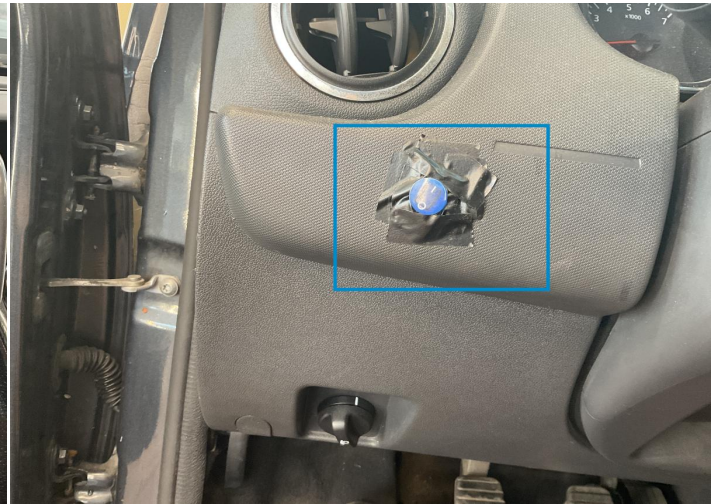
2. Dashboard / Front
Interior / Broken -

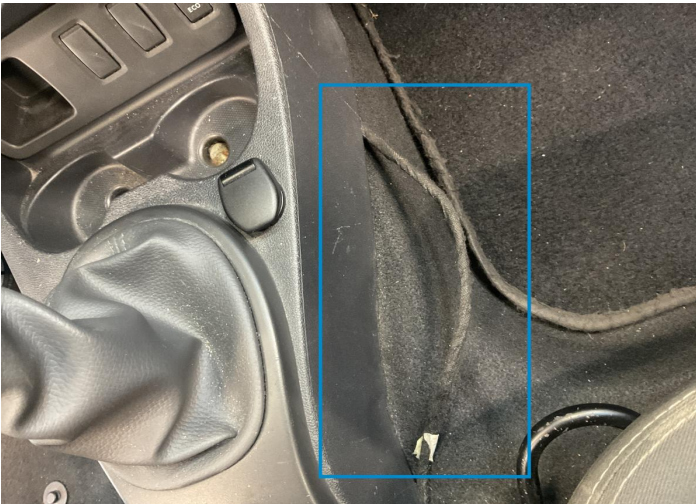
3. Center Console
Interior / Broken -

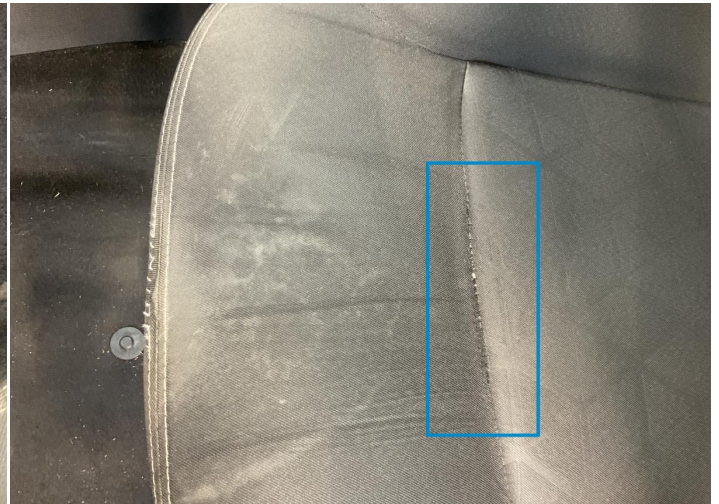
4. Seat Cushion / Front Left
Interior / Ripped -

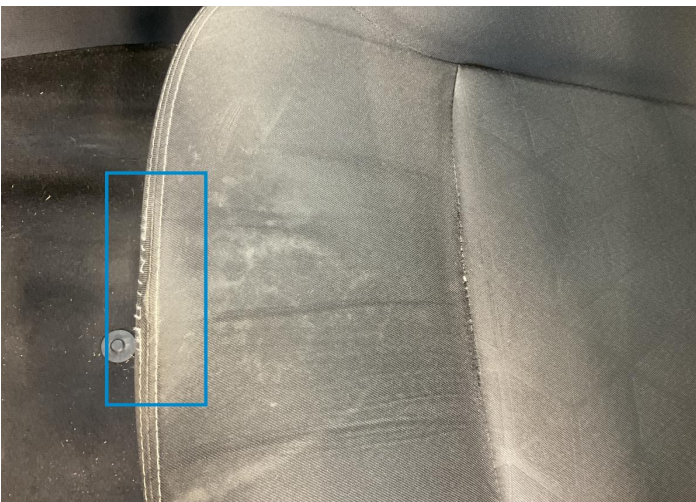
5. Seat Cushion / Front Left
Interior / Ripped -

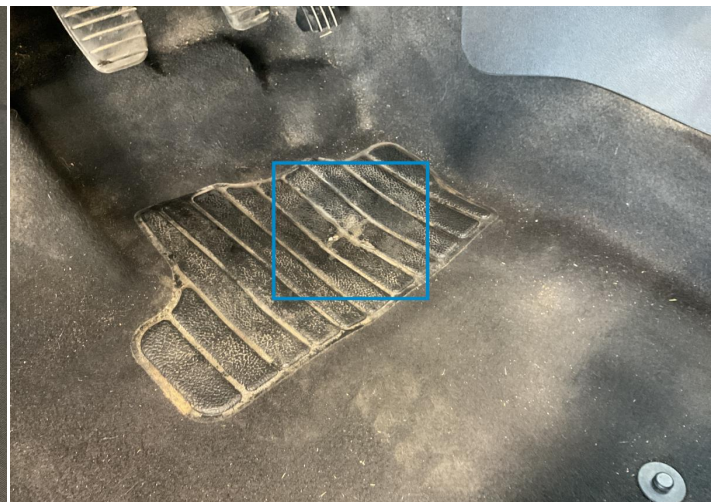
6. Floor Carpet
Interior / Ripped -

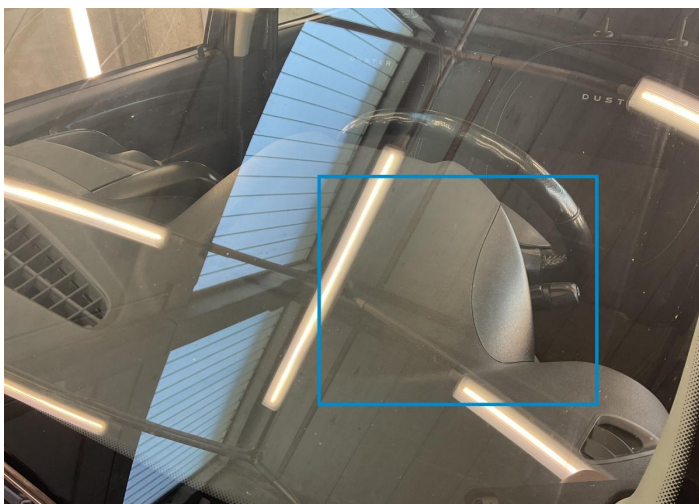
7. Windshield / Front
Glass Break / Impact -

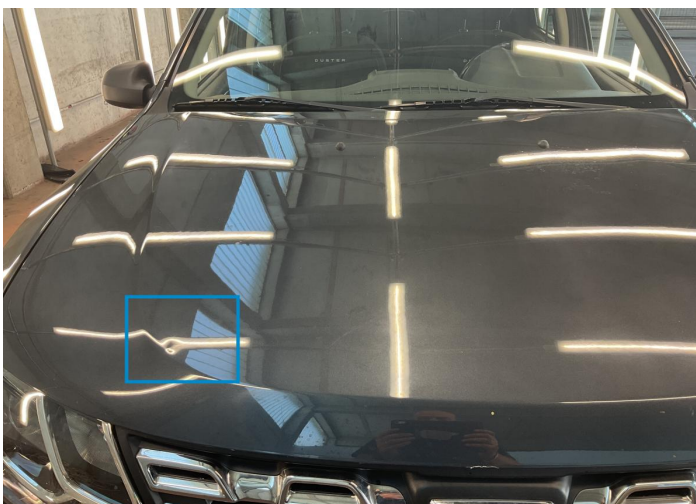
8. Hood
Bodywork / Dent -

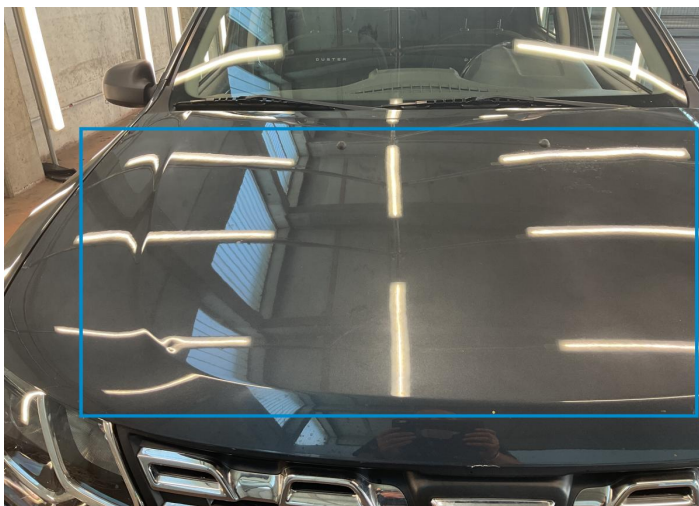
9. Hood
Bodywork / Dent -

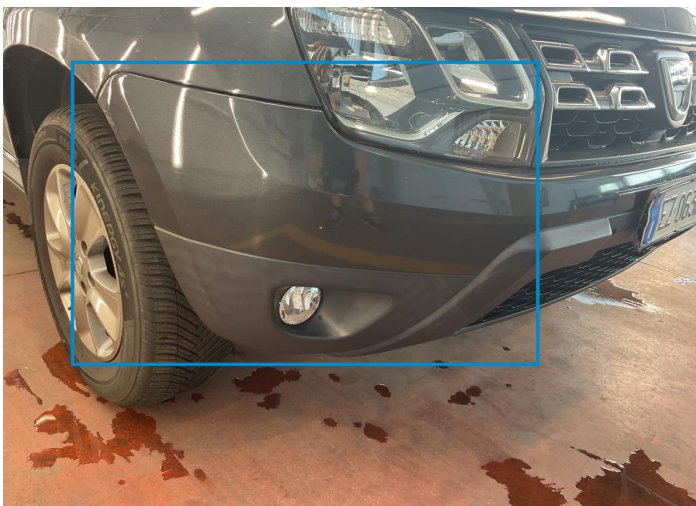
10. Bumper / Front
Bodywork / Dent -

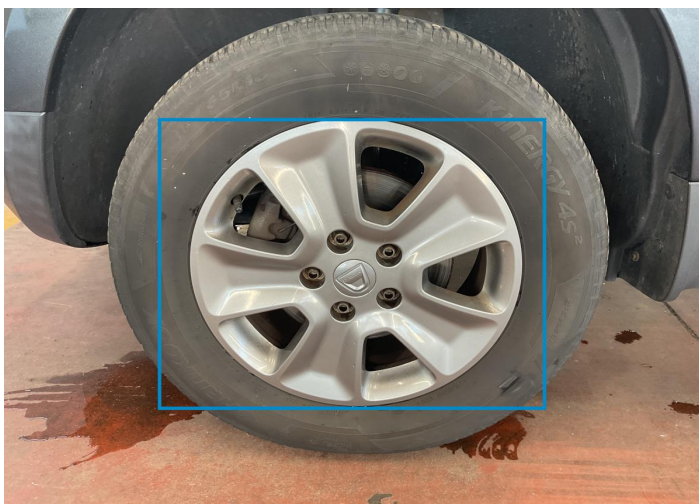
11. Rim / Front Left
Out of Bodywork / Scratch -

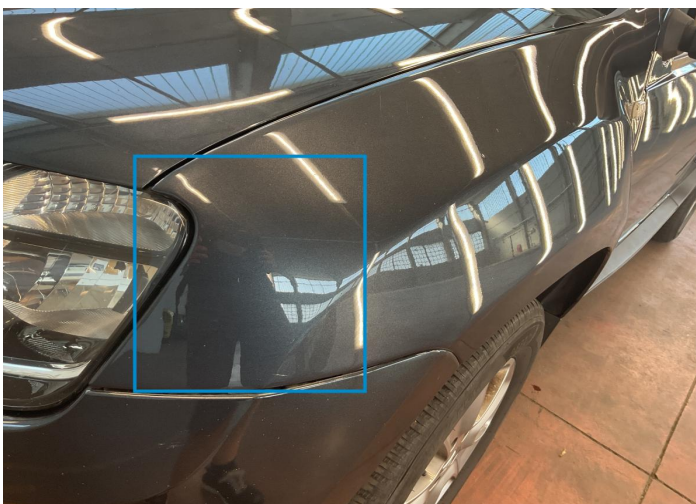
12. Fender / Front Left
Paint / Chipping -

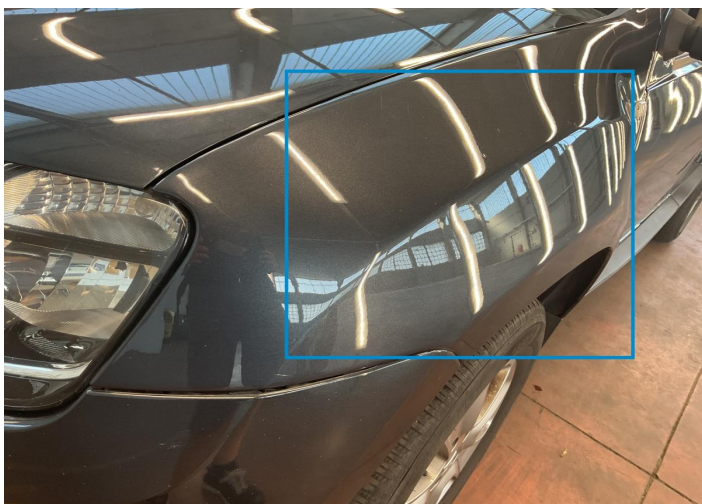
13. Fender / Front Left
Bodywork / Poor Previous Repair -

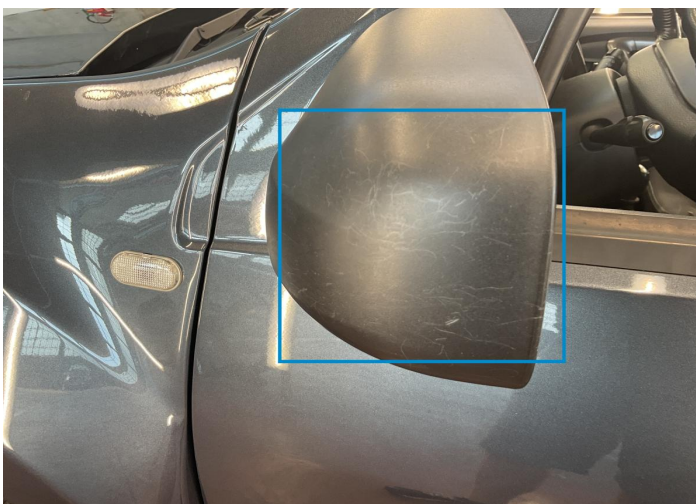
14. Mirror Shell / Front Left
Paint / Scratch / Line -

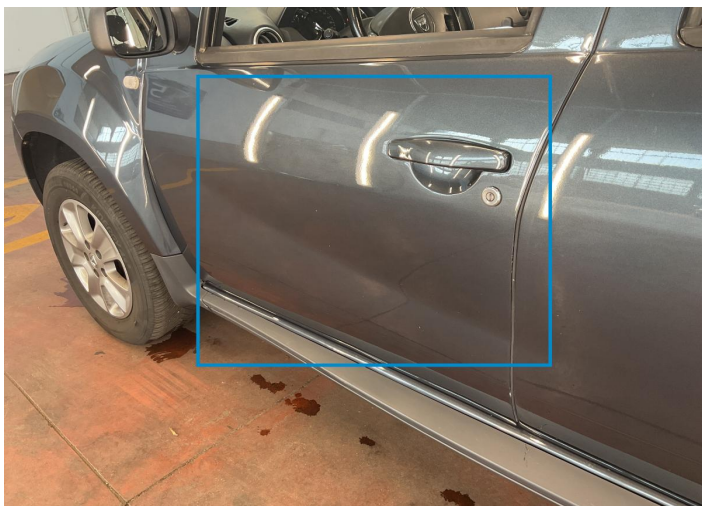
15. Door / Front Left
Bodywork / Dent -

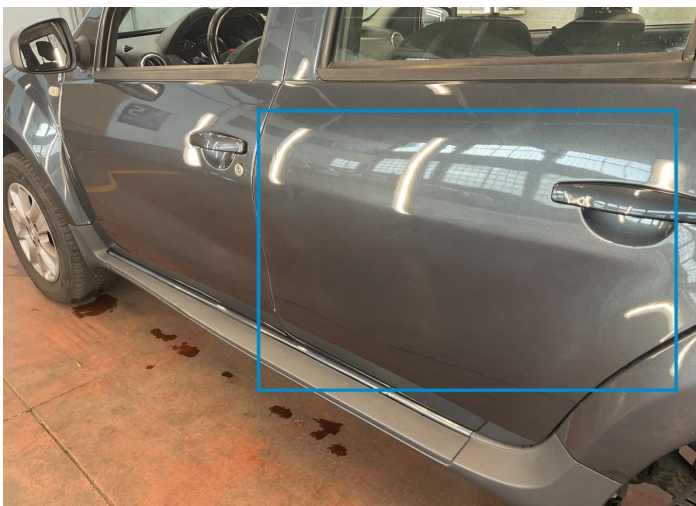
16. Door / Back Left
Bodywork / Dent -

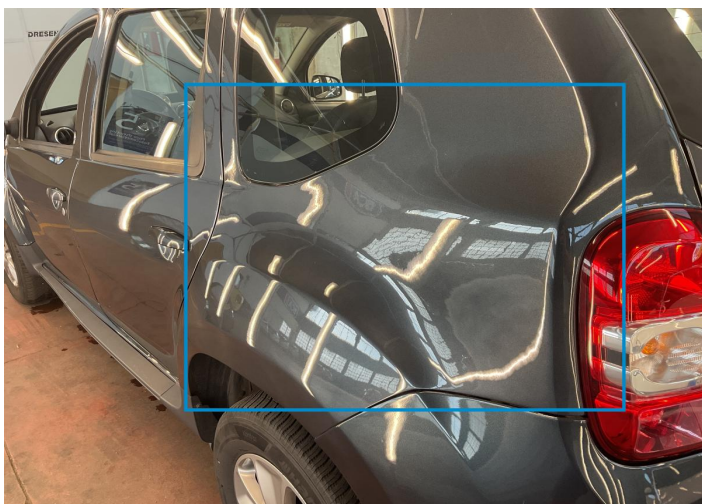
17. Fender / Back Left
Bodywork / Dent -

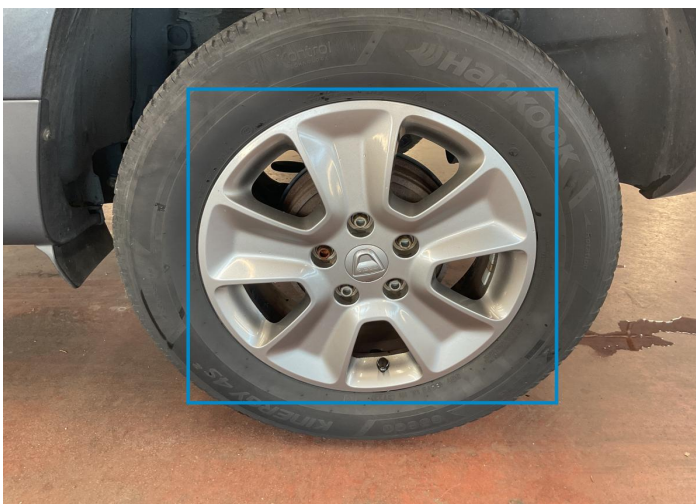
18. Rim / Back Left
Out of Bodywork / Scratch -

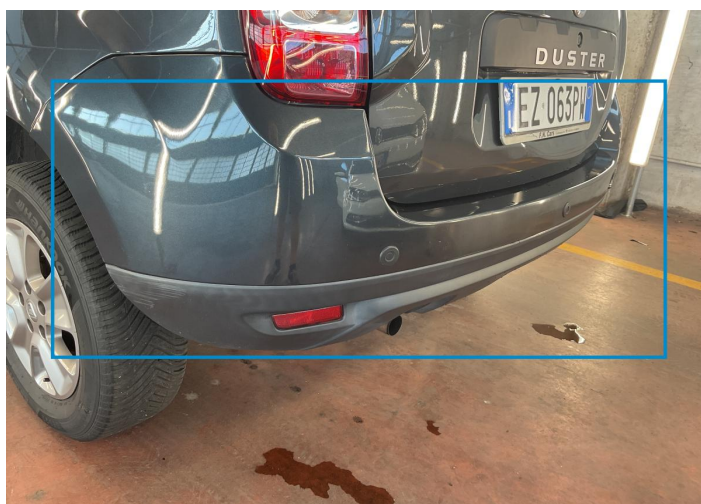
19. Bumper / Back
Bodywork / Dent -

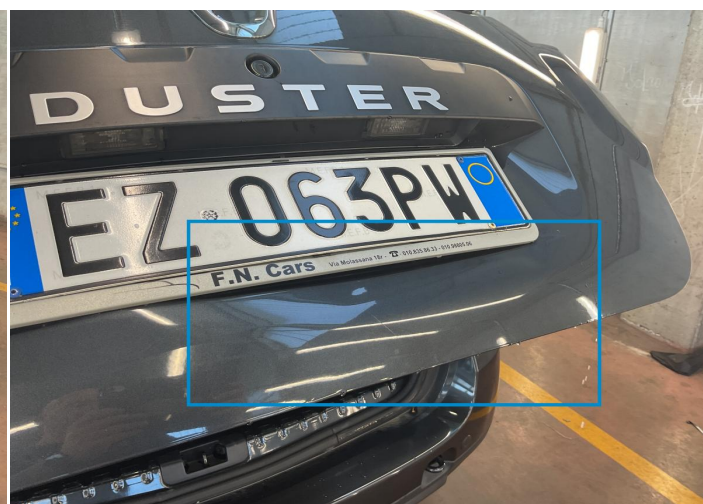
20. Tailgate
Bodywork / Dent -

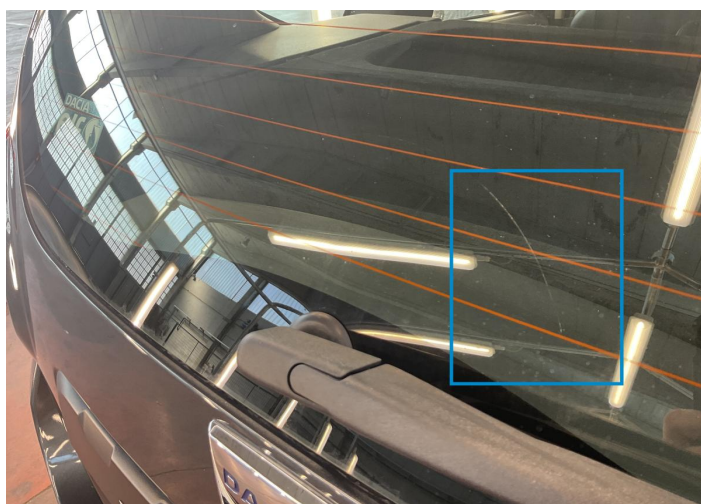
21. Rear Window / Back
Glass Break / Scratch -

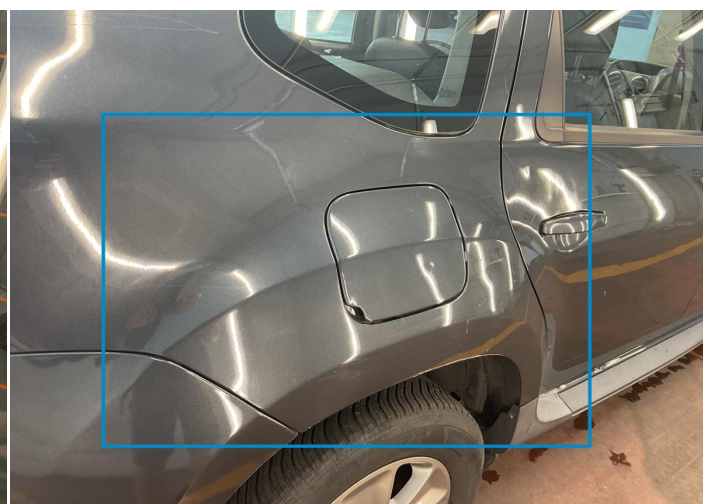
22. Fender / Back Right
Bodywork / Dent -

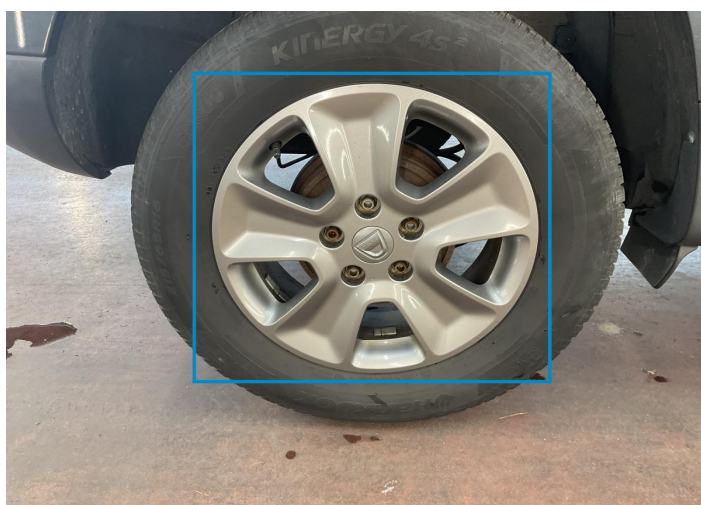
23. Rim / Back Right
Out of Bodywork / Scratch -

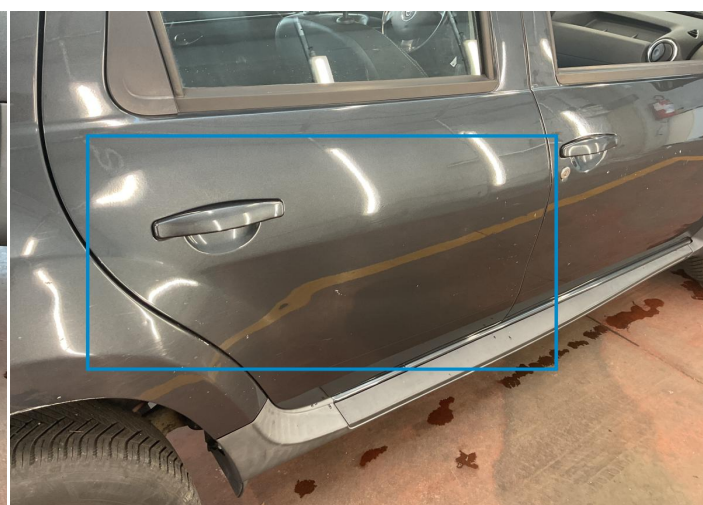
24. Door / Back Right
Bodywork / Dent -

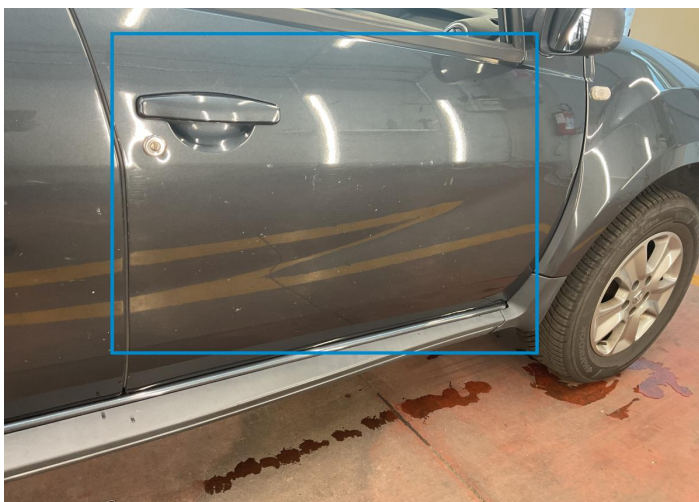
25. Door / Front Right
Bodywork / Dent -

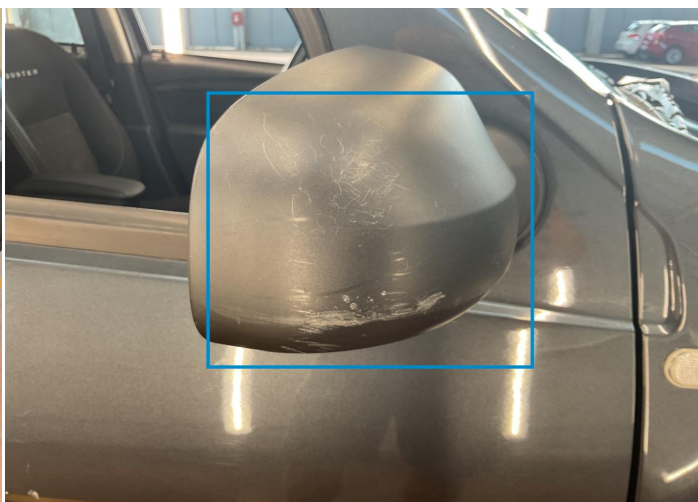
26. Mirror Shell / Front Right
Paint / Scratch / Line -

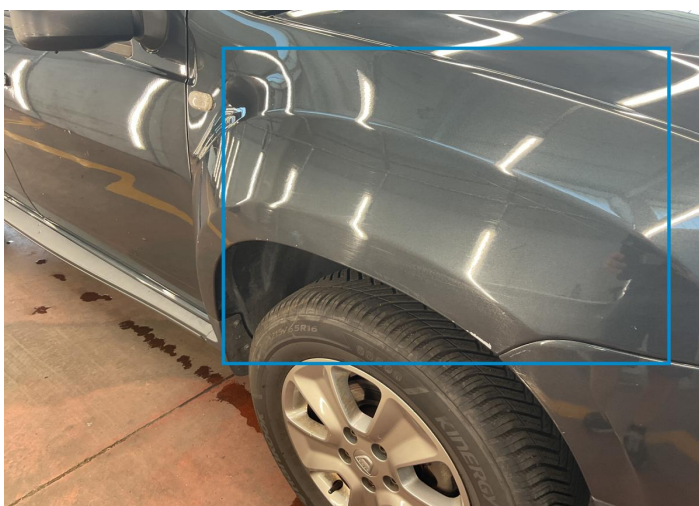
27. Fender / Front Right
Bodywork / Dent -

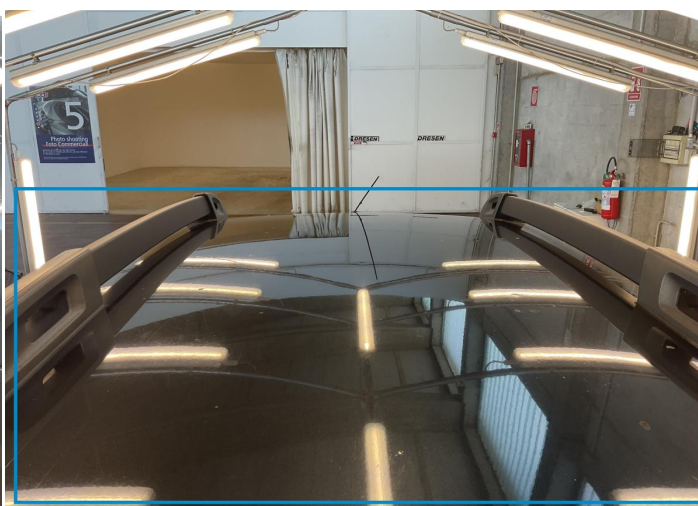
28. Roof
Bodywork / Dent / Hail Area -

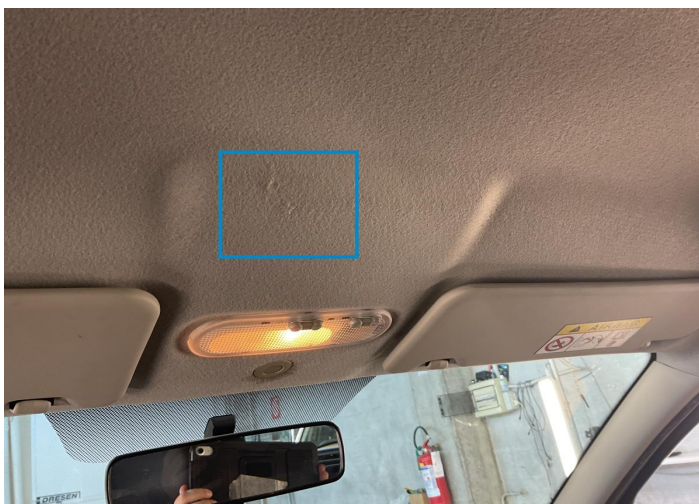
29. Roof Upholstery
Interior / Ripped -

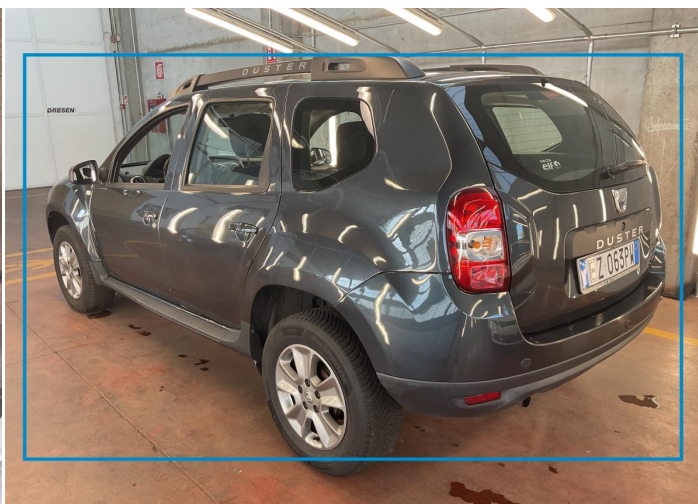
30.
Bodywork / Poor Previous Repair -

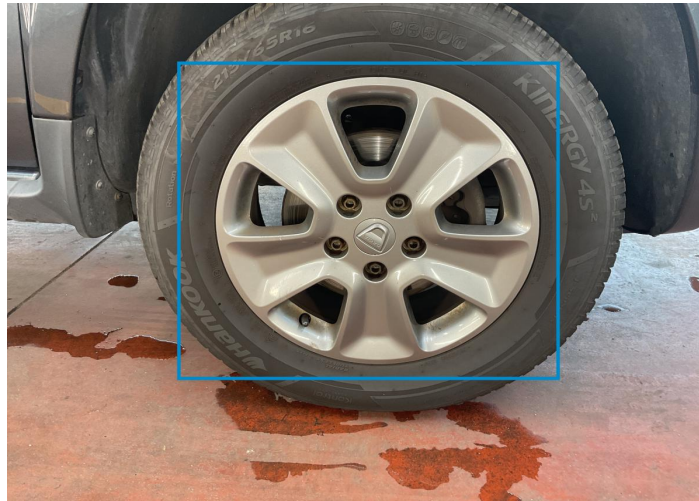
31. Rim / Front Right
Out of Bodywork / Scratch -
