DACIA DUSTER  
Duster 1.5 dCi 110 4x4 Ambiance

VIN NO UU1HSDADG52012089

Inspection Report Summary

Customer	BCAuto Encheres	Report Number	P20251001163205
Inspection Date / Place	2025-10-01 / BCA SOLOGNE	Cosmetic Grade	4

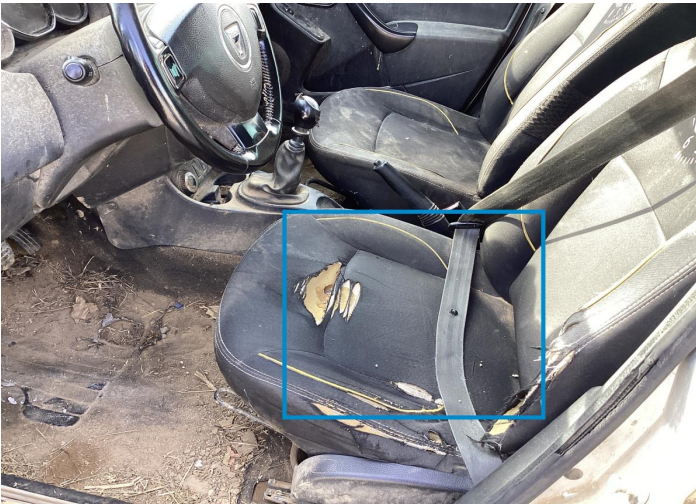
1. Seat / Front Left  
Interior / Ripped -

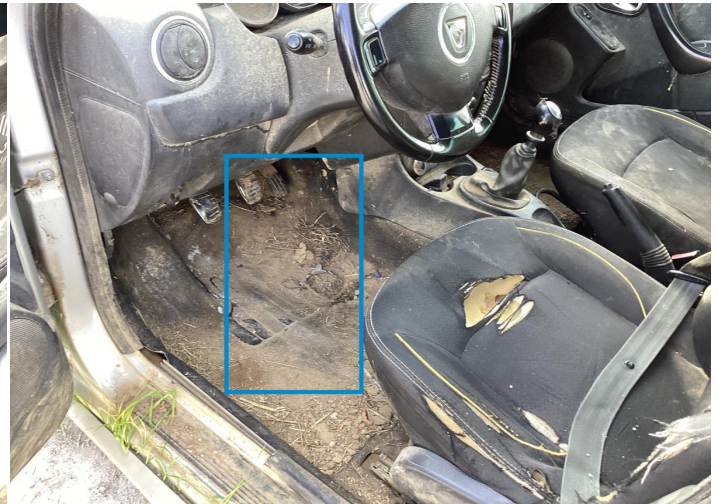
2. Floor Carpet  
Interior / Dirty -

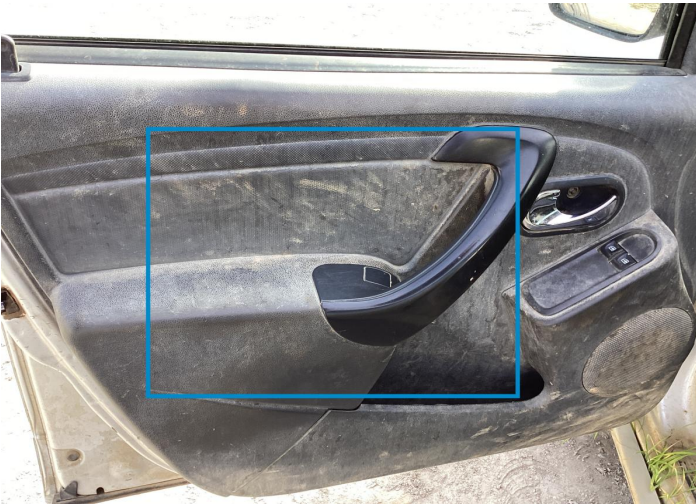
3. Panel Filling / Front Left  
Interior / Dirty -

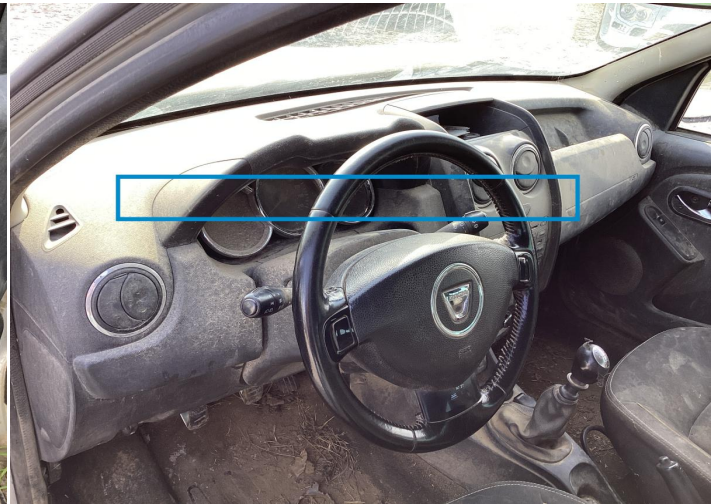
4. Dashboard / Front  
Interior / Dirty -

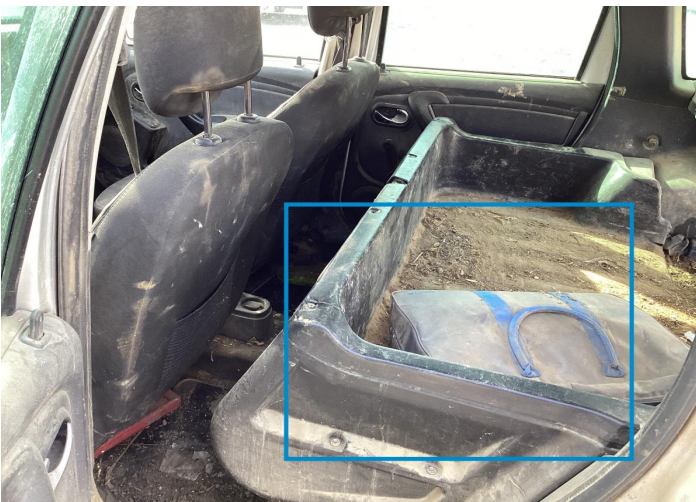
5. Seat / Back Center  
Interior / Dirty -

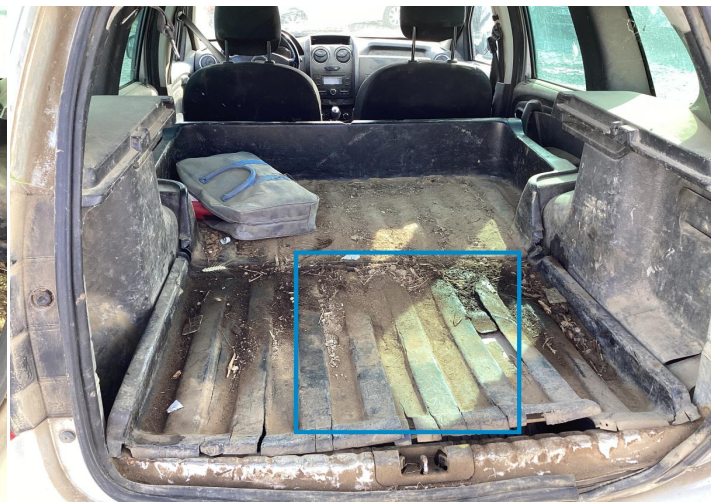
6. Trunk Carpet  
Interior / Dirty -

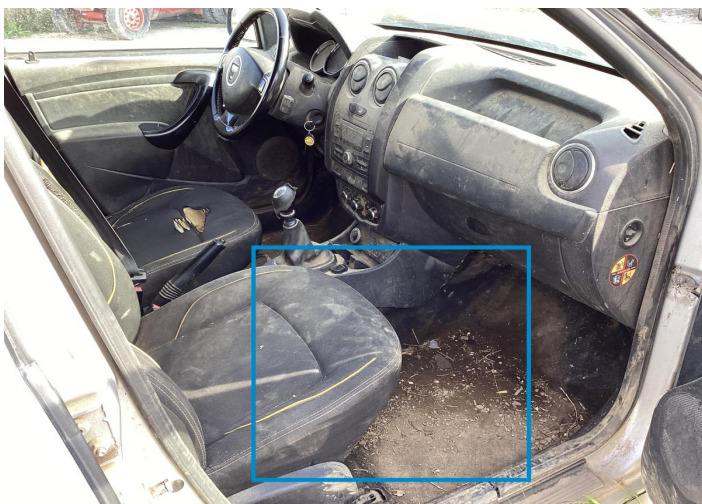
7. Seat / Front Right  
Interior / Dirty -

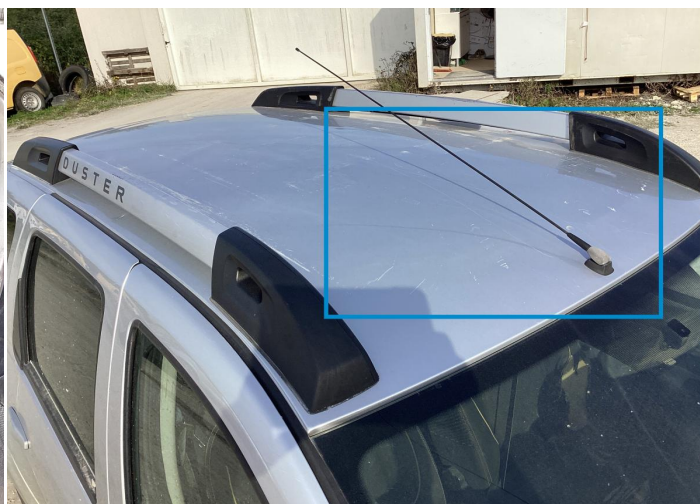
8. Roof  
Paint / Scratch / Line -

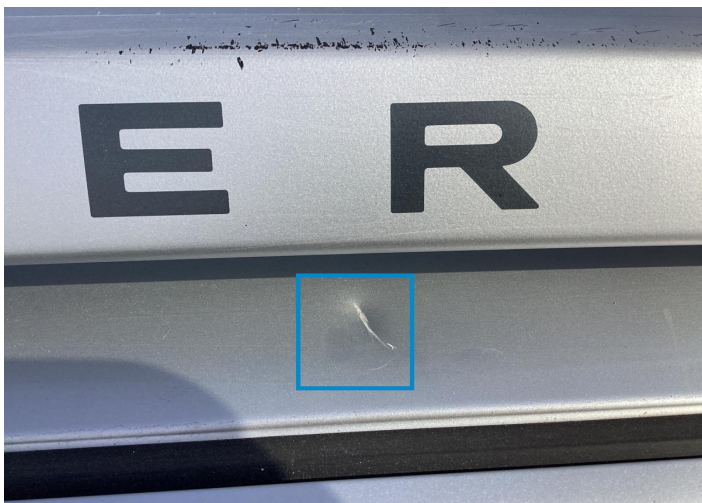
9. Roof  
Bodywork / Dent / Dent -

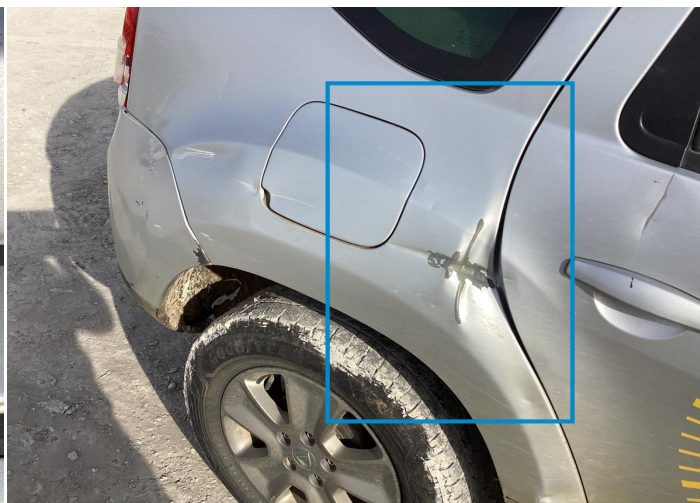
10. Fender / Back Right  
Bodywork / Dent / Deformation -

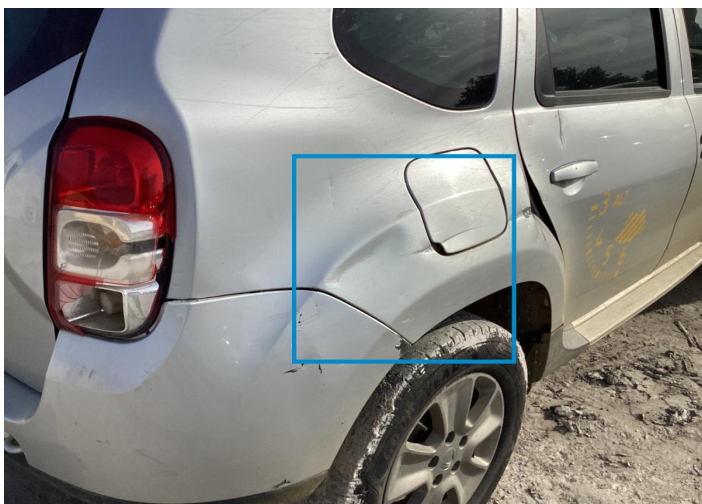
11. Fender / Back Right  
Bodywork / Dent / Dent -

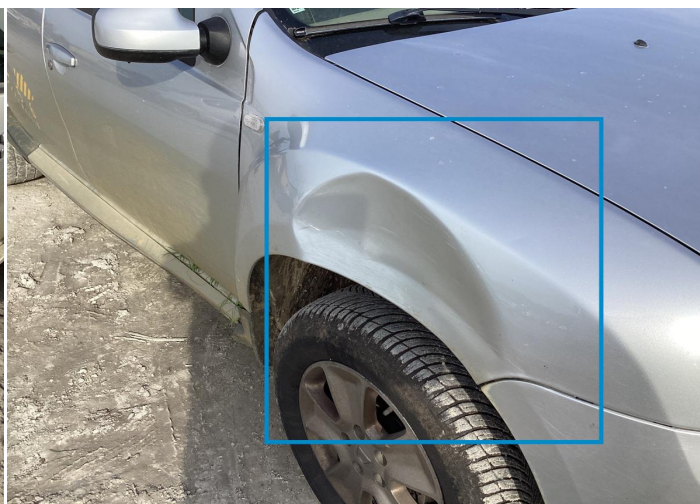
12. Fender / Front Right  
Bodywork / Dent / Deformation -

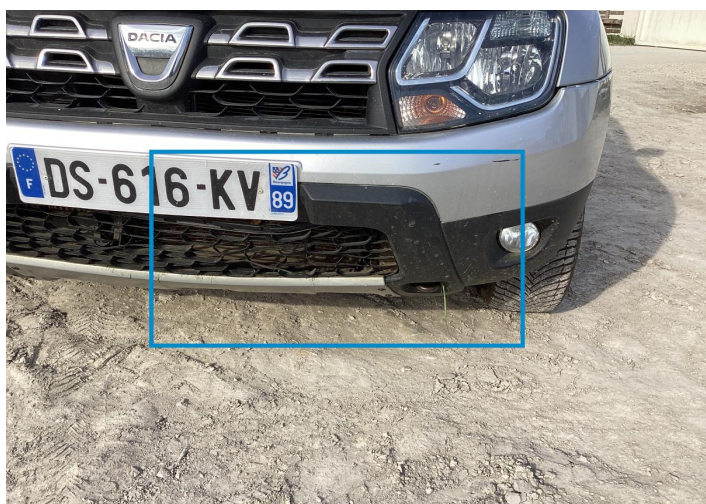
13. Shield / Front  
Bodywork / Dent / Deformation -

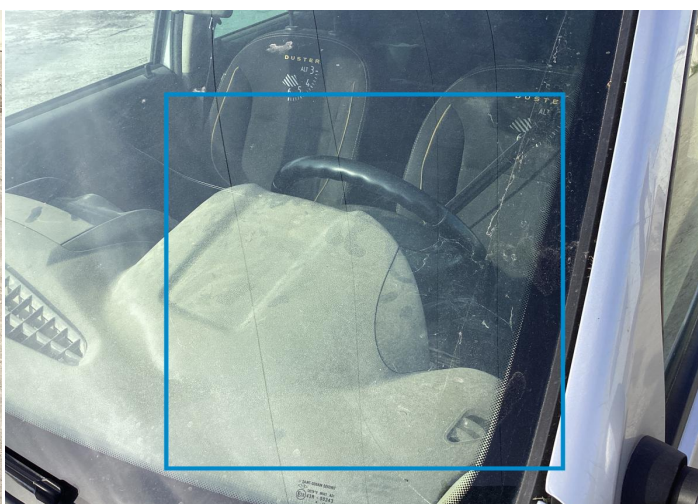
14. Windshield / Front  
Glass Break / Impact -

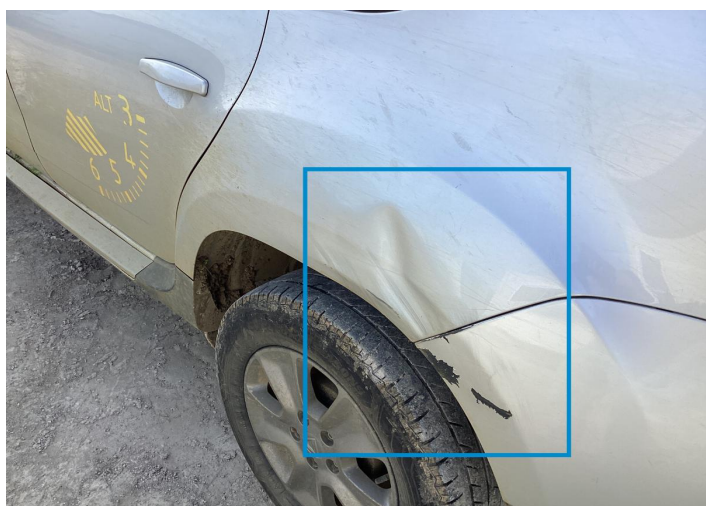
15. Fender / Back Left  
Bodywork / Dent / Deformation -

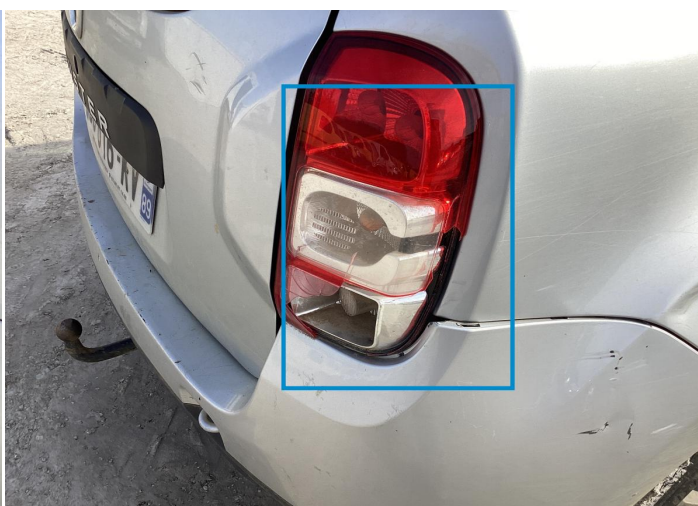
16. Back Light / Right  
Bodywork / Breakage / Crack -

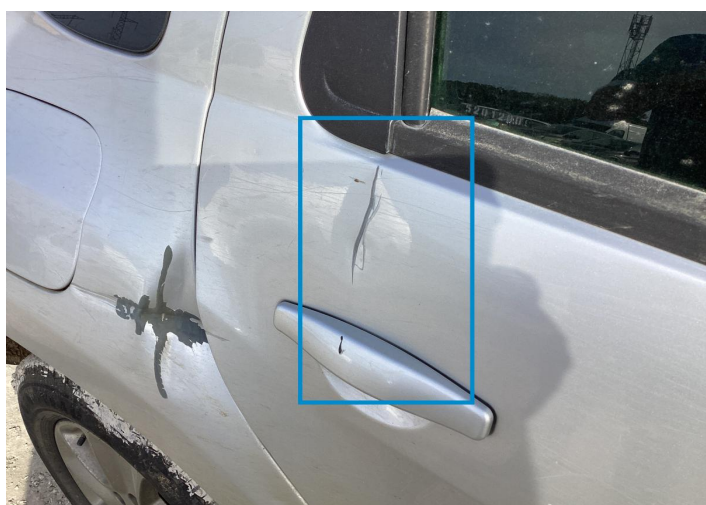
17. Door / Back Right  
Bodywork / Dent / Dent -

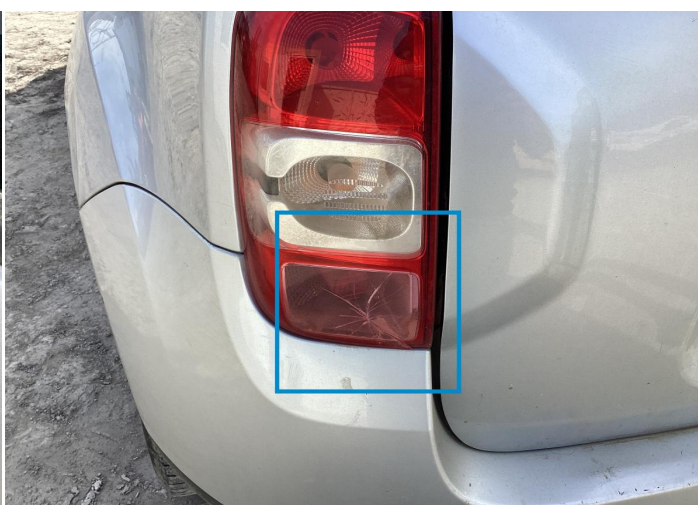
18. Back Light / Left  
Bodywork / Breakage -
