DACIA DUSTER Duster TCe 125 4x2 Prestige Edition 2016

VIN NO UU1HSDCW654013443 Registration Number DY737YR

Inspection Report Summary

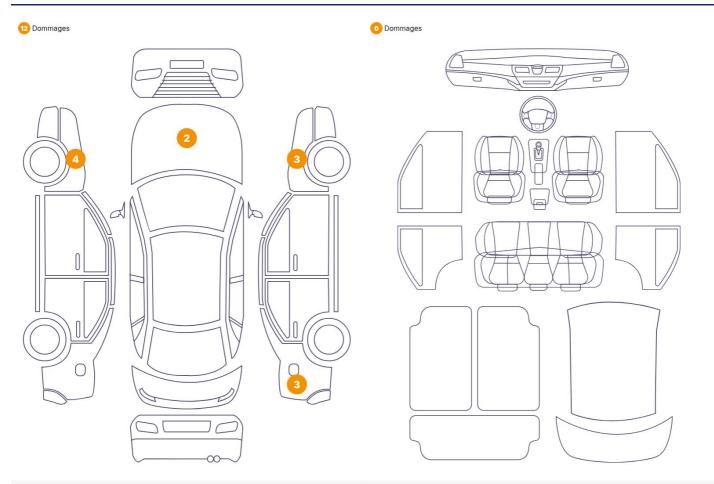
Cosmetic Damage

| | Component | Damage | Comments |
|---|---|---|---|
| 1 | Fender / Front Left | Paint / Scratch / Scuff | |
| 2 | Fender / Front Left | Bodywork / Breakage | |
| 3 | Fender / Front Left | Paint / Stone Chip | |
| 4 | Fender / Front Left | Bodywork / Dent / Dent | |
| 5 | Side Panel / Back Right | Paint / Scratch / Scuff | |
| 6 | Side Panel / Back Right | Bodywork / Dent / Dent | |
| 7 | Side Panel / Back Right | Paint / Scratch / Line | |
| 8 | Fender / Front Right | Paint / Stone Chip | |
| 9 | Fender / Front Right | Paint / Scratch / Line | |
| 10 | Fender / Front Right | Paint / Chipping | |
| 11 | Hood | Paint / Scratch / Scuff | |
| 12 | Hood | Paint / Stone Chip | |

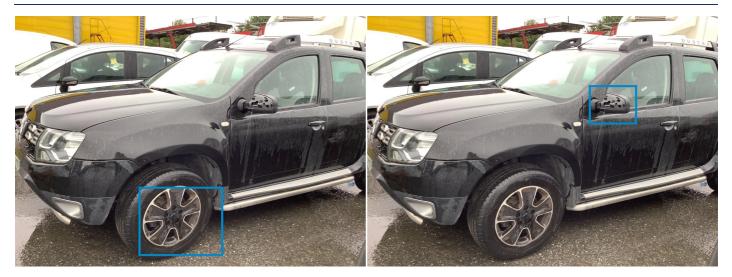
1. Fender / Front Left Paint / Scratch / Scuff -

2. Fender / Front Left Bodywork / Breakage -

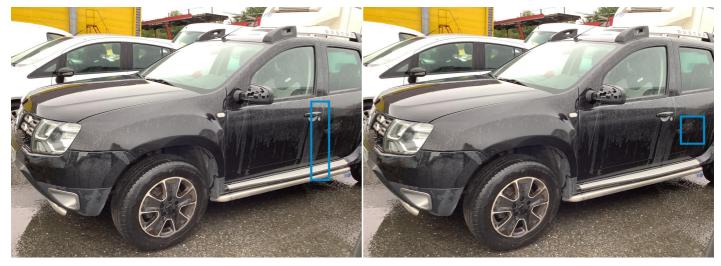
3. Fender / Front Left Paint / Stone Chip -

4. Fender / Front Left Bodywork / Dent / Dent -

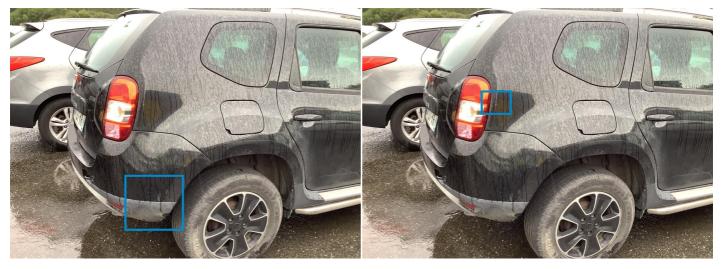
5. Side Panel / Back Right Paint / Scratch / Scuff -

6. Side Panel / Back Right Bodywork / Dent / Dent -

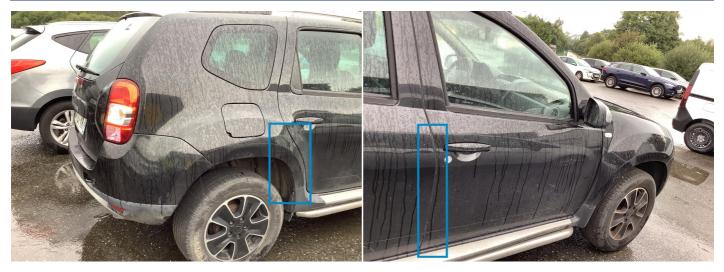
7. Side Panel / Back Right Paint / Scratch / Line -

8. Fender / Front Right Paint / Stone Chip -

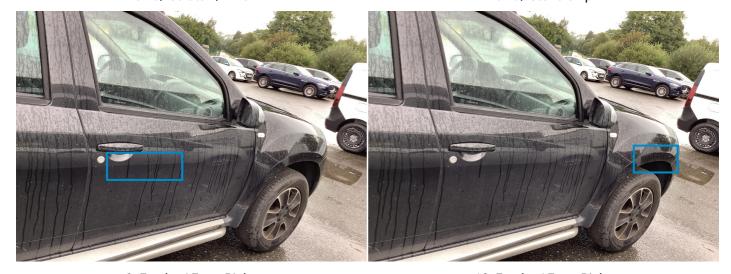
9. Fender / Front Right Paint / Scratch / Line -

10. Fender / Front Right Paint / Chipping -

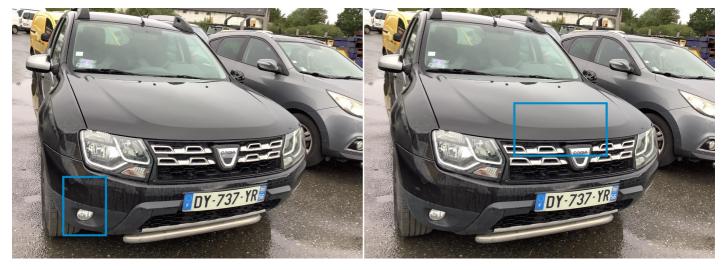
11. Hood Paint / Scratch / Scuff -

12. Hood Paint / Stone Chip -
