## status report

#### Dacia Dokker Stepway

| Vehicle identification number | <b>UU1K6720164200706</b> | mileage read: | <b>75797 km</b> |

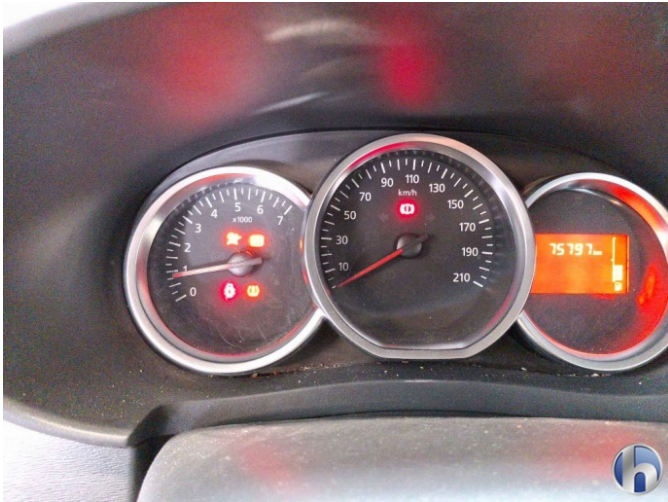
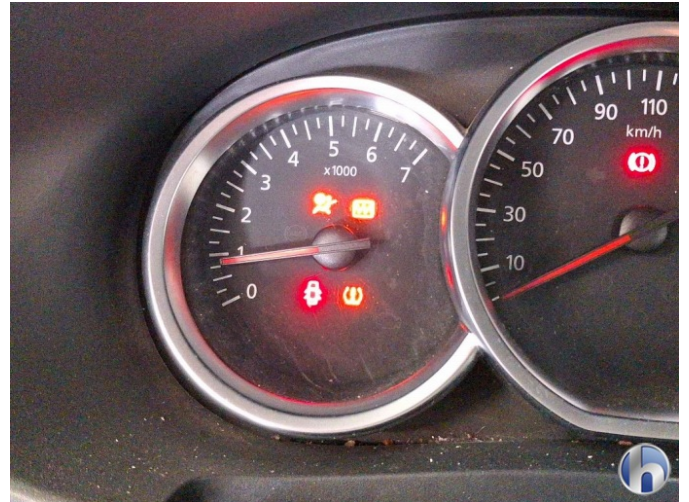
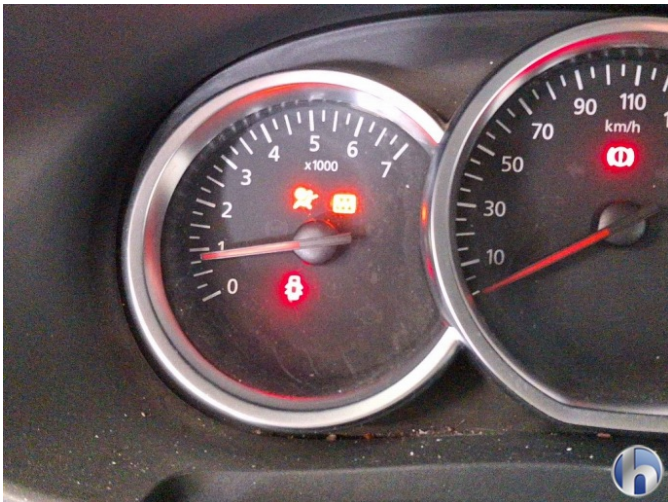
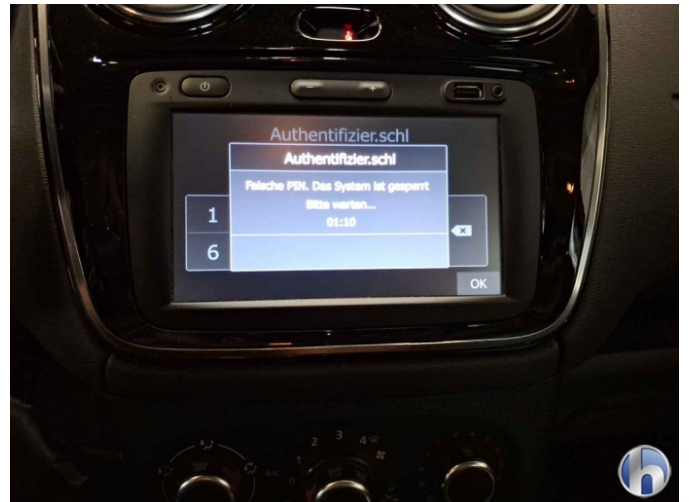
| component | Damage | Rep kind |
|---|---|---|
| 1. Fehlermeldungen, Schaden erweiterung möglich | Error message | Carry out a fault diagnosis |

1. Fehlermeldungen, Schaden erweiterung möglich

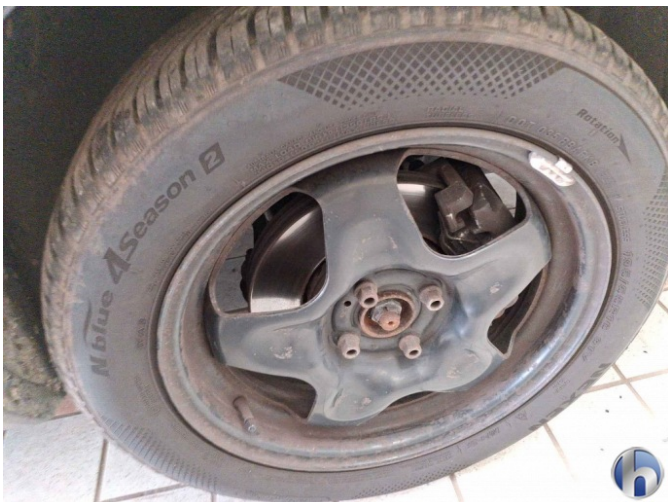
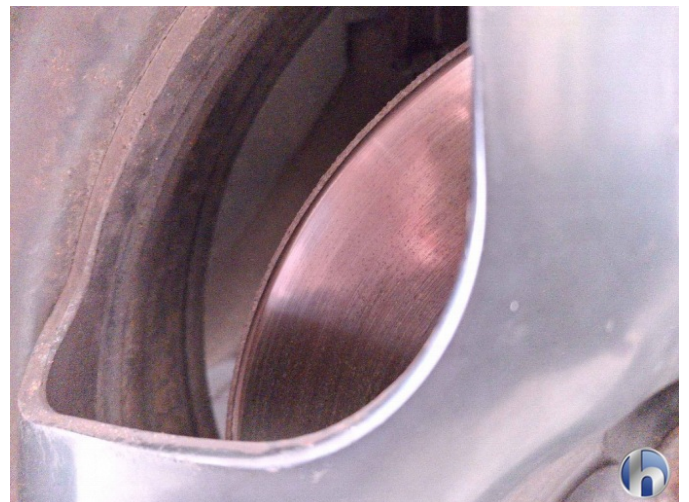
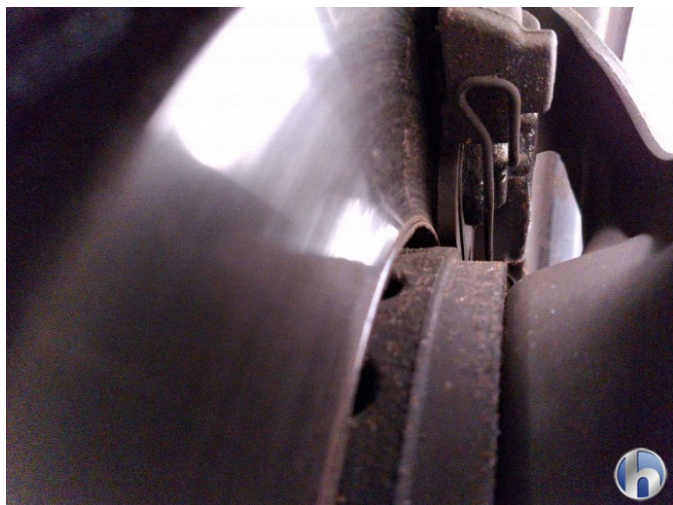
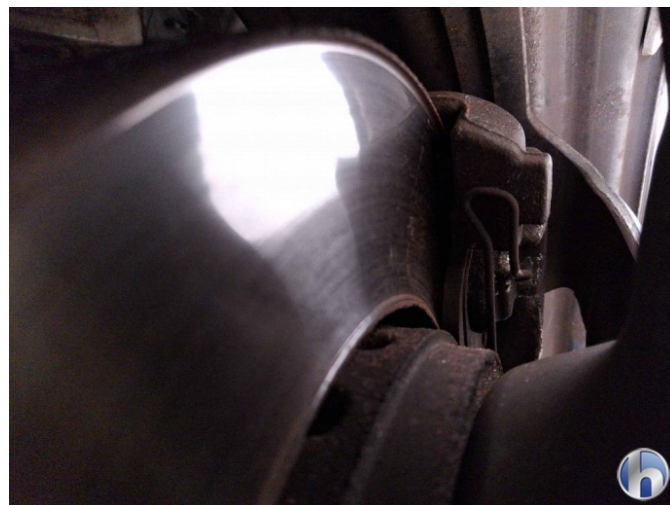
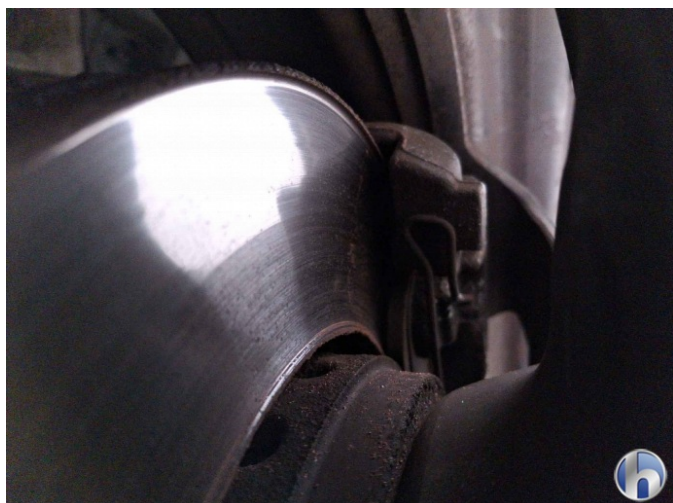
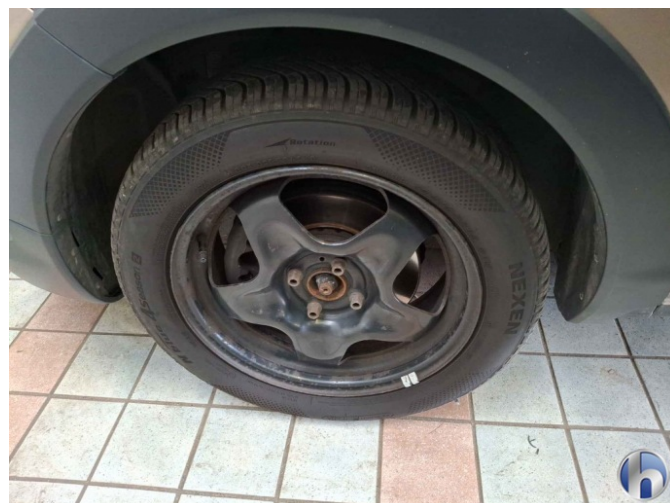
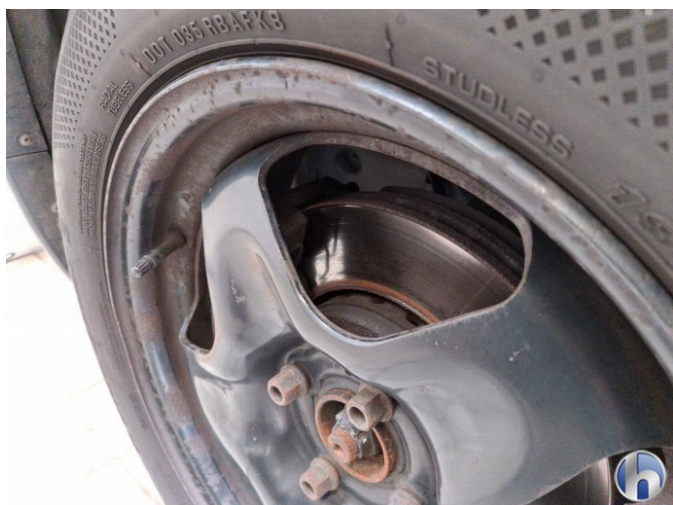
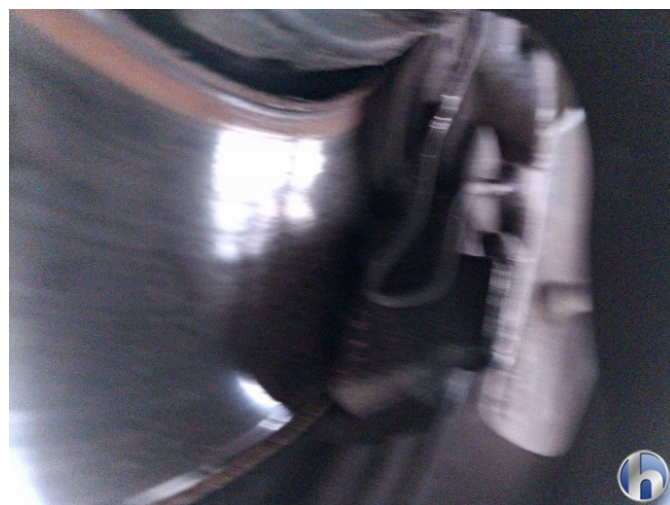
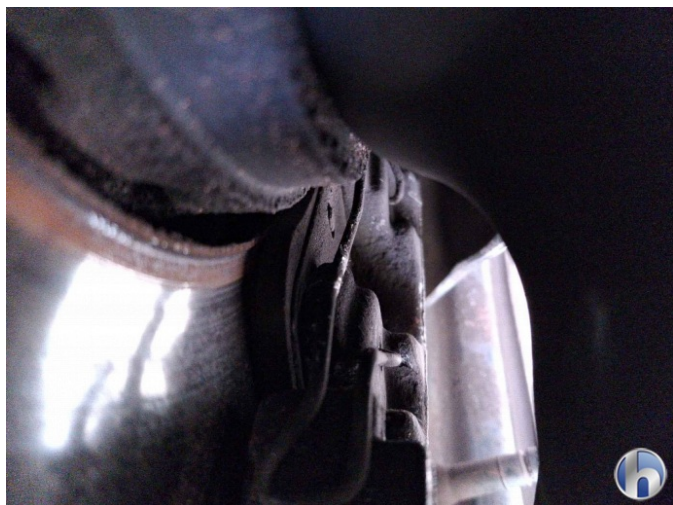
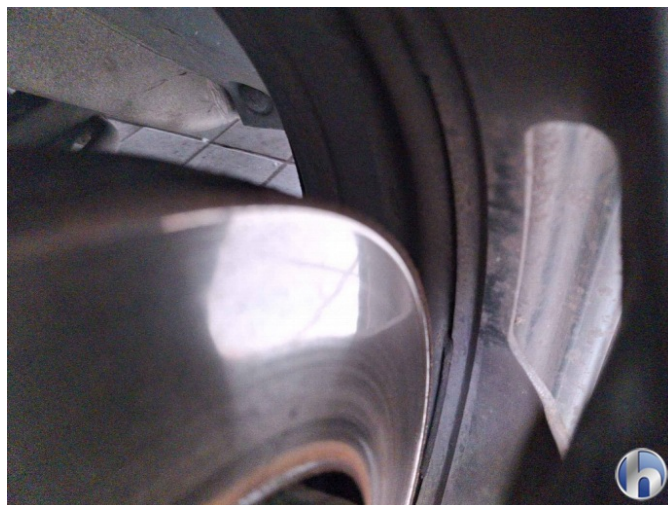
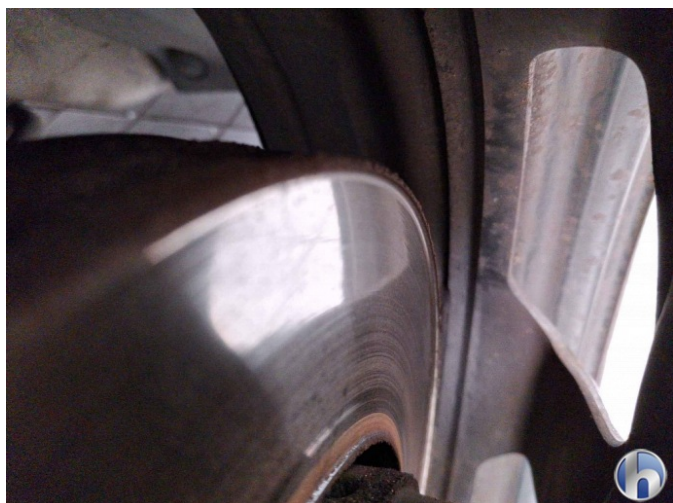
| component | Damage | Rep kind |
|---|---|---|
| 2. | Not okay | Replace |

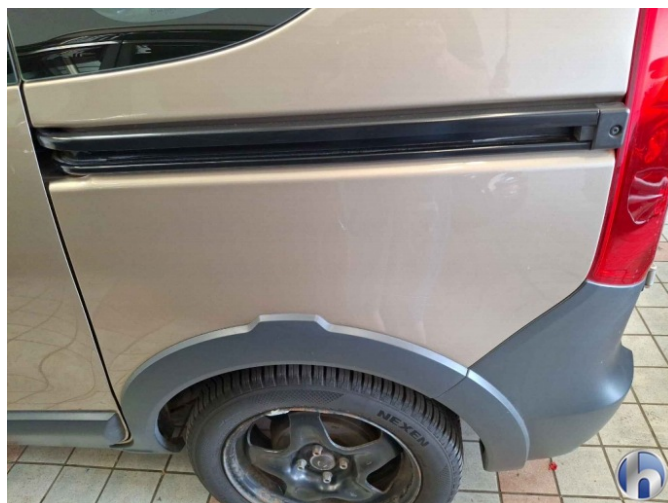
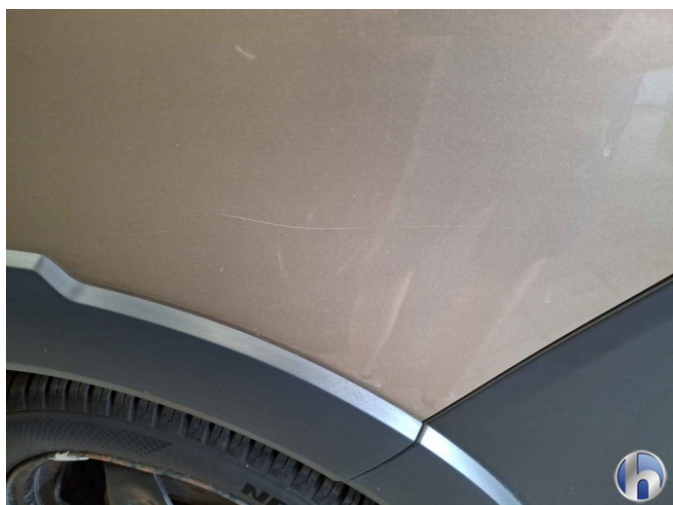
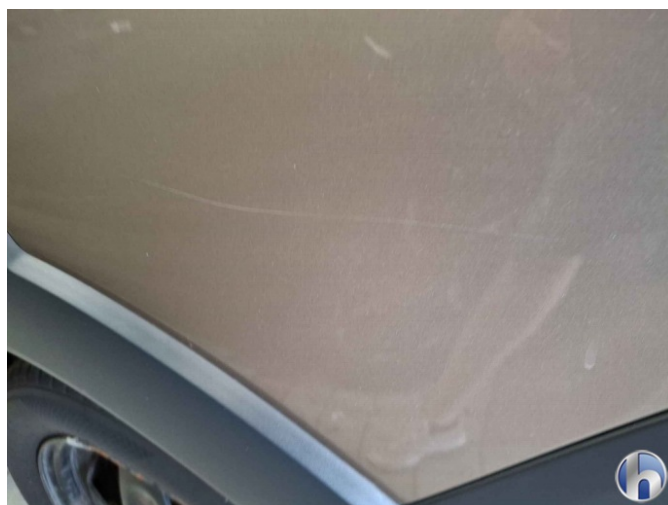
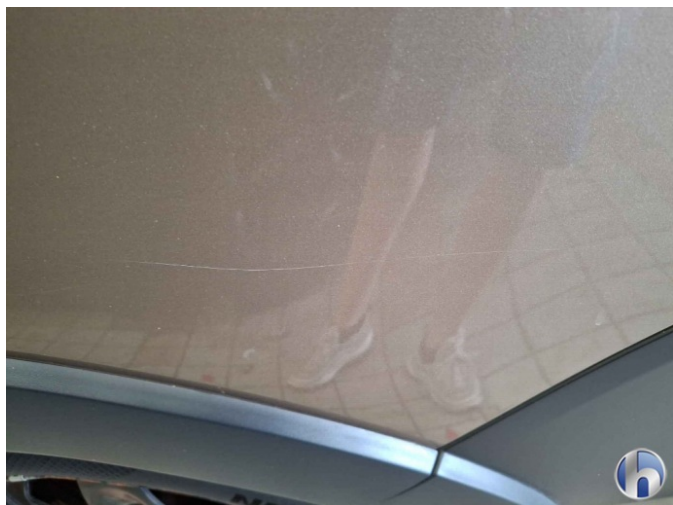
| component | Damage | Rep kind |
|---|---|---|
| 4. Sidewall - Rear - Left | Scratch(es) | Smart repair |

4. Sidewall - Rear - Left

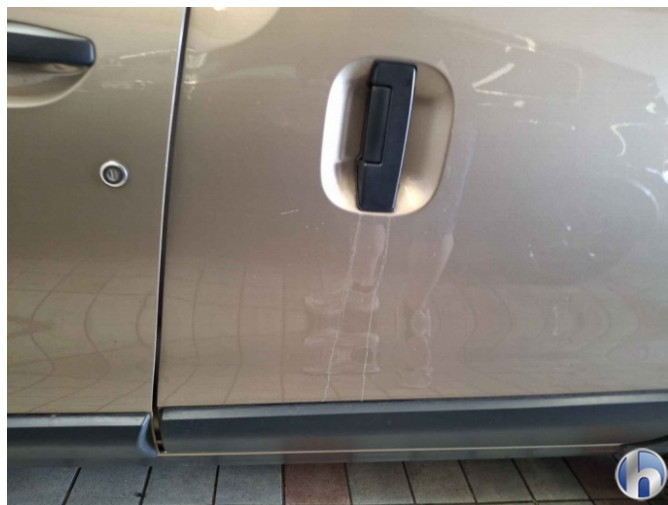
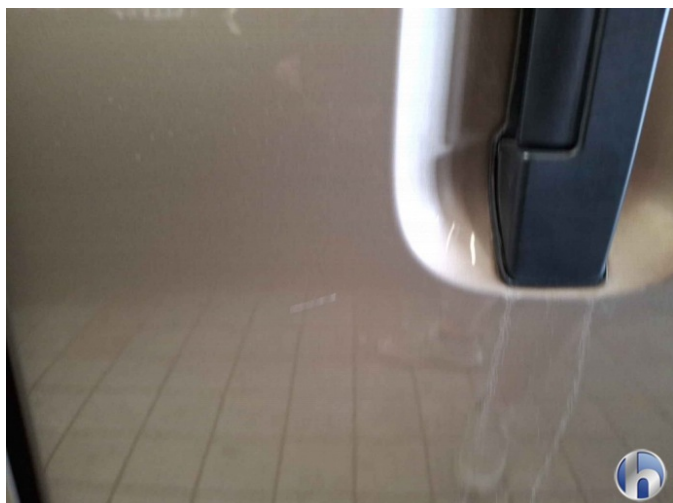
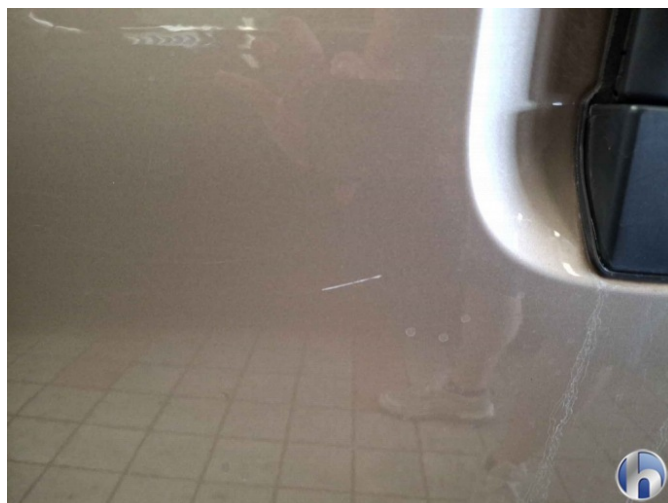
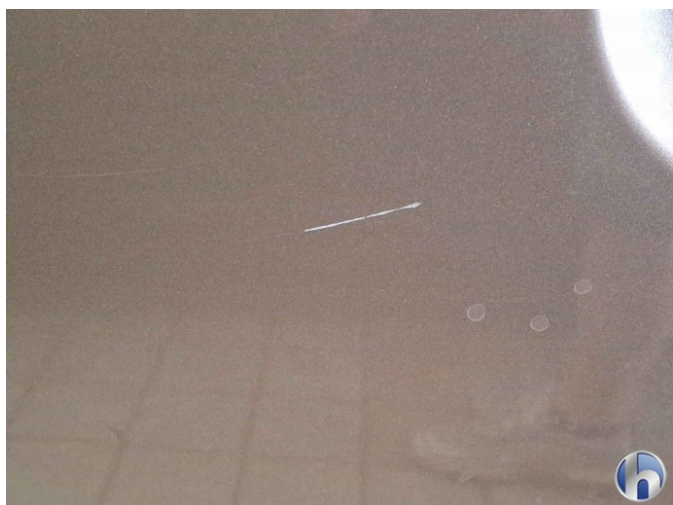
| component | Damage | Rep kind |
|---|---|---|
| 5. Rear door - left | Scratch(es) | Smart repair |

5. Rear door - left

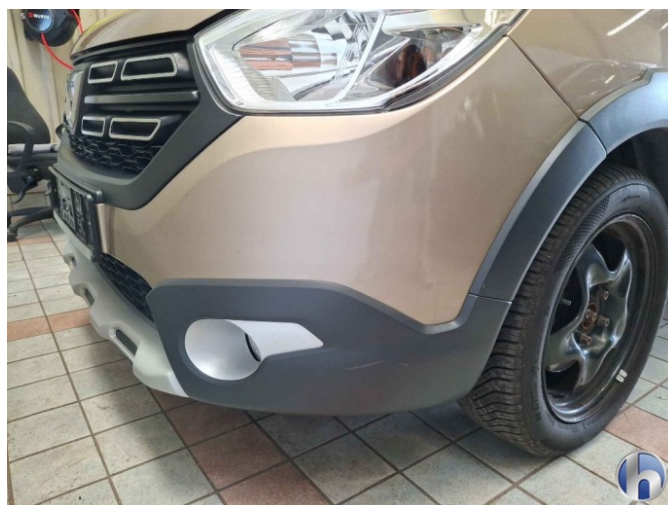
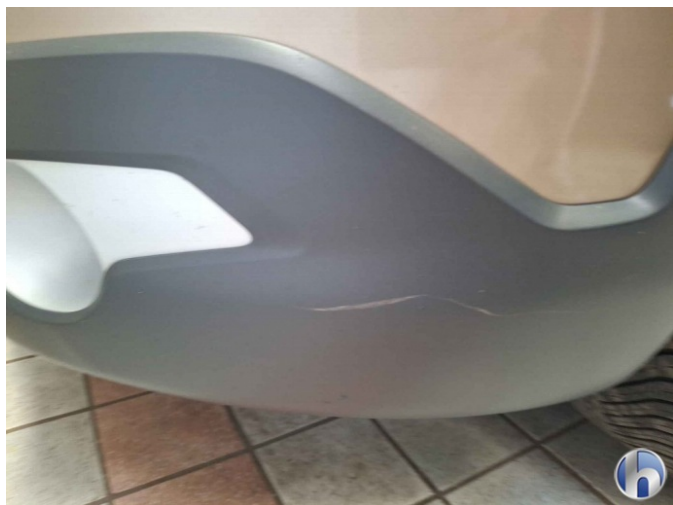
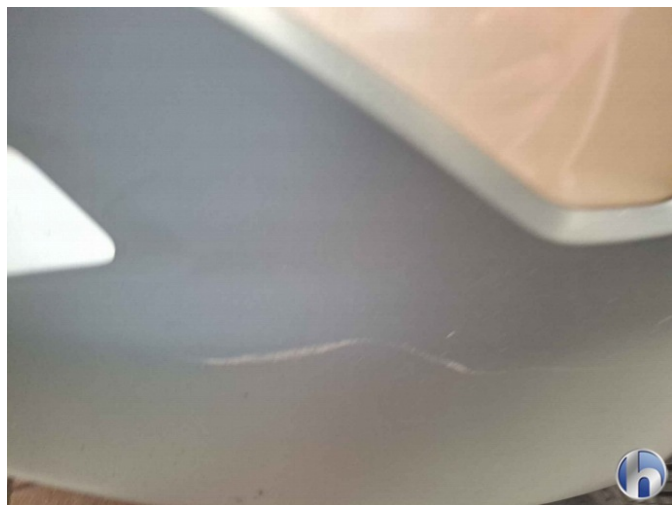
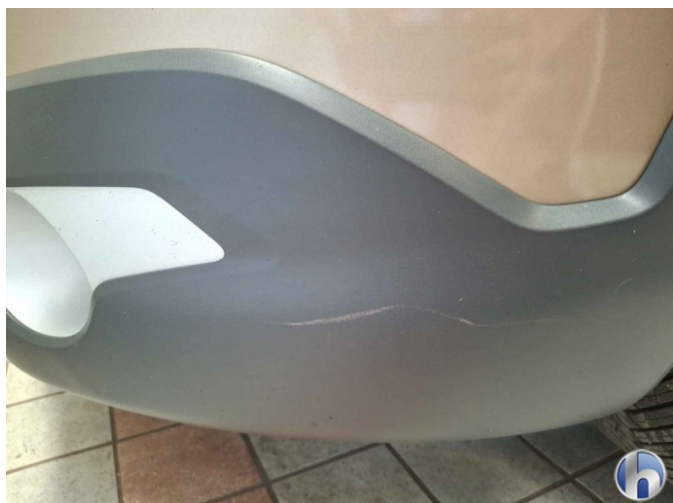
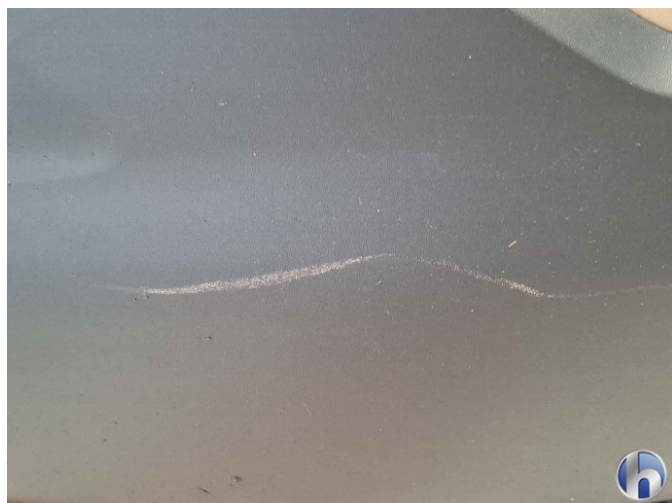
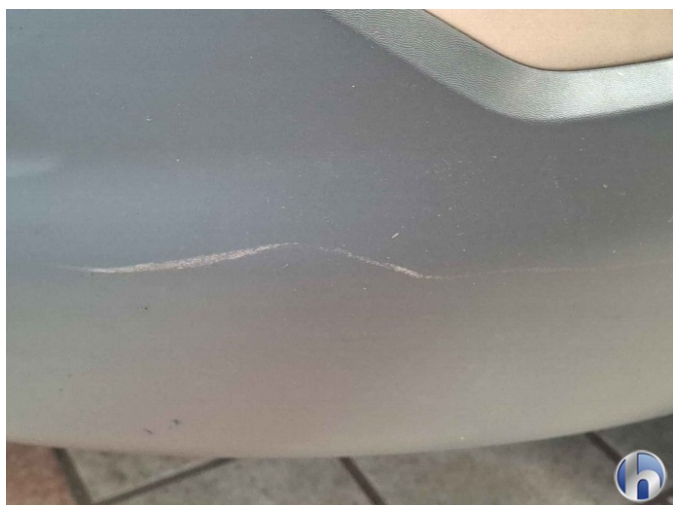
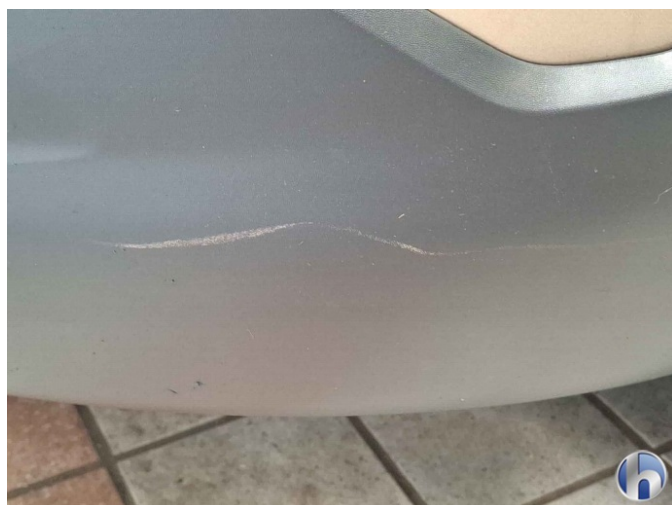
| component | Damage | Rep kind |
|---|---|---|
| 6. spoiler | Scratch(es) | Replace |

6. spoiler

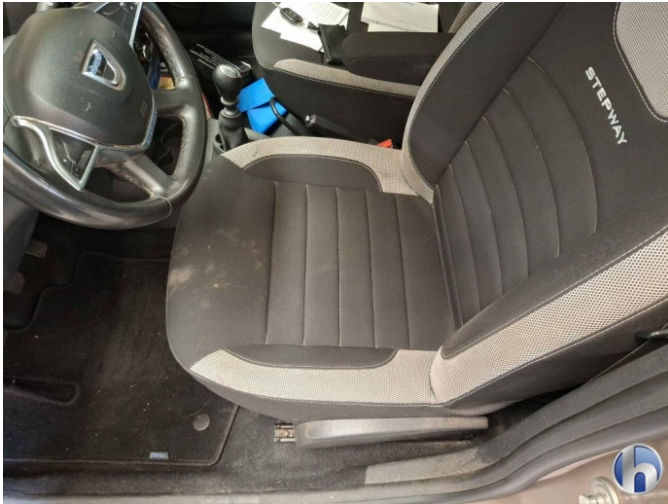
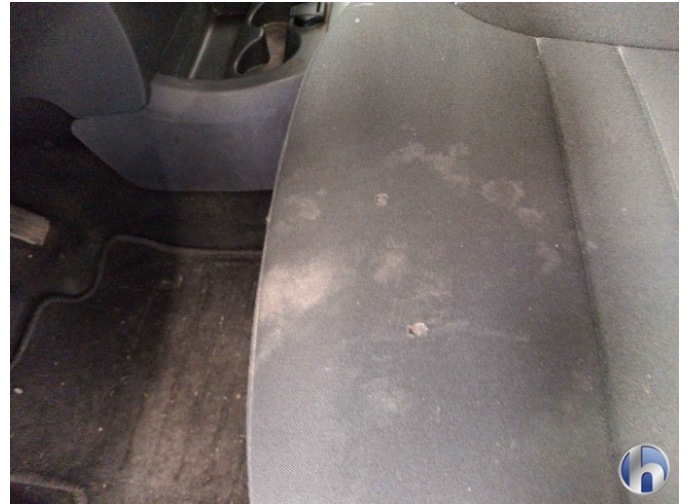
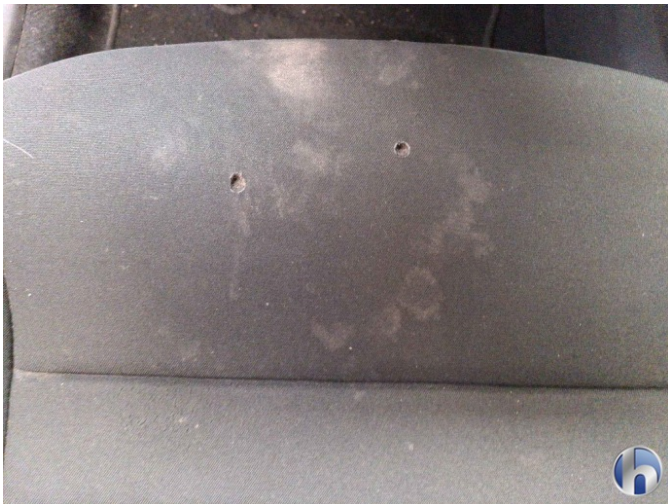
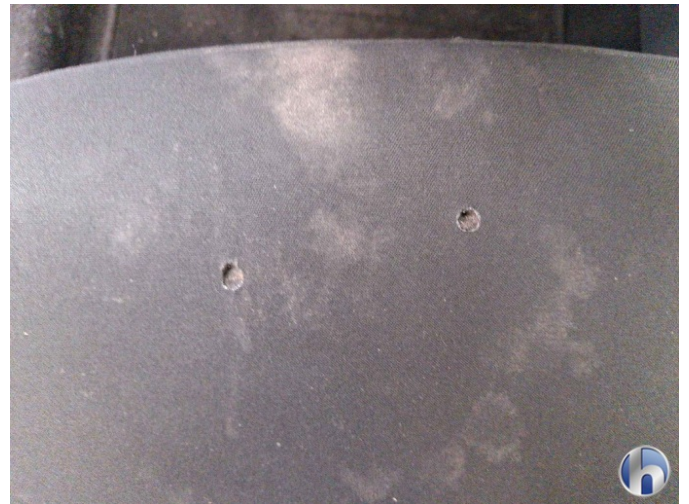
| component | Damage | Rep kind |
|---|---|---|
| 7. | Burn hole | Replace |

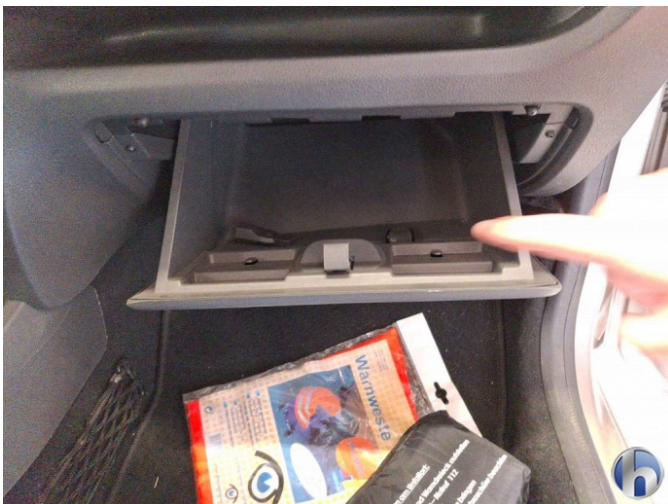
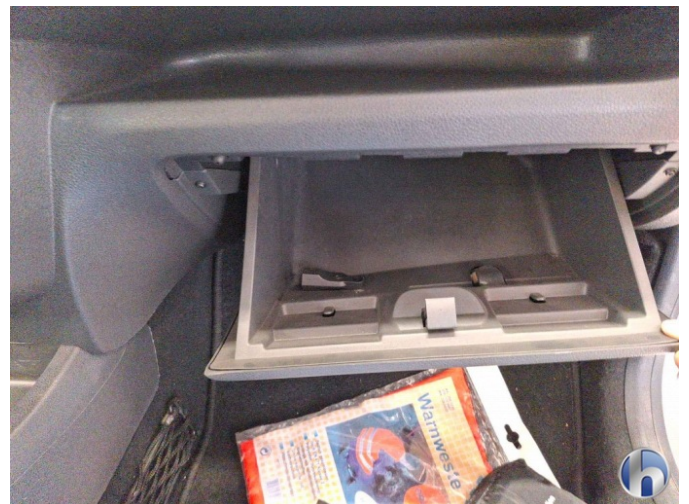
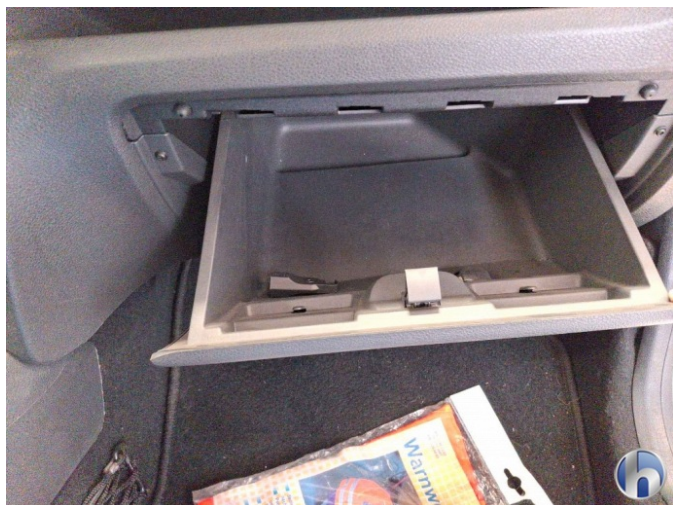
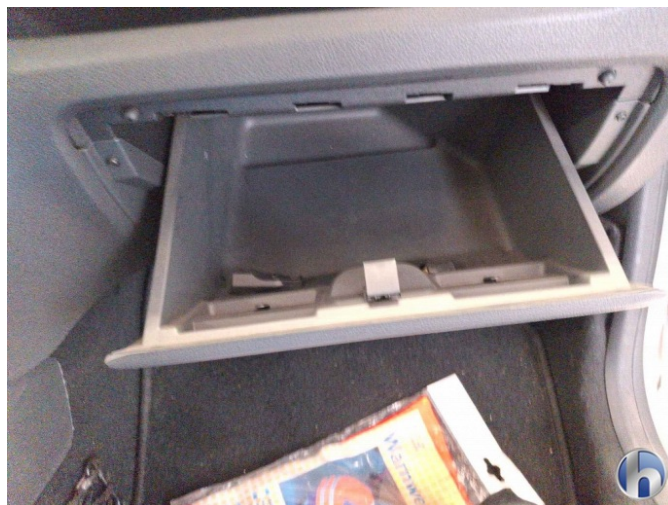
| component | Damage | Rep kind |
|---|---|---|
| 8. Glove compartment | Damaged | Replace |

8. Glove compartment

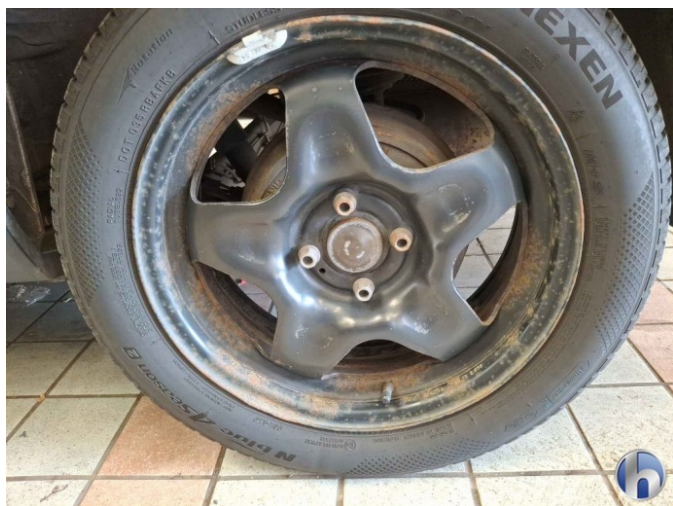
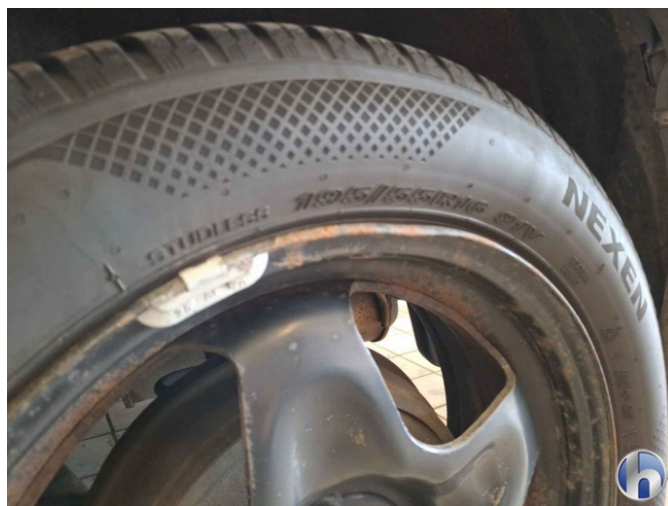
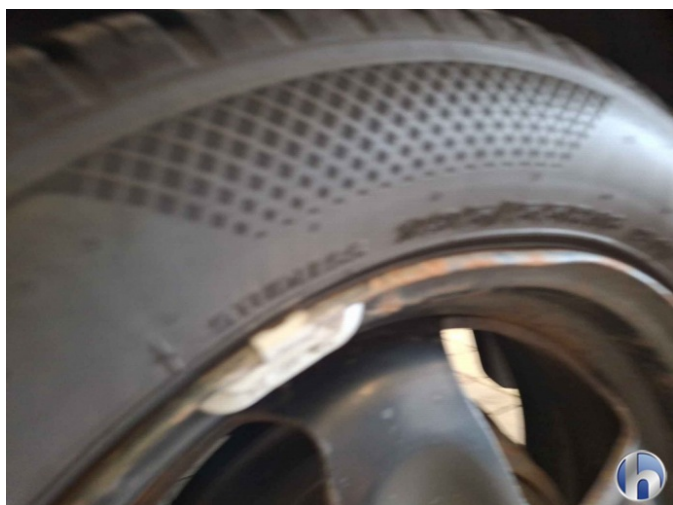
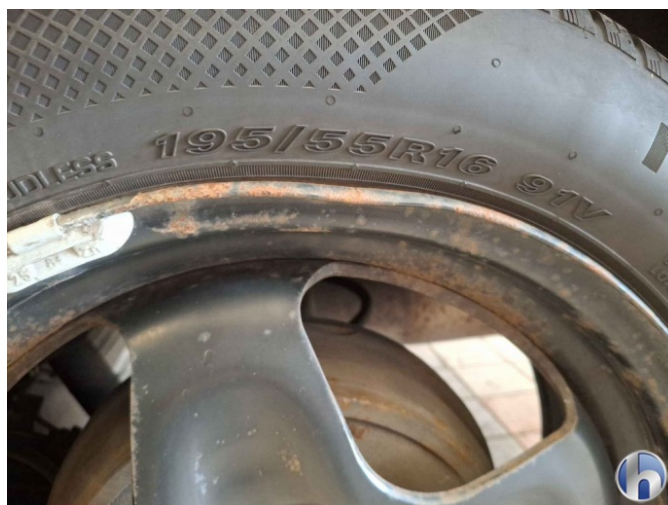
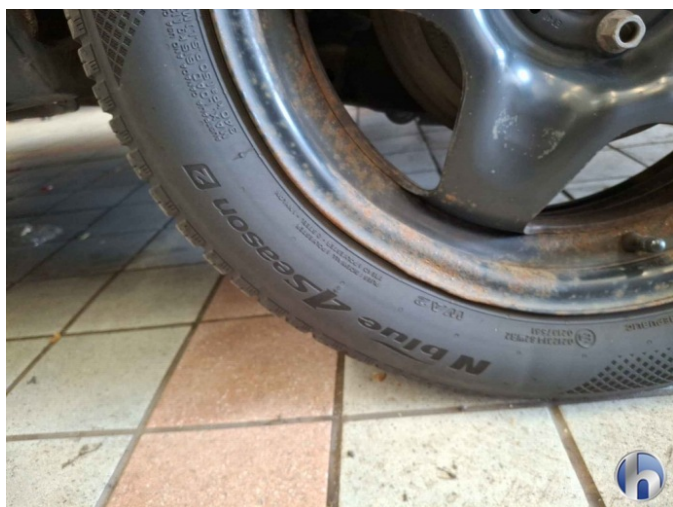
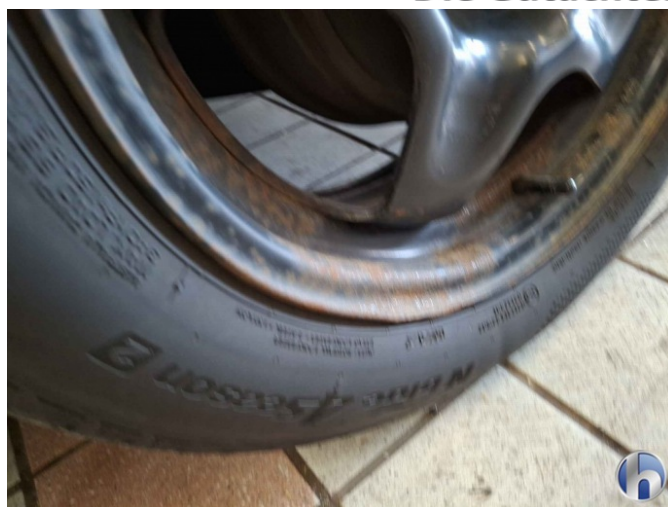
| component | Damage | Rep kind |
|---|---|---|
| 9. | Damaged | Replace |

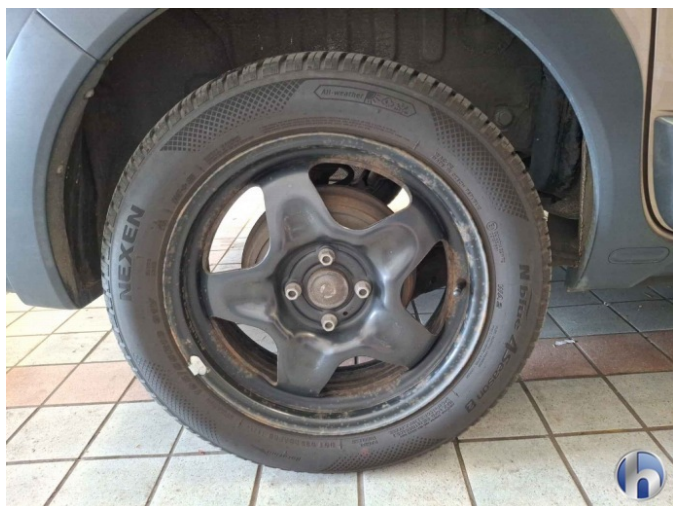
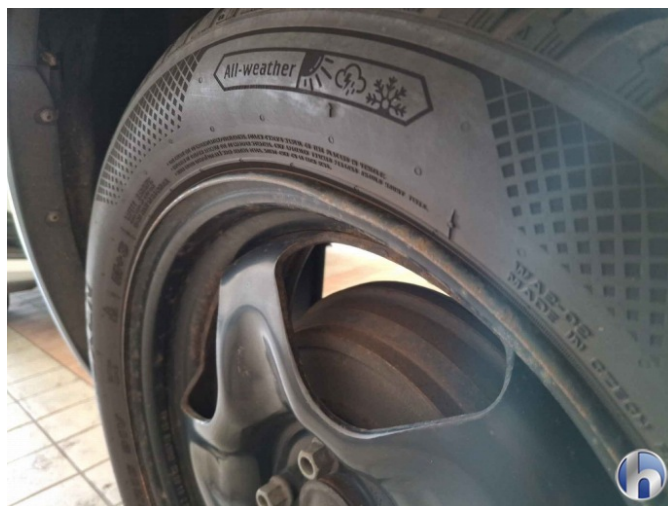
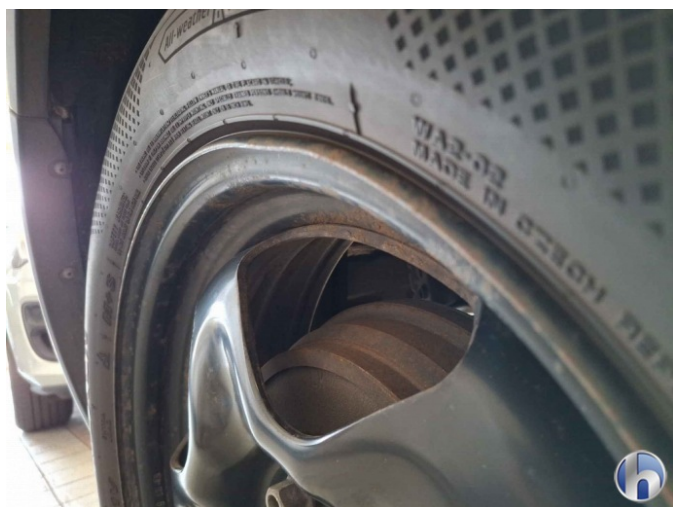
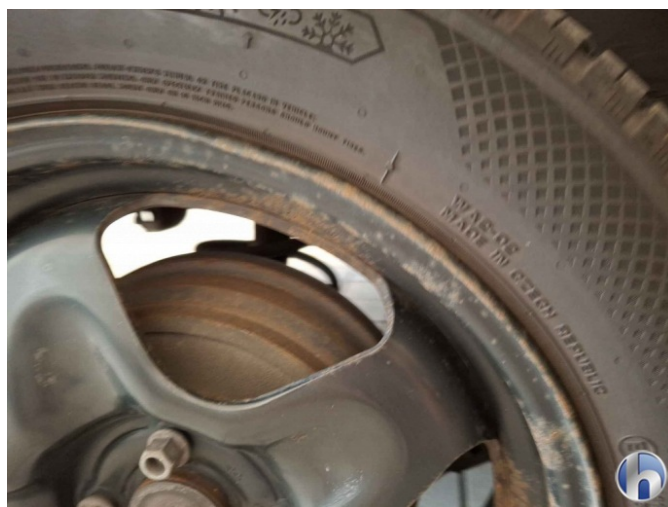
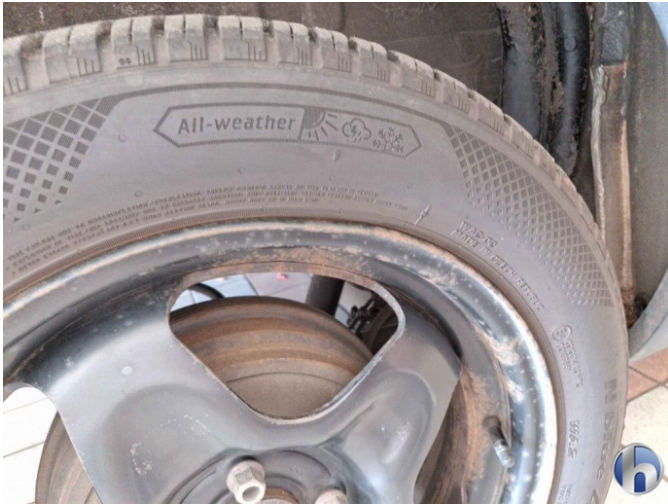
| component | Damage | Rep kind |
|---|---|---|
| 10. | Damaged | Replace |
