RENAULT CAPTUR
Captur TCe 120 Energy Intens

VIN NO VF12R031657357351
Registration Number ES403FT

Inspection Report Summary

Customer	BCAuto Encheres	Report Number	P20250929075211
Inspection Date / Place	2025-09-29 / BCA NANTES	Cosmetic Grade	3

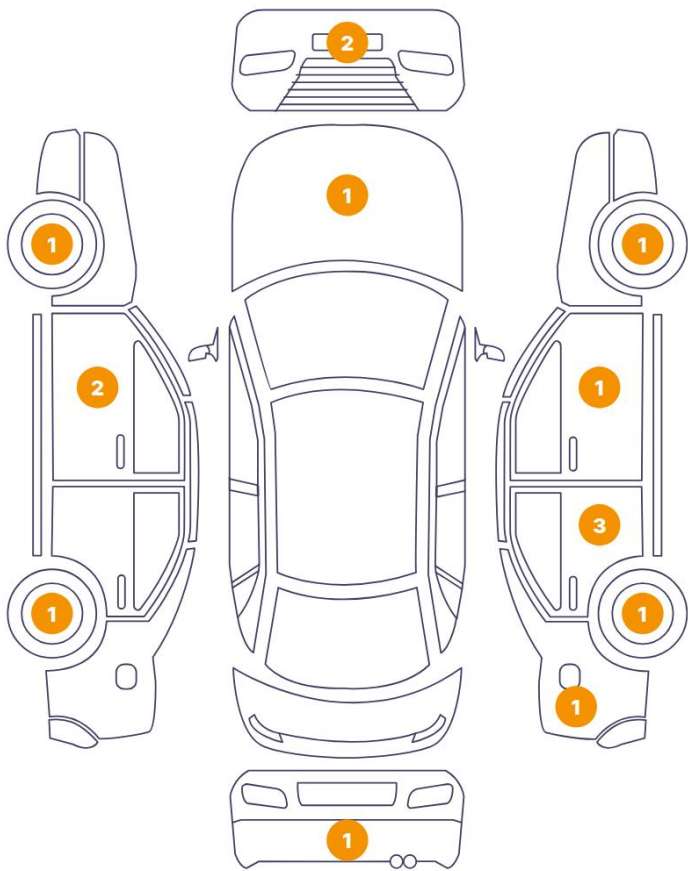
15 Dommages

Component		Damage	Comments
1	Corner Bumper / Front Right	Paint / Scratch / Line	
2	Shield / Front	Paint / Scratch / Line	
3	Rim / Front Left	Out of Bodywork / Scratch	
4	Door / Front Left	Bodywork / Dent / Dent	
5	Door / Front Left	Paint / Scratch / Line	
6	Rim	Out of Bodywork / Scratch	
7	Corner Bumper / Back Right	Paint / Scratch / Line	
8	Rim Brake pads	Out of Bodywork / Scratch	
9	Door / Back Right	Bodywork / Dent / Deformation	
10	Wing Stick / Back Right	Paint / Scratch / Line	
11	Door / Back Right	Paint / Scratch / Line	
12	Door / Back Right	Paint / Scratch / Line

13	Door / Front Right	Bodywork / Dent / Dent
14	Rim	Out of Bodywork / Scratch
15	Hood	Bodywork / Dent / Deformation

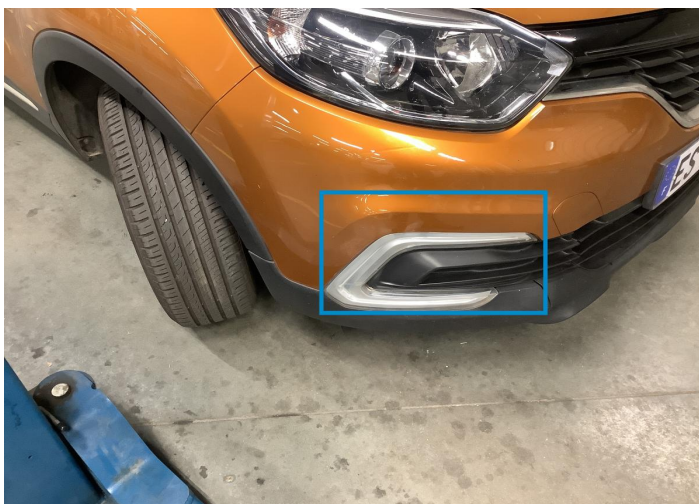
1. Corner Bumper / Front Right
Paint / Scratch / Line -

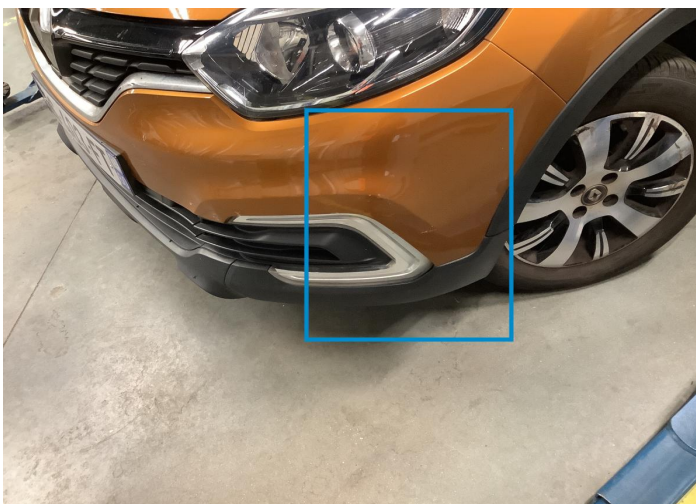
2. Shield / Front
Paint / Scratch / Line -

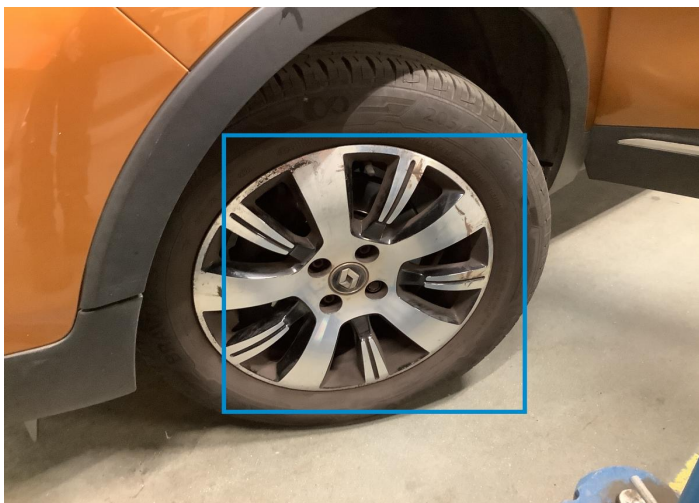
3. Rim / Front Left
Out of Bodywork / Scratch -

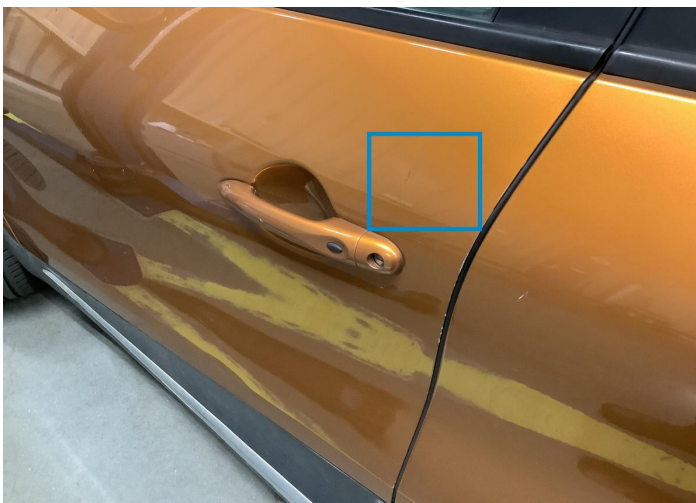
4. Door / Front Left
Bodywork / Dent / Dent -

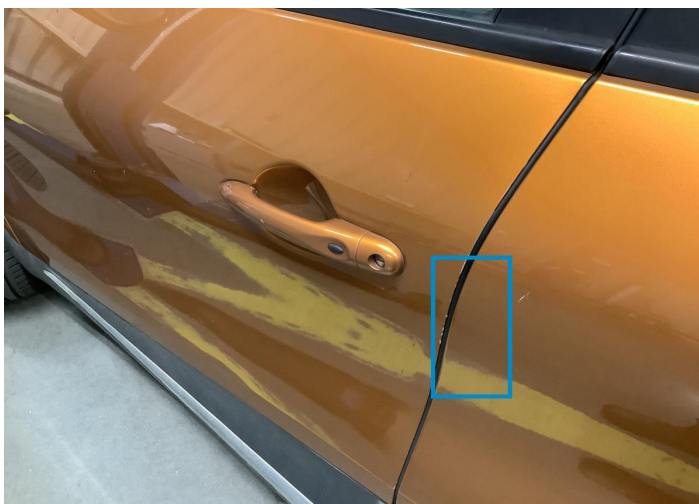
5. Door / Front Left
Paint / Scratch / Line -

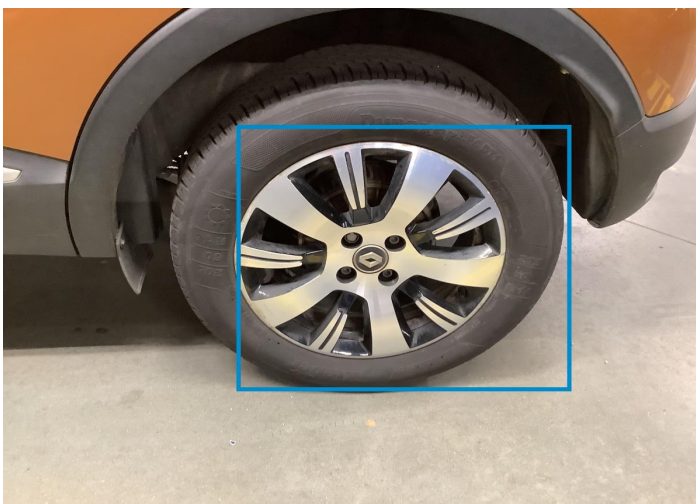
6. Rim
Out of Bodywork / Scratch -

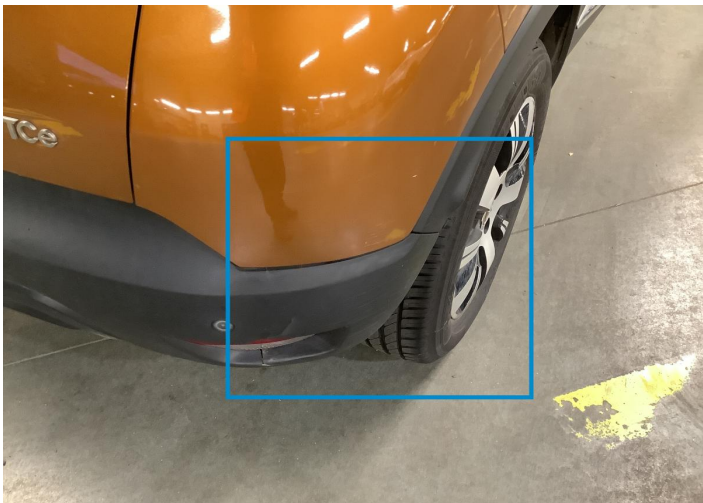
7. Corner Bumper / Back Right
Paint / Scratch / Line -

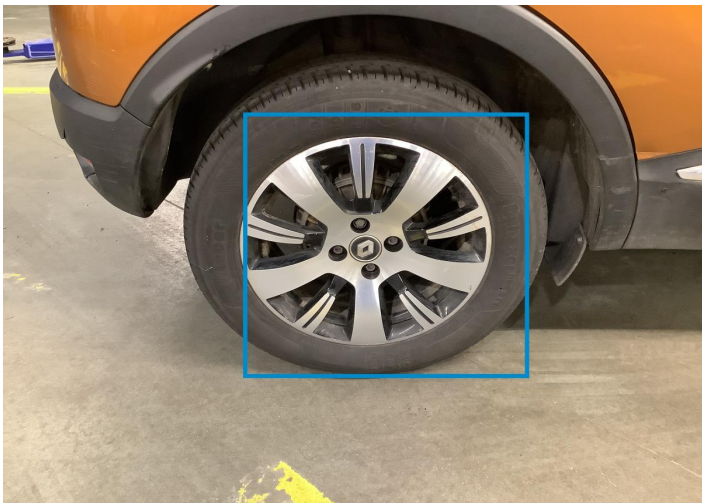
8. Rim Brake pads
Out of Bodywork / Scratch -

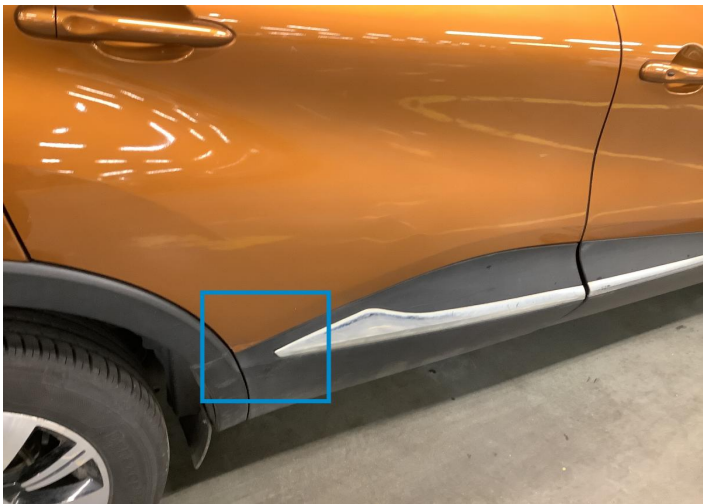
9. Door / Back Right
Bodywork / Dent / Deformation -

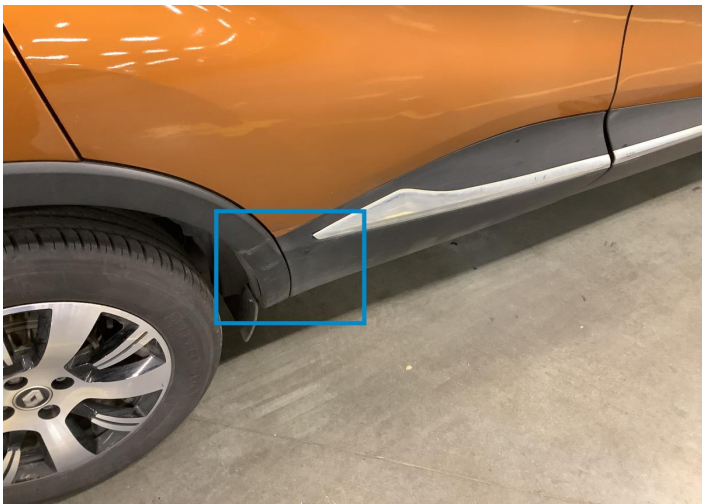
10. Wing Stick / Back Right
Paint / Scratch / Line -

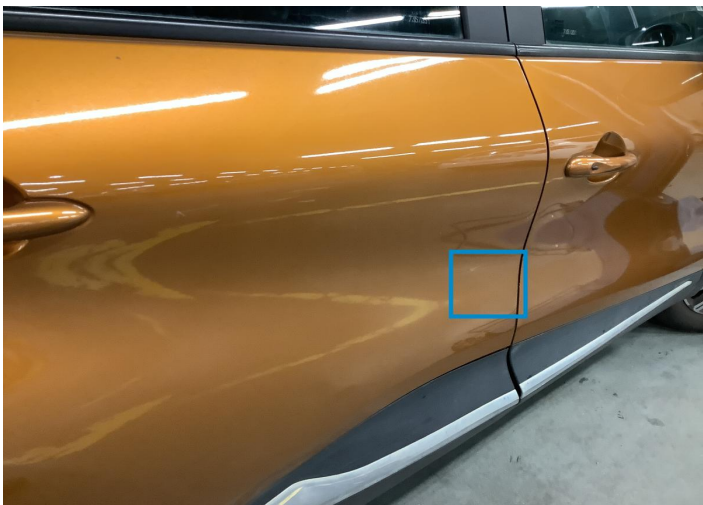
11. Door / Back Right
Paint / Scratch / Line -

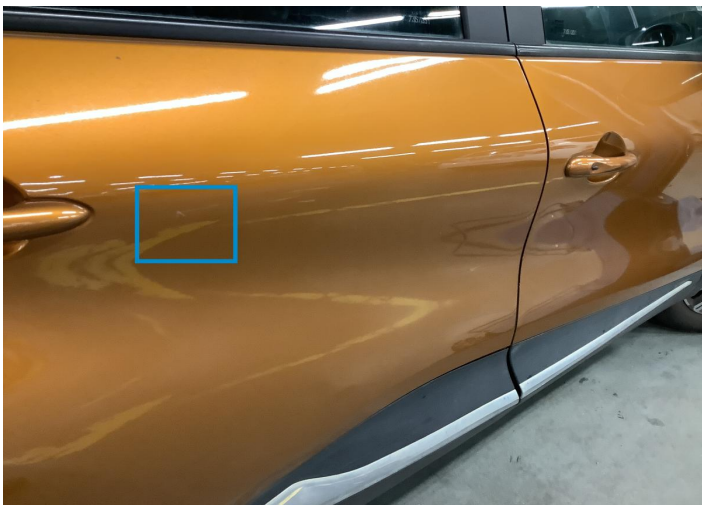
12. Door / Back Right
Paint / Scratch / Line -

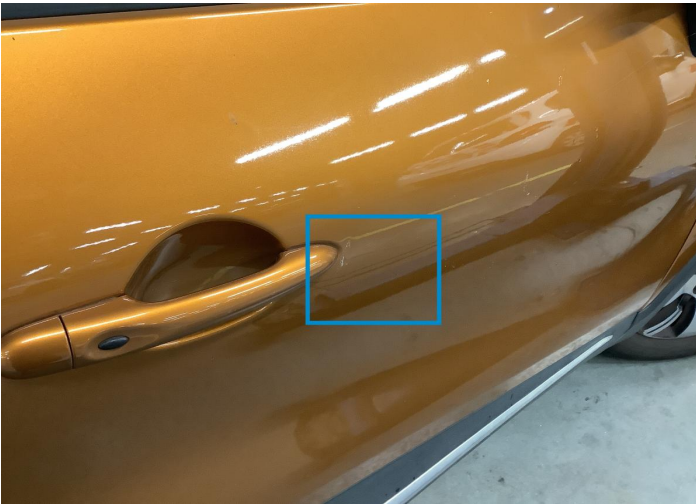
13. Door / Front Right
Bodywork / Dent / Dent -

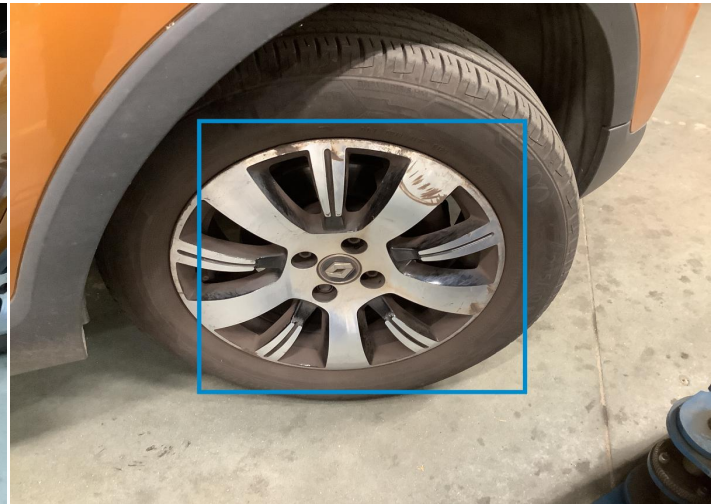
14. Rim
Out of Bodywork / Scratch -

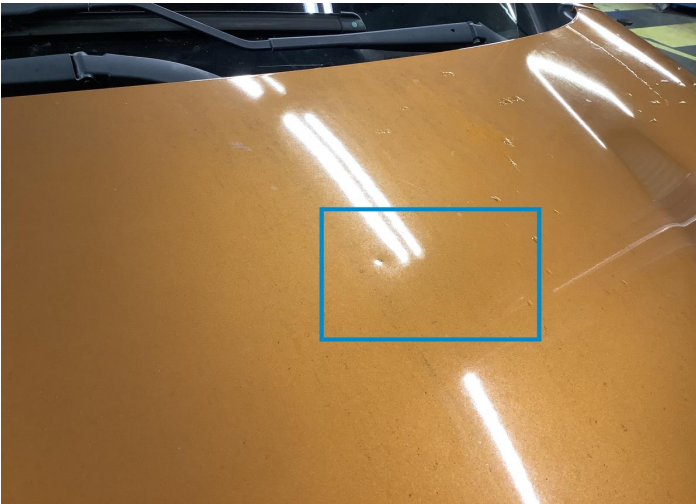
15. Hood
Bodywork / Dent / Deformation -
