RENAULT Captur

Captur ENERGY TCe 90 Start&Stop

VIN NO VF12R5A1H52443995
Registration Number 1H52443995

Inspection Report Summary

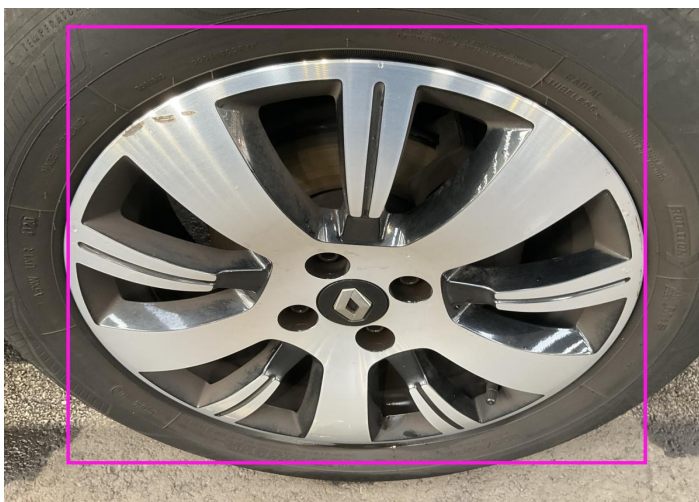
1. Rim / Front Right
Out of Bodywork / Scratch -

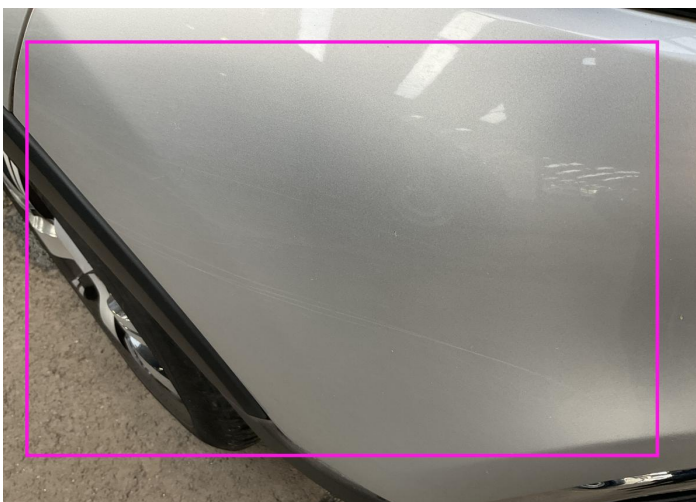
2. Corner Bumper / Front Right
Paint / Scratch / Scuff -

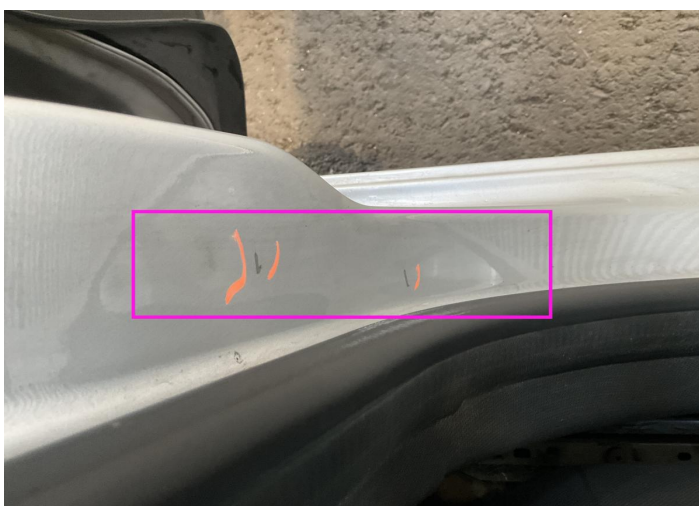
3. Rocker Panel / Center Left
Bodywork / Dent / Dent -

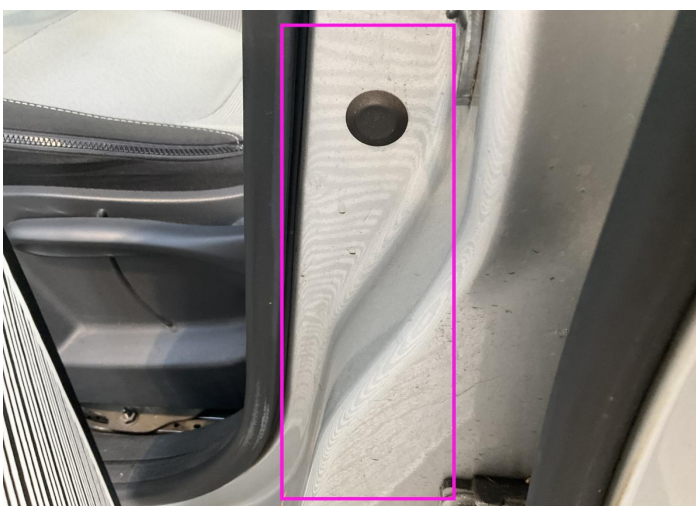
4. B Pillar / Center Left
Bodywork / Dent / Dent -

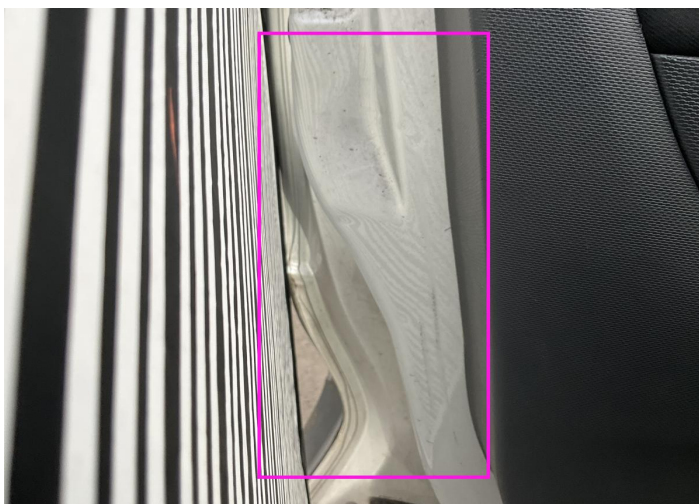
5. Door / Front Left
Bodywork / Dent / Dent -

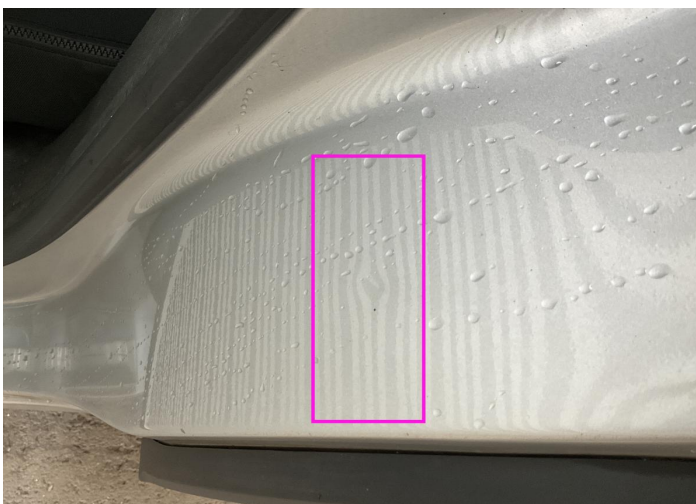
6. Rocker Panel / Center Left
Bodywork / Dent / Dent -

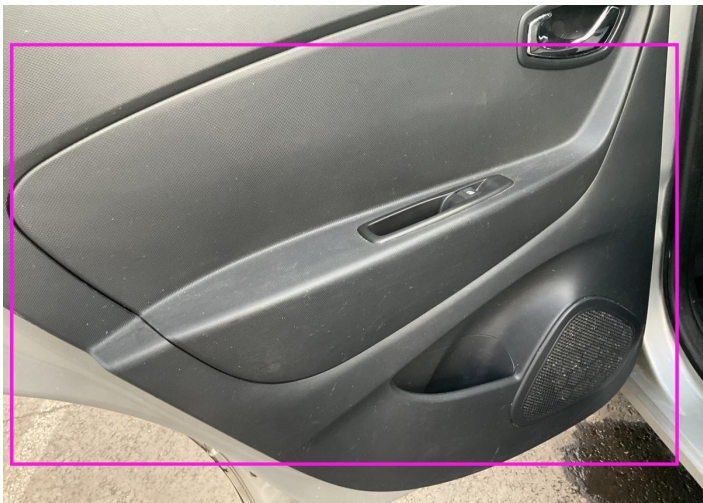
7. Panel Filling / Back Left
Interior / Scratched -

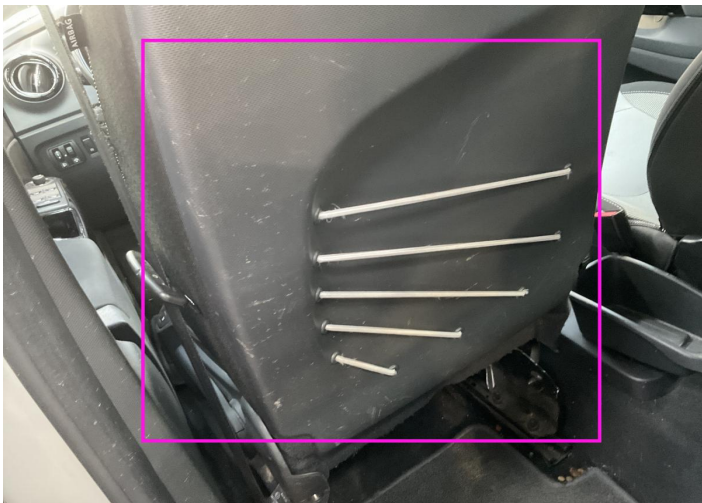
8. Backrest Cover / Front Left
Interior / Scratched -

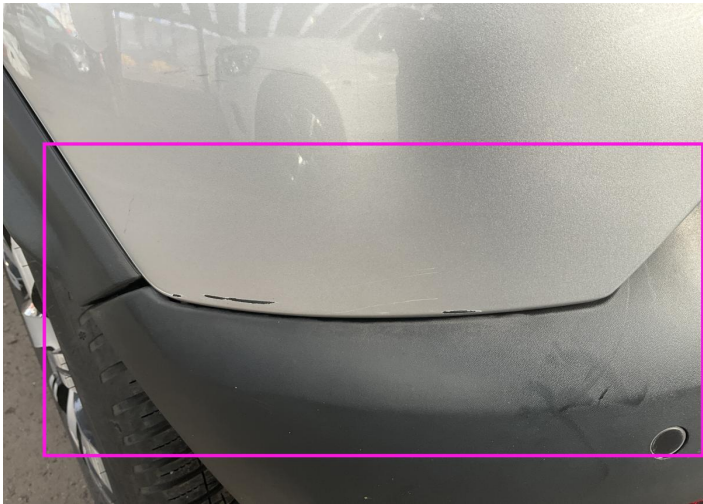
9. Corner Bumper / Back Left
Bodywork / Breakage / Crack -

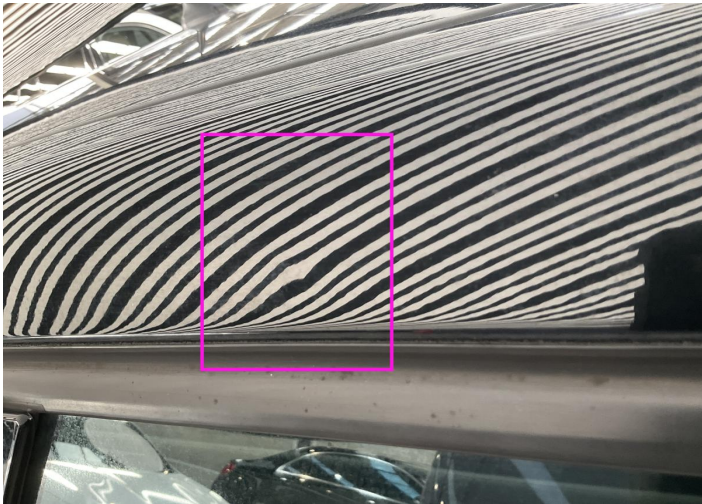
10. Roof
Bodywork / Dent / Dent -

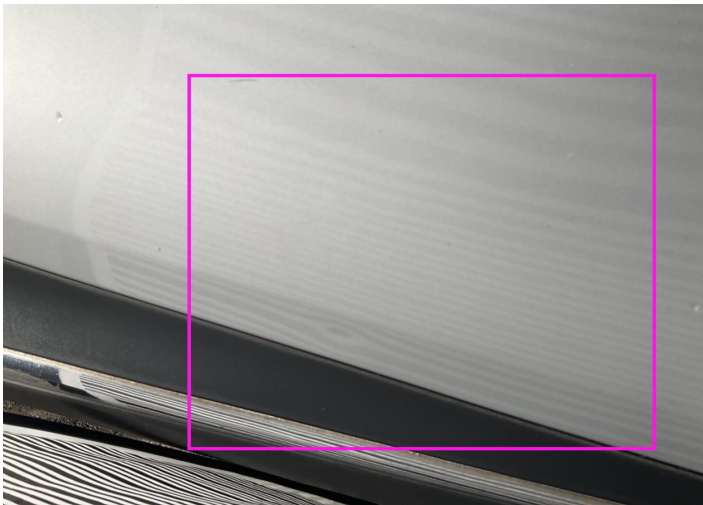
11. Door / Front Right
Bodywork / Dent / Dent -

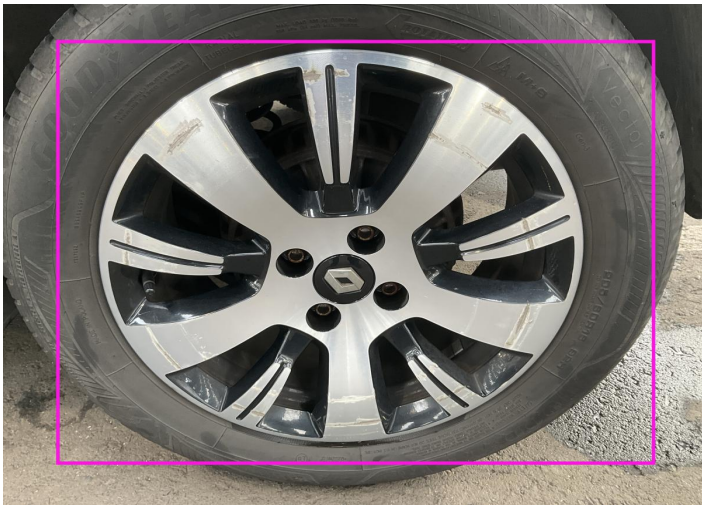
12. Rim / Back Left
Out of Bodywork / Scratch -

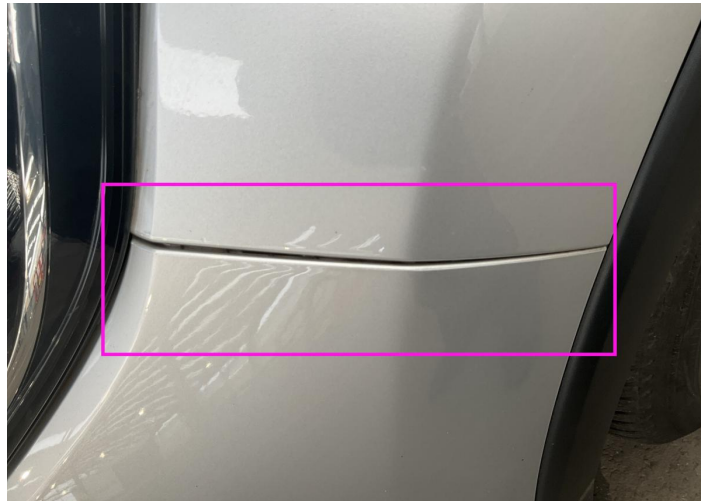
13. Corner Bumper / Front Left
Bodywork / Breakage / Crack -
