# RENAULT CLIO

## Clio IV TCe 120 Initiale Paris EDC

VIN NO VF15R400E51967934  
Registration Number DT195EL

### Inspection Report Summary

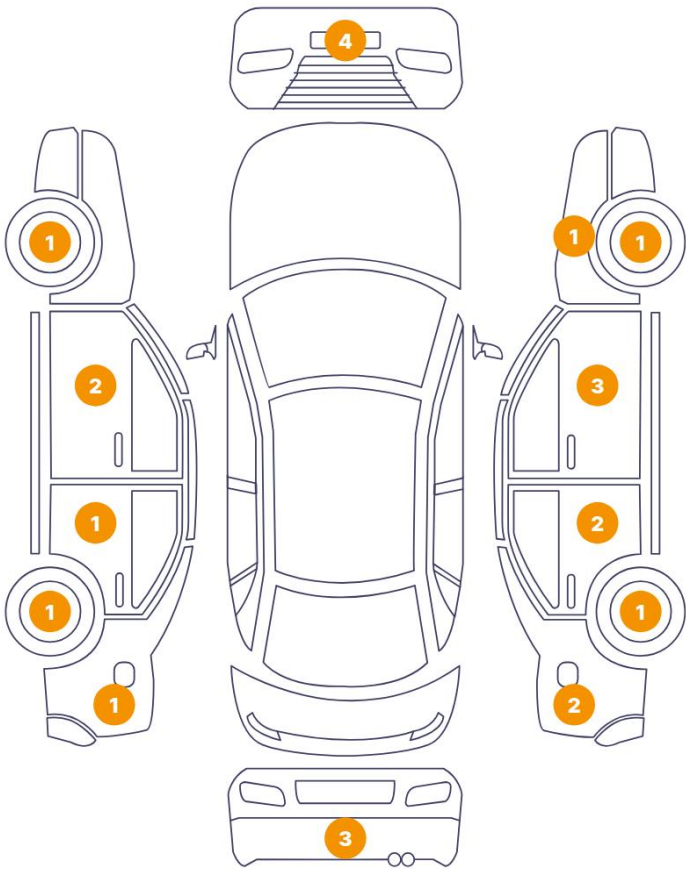
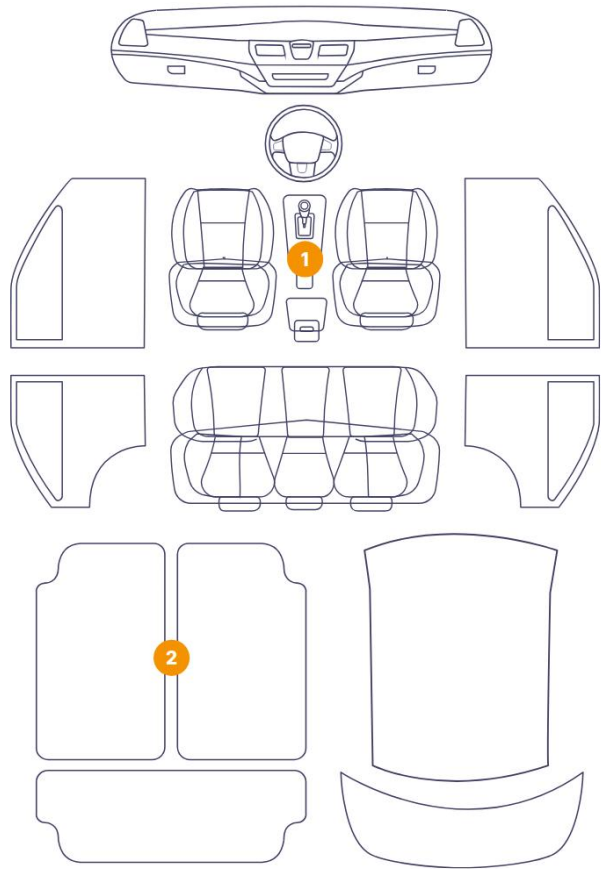
Cosmetic Damage

Component		Damage	Comments
1	Floor Carpet	Interior / Dirty	
2	Corner Bumper / Front Right	Paint / Poor Previous Repair	
3	Door / Back Left	Paint / Scratch / Line	
4	Floor Carpet	Interior / Dirty	
5	Door / Front Right	Paint / Scratch / Line	
6	Door / Front Left	Paint / Scratch / Line	
7	Corner Bumper / Back Left	Paint / Scratch / Scuff	
8	Bumper / Back	Paint / Scratch / Scuff	
9	Side Panel / Back Left	Paint / Scratch / Line	
10	Corner Bumper / Back Right	Paint / Scratch / Scuff	
11	Corner Bumper / Front Left	Paint / Poor Previous Repair	
12	Bumper / Front	Paint / Poor Previous Repair

13	Corner Bumper / Front Right	Paint / Scratch / Scuff
14	Side Window / Front Right	Paint / Poor Previous Repair
15	Rim / Back Left	Out of Bodywork / Scratch
16	Rim / Front Right	Out of Bodywork / Scratch
17	Rim / Back Right	Out of Bodywork / Scratch
18	Rim / Front Left	Out of Bodywork / Scratch
19	Mirror / Front Right	Paint / Scratch / Scuff
20	Fender / Front Right	Paint / Scratch / Line
21	Mirror / Front Left	Paint / Scratch / Line
22	Side Panel / Back Right	Paint / Scratch / Line
23	Side Panel / Back Right	Paint / Scratch / Scuff
24	Door / Back Right	Paint / Scratch / Line
25	Door / Back Right	Paint / Scratch / Line
26	Gear Knob	Interior / Missing

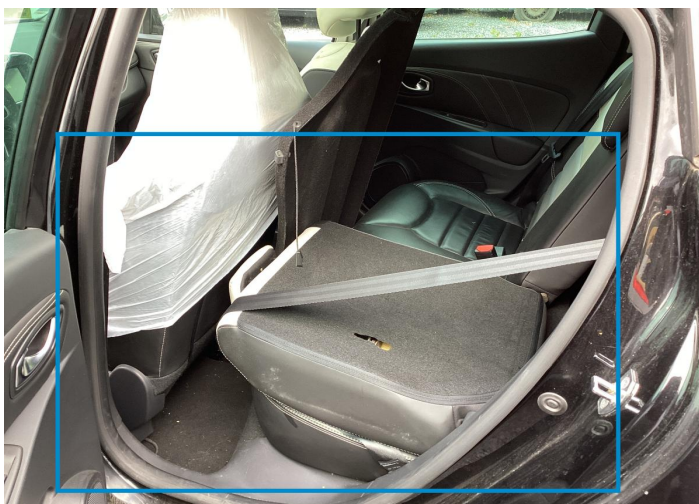
1. Floor Carpet  
Interior / Dirty -

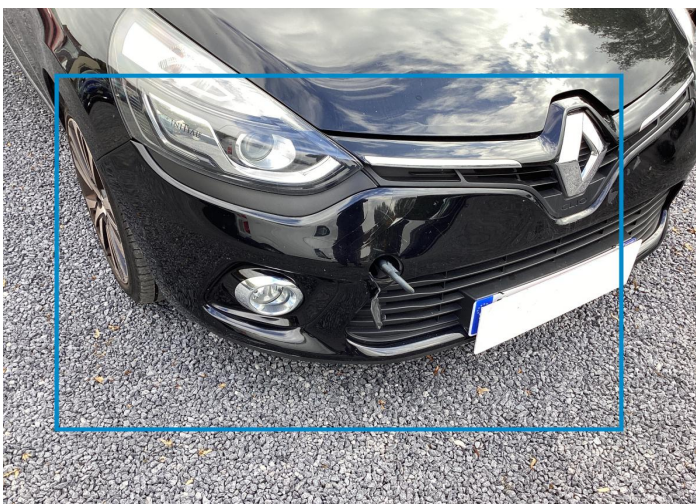
2. Corner Bumper / Front Right  
Paint / Poor Previous Repair -

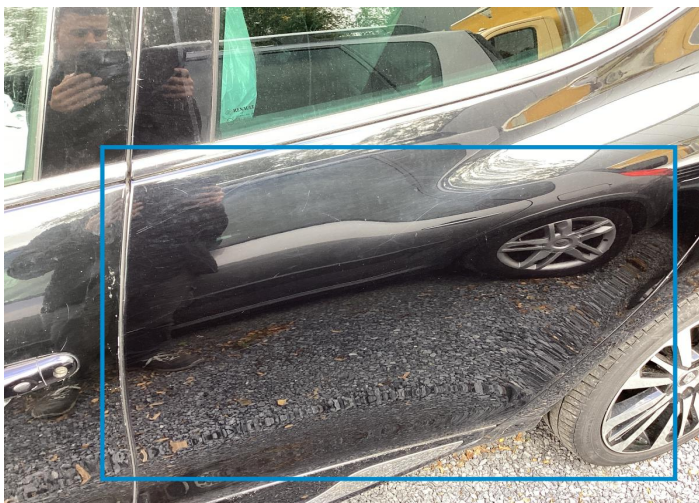
3. Door / Back Left  
Paint / Scratch / Line -

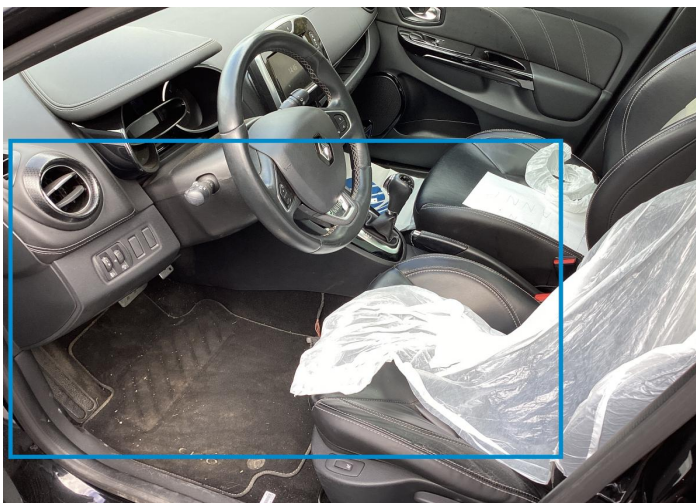
4. Floor Carpet  
Interior / Dirty -

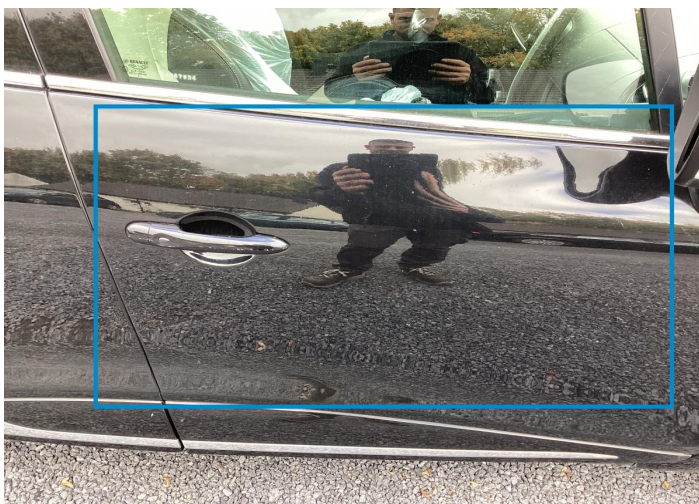
5. Door / Front Right  
Paint / Scratch / Line -

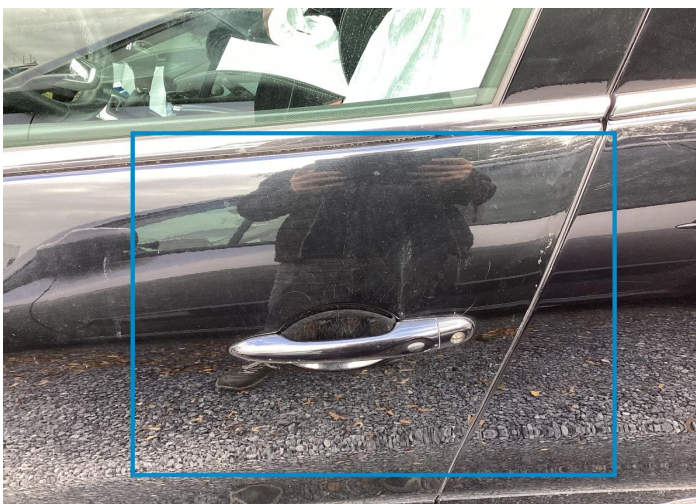
6. Door / Front Left  
Paint / Scratch / Line -

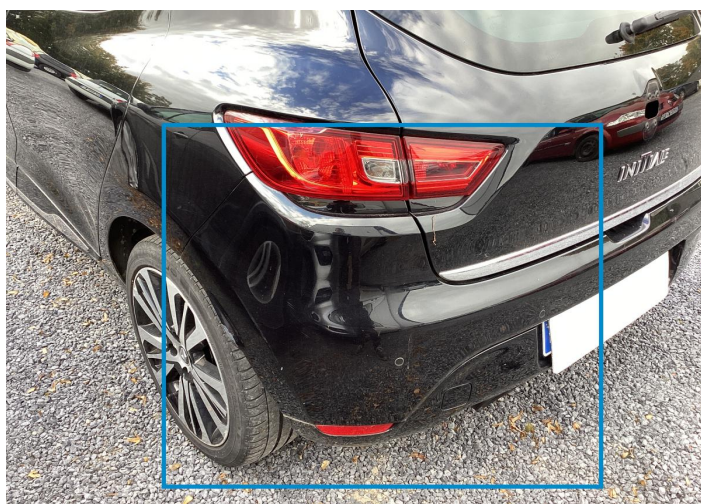
7. Corner Bumper / Back Left  
Paint / Scratch / Scuff -

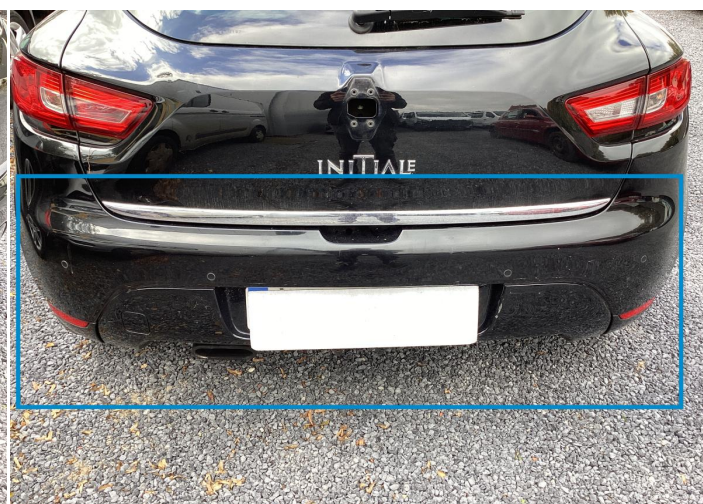
8. Bumper / Back  
Paint / Scratch / Scuff -

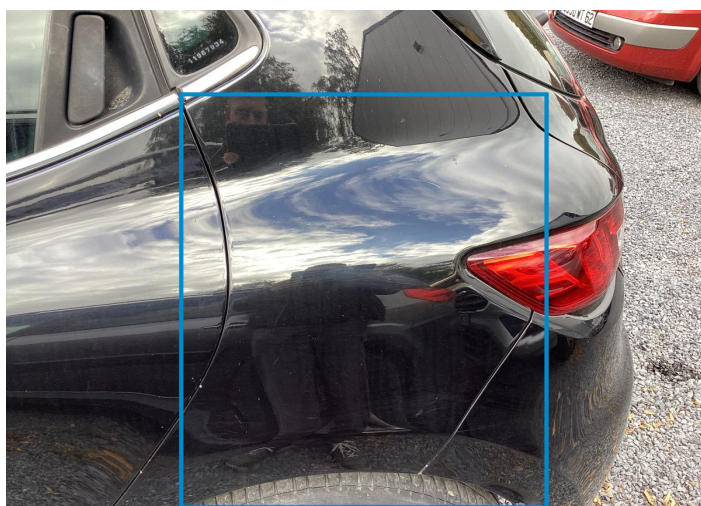
9. Side Panel / Back Left  
Paint / Scratch / Line -

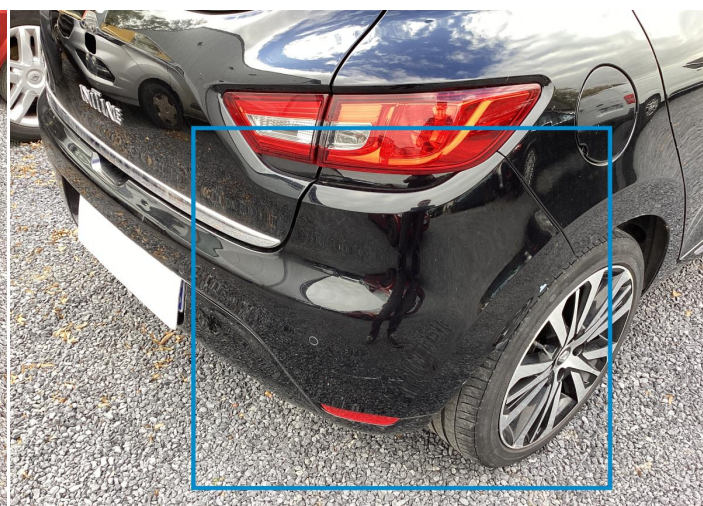
10. Corner Bumper / Back Right  
Paint / Scratch / Scuff -

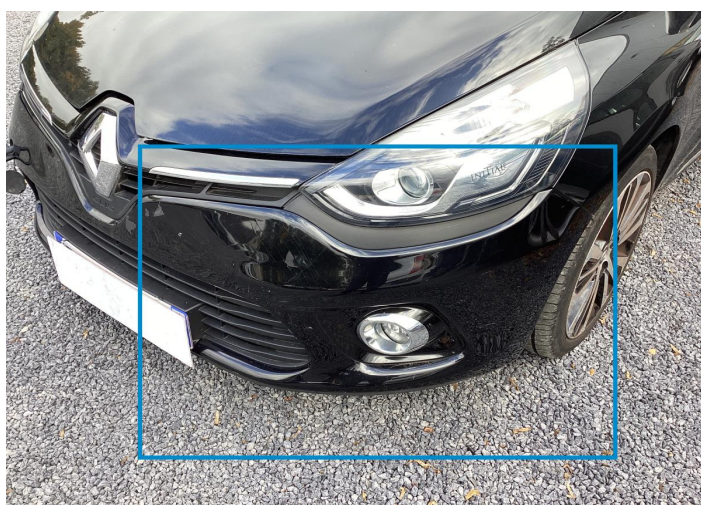
11. Corner Bumper / Front Left  
Paint / Poor Previous Repair -

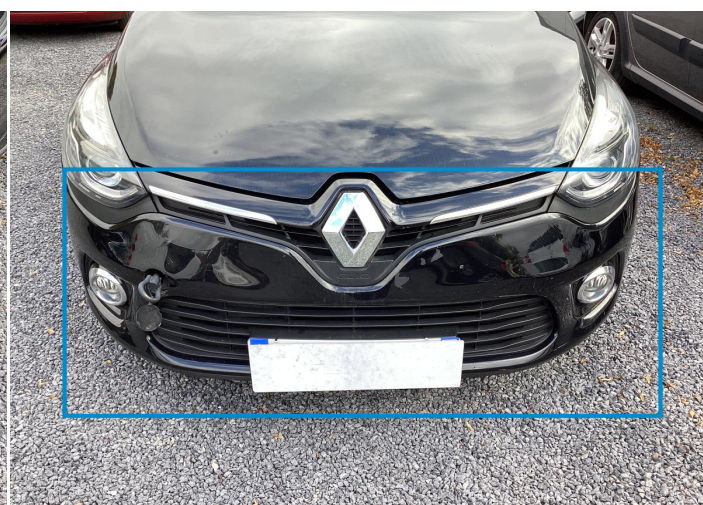
12. Bumper / Front  
Paint / Poor Previous Repair -

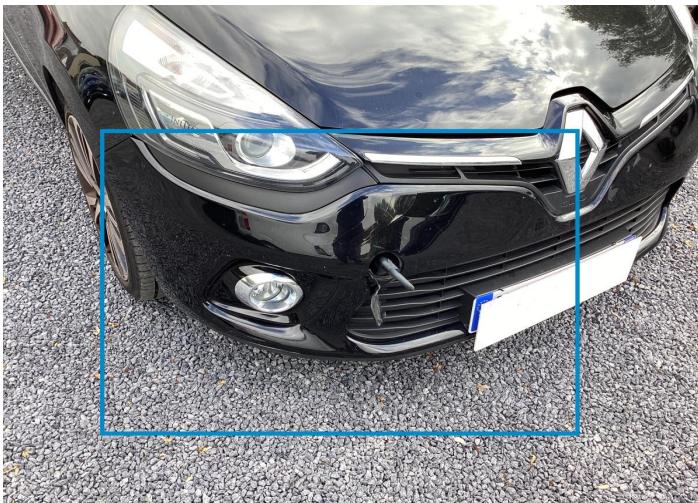
13. Corner Bumper / Front Right  
Paint / Scratch / Scuff -

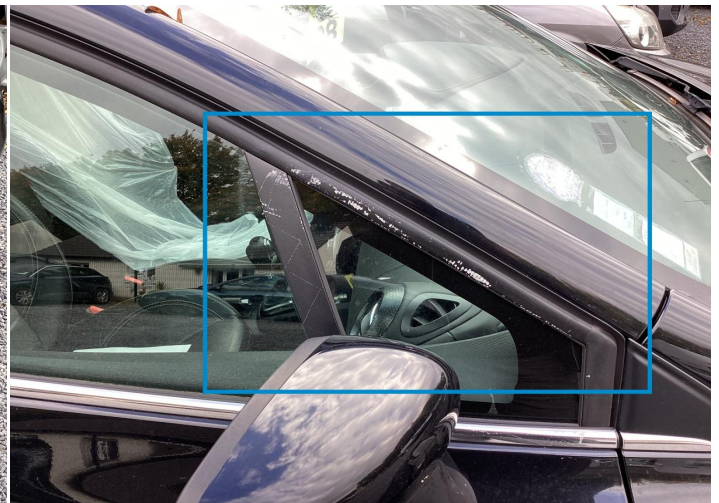
14. Side Window / Front Right  
Paint / Poor Previous Repair -

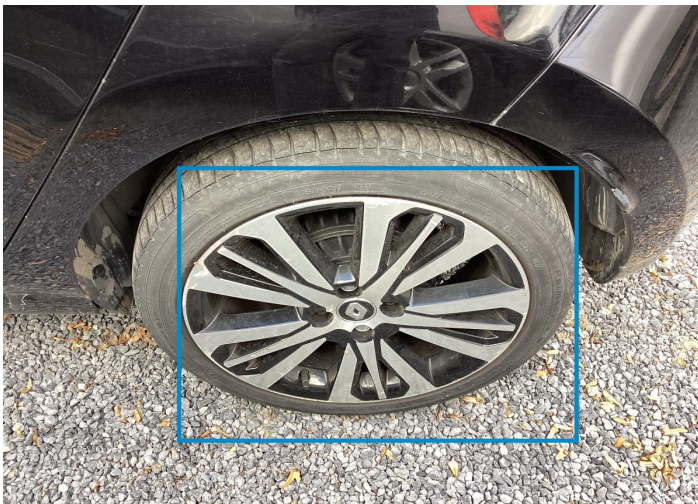
15. Rim / Back Left  
Out of Bodywork / Scratch -

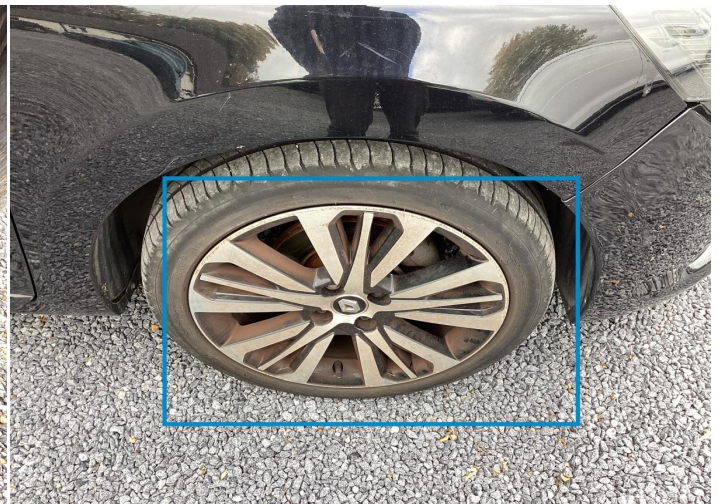
16. Rim / Front Right  
Out of Bodywork / Scratch -

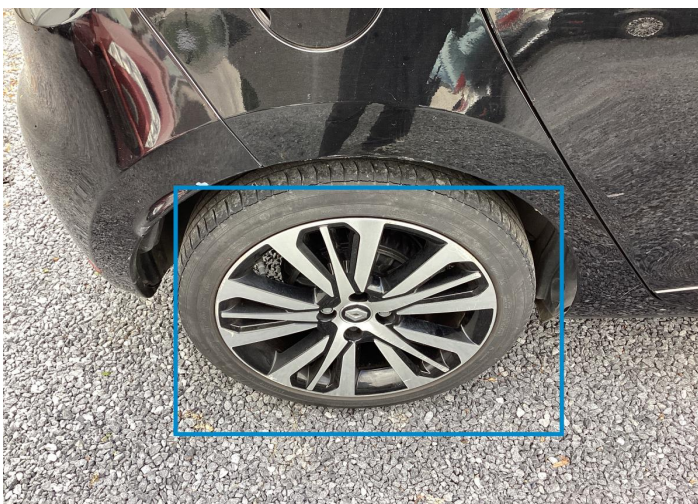
17. Rim / Back Right  
Out of Bodywork / Scratch -

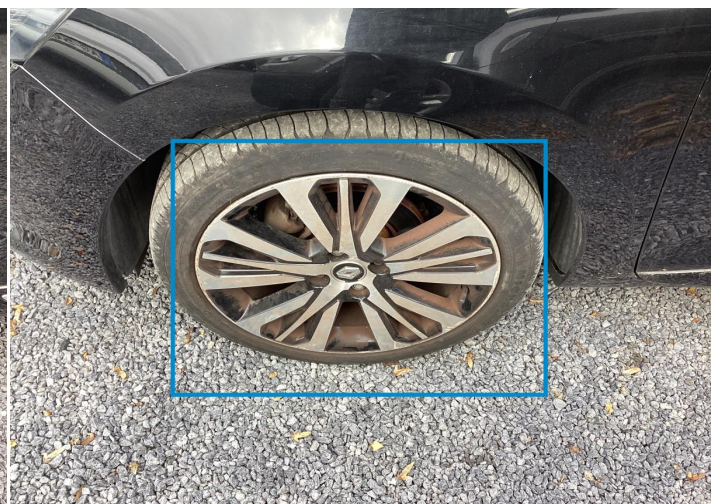
18. Rim / Front Left  
Out of Bodywork / Scratch -

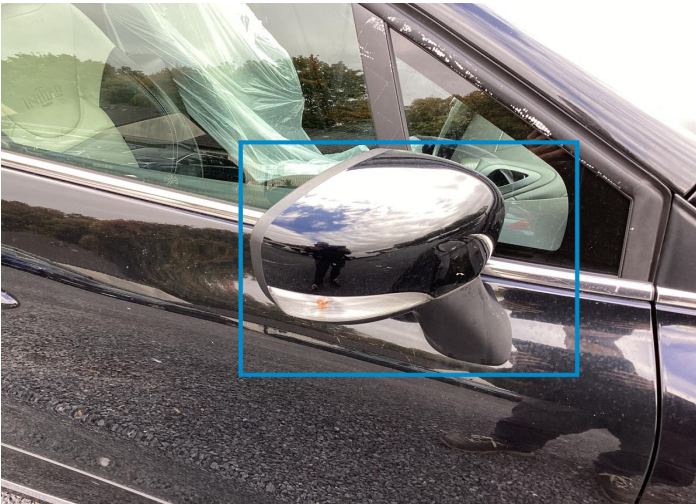
19. Mirror / Front Right  
Paint / Scratch / Scuff -

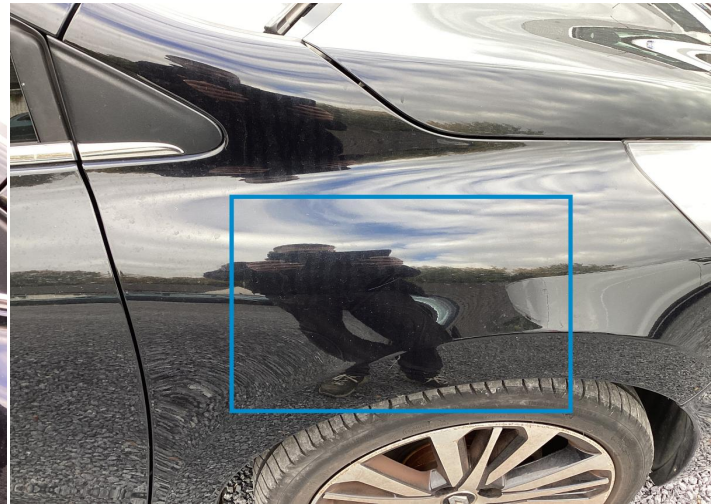
20. Fender / Front Right  
Paint / Scratch / Line -

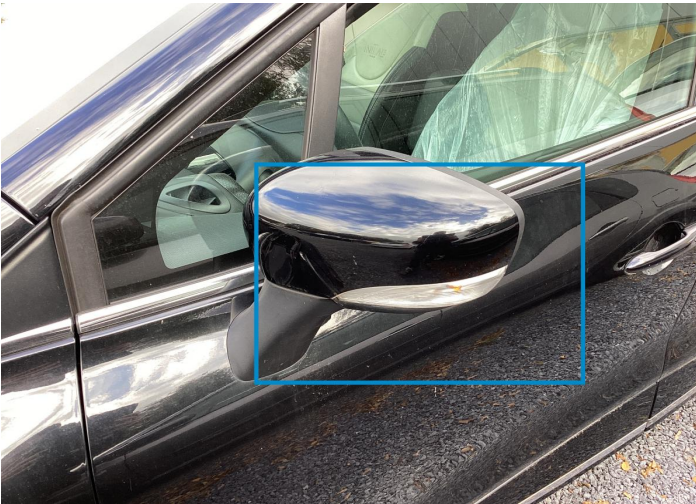
21. Mirror / Front Left  
Paint / Scratch / Line -

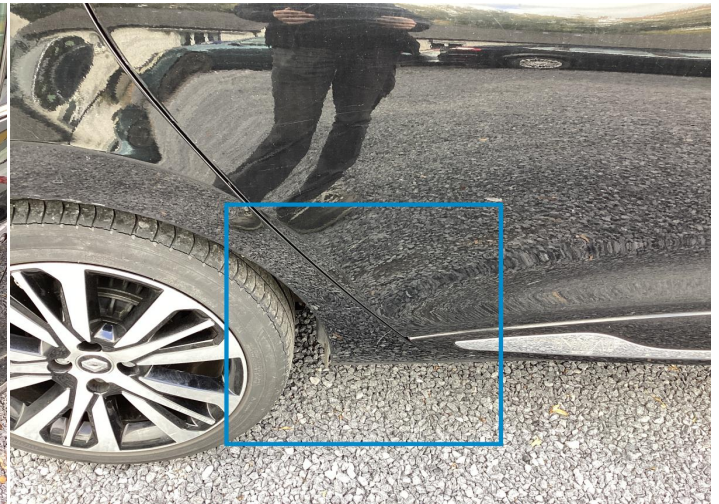
22. Side Panel / Back Right  
Paint / Scratch / Line -

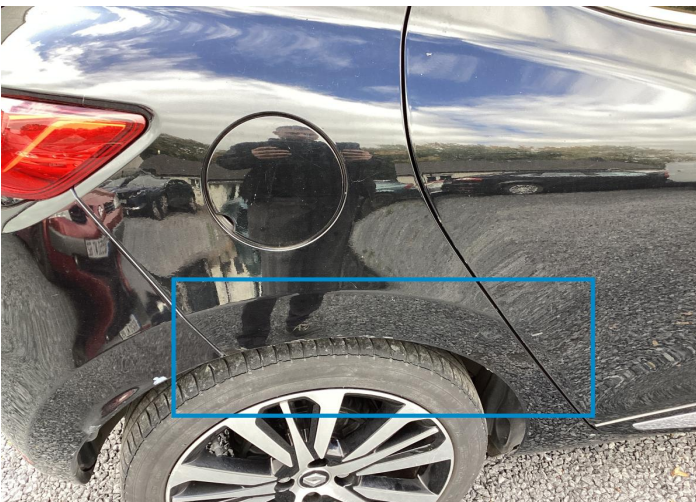
23. Side Panel / Back Right  
Paint / Scratch / Scuff -

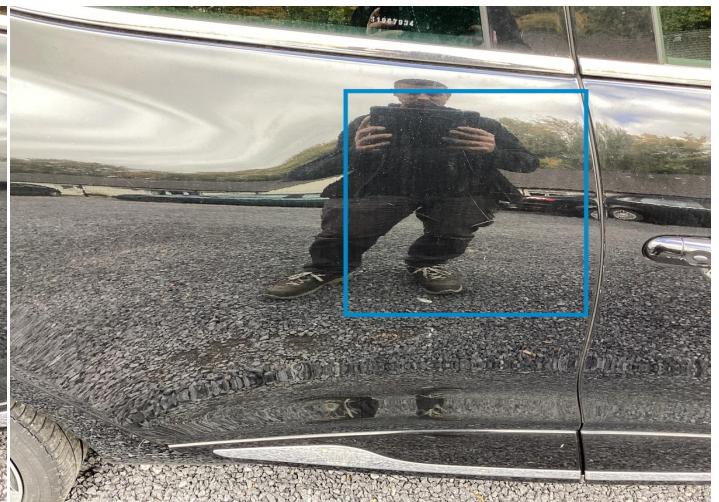
24. Door / Back Right  
Paint / Scratch / Line -

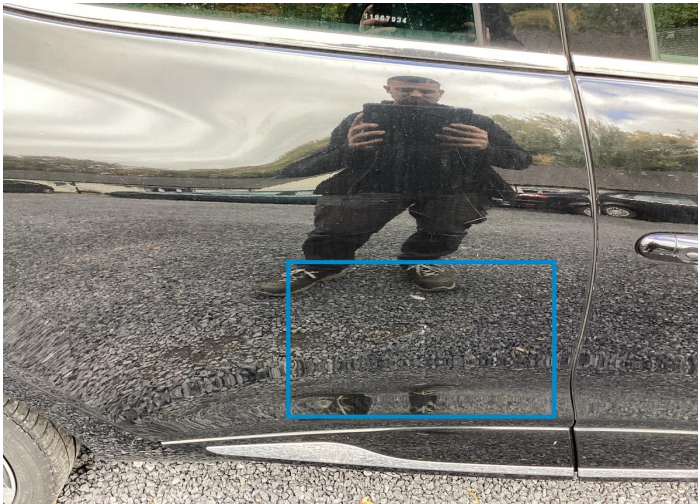
25. Door / Back Right  
Paint / Scratch / Line -

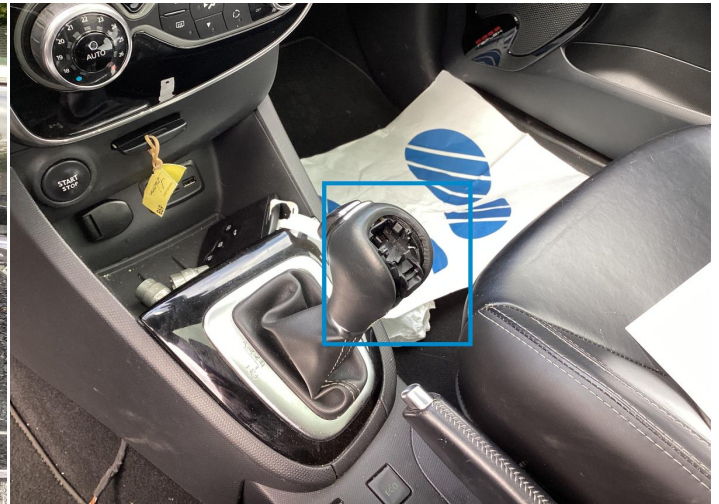
26. Gear Knob  
Interior / Missing -
