RENAULT CLIO

Clio IV 1.2 16V 75 Zen

Inspection Report Summary

Customer	BCAuto Encheres	Report Number	P20250627180207
Inspection Date / Place	2025-06-27 / BCA BETHUNE	Cosmetic Grade	3

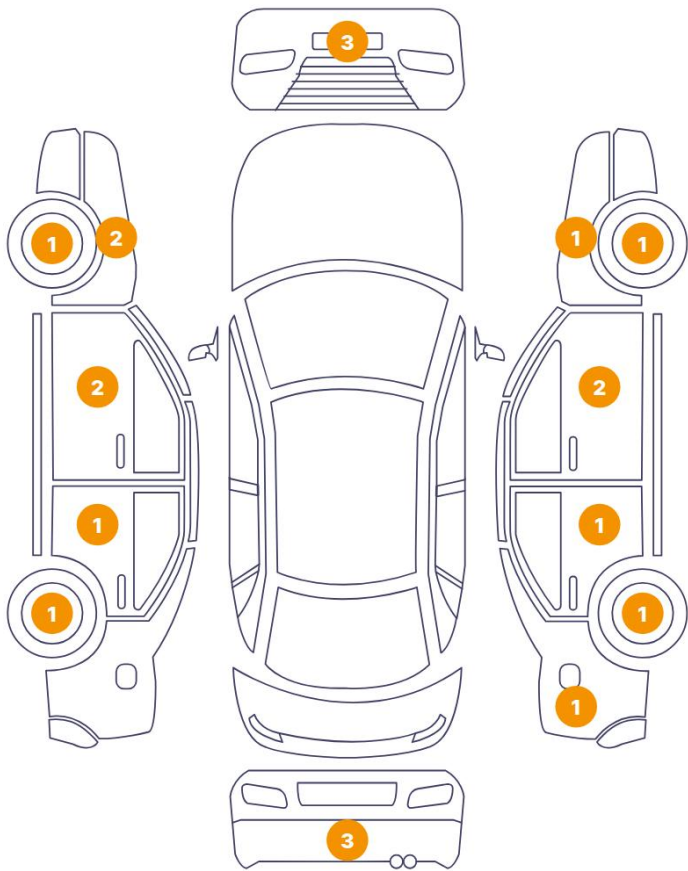
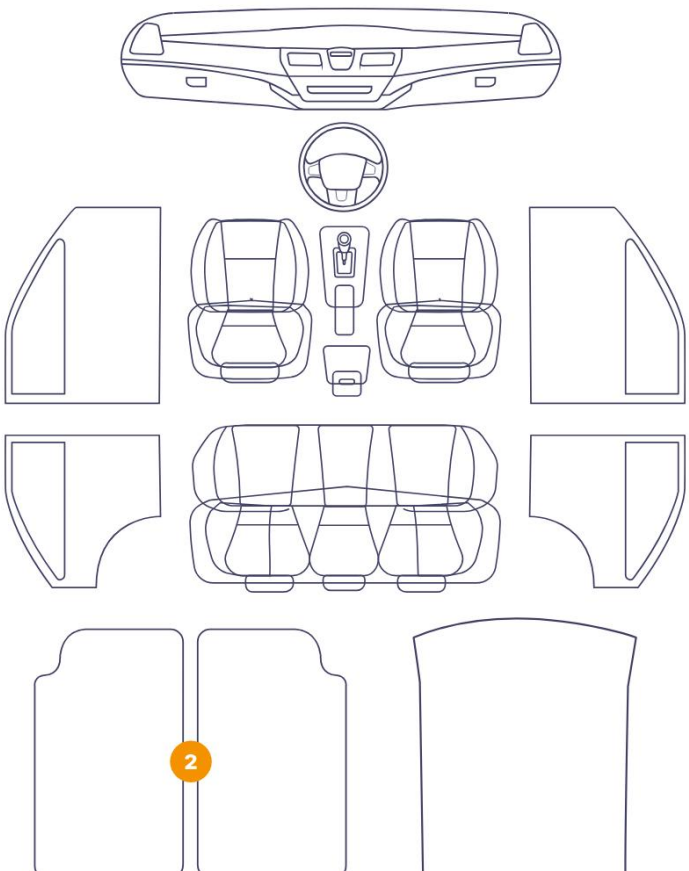
Cosmetic Damage

Component		Damage	Comments
1	Floor Carpet	Interior / Dirty	
2	Floor Carpet	Interior / Dirty	
3	Corner Bumper / Front Right	Paint / Scratch / Scuff	
4	Bumper / Front	Paint / Scratch / Scuff	
5	Corner Bumper / Front Left	Paint / Scratch / Scuff	
6	Fender / Front Left	Paint / Scratch / Scuff	
7	Fender / Front Left	Paint / Scratch / Line	
8	Rim / Front Left	Out of Bodywork / Scratch	
9	Mirror / Front Left	Paint / Scratch / Line	
10	Door / Front Left	Bodywork / Dent / Deformation	
11	Door / Back Left	Paint / Scratch / Line	
12	Rim / Back Left	Out of Bodywork / Scratch	
13	Corner Bumper / Back Left	Paint / Scratch / Scuff

14	Bumper / Back	Paint / Scratch / Scuff
15	Corner Bumper / Back Right	Paint / Scratch / Scuff
16	Rim / Back Right	Out of Bodywork / Scratch
17	Door / Back Right	Paint / Scratch / Scuff
18	Door / Front Right	Paint / Scratch / Line
19	Mirror / Front Right	Paint / Scratch / Scuff
20	Fender / Front Right	Paint / Scratch / Line
21	Fender / Back Right	Paint / Scratch / Scuff
22	Rim / Front Right	Out of Bodywork / Scratch

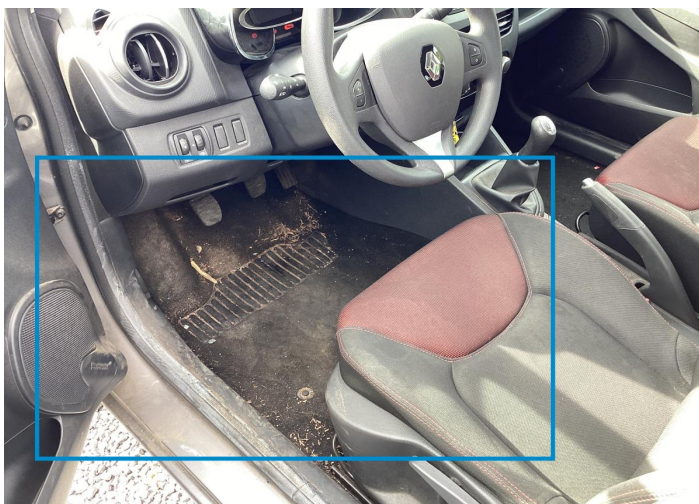
1. Floor Carpet
Interior / Dirty -

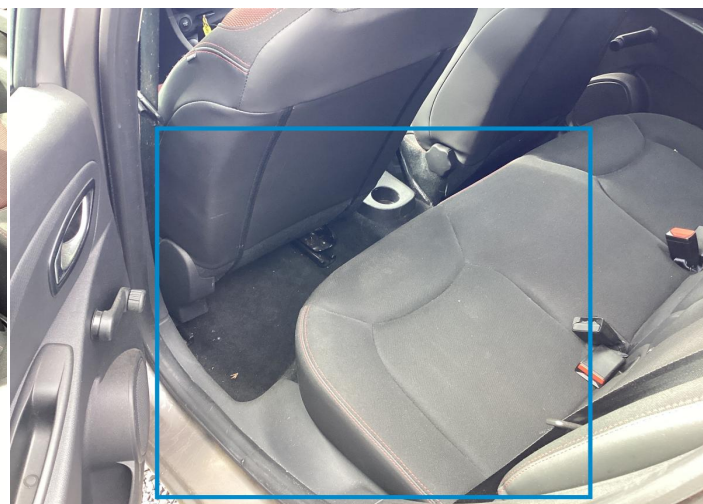
2. Floor Carpet
Interior / Dirty -

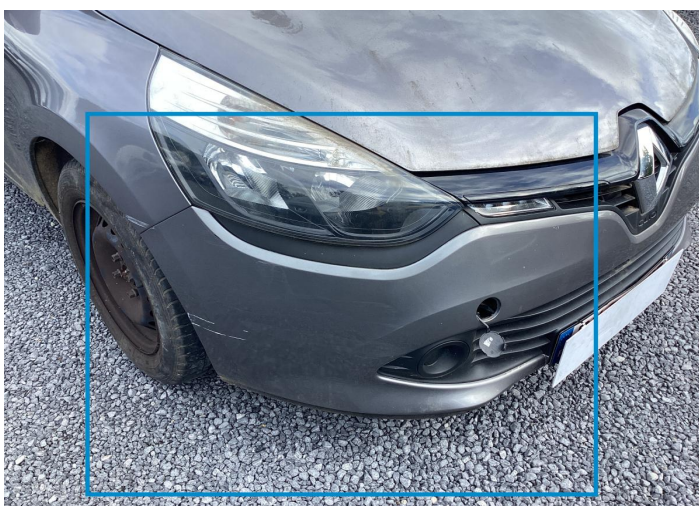
3. Corner Bumper / Front Right
Paint / Scratch / Scuff -

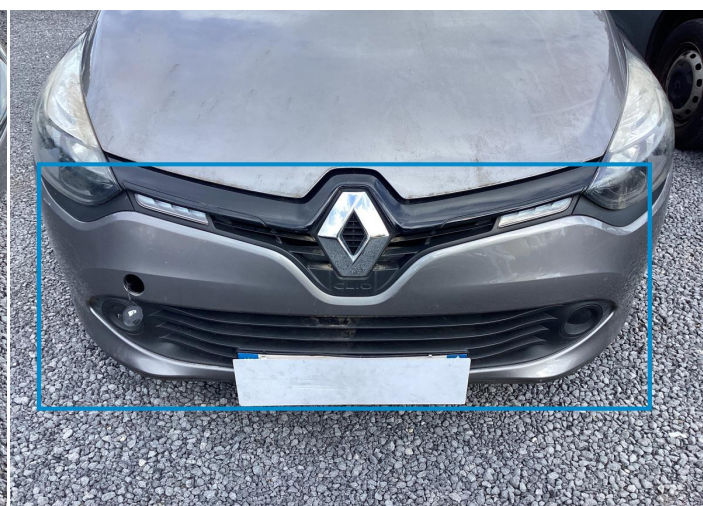
4. Bumper / Front
Paint / Scratch / Scuff -

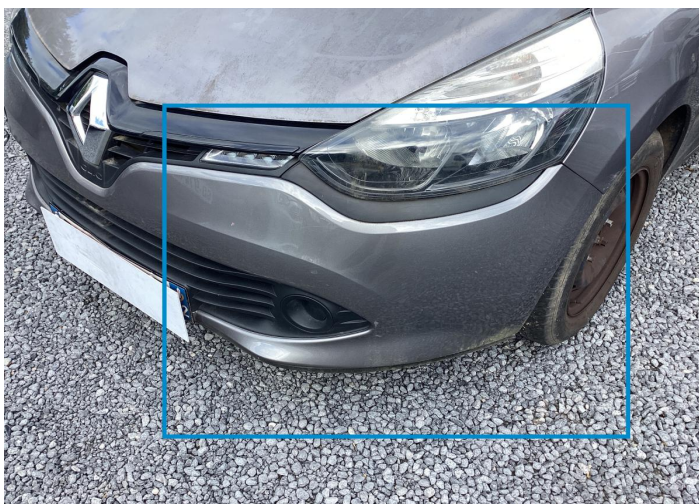
5. Corner Bumper / Front Left
Paint / Scratch / Scuff -

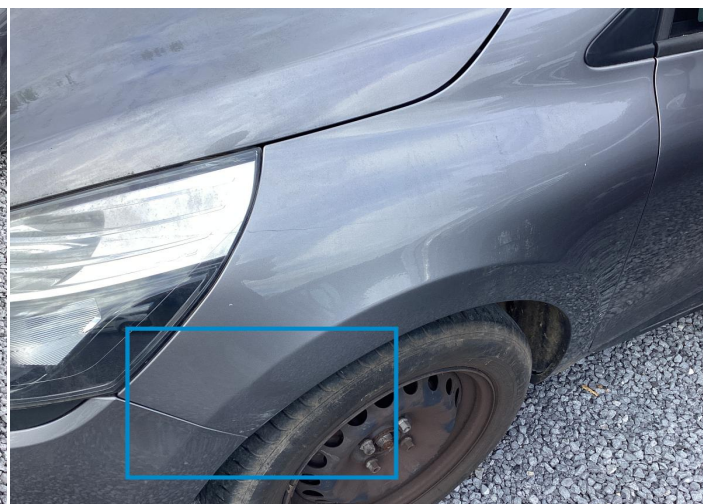
6. Fender / Front Left
Paint / Scratch / Scuff -

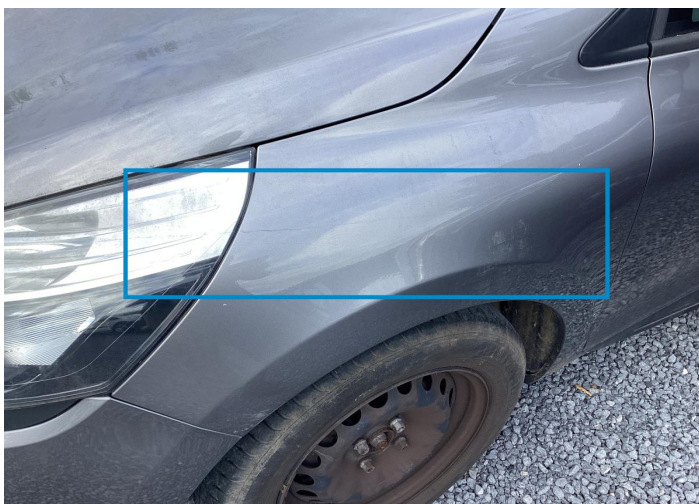
7. Fender / Front Left
Paint / Scratch / Line -

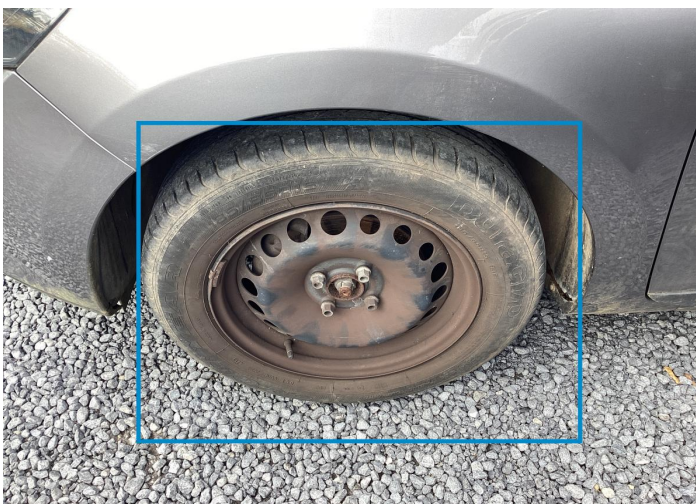
8. Rim / Front Left
Out of Bodywork / Scratch -

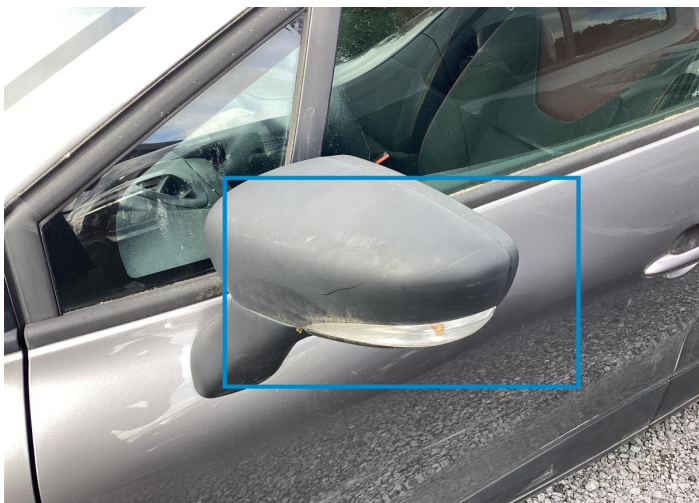
9. Mirror / Front Left
Paint / Scratch / Line -

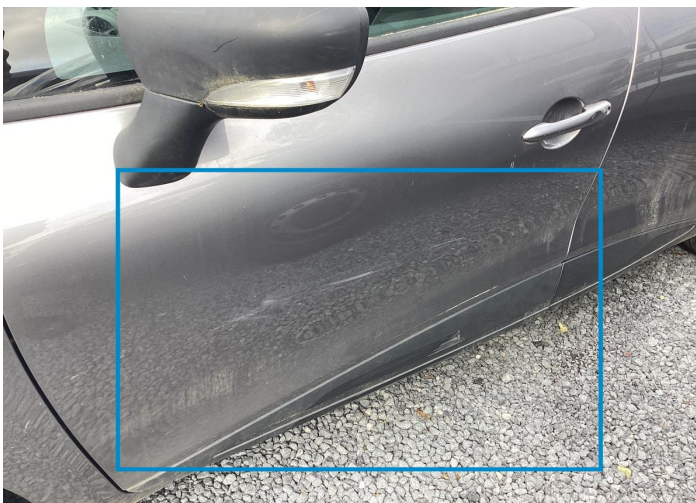
10. Door / Front Left
Bodywork / Dent / Deformation -

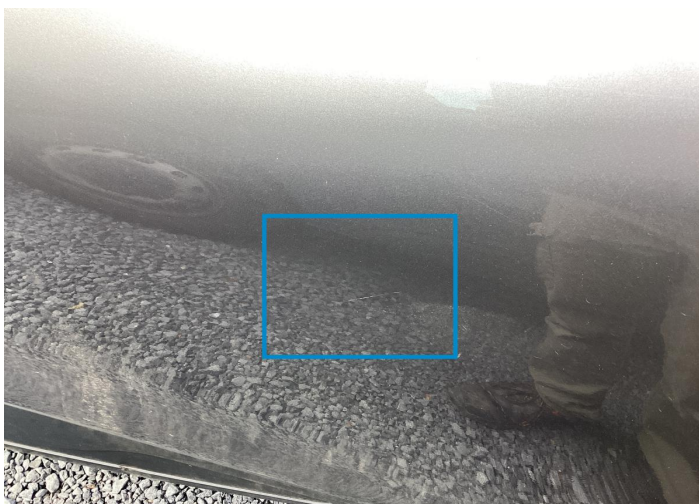
11. Door / Back Left
Paint / Scratch / Line -

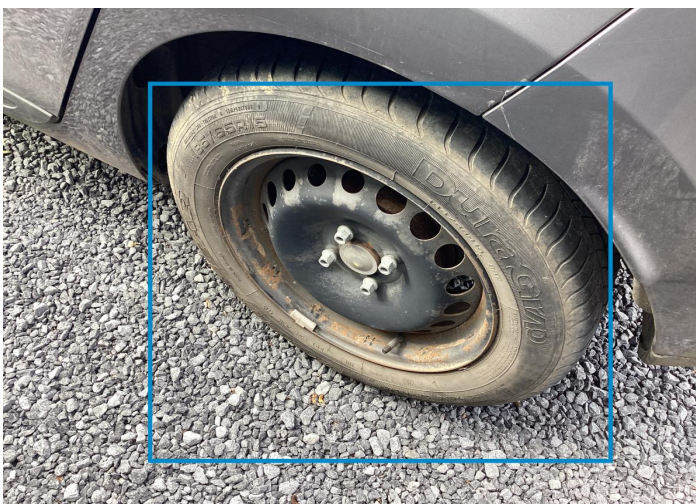
12. Rim / Back Left
Out of Bodywork / Scratch -

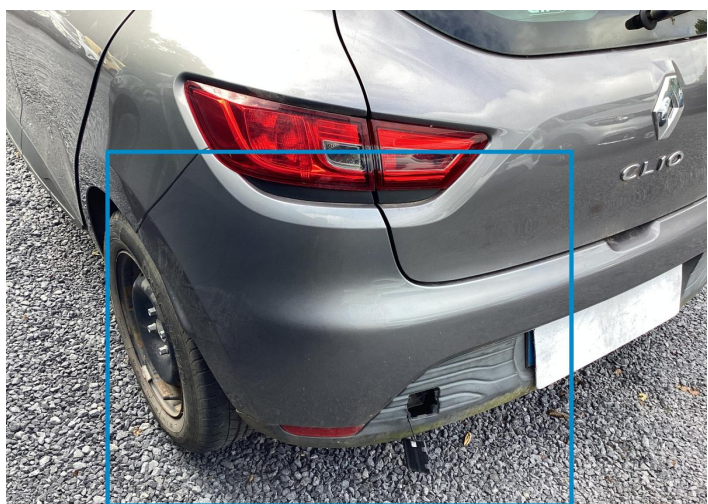
13. Corner Bumper / Back Left
Paint / Scratch / Scuff -

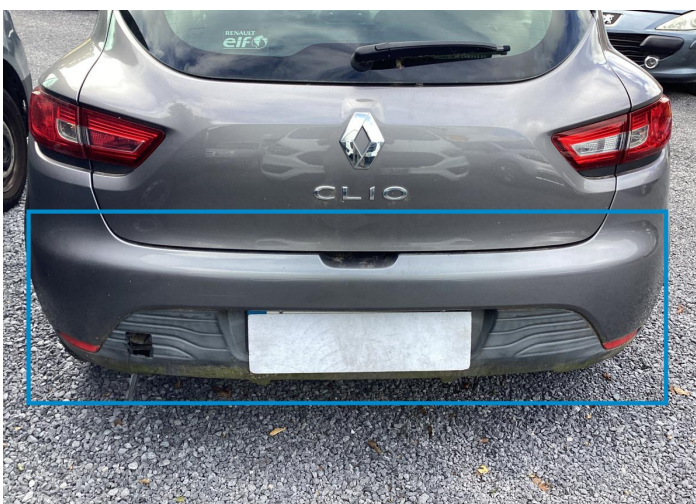
14. Bumper / Back
Paint / Scratch / Scuff -

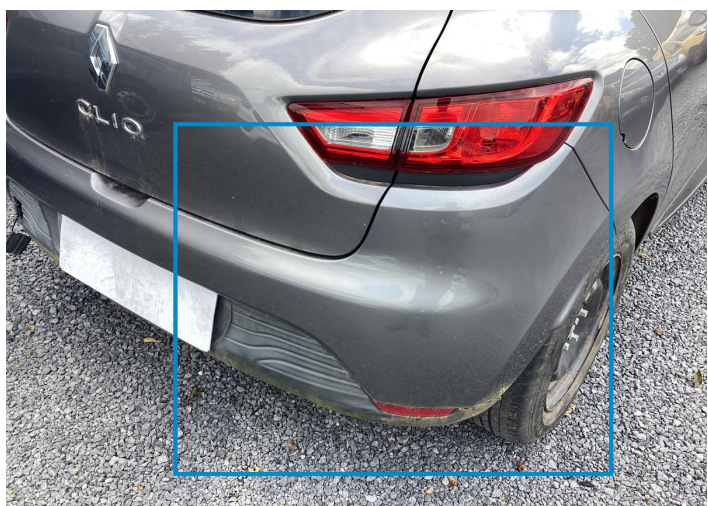
15. Corner Bumper / Back Right
Paint / Scratch / Scuff -

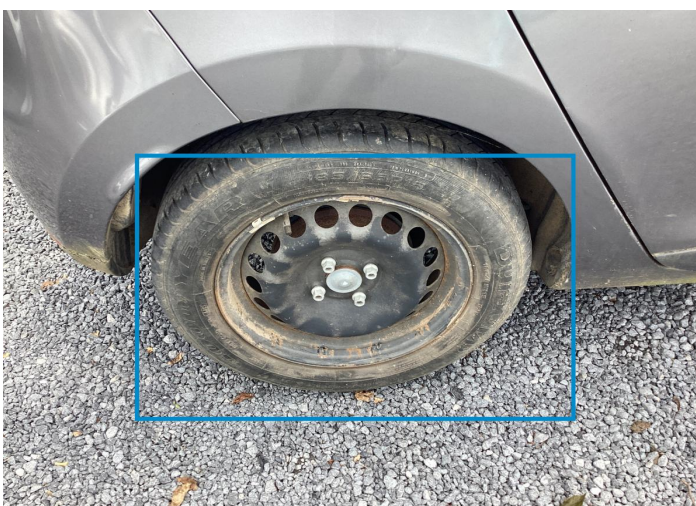
16. Rim / Back Right
Out of Bodywork / Scratch -

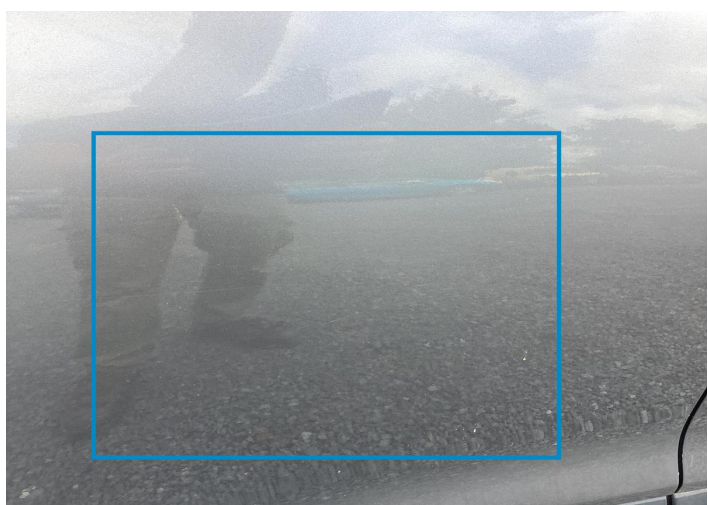
17. Door / Back Right
Paint / Scratch / Scuff -

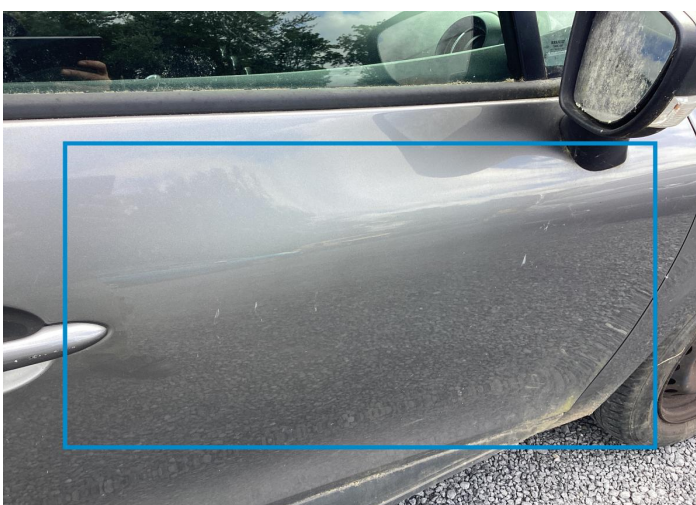
18. Door / Front Right
Paint / Scratch / Line -

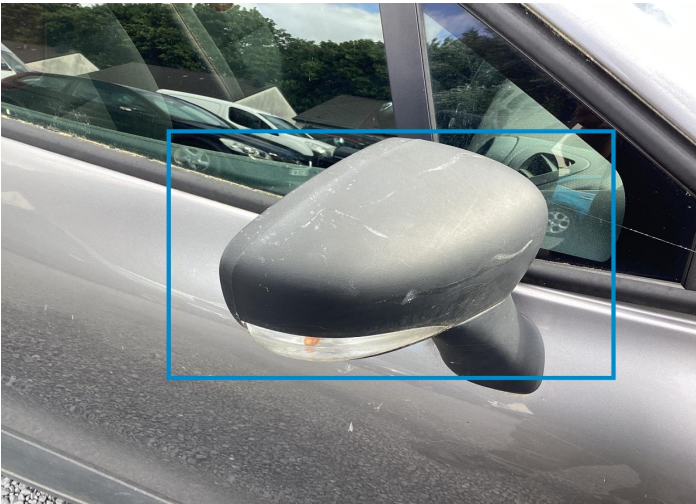
19. Mirror / Front Right
Paint / Scratch / Scuff -

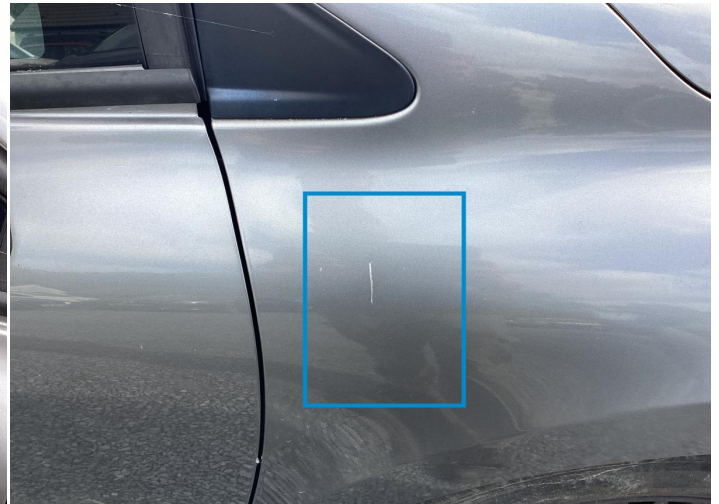
20. Fender / Front Right
Paint / Scratch / Line -

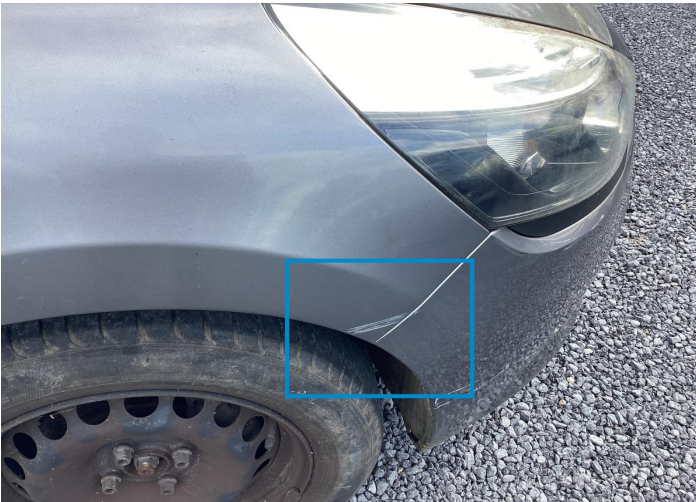
21. Fender / Back Right
Paint / Scratch / Scuff -

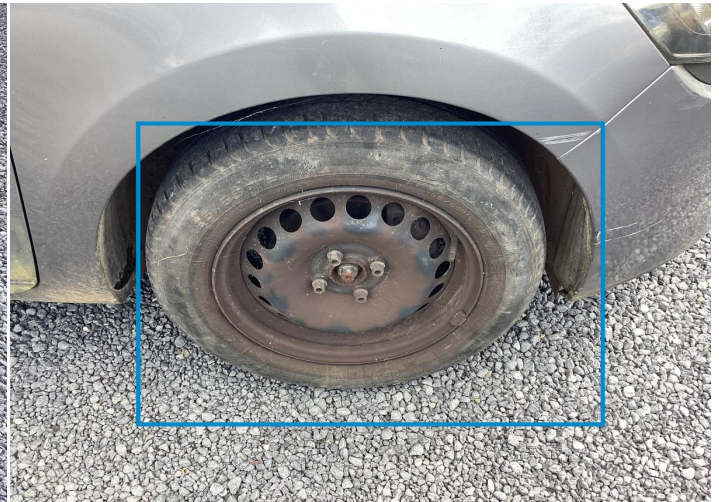
22. Rim / Front Right
Out of Bodywork / Scratch -
