Expertise

Protocol number: 41210858  
Order No. / Reference: 25150345  
Inspection date: 25 Aug 2025

Manufacturer: Renault	Model: Twingo SCe 65 ZEN
VIN: VF1AH000067637563

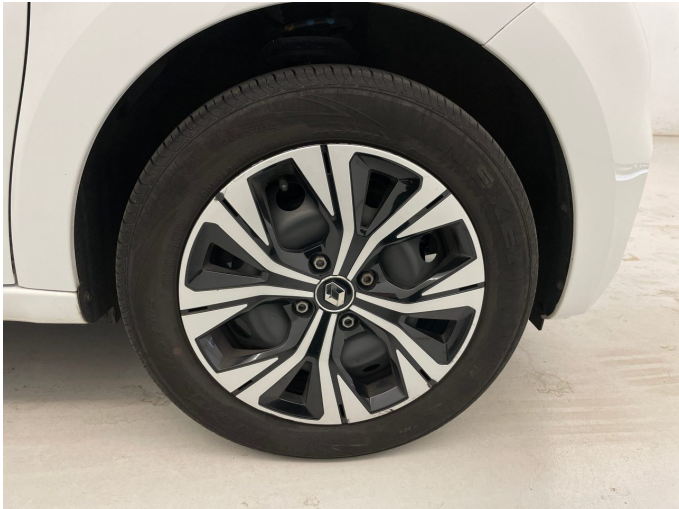
Figure 12: Mounted tyres

#	Tyre size	Type of tyre	Manufacturer	Tread depth
1)	185/60 R15 84T	Summer tyres on Steel rim with wheel cover	Nexen	5mm / 5mm
2)	185/60 R15 84T	Summer tyres on Steel rim with wheel cover	Nexen	4mm / 4mm

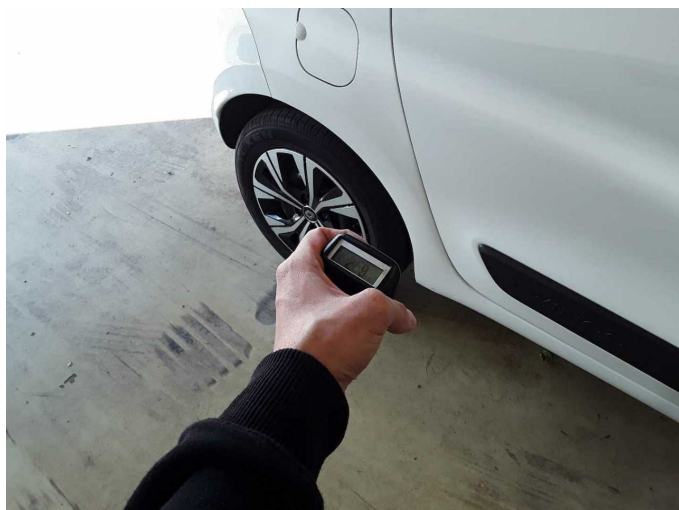
No.	Repainting
1	Side panel - rear right side, Professionally carried out, Invoice of repair done Non-existent

Side panel - rear right side	2,590 µm
------------------------------	-------------

**Repainting 1:** Side panel - rear right side

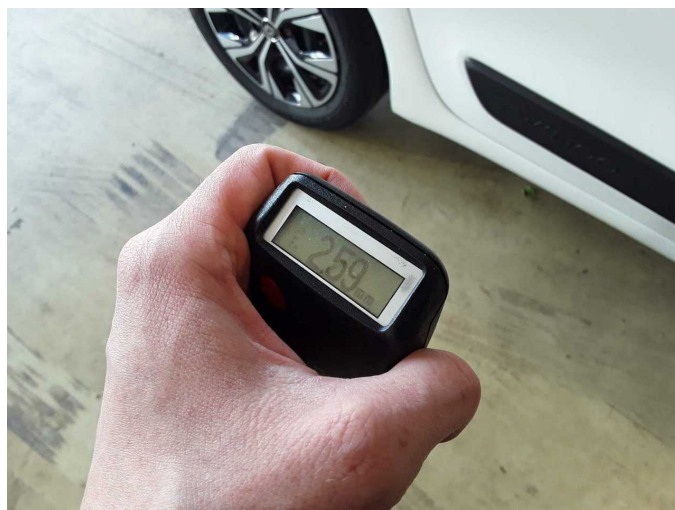
**Repainting 1:** Side panel - rear right side
