status report

Renault Twingo Limited

Vehicle identification number	VF1AH000863505917	mileage read:	122175 km
..			
First Registration / construction year:	08.07.2019 / 2019	Visit Date / place of birth:	30.09.2025 Hoppegarten
Bodywork:	cars	Re - import:	no
Body type:	hatchback	KBA no. :	3333//BLU
Fuel / emission class:	gasoline / € 6	transmission type:	manual transmission
Displacement / power:	999 ccm / 54 kW (73 PS)	Engine:	rear-wheel drive
paint:	CRYSTAL WEISS	Number of previous owners:	2
Doors / seats:	5 / 4	number keys:	1
Next HU / AU:	- / -	cushion type:	substance
Service book available:	yes	Interior Color:	gray
smoking vehicle:	yes	Last service km / on the:	19972 / 01.06.2020
Vehicle roadworthy:	yes	Vehicle roadworthy:	yes
Submitted vehicle	Eg II (veh - letter)	state outside:	5 - neglected
documents:			
visit condition:	-	condition inside:	4 - moderate
state general:	5 - neglected

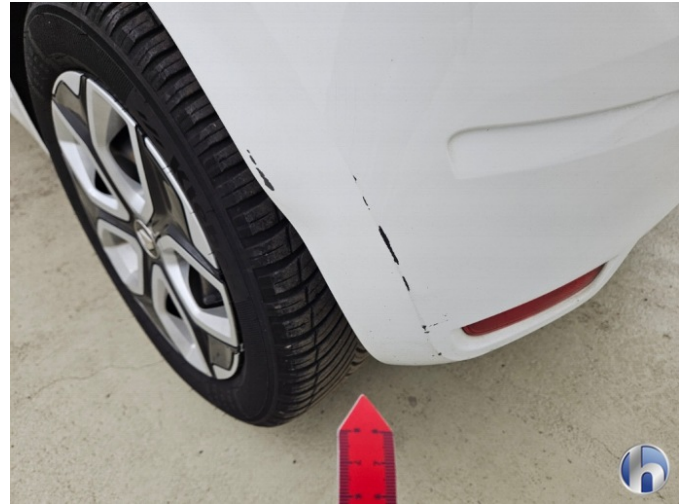
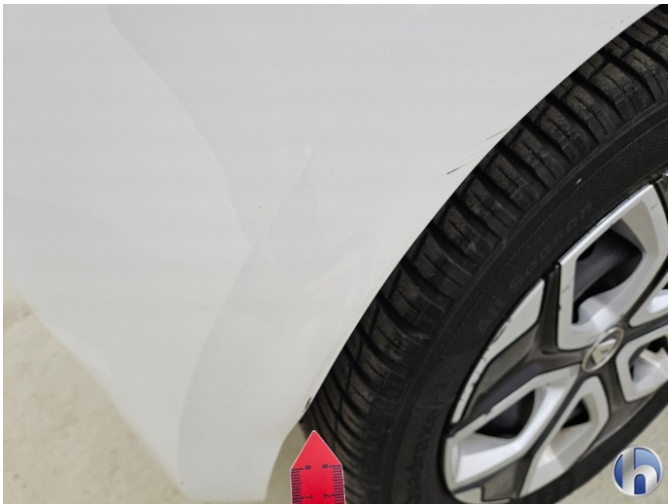
4. Rear bumper

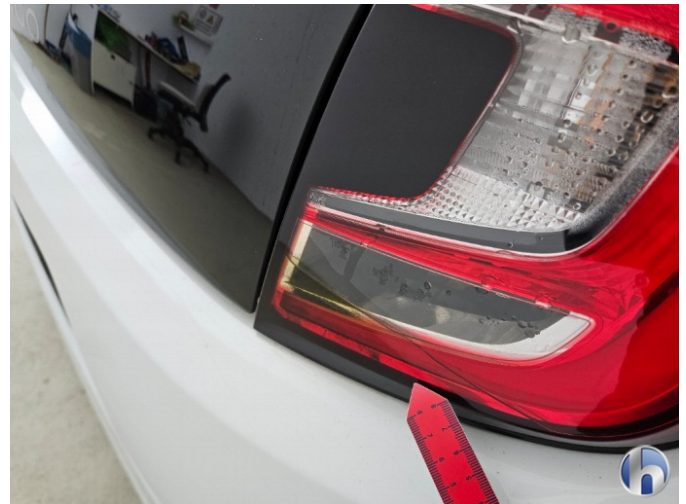
5. Taillight right

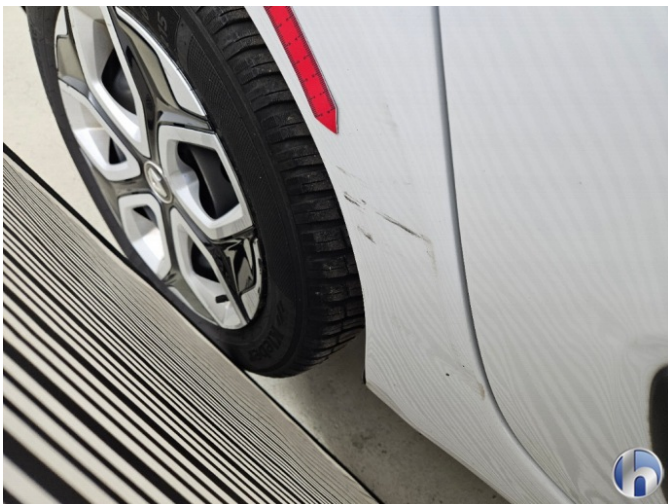
6. Sidewall - Rear - right

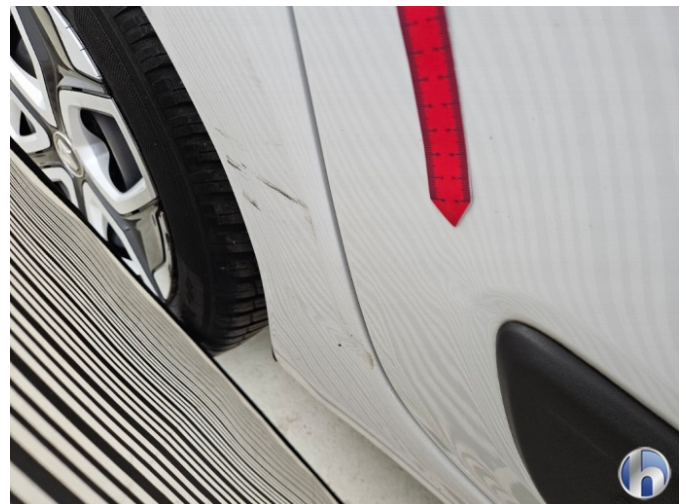
7. Door Rear - right

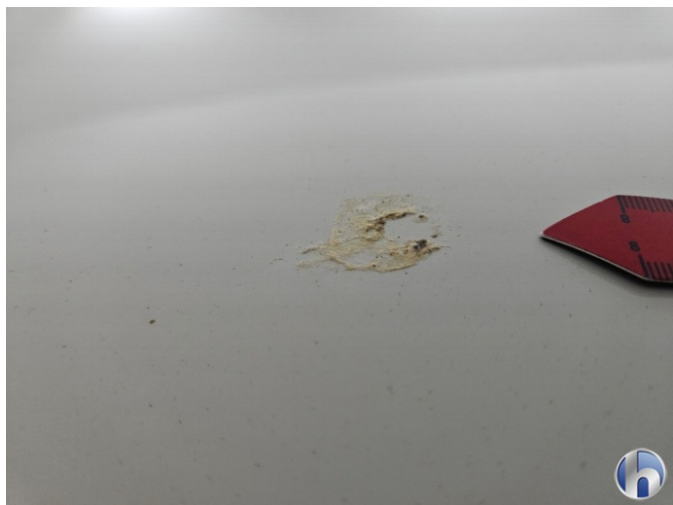
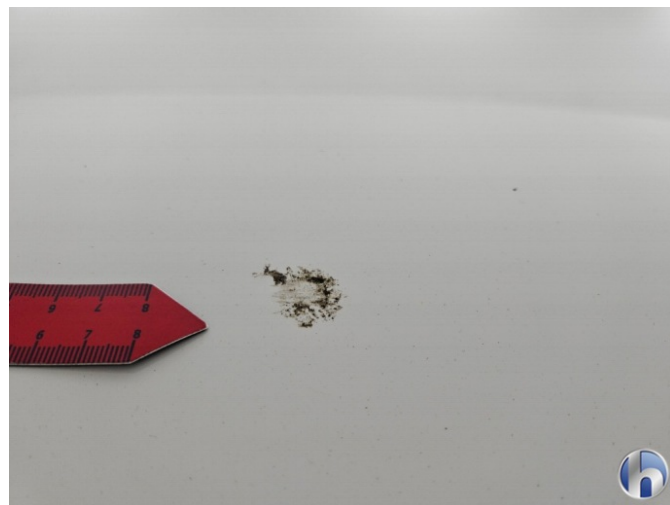
8. roof

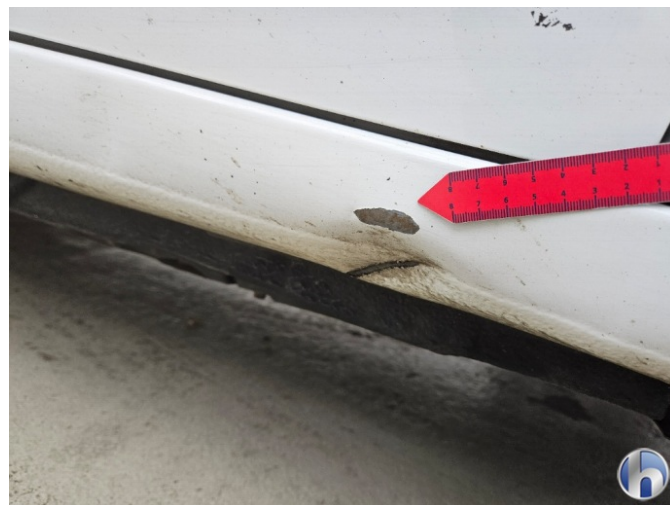
11. side skirt - right

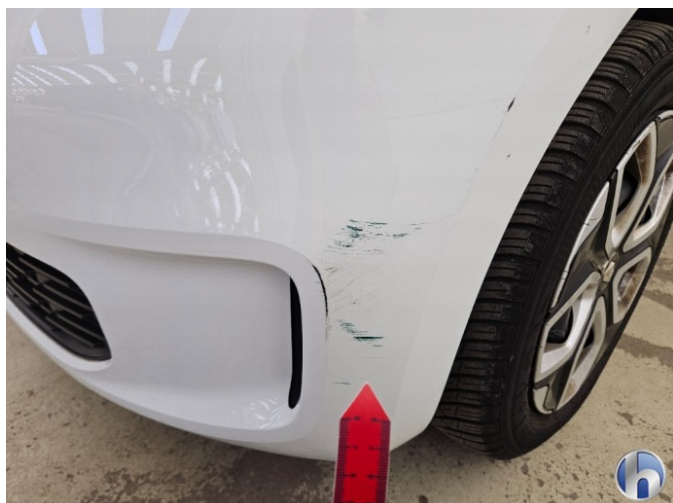
12. Front bumper

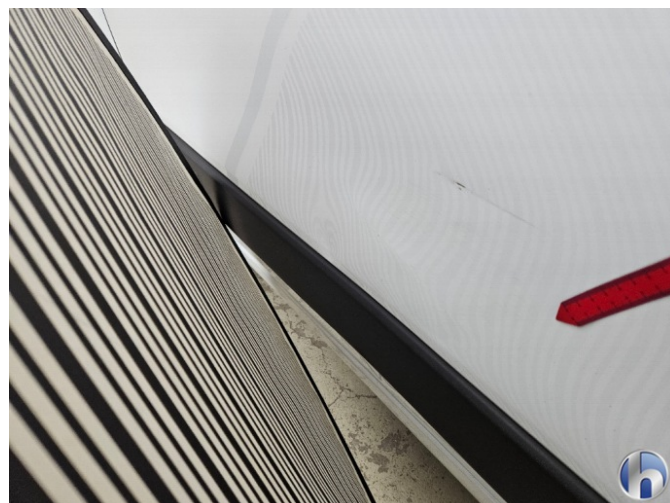
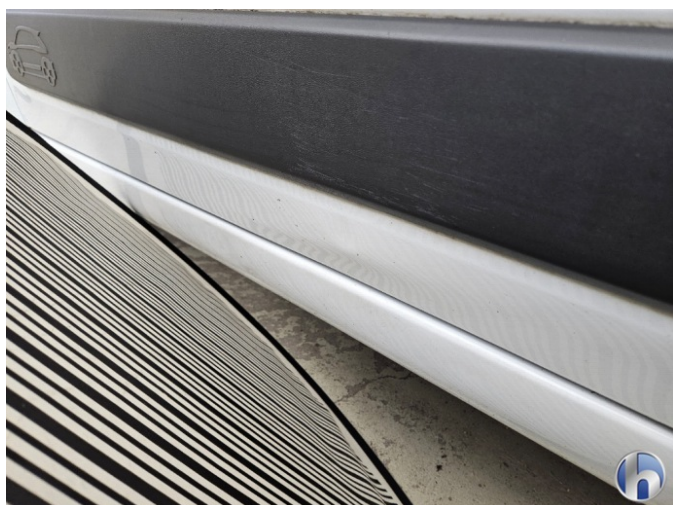
13. Front door - left

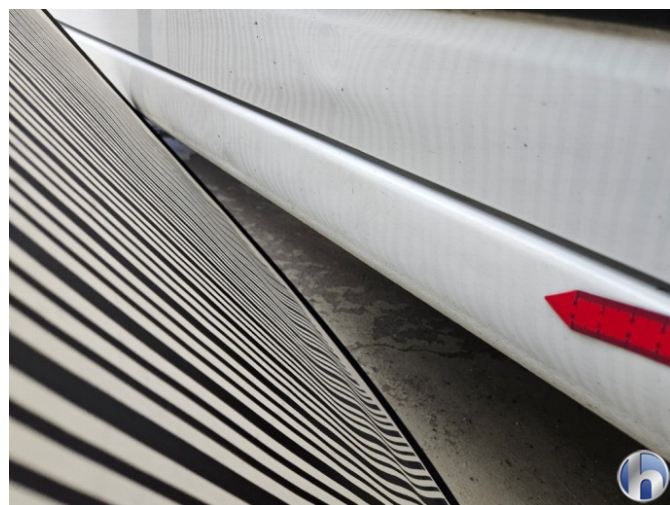
14. side skirt - left

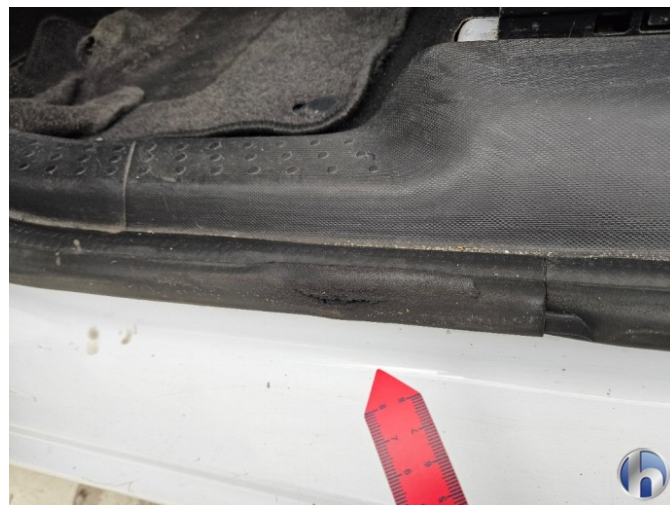
16. Front door seal - left

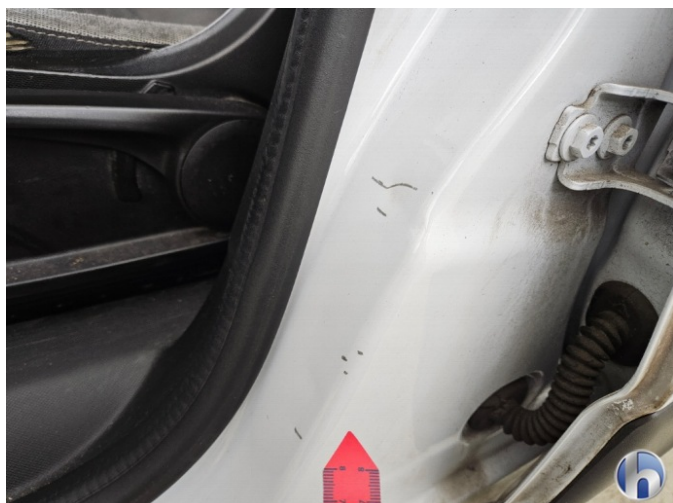
17. Türeinstieg Vorne - Links

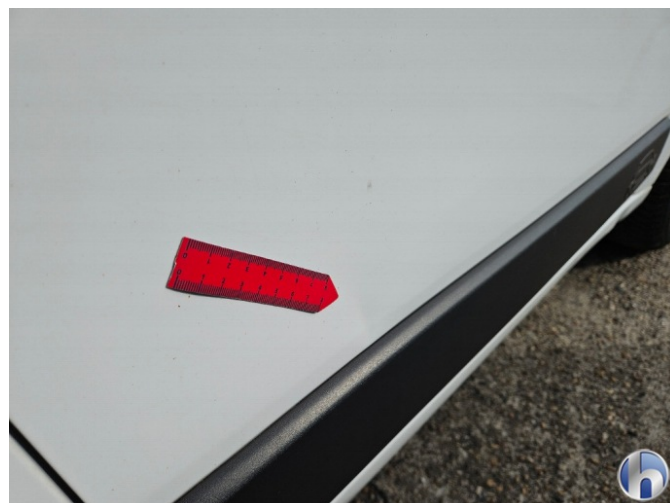
component	Damage	Rep kind
1.	key	Missing	Replace
2.	maintenance	Missing	Replace
3.		Wear and tear	acceptable
4.	Rear bumper	Scrape	Paint
5.	Taillight right	Damaged	Replace
6.	Sidewall - Rear - right	Damaged	Refurbish and paint
7.	Door Rear - right	Deformed	Refurbish and paint
8.	roof		Paint
9.		Dirty (strong)	
10.		Wear and tear	acceptable
11.	side skirt - right	Deformed	Replace
12.	Front bumper	Scrape	Paint
13.	Front door - left	Deformed	Refurbish and paint
14.	side skirt - left	Deformed (slightly)	Refurbish and paint
15.		Damaged	Replace
16.	Front door seal - left	Damaged	Replace
17.	Türeinstieg Vorne - Links	Damaged	Refurbish and paint
18.	Front door - right	Deformed (slightly)	Refurbish and paint
19.	coupling	Not okay	Carry out a fault diagnosis

18. Front door - right
