RENAULT MÉGANE

Mégane 1.6 16V Luxe Dynamique

VIN NO VF1BM1R0H34986764
Registration Number 8950WT62

Customer	BCAuto Encheres	Report Number	P20251008175145
Inspection Date / Place	2025-10-08 / BCA BETHUNE	Cosmetic Grade	2

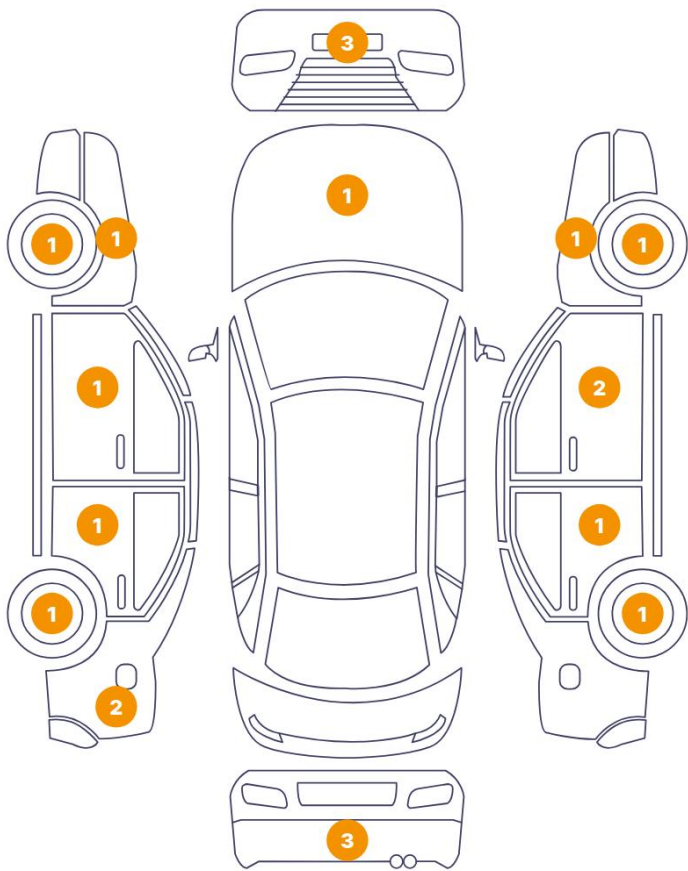
20 Dommages

Component		Damage	Comments
1	Floor Carpet	Interior / Dirty	
2	Floor Carpet	Interior / Dirty	
3	Roof Upholstery	Interior / Loose	
4	Corner Bumper / Front Right	Paint / Scratch / Scuff	
5	Roof Upholstery	Interior / Loose	
6	Bumper / Back	Paint / Scratch / Scuff	
7	Corner Bumper / Front Right	Paint / Scratch / Scuff	
8	Bumper / Front	Paint / Scratch / Scuff	
9	Door / Back Right	Paint / Scratch / Line	
10	Fender / Front Left	Paint / Scratch / Line	
11	Corner Bumper / Back Left	Paint / Scratch / Scuff	
12	Rim / Front Left	Out of Bodywork / Scratch	À plat

13	Corner Bumper / Back Right	Paint / Scratch / Scuff	
14	Door / Front Right	Paint / Scratch / Line	
15	Rim / Front Right	Out of Bodywork / Scratch	
16	Rim / Back Left	Out of Bodywork / Scratch	À plat
17	Door / Back Left	Paint / Scratch / Line	
18	Rim / Back Right	Out of Bodywork / Scratch	À plat
19	Mirror / Front Left	Paint / Scratch / Scuff	
20	Hood	Paint / Chipping	
21	Fender / Front Right	Paint / Scratch / Scuff	
22	Side Panel / Back Left	Paint / Scratch / Scuff	
23	Mirror / Front Right	Bodywork / Breakage	
24	Side Panel / Back Left	Bodywork / Dent / Dent

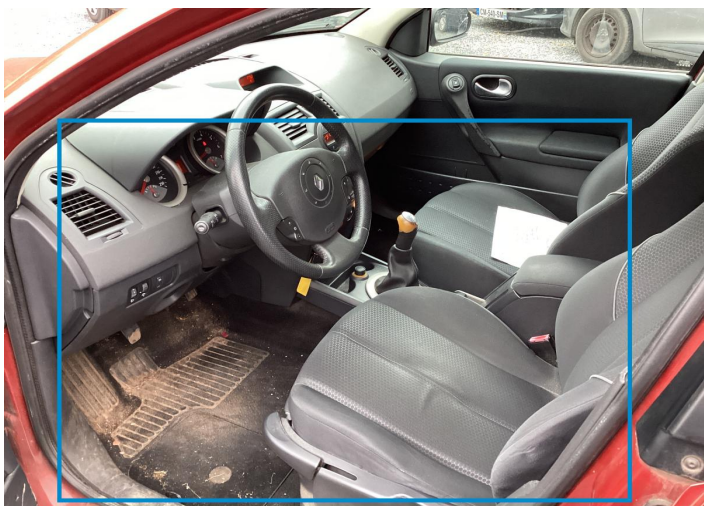
1. Floor Carpet
Interior / Dirty -

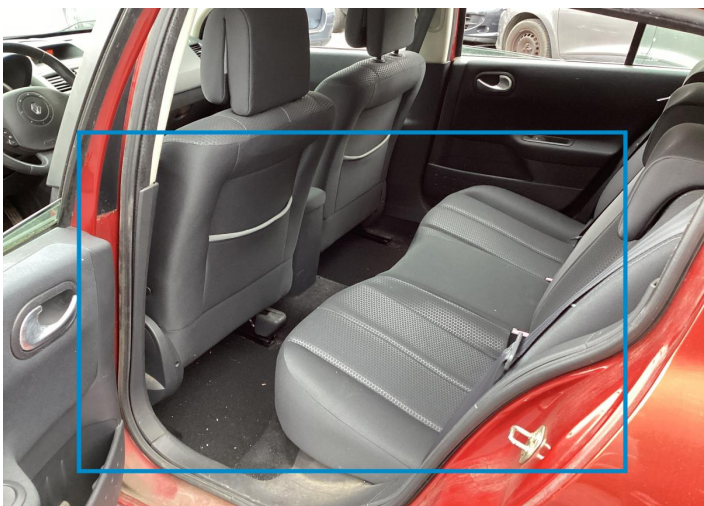
2. Floor Carpet
Interior / Dirty -

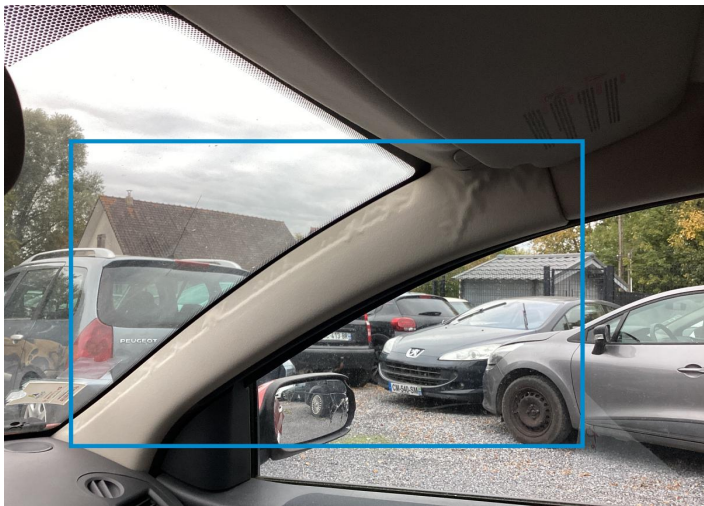
3. Roof Upholstery
Interior / Loose -

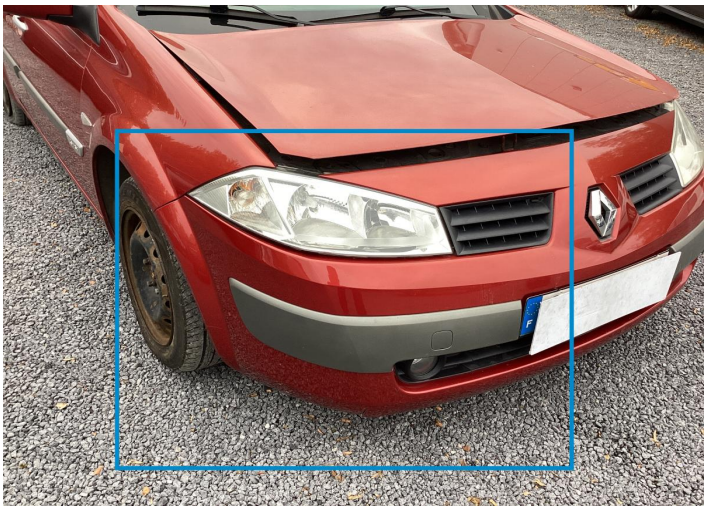
4. Corner Bumper / Front Right
Paint / Scratch / Scuff -

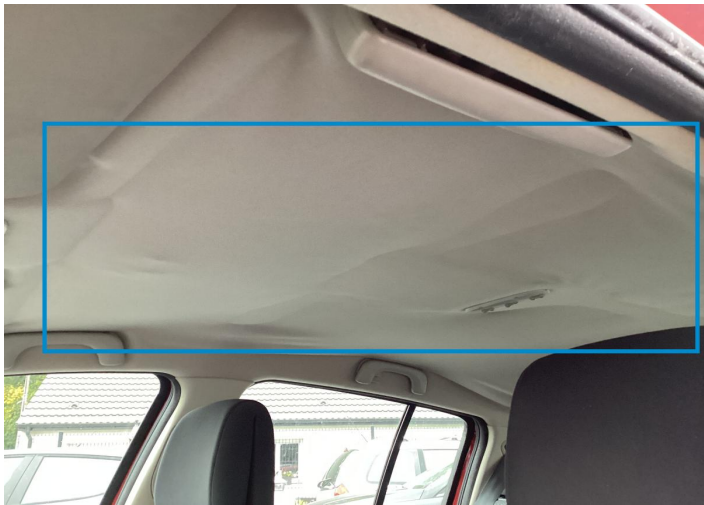
5. Roof Upholstery
Interior / Loose -

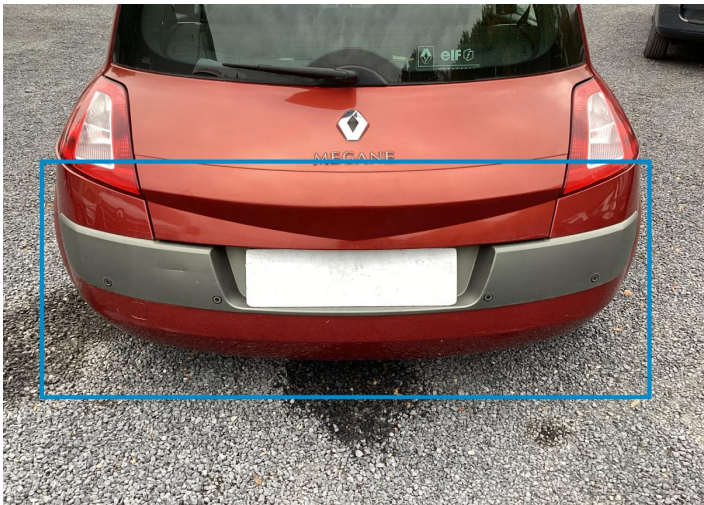
6. Bumper / Back
Paint / Scratch / Scuff -

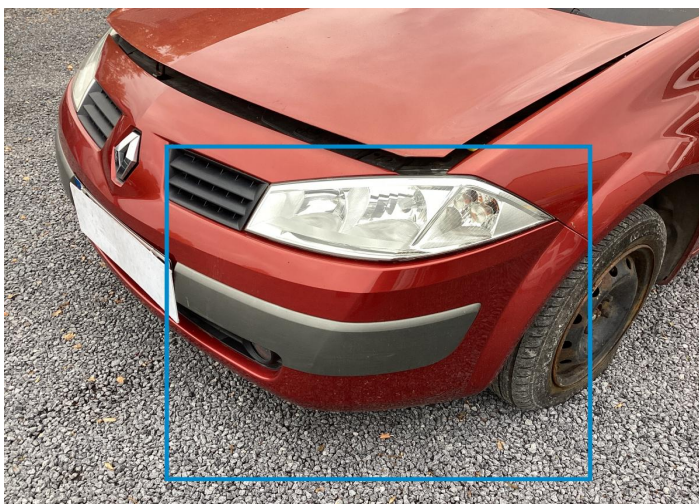
7. Corner Bumper / Front Right
Paint / Scratch / Scuff -

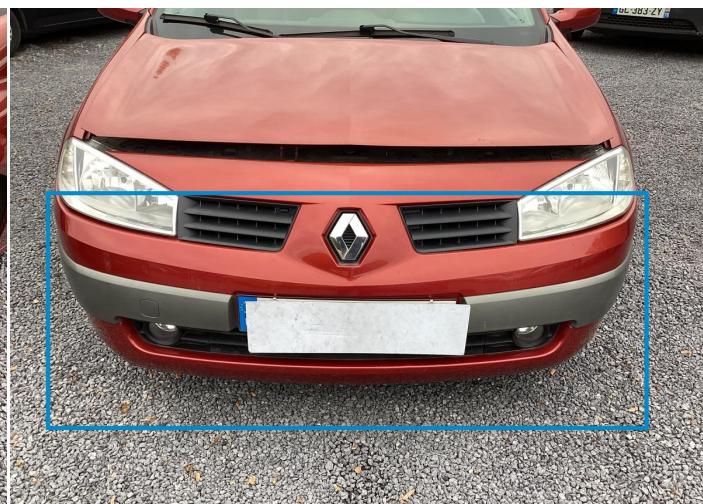
8. Bumper / Front
Paint / Scratch / Scuff -

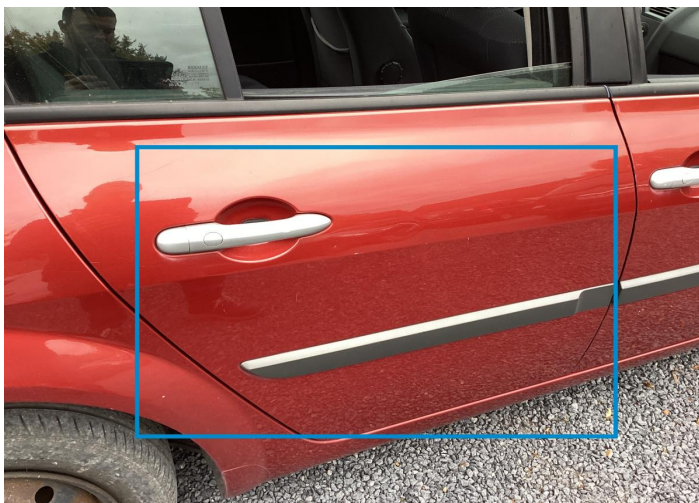
9. Door / Back Right
Paint / Scratch / Line -

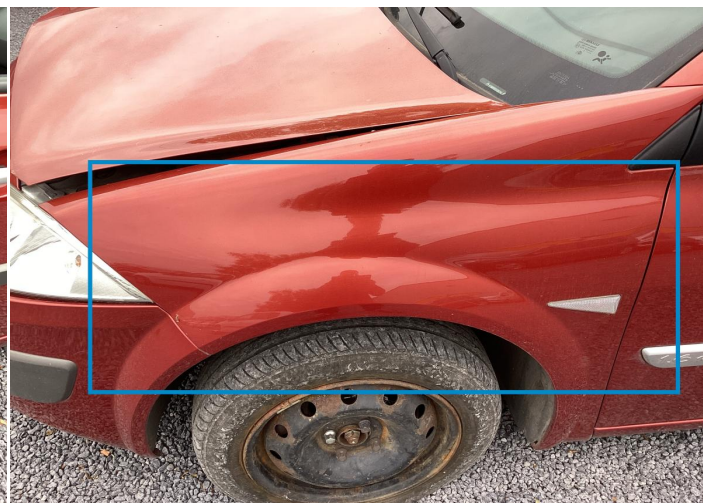
10. Fender / Front Left
Paint / Scratch / Line -

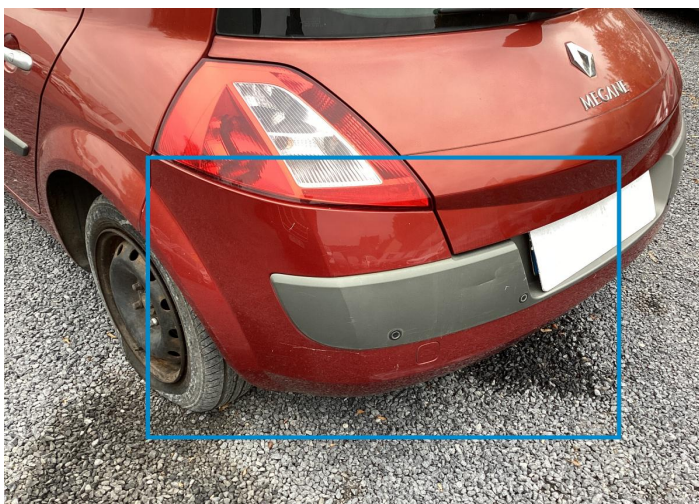
11. Corner Bumper / Back Left
Paint / Scratch / Scuff -

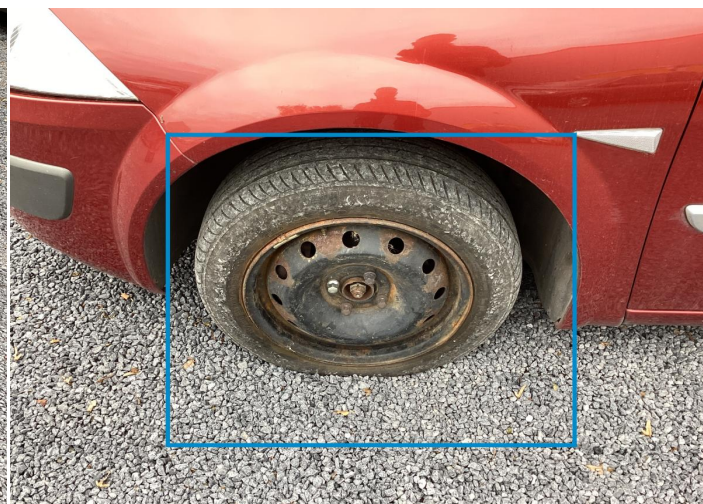
12. Rim / Front Left
Out of Bodywork / Scratch -
À plat

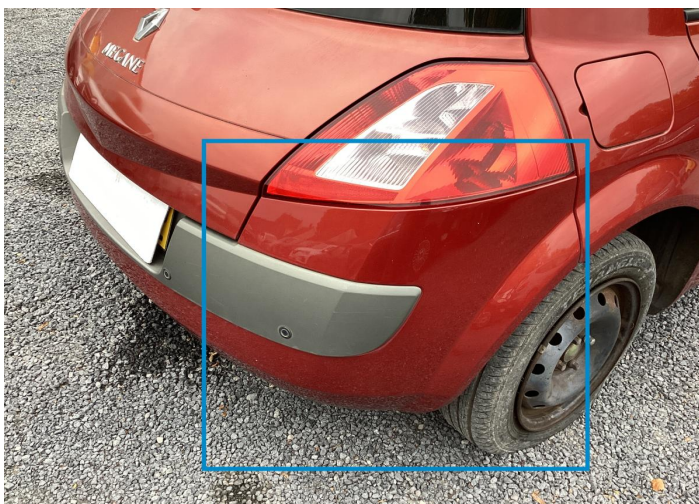
13. Corner Bumper / Back Right
Paint / Scratch / Scuff -

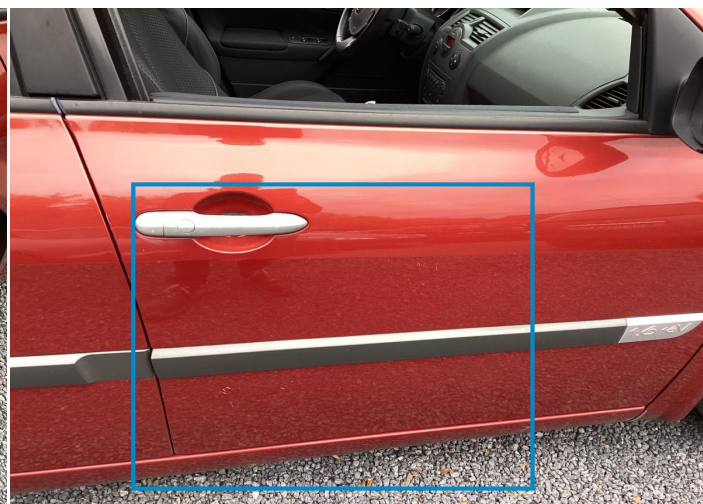
14. Door / Front Right
Paint / Scratch / Line -

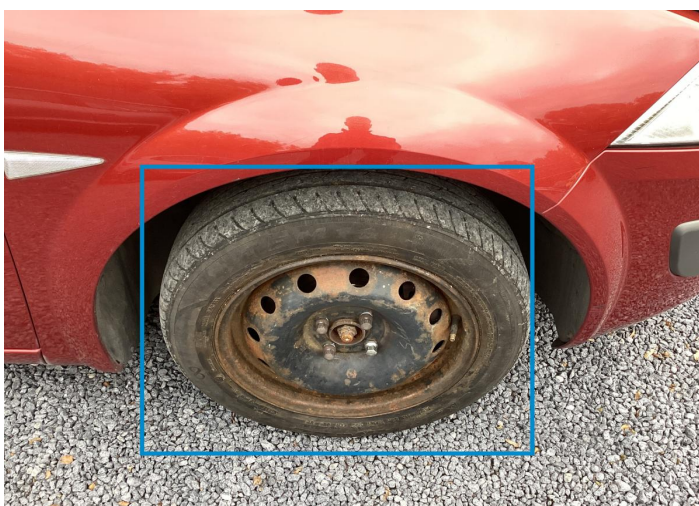
15. Rim / Front Right
Out of Bodywork / Scratch -

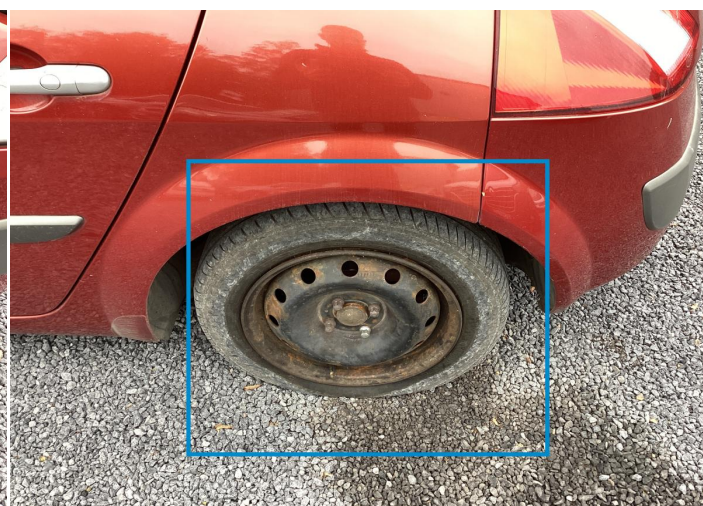
16. Rim / Back Left
Out of Bodywork / Scratch -
À plat

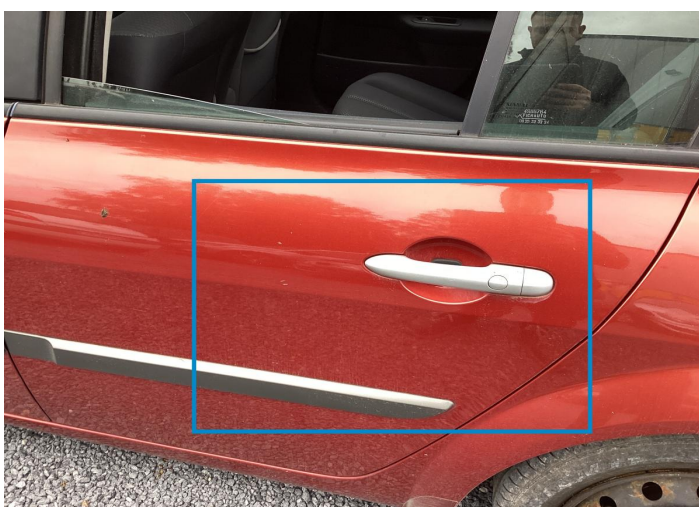
17. Door / Back Left
Paint / Scratch / Line -

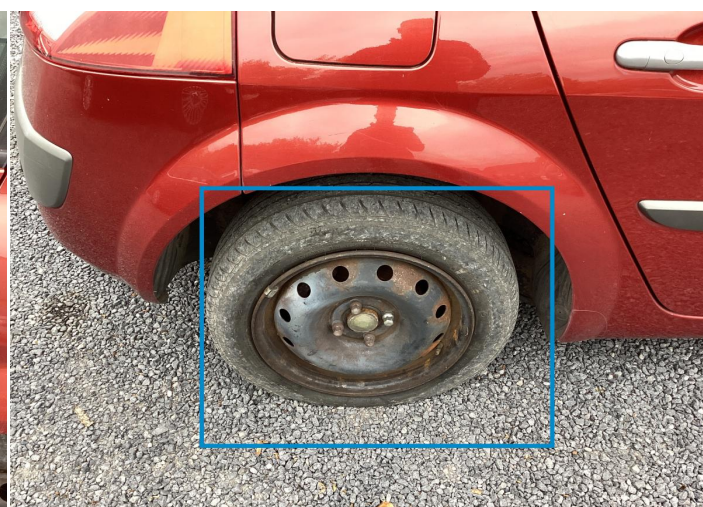
18. Rim / Back Right
Out of Bodywork / Scratch -
À plat

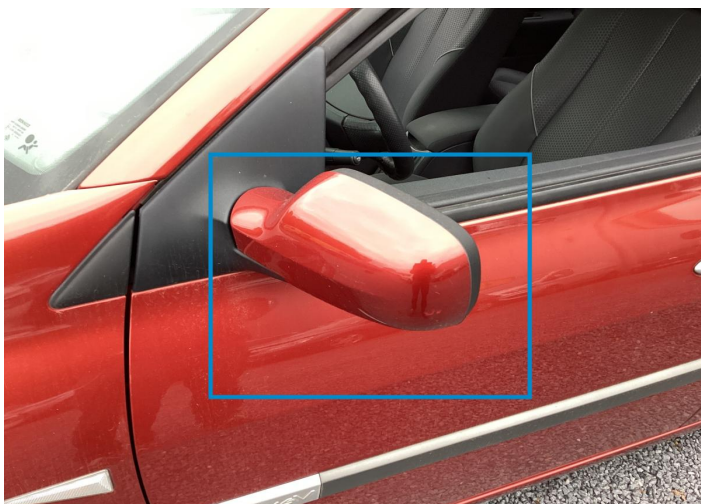
19. Mirror / Front Left
Paint / Scratch / Scuff -

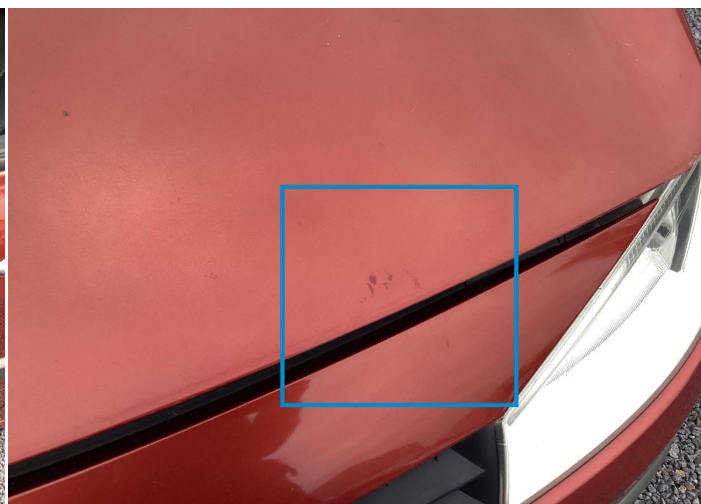
20. Hood
Paint / Chipping -

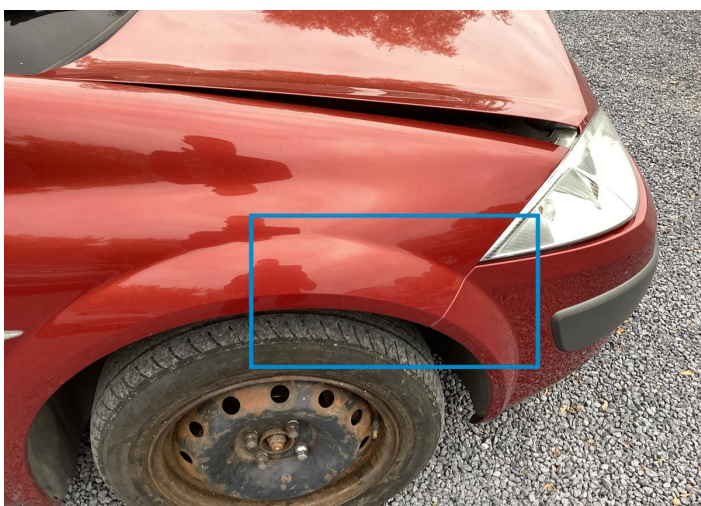
21. Fender / Front Right
Paint / Scratch / Scuff -

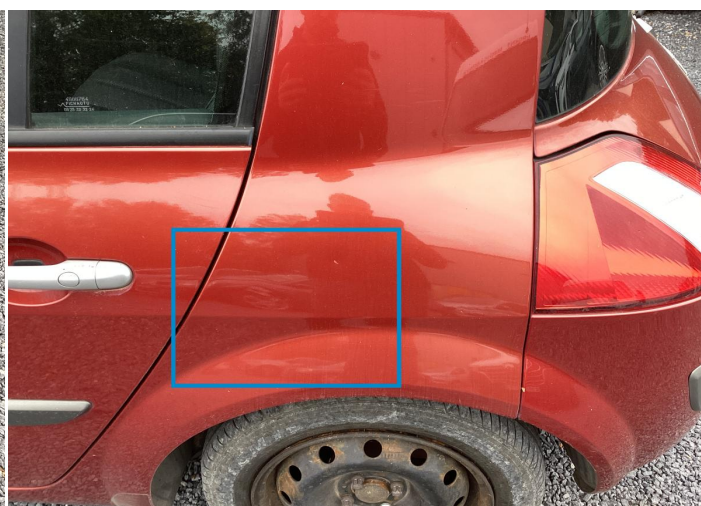
22. Side Panel / Back Left
Paint / Scratch / Scuff -

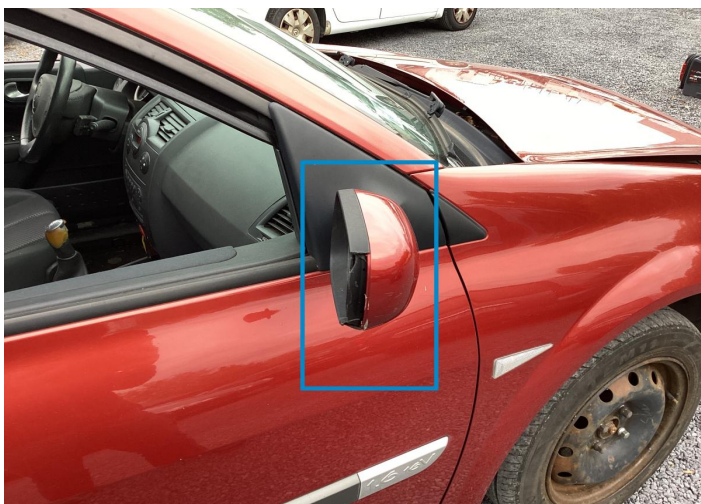
23. Mirror / Front Right
Bodywork / Breakage -

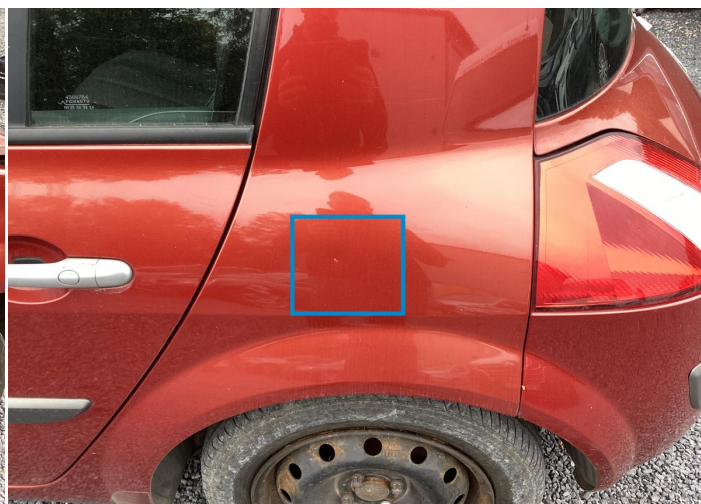
24. Side Panel / Back Left
Bodywork / Dent / Dent -
