RENAULT Megane

Megane ENERGY TCe 115 Start & Stop

Inspection Report Summary

Customer	BCA Online	Report Number	P20251002085538
Inspection Date / Place	2025-10-02 / BCA Berlin	Cosmetic Grade	5

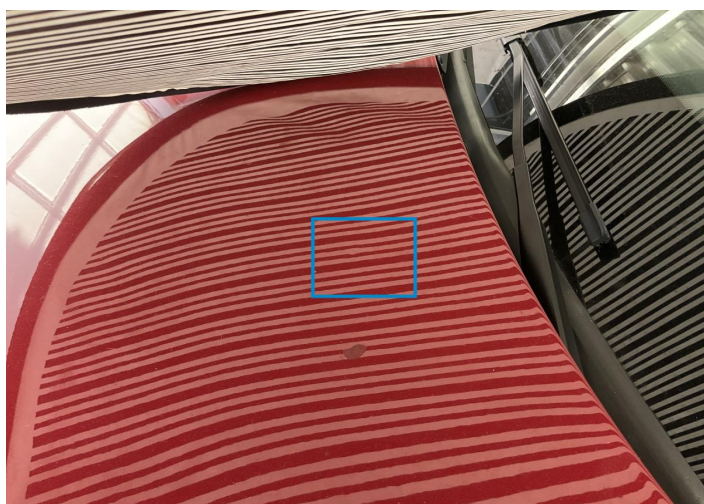
1. Hood
Bodywork / Dent / Dent -

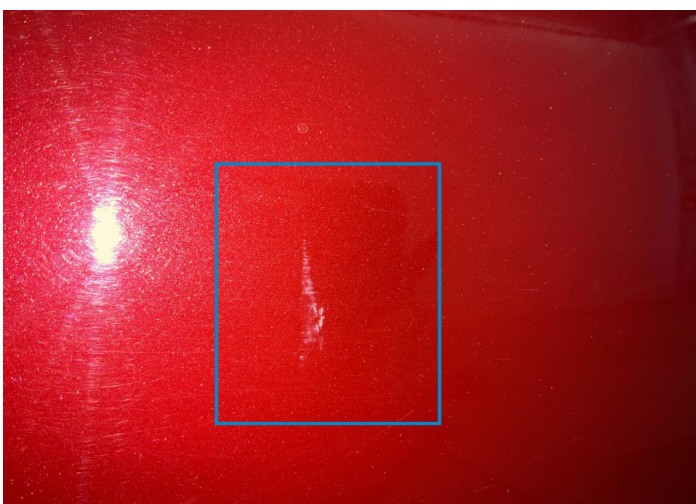
2. Door / Front Left
Paint / Scratch / Scuff -

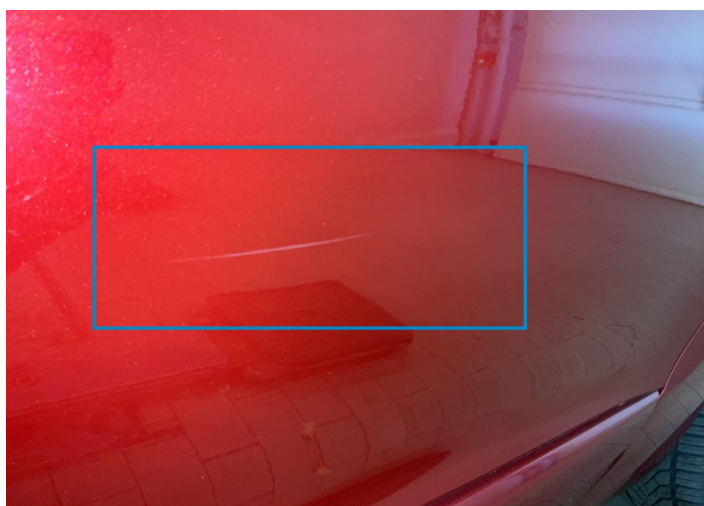
3. Door / Back Left
Paint / Scratch / Scuff -

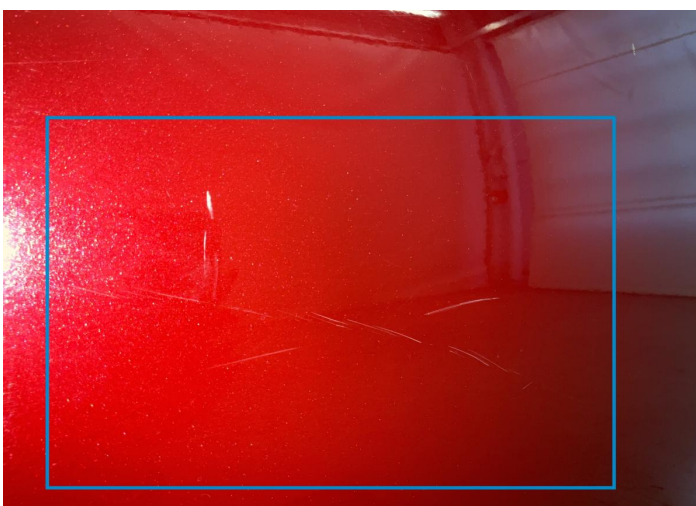
4. Door / Back Left
Paint / Scratch / Scuff -

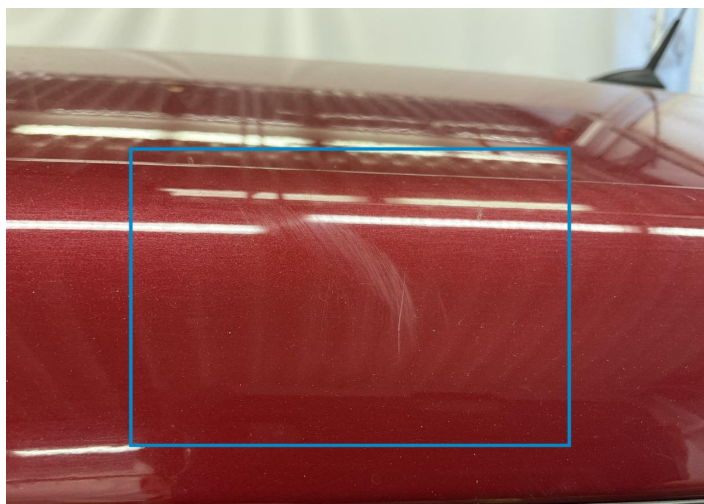
5. Roof
Paint / Scratch / Scuff -

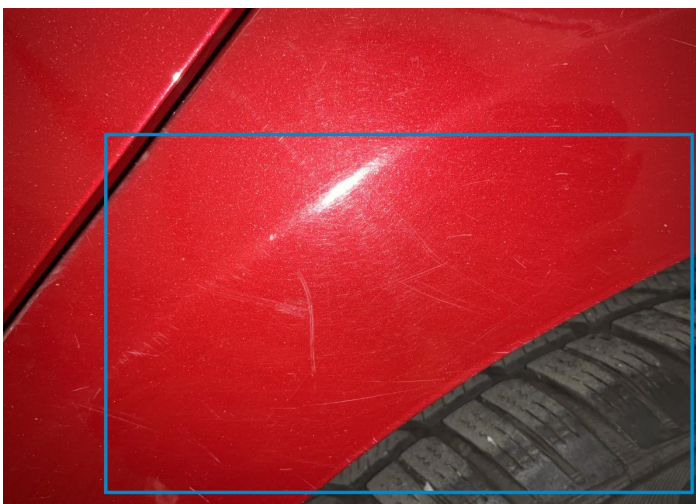
6. Fender / Back Left
Paint / Scratch / Scuff -

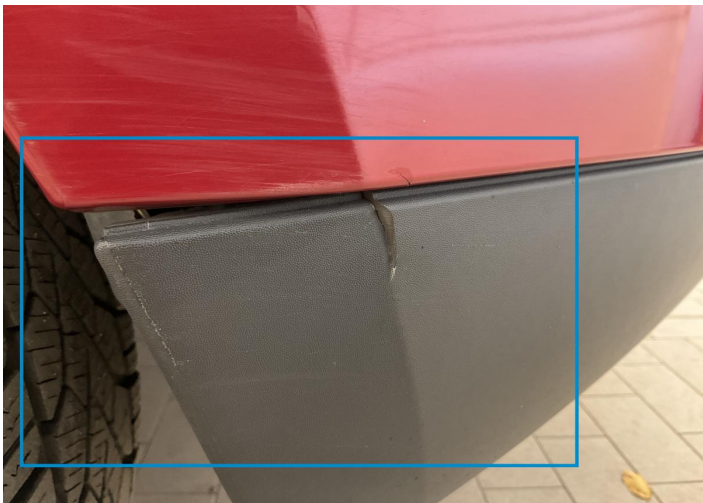
7. Bumper / Back
Bodywork / Breakage / Crack -

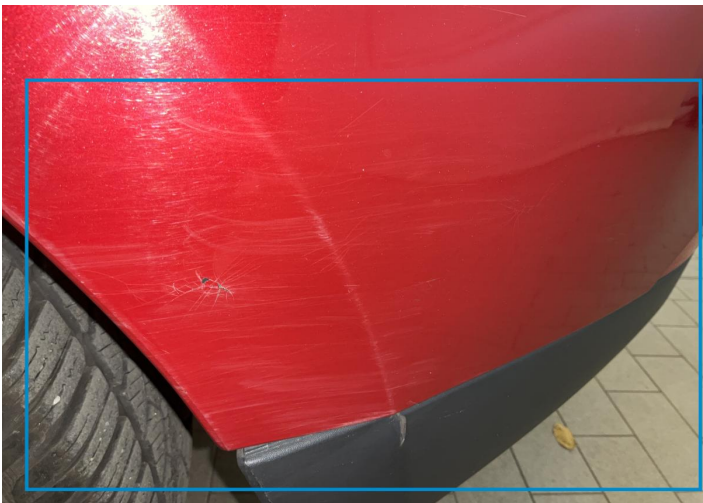
8. Bumper / Back
Paint / Scratch / Scuff -

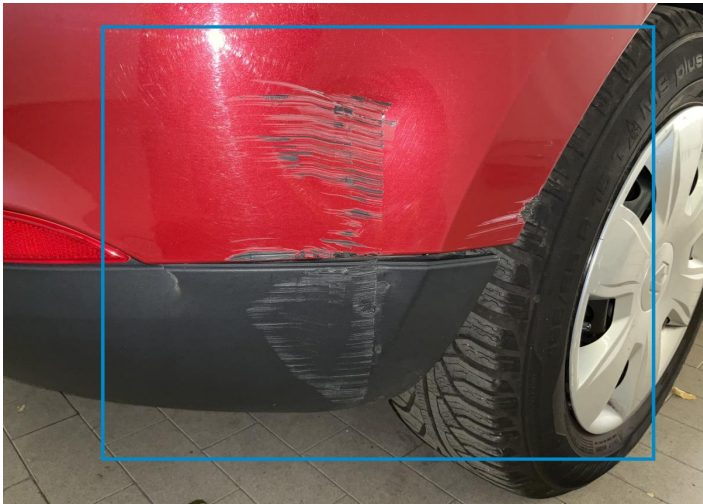
9. Bumper / Back
Paint / Scratch / Scuff -

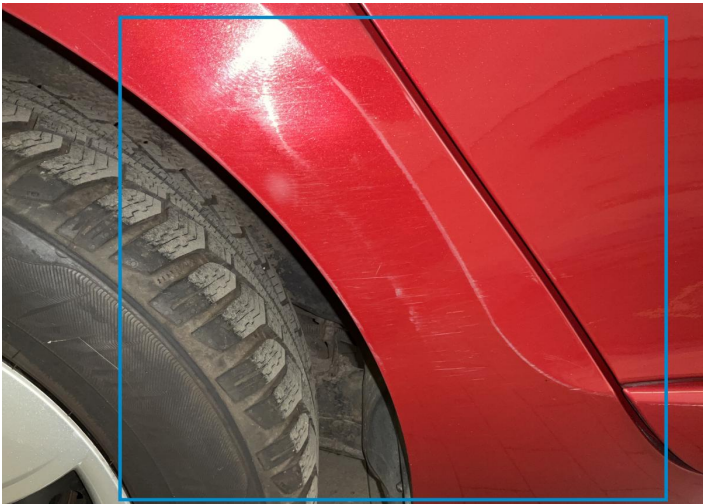
10. Side Panel / Back Right
Paint / Scratch / Scuff -

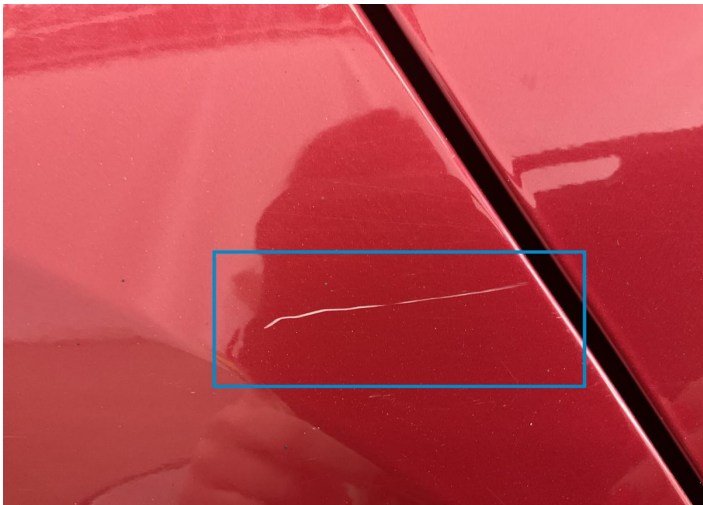
11. Side Panel / Back Right
Paint / Scratch / Scuff -

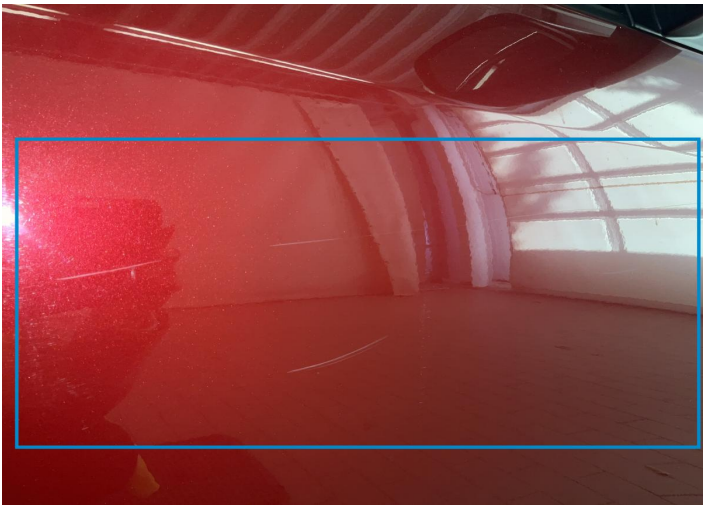
12. Door / Front Right
Paint / Scratch / Scuff -

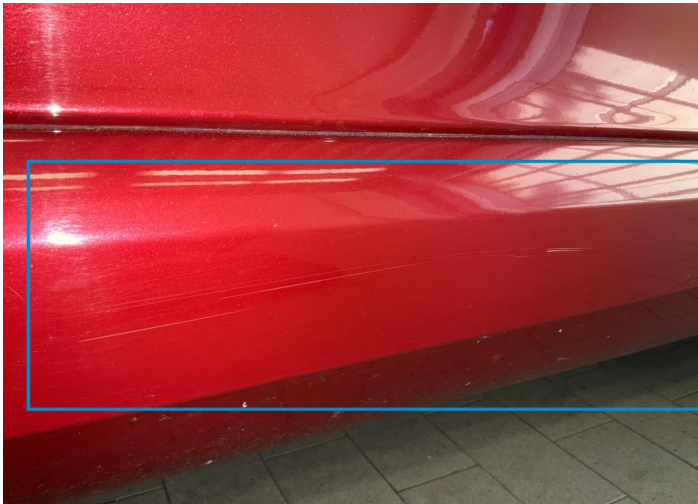
13. Door / Front Right
Paint / Scratch / Scuff -

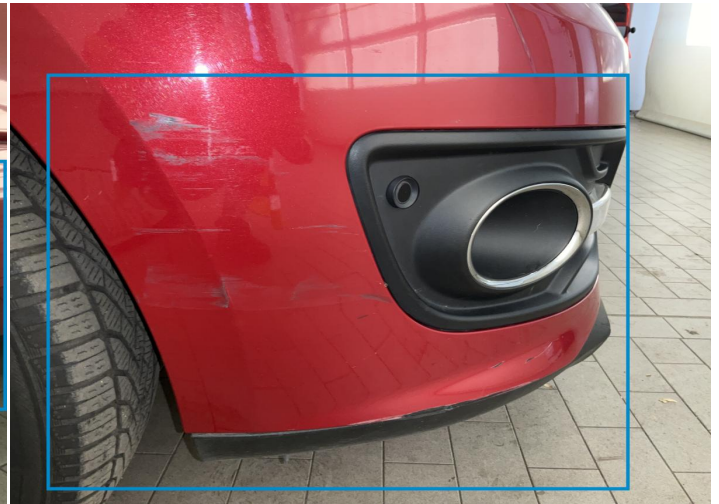
14. Bumper / Front
Paint / Scratch / Scuff -

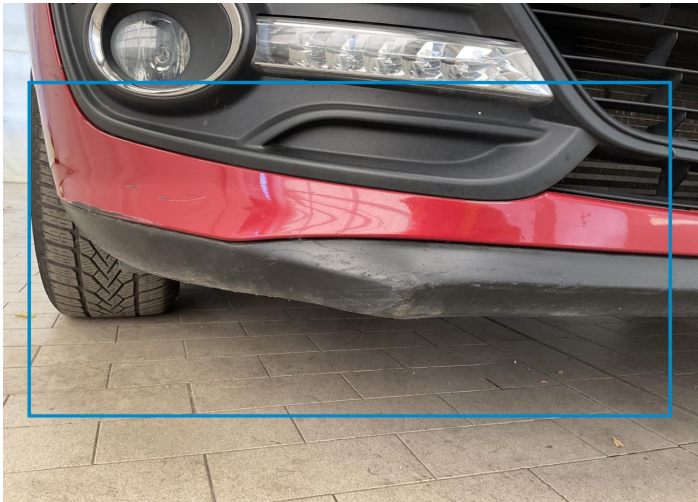
15. Bumper / Front
Paint / Scratch / Scuff -
