RENAULT Twingo

Twingo 1.2 16V LEV

Inspection Report Summary

Customer	BCA Online	Report Number	P20251014133352
Inspection Date / Place	2025-10-14 / BCA Heidenheim	Cosmetic Grade	4

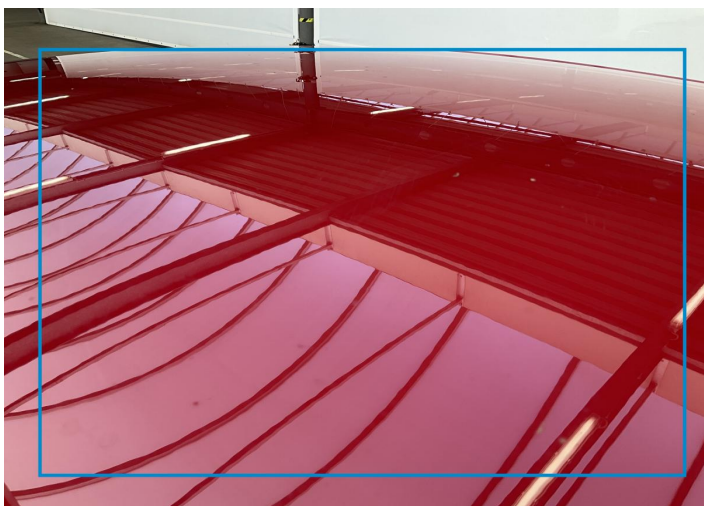
1. Roof
Paint / Scratch / Scuff -

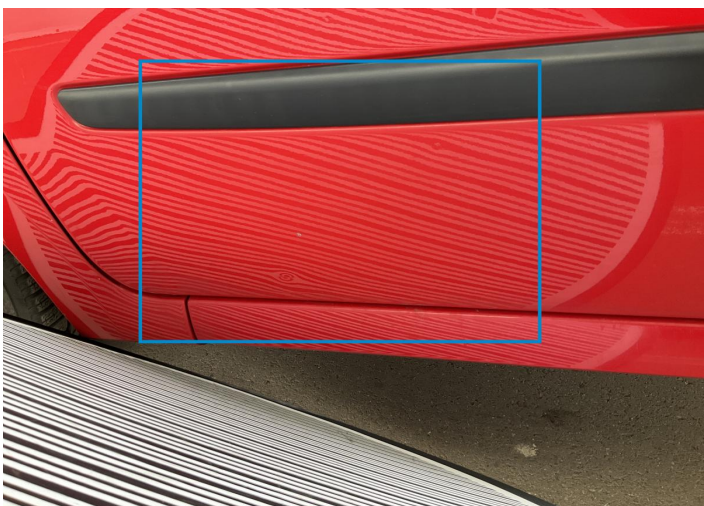
2. Door / Front Left
Bodywork / Dent / Dent -

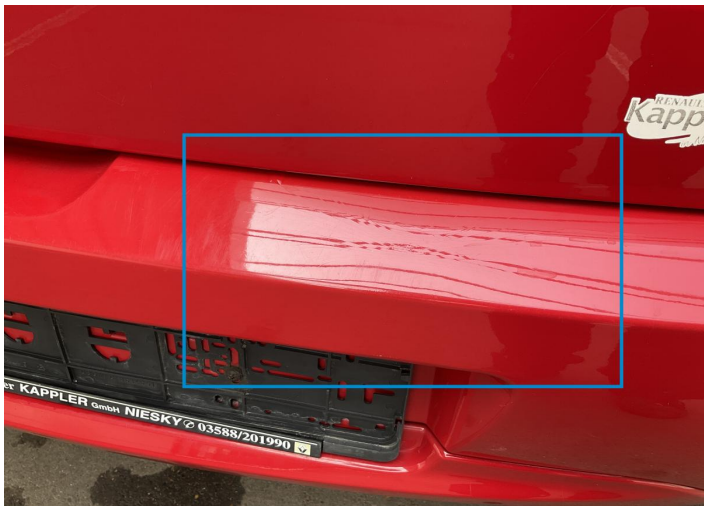
3. Bumper / Back
Paint / Poor Previous Repair -

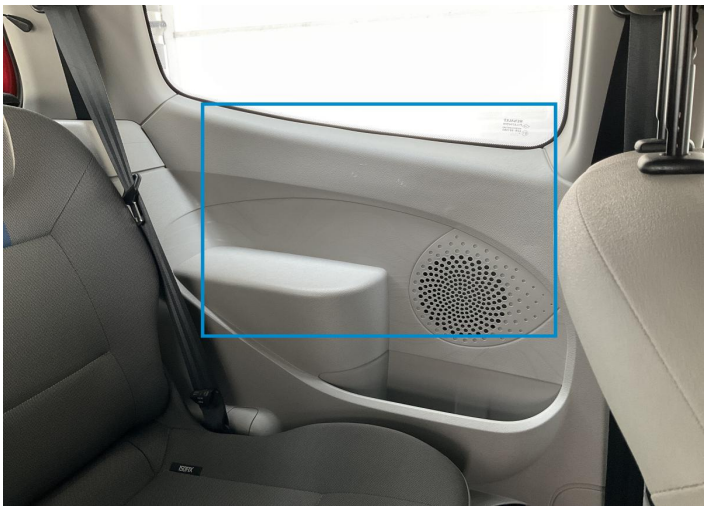
4. Trunk Upholstery / Back
Interior / Scratched -

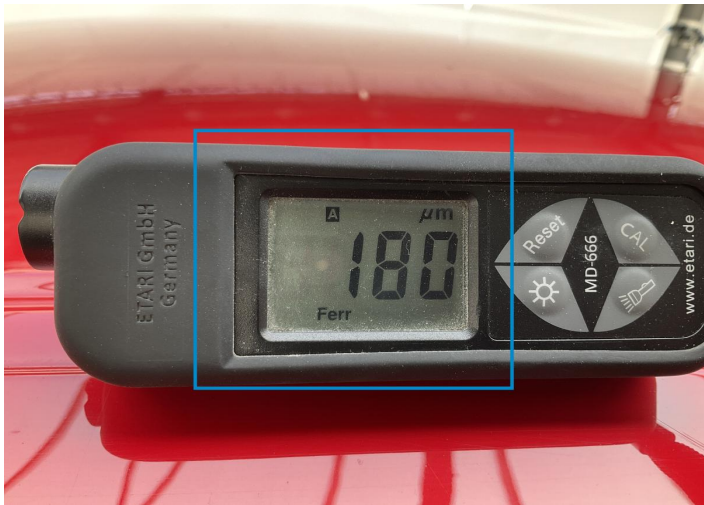
5. Door / Front Left
Paint / Poor Previous Repair -

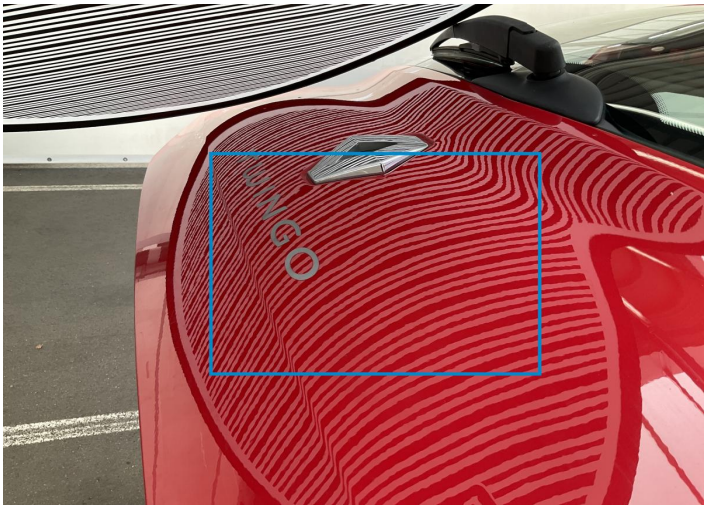
6. Tailgate
Bodywork / Dent / Dent -

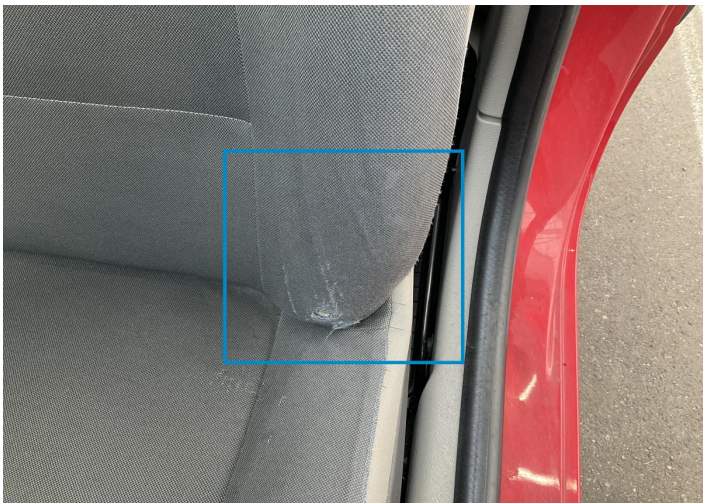
7. Seat / Front Left
Interior / Holed -

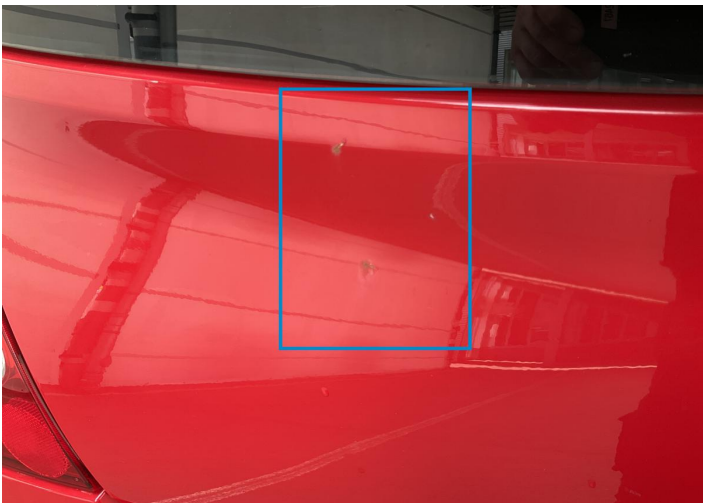
8. Tailgate
Paint / Corrosion -

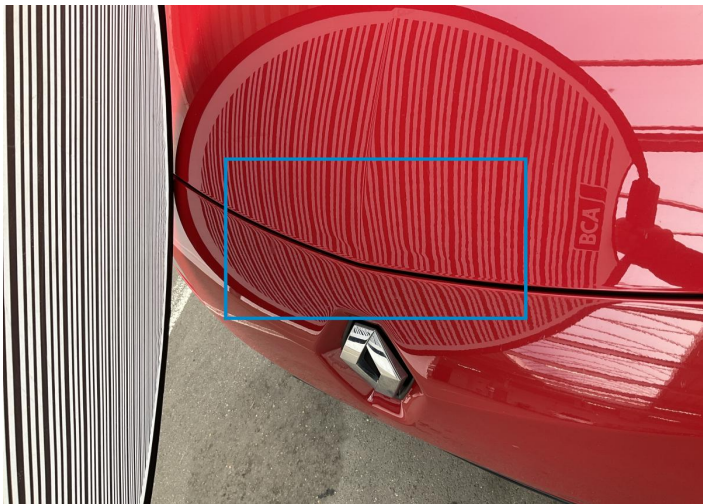
9. Hood
Bodywork / Dent / Dent -

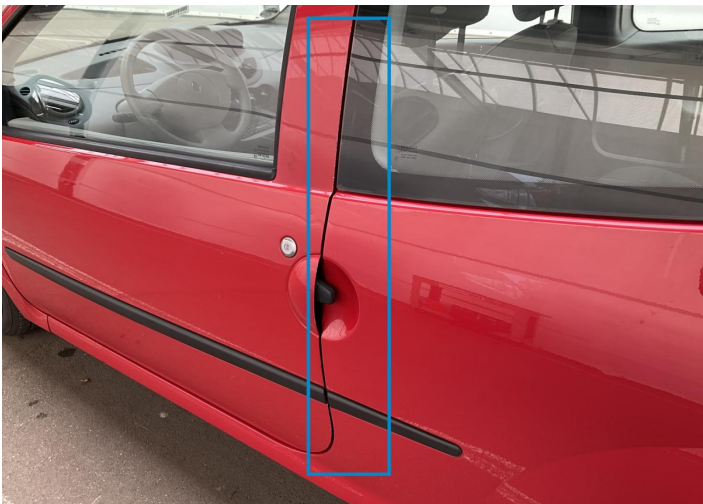
10. Door / Front Left
Paint / Scratch / Scuff -

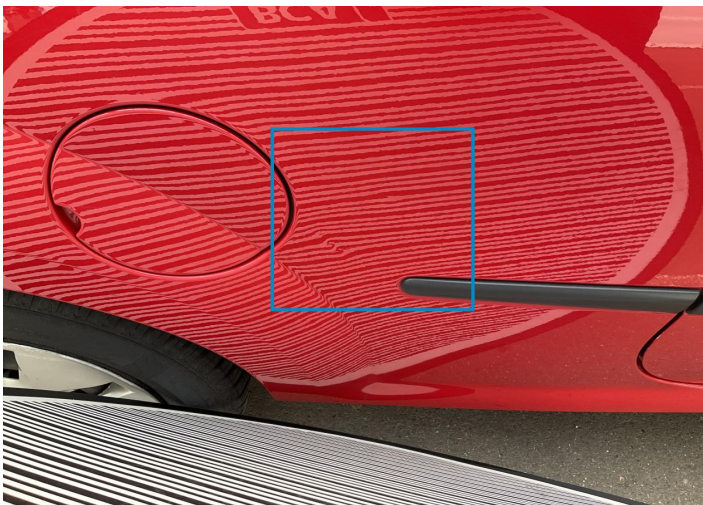
11. Side Panel / Back Right
Bodywork / Dent / Dent -

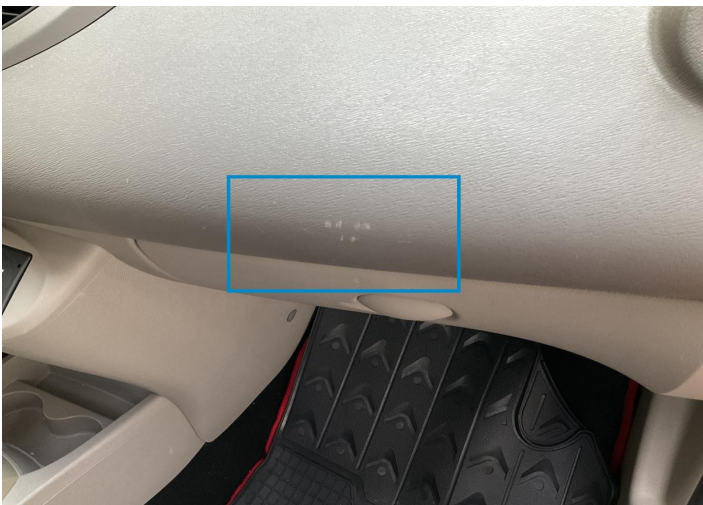
12. Dashboard / Front
Interior / Scratched -

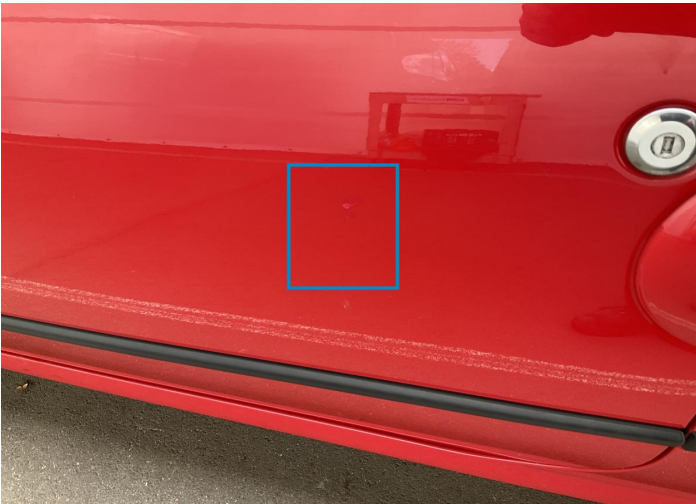
13. Door / Front Left
Paint / Scratch / Scuff -

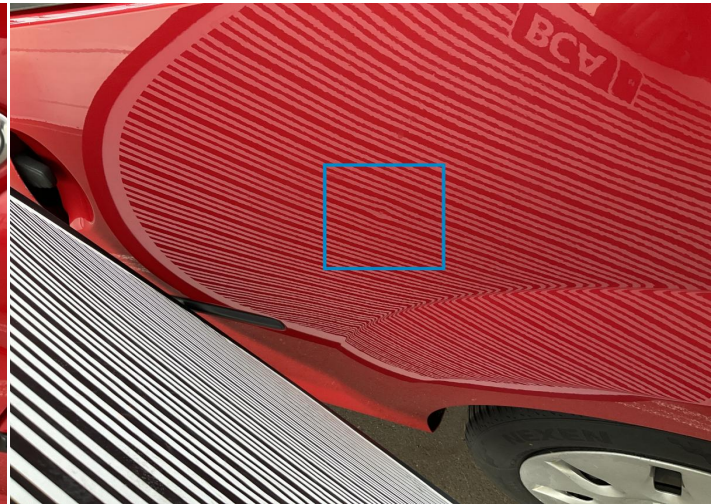
14. Side Panel / Back Left
Bodywork / Dent / Dent -

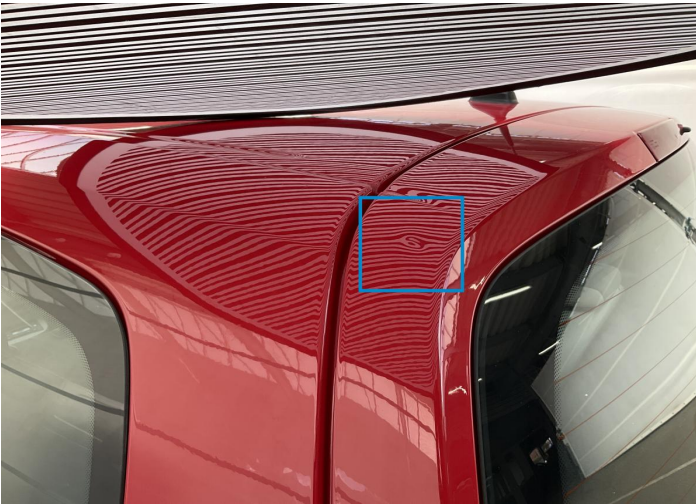
15. Tailgate
Bodywork / Dent / Dent -

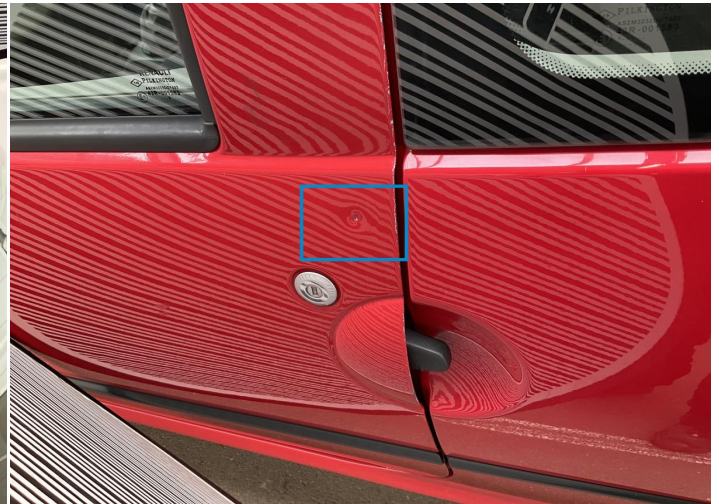
16. Door / Front Left
Bodywork / Dent / Dent -
