Expertise

Protocol number: 41657258  
Order No. / Reference: 25241643  
Inspection date: 23 Sept 2025

Manufacturer: Renault

Model: Trafic ENERGY dCi 120 L1H1 3,0t Komfort

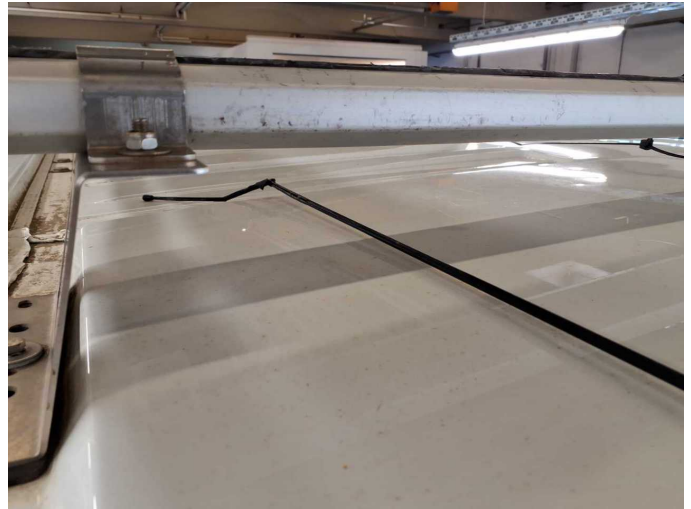
| No. | Component group | Description |
|---|---|---|
| 1 | Roof | Stub aerial - Broken / torn - Replace |

**Damage 1:** Roof: Stub aerial - Broken / torn - Replace

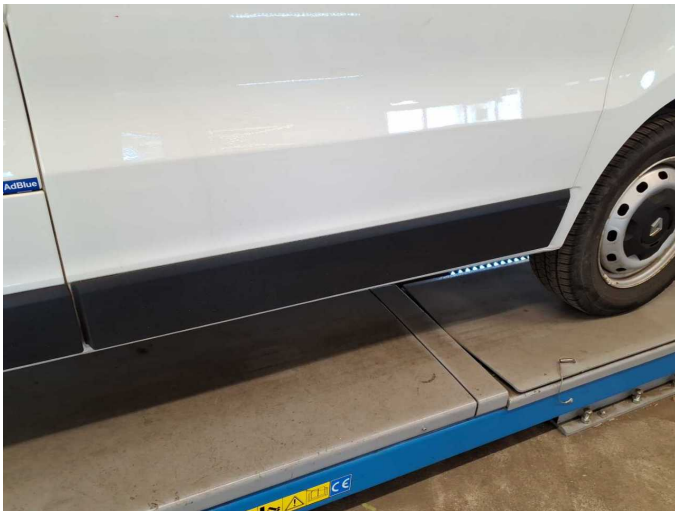
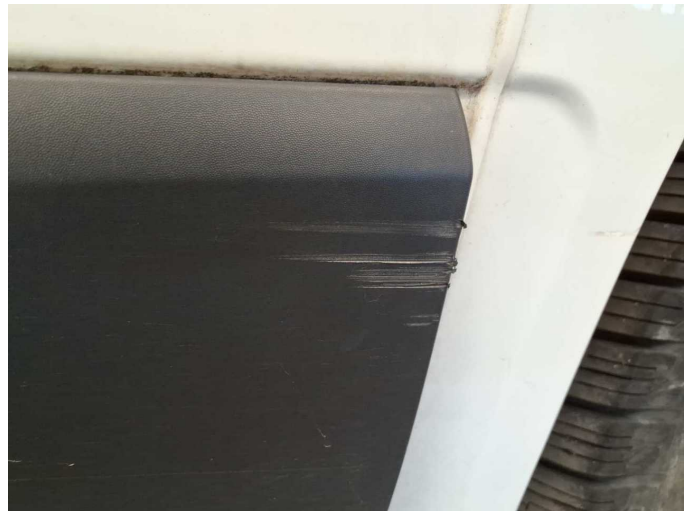
| No. | Component group | Description |
|---|---|---|
| 2 | Trim / covers | Brightware / decorative strip (Seitenwand links) - Scratch(es) - Loss in value |

**Damage 2:** Trim / covers: Brightware / decorative strip (Seitenwand links)  
- Scratch(es) - Loss in value

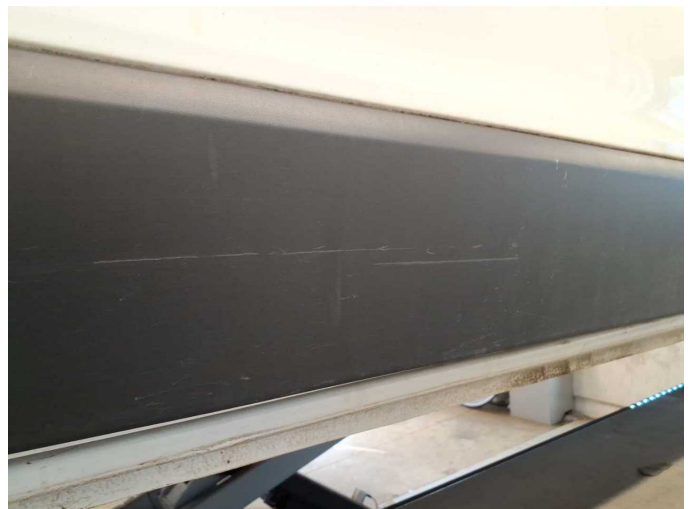
| No. | Component group | Description |
|---|---|---|
| 3 | Trim / covers | Brightware / decorative strip (Schiebetür rechts) - Scratch(es) - Loss in value |

**Damage 3:** Trim / covers: Brightware / decorative strip (Schiebetür rechts)  
- Scratch(es) - Loss in value

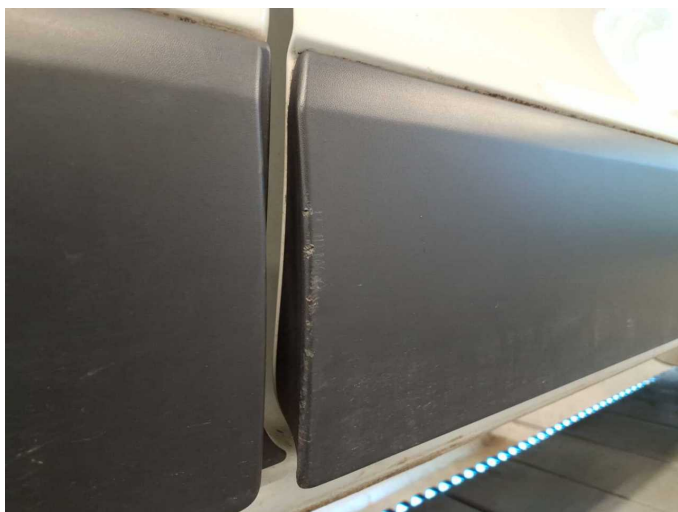
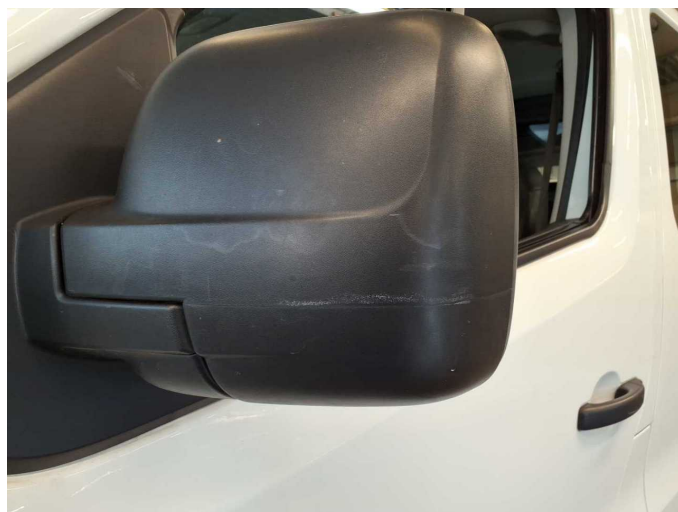
| No. | Component group | Description |
|---|---|---|
| 4 | Trim / covers | Brightware / decorative strip (Tür Vorne rechts) - Scratch(es) - Loss in value |

**Damage 4:** Trim / covers: Brightware / decorative strip (Tür Vorne rechts) - Scratch(es) - Loss in value

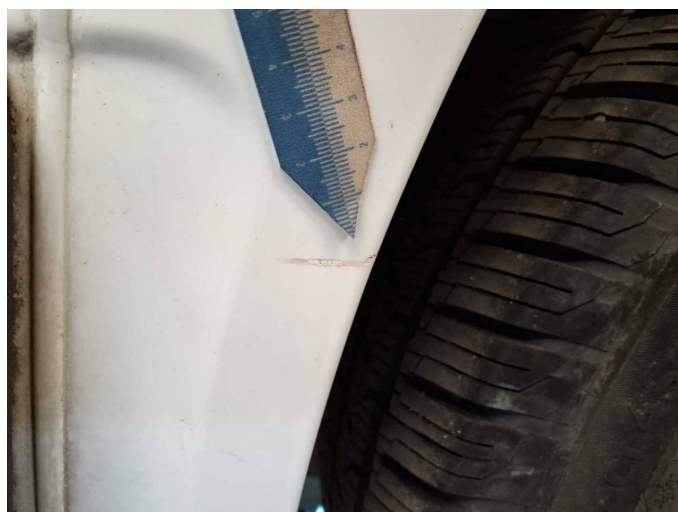
| No. | Component group | Description |
|---|---|---|
| 6 | Side panel - rear left side | Side panel - Scratch(es) - Smart repair |

**Damage 6:** Side panel - rear left side: Side panel - Scratch(es) - Smart repair

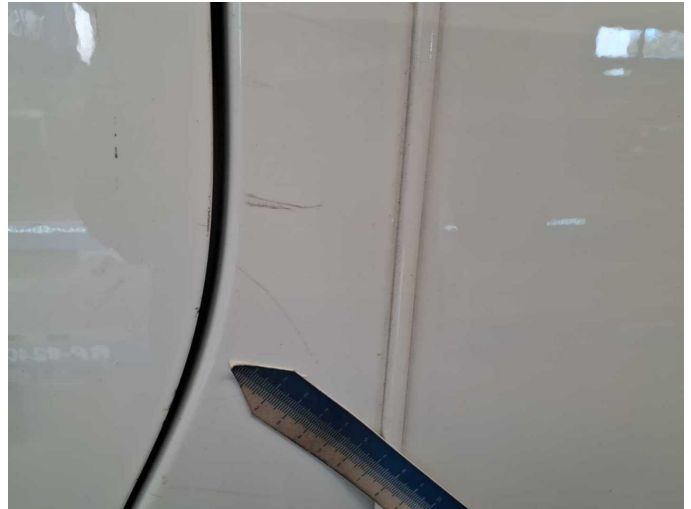
| No. | Component group | Description |
|---|---|---|
| 7 | Side panel - rear left side | Side panel - Scratch(es) - Smart repair |

**Damage 7:** Side panel - rear left side: Side panel - Scratch(es) - Smart repair

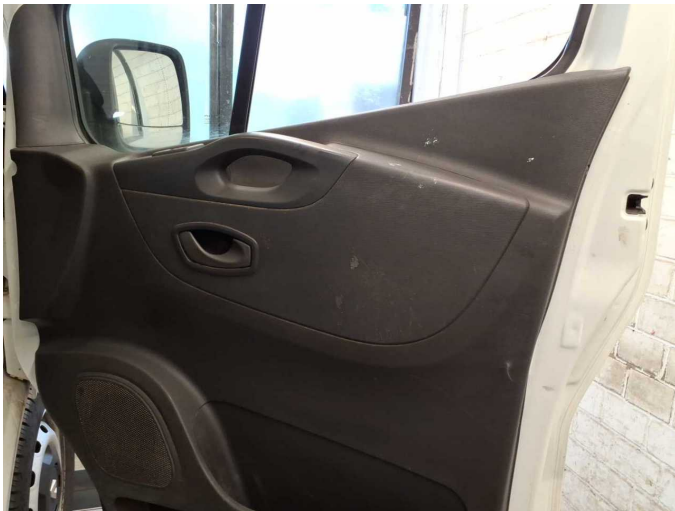
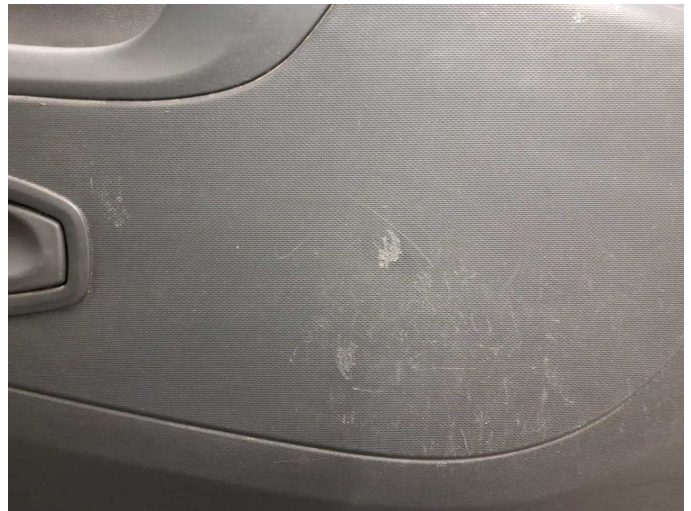
| No. | Component group | Description |
|---|---|---|
| 8 | Trim / covers | Door trim - front right side - Scratched - Loss in value |

**Damage 8:** Trim / covers: Door trim - front right side - Scratched - Loss in value

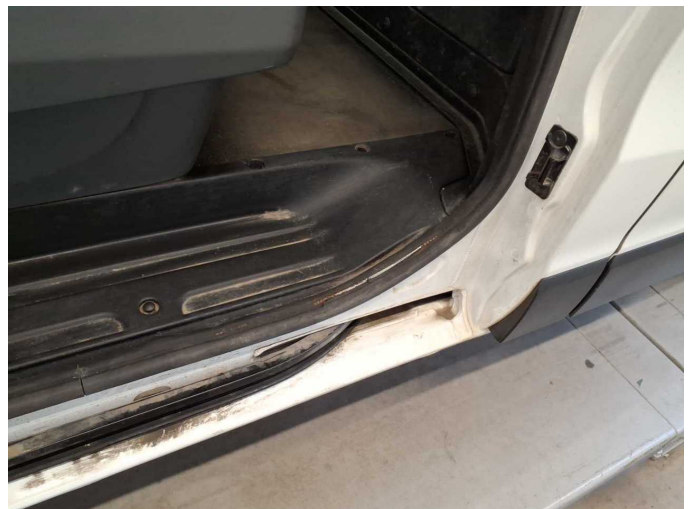
| No. | Component group | Description |
|---|---|---|
| 9 | Body | Seal - sliding door - right side - Broken / torn - Replace |

**Damage 9:** Body: Seal - sliding door - right side - Broken / torn - Replace

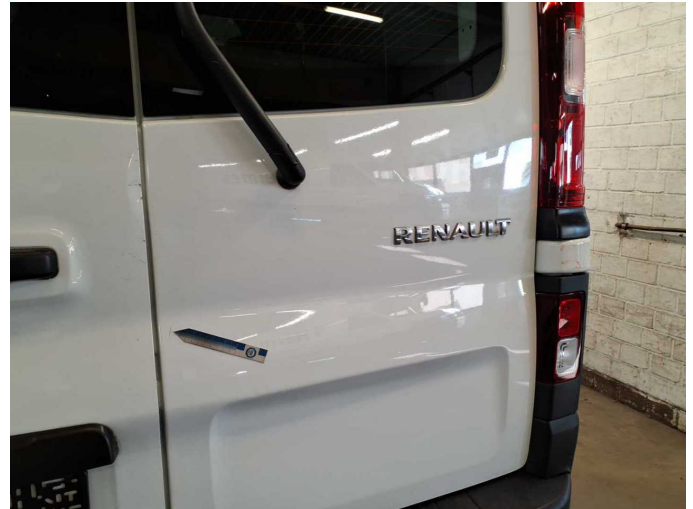
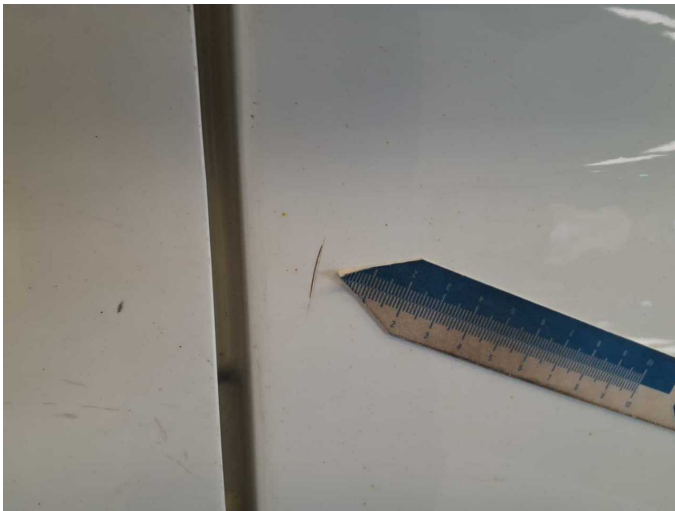
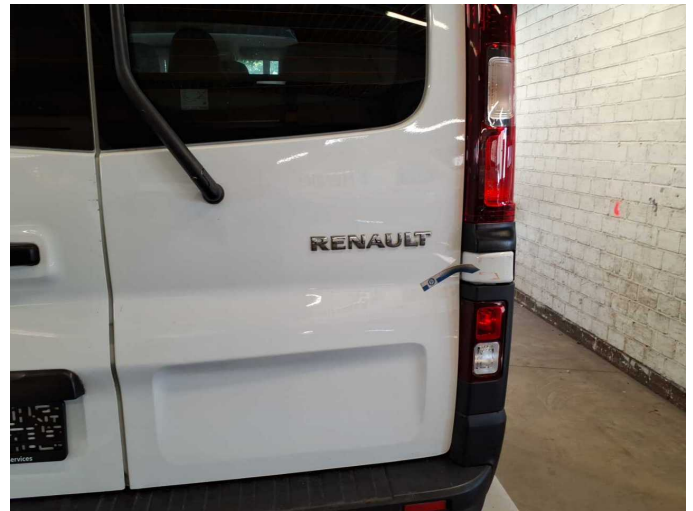
| No. | Component group | Description |
|---|---|---|
| 10 | Boot lid / rear door | Rear door - right side - Scratch(es) - Smart repair |

**Damage 10:** Boot lid / rear door: Rear door - right side - Scratch(es) - Smart repair

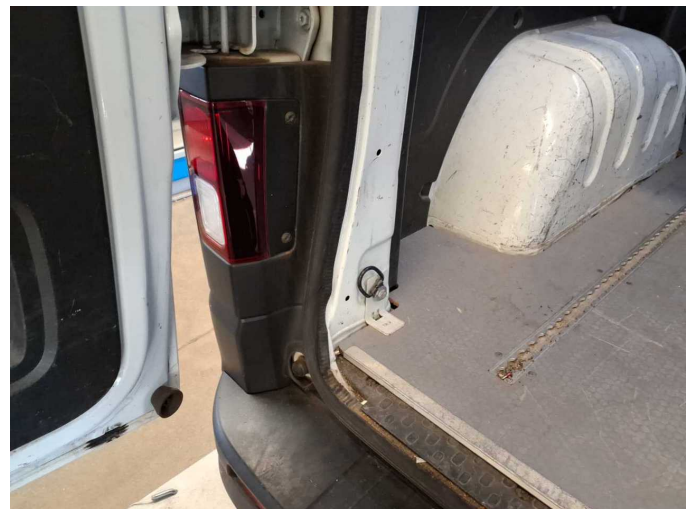
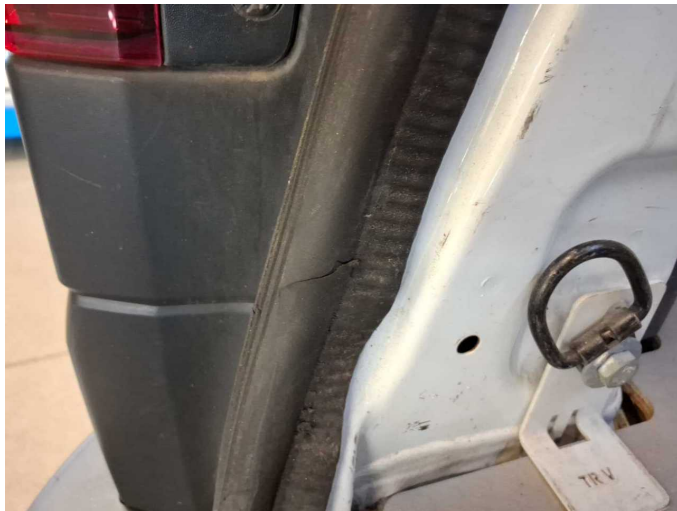
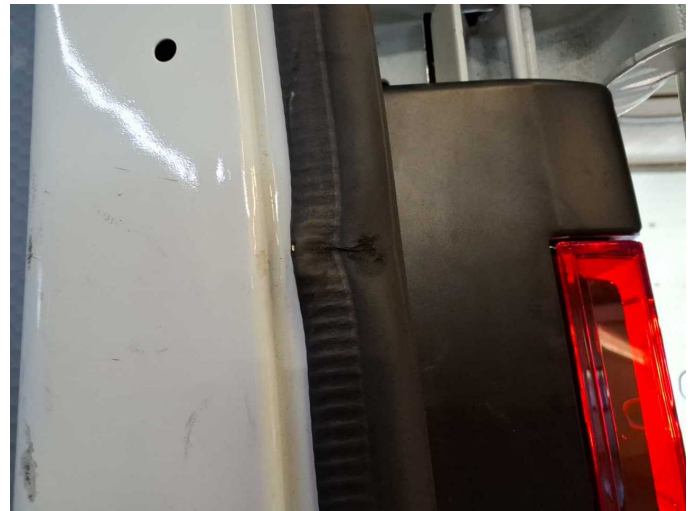
| No. | Component group | Description |
|---|---|---|
| 11 | Boot lid / rear door | Seal - Broken / torn - Replace |

**Damage 11:** Boot lid / rear door: Seal - Broken / torn - Replace

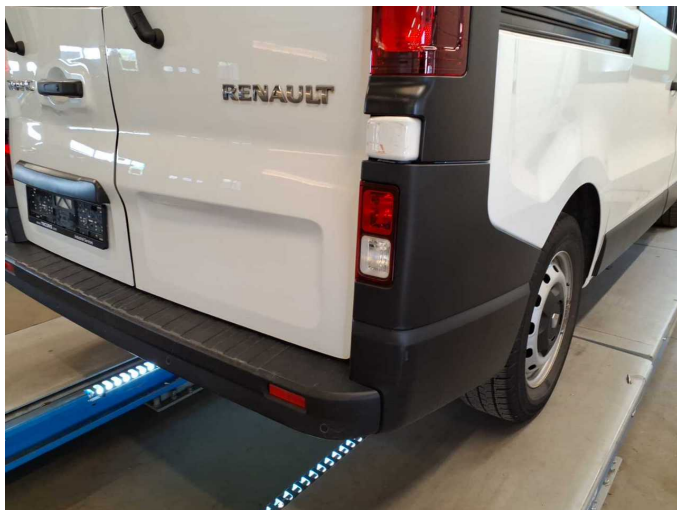
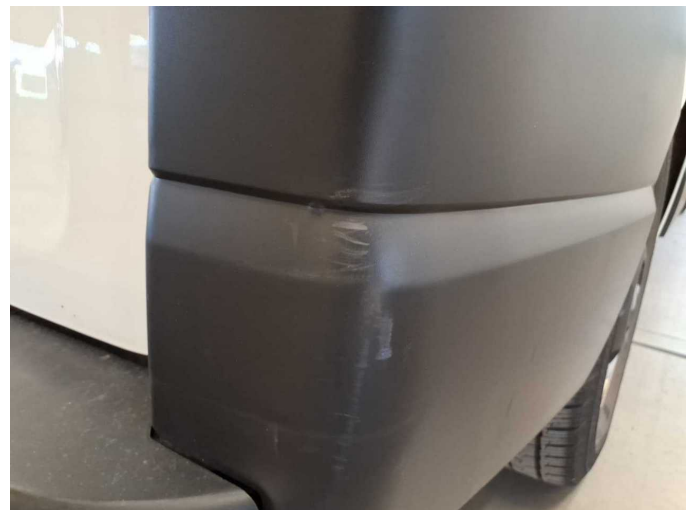
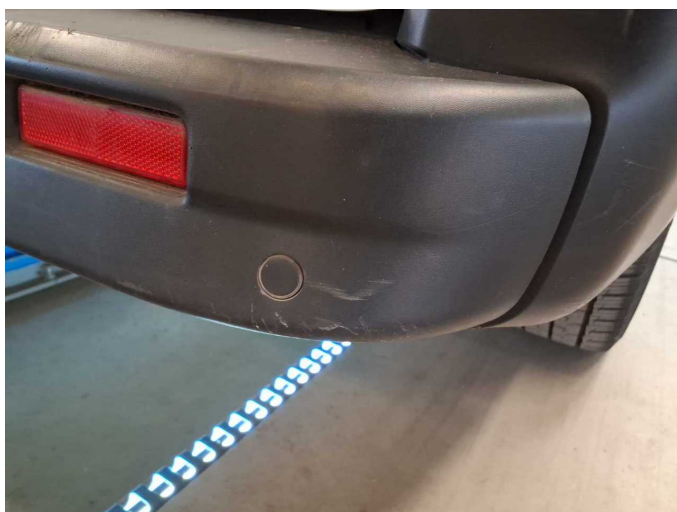
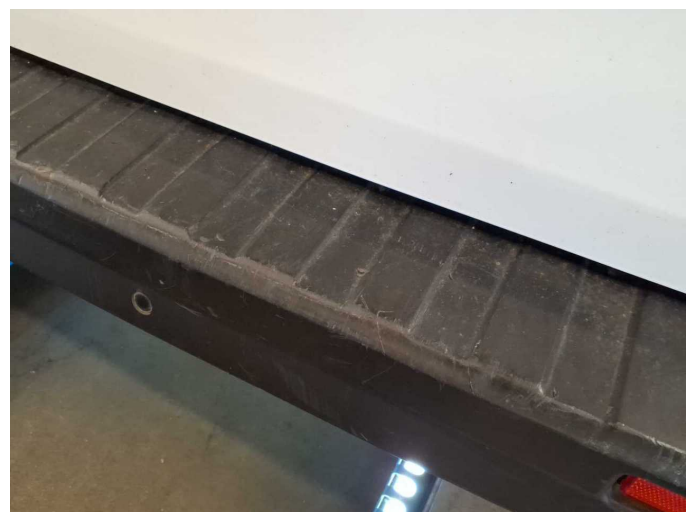
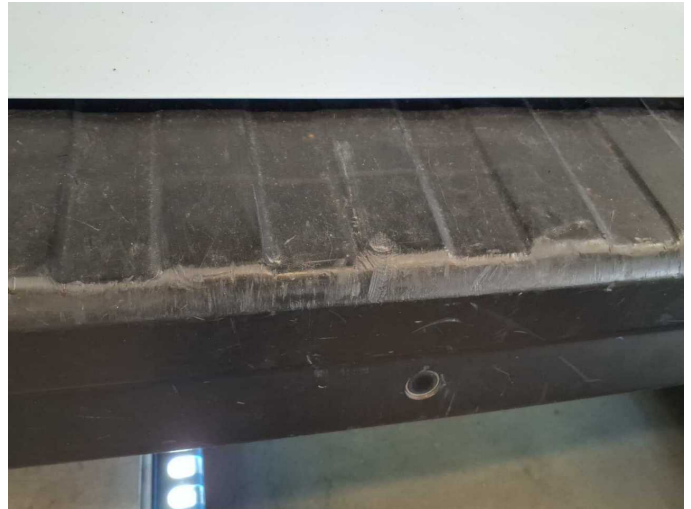
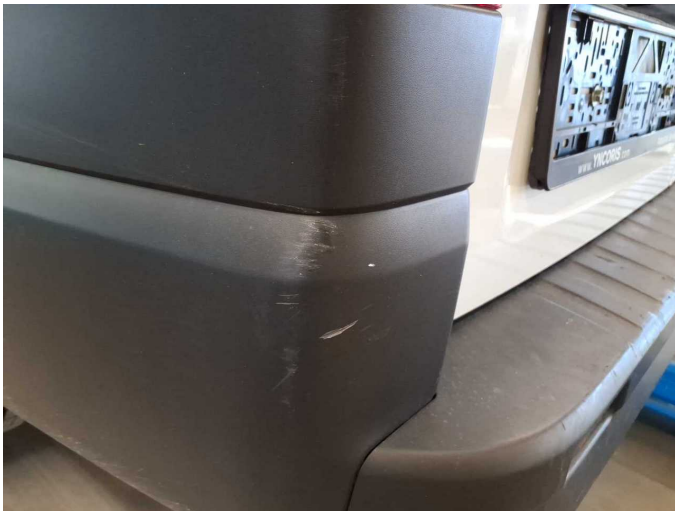
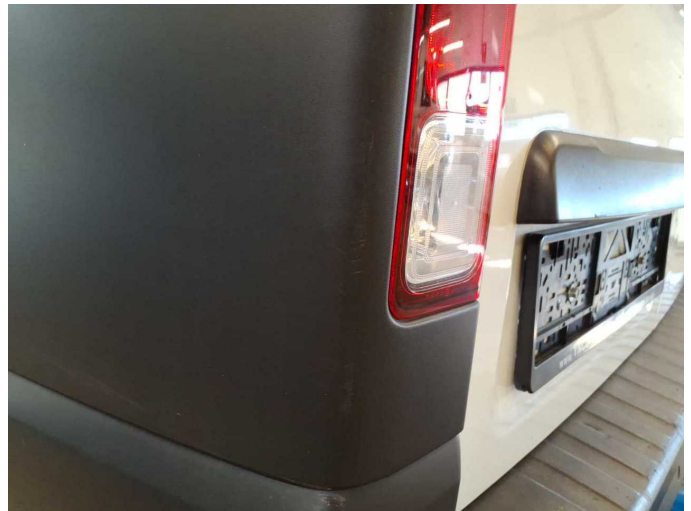
| No. | Component group | Description |
|---|---|---|
| 12 | Rear bumper | Rear bumper - Scratch(es) - Loss in value |

**Damage 12:** Rear bumper: Rear bumper - Scratch(es) - Loss in value

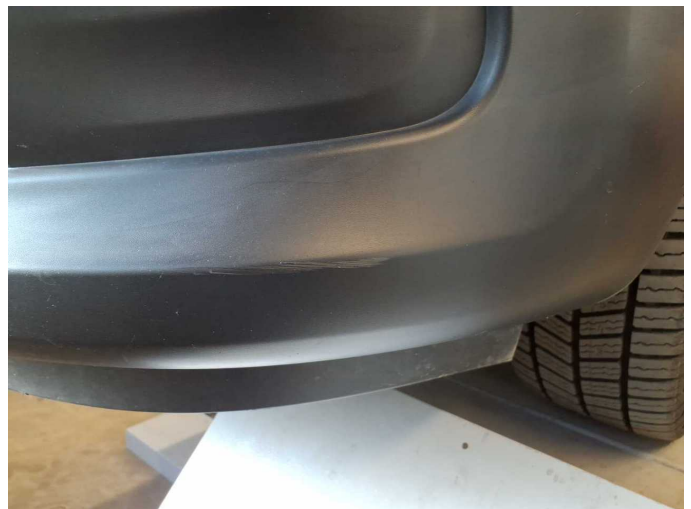
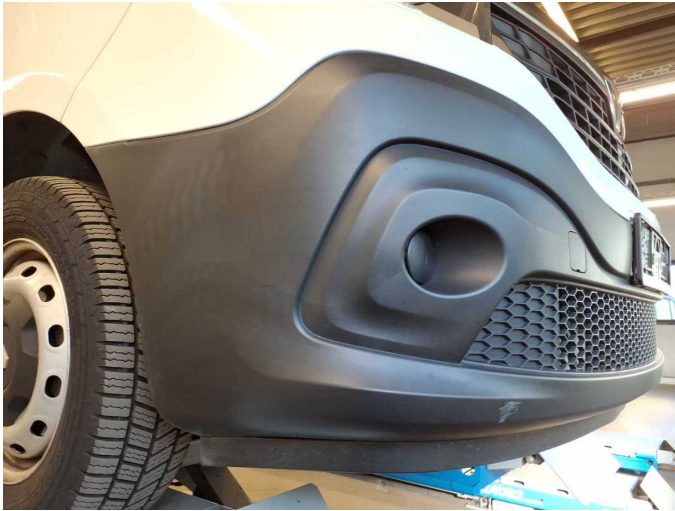
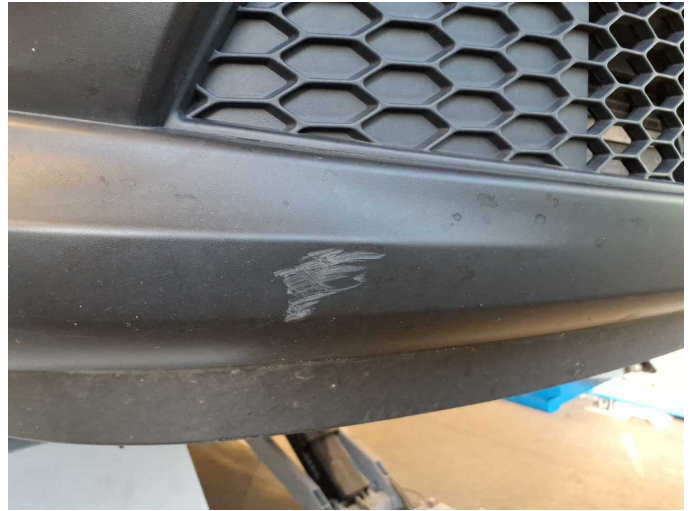
| No. | Component group | Description |
|---|---|---|
| 13 | Front bumper | Front bumper - Scratch(es) - Loss in value |

**Damage 13:** Front bumper: Front bumper - Scratch(es) - Loss in value

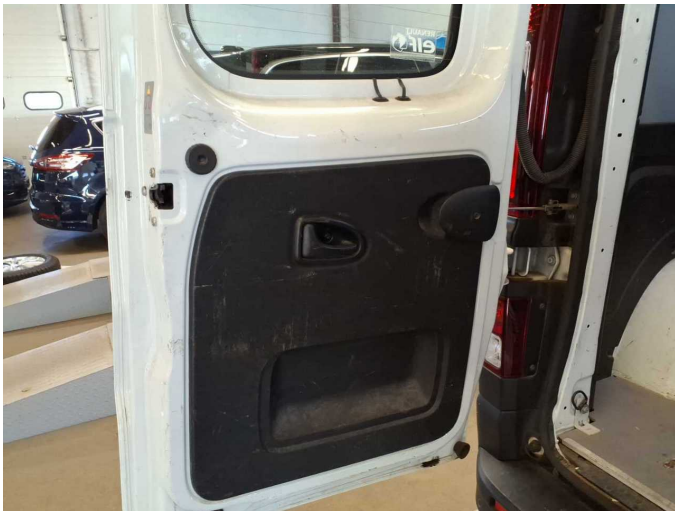
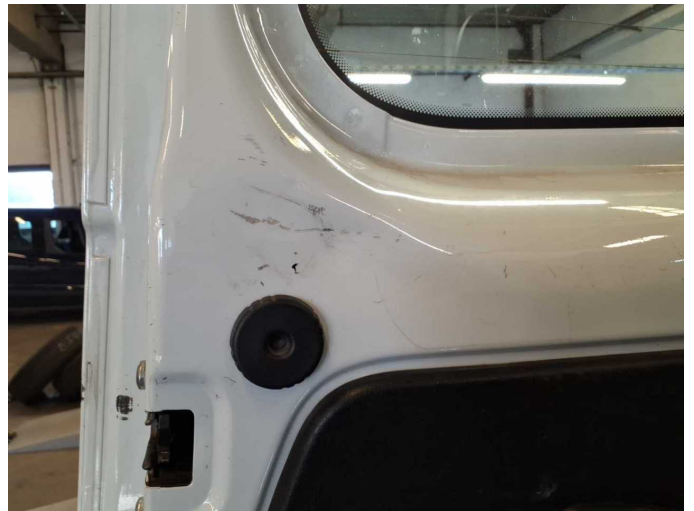
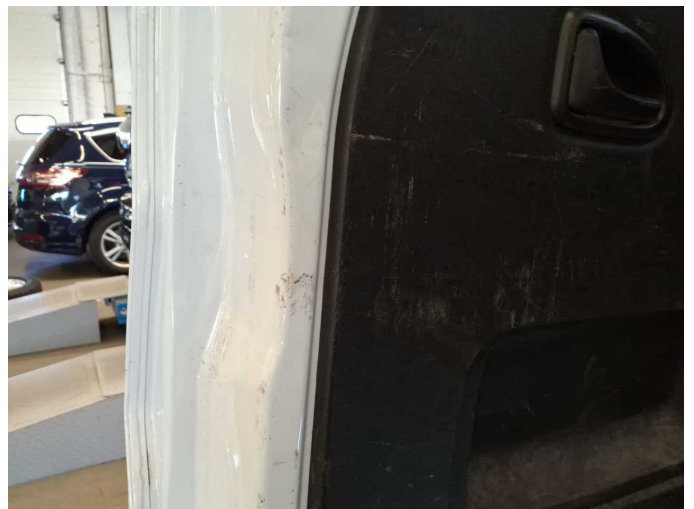
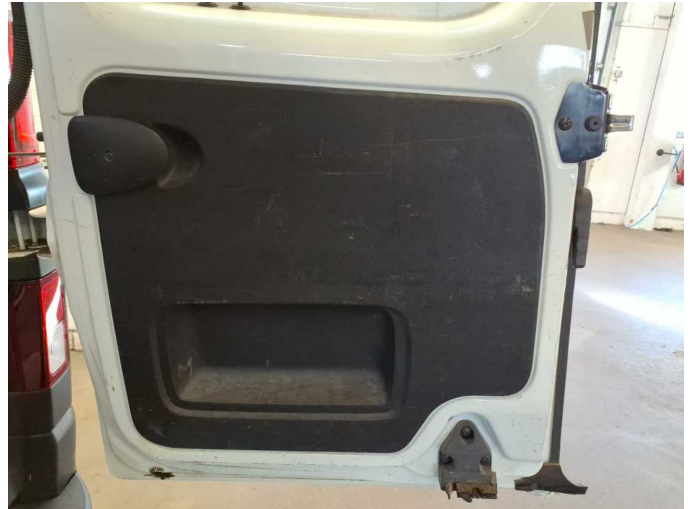
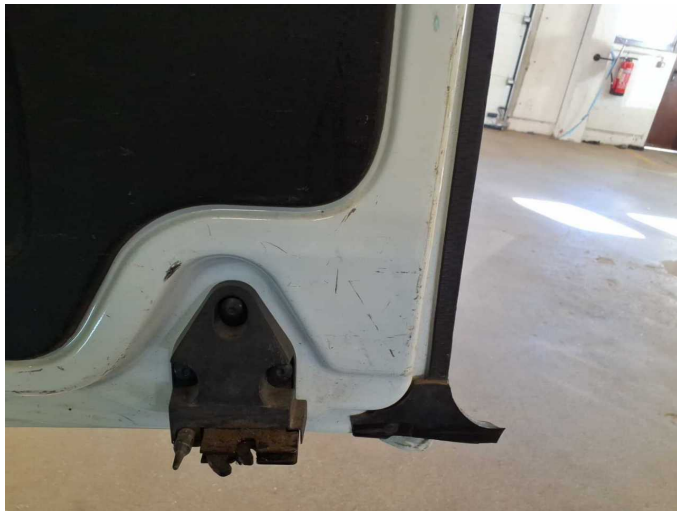
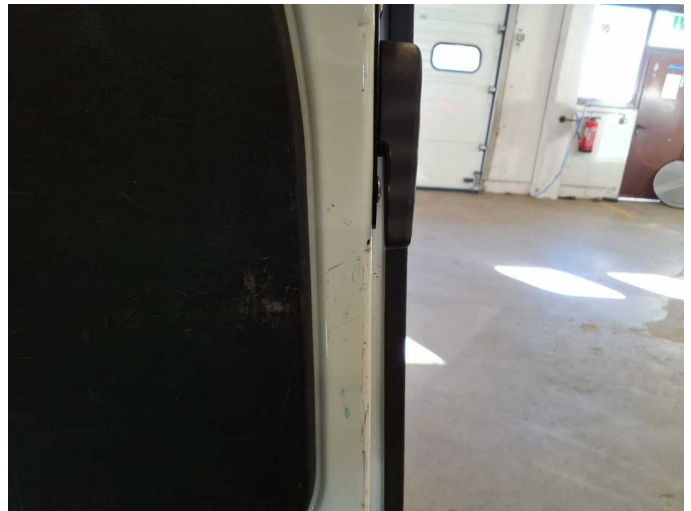
| No. | Component group | Description |
|---|---|---|
| 14 | Interior | Cargo space division - Dent / paintcoat damage - Loss in value |

**Damage 14:** Interior: Cargo space division - Dent / paintcoat damage - Loss in value

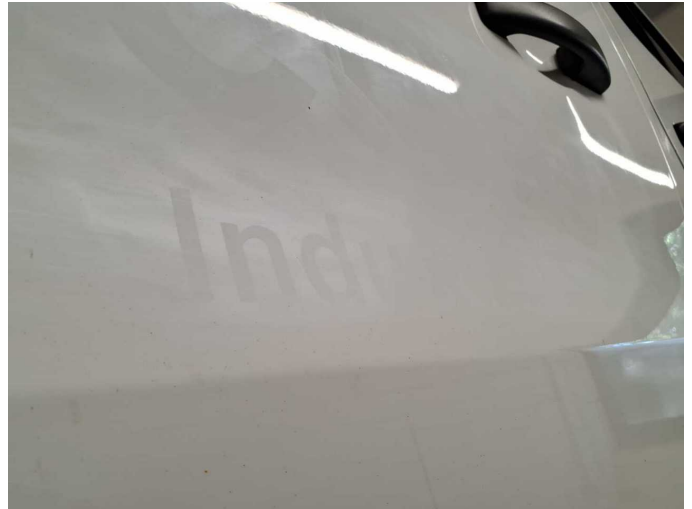
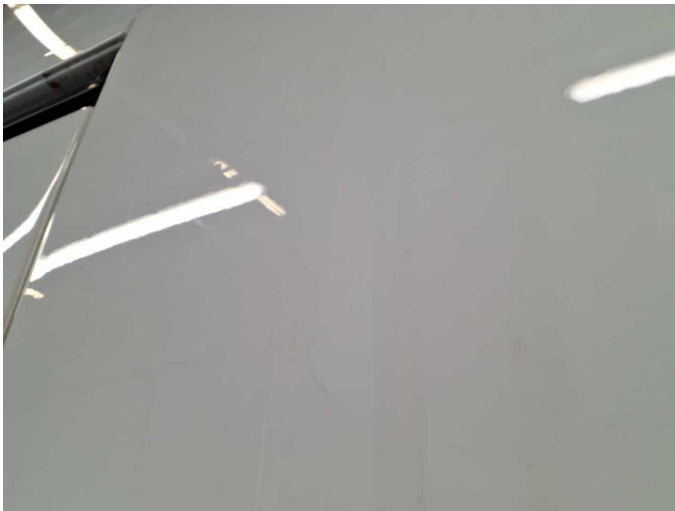
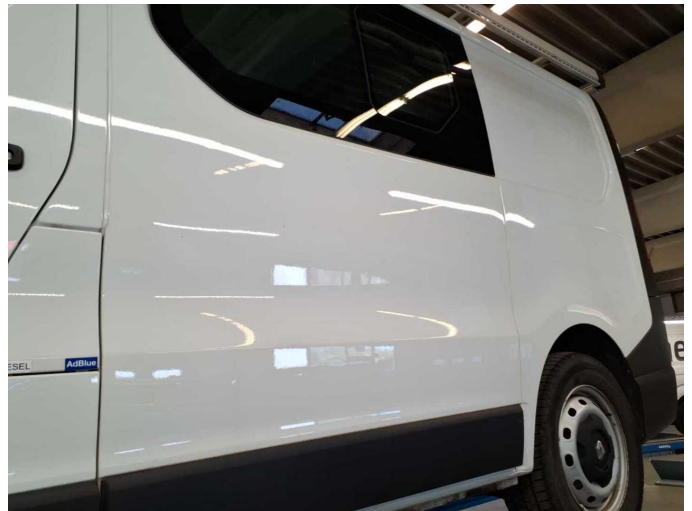
| No. | Component group | Description |
|---|---|---|
| 15 | Body | Body (Klebereste) - Glued / labelled - De-glue / neutralise |

**Damage 15:** Body: Body (Klebereste) - Glued / labelled - De-glue / neutralise

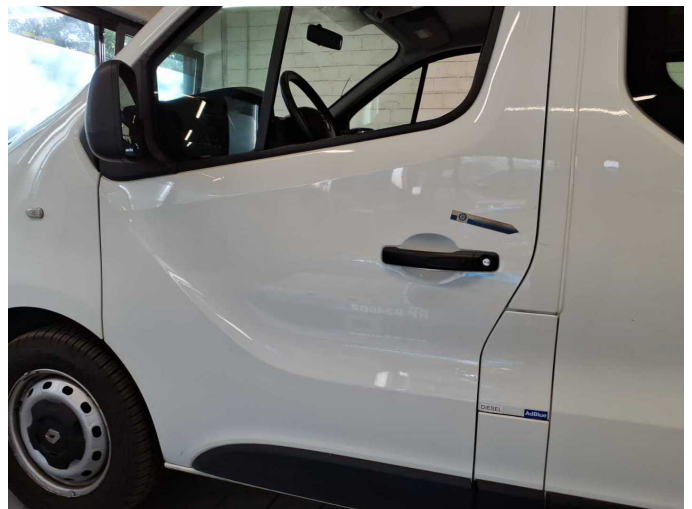
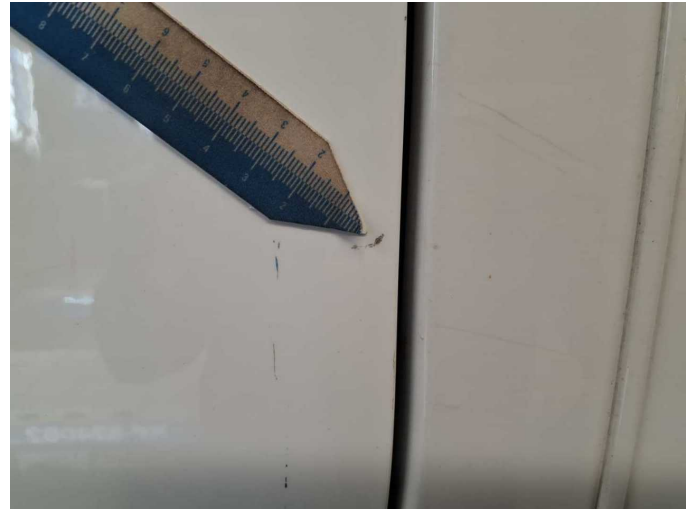
| No. | Component group | Description |
|---|---|---|
| 16 | Door - front left side | Door - Scratch(es) - Paint |

**Damage 16:** Door - front left side: Door - Scratch(es) - Paint

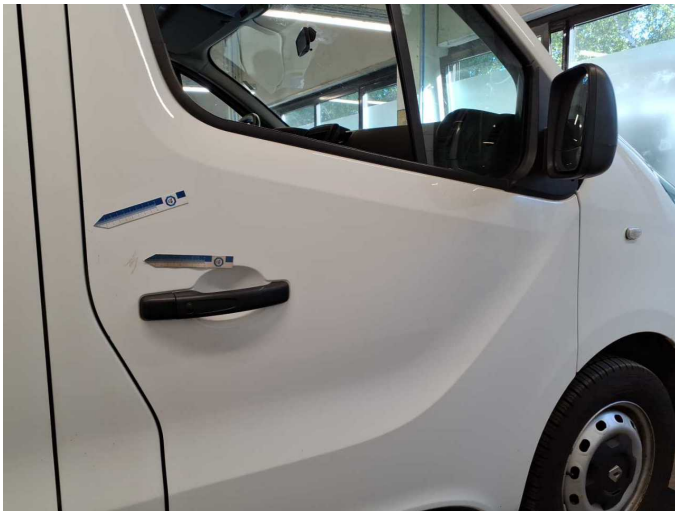
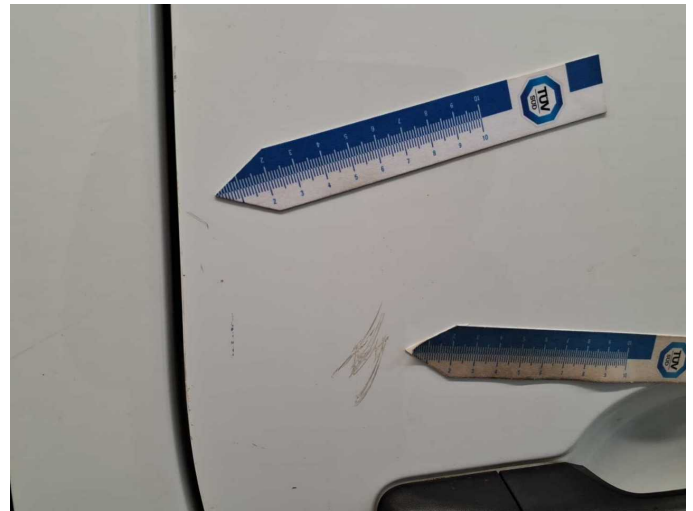
| No. | Component group | Description |
|---|---|---|
| 17 | Door - front right side | Door - Scratch(es) - Paint |

**Damage 17:** Door - front right side: Door - Scratch(es) - Paint

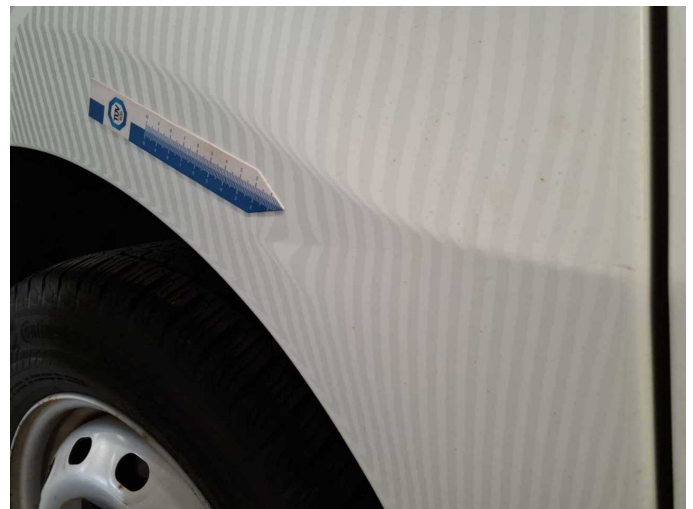
| No. | Component group | Description |
|---|---|---|
| 18 | Side panel - rear right side | Side panel - Deformed - Repair and paint |

**Damage 18:** Side panel - rear right side: Side panel - Deformed - Repair and paint

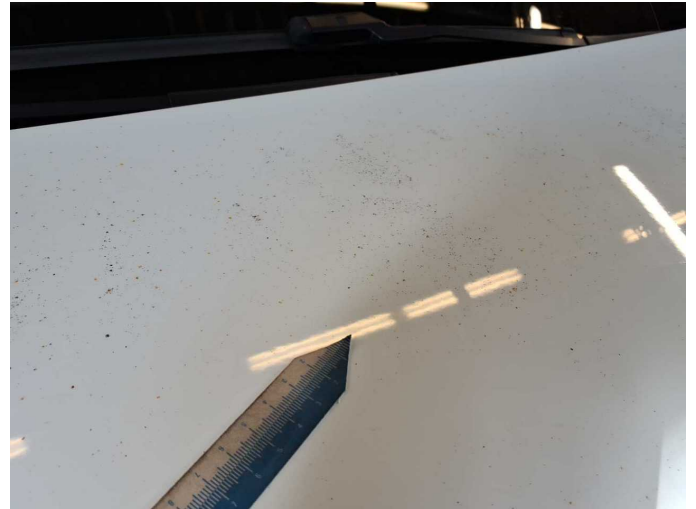
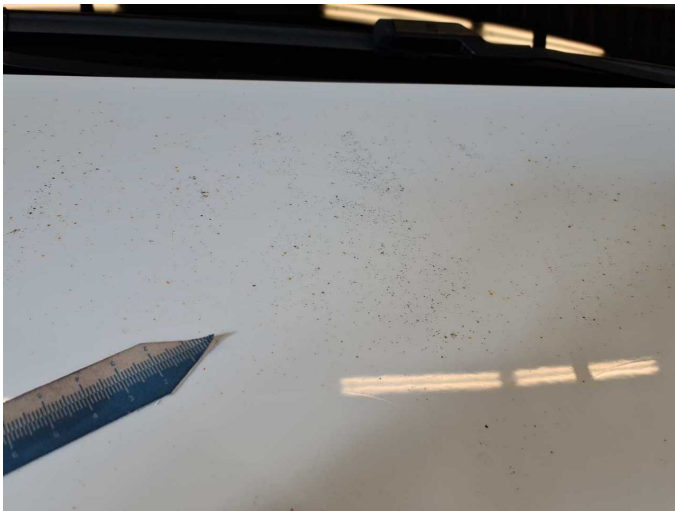
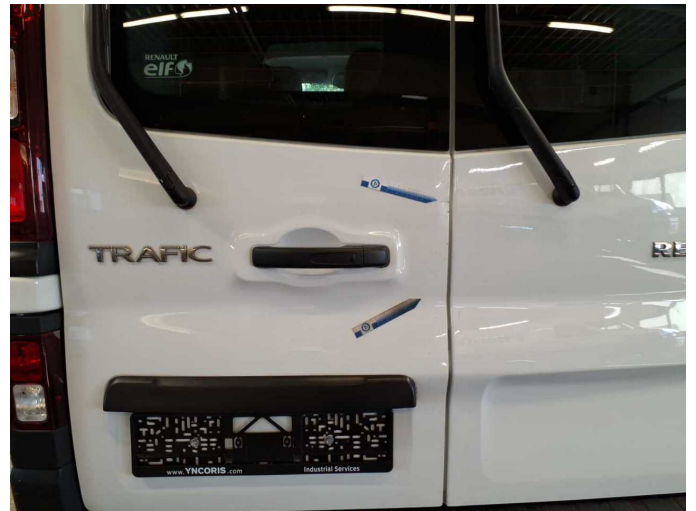
| No. | Component group | Description |
|---|---|---|
| 19 | Bonnet | Bonnet (Verschnutzung eingebrannt) - Paint defect - Paint |

**Damage 19:** Bonnet: Bonnet (Verschnutzung eingebrannt) - Paint defect - Paint

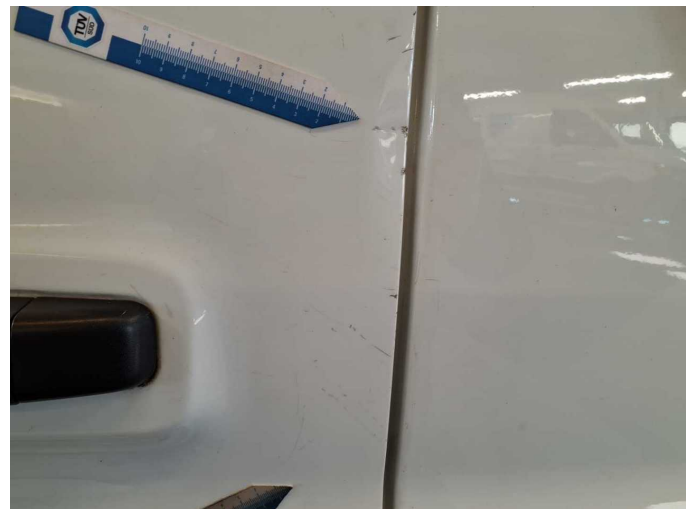
| No. | Component group | Description |
|---|---|---|
| 20 | Boot lid / rear door | Rear door - left side (+ Kratzer) - Deformed - Repair and paint |

**Damage 20:** Boot lid / rear door: Rear door - left side (+ Kratzer) - Deformed - Repair and paint

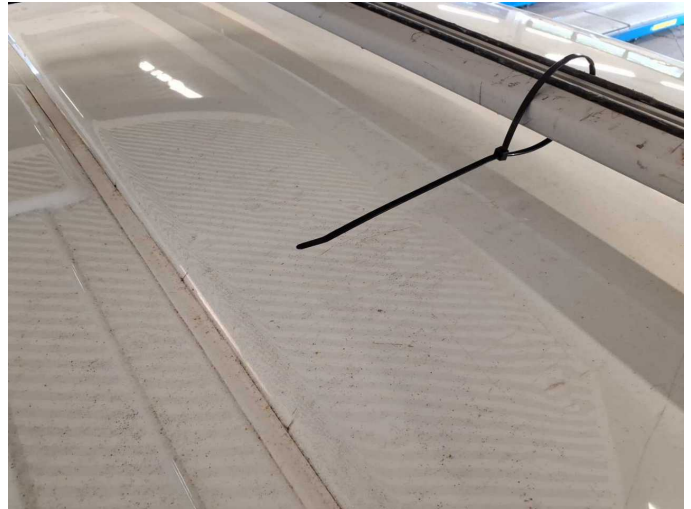
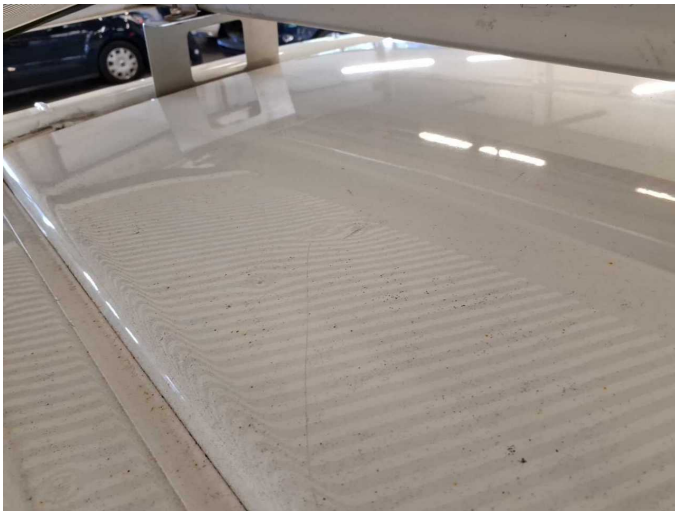
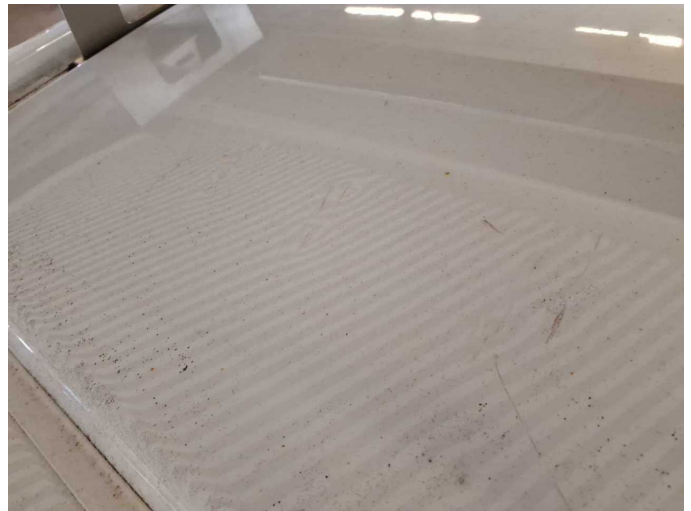
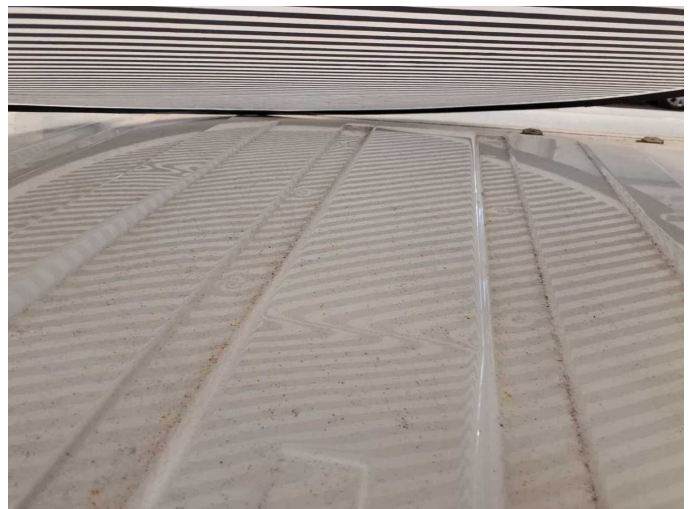
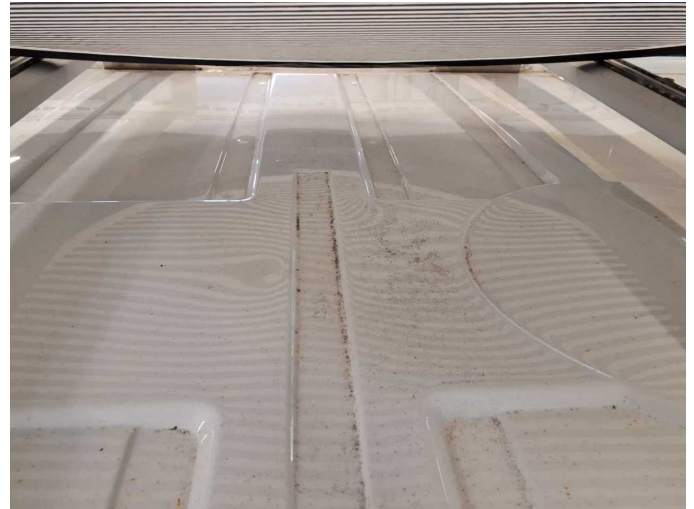
| No. | Component group | Description |
|---|---|---|
| 21 | Roof | Roof (+ Delle) - Deformed - Repair and paint |

**Damage 21:** Roof: Roof (+ Delle) - Deformed - Repair and paint

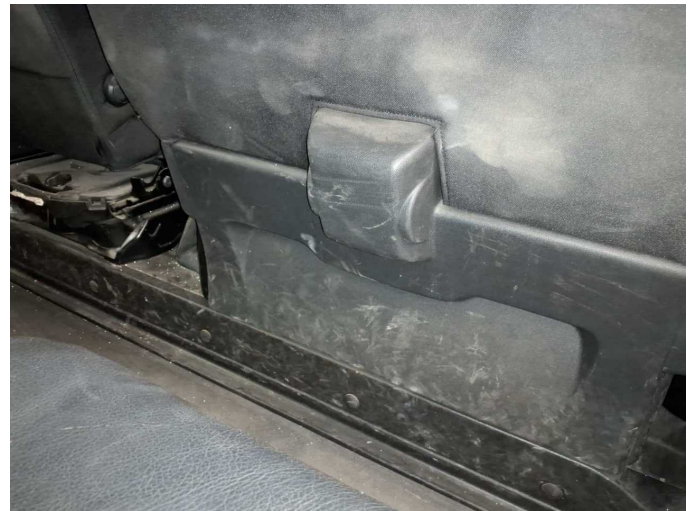
| No. | Component group | Description |
|---|---|---|
| 4 | Interior | Interior - Abrasion - No deduction |

**Wear and tear 4:** Interior: Interior - Abrasion - No deduction

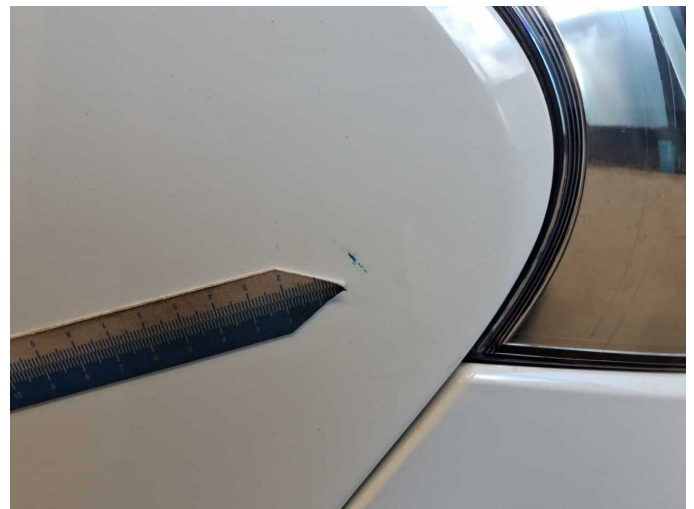
| No. | Component group | Description |
|---|---|---|
| 5 | Mudguard - right side | Mudguard - right side - Scratch(es) - Conditioning |

**Wear and tear 5:** Mudguard - right side: Mudguard - right side - Scratch(es) - Conditioning
