Expertise

Protocol number: 41720987
Order number / reference: 25217392
Inspection date: 25 Sept 2025

Manufacturer: Renault

Model: Trafic ENERGY dCi 120 L2H1 3,0t Komfort

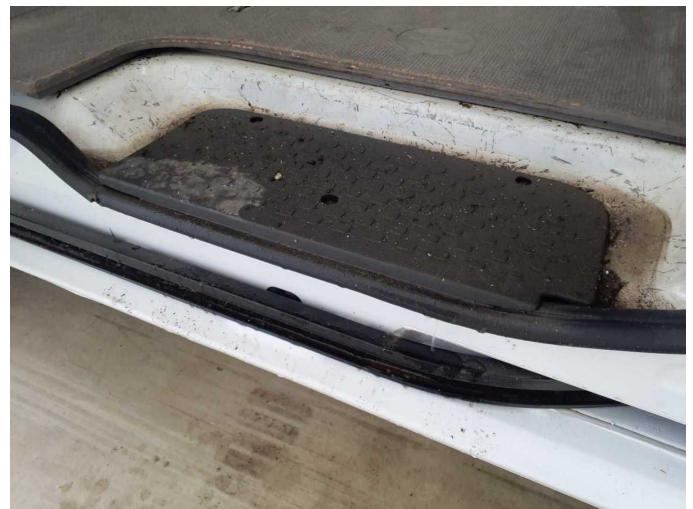
Damage 1: Body: Body - Leaking - Perform diagnosis

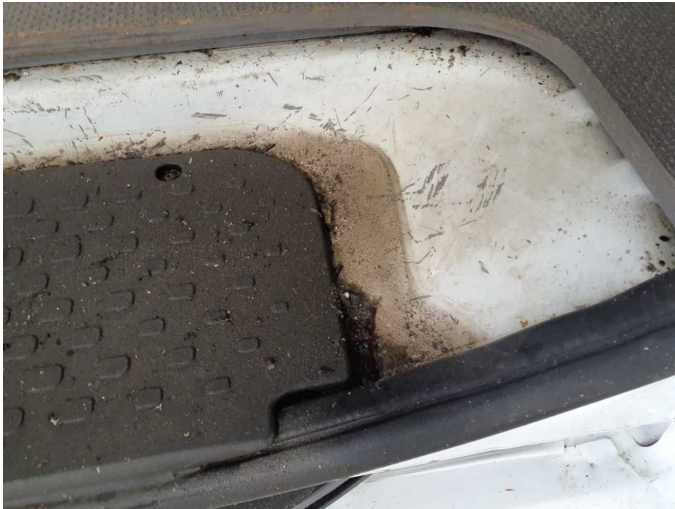
Damage 1: Body: Body - Leaking - Perform diagnosis

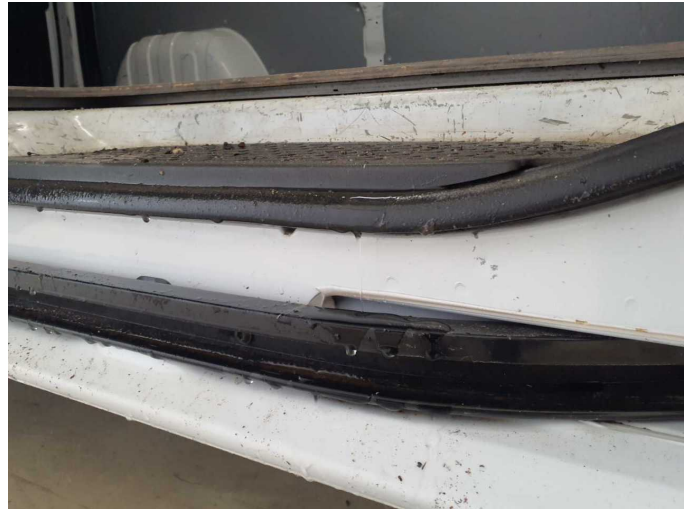
Damage 1: Body: Body - Leaking - Perform diagnosis

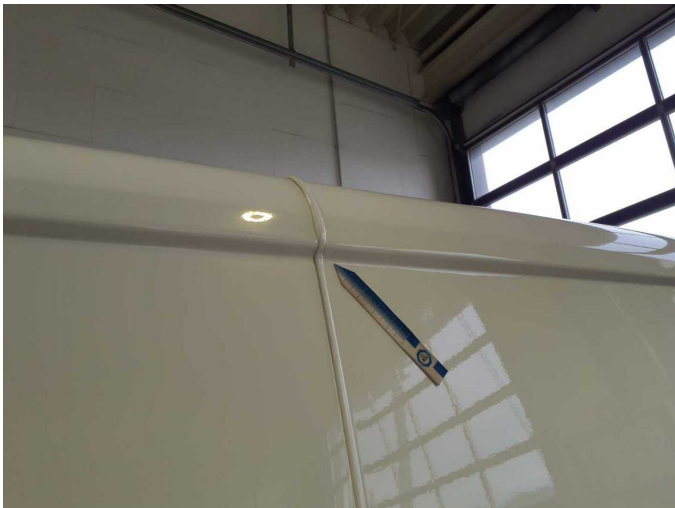
1 Side panel - rear left side, Unprofessionally carried out, Invoice of repair done Non-existent

Damage 2: Side panel - rear left side: Side panel (Kleber nacharbeiten) - Unprofessionally repaired - Repair

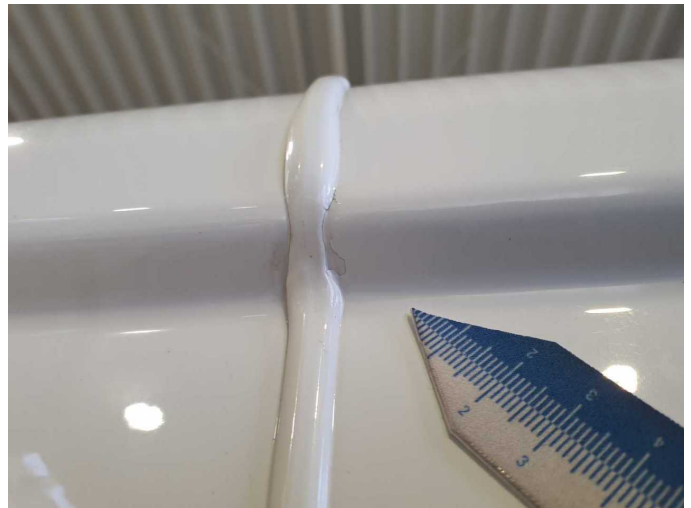
Damage 2: Side panel - rear left side: Side panel (Kleber nacharbeiten) - Unprofessionally repaired - Repair

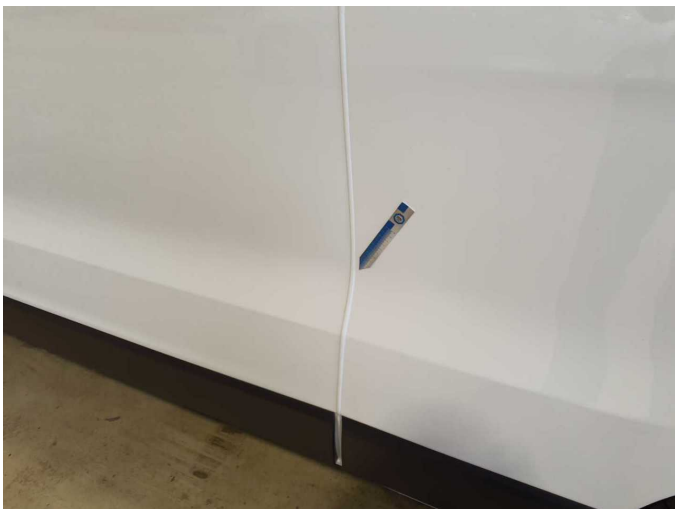
Damage 2: Side panel - rear left side: Side panel (Kleber nacharbeiten) - Unprofessionally repaired - Repair

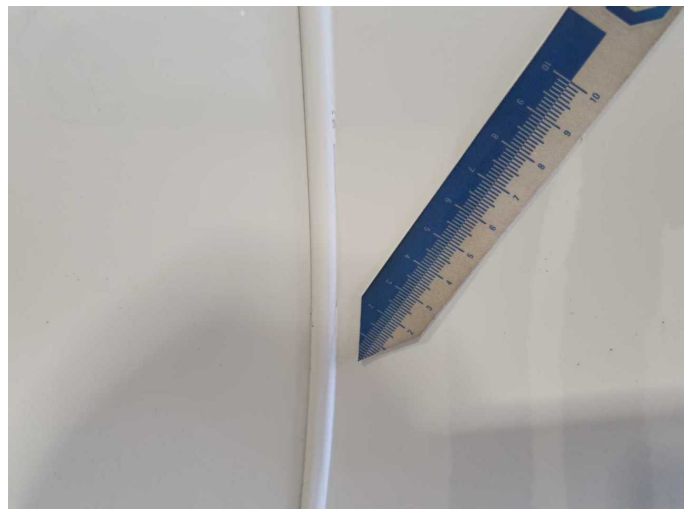
Damage 2: Side panel - rear left side: Side panel (Kleber nacharbeiten) - Unprofessionally repaired - Repair

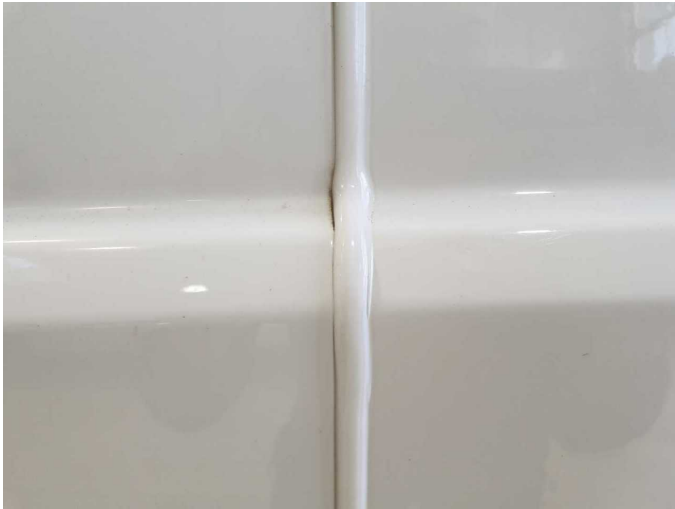
Damage 2: Side panel - rear left side: Side panel (Kleber nacharbeiten) - Unprofessionally repaired - Repair

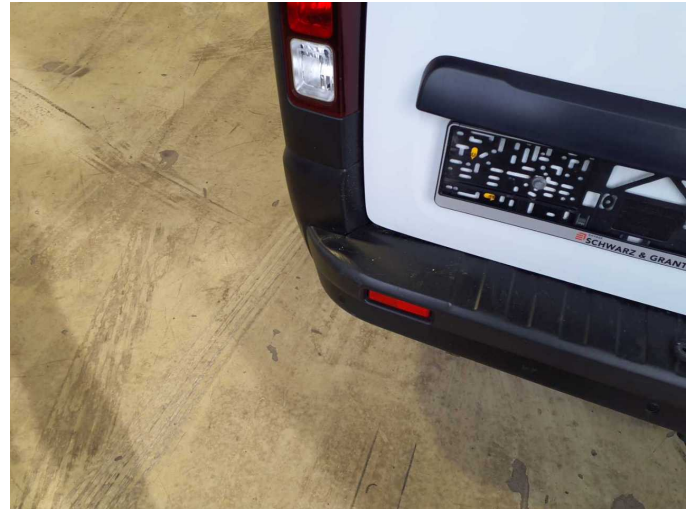
Damage 3: Rear bumper: Rear bumper - Deformed - Loss in value

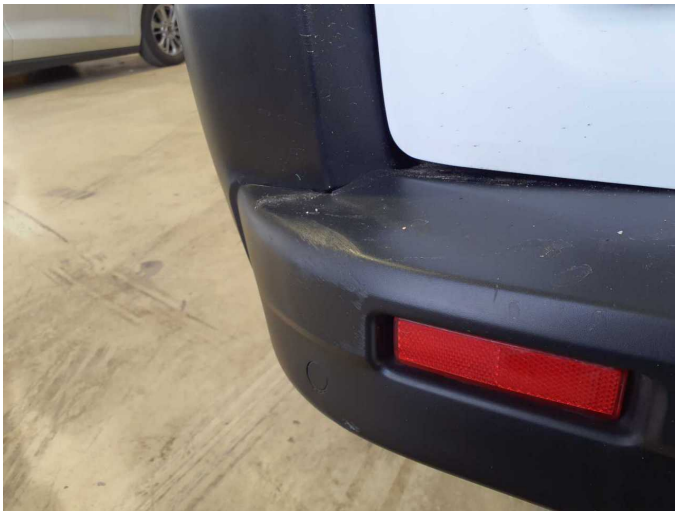
Damage 3: Rear bumper: Rear bumper - Deformed - Loss in value

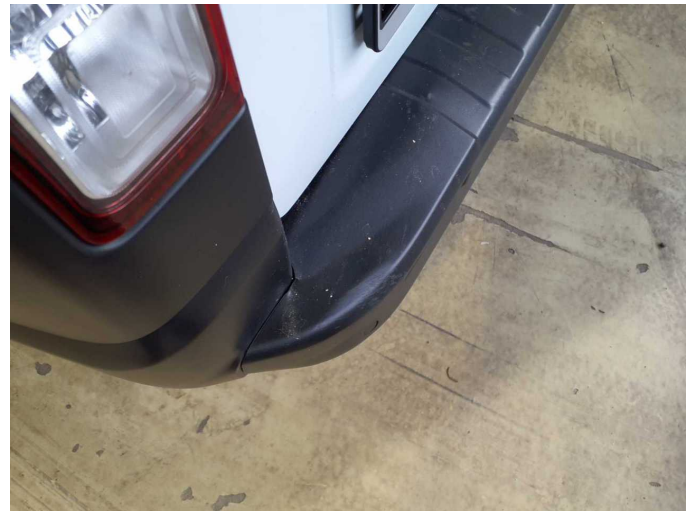
Damage 3: Rear bumper: Rear bumper - Deformed - Loss in value

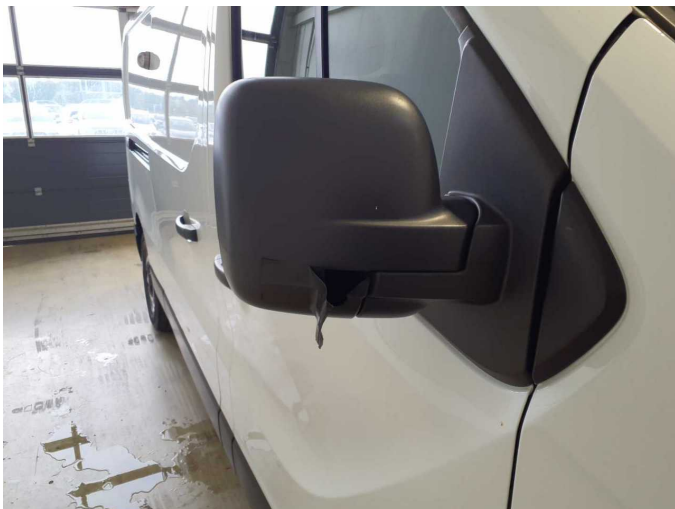
Damage 4: Wing mirror - right side: Wing mirror - Damaged - Replace

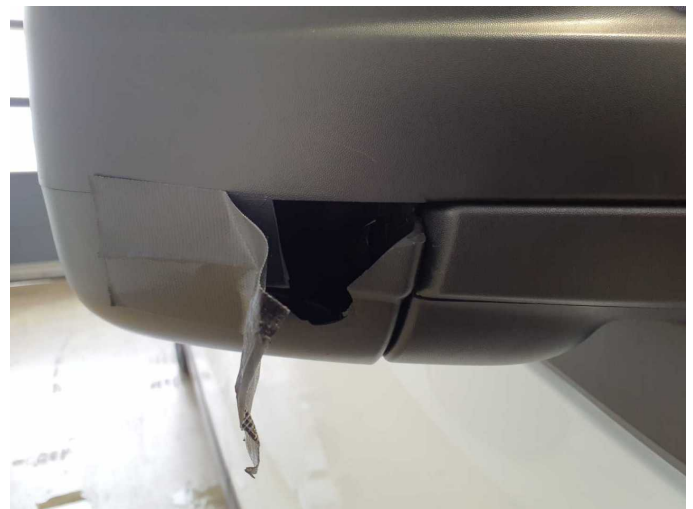
Damage 4: Wing mirror - right side: Wing mirror - Damaged - Replace

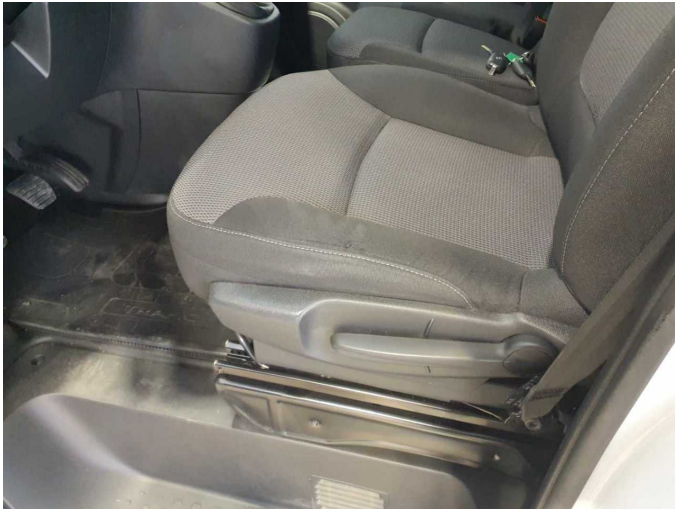
Damage 5: Seat - front: Seat cover - left side - Damaged - Replace

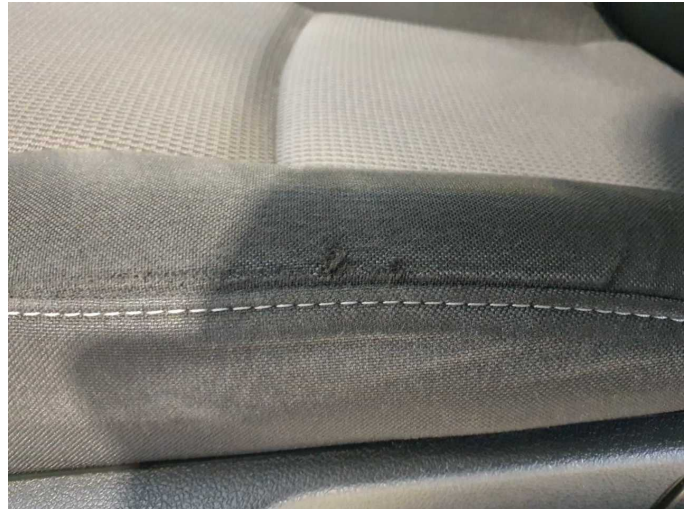
Damage 5: Seat - front: Seat cover - left side - Damaged - Replace

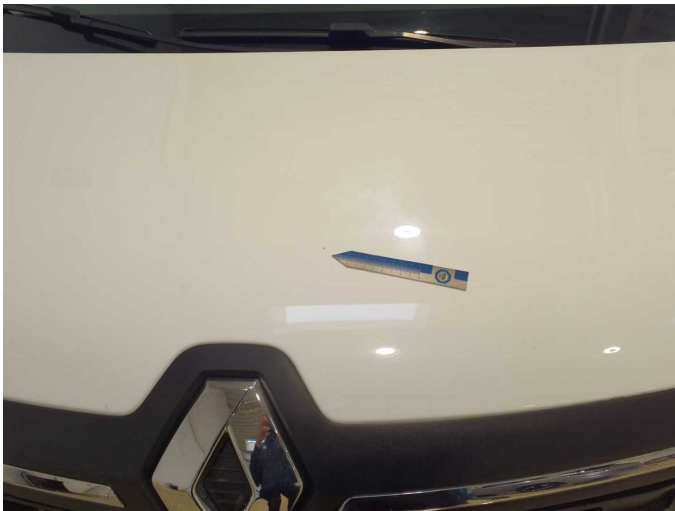
Damage 6: Bonnet: Bonnet - Corrosion - Paint

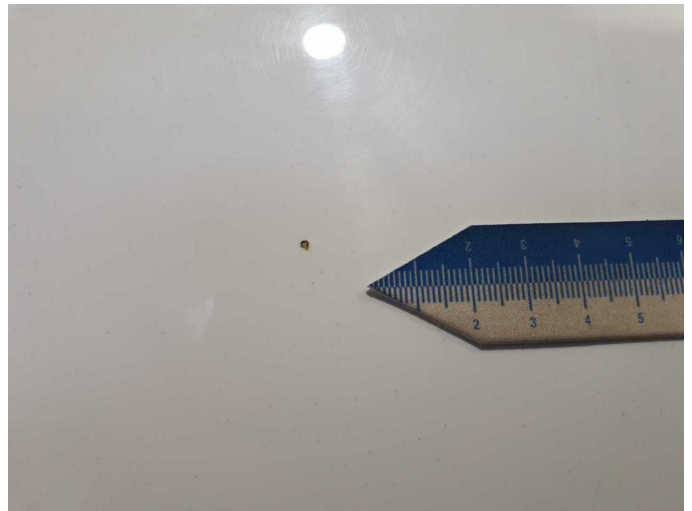
Damage 6: Bonnet: Bonnet - Corrosion - Paint

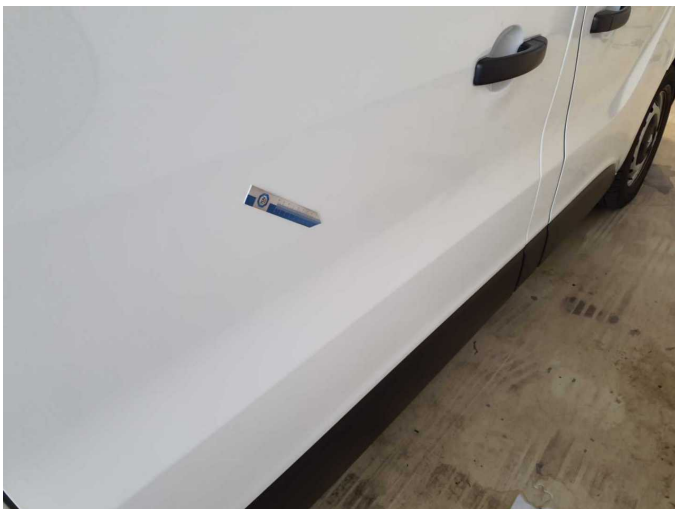
Damage 7: Sliding door, right: Sliding door - Deformed - Repair and paint

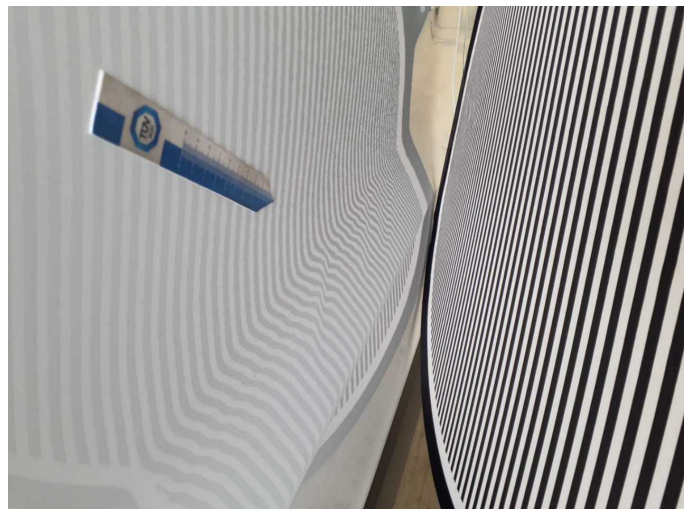
Damage 7: Sliding door, right: Sliding door - Deformed - Repair and paint

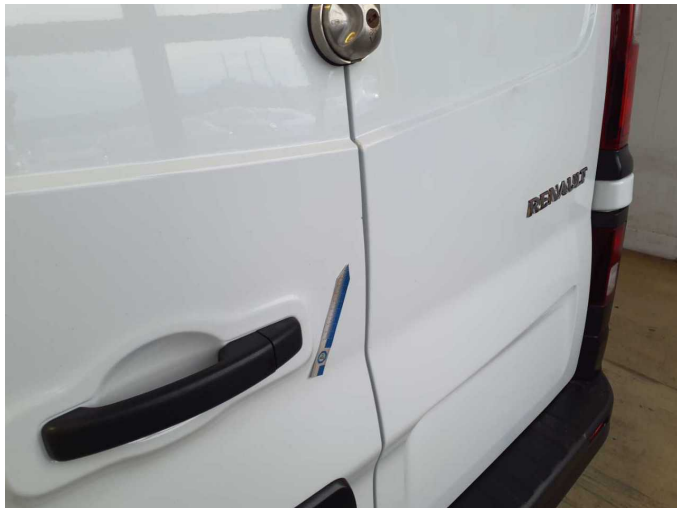
Damage 8: Boot lid / rear door: Rear door - left side - Dent / paintcoat damage - Repair and paint

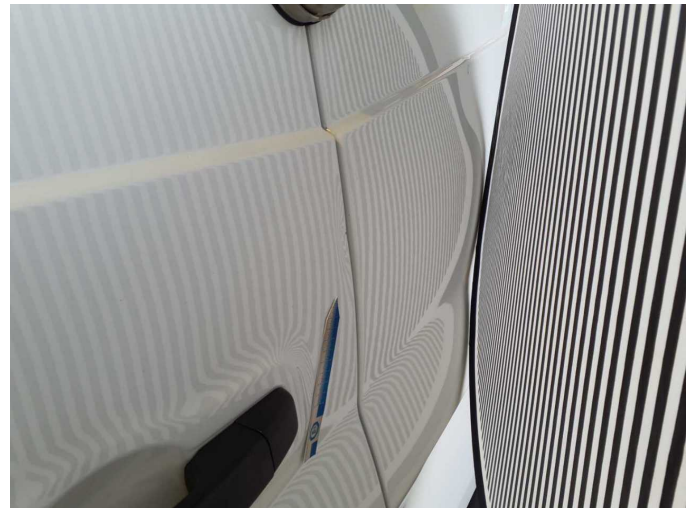
Damage 8: Boot lid / rear door: Rear door - left side - Dent / paintcoat damage - Repair and paint

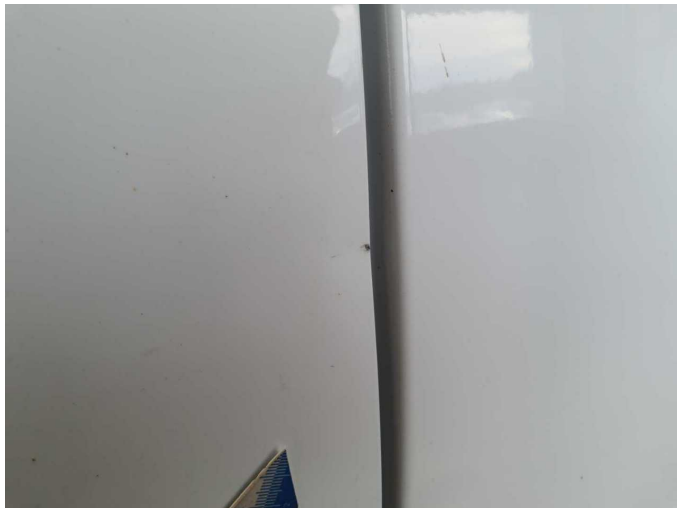
Damage 8: Boot lid / rear door: Rear door - left side - Dent / paintcoat damage - Repair and paint

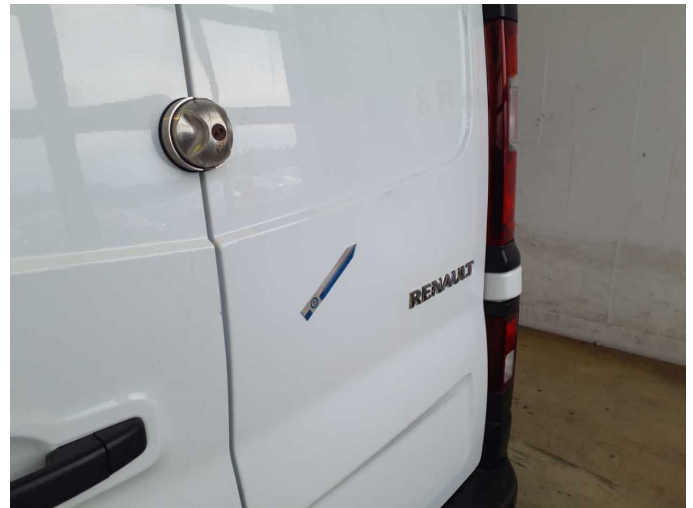
Damage 9: Boot lid / rear door: Rear door - right side - Deformed - Repair and paint

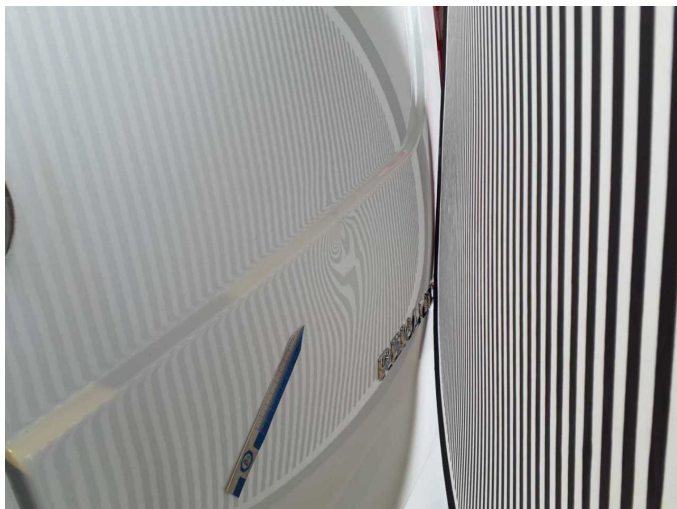
Damage 9: Boot lid / rear door: Rear door - right side - Deformed - Repair and paint

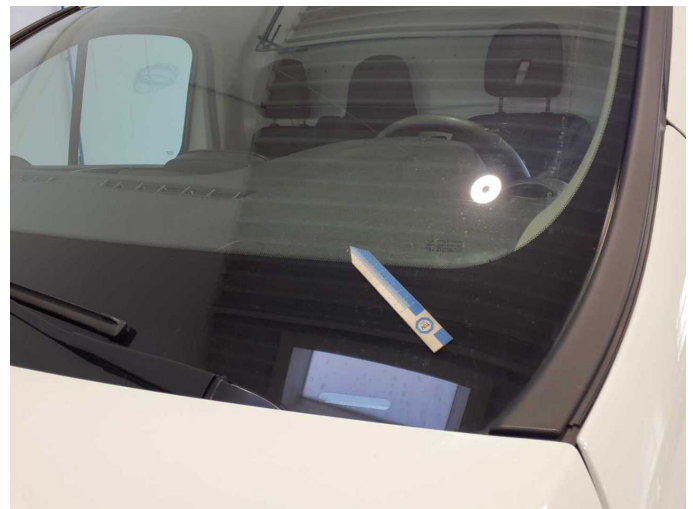
Damage 10: Vehicle glazing: Windscreen - Stone chips - Replace

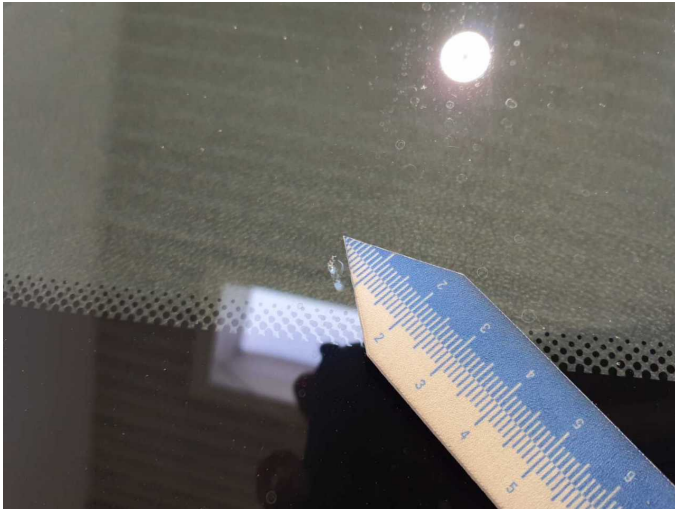
Damage 10: Vehicle glazing: Windscreen - Stone chips - Replace

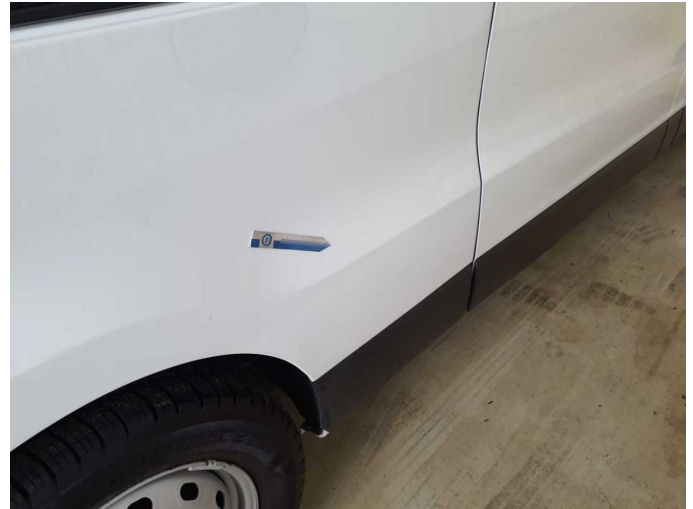
Damage 11: Side panel - rear right side: Side panel - Dent / paintcoat damage - Repair and paint

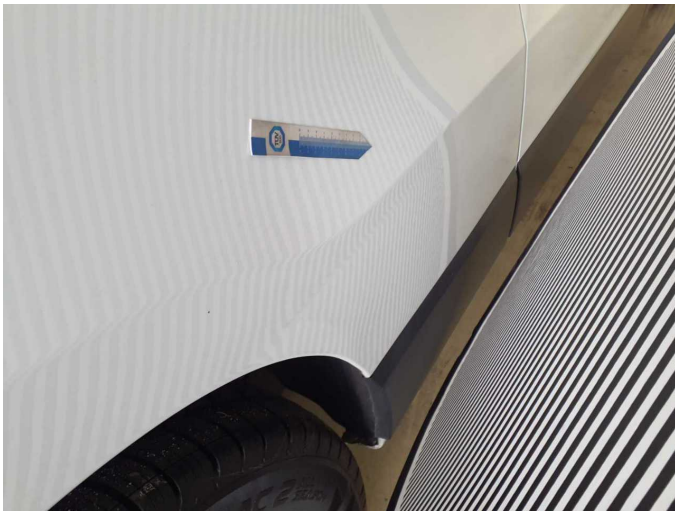
Damage 11: Side panel - rear right side: Side panel - Dent / paintcoat damage - Repair and paint

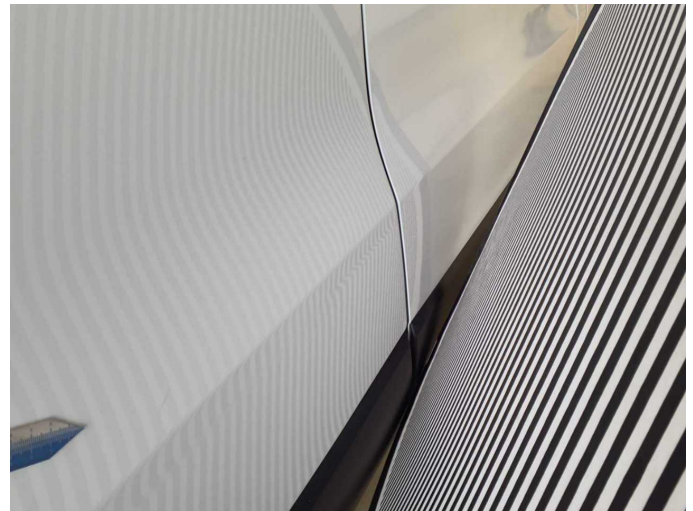
Damage 11: Side panel - rear right side: Side panel - Dent / paintcoat damage - Repair and paint

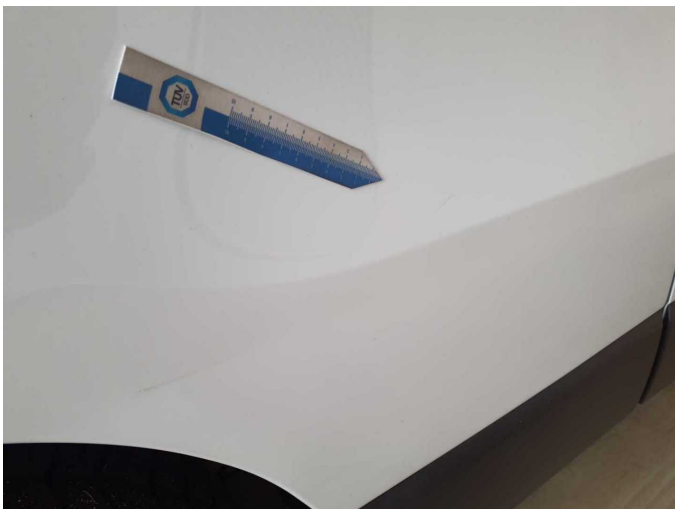
Damage 11: Side panel - rear right side: Side panel - Dent / paintcoat damage - Repair and paint

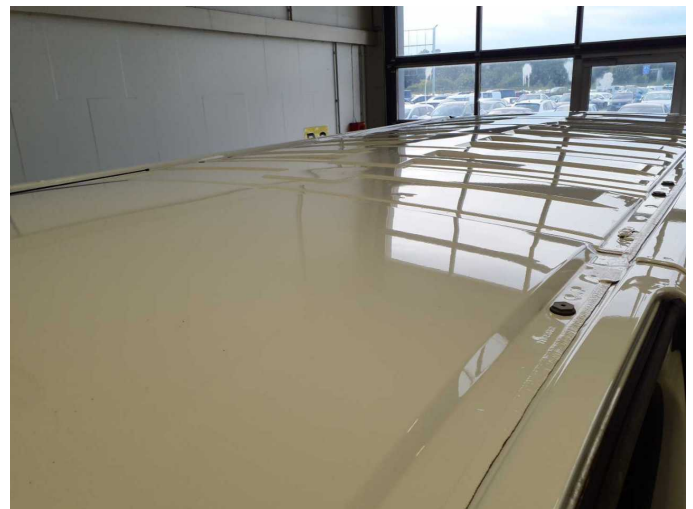
Damage 12: Roof: Roof - Deformed - Repair and paint

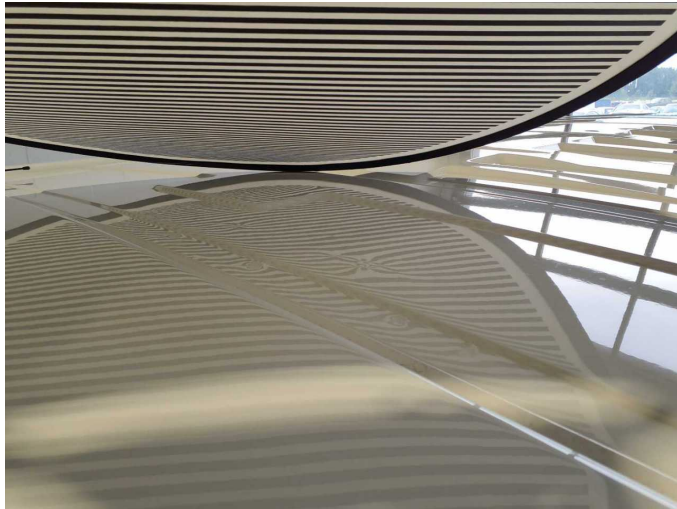
Damage 12: Roof: Roof - Deformed - Repair and paint

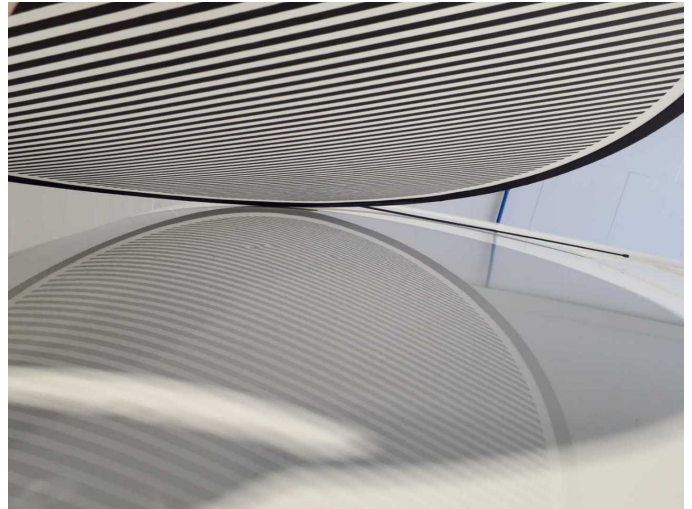
Damage 12: Roof: Roof - Deformed - Repair and paint

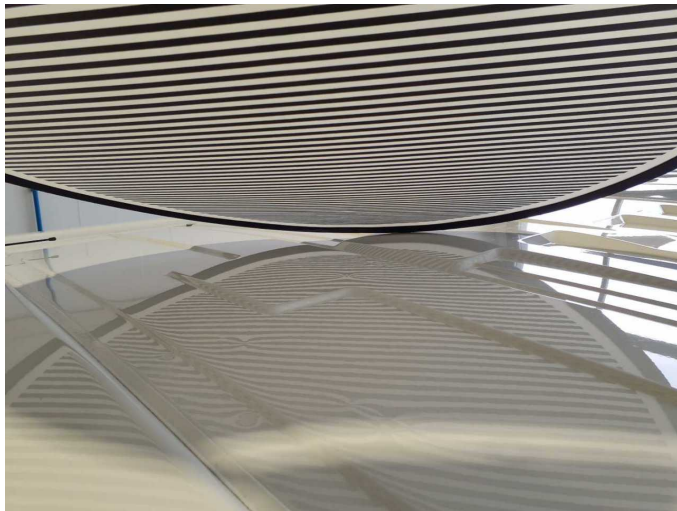
Damage 12: Roof: Roof - Deformed - Repair and paint

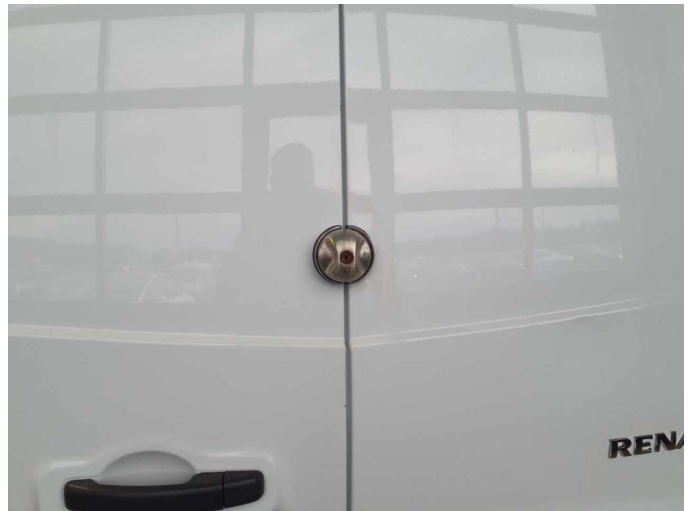
Wear and tear 1: Body: Body - Differs from the original configuration - No deduction

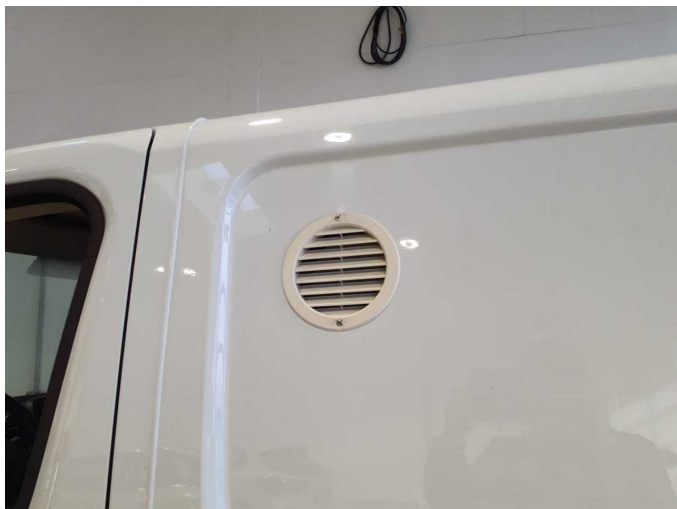
Wear and tear 1: Body: Body - Differs from the original configuration - No deduction

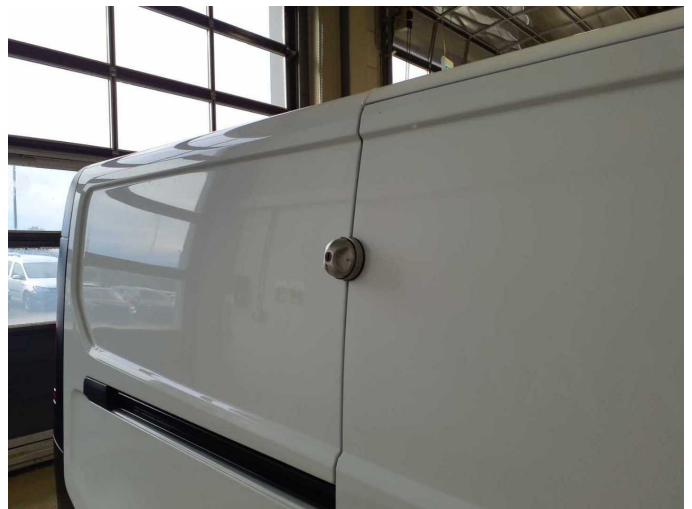
Wear and tear 1: Body: Body - Differs from the original configuration - No deduction

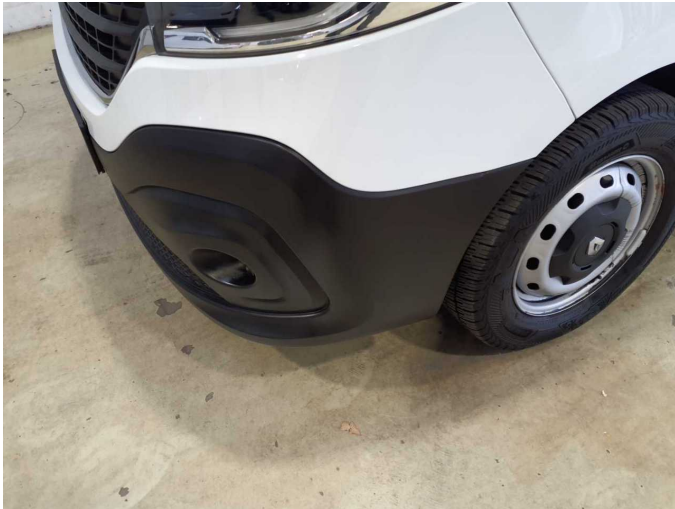
Wear and tear 2: Front bumper: Front bumper - Scratch(es) - No deduction

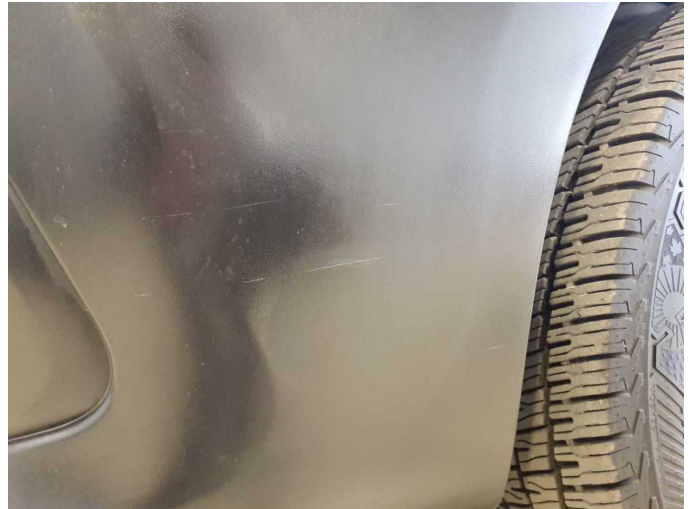
Wear and tear 2: Front bumper: Front bumper - Scratch(es) - No deduction

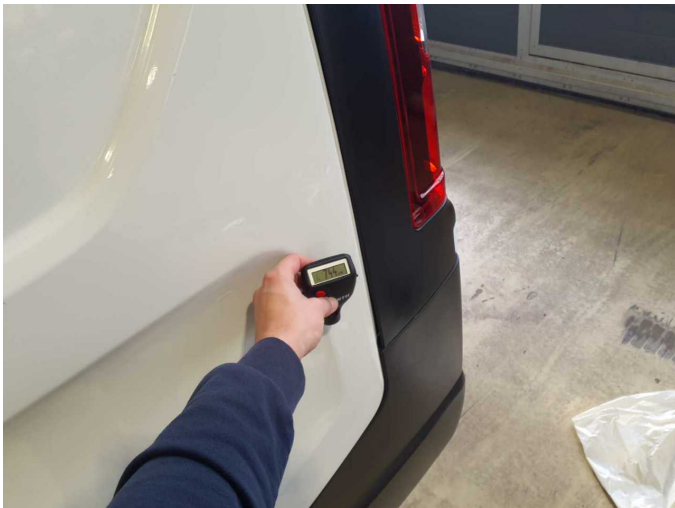
Side panel - rear left side: 744 µm

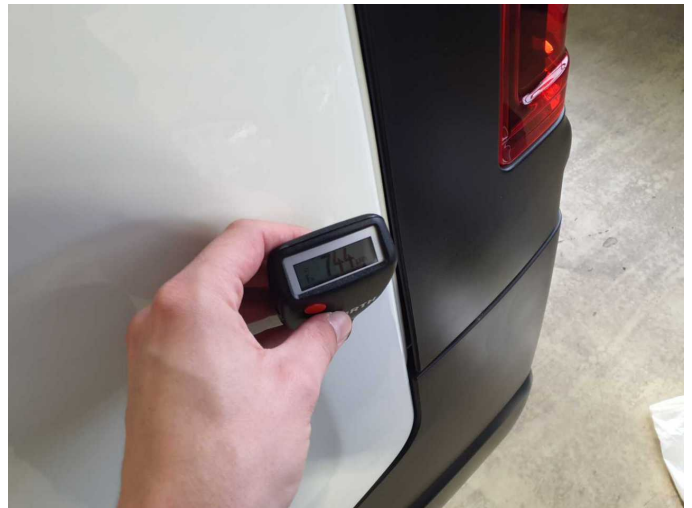
Side panel - rear left side: 744 µm
