## status report

**customer:** Bank 11, Neuss  
**contract number:** 934788730-INSO  
**reference:**

#### Renault Trafic Kasten L1H1 2,8t Komfort

| Vehicle identification number | <b>VF1FL000869403681</b> | mileage read: | <b>30652 km</b> |

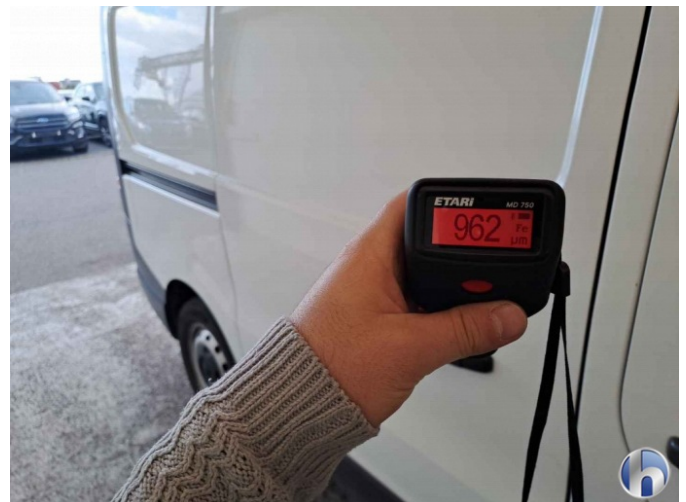
| component | Damage | Rep kind |
|---|---|---|
| 1. Door Rear - right | Subsequently painted | acceptable |

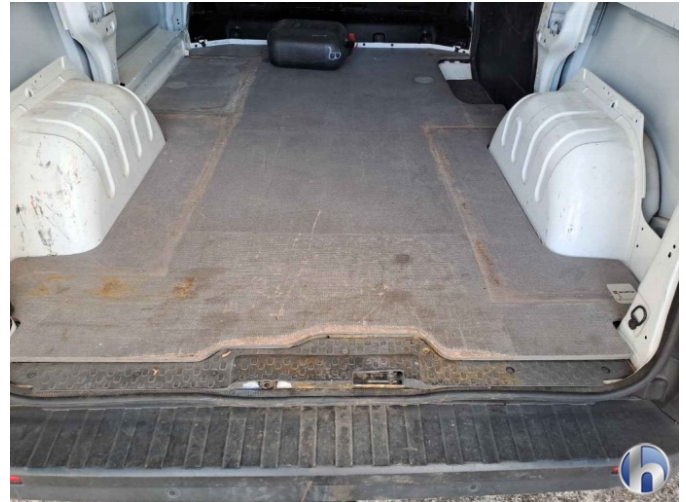
| component | Damage | Rep kind |
|---|---|---|
| 6. flooring | Scrape | Replace |

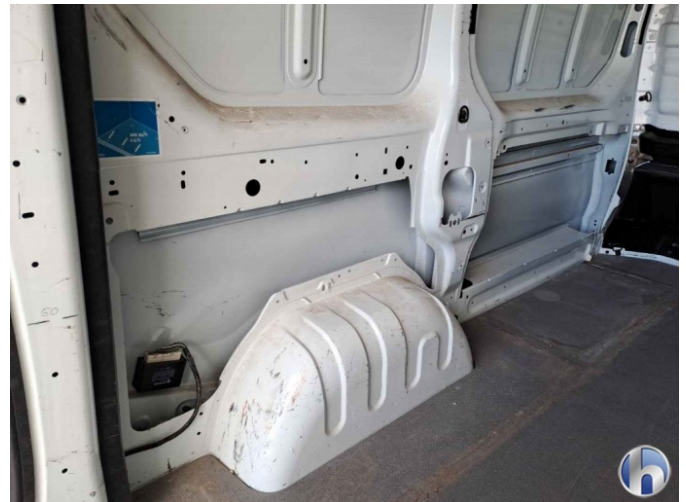
| component | Damage | Rep kind |
|---|---|---|
| 7. Laderaum Verkleidungen | Missing | Replace |

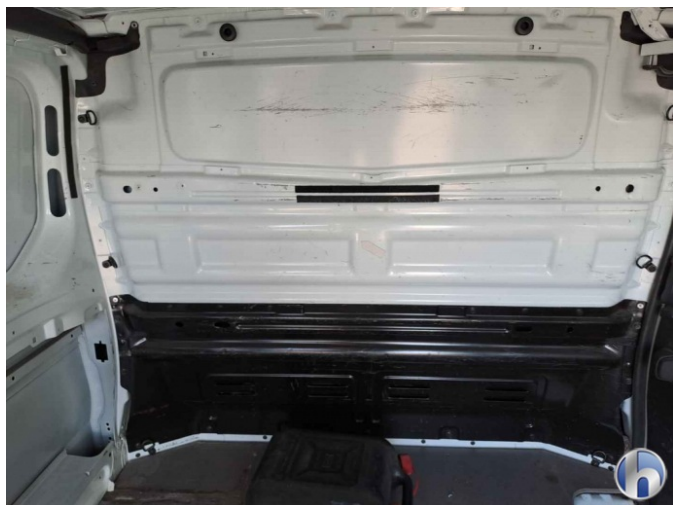
| component | Damage | Rep kind |
|---|---|---|
| 10. Partition load space | Damaged | Refurbish and paint |

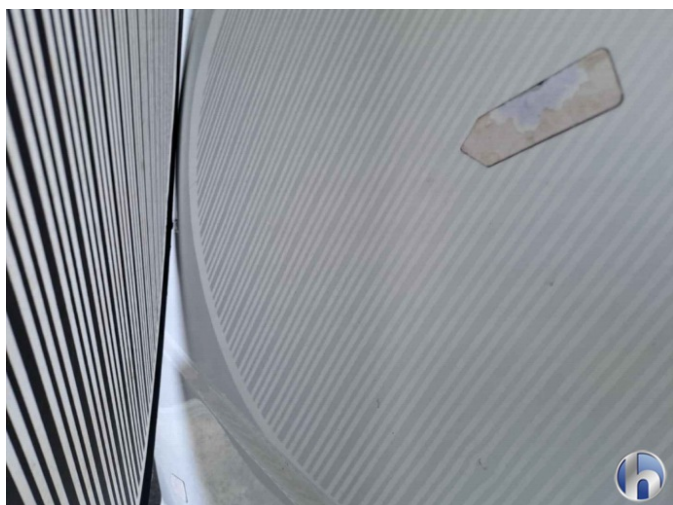
| component | Damage | Rep kind |
|---|---|---|
| 11. Tailgate right | Damaged | Refurbish and paint |

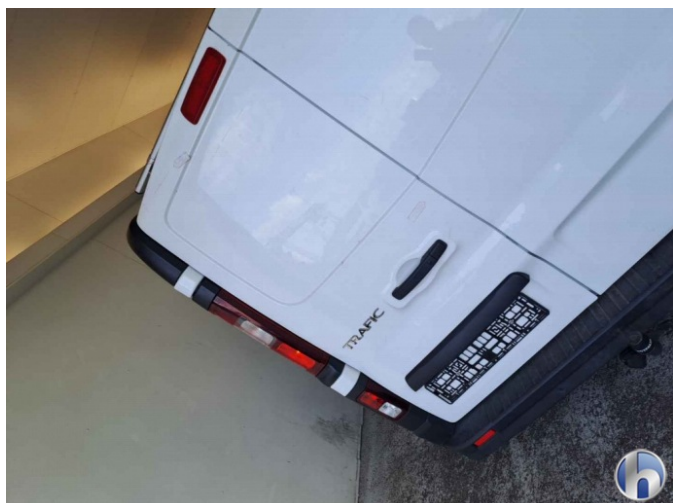
| component | Damage | Rep kind |
|---|---|---|
| 12. Tailgate left | Damaged | Refurbish and paint |

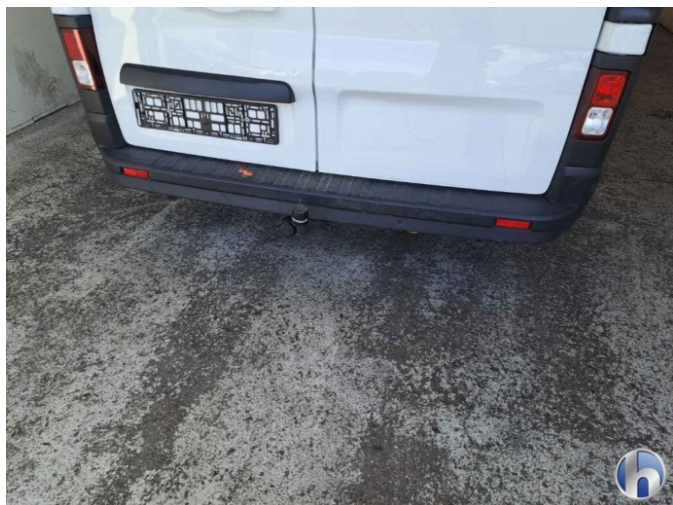
| component | Damage | Rep kind |
|---|---|---|
| 13. Rear bumper | Damaged | Replace |

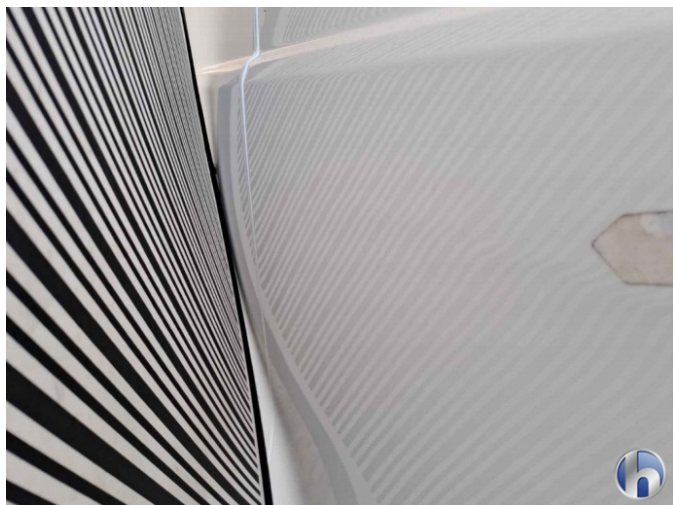
| component | Damage | Rep kind |
|---|---|---|
| 14. Seitenwand - Links | Damaged | Refurbish and paint |

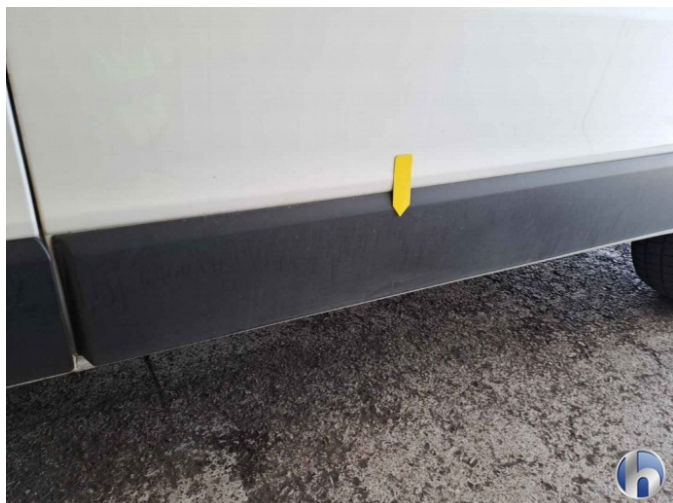
| component | Damage | Rep kind |
|---|---|---|
| 16. Seitenwand - Beplankung- Links | Scratch(es) | Replace |

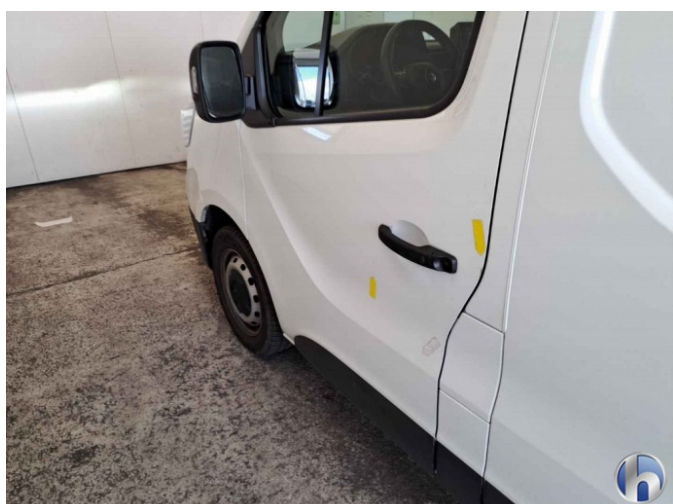
| component | Damage | Rep kind |
|---|---|---|
| 17. Front door - left | Damaged | Refurbish and paint |

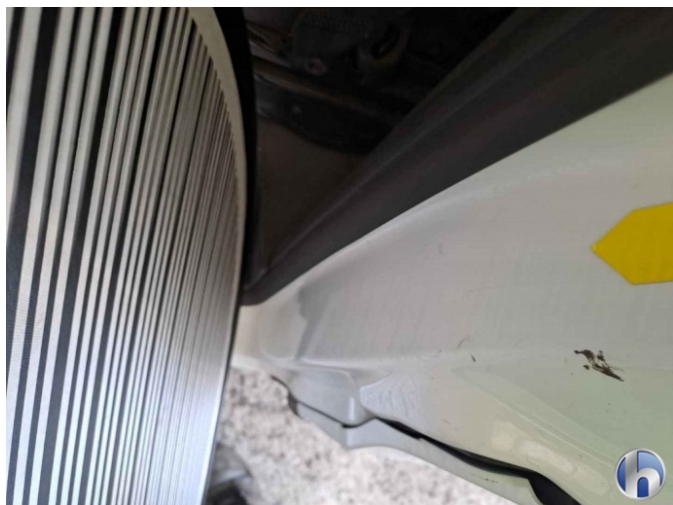
| component | Damage | Rep kind |
|---|---|---|
| 18. Türeinstieg Vorne - Links | Damaged | Refurbish and paint |

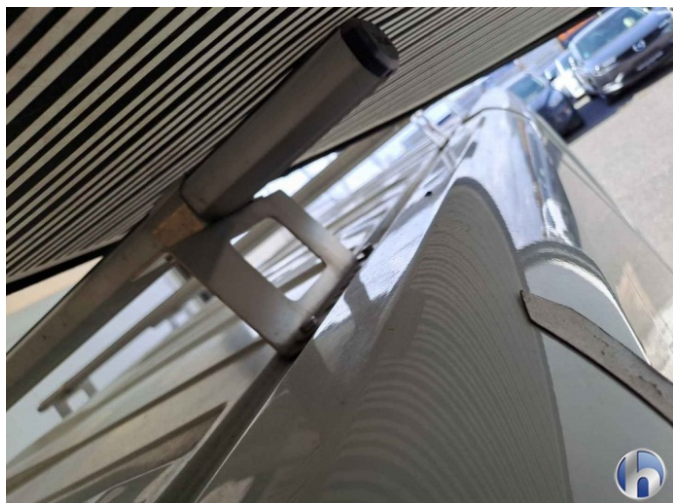
| Performed testing technology | |
|---|---|
| <b>reference:</b> | *Alters-, Transport- und Laufleistungsbedingte Gebrauchsspuren vorhanden. Es handelt sich um ein Nutzfahrzeug. Dementsprechend sind ggf. stärkere Gebrauchsspuren am und im Fahrzeug vorhanden. Kosten- und Schadenserweiterung möglich. Aufgrund der Höhe ist die Begutachtung vom Dach und der Dachrahmen nicht möglich. Schäden sind nicht ausgeschlossen. Aufgrund der Höhe ist die Lackmessung nur bedingt möglich. Schäden sind nicht ausgeschlossen. Die Lackschichtdicke ist erhöht. Die Stahlfelgen weisen Korrosion auf. Schäden sind nicht ausgeschlossen. Der Motor läuft mit erhöht Drehzahl und hat unnormale Geräusche. Schäden und Folgeschäden sind nicht ausgeschlossen. Das Dach und die Dachrahmen sind stark beschädigt. Weitere Schäden sind nicht ausgeschlossen. |

| component | Damage | Rep kind |
|---|---|---|
| 22. Roof frame - left | Damaged | Refurbish and paint |

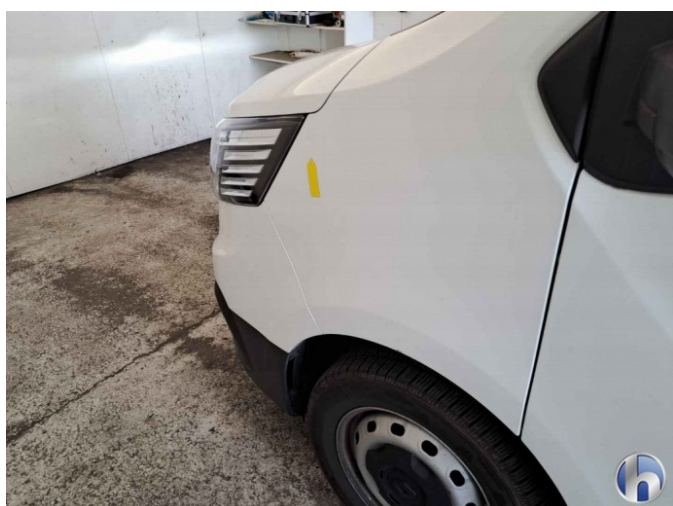
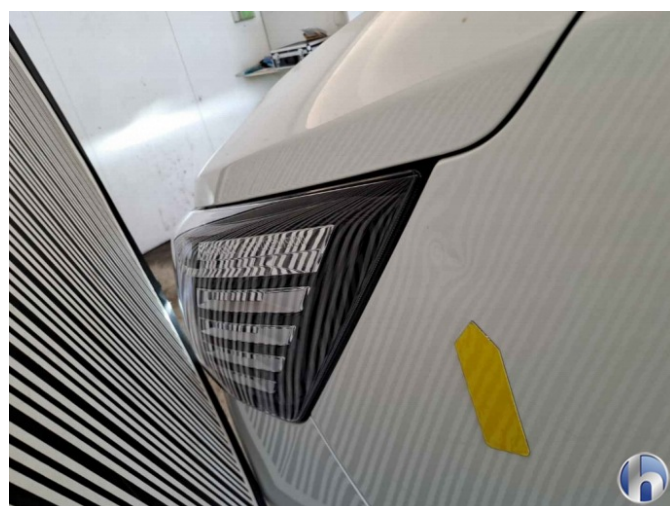
| component | Damage | Rep kind |
|---|---|---|
| 23. Front fender - left | Deformed | Refurbish and paint |

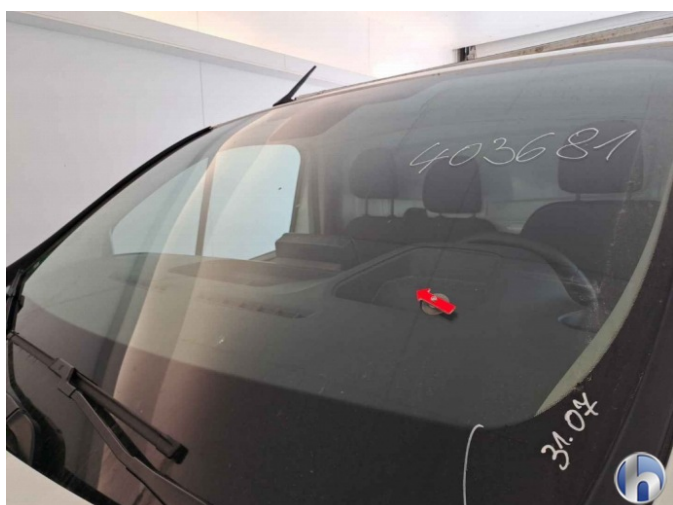
| component | Damage | Rep kind |
|---|---|---|
| 24. Windshield | Damaged | Replace |

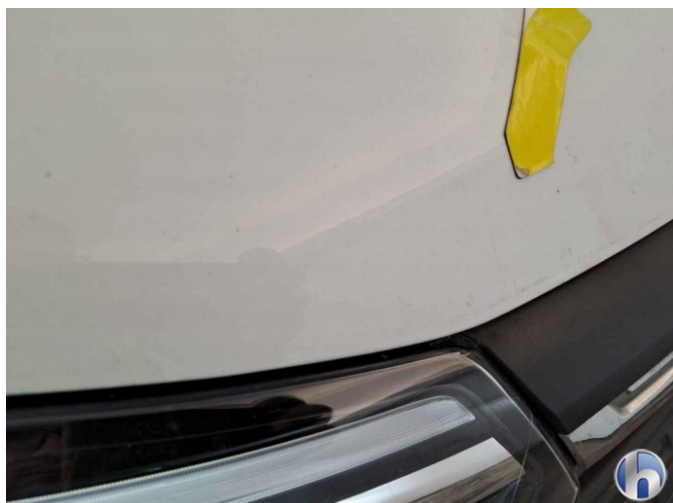
| component | Damage | Rep kind |
|---|---|---|
| 25. hood | Damaged | Refurbish and paint |

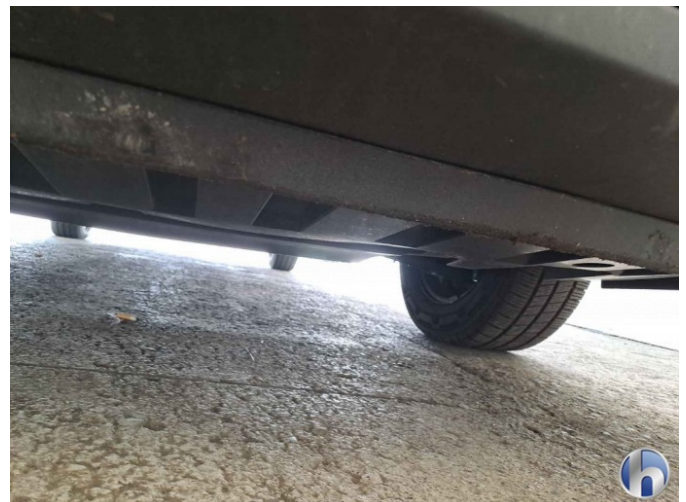
| component | Damage | Rep kind |
|---|---|---|
| 28. spoiler | Scrape | Replace |

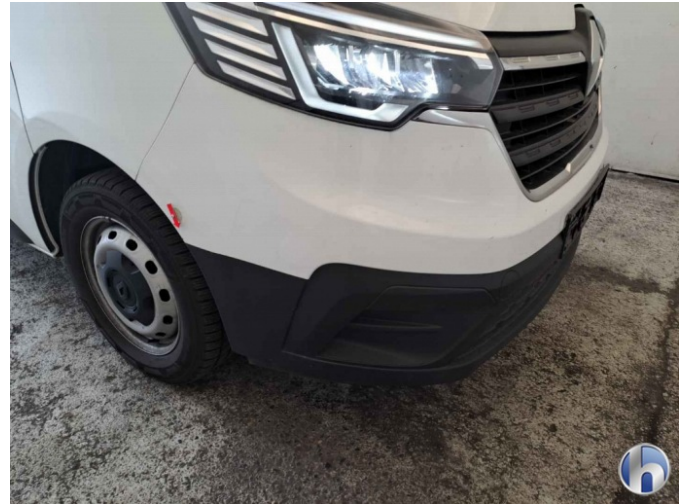
| component | Damage | Rep kind |
|---|---|---|
| 29. Front bumper | Scratch(es) | Replace |

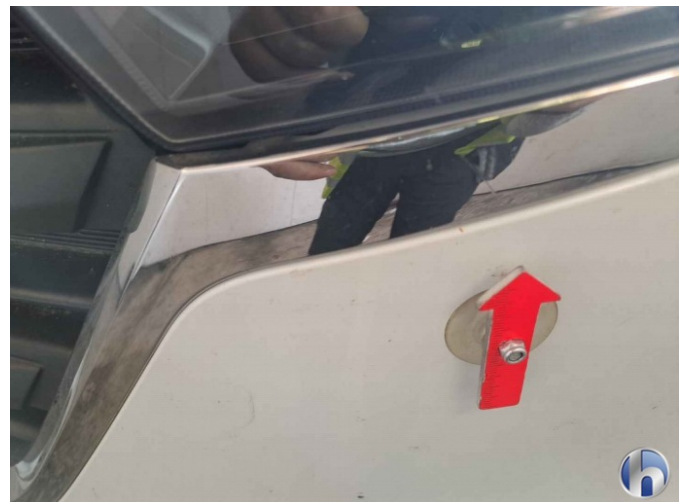
| component | Damage | Rep kind |
|---|---|---|
| 30. Front grille top | Scratch(es) | Replace |

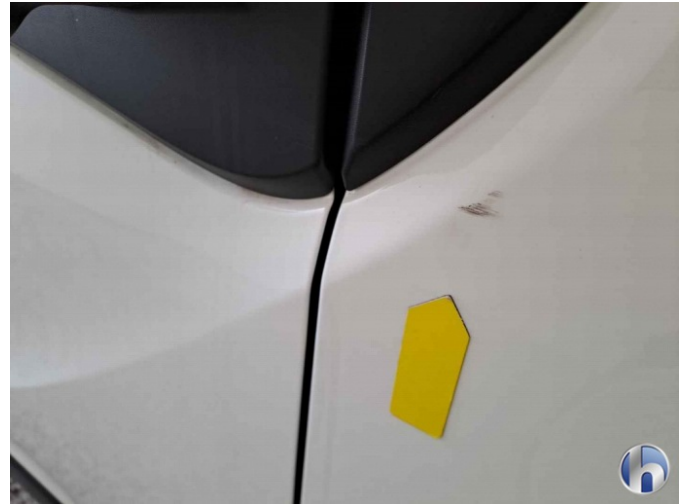
| component | Damage | Rep kind |
|---|---|---|
| 31. Front fender - right | Scratch(es) | Paint |

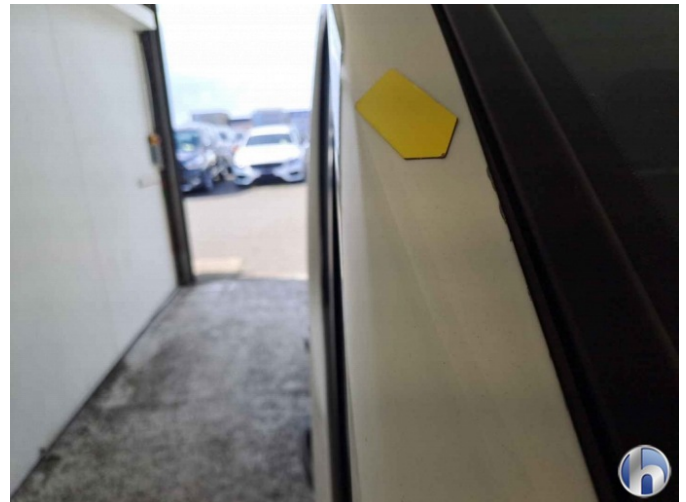
| component | Damage | Rep kind |
|---|---|---|
| 32. Front door - right | Damaged | Refurbish and paint |

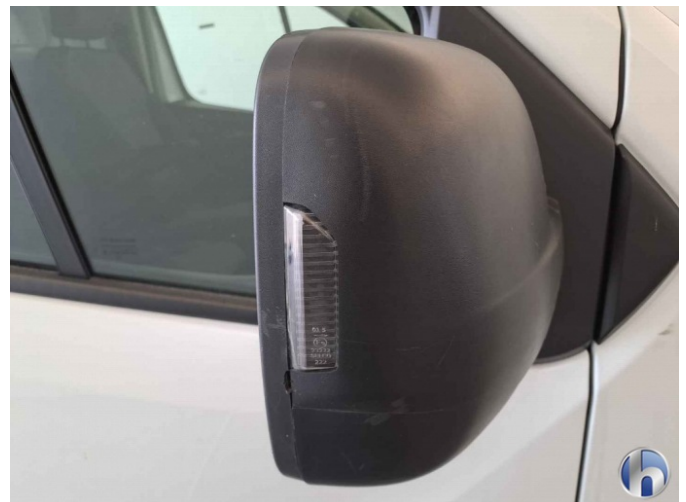
| component | Damage | Rep kind |
|---|---|---|
| 33. Outside mirror - right | Damaged | Replace |

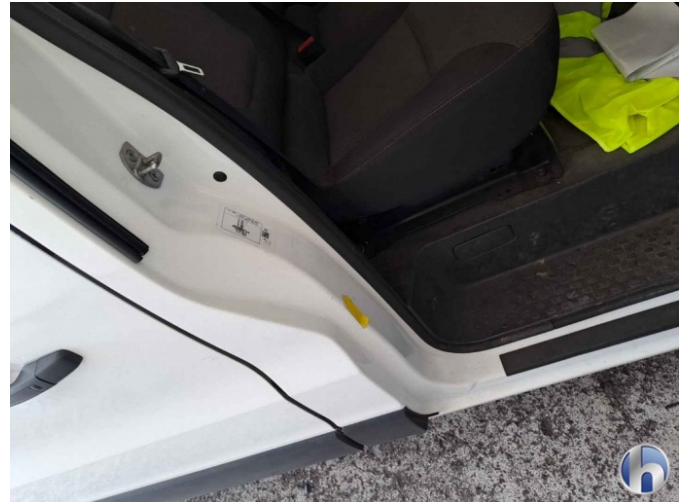
| component | Damage | Rep kind |
|---|---|---|
| 34. Türeinstieg Vorne - Rechts | Damaged | Refurbish and paint |

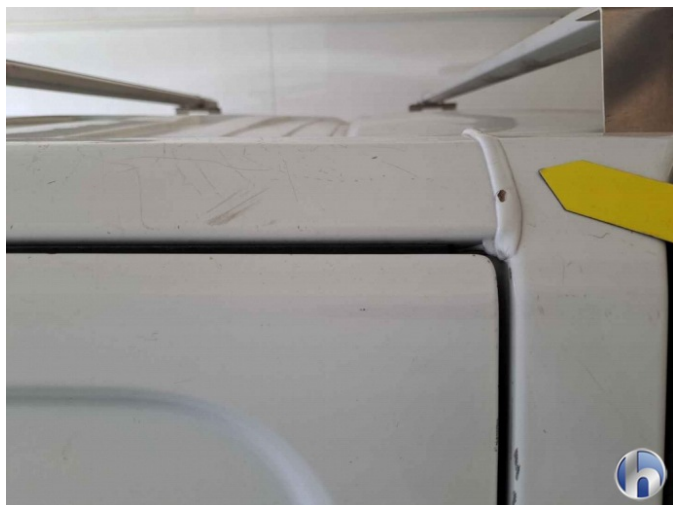
| component | Damage | Rep kind |
|---|---|---|
| 36. Roof frame - right | Damaged | Refurbish and paint |

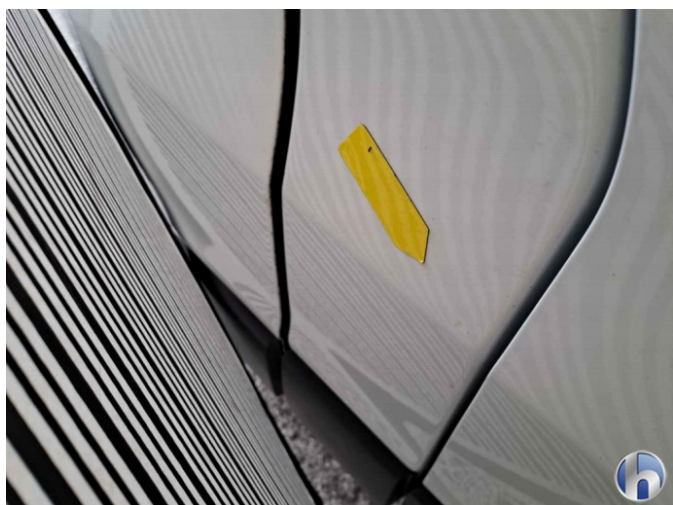
| component | Damage | Rep kind |
|---|---|---|
| 37. B-pillar center - right | Damaged | Refurbish and paint |

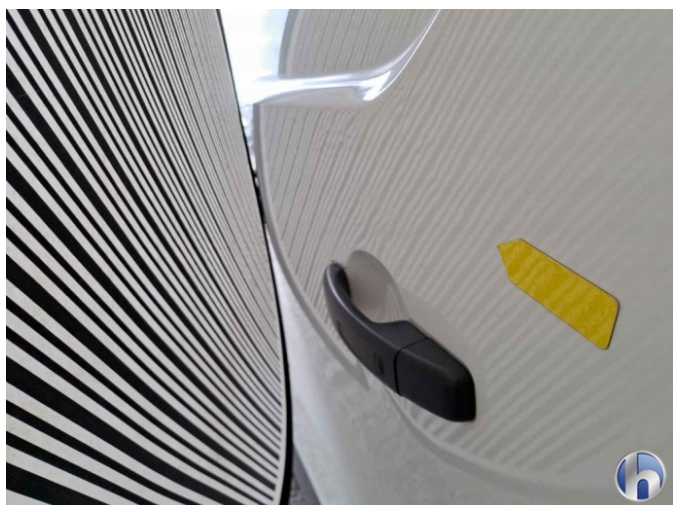
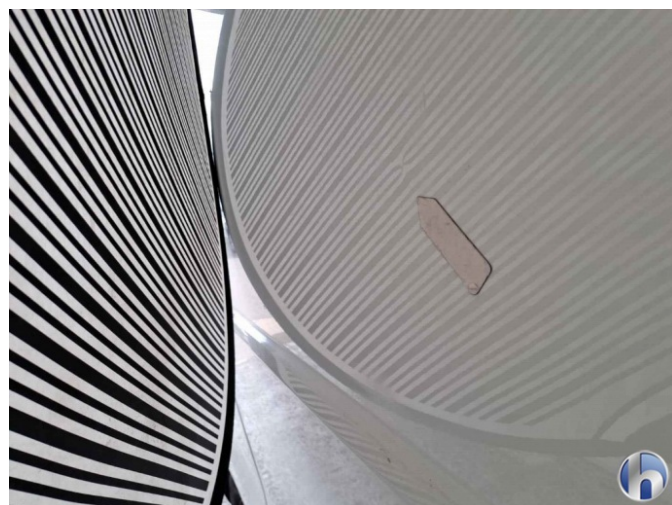
41. Sliding door - right

| 41. | Sliding door - right | Execution defect | Refurbish and paint |

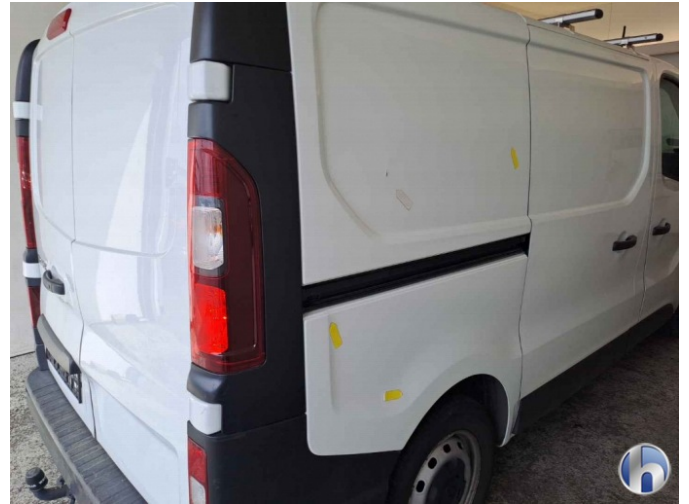
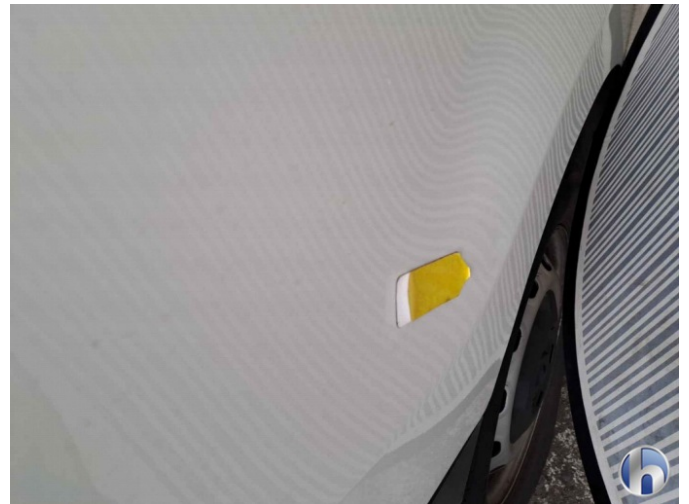
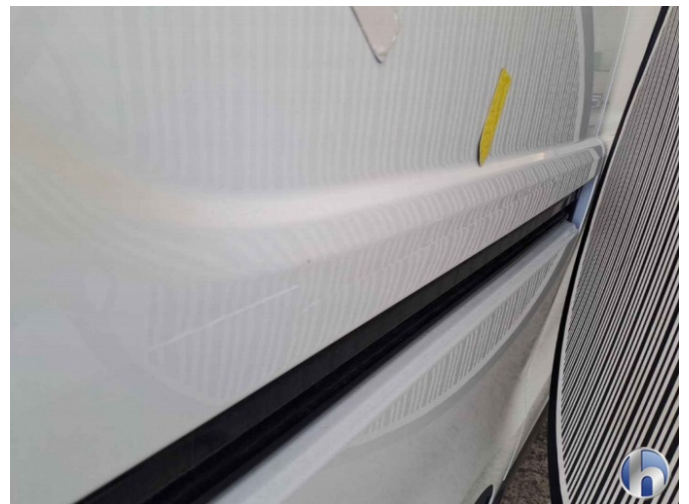
42. Sidewall - Rear - right

| 42. | Sidewall - Rear - right | Damaged | Refurbish and paint |

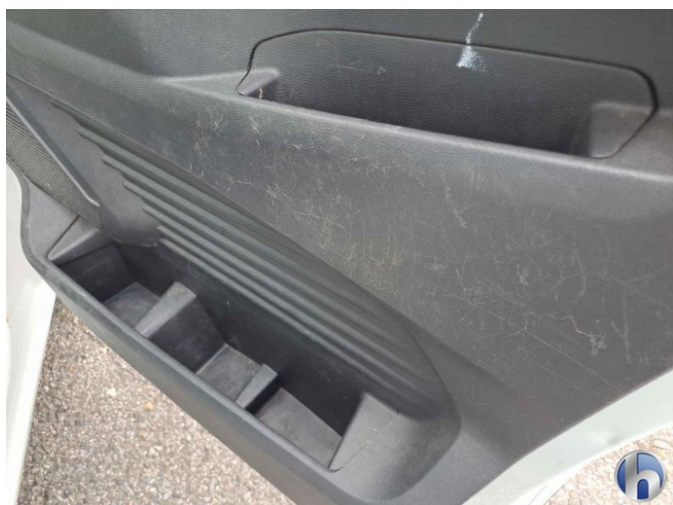
51. Door trim Front - right

| 51. | Door trim Front - right | Scratch(es) | Replace |

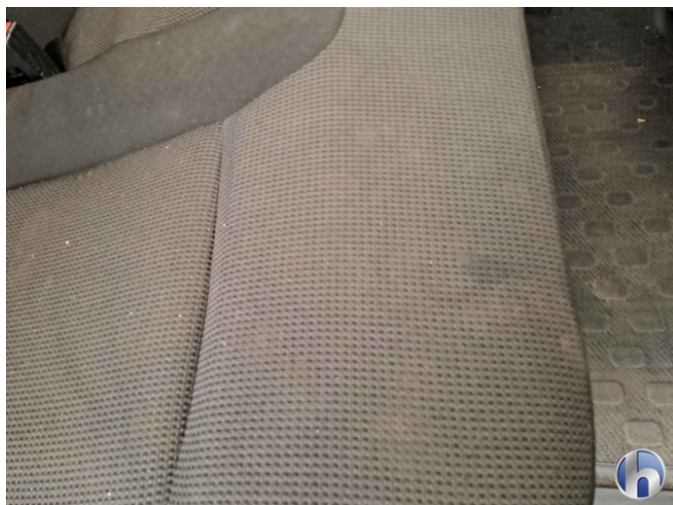
52. Sitz - Vorne - Rechts Bank: Kissen (Stoff)

| 52. | Sitz - Vorne - Rechts Bank: Kissen (Stoff) | Damaged | Replace |

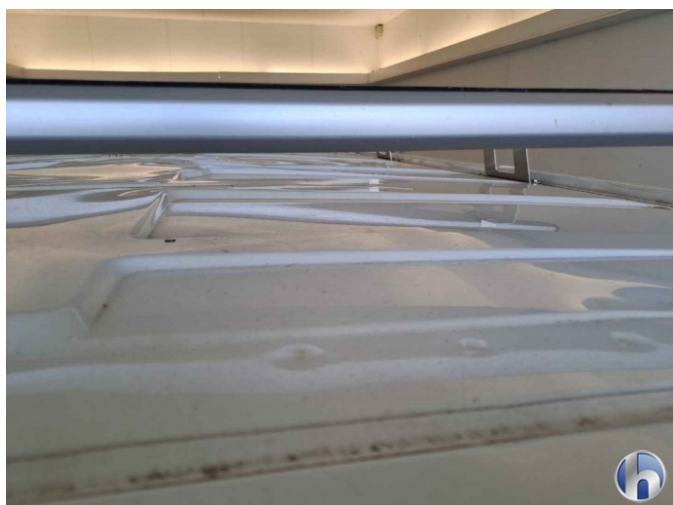
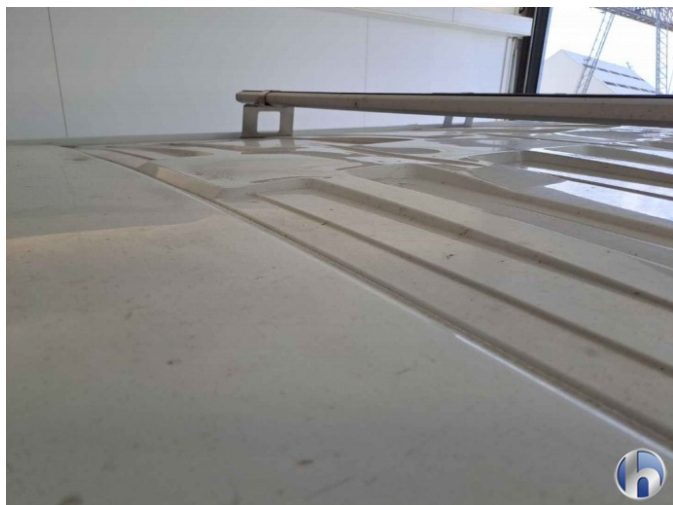
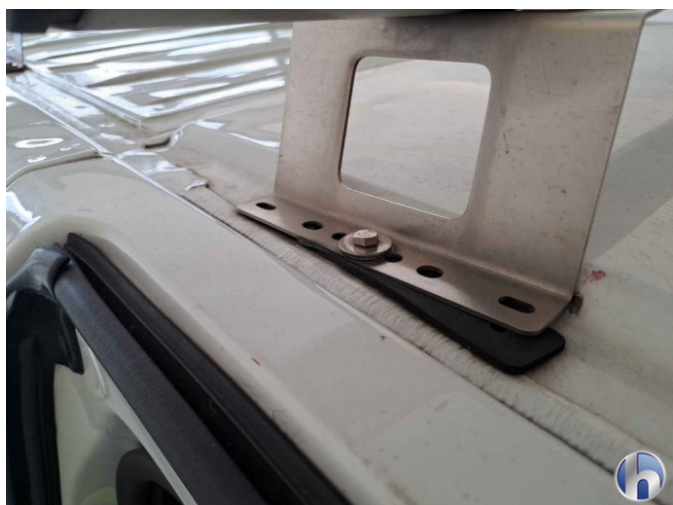
56. roof

| 56. | roof | Damaged | Replace |
