## status report

| vehicle data | | | |
|---|---|---|---|
| <b>Renault Trafic Kasten L1H1 2,7t Komfort</b> | | | |
| Vehicle identification number | <b>VF1FL000963546139</b> | mileage estimated: | <b>999999 km</b> |
| First Registration / construction year: | <b>01.07.2019 / 2019</b> | Visit Date / place of birth: | <b>17.07.2025 Neuss</b> |

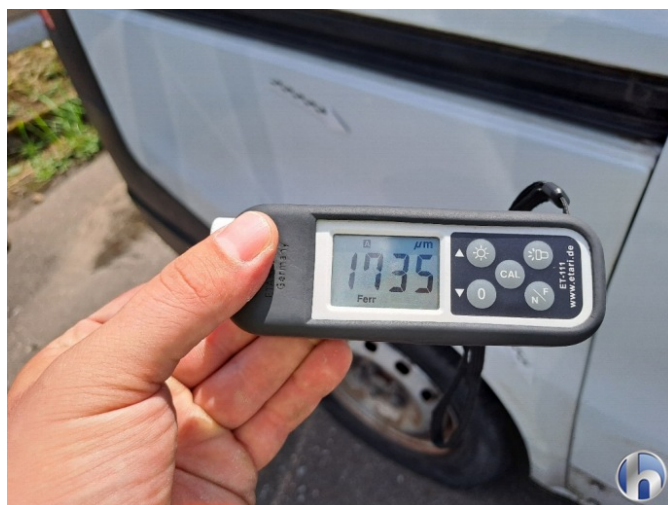
| component | Damage | Rep kind |
|---|---|---|
| 1. Sidewall - Rear - right | Subsequently painted | acceptable |

1. Sidewall - Rear - right

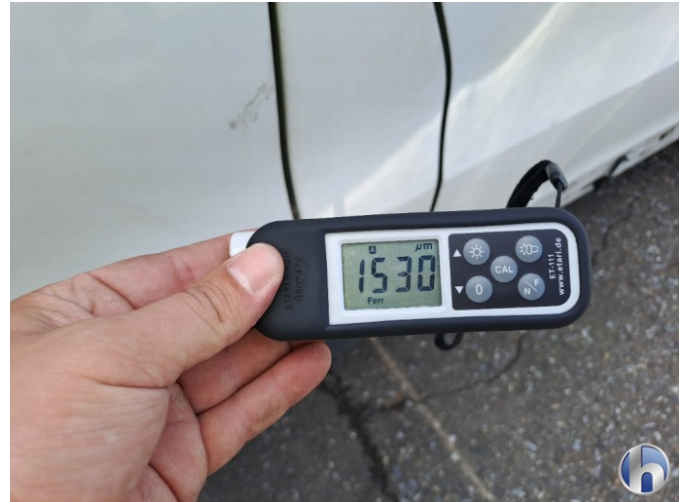
| component | Damage | Rep kind |
|---|---|---|
| 3. B-pillar center - right | Subsequently painted | acceptable |

3. B-pillar center - right

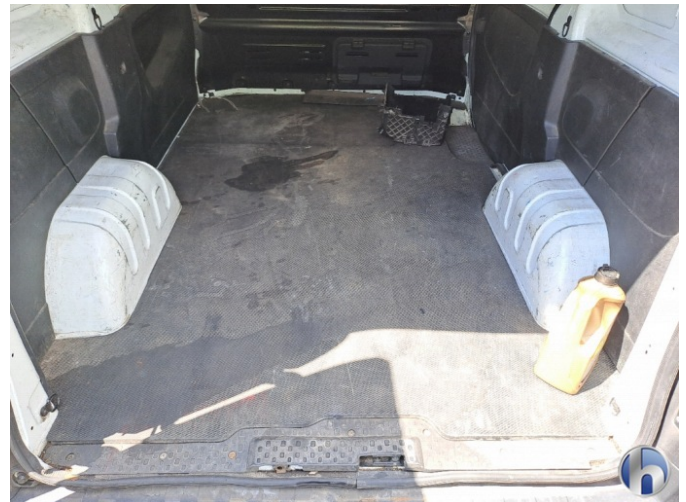
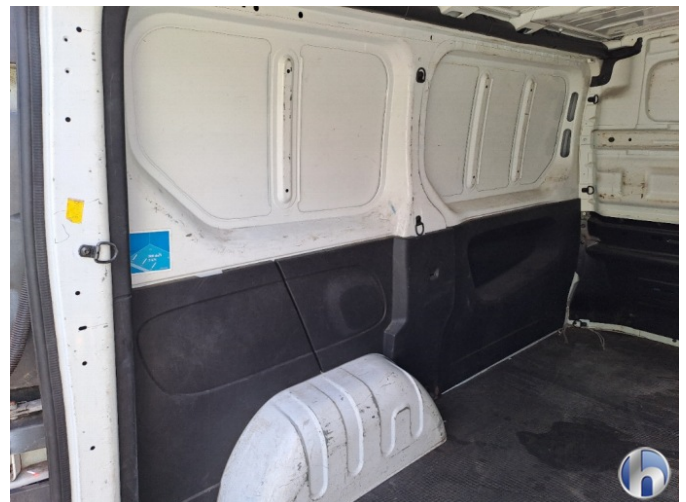
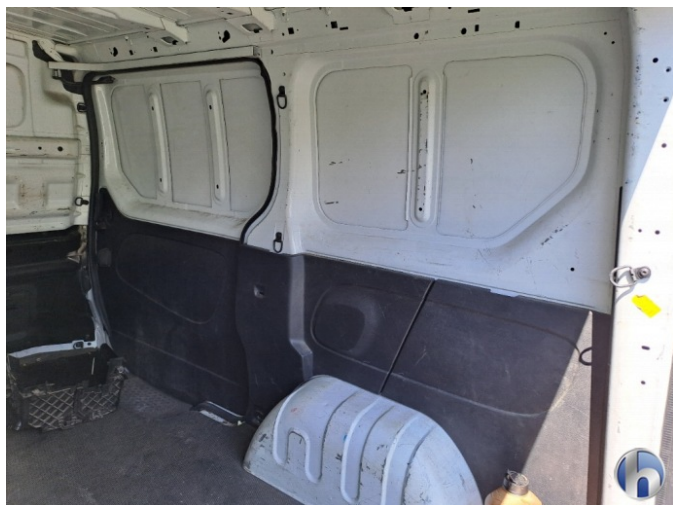
| component | Damage | Rep kind |
|---|---|---|
| 8. | Wear and tear | acceptable |

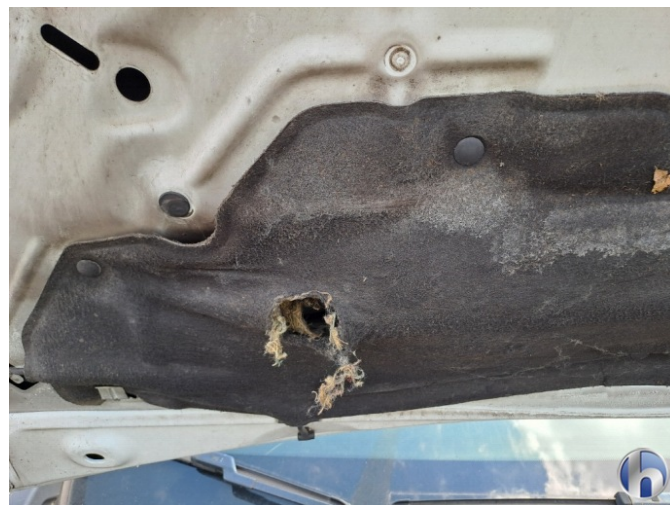
| component | Damage | Rep kind |
|---|---|---|
| 9. motor insulation | | Replace |

9. motor insulation

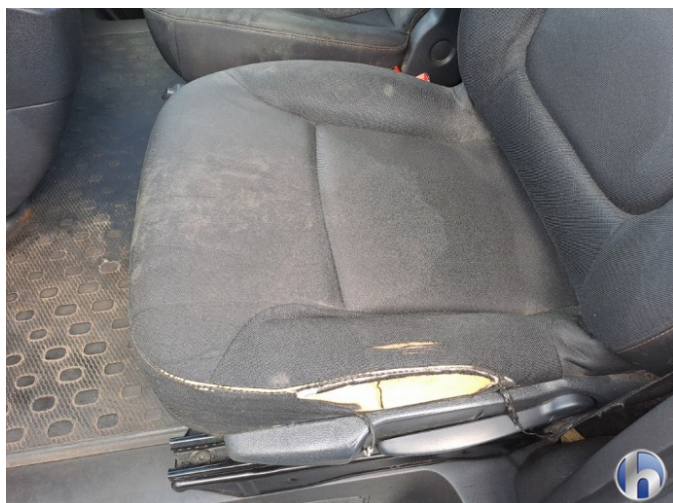
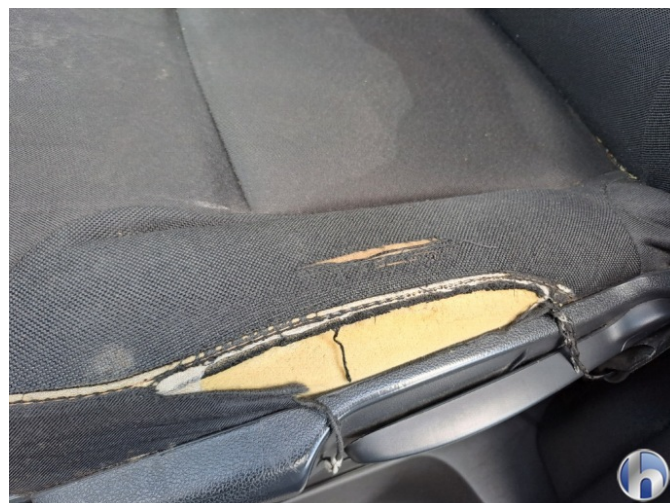
| component | Damage | Rep kind |
|---|---|---|
| 10. | Damaged | Replace |

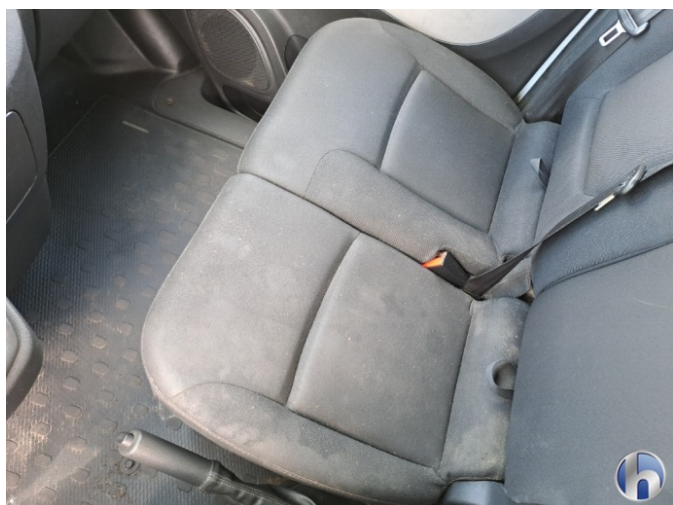
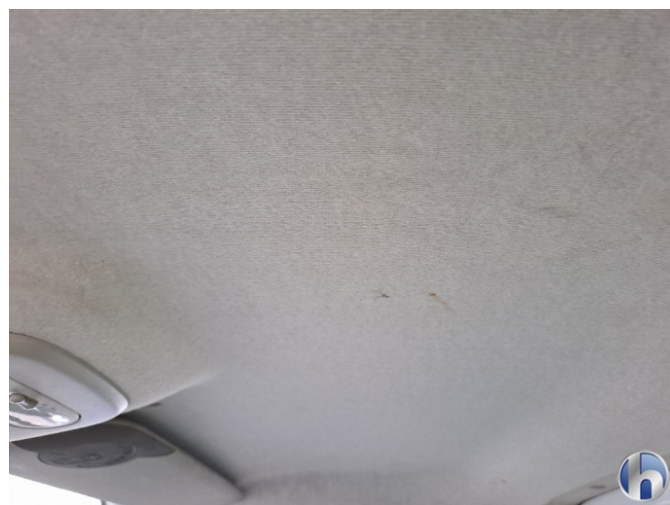
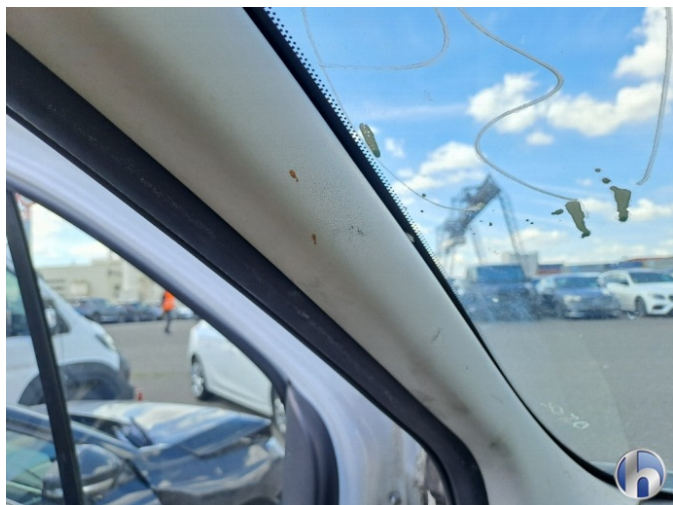
| component | Damage | Rep kind |
|---|---|---|
| 11. | Dirty | |

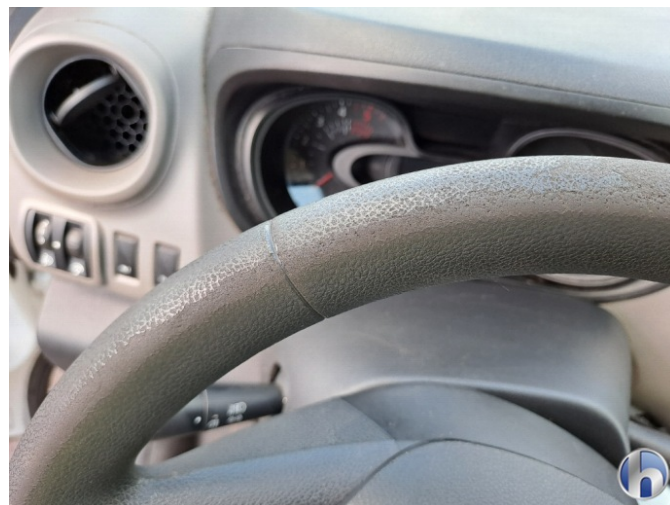
| component | Damage | Rep kind |
|---|---|---|
| 12. steering wheel | Worn | Replace |

12. steering wheel

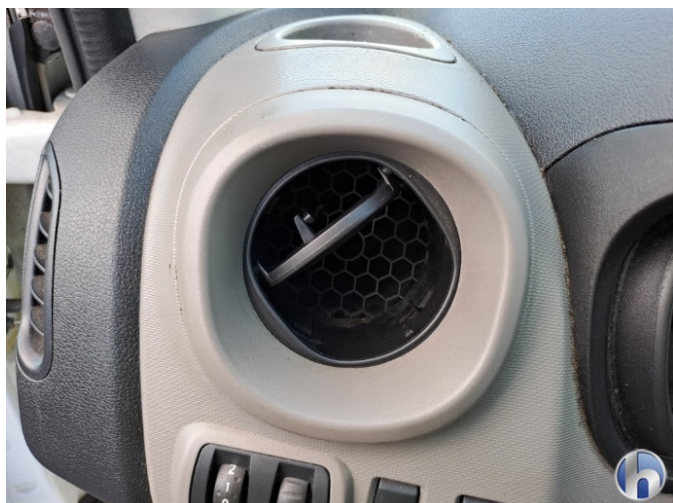
| component | Damage | Rep kind |
|---|---|---|
| 13. Luftausströmer VL | Damaged | Replace |

13. Luftausströmer VL

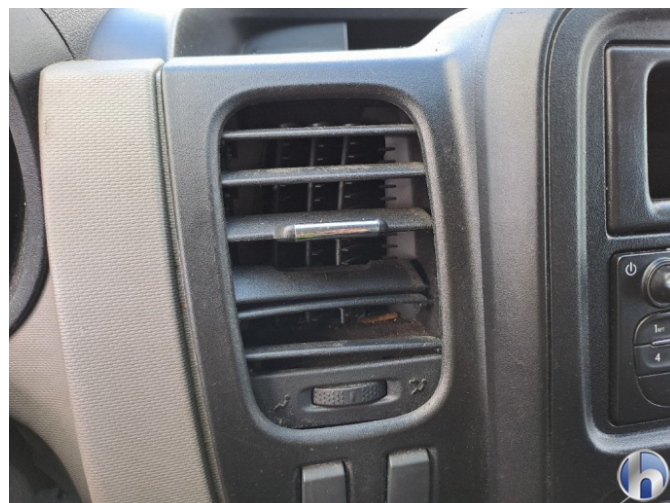
| component | Damage | Rep kind |
|---|---|---|
| 14. Luftausströmer VML | Damaged | Replace |

14. Luftausströmer VML

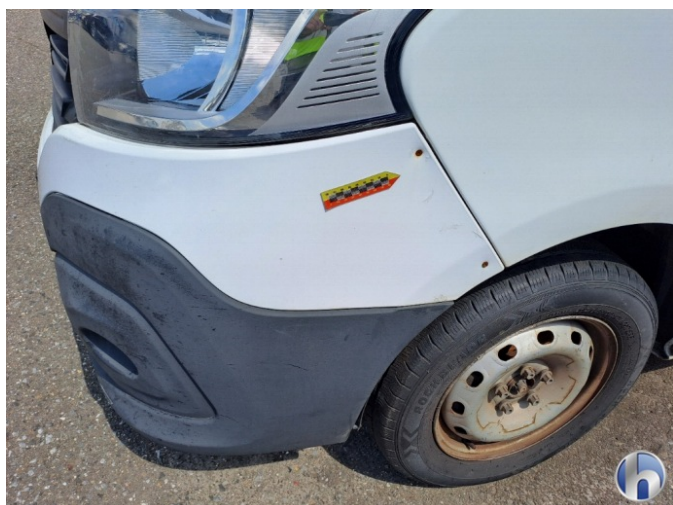
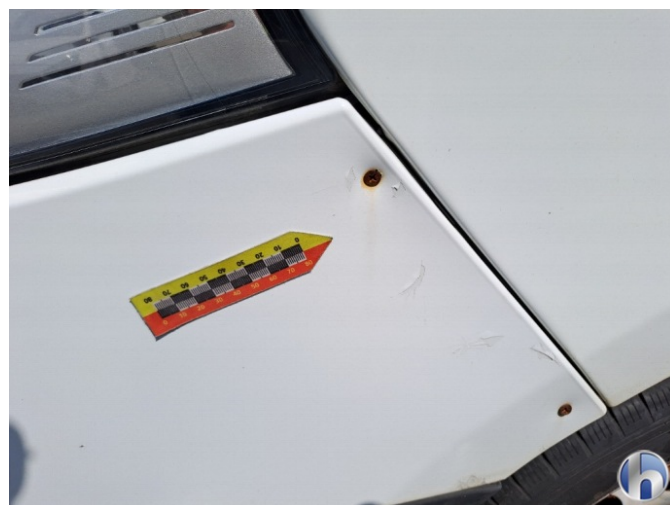
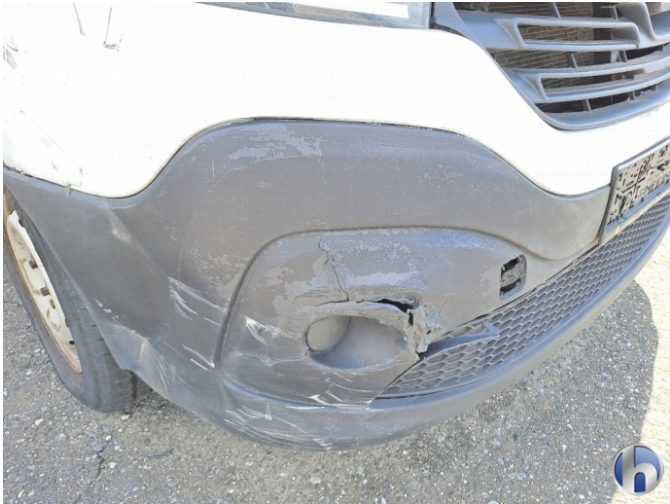
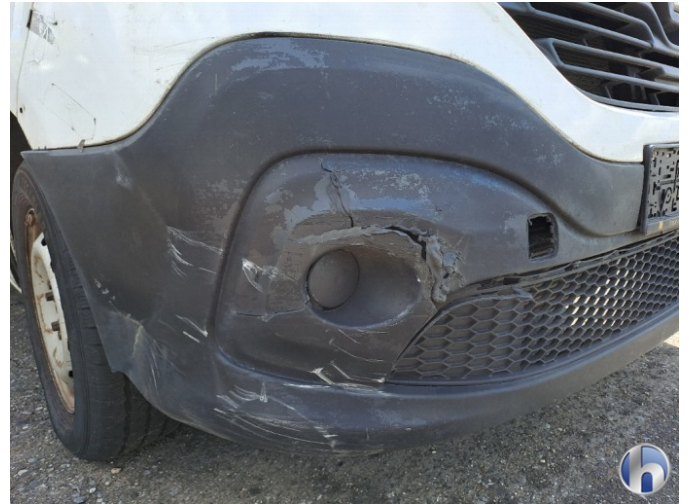
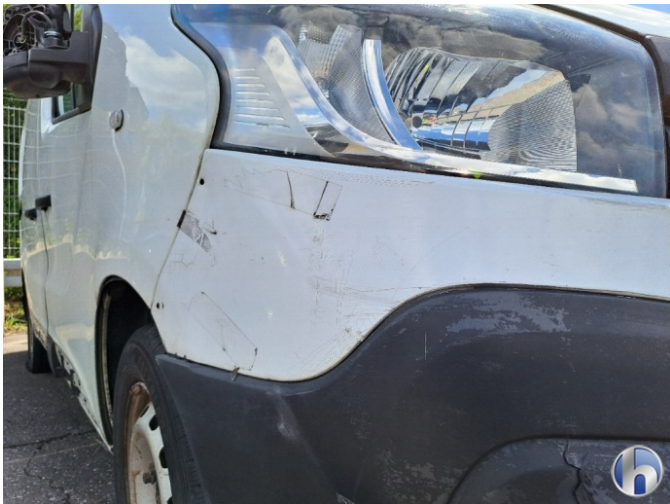
| component | Damage | Rep kind |
|---|---|---|
| 17. Front bumper | Damaged | Replace |

17. Front bumper

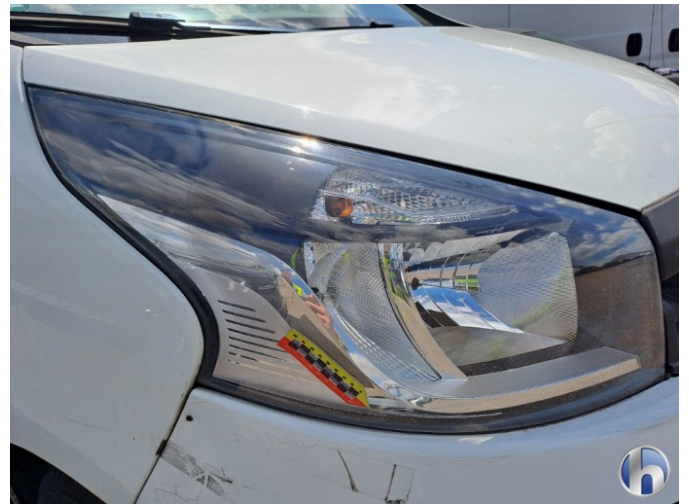
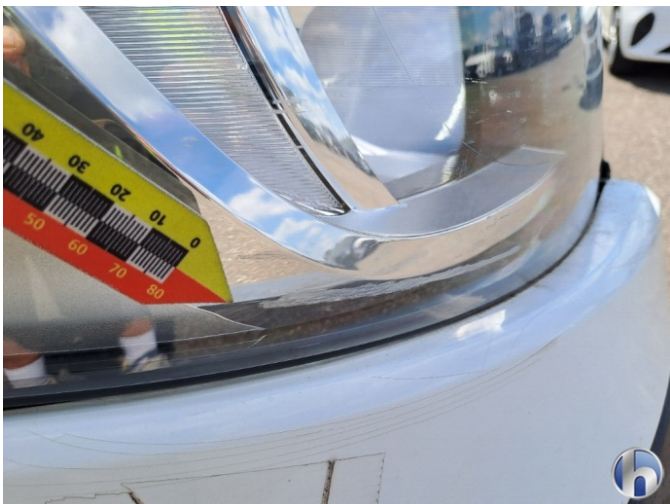
| component | Damage | Rep kind |
|---|---|---|
| 18. Halogen headlights - right | Scratch(es) | Replace |

18. Halogen headlights - right

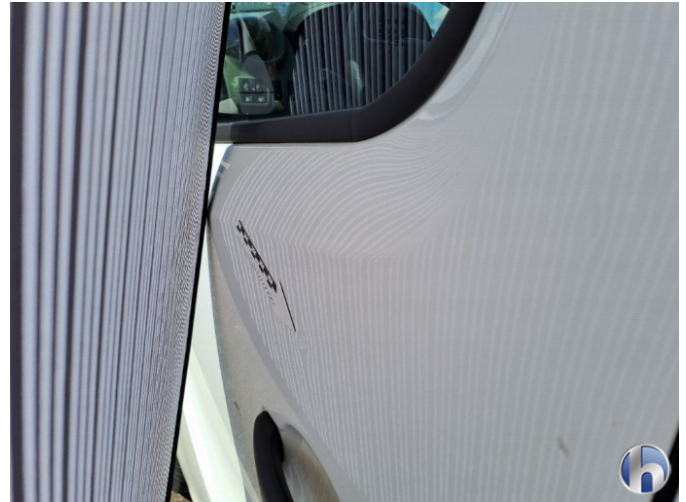
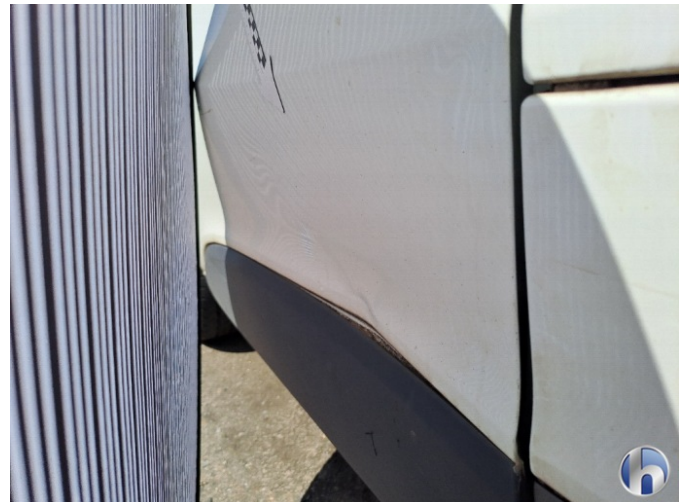
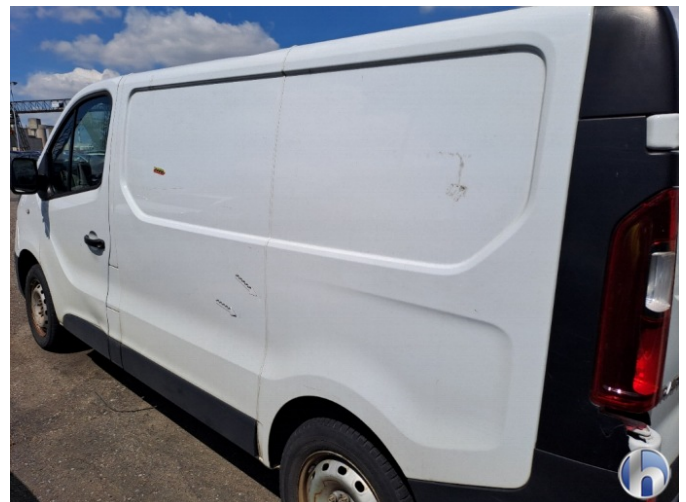
| component | Damage | Rep kind |
|---|---|---|
| 20. Front door - left | Damaged | Refurbish and paint |

20. Front door - left

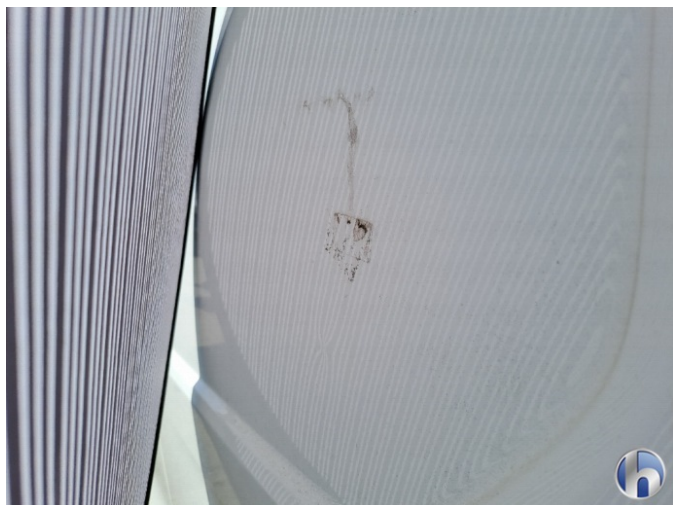
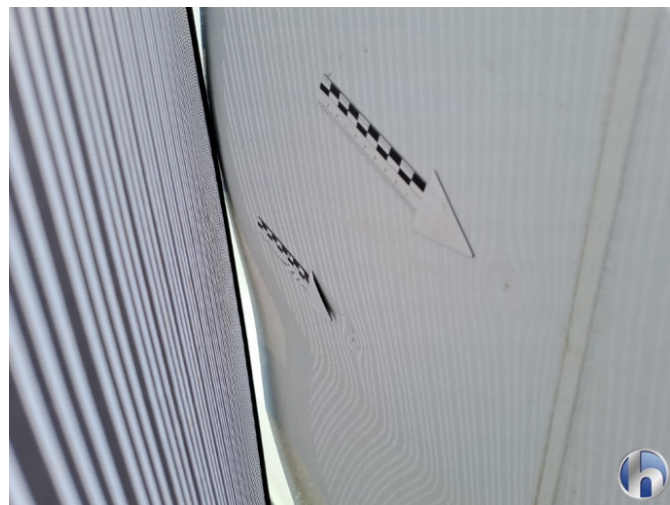
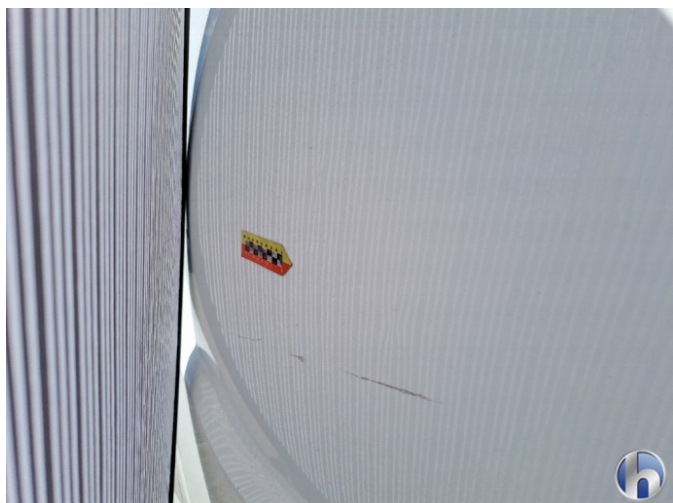
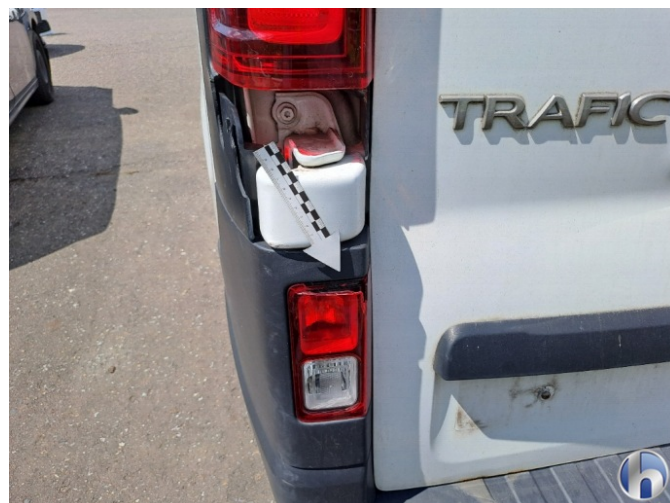
| component | Damage | Rep kind |
|---|---|---|
| 21. Sidewall - Rear - Left | Damaged | Refurbish and paint |

21. Sidewall - Rear - Left

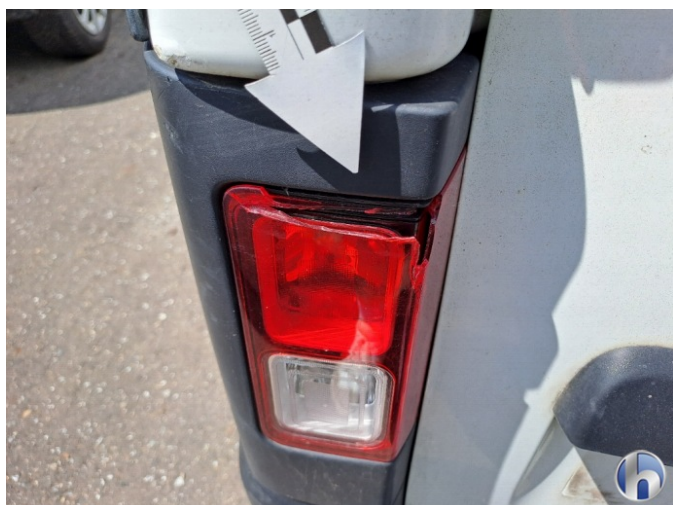
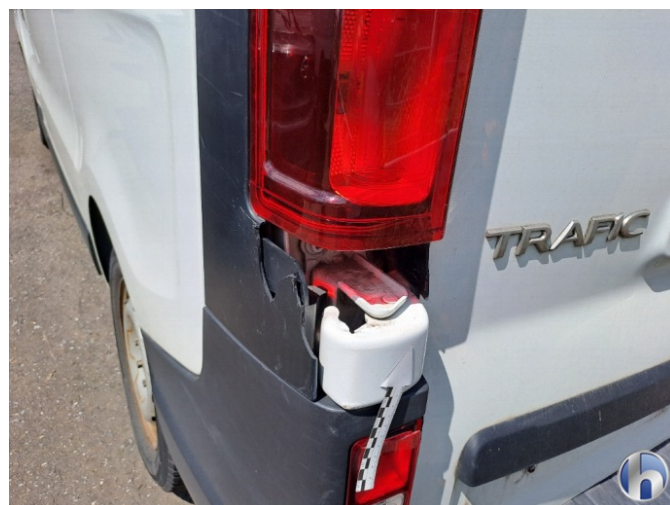
| component | Damage | Rep kind |
|---|---|---|
| 22. Taillight left | Breakage | Replace |

22. Taillight left

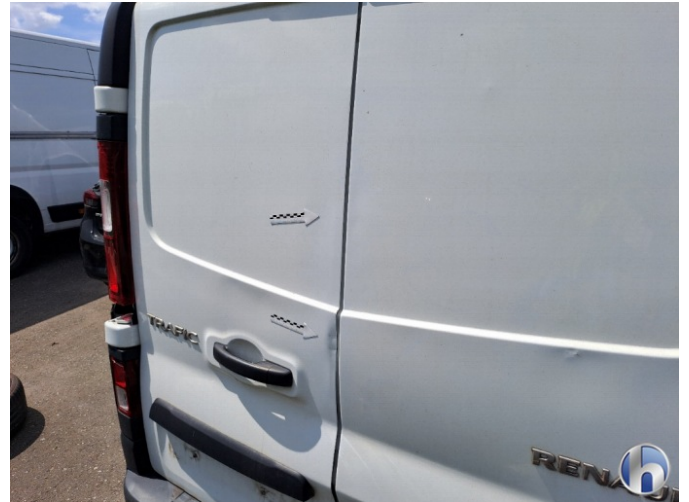
| component | Damage | Rep kind |
|---|---|---|
| 23. Verkleidung Rücklicht links | Damaged | Replace |

23. Verkleidung Rücklicht links

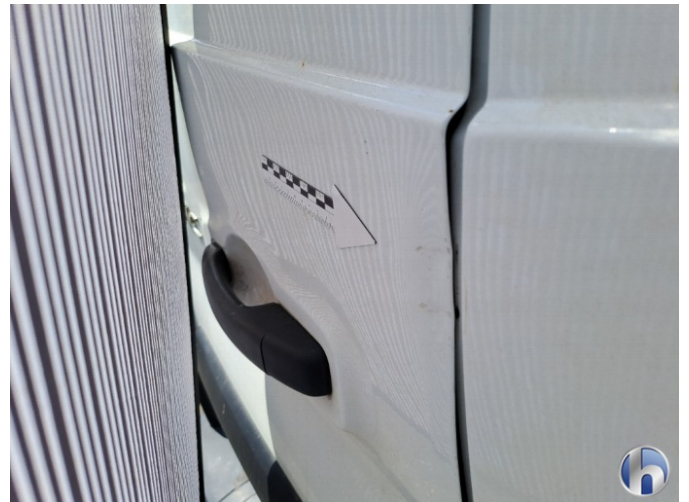
| component | Damage | Rep kind |
|---|---|---|
| 24. Tailgate left | Damaged | Refurbish and paint |

24. Tailgate left

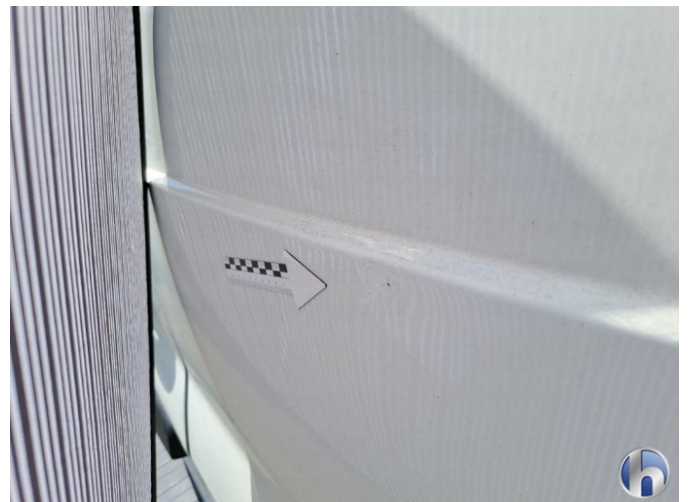
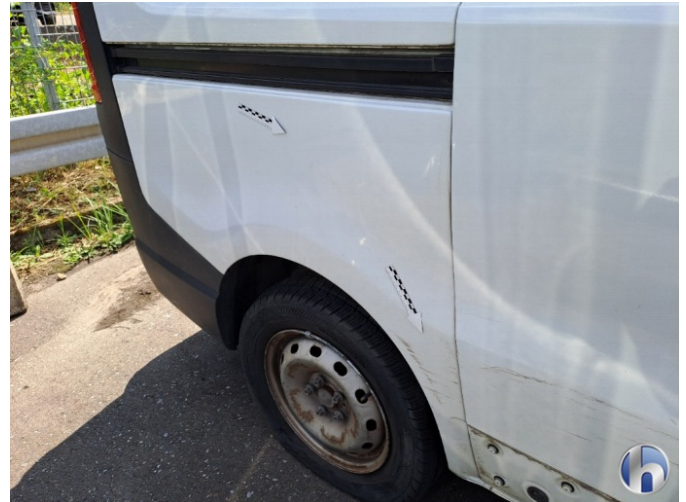
| component | Damage | Rep kind |
|---|---|---|
| 25. Tailgate right | Damaged | Refurbish and paint |

25. Tailgate right

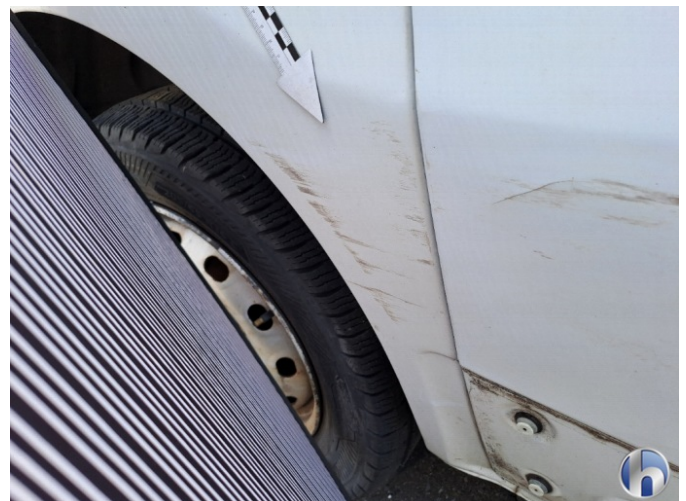
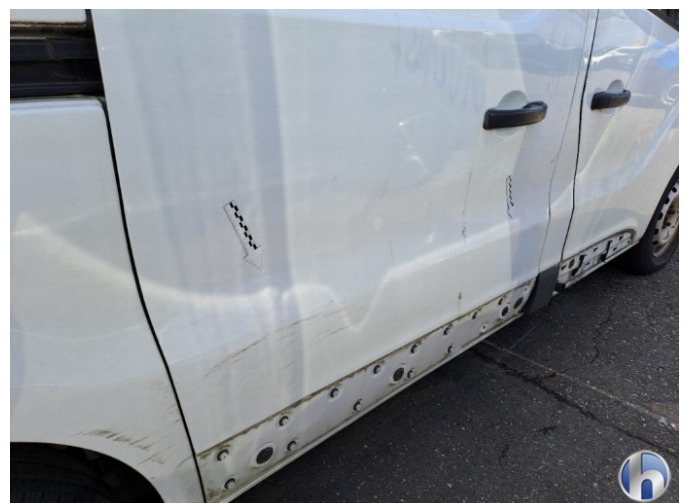
| component | Damage | Rep kind |
|---|---|---|
| 26. Sidewall - Rear - right | Damaged | Refurbish and paint |

26. Sidewall - Rear - right

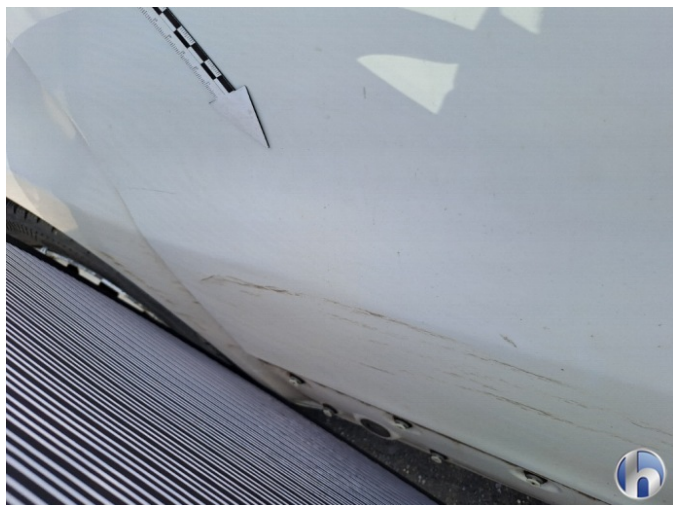
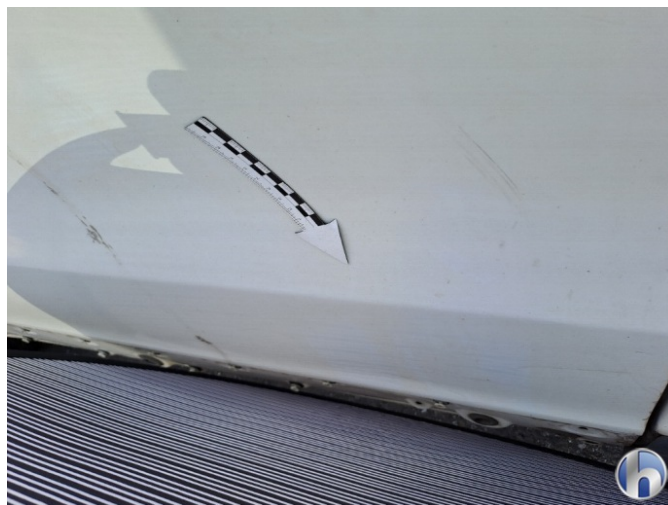
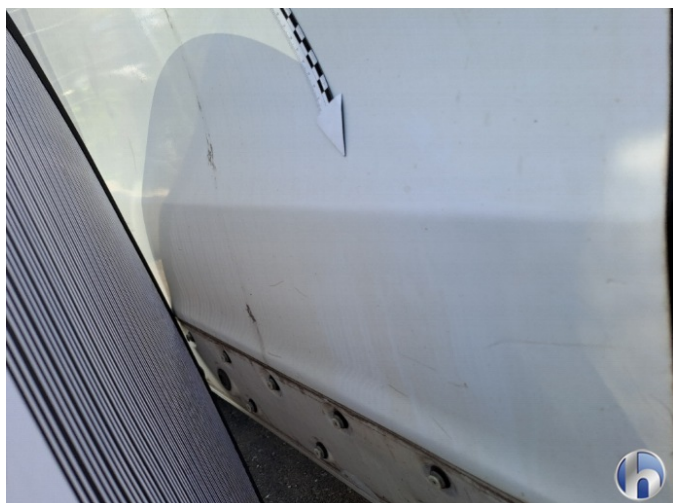
| component | Damage | Rep kind |
|---|---|---|
| 27. Sliding door - right | Damaged | Refurbish and paint |

27. Sliding door - right

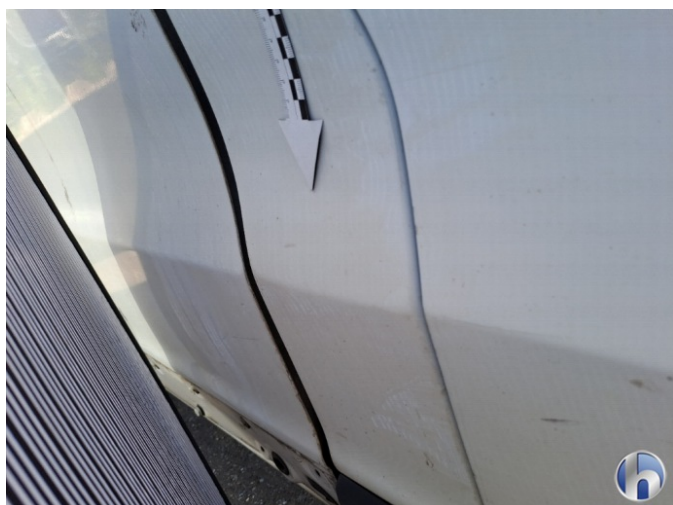
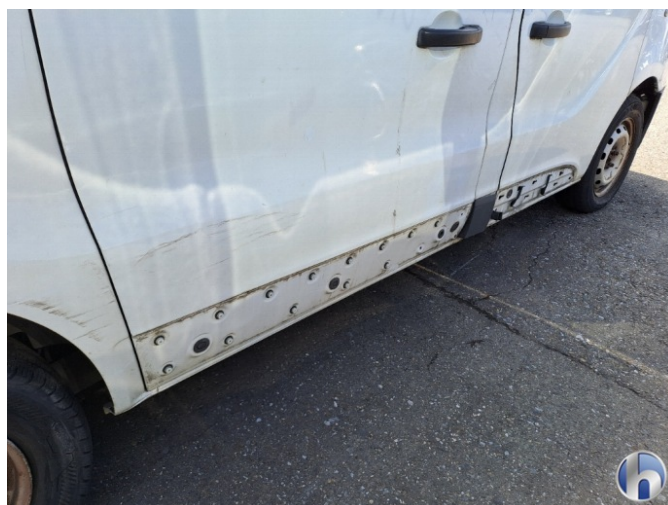
| component | Damage | Rep kind |
|---|---|---|
| 28. B-pillar center - right | Execution defect | Refurbish and paint |

28. B-pillar center - right

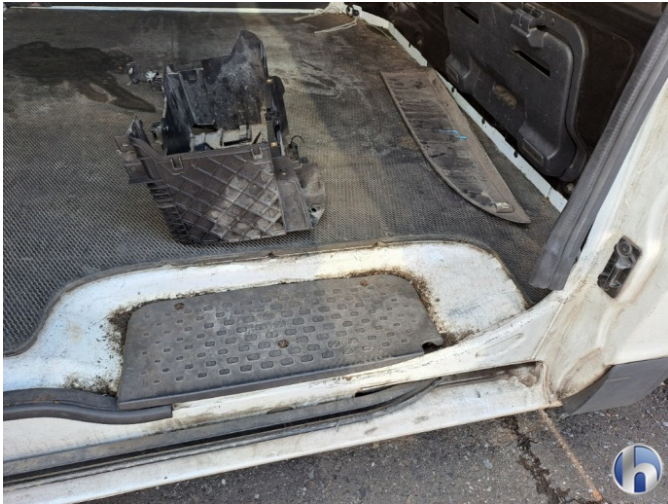
| component | Damage | Rep kind |
|---|---|---|
| 29. Zierleisten rechte Fahrzeugseite | Missing | Replace |

29. Zierleisten rechte Fahrzeugseite

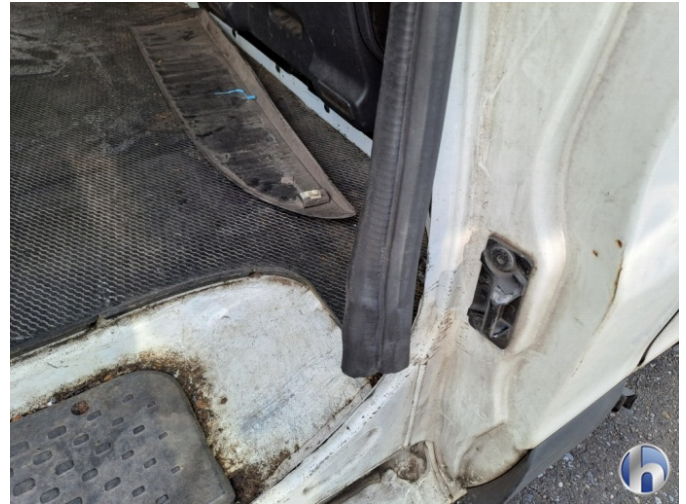
| component | Damage | Rep kind |
|---|---|---|
| 30. Door seal Rear - right | Damaged | Replace |

30. Door seal Rear - right

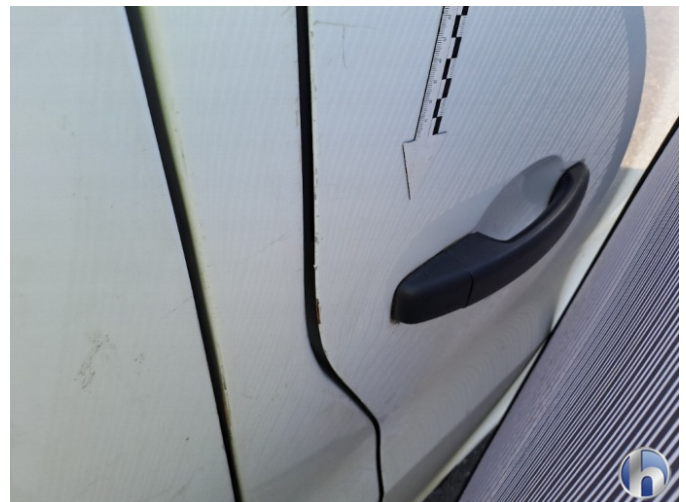
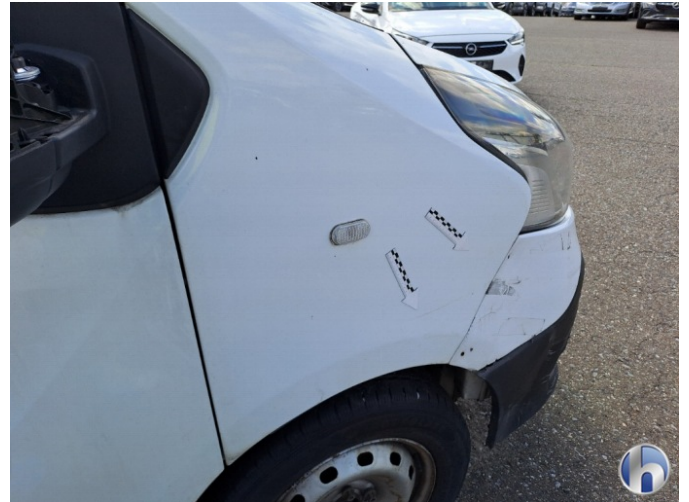
| component | Damage | Rep kind |
|---|---|---|
| 32. Front door - right | Deformed | Refurbish and paint |

32. Front door - right

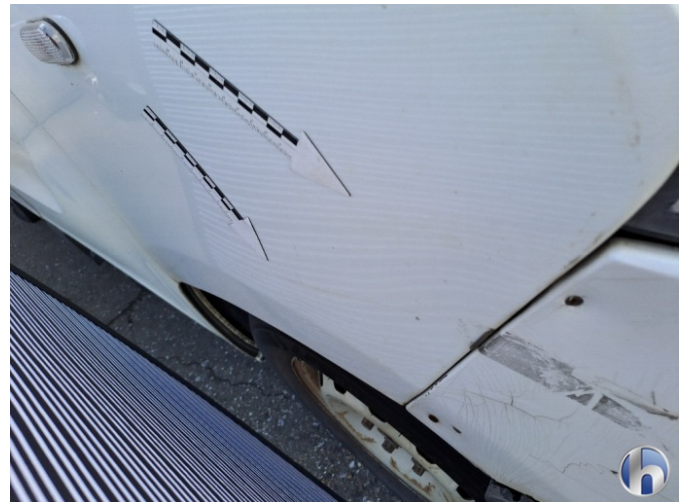
| component | Damage | Rep kind |
|---|---|---|
| 33. Front fender - right | Damaged | Refurbish and paint |

33. Front fender - right

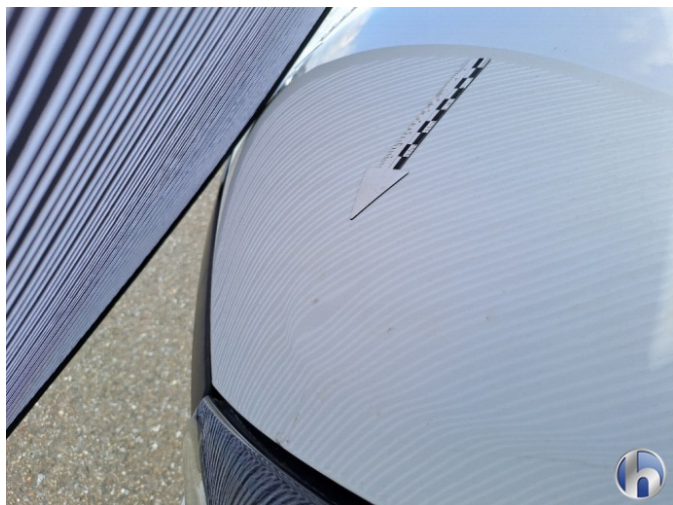
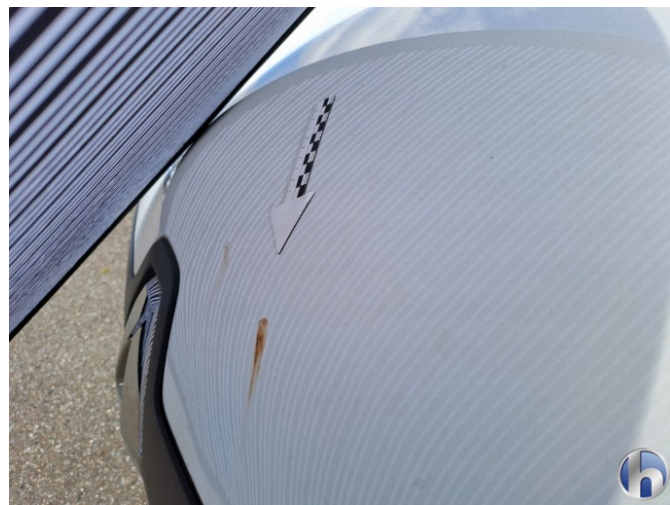
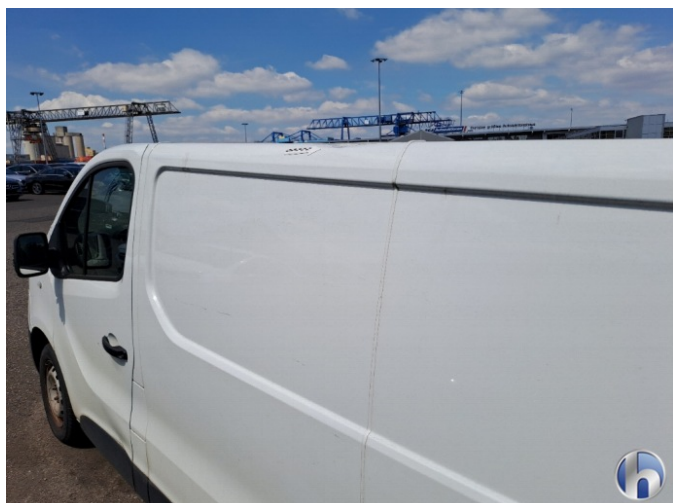
| component | Damage | Rep kind |
|---|---|---|
| 35. hood | Deformed | Refurbish and paint |

35. hood

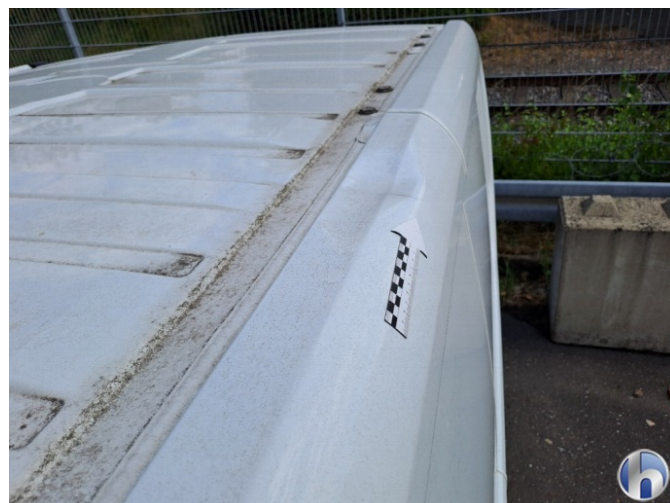
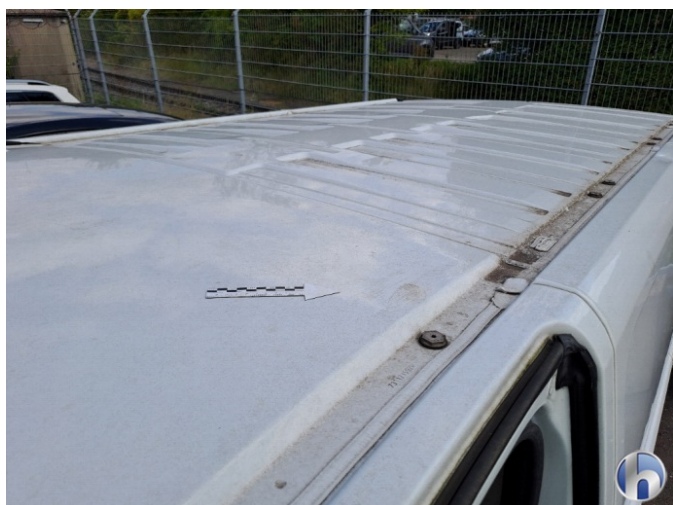
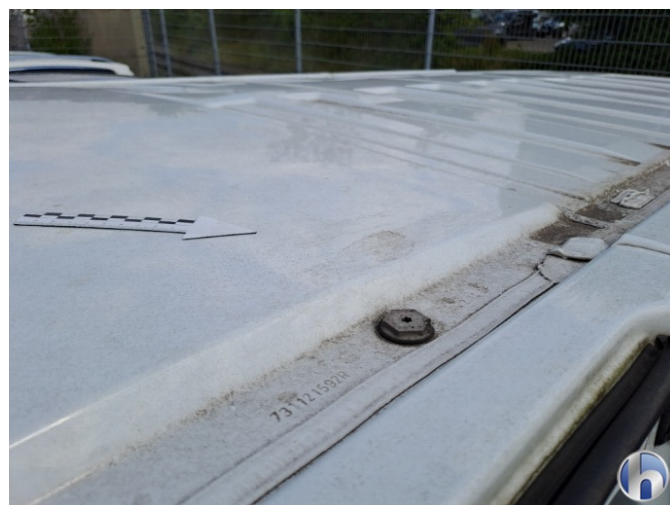
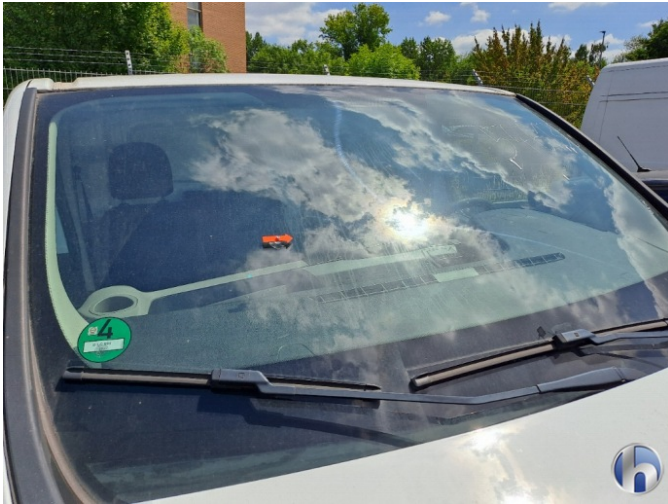
| component | Damage | Rep kind |
|---|---|---|
| 36. roof | Damaged | Refurbish and paint |

36. roof

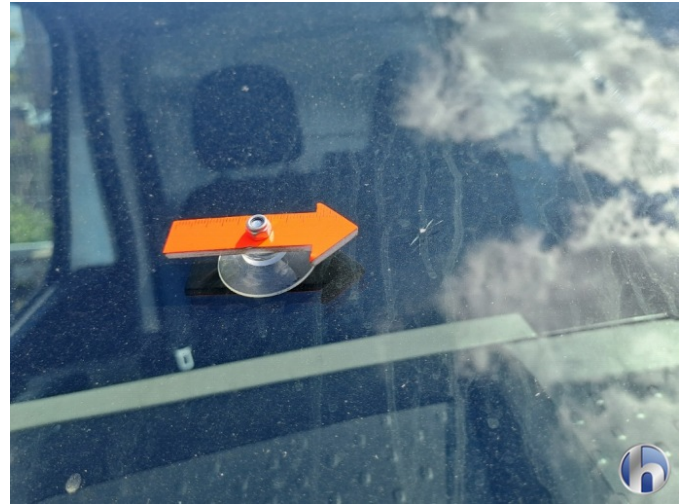
| component | Damage | Rep kind |
|---|---|---|
| 37. Windshield | Damaged | Replace |

37. Windshield
