## status report

#### Renault Trafic Kasten L1H1 2,8t Komfort

| Vehicle identification number | <b>VF1FL000969403673</b> | mileage read: | <b>26357 km</b> |

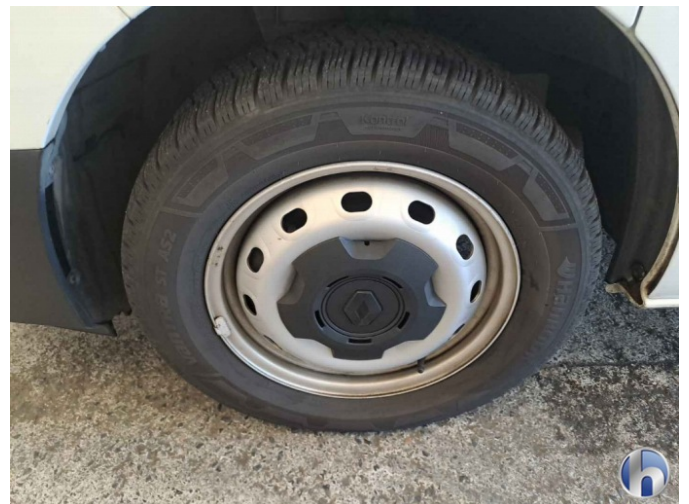
| component | Damage | Rep kind |
|---|---|---|
| 1. tire front - left | Damaged | Replace |

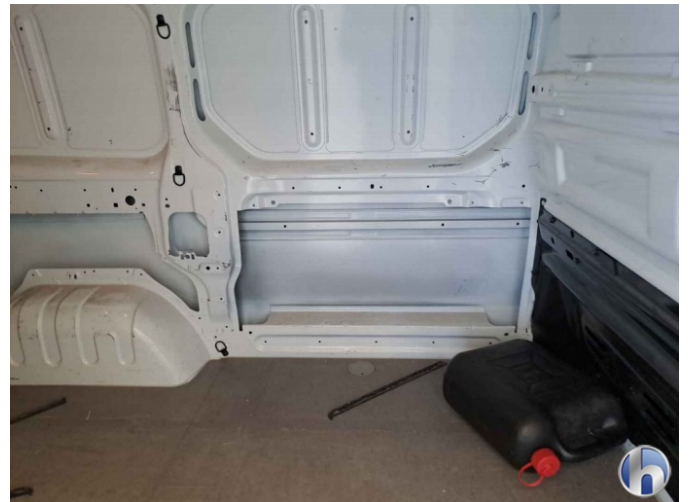
| component | Damage | Rep kind |
|---|---|---|
| 7. Hecktür Links Verkleidung | Damaged | Replace |

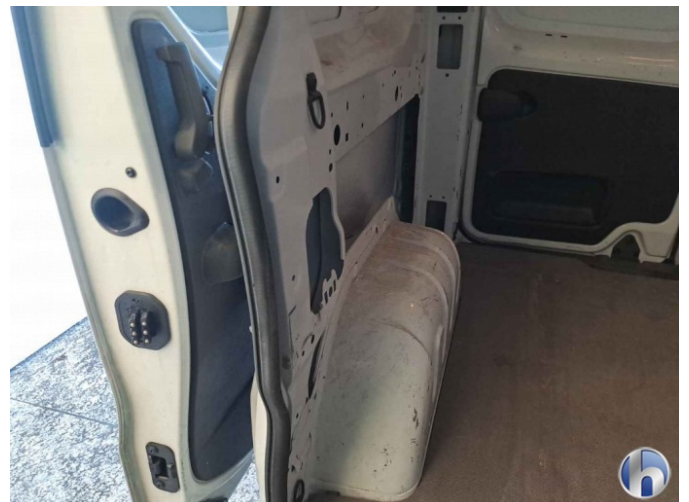
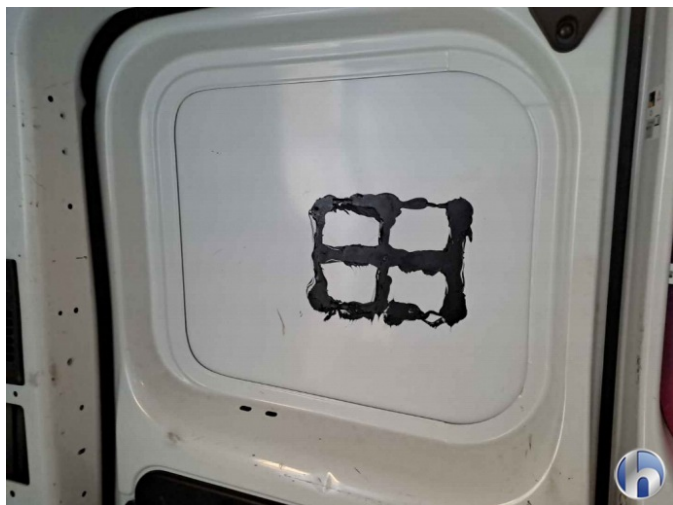
| component | Damage | Rep kind |
|---|---|---|
| 8. Laderaum Verkleidungen | Missing | Replace |

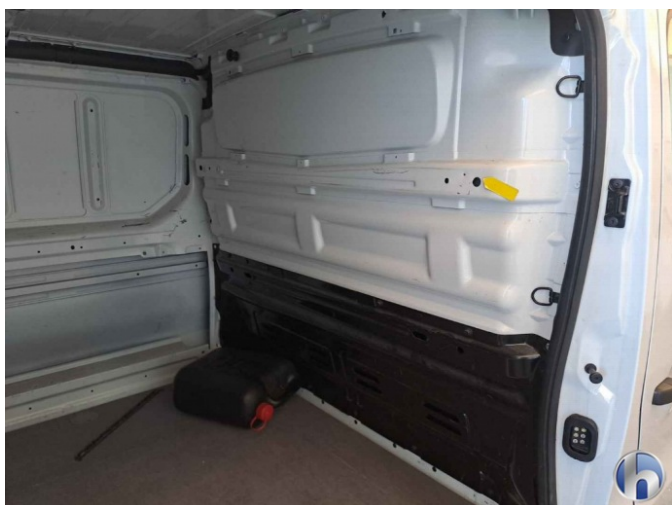
| component | Damage | Rep kind |
|---|---|---|
| 10. flooring | Damaged | Replace |

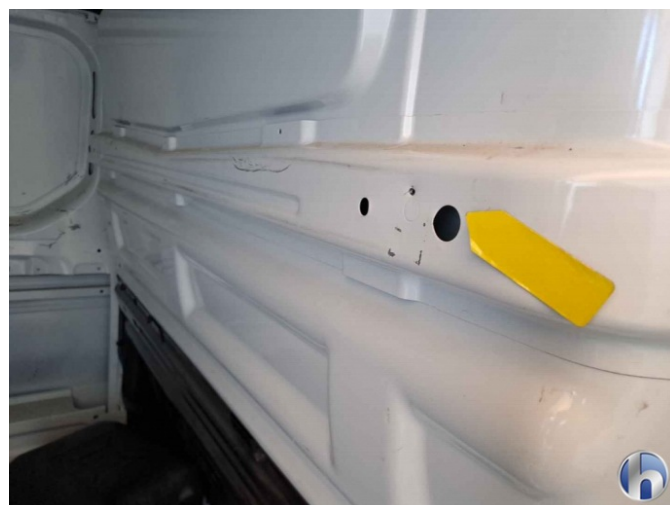
| component | Damage | Rep kind |
|---|---|---|
| 11. Partition load space | Damaged | Replace |

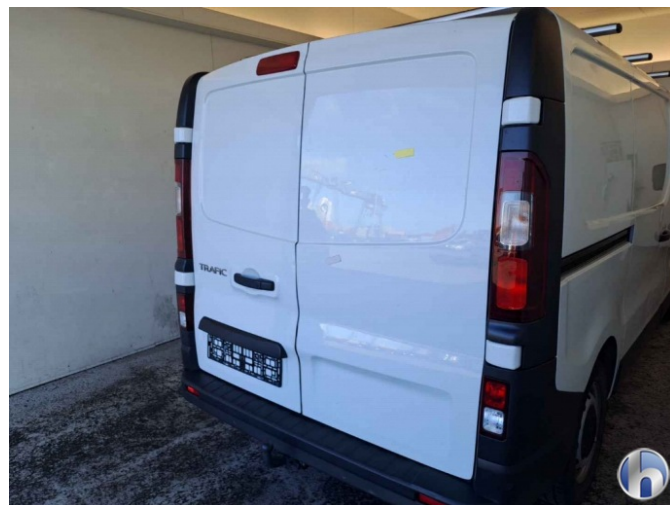
| component | Damage | Rep kind |
|---|---|---|
| 12. Hecktüren schloss | Defective | Replace |

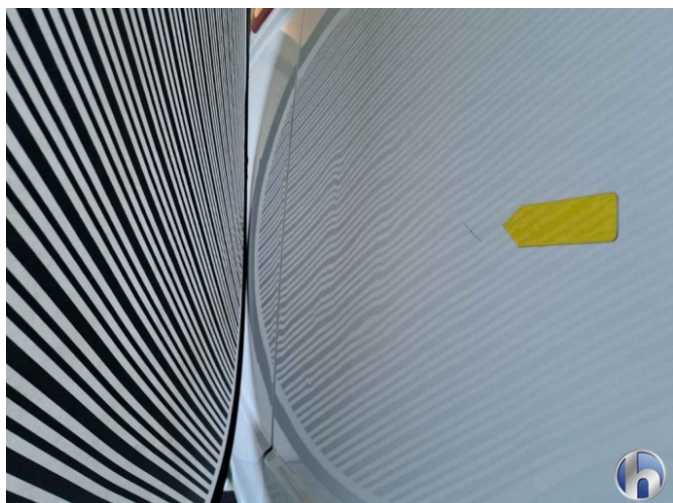
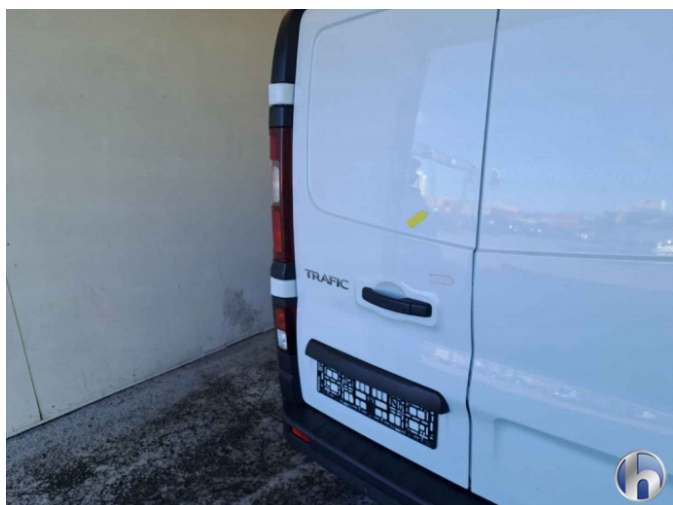
| component | Damage | Rep kind |
|---|---|---|
| 13. Tailgate right | Damaged | Refurbish and paint |

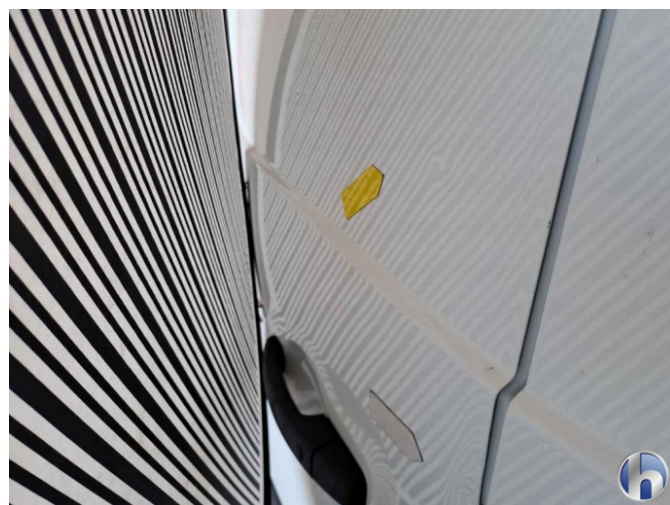
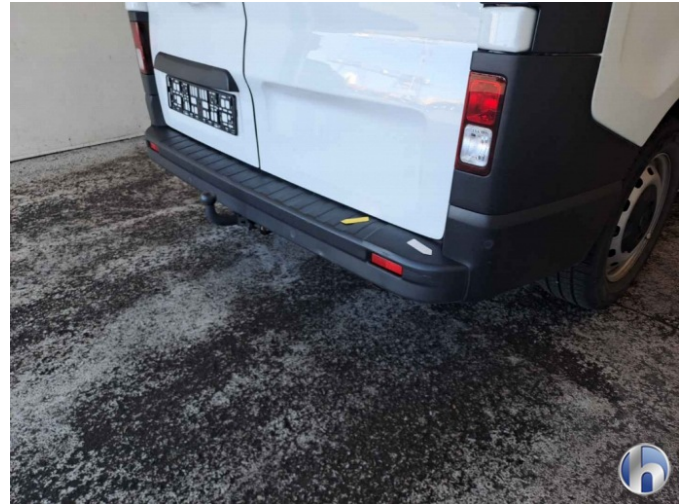
| component | Damage | Rep kind |
|---|---|---|
| 14. Tailgate left | Damaged | Refurbish and paint |

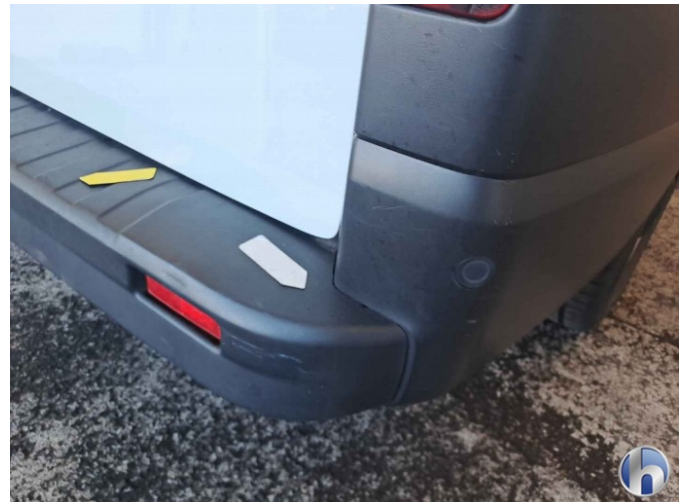
| component | Damage | Rep kind |
|---|---|---|
| 15. Rear bumper | Damaged | Replace |

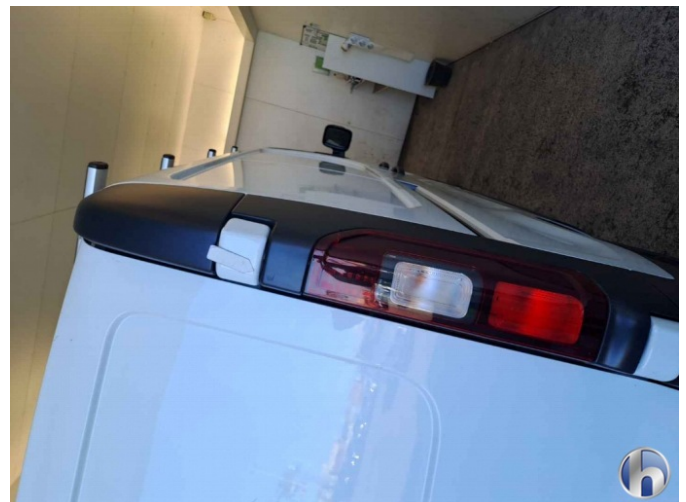
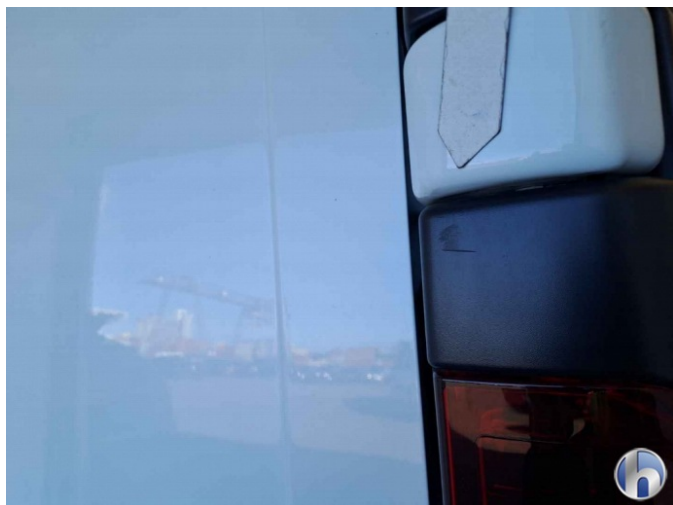
| component | Damage | Rep kind |
|---|---|---|
| 16. | Scratch(es) | Replace |

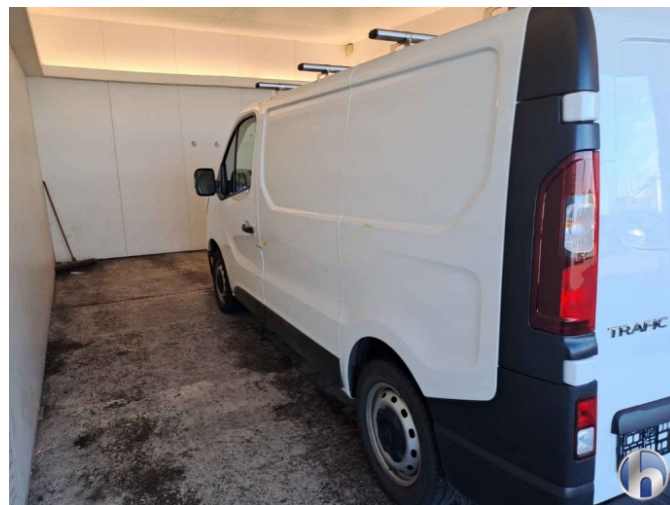
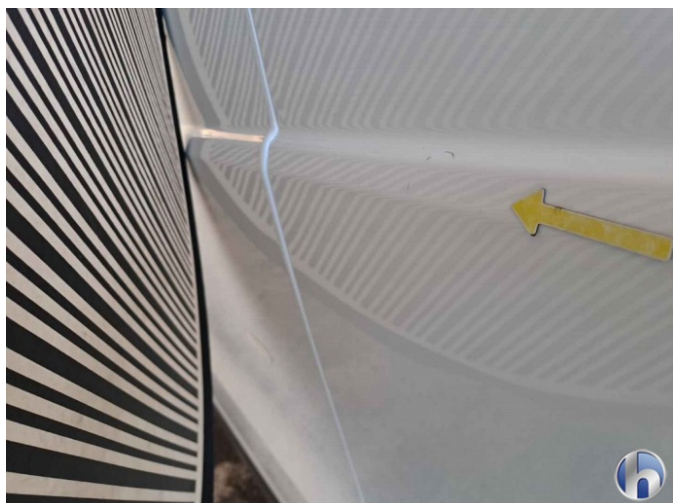
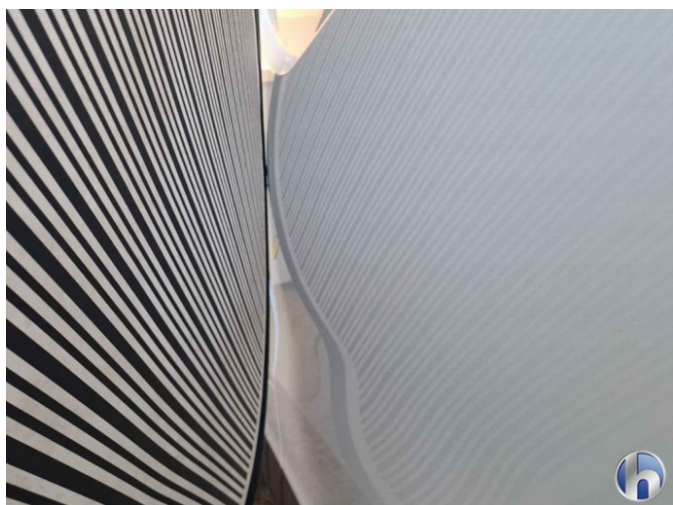
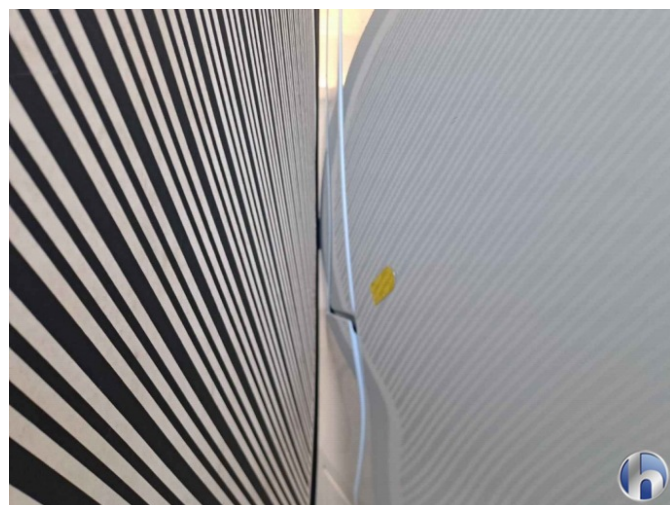
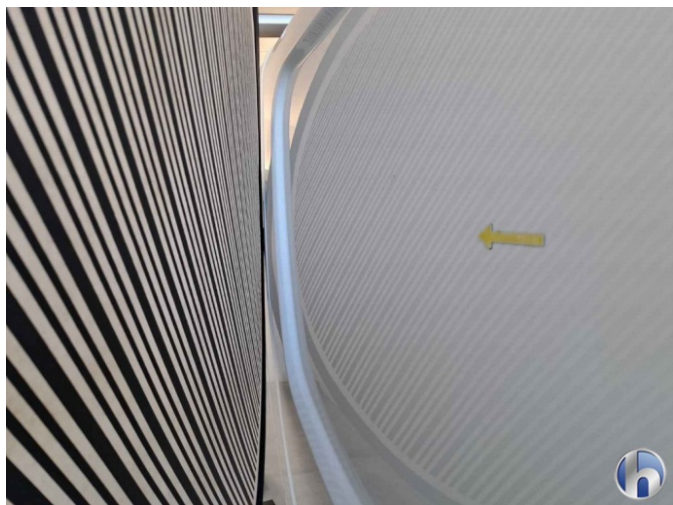
| component | Damage | Rep kind |
|---|---|---|
| 17. Seitenwand - Links | Damaged | Refurbish and paint |

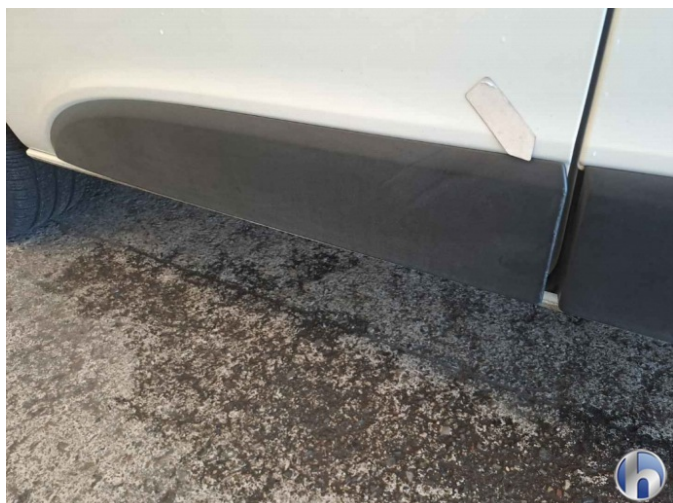
| component | Damage | Rep kind |
|---|---|---|
| 18. B-säule Mitte - Links Beplankung | Scrape | Replace |

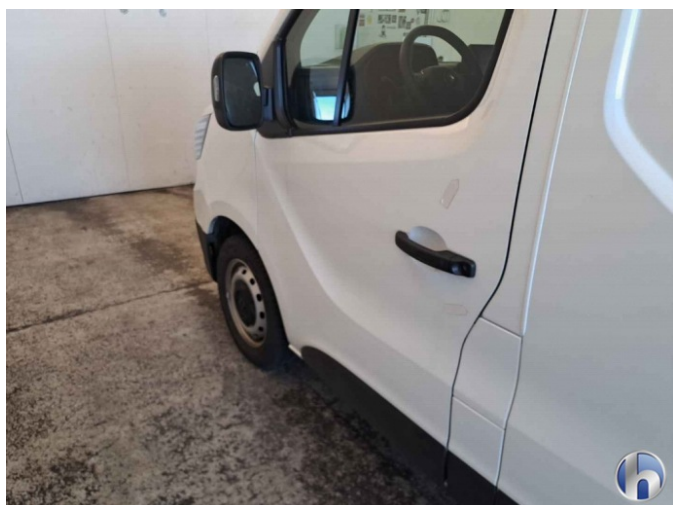
| component | Damage | Rep kind |
|---|---|---|
| 19. Tür Vorne - Links Beplankung | Scrape | Replace |

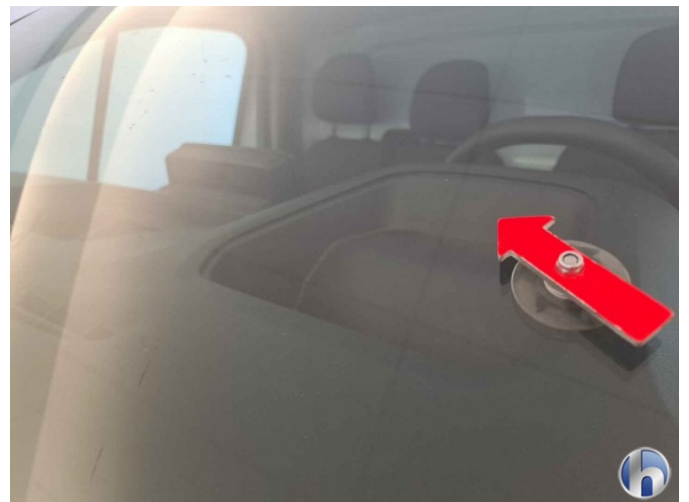
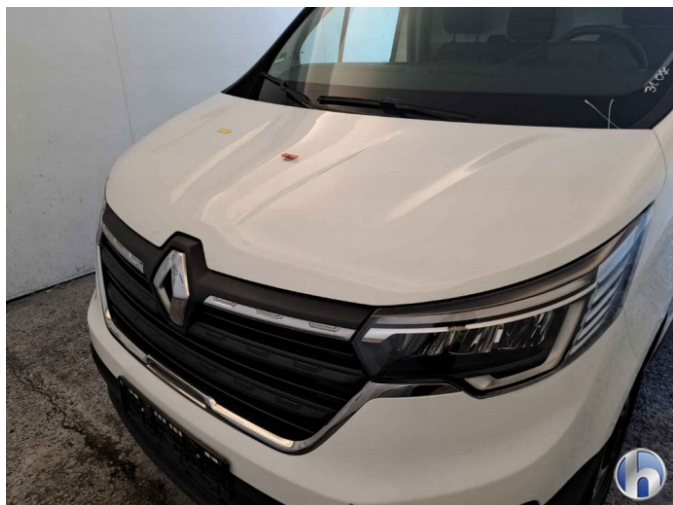
| component | Damage | Rep kind |
|---|---|---|
| 23. Windshield | Chipping from stones in field of view | Replace |

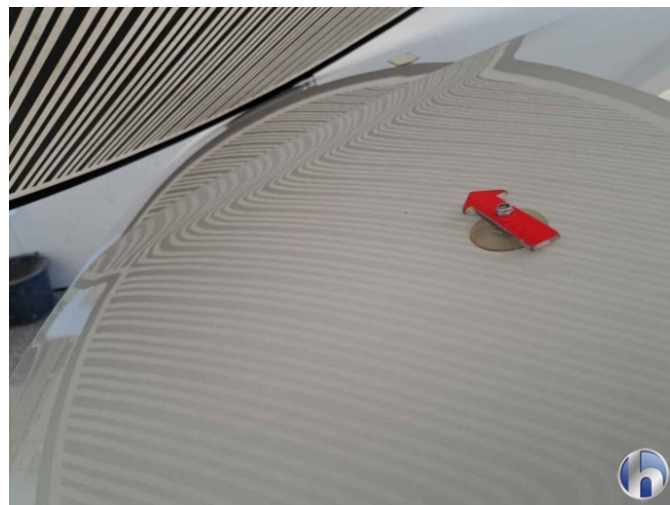
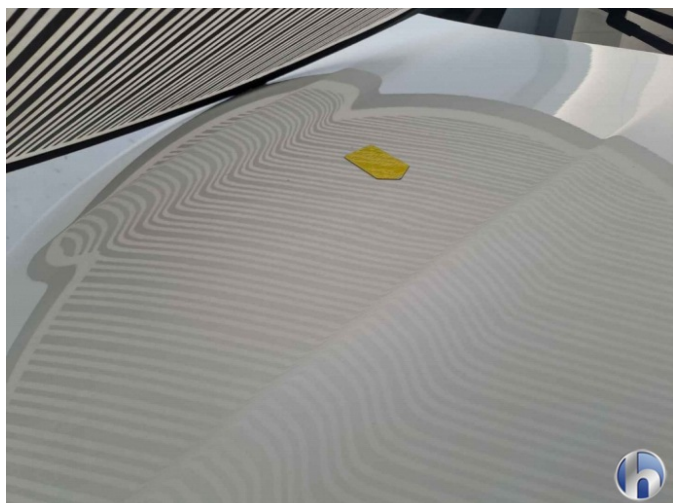
| component | Damage | Rep kind |
|---|---|---|
| 24. hood | Deformed | Refurbish and paint |

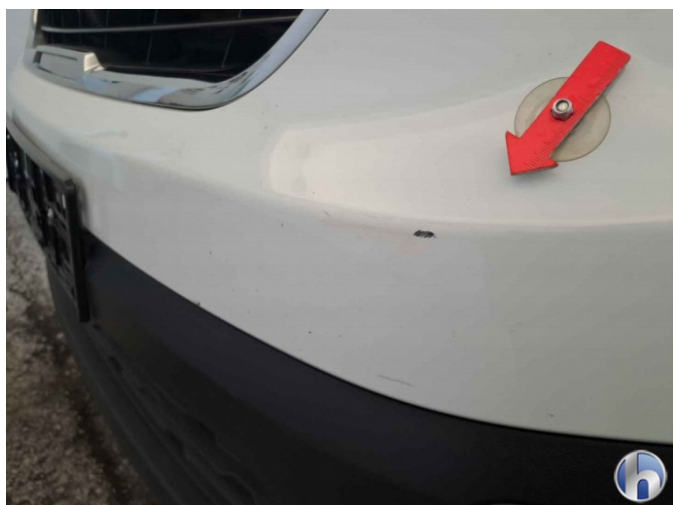
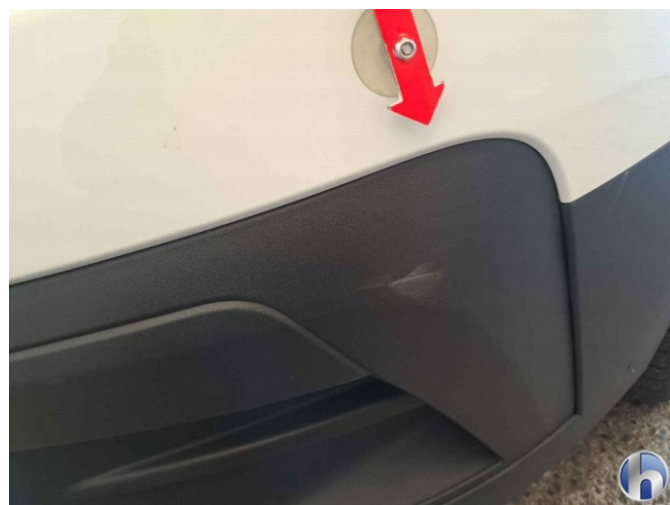
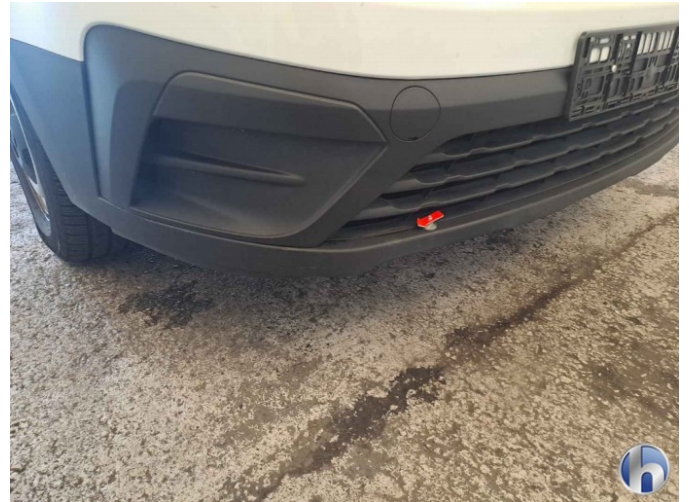
| component | Damage | Rep kind |
|---|---|---|
| 25. Front bumper | Scrape | Replace |

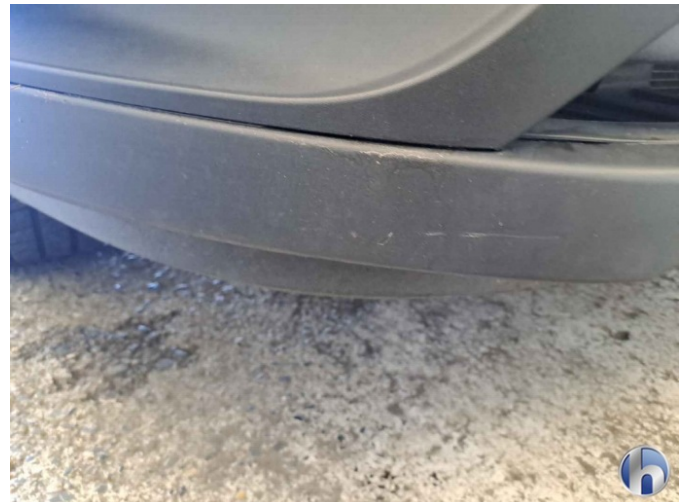
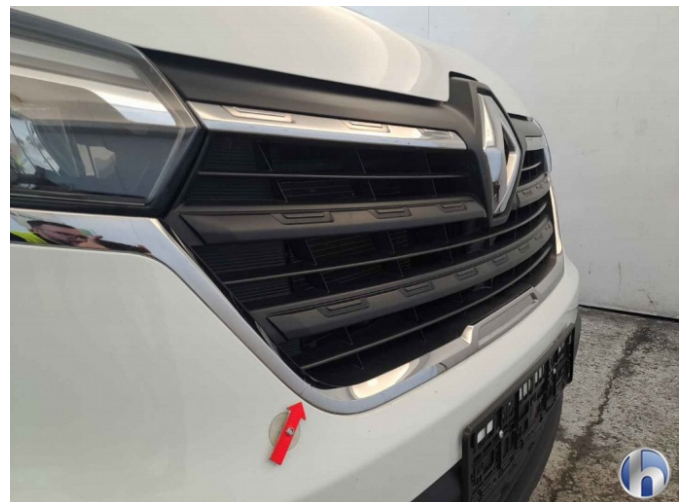
| component | Damage | Rep kind |
|---|---|---|
| 26. spoiler | Scrape | Replace |

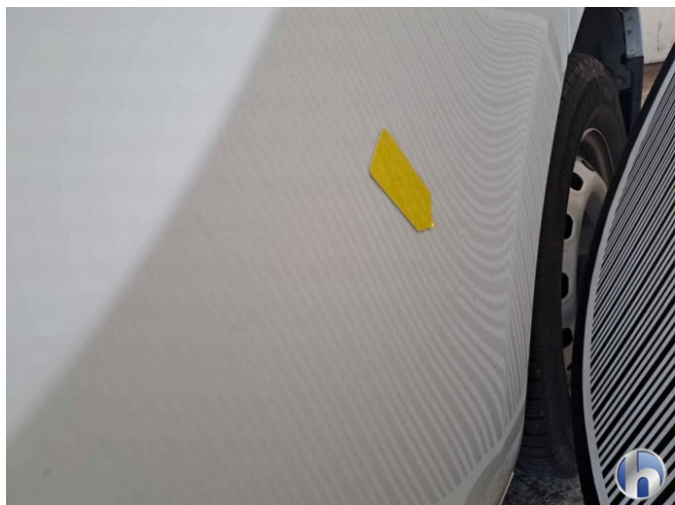
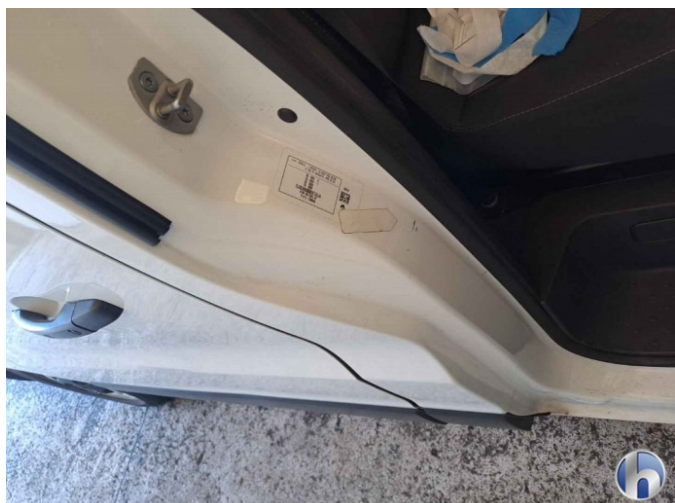
| component | Damage | Rep kind |
|---|---|---|
| 31. Front door - right | Damaged | Refurbish and paint |

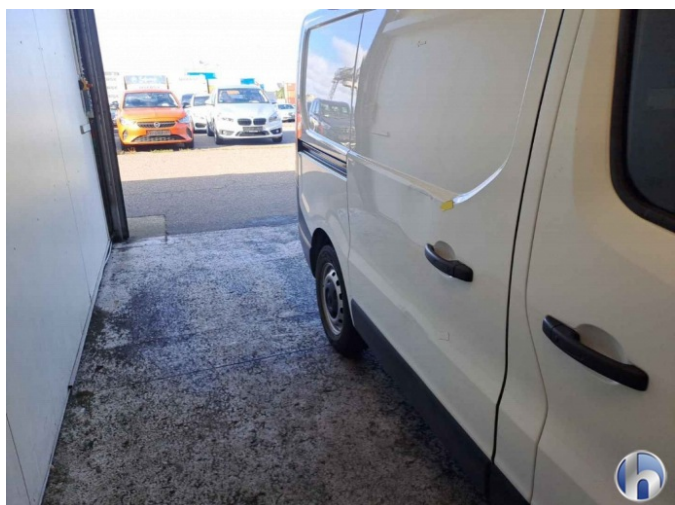
| component | Damage | Rep kind |
|---|---|---|
| 32. Türeinstieg Vorne - Rechts | Damaged | Refurbish and paint |

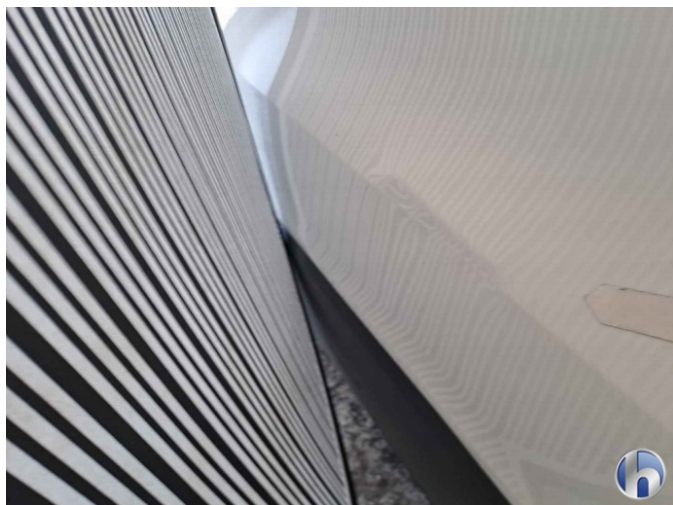
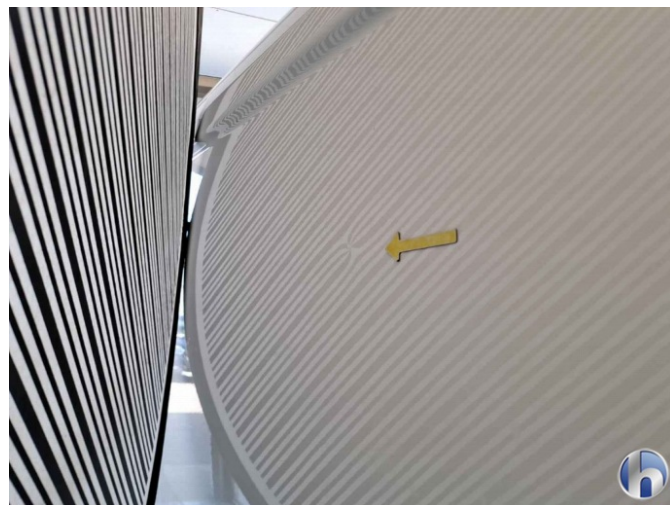
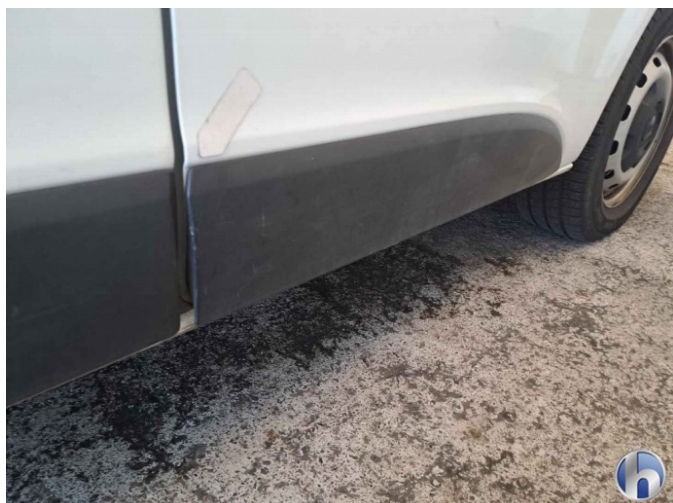
| component | Damage | Rep kind |
|---|---|---|
| 33. Sliding door - right | Damaged | Replace |

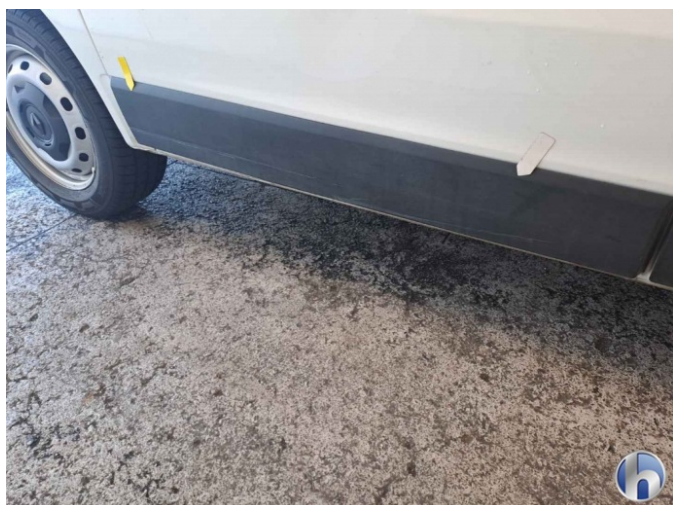
| component | Damage | Rep kind |
|---|---|---|
| 34. Tür Vorne - Rechts Beplankung | Scrape | Replace |

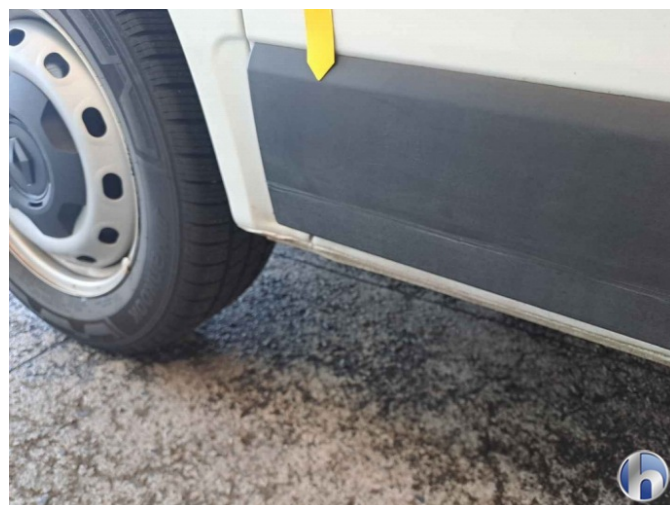
| component | Damage | Rep kind |
|---|---|---|
| 35. Schiebetür - Rechts Beplankung | Scrape | Replace |

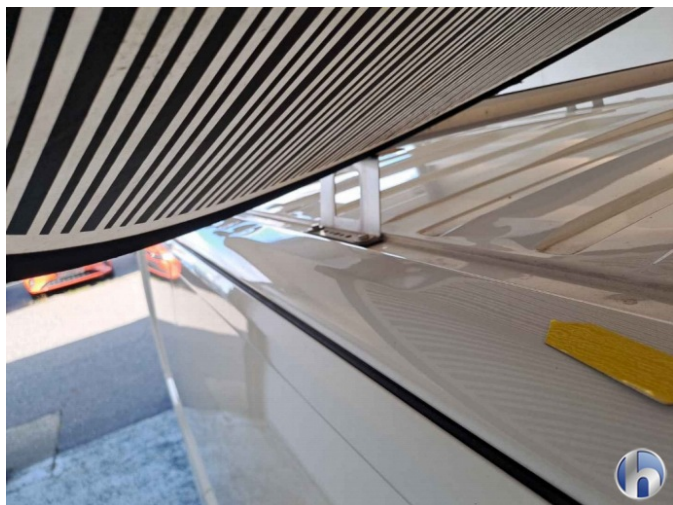
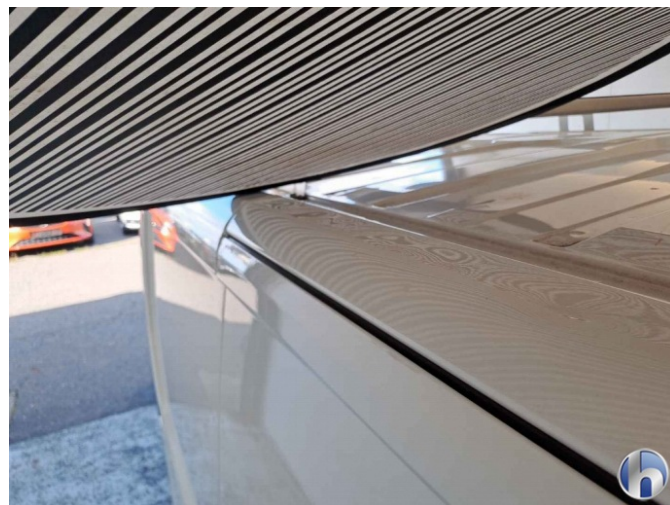
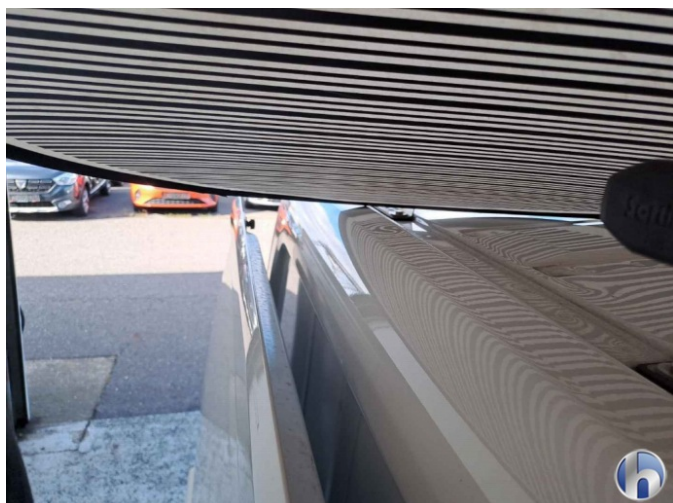
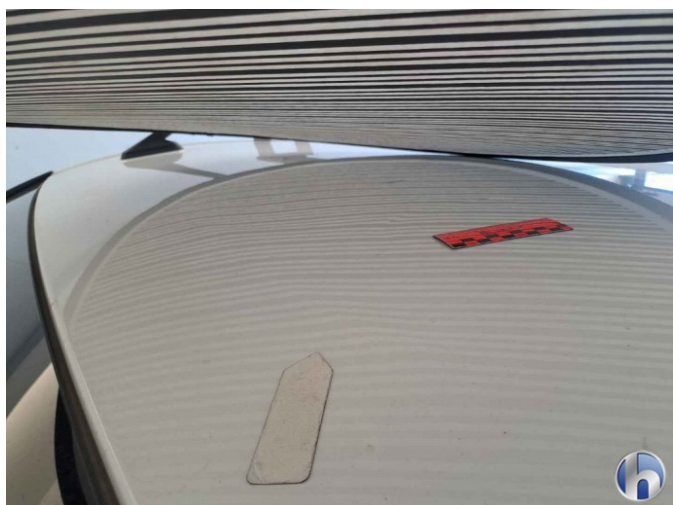
| component | Damage | Rep kind |
|---|---|---|
| 38. Roof frame - right | Damaged | Refurbish and paint |

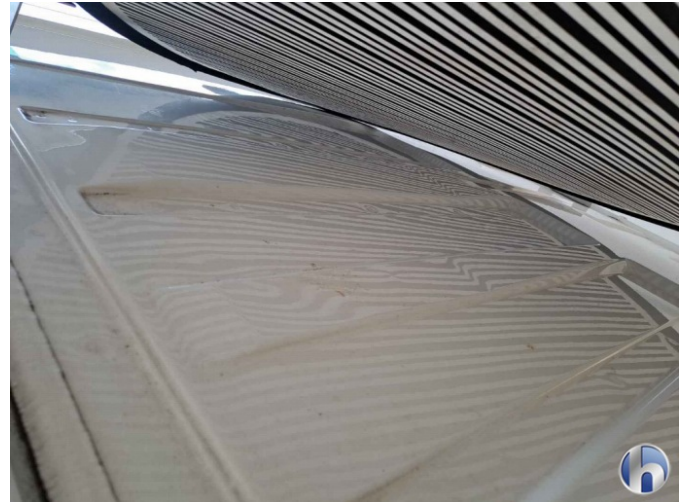
39. roof

| 39. | roof | Damaged | Refurbish and paint |

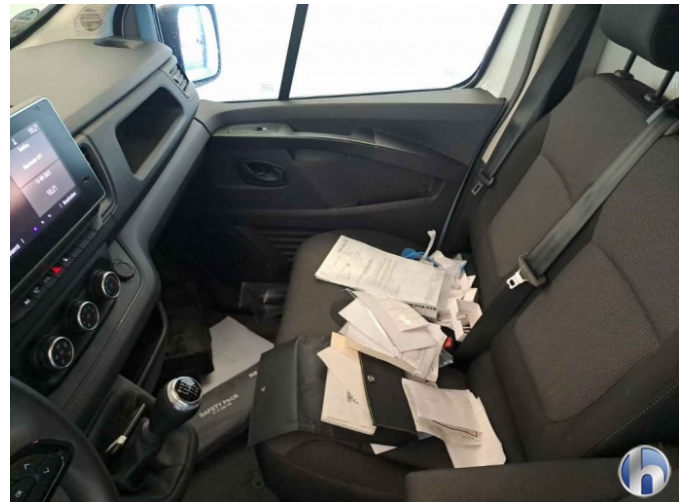
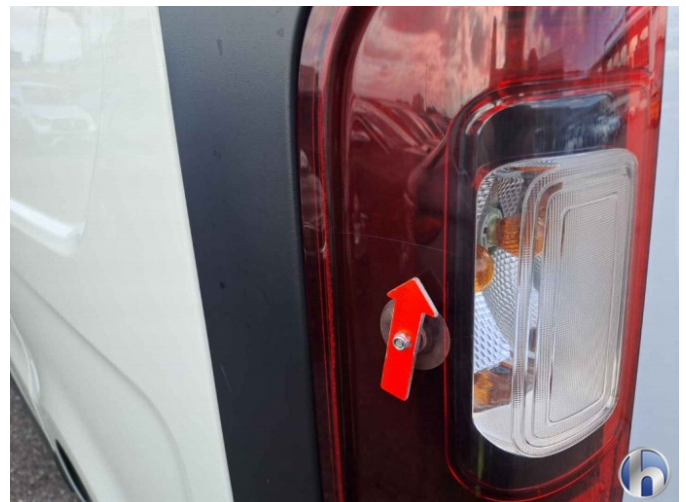
| 40. | | Dirty (strong) | |
