RENAULT Kangoo Kangoo Rapid (ENERGY) dCi 90

VIN NO VF1FW51J161780863 Registration Number J161780863

Inspection Report Summary

Customer	BCA Online	Report Number	P20250924115243
Inspection Date / Place	2025-09-24 / BCA Berlin	Cosmetic Grade	5

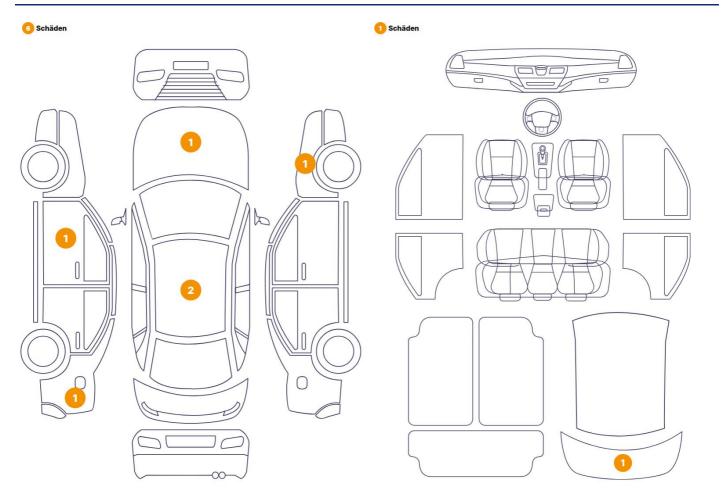
Cosmetic Damage

Component	Damage	Comments
1	Antenna Rod	Out of Bodywork / Breakage	
2	Hood	Bodywork / Dent / Dent	
3	Fender / Front Right	Paint / Scratch / Scuff	
4	Side Panel / Back Left	Bodywork / Dent / Dent	
5	Door / Front Left	Bodywork / Dent / Dent	
6	Tailgate Upholstery / Back	Interior / Broken	
7	Roof	Paint / Corrosion

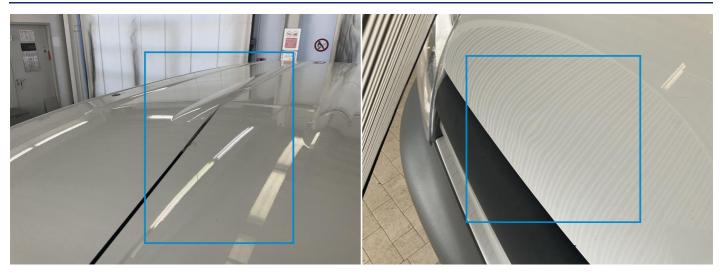
1. Antenna Rod Out of Bodywork / Breakage -

2. Hood Bodywork / Dent / Dent -

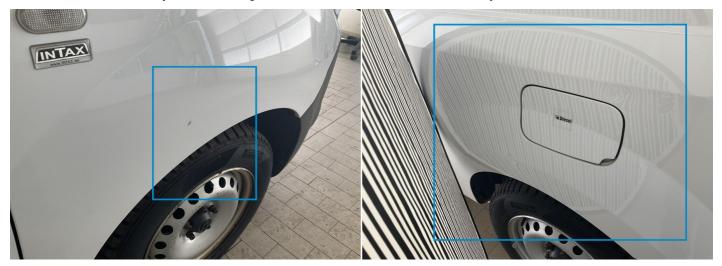
3. Fender / Front Right Paint / Scratch / Scuff -

4. Side Panel / Back Left Bodywork / Dent / Dent -

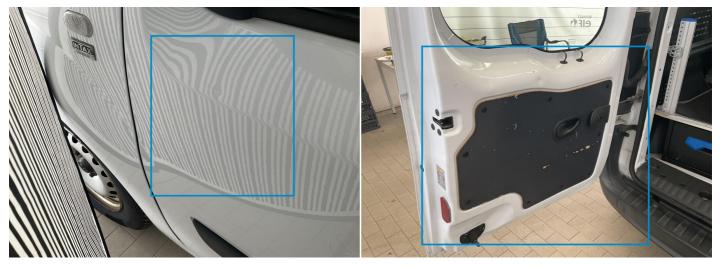
5. Door / Front Left Bodywork / Dent / Dent -

6. Tailgate Upholstery / Back Interior / Broken -

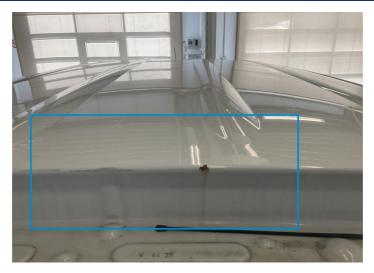
7. Roof Paint / Corrosion -
