RENAULT TRAFIC COMBI  
Trafic L2 dCi 170 Energy S&S EDC Intens

VIN NO VF1JL000172821570  
Registration Number GW828FR

Inspection Report Summary

| Customer | BCAuto Encheres | Report Number | P20251008143149 |

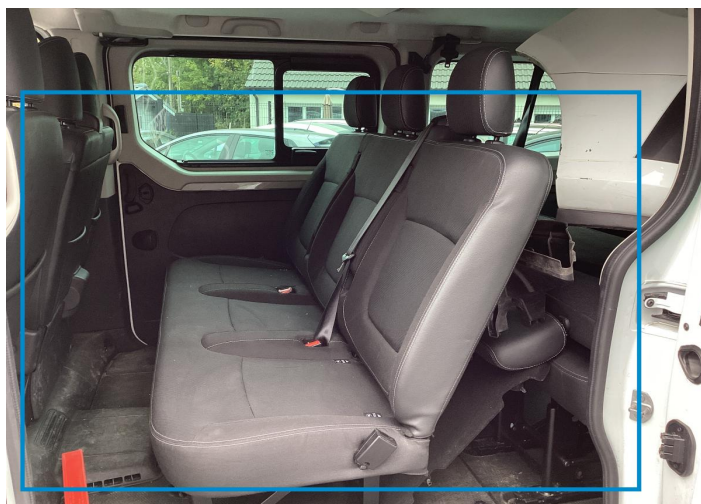
| Component | Damage | Comments |
|---|---|---|
| 1 Floor Carpet | Interior / Dirty | |

1. Floor Carpet  
Interior / Dirty -

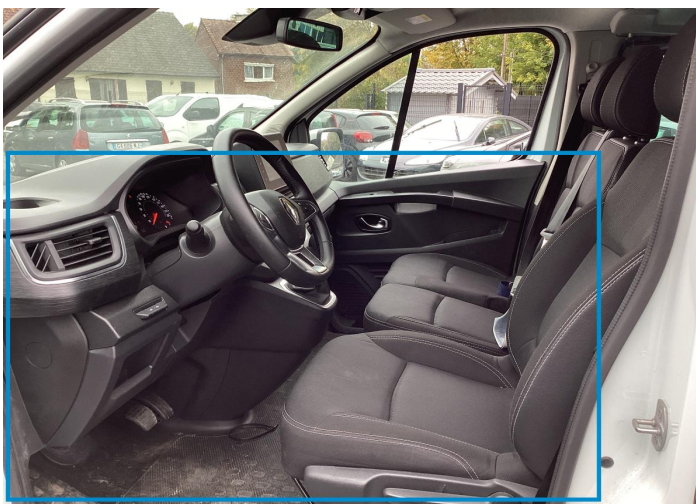
| Component | Damage | Comments |
|---|---|---|
| 2 Floor Carpet | Interior / Dirty | |

2. Floor Carpet  
Interior / Dirty -

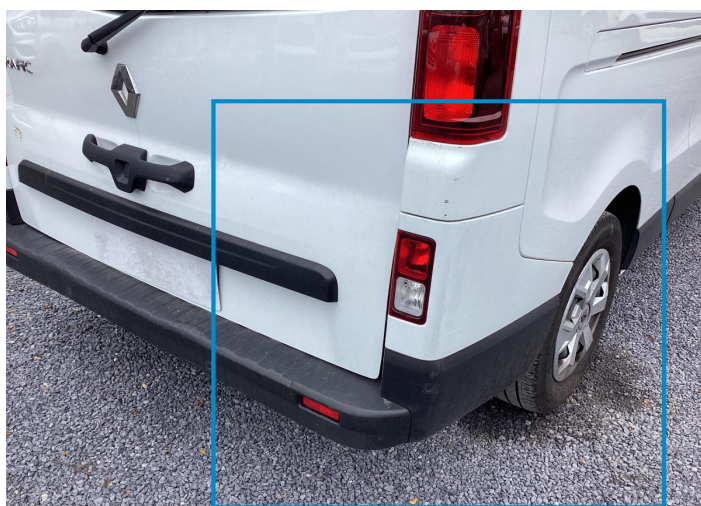
| Component | Damage | Comments |
|---|---|---|
| 3 Corner Bumper / Back Right | Paint / Scratch / Scuff | |

3. Corner Bumper / Back Right  
Paint / Scratch / Scuff -

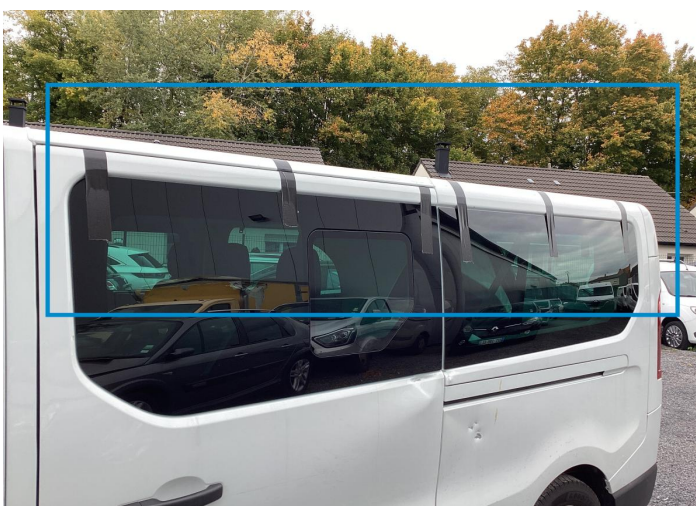
| Component | Damage | Comments |
|---|---|---|
| 4 Roof | Bodywork / Poor Previous Repair | Ruban adhésif ( dégât sous réserve de diagnostic ) |

4. Roof  
Bodywork / Poor Previous Repair -  
Ruban adhésif ( dégât sous réserve de diagnostic )

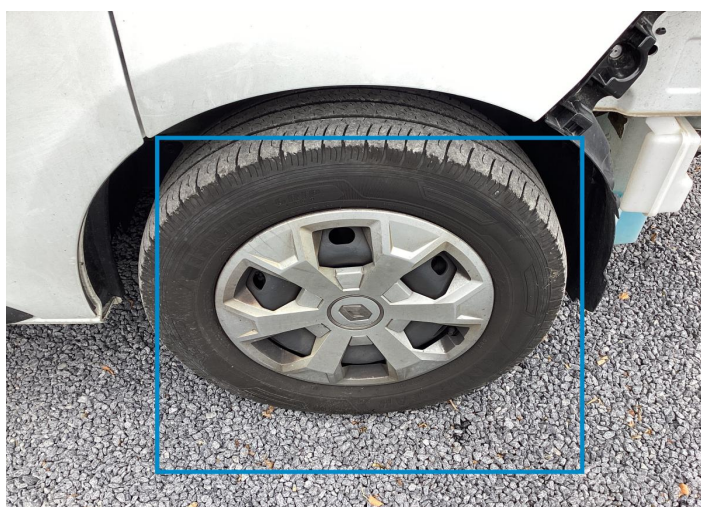
| Component | Damage | Comments |
|---|---|---|
| 5 Hubcap / Front Right | Out of Bodywork / Scratch | |

5. Hubcap / Front Right  
Out of Bodywork / Scratch -

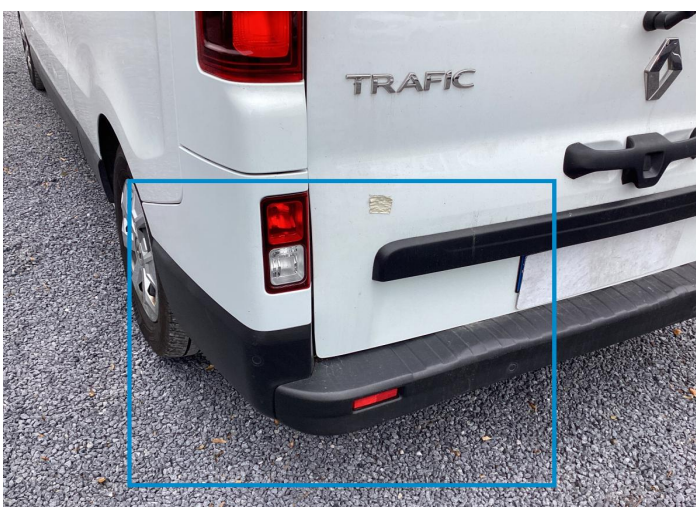
| Component | Damage | Comments |
|---|---|---|
| 6 Corner Bumper / Back Left | Paint / Scratch / Scuff | |

6. Corner Bumper / Back Left  
Paint / Scratch / Scuff -

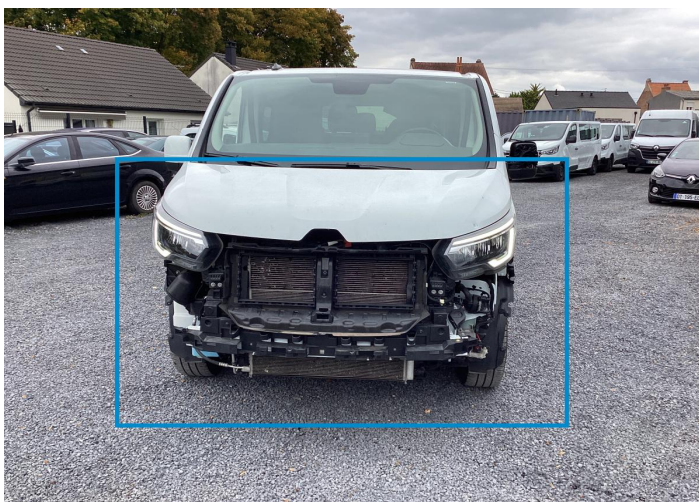
| Component | Damage | Comments |
|---|---|---|
| 7 Bumper / Front | Missing Part | |

7. Bumper / Front  
Missing Part -

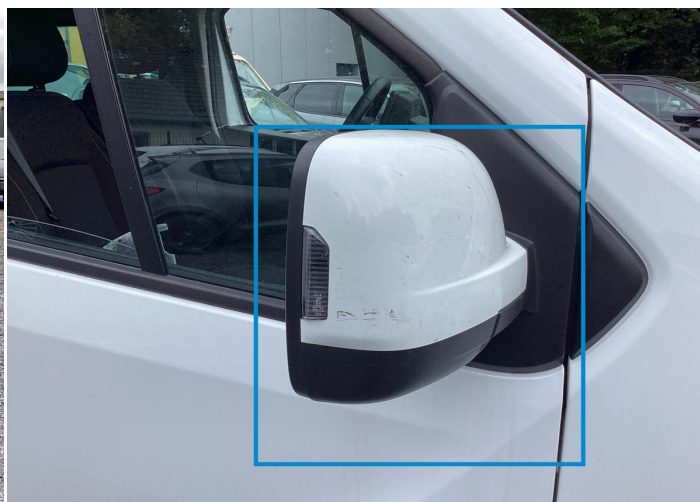
| Component | Damage | Comments |
|---|---|---|
| 8 Mirror / Front Right | Paint / Scratch / Scuff | |

8. Mirror / Front Right  
Paint / Scratch / Scuff -

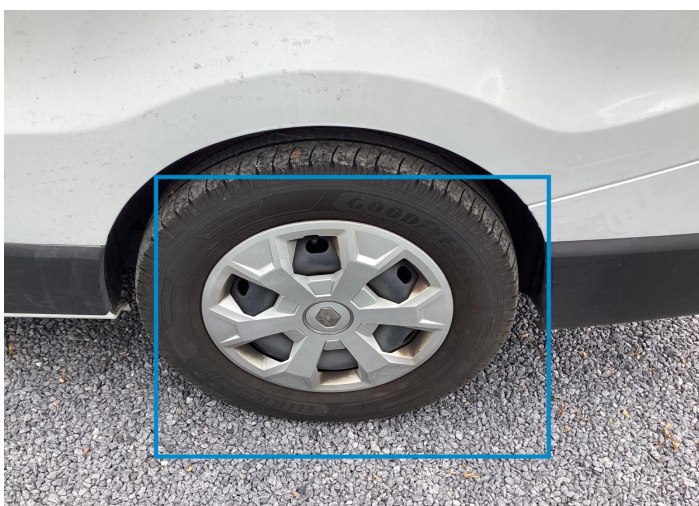
| Component | Damage | Comments |
|---|---|---|
| 9 Hubcap / Back Left | Out of Bodywork / Scratch | |

9. Hubcap / Back Left  
Out of Bodywork / Scratch -

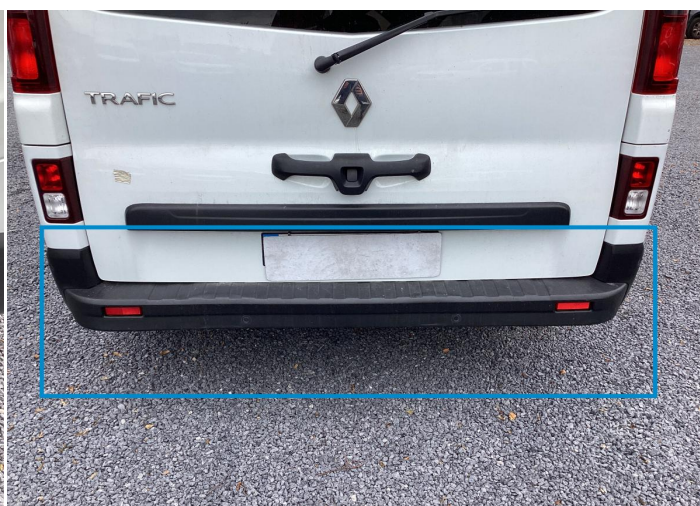
| Component | Damage | Comments |
|---|---|---|
| 10 Bumper / Back | Paint / Scratch / Scuff | |

10. Bumper / Back  
Paint / Scratch / Scuff -

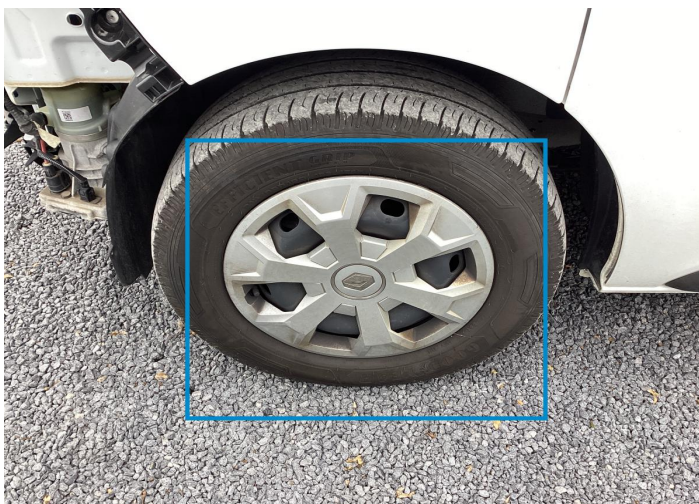
| Component | Damage | Comments |
|---|---|---|
| 11 Hubcap / Front Left | Out of Bodywork / Scratch | |

11. Hubcap / Front Left  
Out of Bodywork / Scratch -

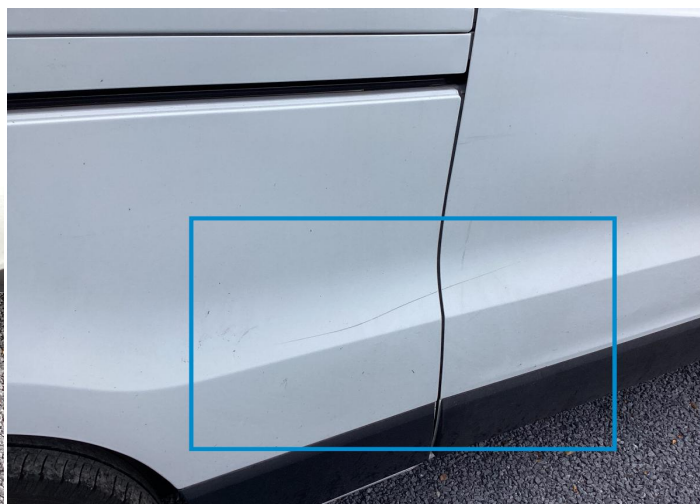
| Component | Damage | Comments |
|---|---|---|
| 12 Door / Back Right | Paint / Scratch / Line | |

12. Door / Back Right  
Paint / Scratch / Line -

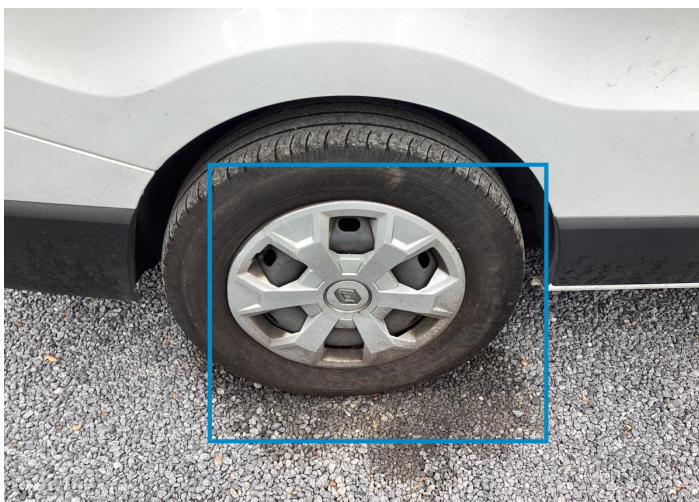
| 13 Hubcap / Back Right | Out of Bodywork / Scratch |

13. Hubcap / Back Right  
Out of Bodywork / Scratch -

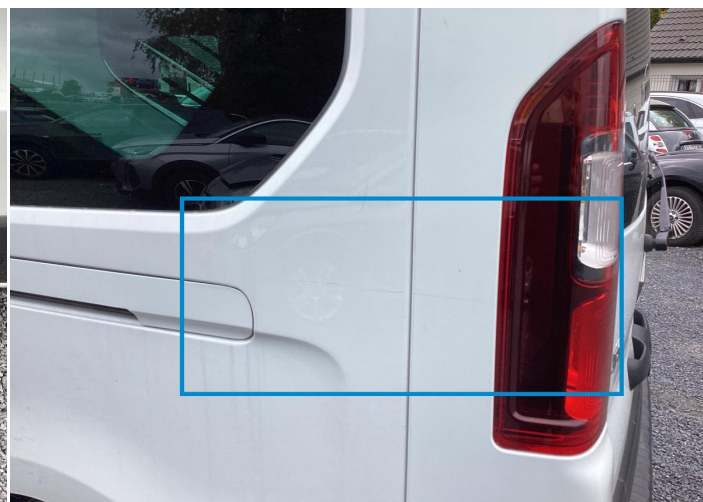
| 14 Side Panel / Back Left | Paint / Scratch / Line |

14. Side Panel / Back Left  
Paint / Scratch / Line -

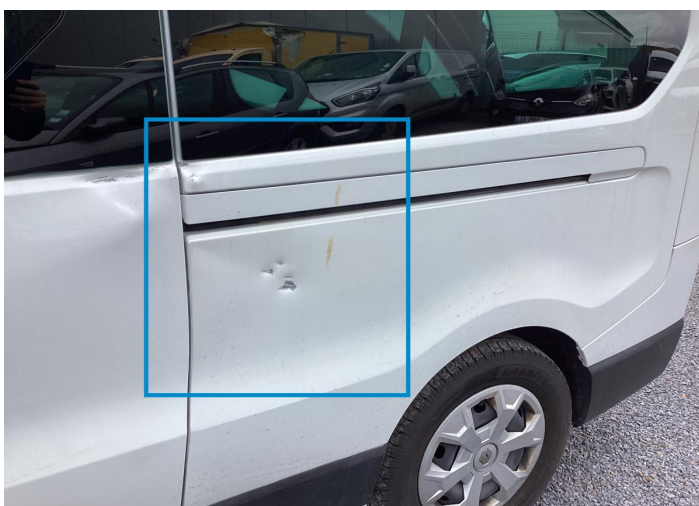
| 15 Side Panel / Back Left | Bodywork / Dent / Deformation |

15. Side Panel / Back Left  
Bodywork / Dent / Deformation -

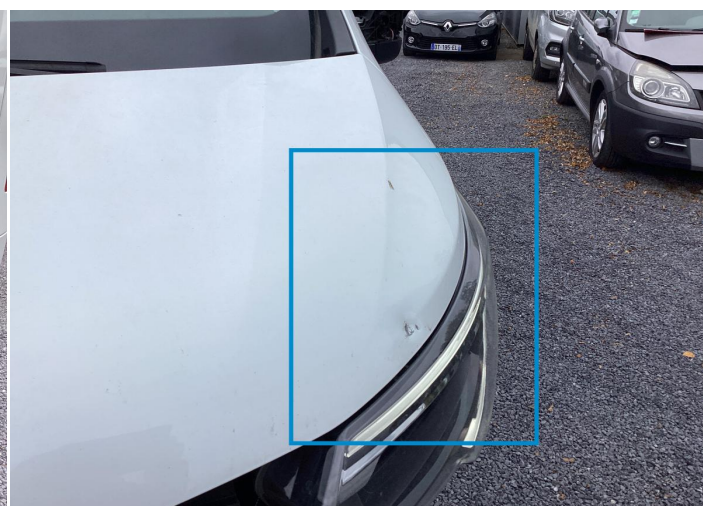
| 16 Hood | Bodywork / Dent / Deformation |

16. Hood  
Bodywork / Dent / Deformation -

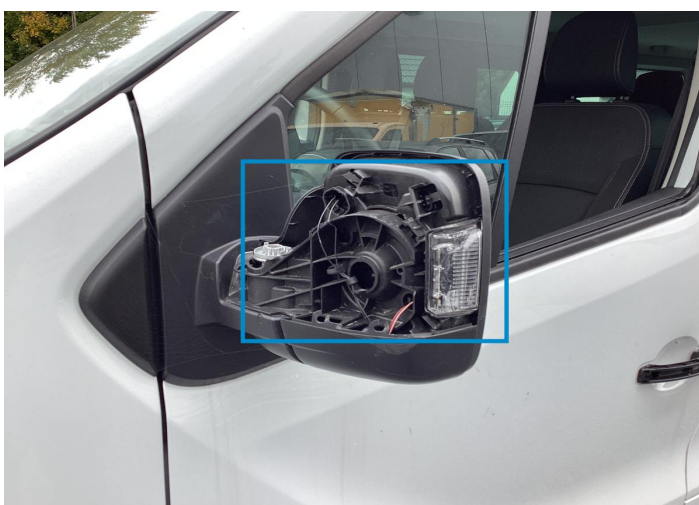
| 17 Mirror / Front Left | Missing Part |

17. Mirror / Front Left  
Missing Part -

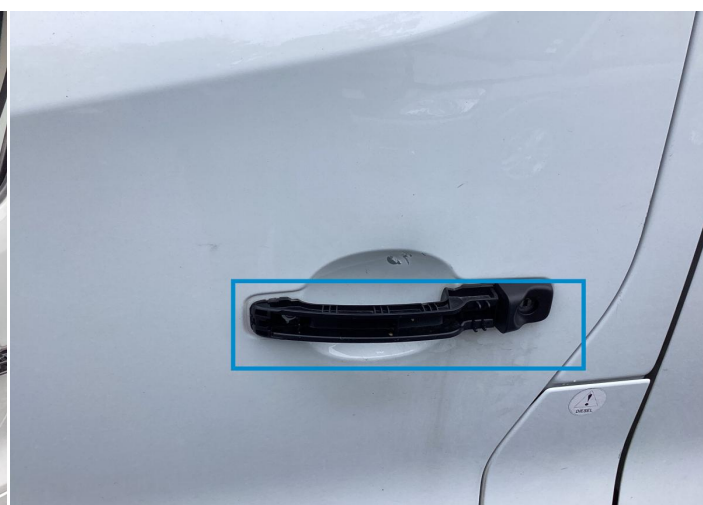
| 18 Door Handle / Front Left | Missing Part |

18. Door Handle / Front Left  
Missing Part -

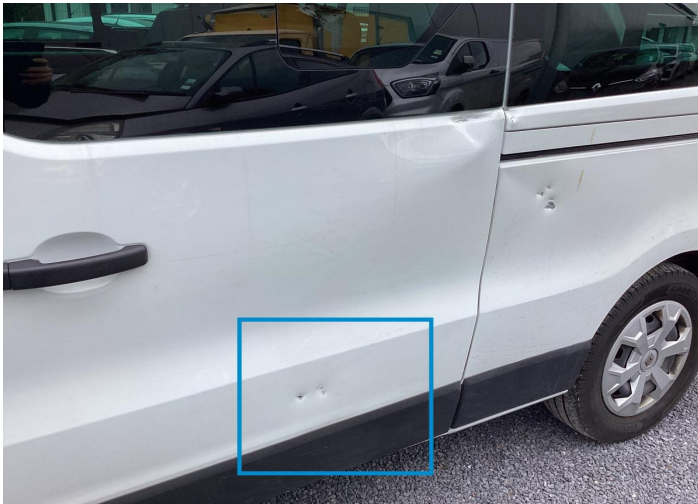
| 19 Door / Back Left | Bodywork / Dent / Deformation |

19. Door / Back Left  
Bodywork / Dent / Deformation -

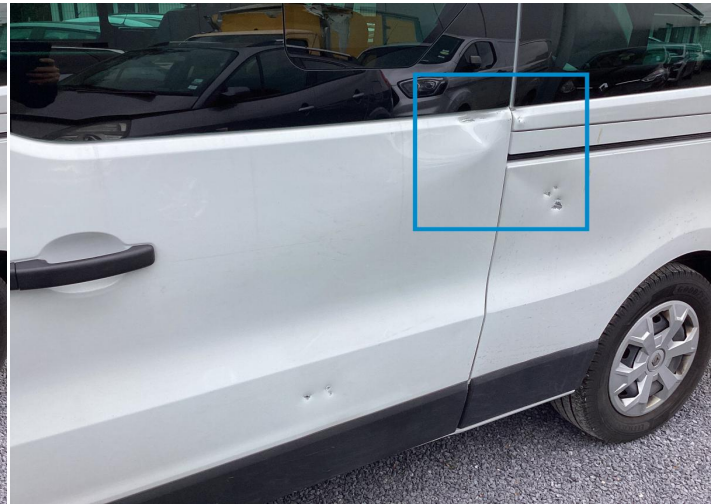
| 20 Door / Back Left | Bodywork / Dent / Deformation |

20. Door / Back Left  
Bodywork / Dent / Deformation -

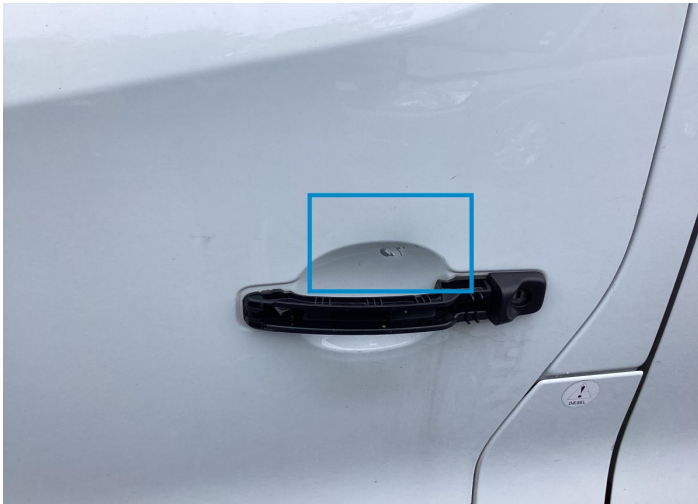
| 21 Door Handle / Front Left | Bodywork / Dent / Deformation |

21. Door Handle / Front Left  
Bodywork / Dent / Deformation -
