# RENAULT MÉGANE

## Mégane Estate III 1.9 dCi 130 FAP eco2 Dynamique Euro 5

VIN NO VF1KZ1S0644721564  
Registration Number BG486ZV

### Inspection Report Summary

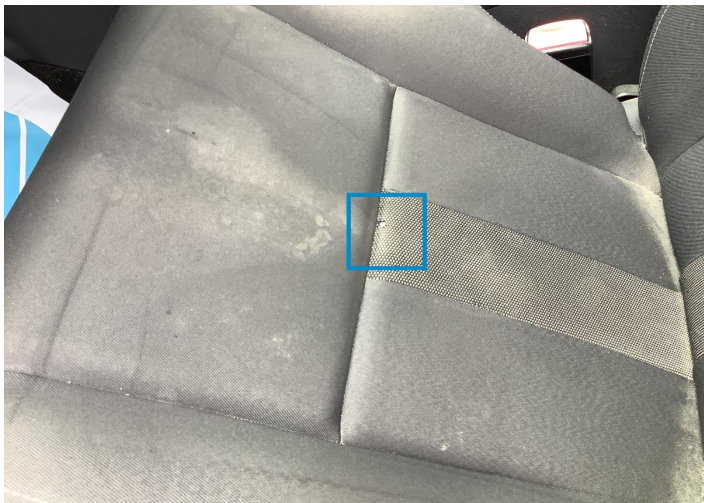
| Component | | Damage | Comments |
|---|---|---|---|
| 1 | Seat Cushion / Front Left | Interior / Burn | |

1. Seat Cushion / Front Left  
Interior / Burn -

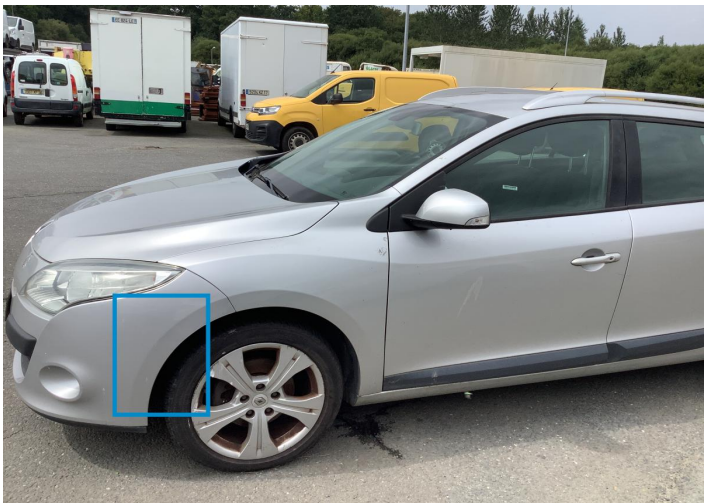
| Component | | Damage | Comments |
|---|---|---|---|
| 2 | Fender / Front Left | Paint / Scratch / Scuff | |

2. Fender / Front Left  
Paint / Scratch / Scuff -

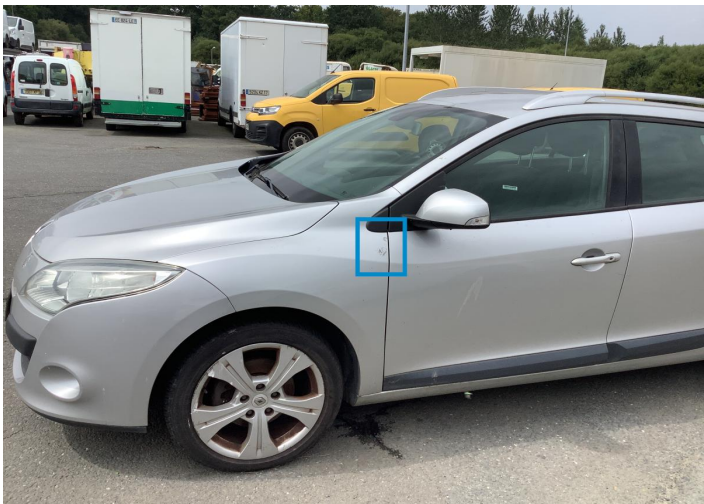
| Component | | Damage | Comments |
|---|---|---|---|
| 4 | Fender / Front Left | Paint / Chemical Damage | |

4. Fender / Front Left  
Paint / Chemical Damage -

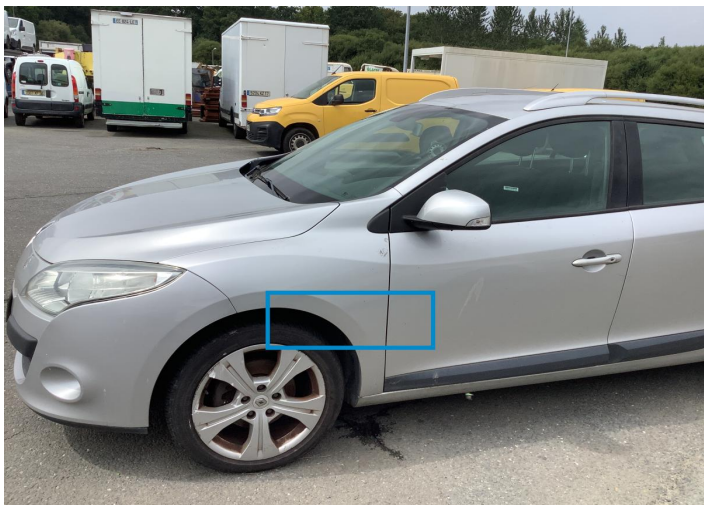
| Component | | Damage | Comments |
|---|---|---|---|
| 5 | Fender / Front Left | Paint / Stone Chip | |

5. Fender / Front Left  
Paint / Stone Chip -

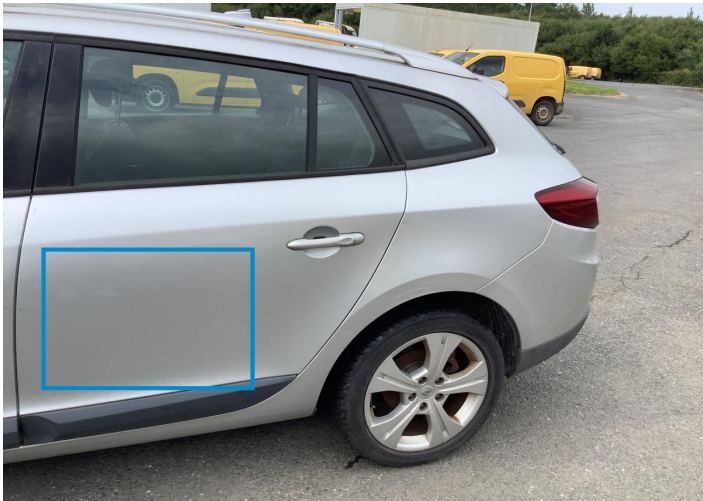
| Component | | Damage | Comments |
|---|---|---|---|
| 7 | Side Panel / Back Left | Paint / Scratch / Line | |

7. Side Panel / Back Left  
Paint / Scratch / Line -

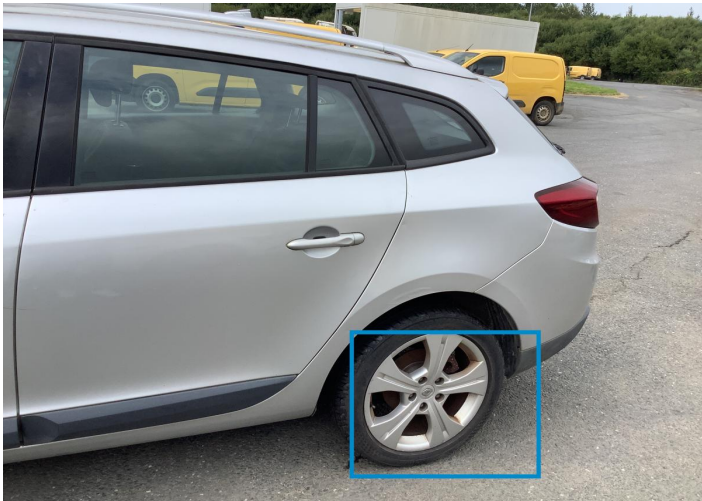
| Component | | Damage | Comments |
|---|---|---|---|
| 8 | Side Panel / Back Left | Paint / Scratch / Scuff | |

8. Side Panel / Back Left  
Paint / Scratch / Scuff -

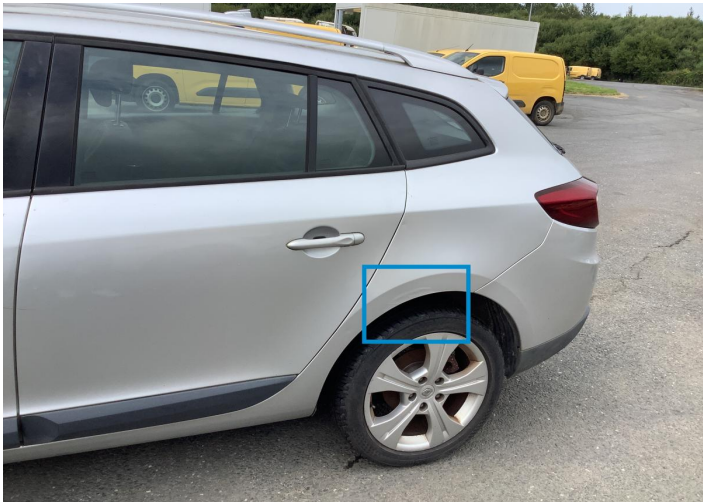
| Component | | Damage | Comments |
|---|---|---|---|
| 9 | Side Panel / Back Left | Paint / Scratch / Scuff | |

9. Side Panel / Back Left  
Paint / Scratch / Scuff -

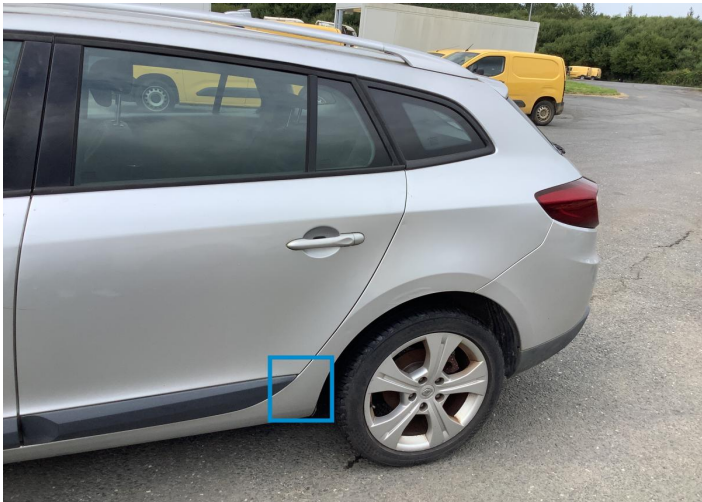
| Component | | Damage | Comments |
|---|---|---|---|
| 10 | Side Panel / Back Left | Paint / Scratch / Line | |

10. Side Panel / Back Left  
Paint / Scratch / Line -

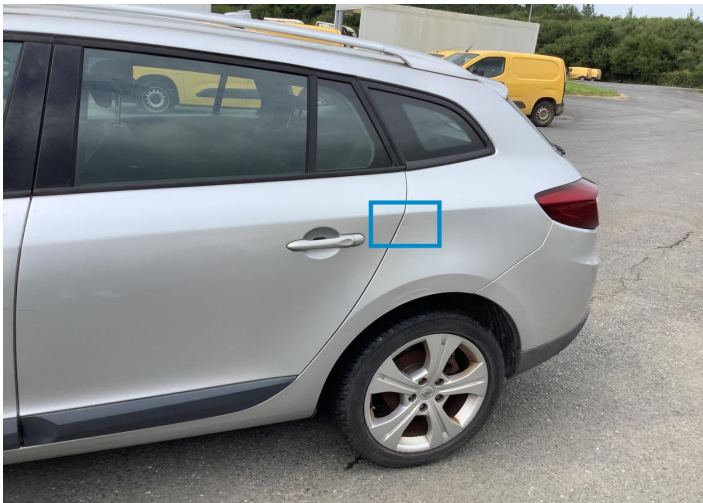
| Component | | Damage | Comments |
|---|---|---|---|
| 11 | Side Panel / Back Left | Bodywork / Dent / Dent | |

11. Side Panel / Back Left  
Bodywork / Dent / Dent -

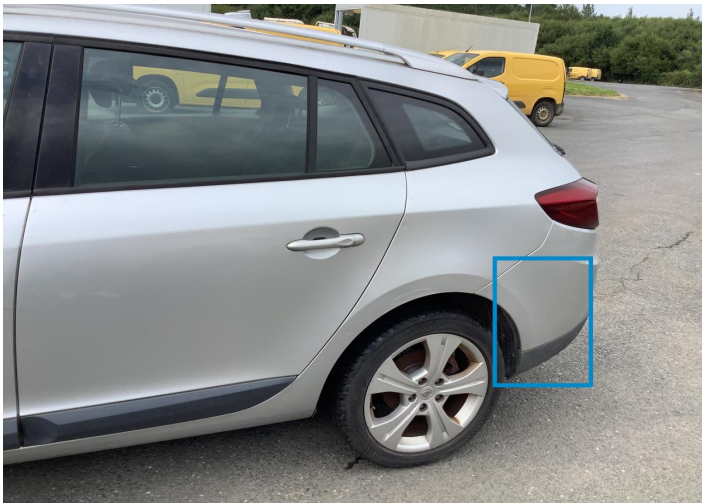
| Component | | Damage | Comments |
|---|---|---|---|
| 12 | Side Panel / Back Left | Paint / Stone Chip | |

12. Side Panel / Back Left  
Paint / Stone Chip -

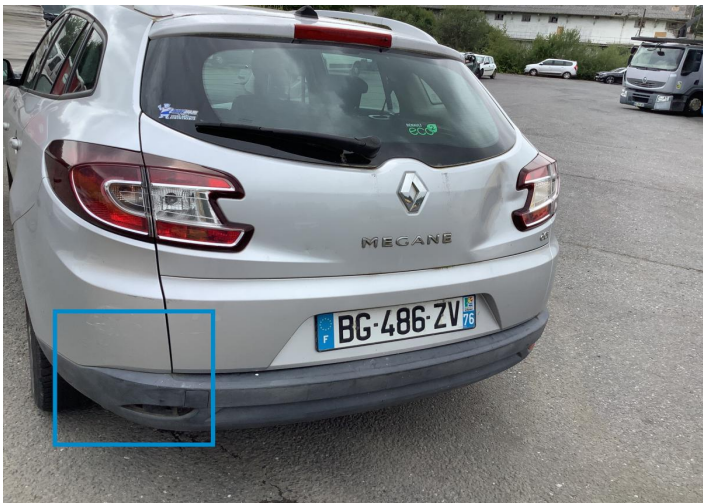
| Component | | Damage | Comments |
|---|---|---|---|
| 13 | Tailgate | Paint / Scratch / Scuff | |

13. Tailgate  
Paint / Scratch / Scuff -

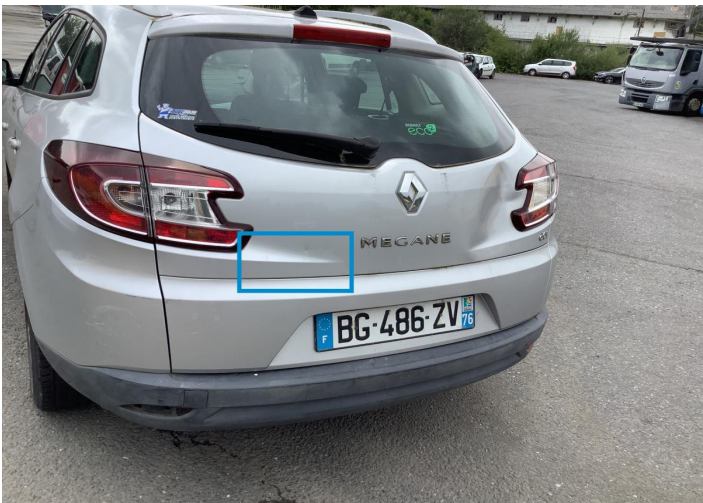
| 14 | Tailgate | Bodywork / Dent / Dent |

14. Tailgate  
Bodywork / Dent / Dent -

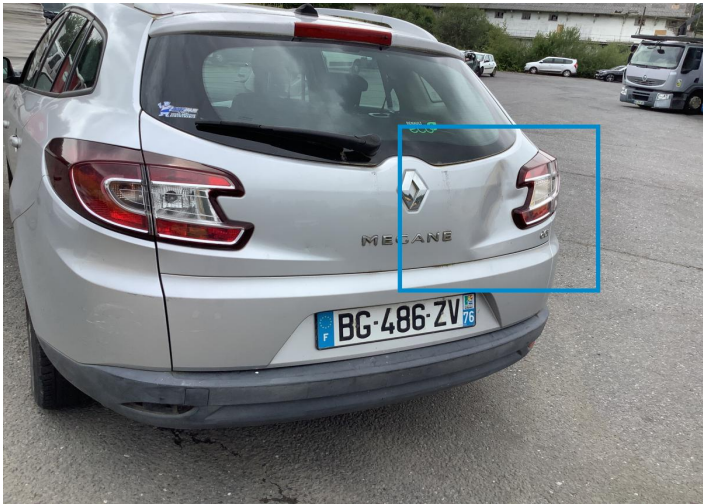
| 15 | Tailgate | Bodywork / Dent / Dent |

15. Tailgate  
Bodywork / Dent / Dent -

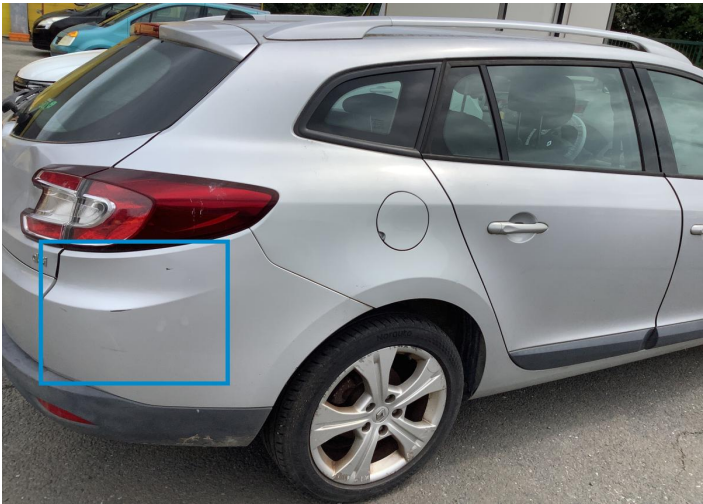
| 16 | Side Panel / Back Right | Paint / Scratch / Line |

16. Side Panel / Back Right  
Paint / Scratch / Line -

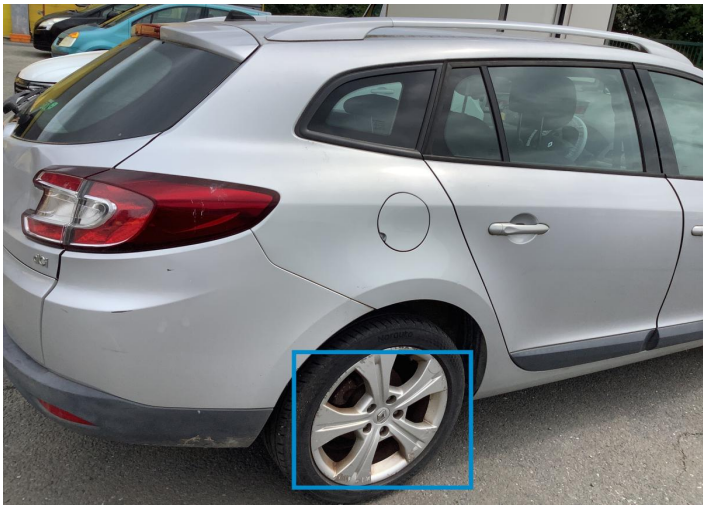
| 17 | Side Panel / Back Right | Paint / Scratch / Scuff |

17. Side Panel / Back Right  
Paint / Scratch / Scuff -

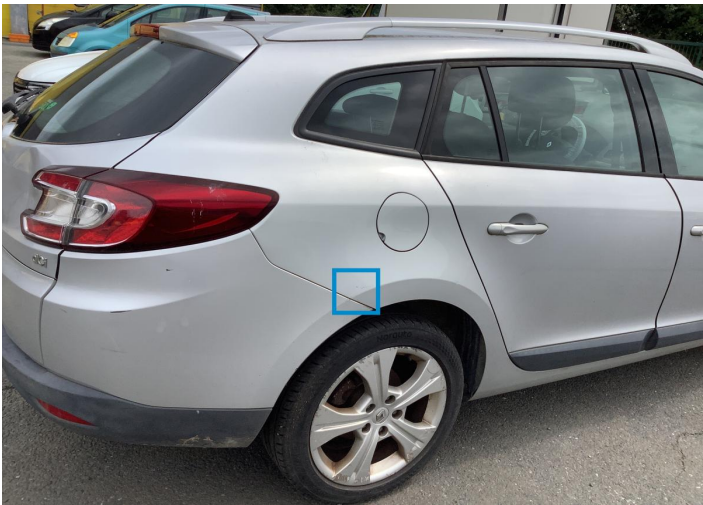
| 18 | Side Panel / Back Right | Paint / Scratch / Line |

18. Side Panel / Back Right  
Paint / Scratch / Line -

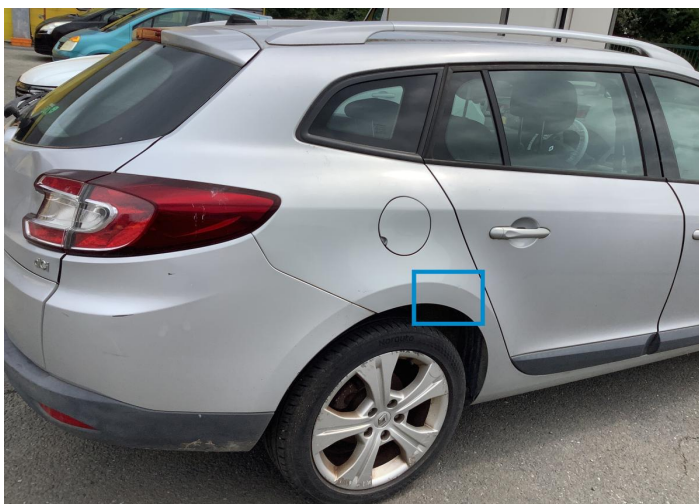
| 19 | Side Panel / Back Right | Paint / Scratch / Line |

19. Side Panel / Back Right  
Paint / Scratch / Line -

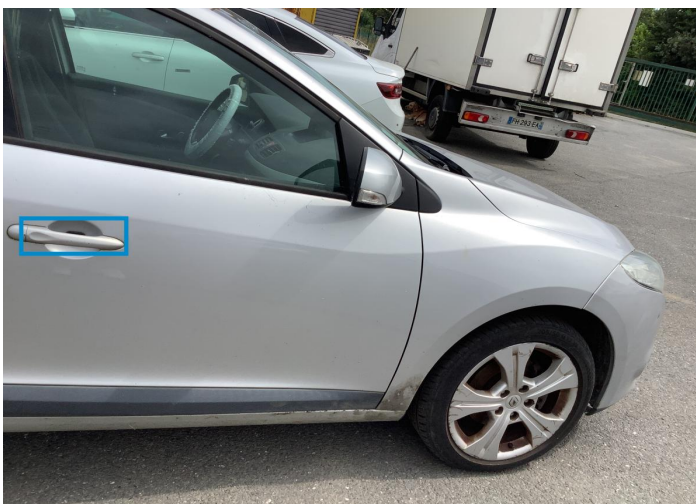
| 20 | Fender / Front Right | Paint / Scratch / Line |

20. Fender / Front Right  
Paint / Scratch / Line -

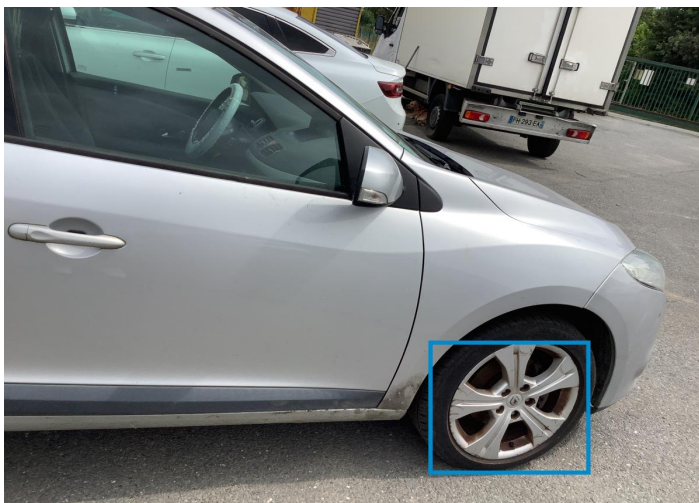
| 21 | Fender / Front Right | Paint / Scratch / Scuff |

21. Fender / Front Right  
Paint / Scratch / Scuff -

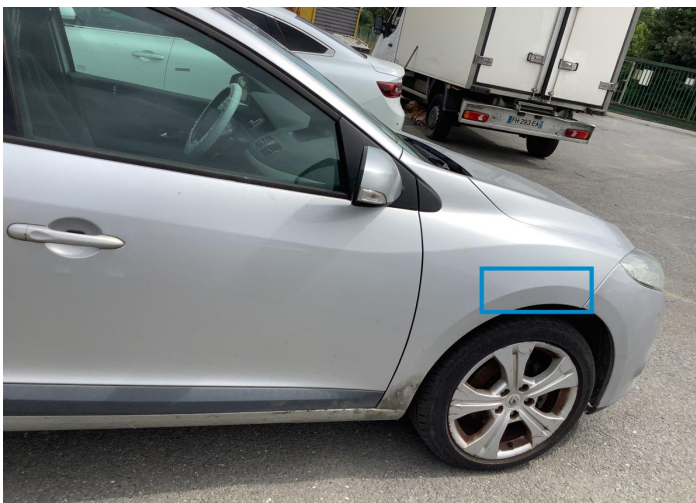
| 22 | Fender / Front Right | Paint / Scratch / Line |

22. Fender / Front Right  
Paint / Scratch / Line -

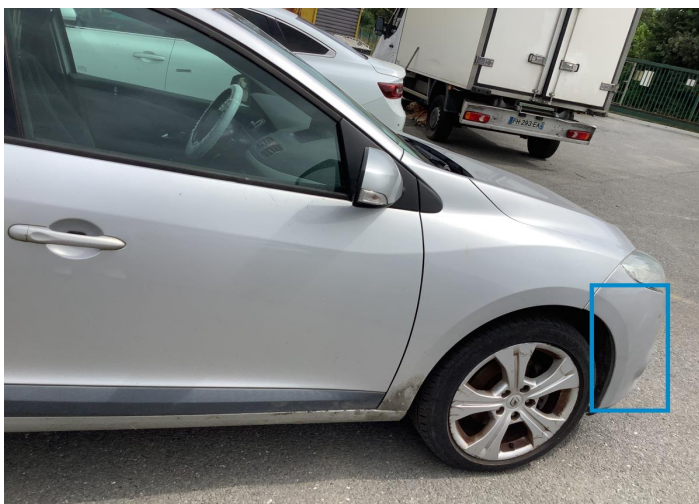
| 23 | Fender / Front Right | Paint / Scratch / Scuff |

23. Fender / Front Right  
Paint / Scratch / Scuff -

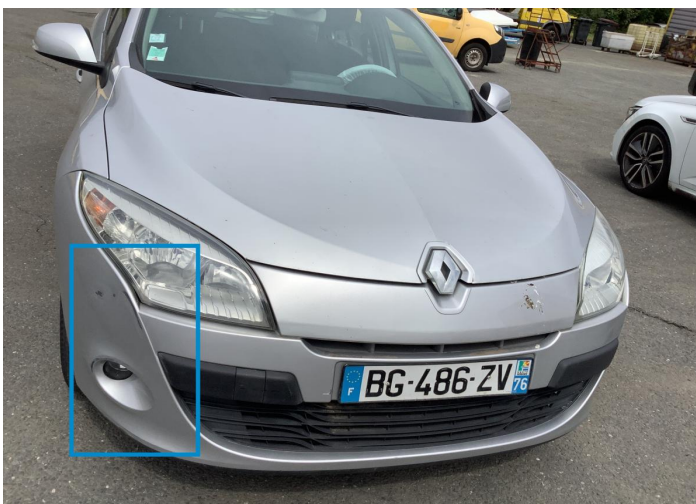
| 24 | Hood | Paint / Scratch / Scuff |

24. Hood  
Paint / Scratch / Scuff -

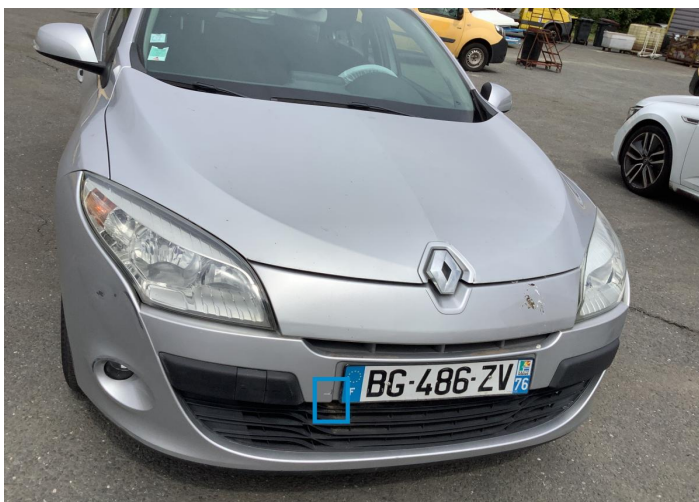
| 25 | Hood | Paint / Scratch / Line |

25. Hood  
Paint / Scratch / Line -

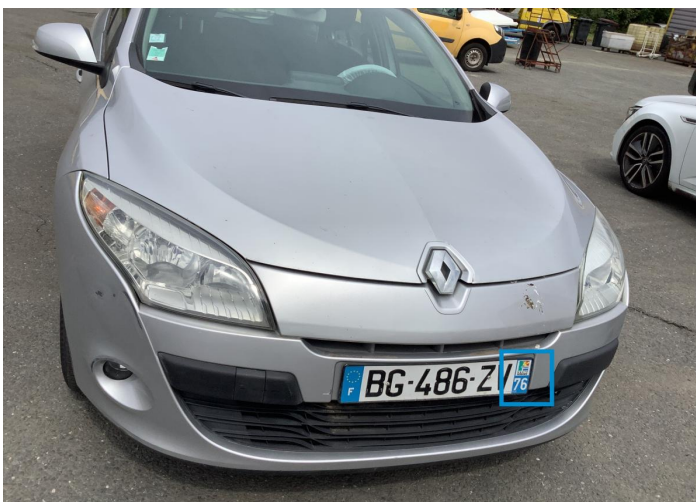
| 26 | Hood | Bodywork / Dent / Deformation |

26. Hood  
Bodywork / Dent / Deformation -

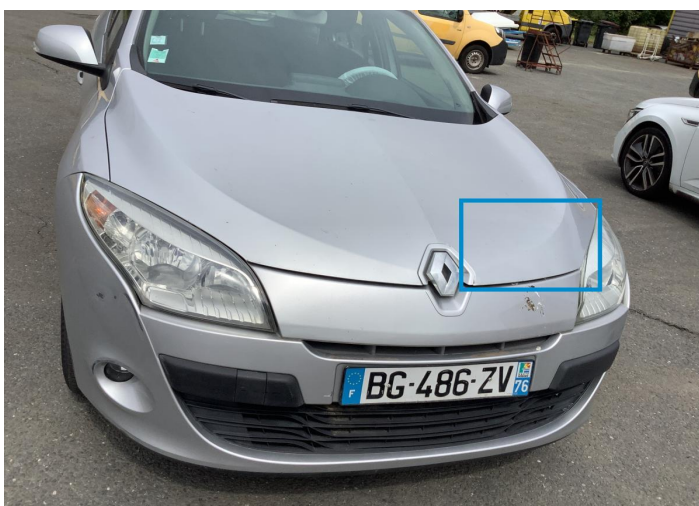
| 27 | Hood | Paint / Stone Chip |

27. Hood  
Paint / Stone Chip -

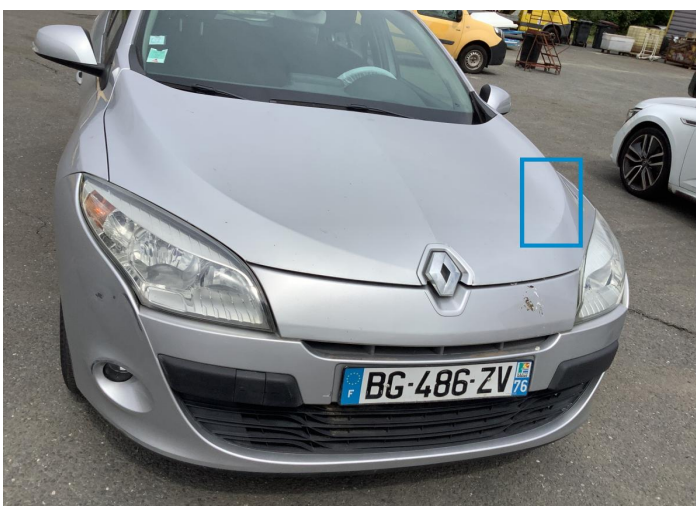
| 28 | Hood | Paint / Scratch / Scuff |

28. Hood  
Paint / Scratch / Scuff -
