## status report

#### Renault Master III Kasten L3H2 HKa 3,5t

| Vehicle identification number | <b>VF1MA000367562813</b> | mileage read: | <b>83672 km</b> |
| First Registration /<br>construction year: | <b>13.12.2021 / 2021</b> | Visit Date / place of birth: | <b>02.09.2025 Hoppegarten</b> |

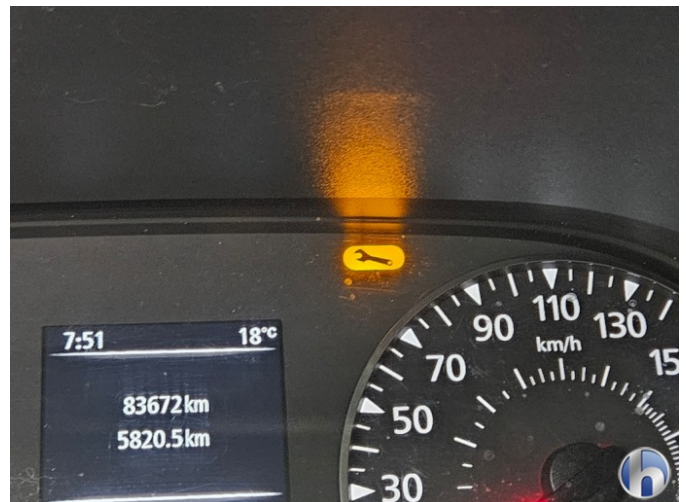
1. maintenance

| | component | Damage | Rep kind |
|---|---|---|---|
| 1. | maintenance | Due | Replace |

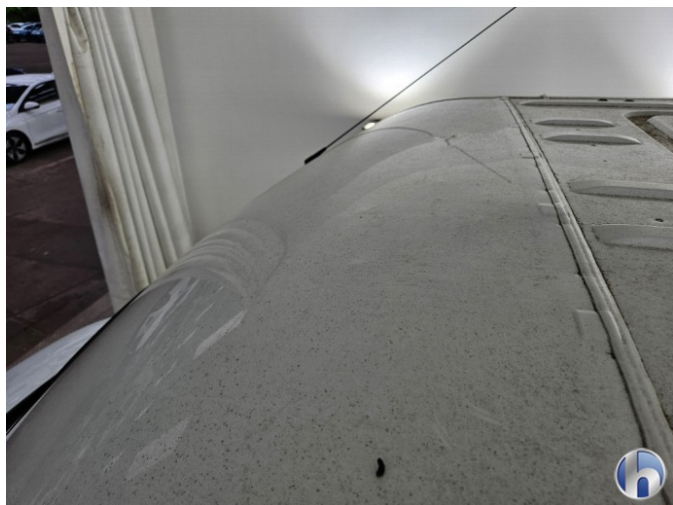
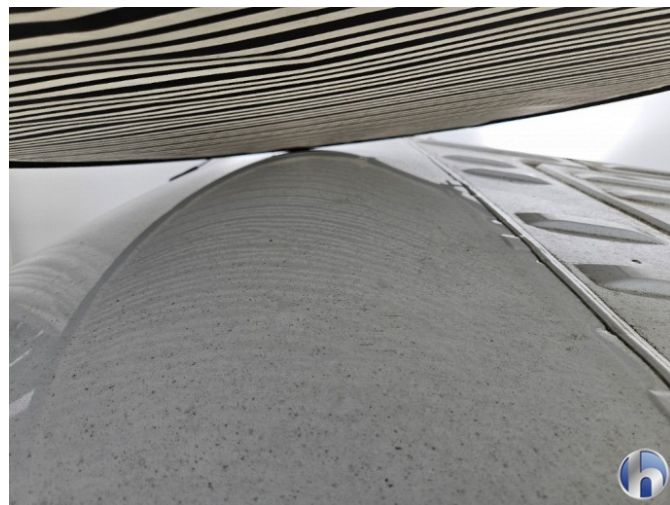
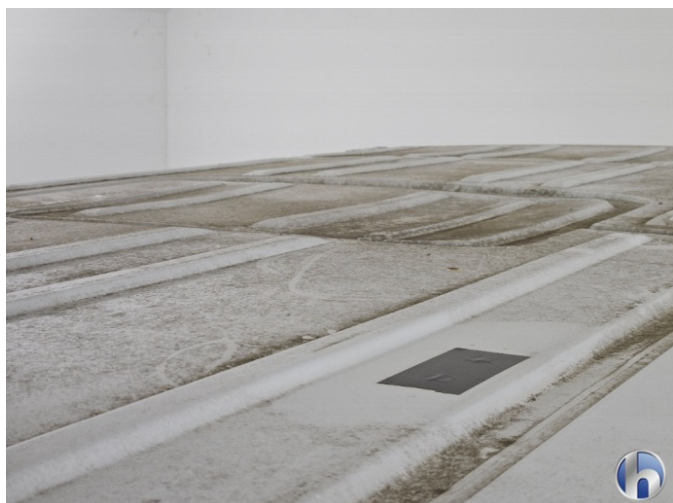
2. roof

| | component | Damage | Rep kind |
|---|---|---|---|
| 2. | roof | Deformed | Refurbish and paint |

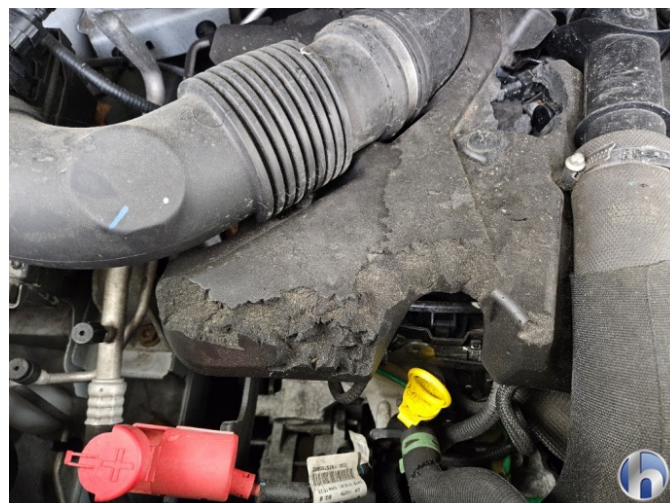
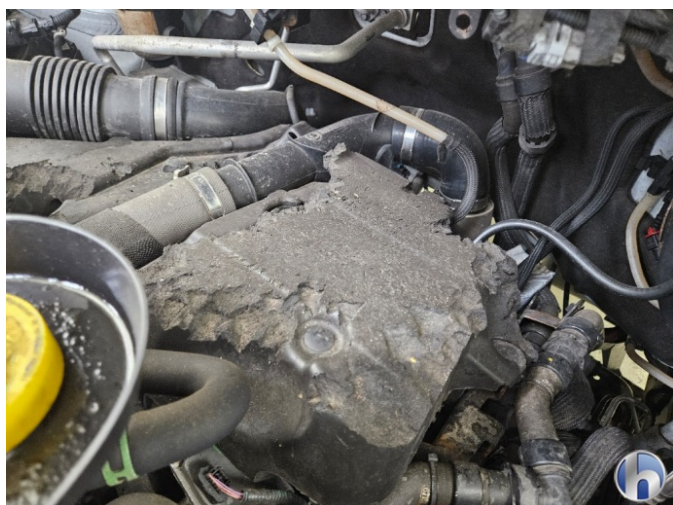
3. motor insulation

| | component | Damage | Rep kind |
|---|---|---|---|
| 3. | motor insulation | Damaged | Replace |

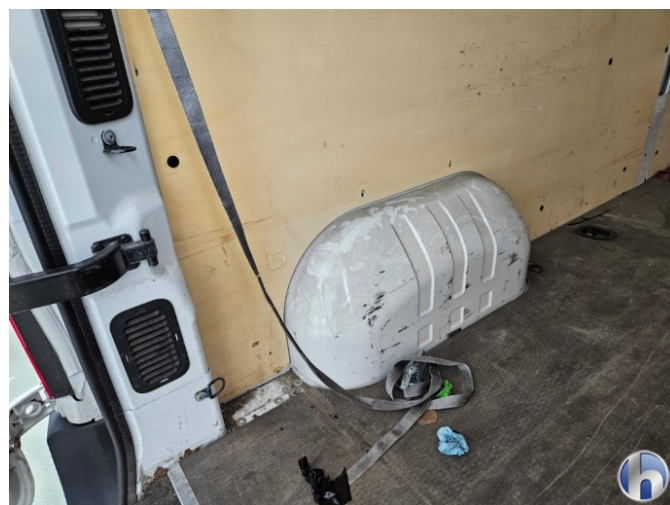
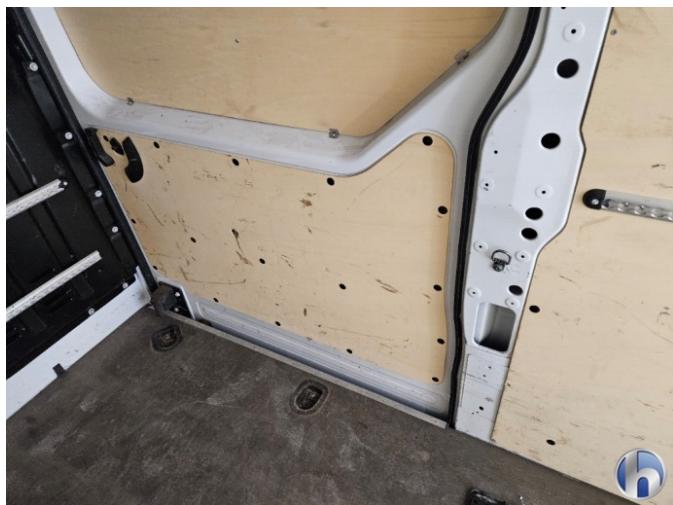
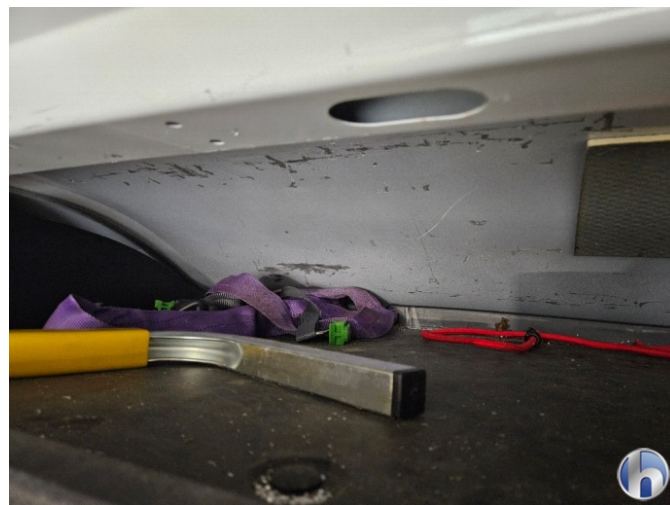
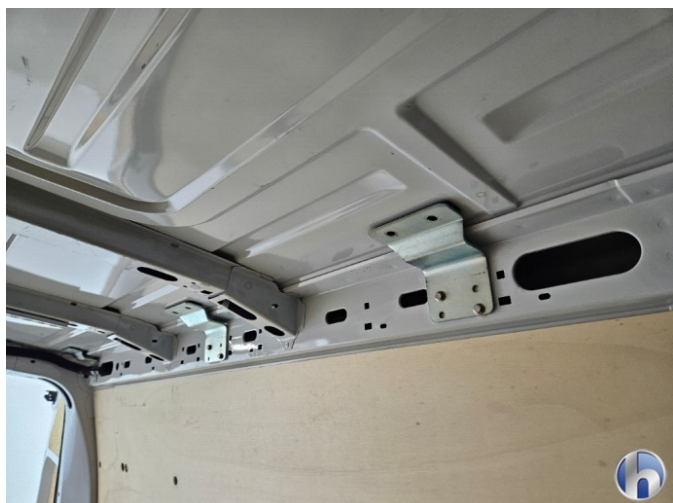
| | component | Damage | Rep kind |
|---|---|---|---|
| 4. | | Wear and tear | acceptable |

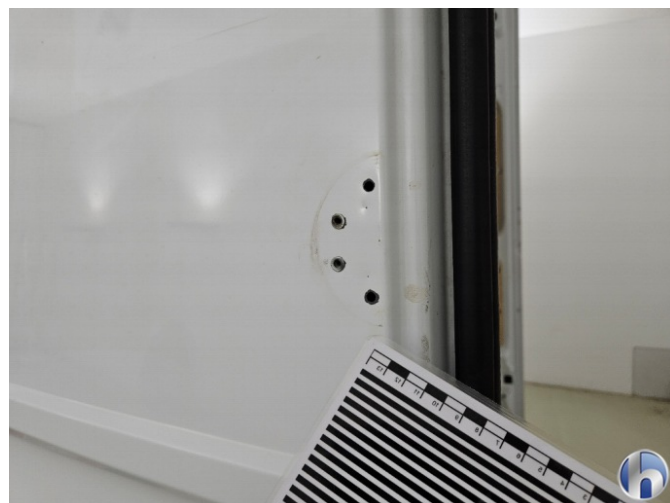
5. Tailgate left

| | component | Damage | Rep kind |
|---|---|---|---|
| 5. | Tailgate left | Hole | Replace |

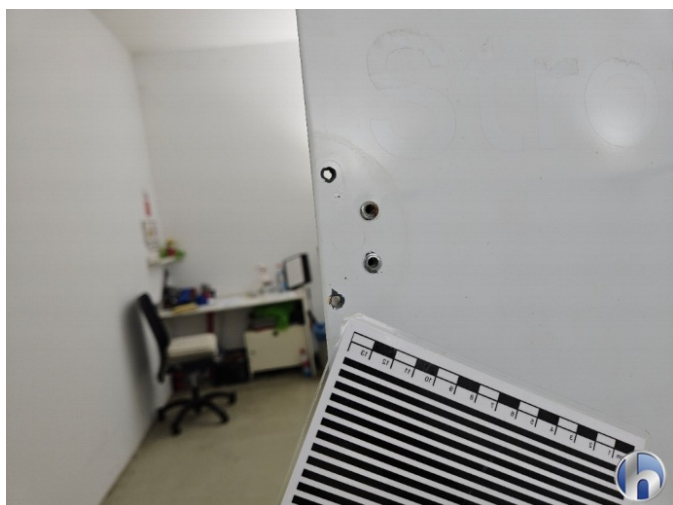
6. Tailgate right

| | component | Damage | Rep kind |
|---|---|---|---|
| 6. | Tailgate right | Hole | Replace |

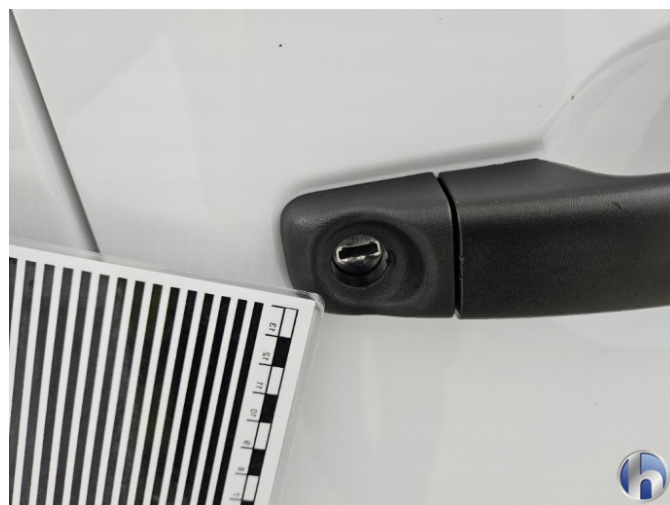
7. Schließzylinder Hecktür

| | component | Damage | Rep kind |
|---|---|---|---|
| 7. | Schließzylinder Hecktür | Wear and tear | acceptable |

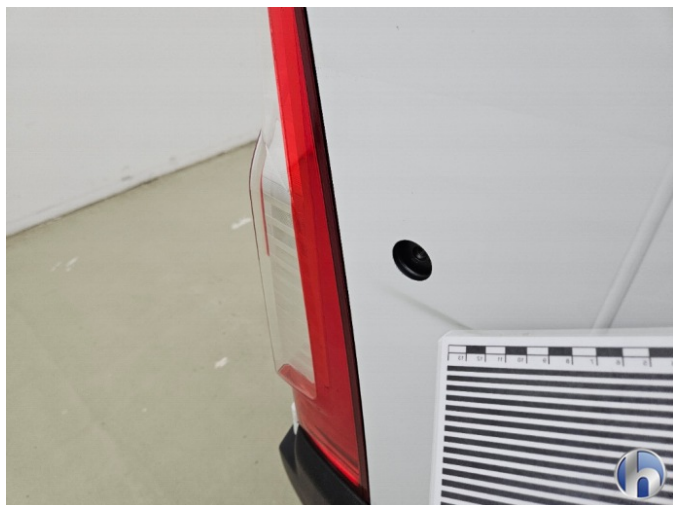
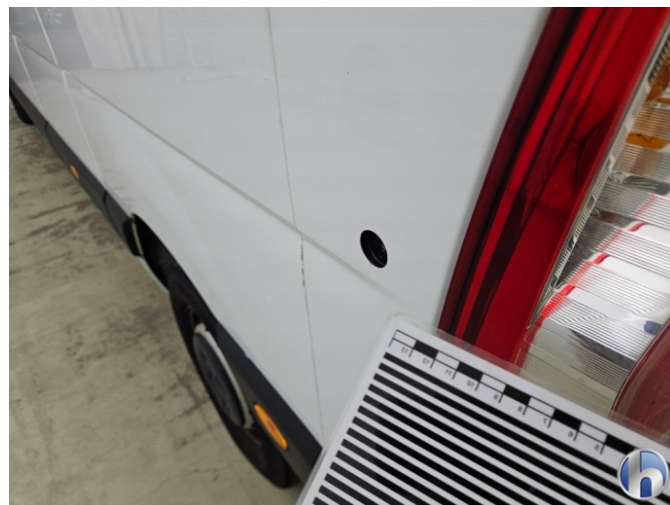
8. Anschlagpuffer li./re.

| | component | Damage | Rep kind |
|---|---|---|---|
| 8. | Anschlagpuffer li./re. | Missing | Replace |

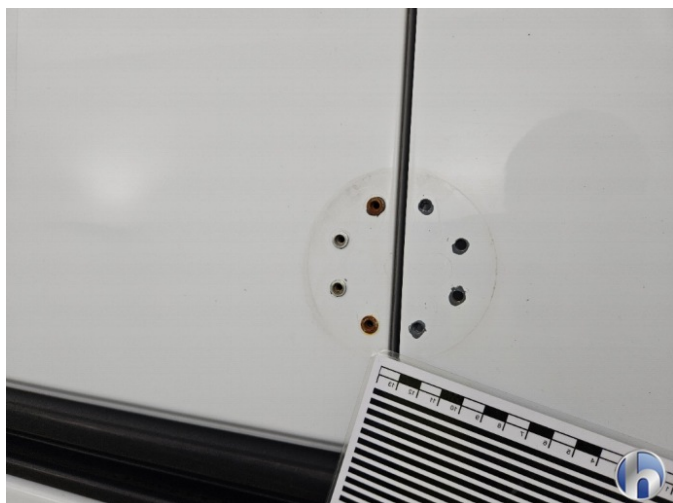
9. Sidewall - Rear - right

| | component | Damage | Rep kind |
|---|---|---|---|
| 9. | Sidewall - Rear - right | Hole | Replace |

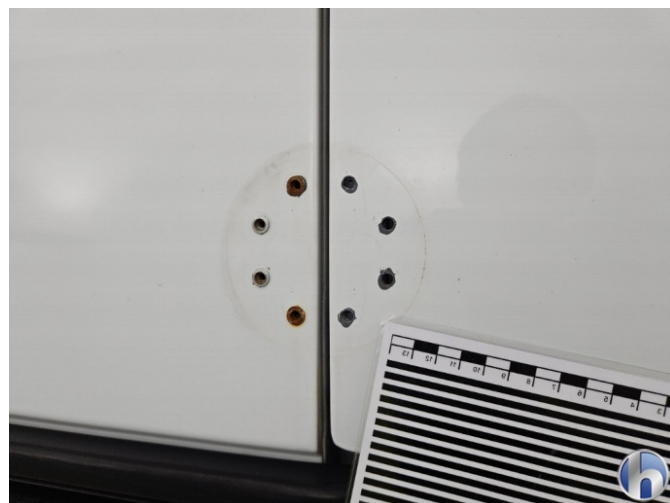
10. Sliding door - right

| | component | Damage | Rep kind |
|---|---|---|---|
| 10. | Sliding door - right | Hole | Replace |

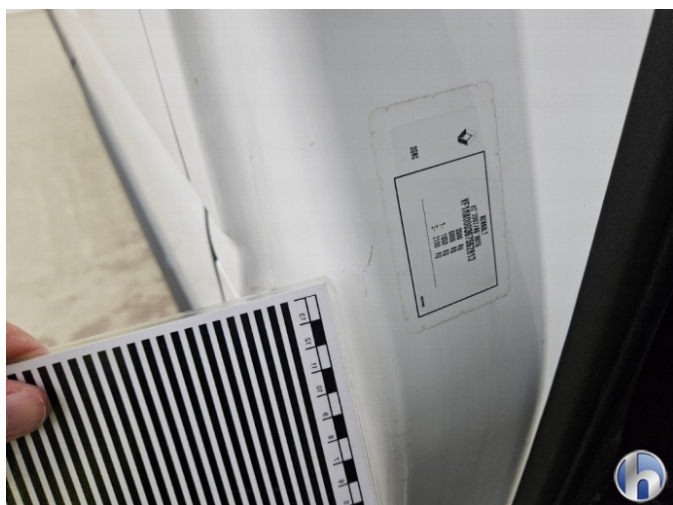
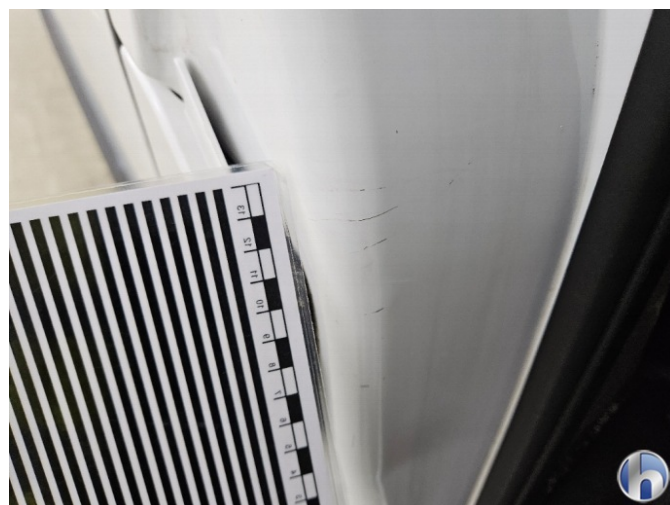
11. B-pillar center - right

| | component | Damage | Rep kind |
|---|---|---|---|
| 11. | B-pillar center - right | Wear and tear | acceptable |

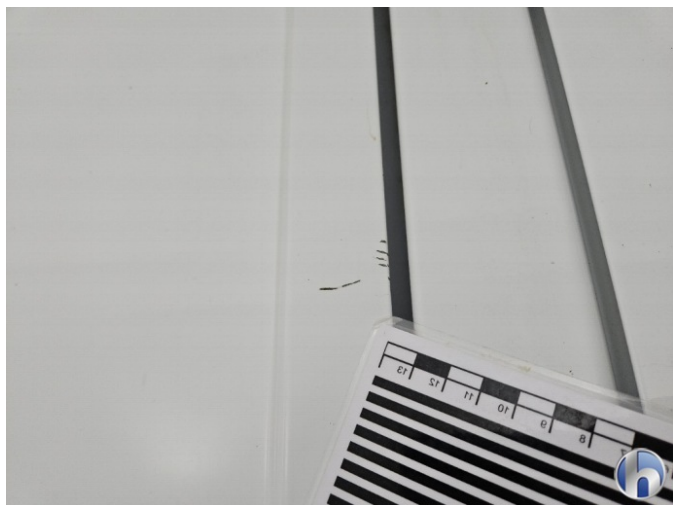
12. Sliding door - right

| | component | Damage | Rep kind |
|---|---|---|---|
| 12. | Sliding door - right | Scratch(es) | acceptable |

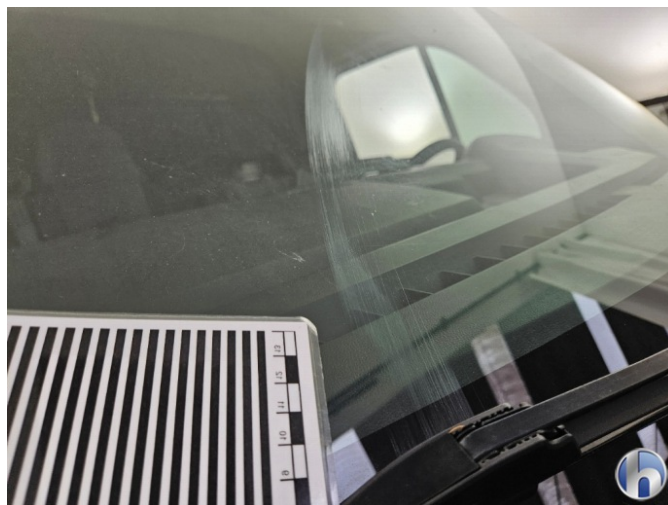
13. Windshield

| | component | Damage | Rep kind |
|---|---|---|---|
| 13. | Windshield | Scratch(es) | Replace |

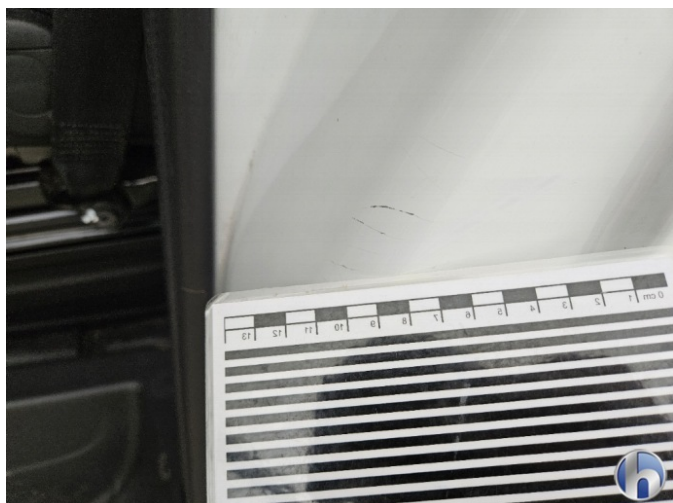
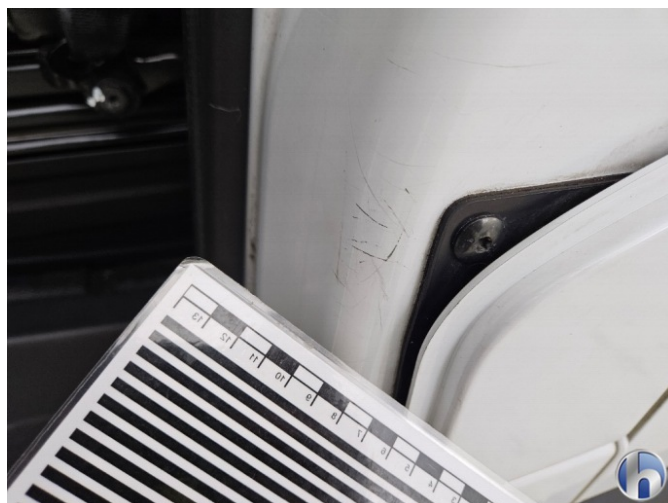
14. B-pillar center - left

| | component | Damage | Rep kind |
|---|---|---|---|
| 14. | B-pillar center - left | Wear and tear | acceptable |

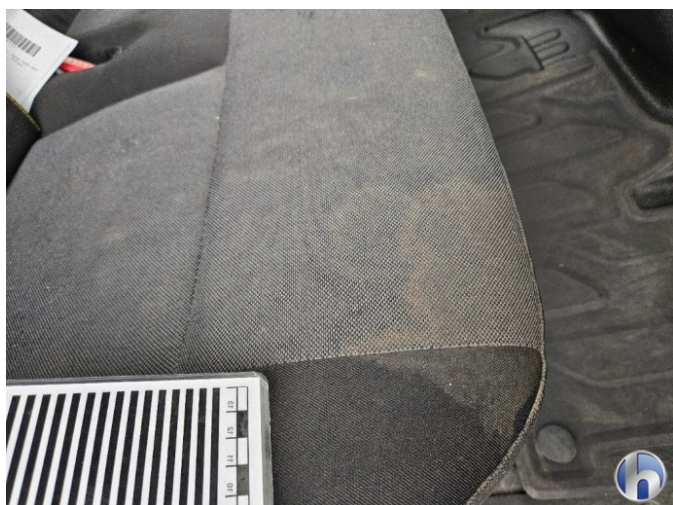
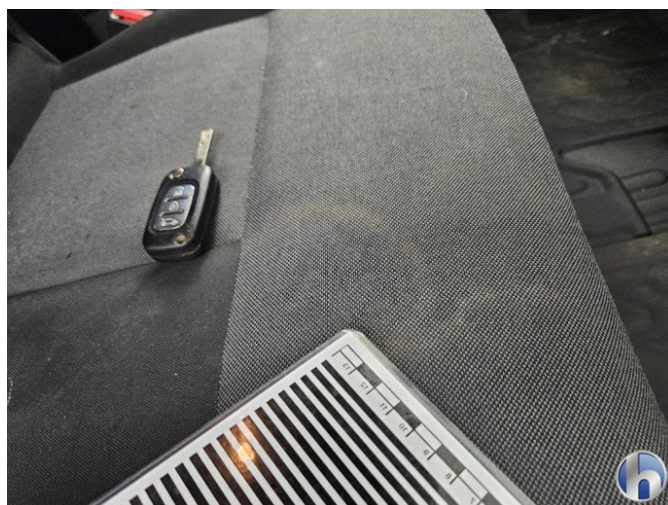
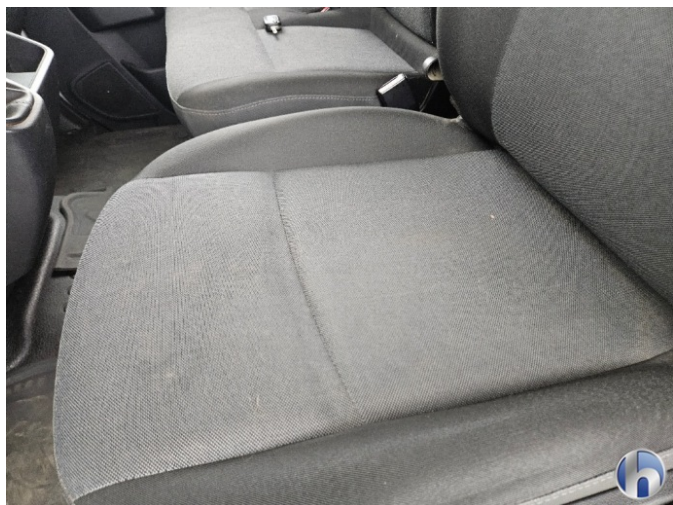
| | component | Damage | Rep kind |
|---|---|---|---|
| 15. | | Dirty | |
