RENAULT MASTER FOURGON

MASTER FGN PROP R3500 L4H3 BLUE DCI

VIN NO VF1MA000369202400
Registration Number GH448DR

Customer	BCA Auto Encheres	Report Number	P20250528110501
Inspection Date / Place	2025-07-30 / BCA TOULOUSE	Cosmetic Grade	5

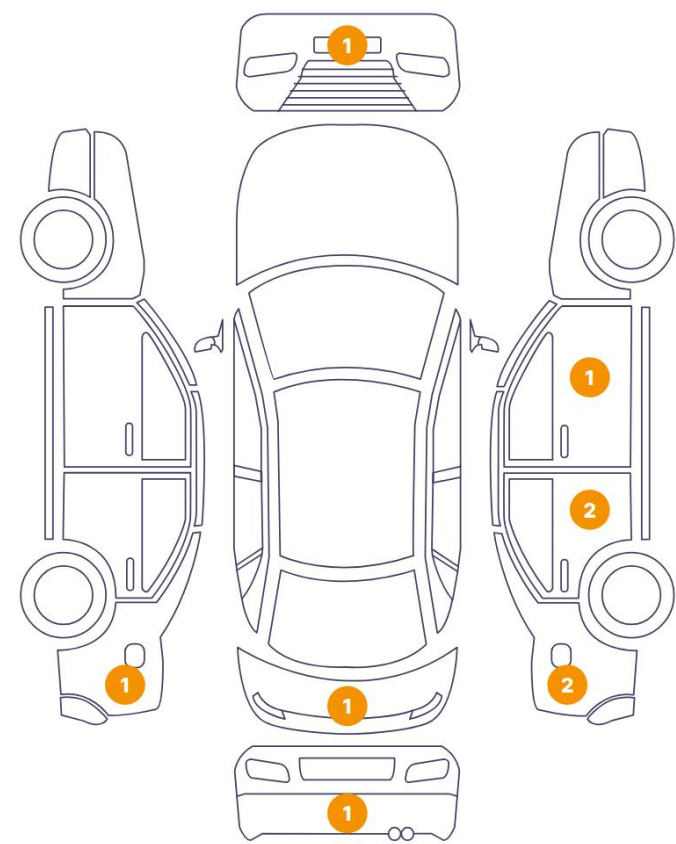
9 Dommages

Component		Damage	Comments
1	Seat Cushion / Front Right	Interior / Dirty	
2	Seat Cushion / Front Left	Interior / Dirty	
3	Side Panel / Back Left	Paint / Scratch / Line	
4	Tailgate	Bodywork / Dent / Deformation	
5	Bumper / Back	Paint / Scratch / Line	
6	Wing Stick / Back Right	Missing Part	
7	Vent Glass / Back Right	Missing Part	
8	Side Panel	Bodywork / Dent / Deformation	
9	Door / Back Right	Missing Part	
10	Door / Front Right	Paint / Scratch / Line	
11	Bumper / Front	Bodywork / Breakage / Hole

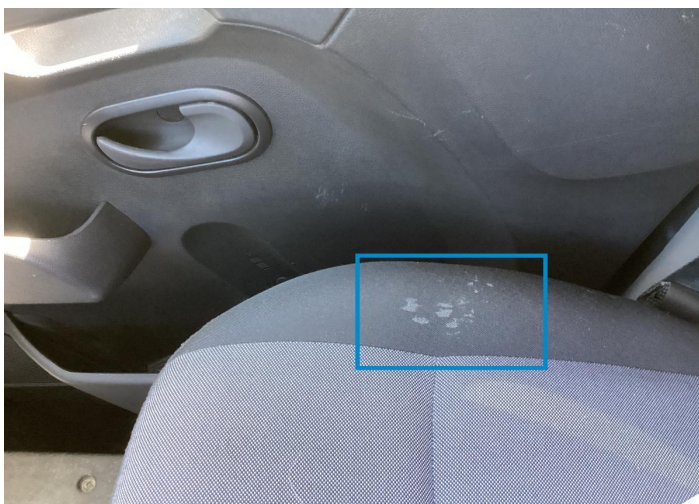
1. Seat Cushion / Front Right
Interior / Dirty -

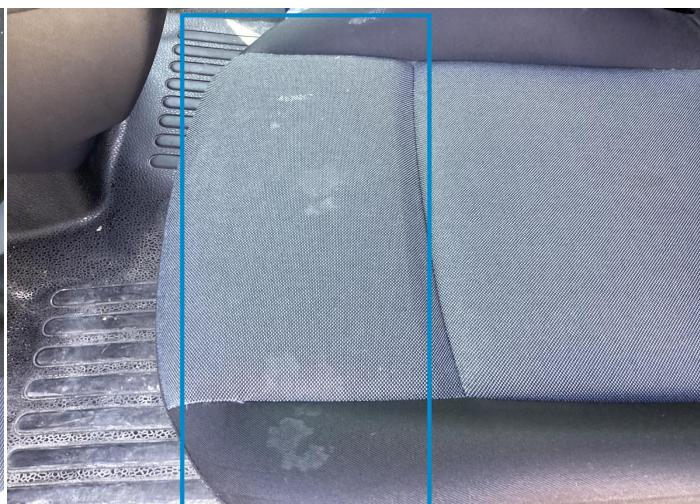
2. Seat Cushion / Front Left
Interior / Dirty -

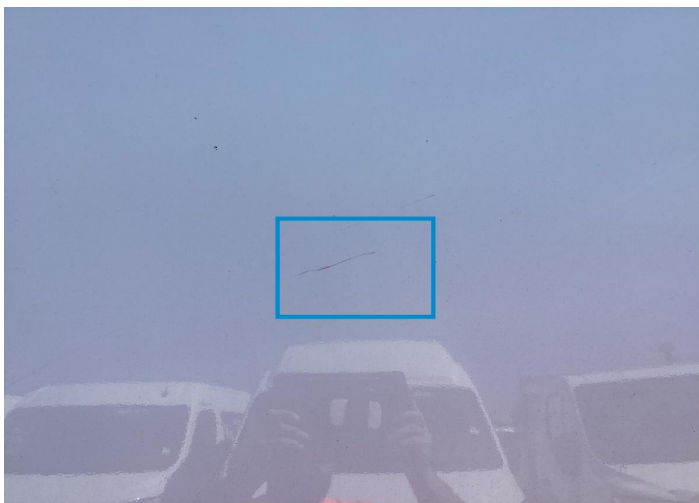
3. Side Panel / Back Left
Paint / Scratch / Line -

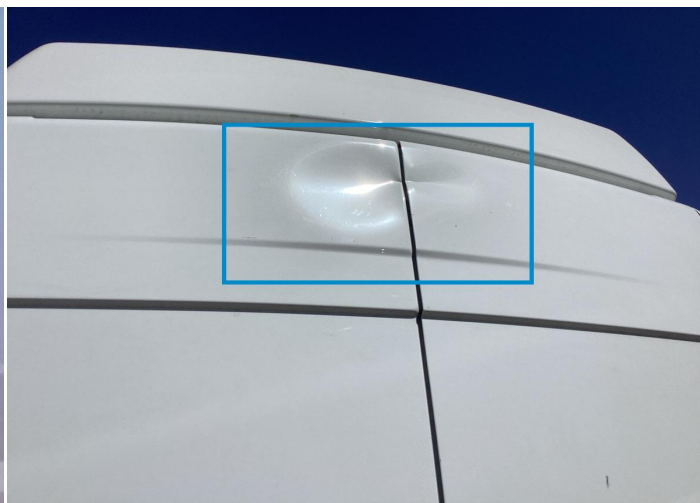
4. Tailgate
Bodywork / Dent / Deformation -

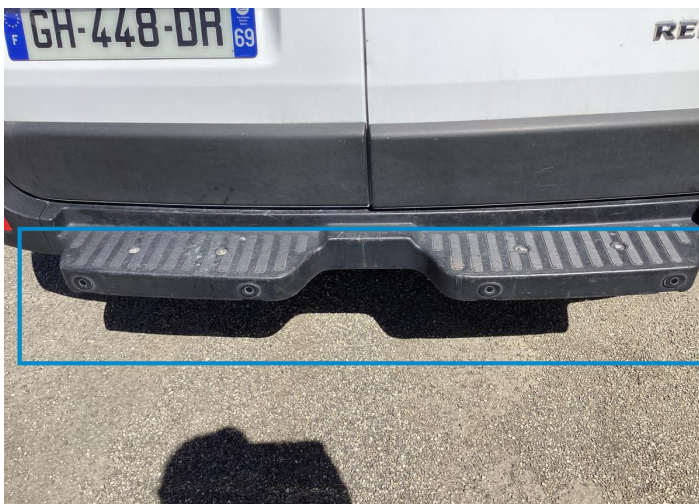
5. Bumper / Back
Paint / Scratch / Line -

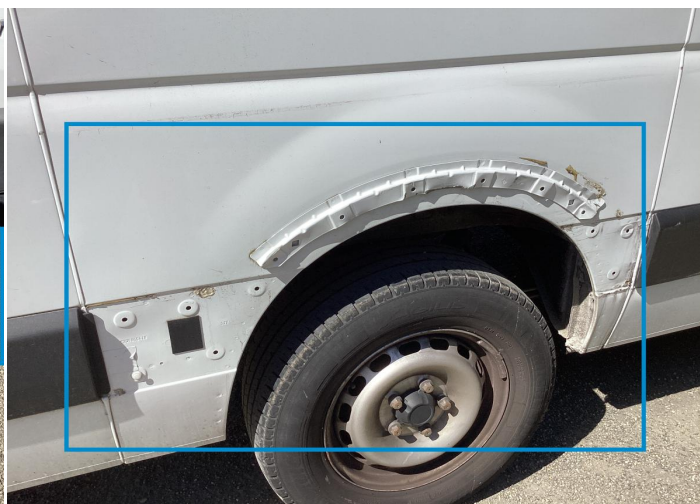
6. Wing Stick / Back Right
Missing Part -

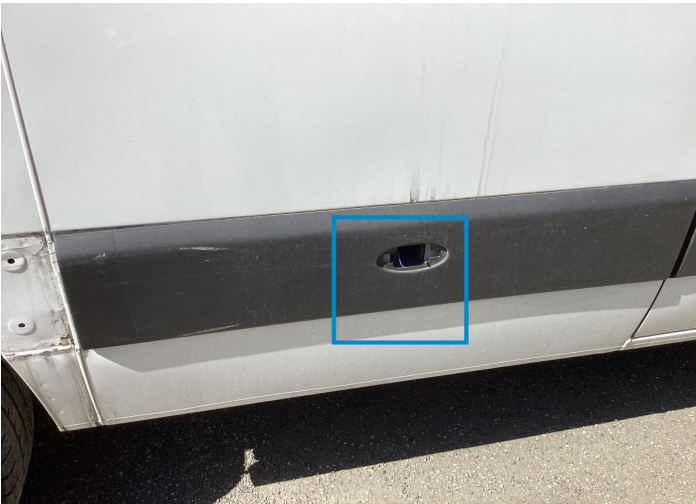
7. Vent Glass / Back Right
Missing Part -

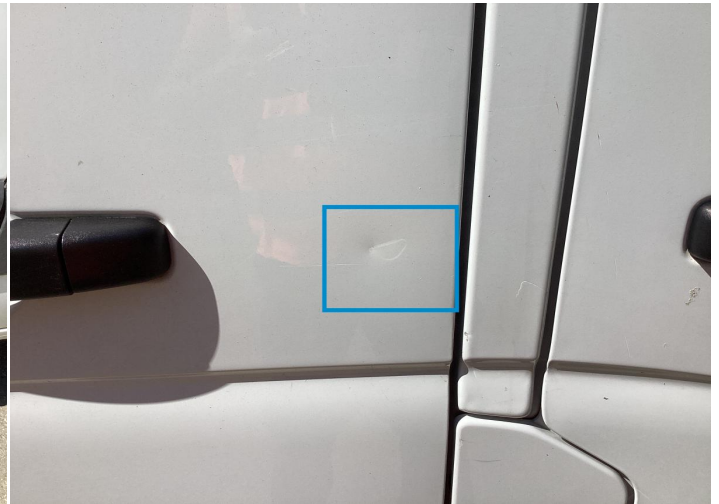
8. Side Panel
Bodywork / Dent / Deformation -

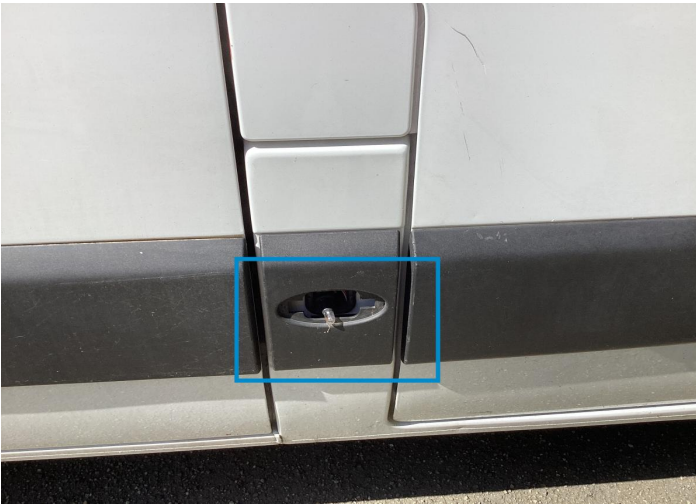
9. Door / Back Right
Missing Part -

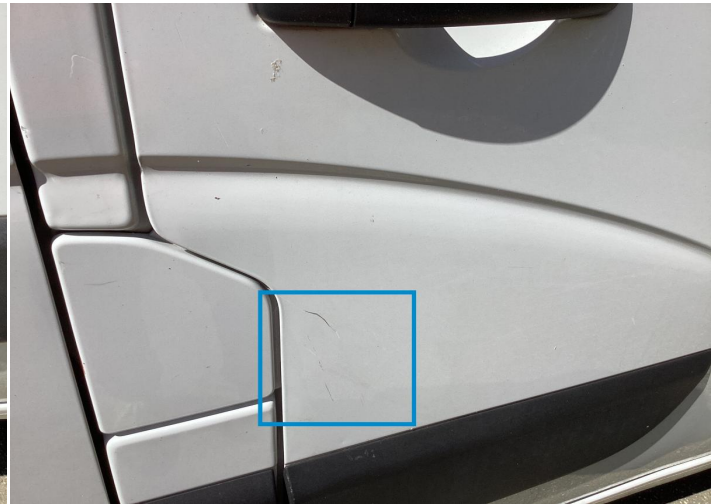
10. Door / Front Right
Paint / Scratch / Line -

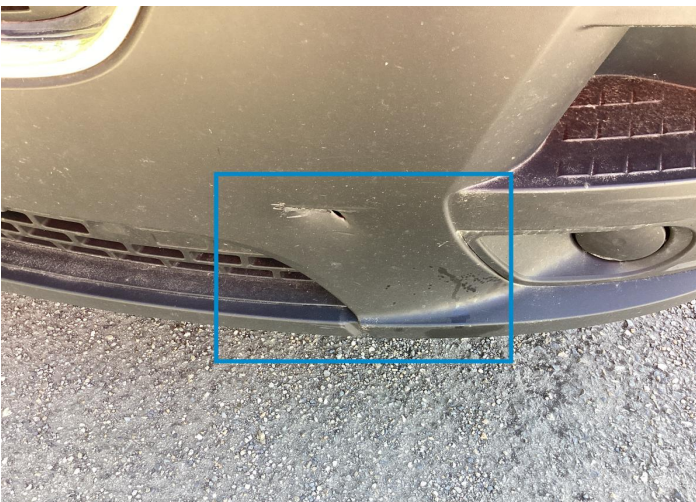
11. Bumper / Front
Bodywork / Breakage / Hole -
